2016 UNDERWATER BRIDGE INSPECTION REPORT

BRIDGE # L9571 TWP 7992 over PELICAN RIVER

Date of Inspection: 06/19/2016

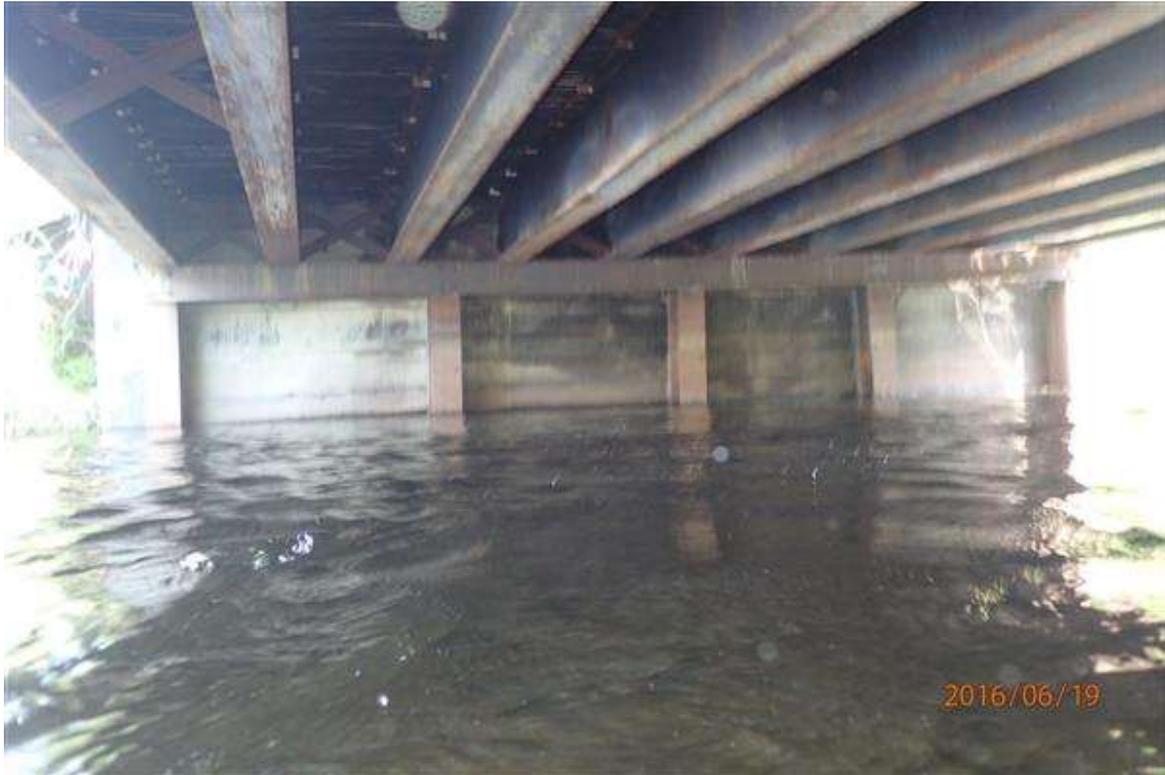
Photo 3 - Overall View of North Abutment, Looking North

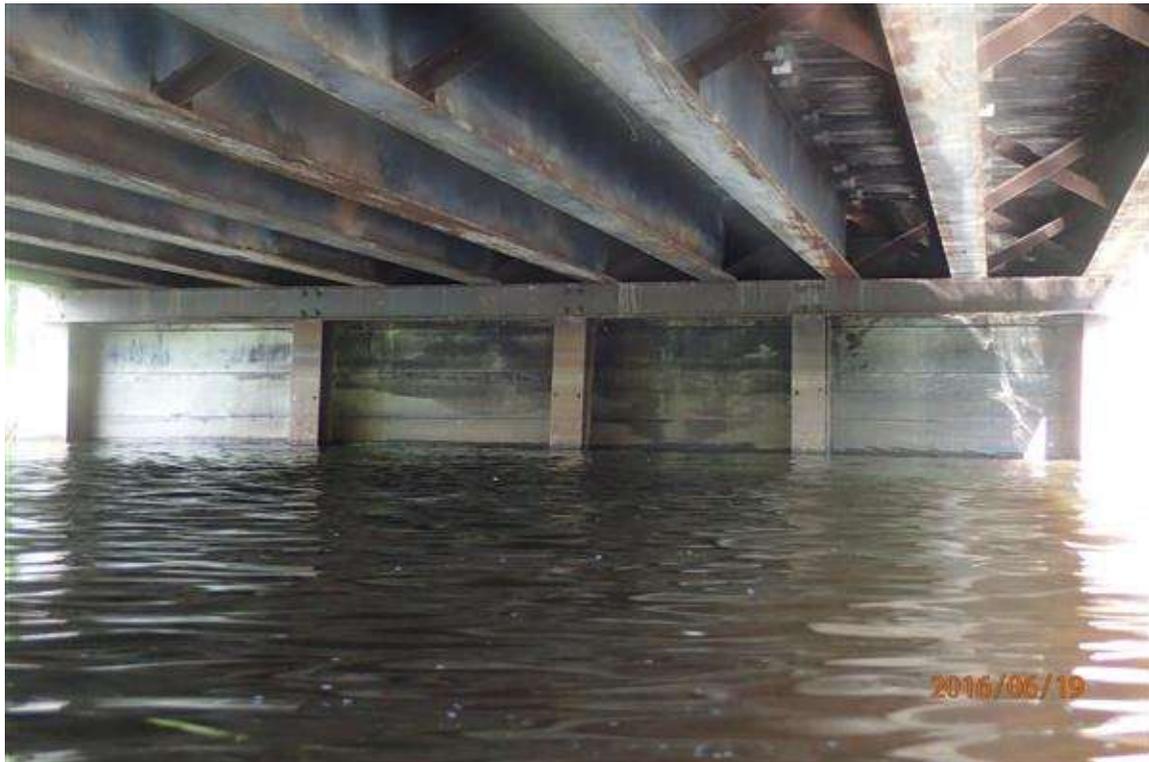
Photo 4 - Overall View of South Abutment, Looking South

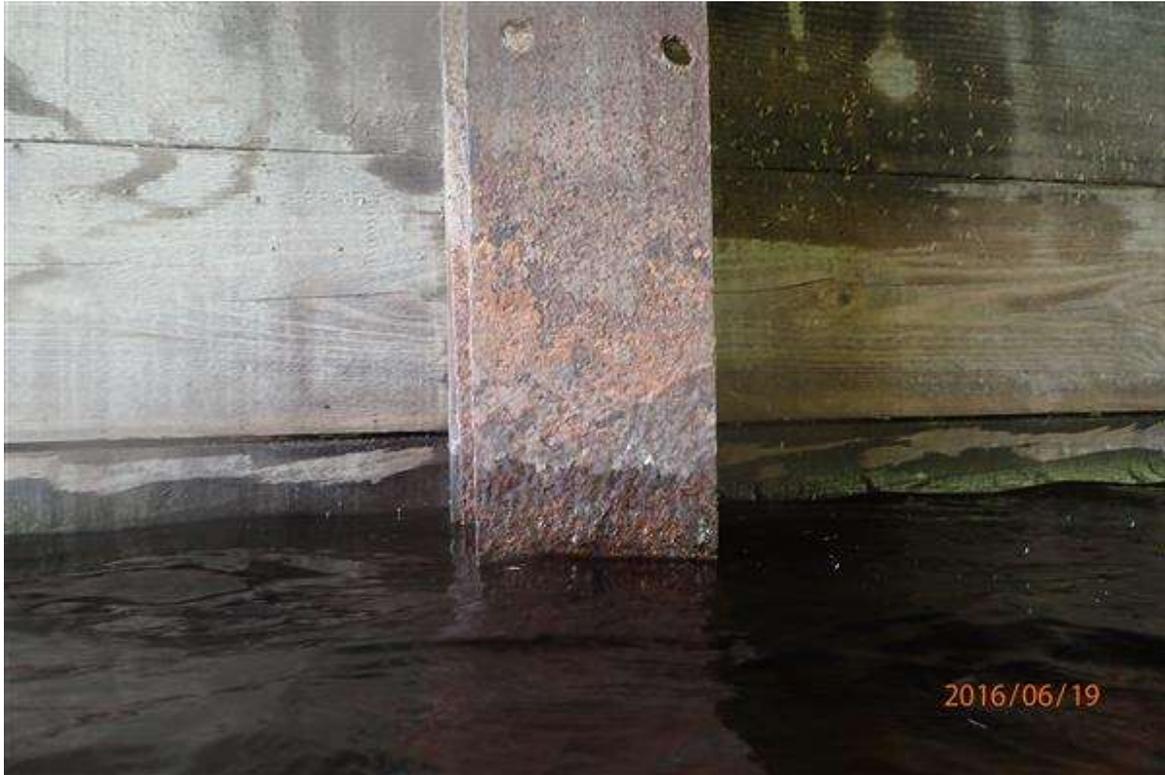
C) The steel H-Piles typically exhibited moderate corrosion with pitting up to 1/8 inch deep and rust delaminations up to 1/8 inch thick, extending from 1.5 feet above the waterline to the channel bottom.

Photo 5 - Typical Steel Condition near Waterline, Looking South

(B) Monitor the extent of corrosion and associated section loss on the steel H-Piles.

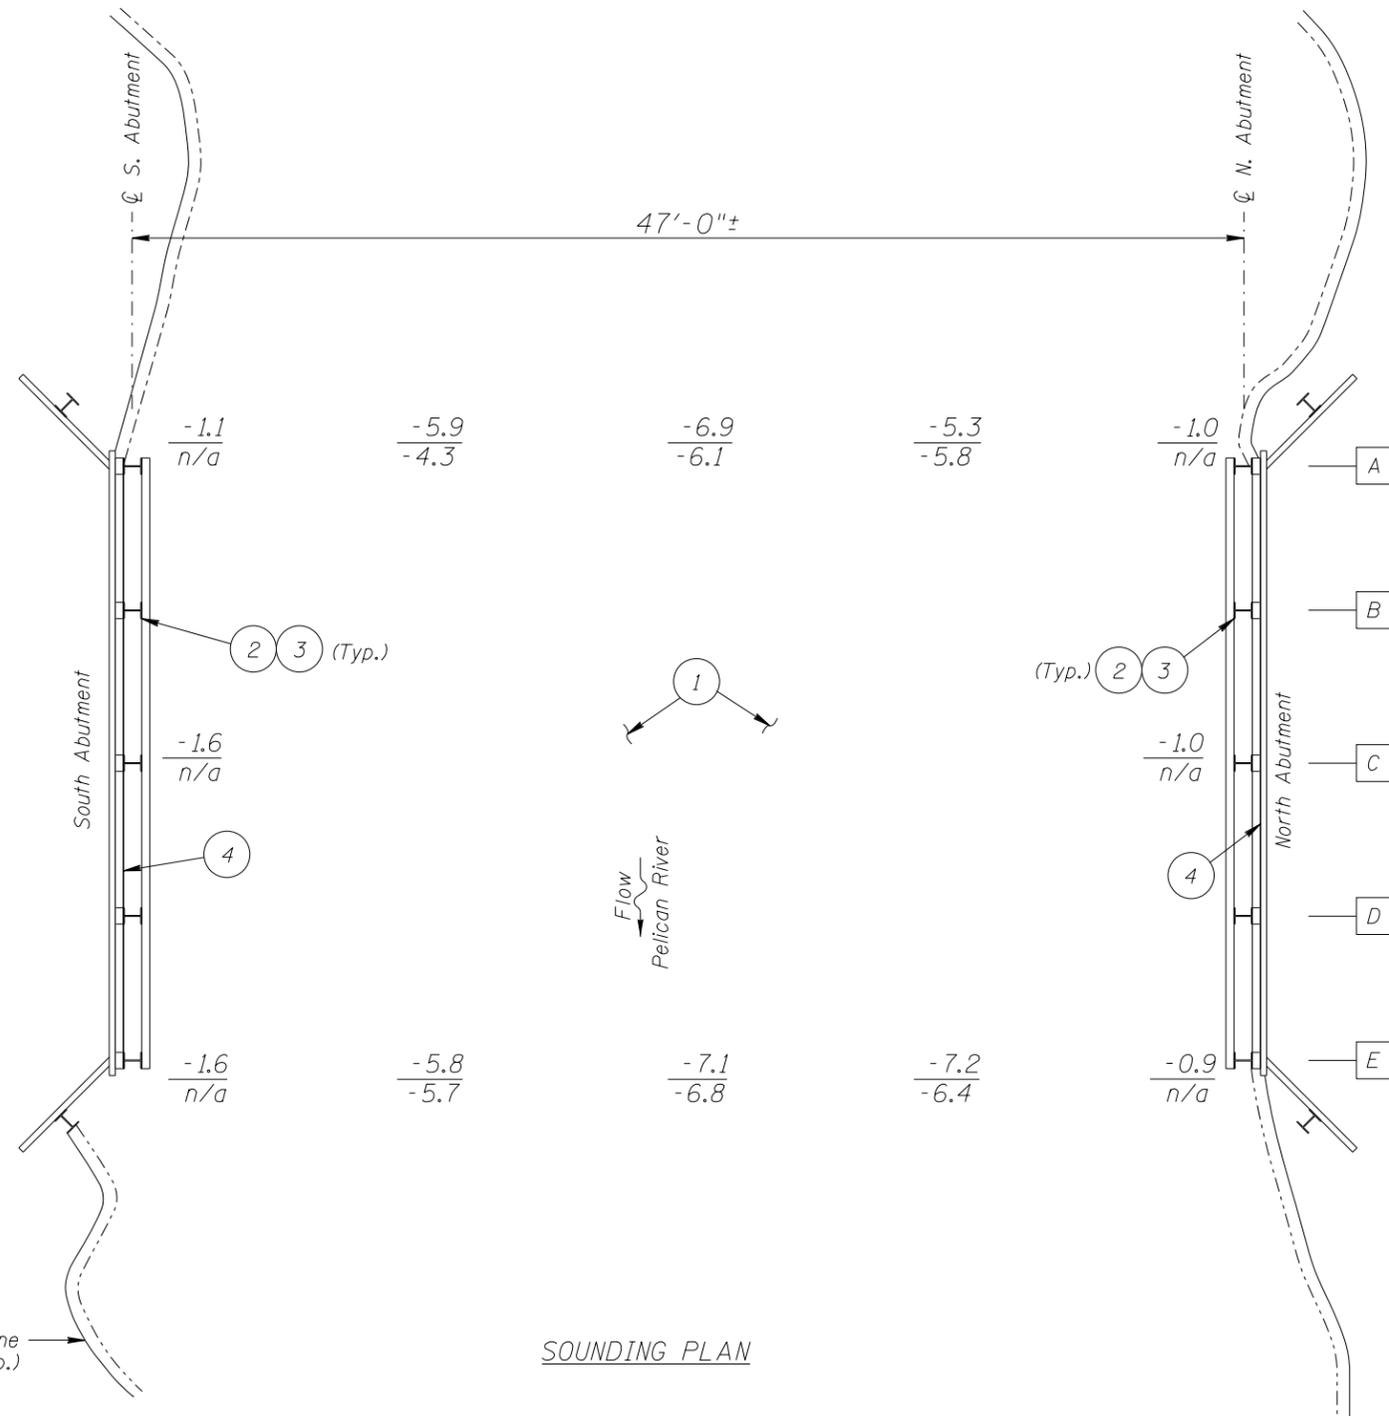
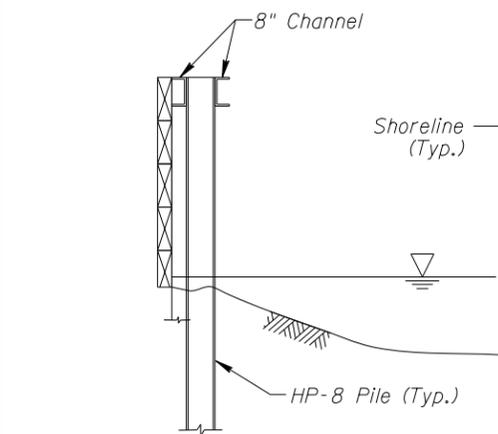
- 1 The channel bottom material typically consisted of riprap up to 2 feet in diameter with sand infill having a maximum probe rod penetration of 6 inches.
- 2 The steel H-Piles typically exhibited light surface corrosion with pitting up to 1/32 inch deep, extending from the top of the pile to 1.5 feet above the waterline.
- 3 The steel H-Piles typically exhibited moderate corrosion with pitting up to 1/8 inch deep and rust delaminations up to 1/8 inch thick, extending from 1.5 feet above the waterline to the channel bottom.
- 4 The timber backwall was typically sound and well aligned with no noticeable loss of backfill or notable defects.
