Winona Bridge Work Package #5

Bridge No. 5900 (Existing Bridge) Rehabilitation and Reconstruction

Q&A #2

This report documents the findings of the routine and fracture critical inspection of Mn/DOT Bridge No. 5900, TH 43 over the Mississippi River, Railroad and City Streets. **The inspection started on June 2, 2008 and was completed on June 5, 2008.**

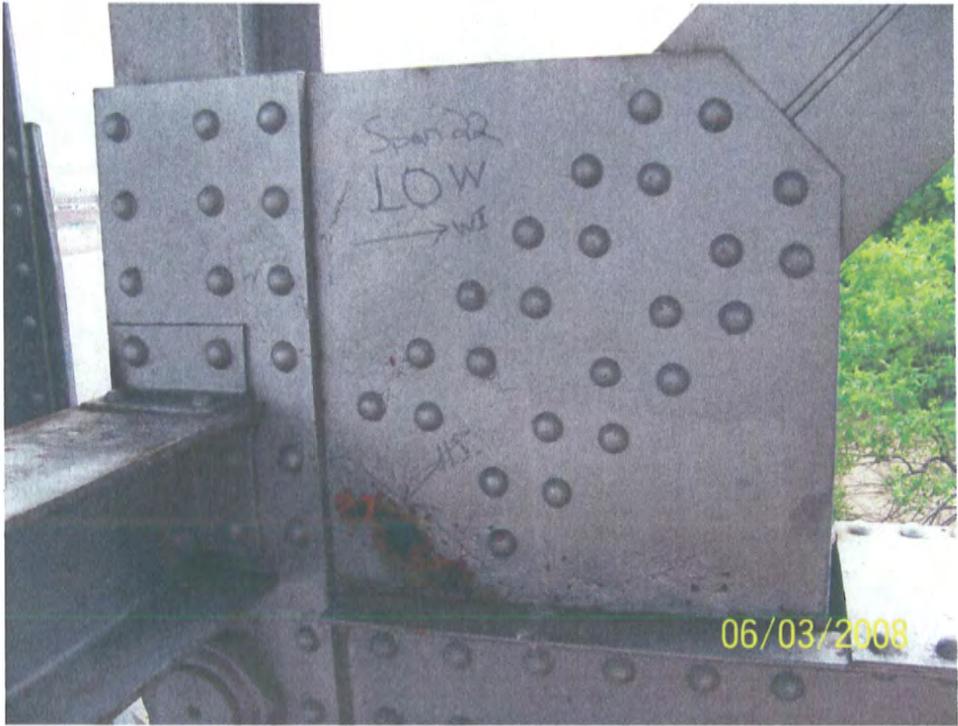
#131: Gussets at piers exhibit severe section loss in the unbraced compression area with through corrosion in most. Plate deformation in these areas is also present up to 7/16" bulging out.

Span 22 West Truss at Pier 21: Inside Gusset Through Corrosion

Recommendation: Repairs have been made (Appendix C). Continue to monitor all gusset areas for section loss and distortion during future inspections.

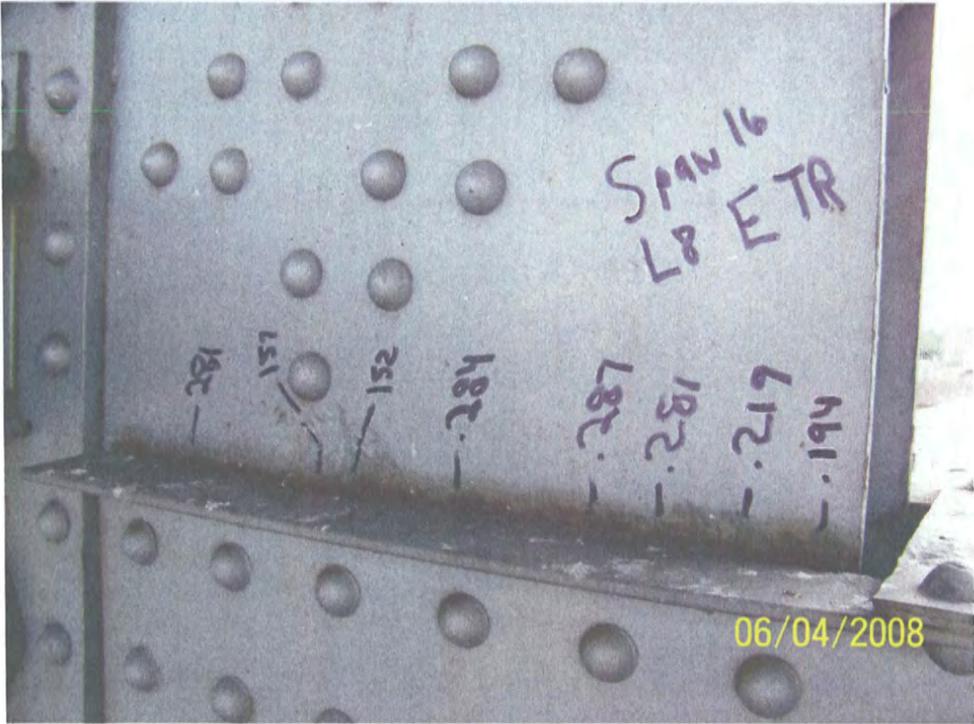
Span 16 East Truss Pier 16: Inside Gusset Ultrasonic Shear Zone Measurements

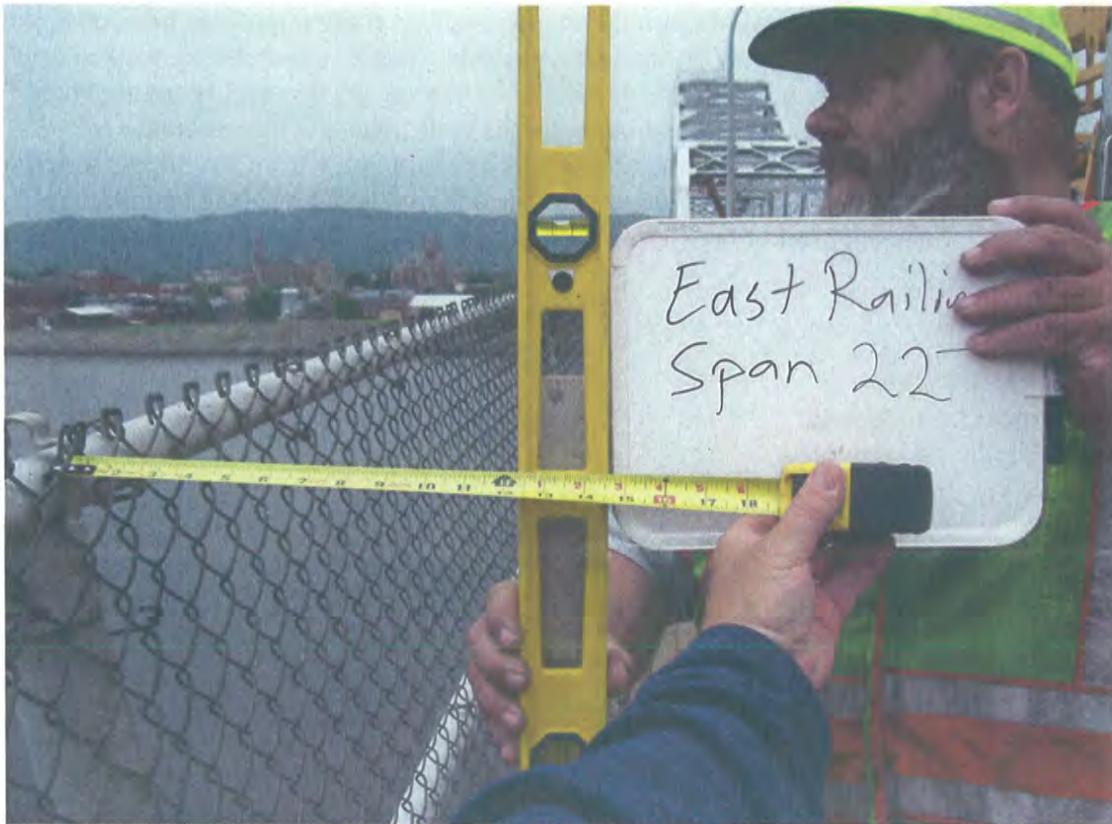
Span 22 Chain Link Fence Bowed Outward 12 Inches

Recommendation: Repairs have been made.

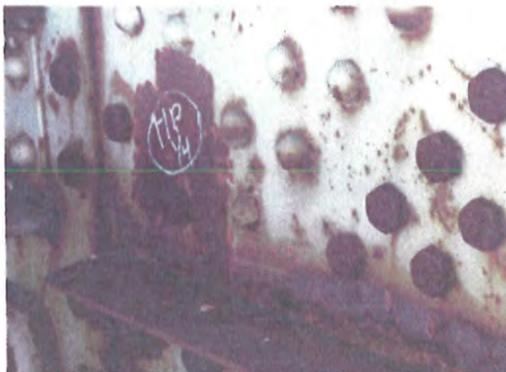
Picture 11: Span 21 East Truss L8 Inside
Plate Hole by Repair

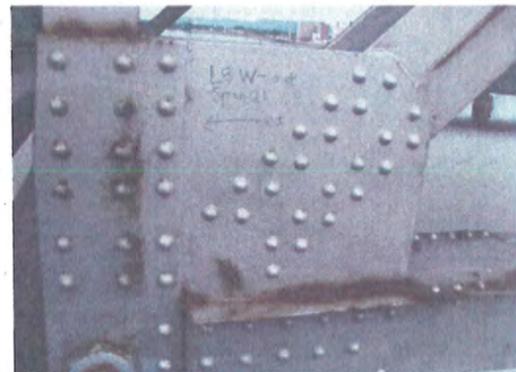
Picture 12: Span 21 West Truss L8 Outside
Plate Hole in Compression Zone

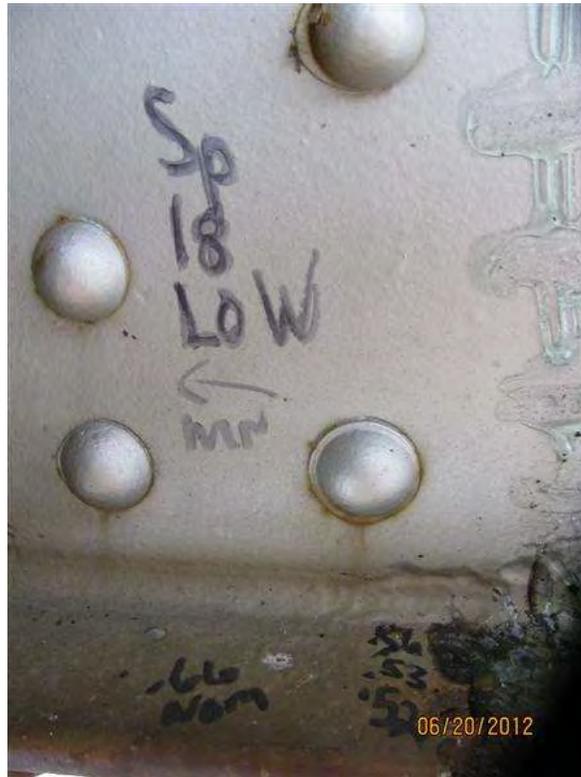
Photo 1 - Span 18 LOW Inside Channel Bottom Flange Losses at LOW

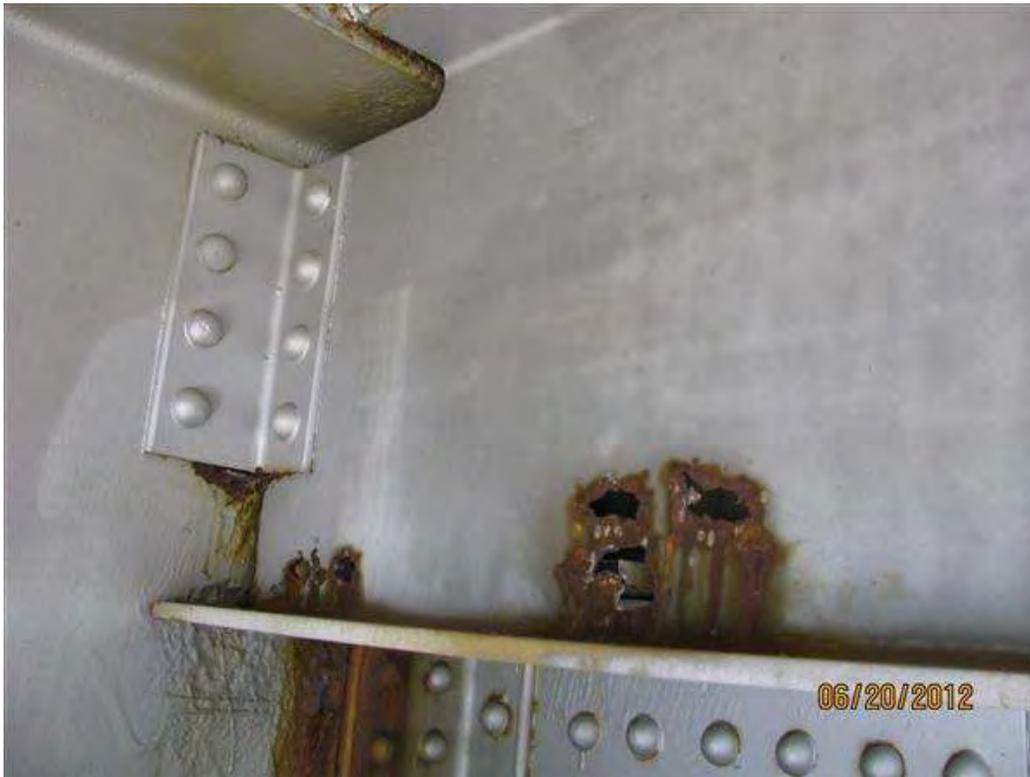
Photo 7 - Span 19 Stringer 1 Web Through Corrosion at L12W North

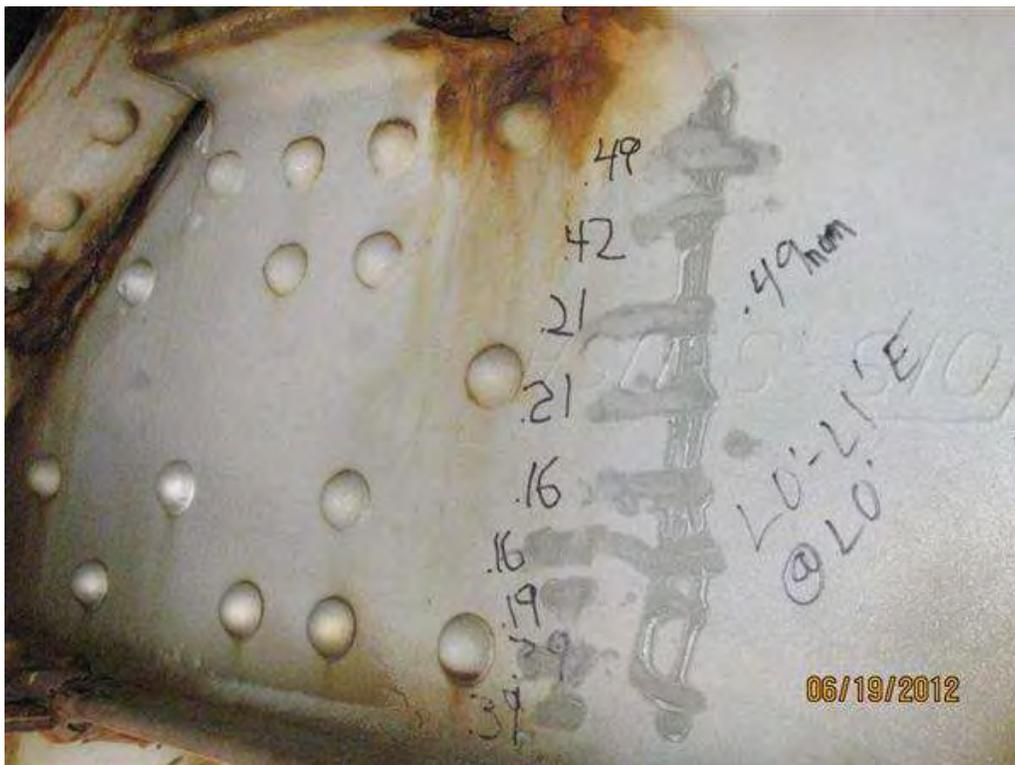
Photo 8 - Span 20 SL on Int web @ L0' down to .16 in

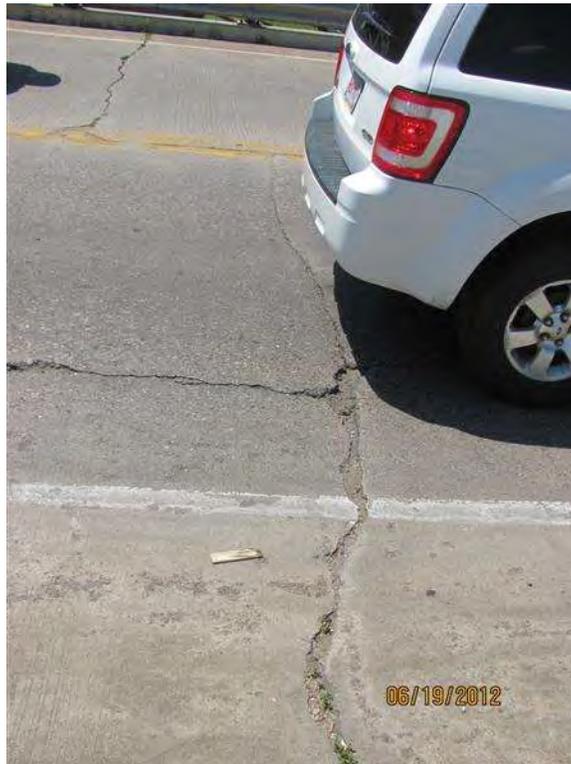
Photo 10 - South Approach Cracking and Spalls

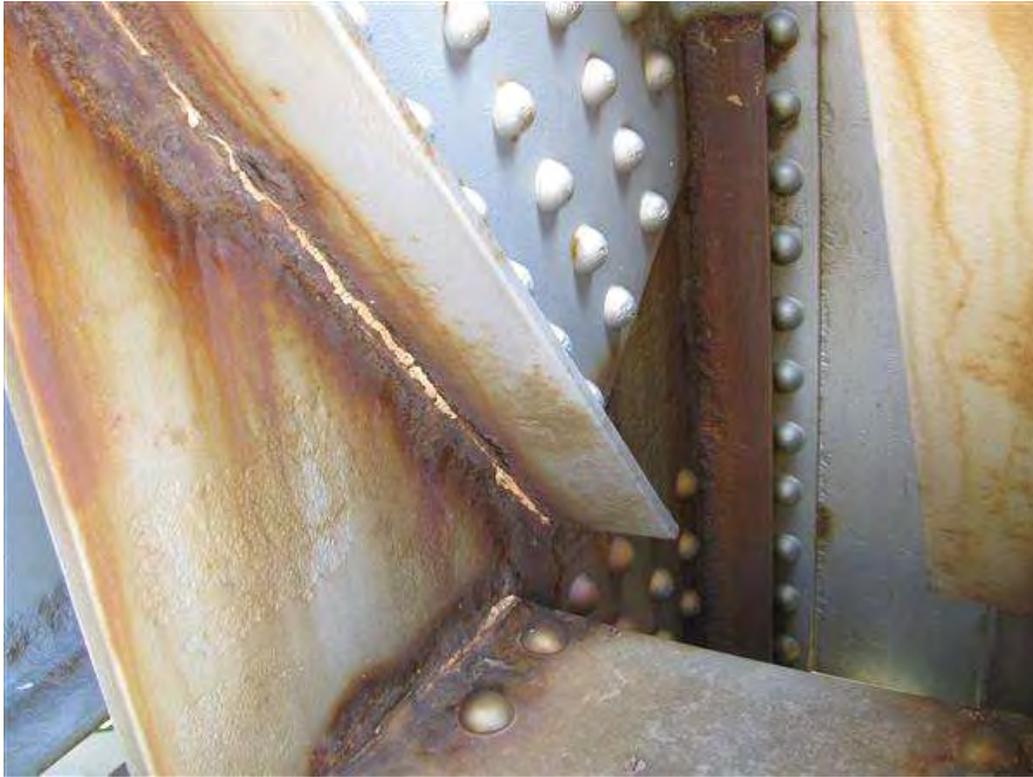
Photo 55 - 55 Span 18 L4W Inside Interior Plate North Corrosion

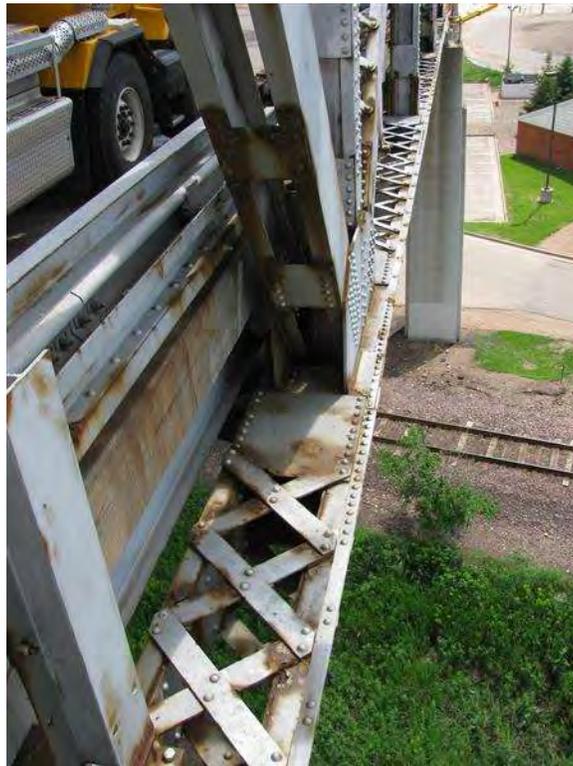
Photo 56 - 56 Span 18 L4-U5W Typical Corrosion

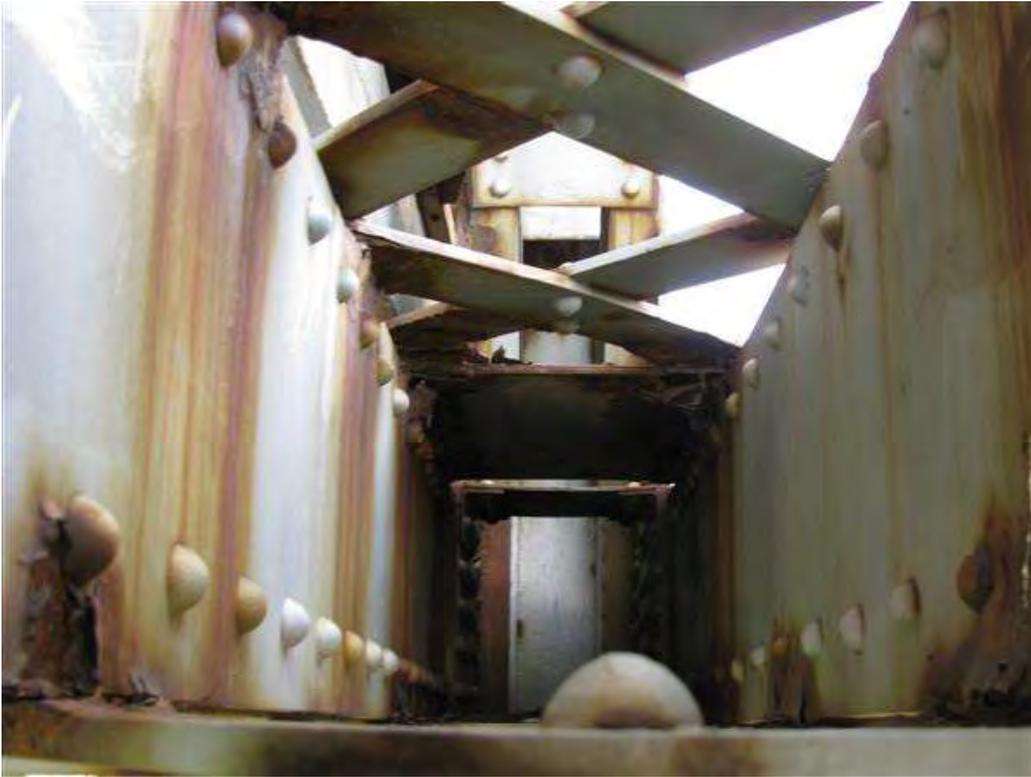
Photo 57 - 57 Span 18L4-L5W Between Bottom Chord Channel Corrosion and Pack Rust Typical Looking South

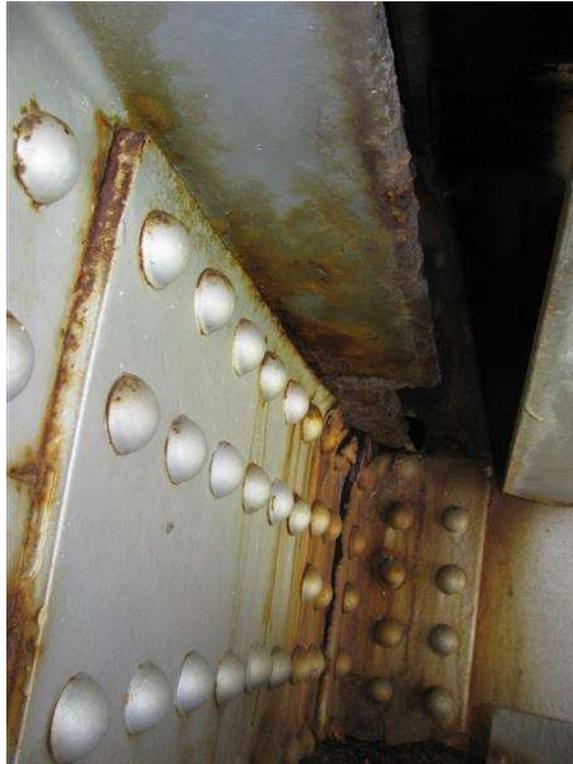
Photo 58 - 58 Span 18 L5-L6E Interior Channel Corrosion at L6E North

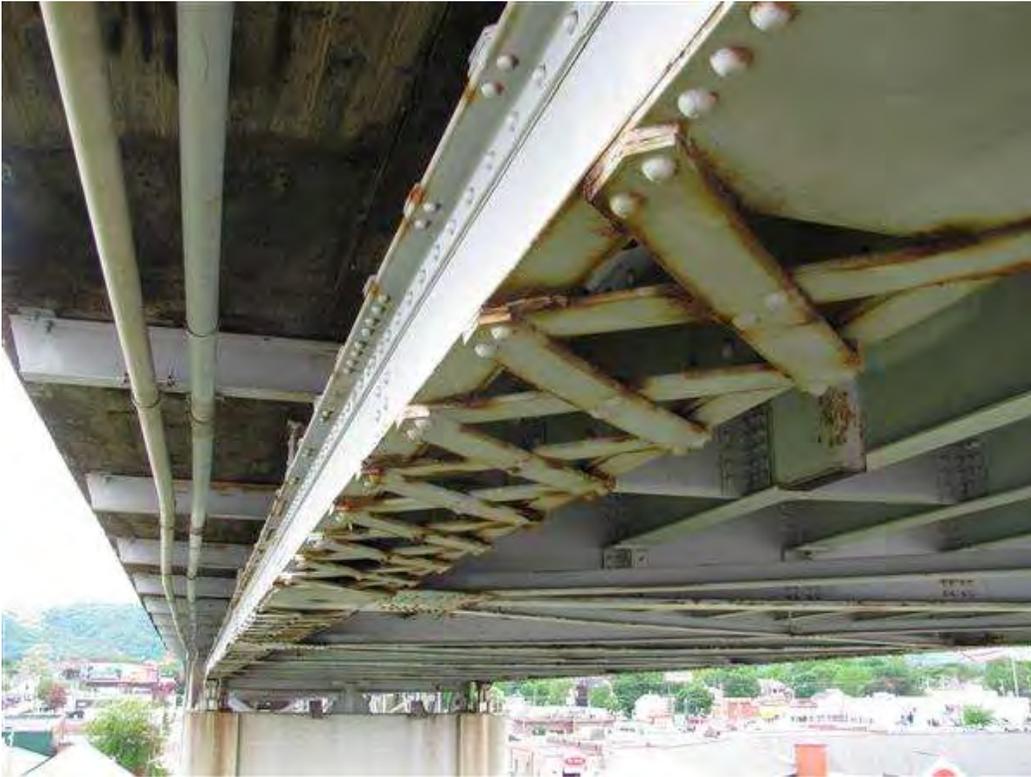
Photo 59 - 59 Span 18 L5-L6E Bottom Chord Corrosion and Pack Rust Looking South

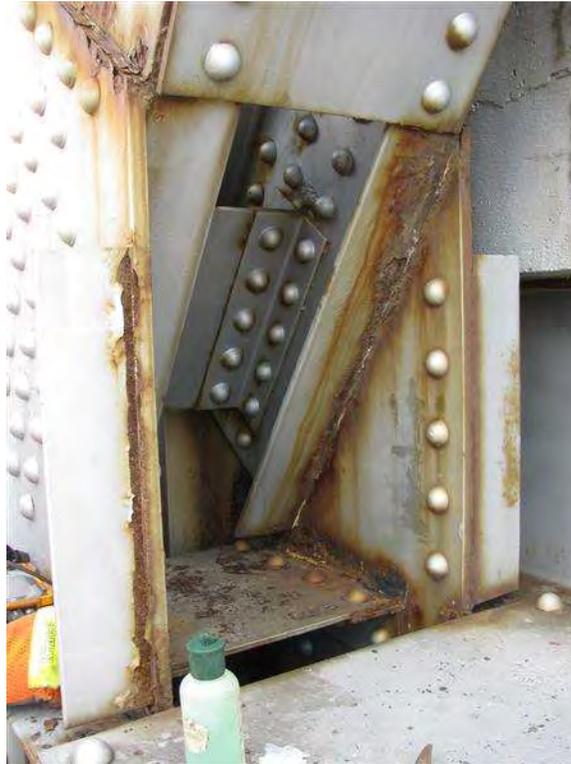
Photo 60 - 60 Span 18 L6W Inside Interior Plate South Losses

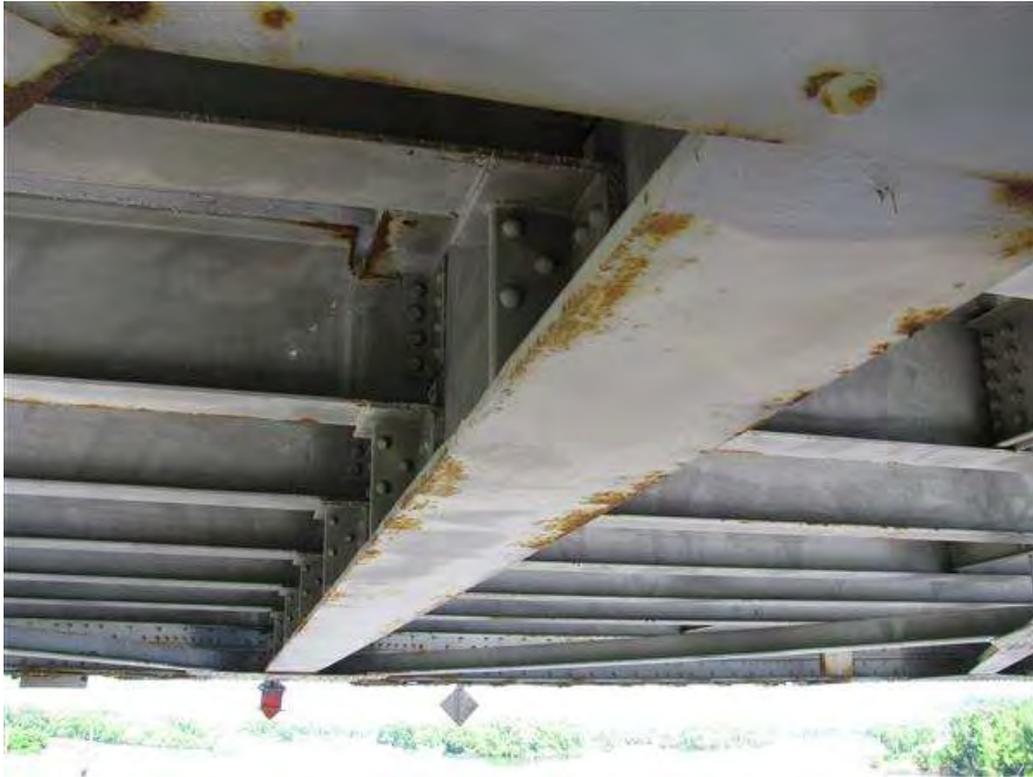
Photo 101 - 101 Span 19 FB 11 Bottom Flange Corrosion

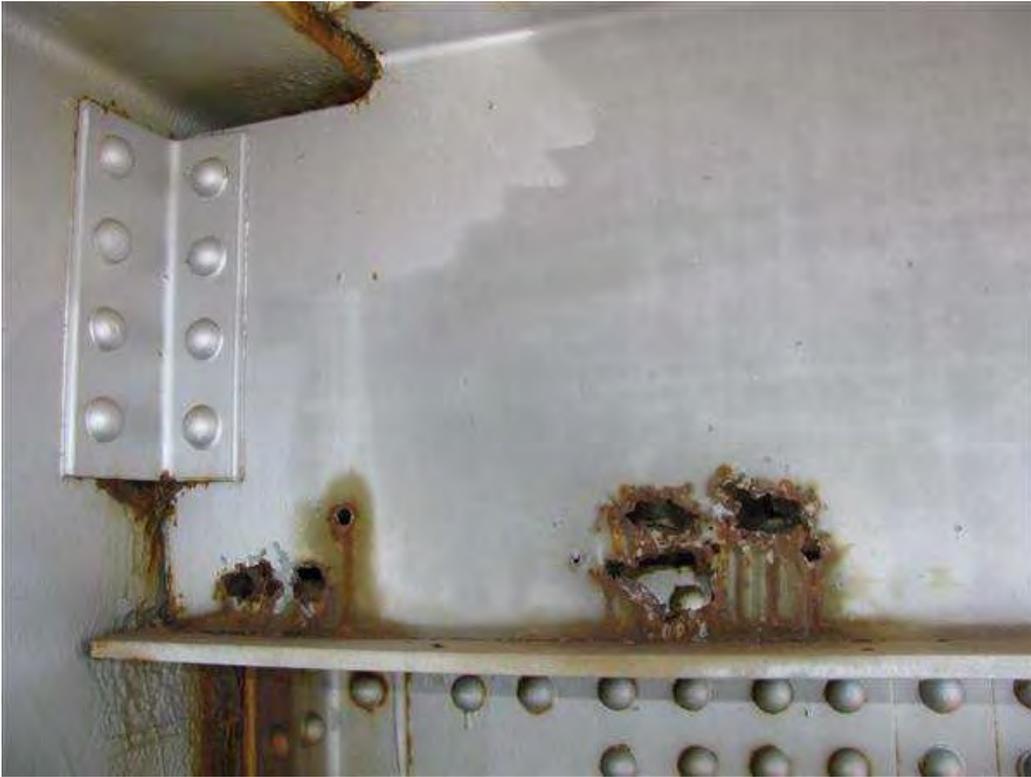
Photo 1 - Span 19 Stringer 1 Web Through Corrosion at L12W

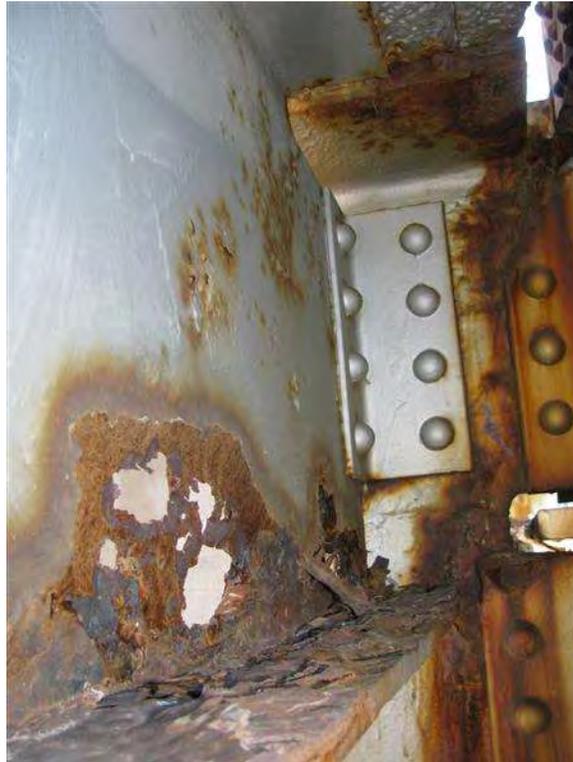
Photo 2 - Span 19 Stringer 1 Web Through Corrosion at L12W

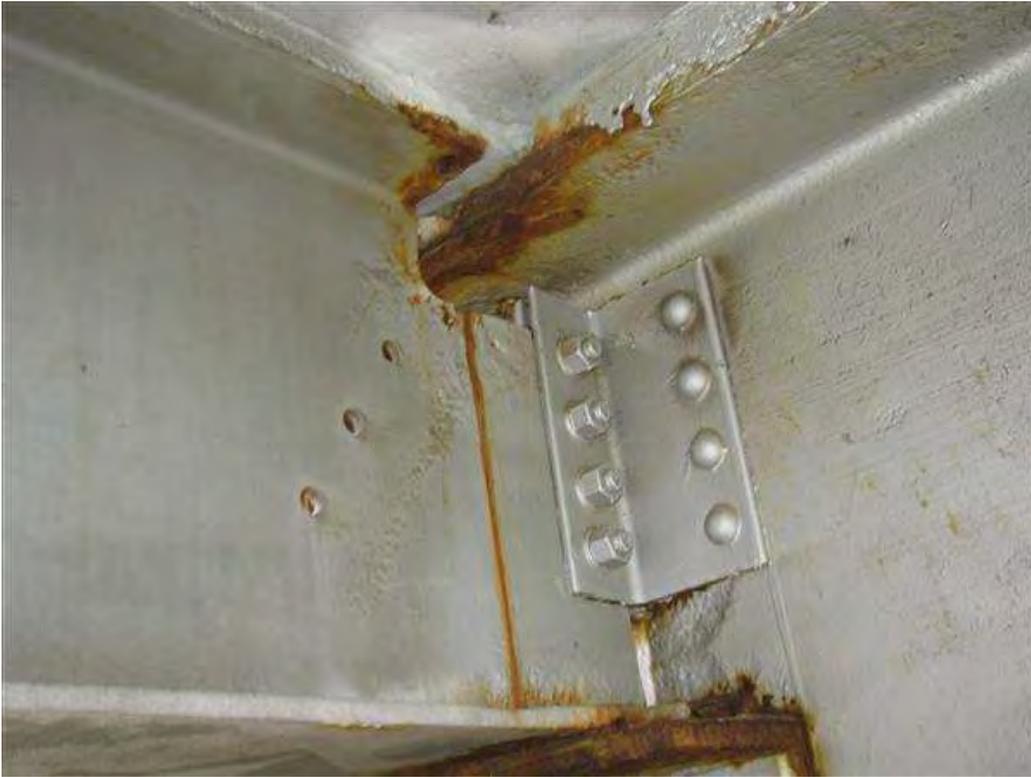
Photo 3 - Span 18 Stringer 1 at L8W Through Corrosion

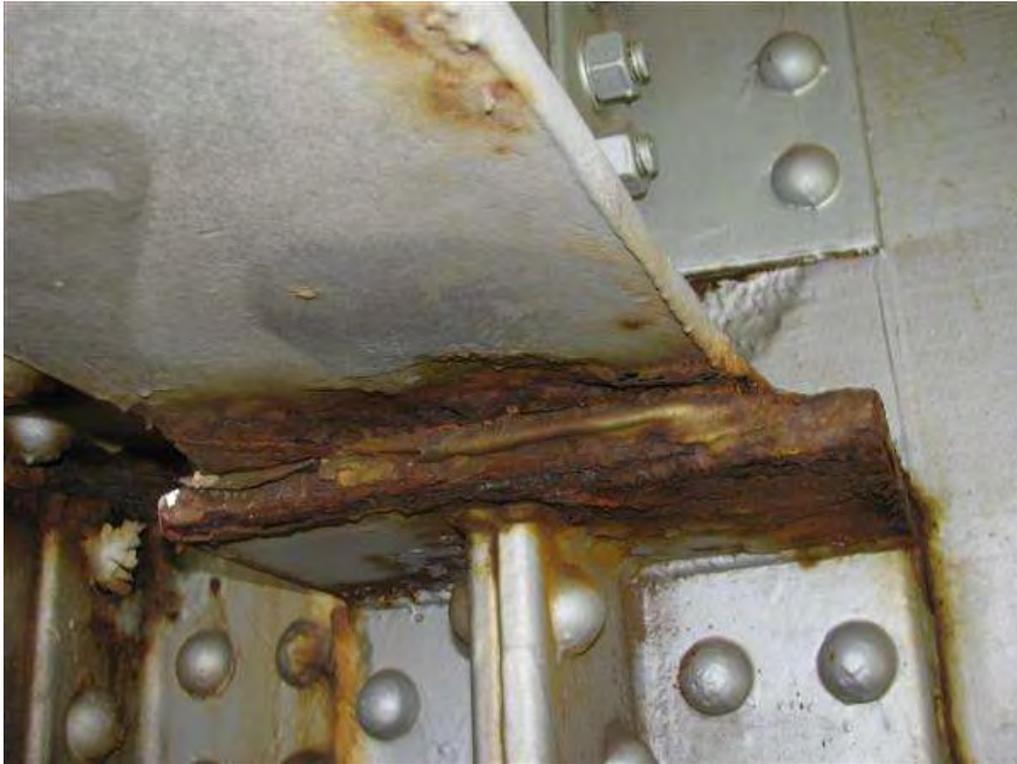
Photo 4 - Span 18 Stringer 1 at L8W Bottom Flange Losses

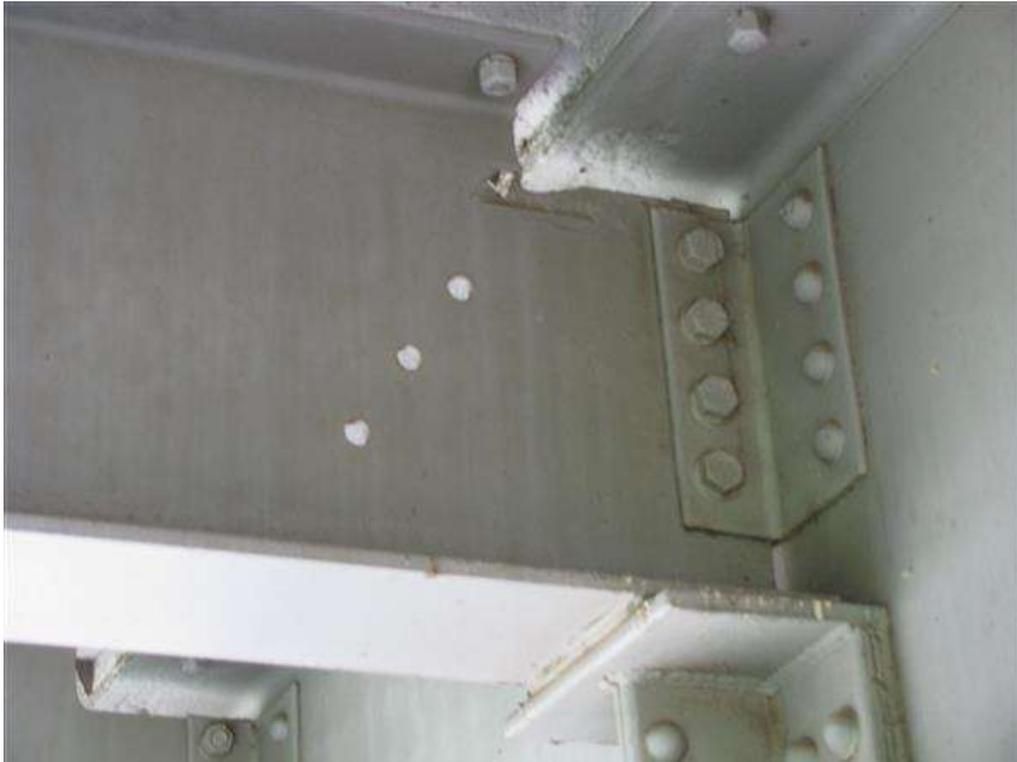
Photo 6 - Span 18 Stringer 6 Cope Through Corrosion at L8E

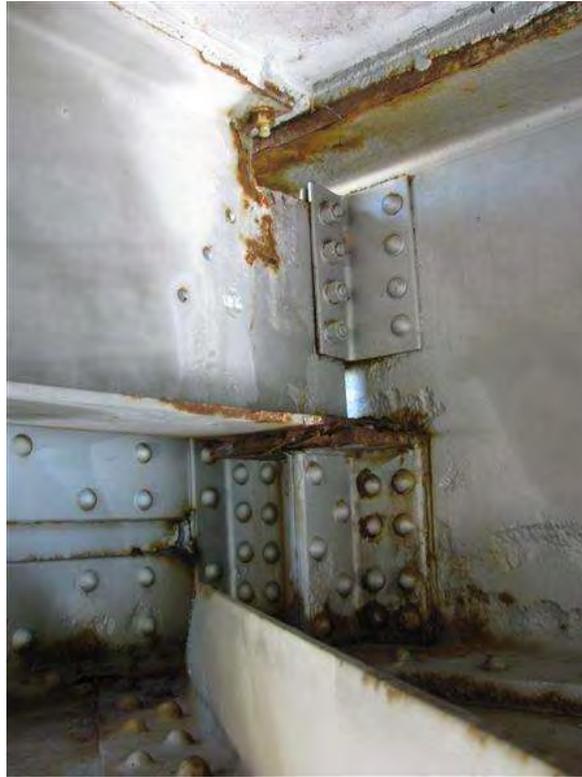
Photo 7 - Span 19 Stringer 1 Corrosion at FB11

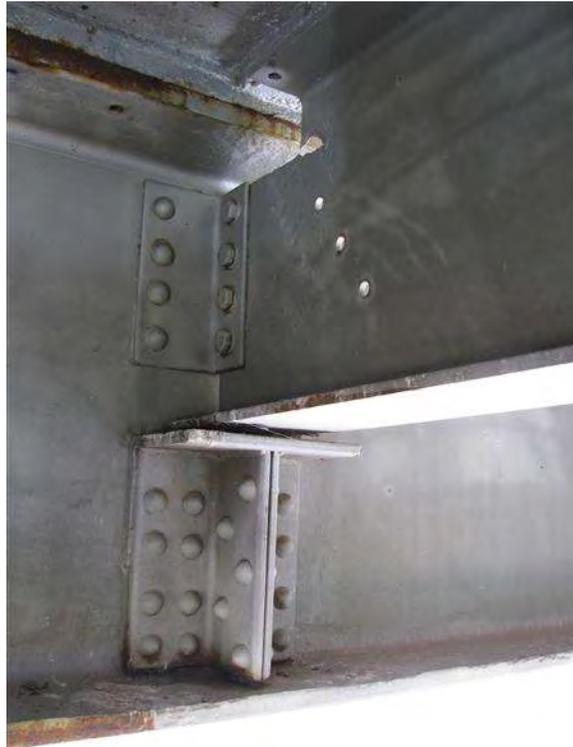
Photo 8 - Span 19 Stringer 2 Through Corrosion at FB11

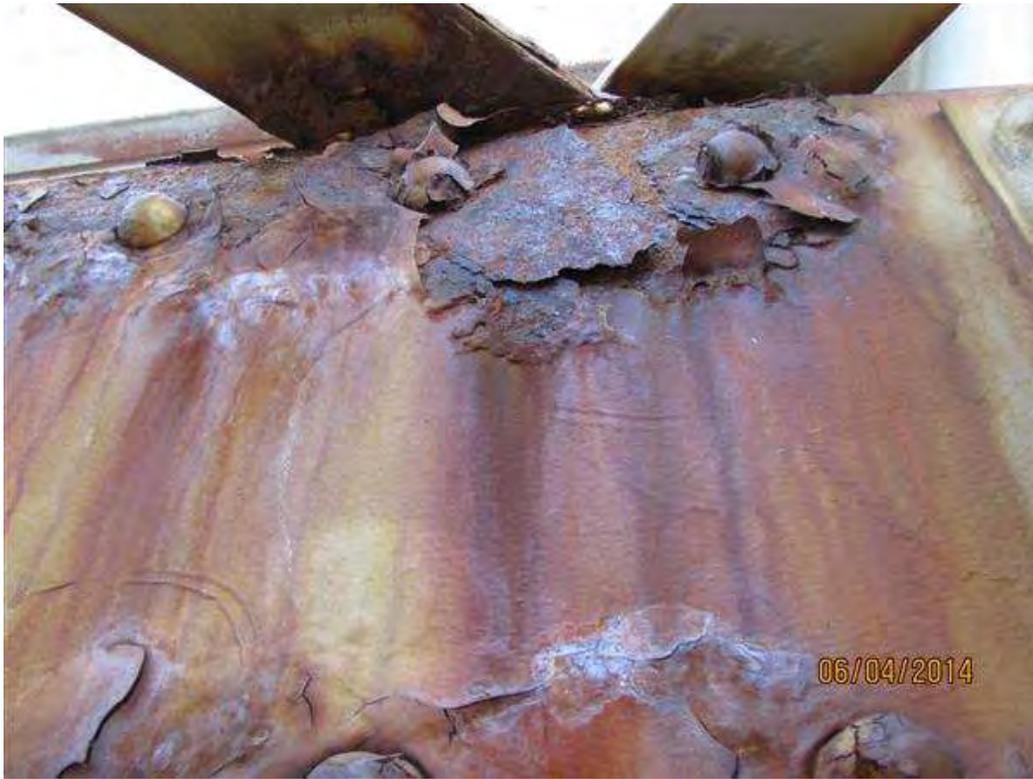
Photo 23 - Span19 L12'W-L13'W TYP Interior Web Pitting & PR

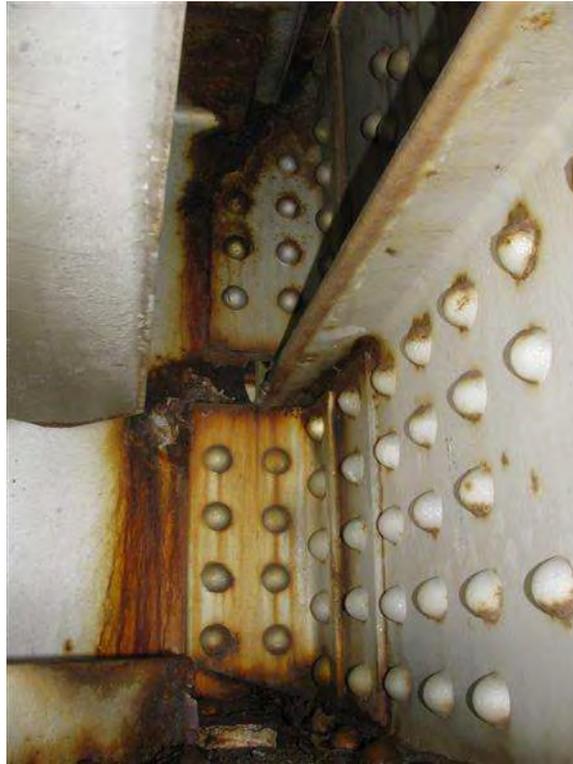
Photo 24 - Span 18 FB2 Extensive Corrosion at L2E South

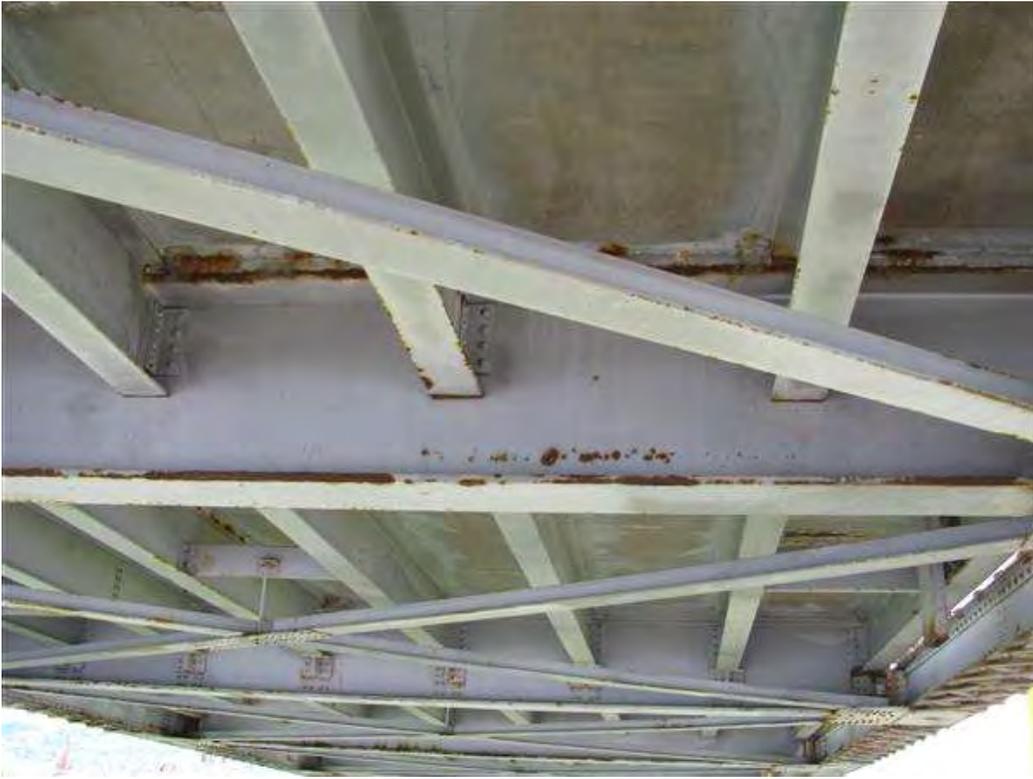
Photo 27 - Span 18 FB6 Extensive Surface Corrosion

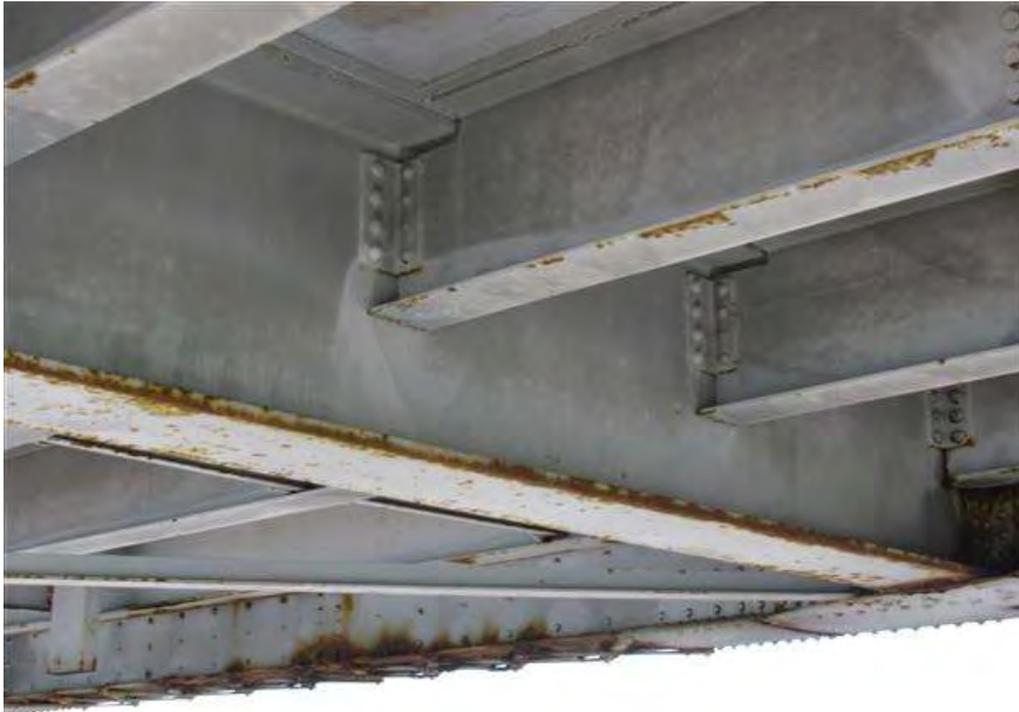
Photo 28 - Span 19 FB17 Bottom Flange Corrosion

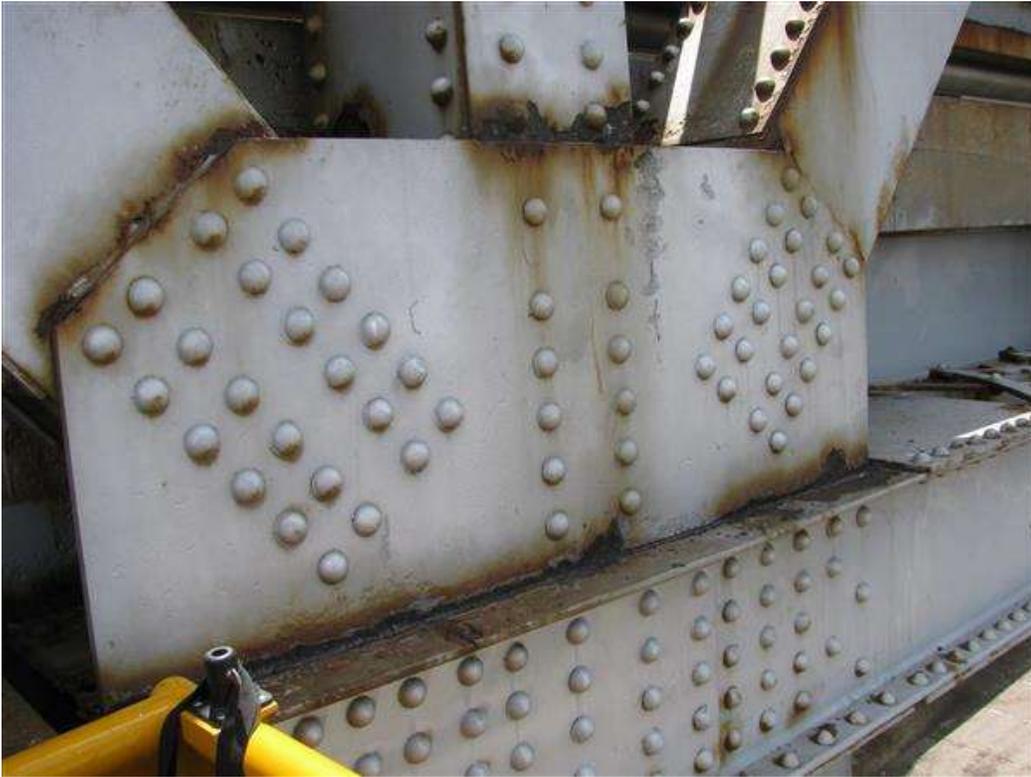
Photo 29 - Span 18 L2W Exterior Plate Corrosion Losses

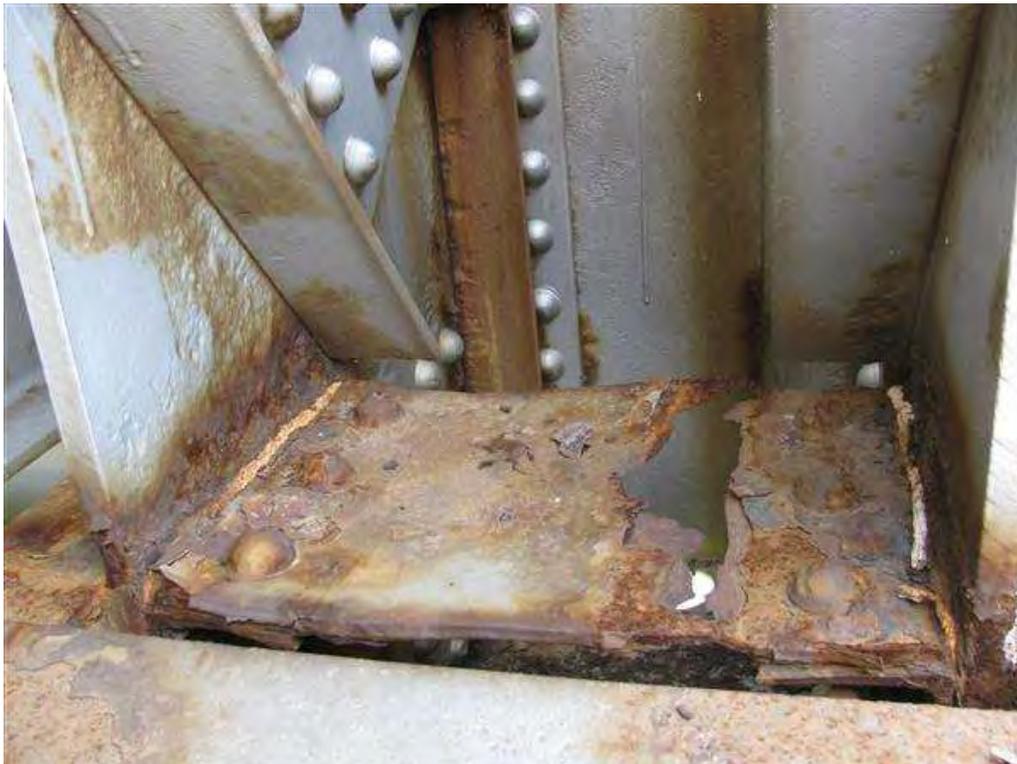
Photo 30 - Span 18 L2W Batten Between Plates North Through Corrosion

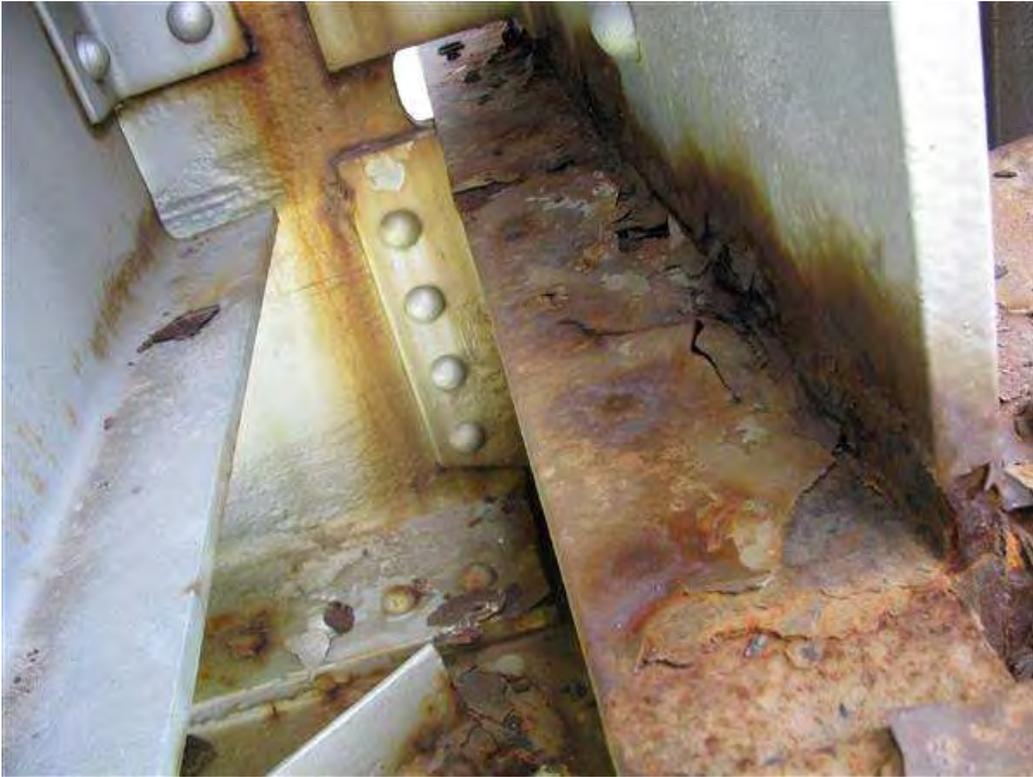
Photo 31 - Span 18 L2W Interior Plate North Horizontal Shear Losses

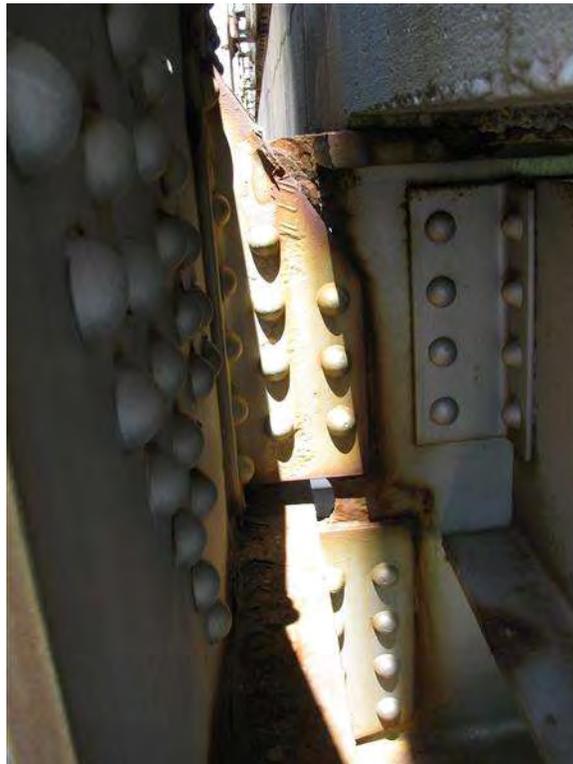
Photo 32 - Span 18 L4W Inside Plate South Corrosion

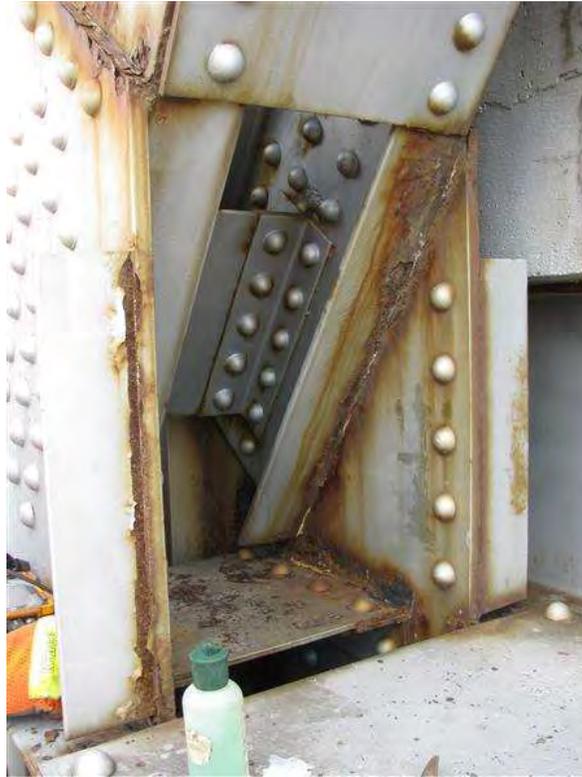
Photo 33 - Span 18 L6W Inside Interior Plate South Losses

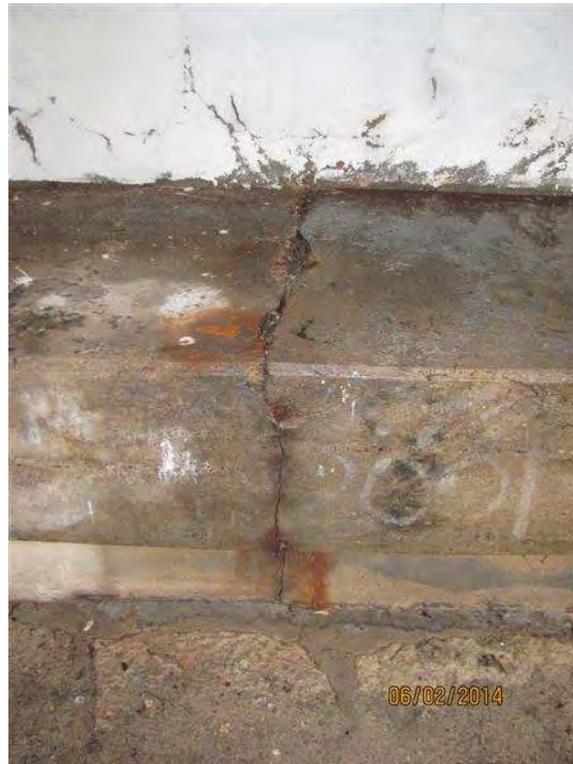
Photo 36 - North Abutment Crack Under Stringer 5

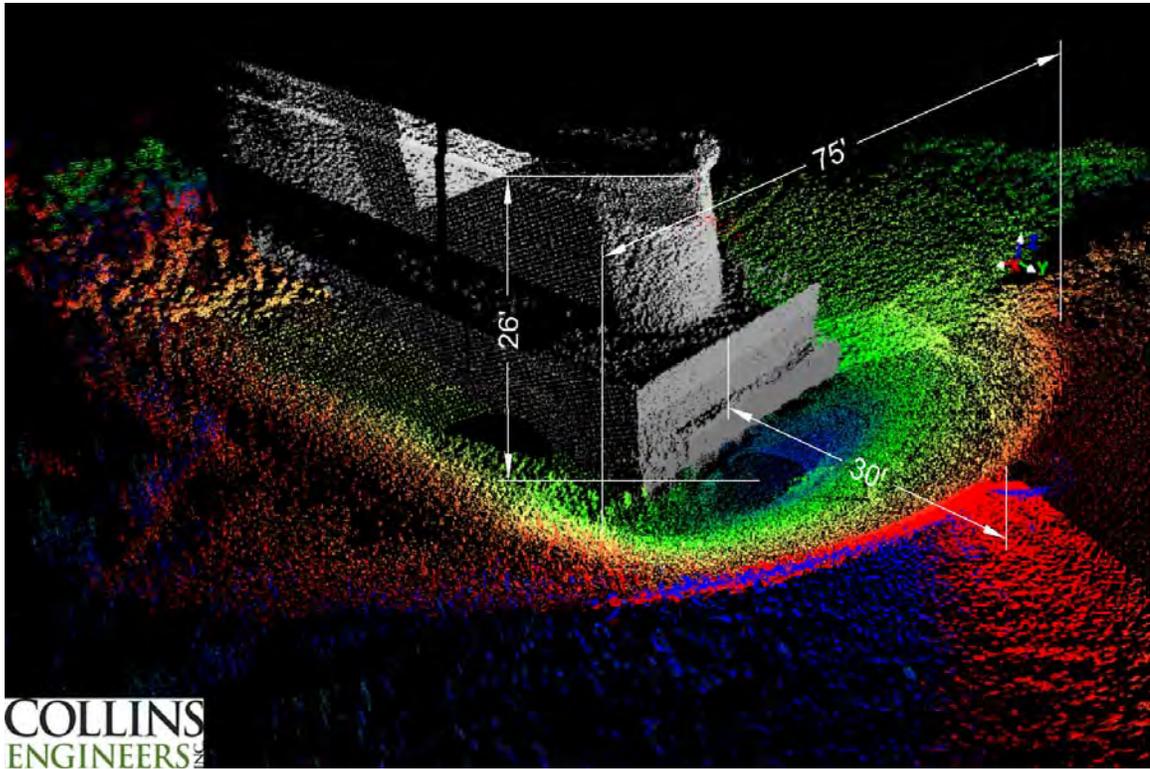
Acoustic Image 1. Scour depression at upstream nose of Pier 19, Looking South.

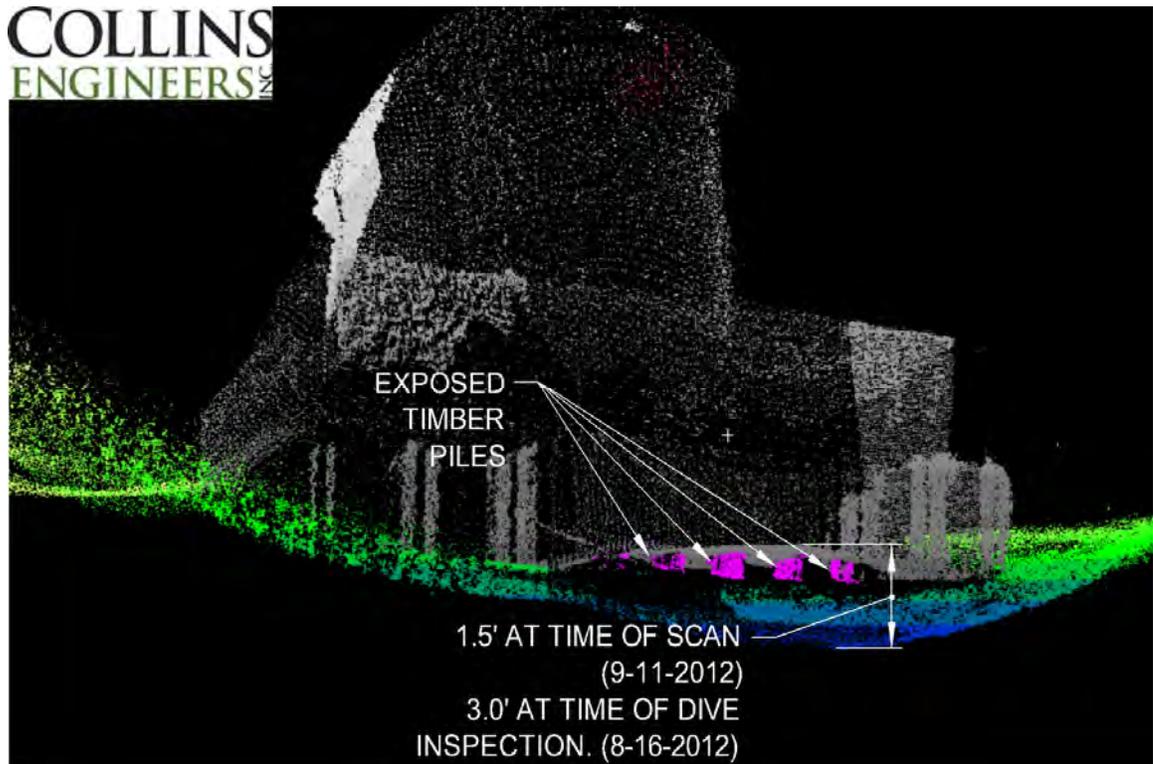
Acoustic Image 2. Undermined seal with exposed timber piles at the upstream nose of Pier 19, Looking South.
