UNDERWATER BRIDGE INSPECTION REPORT

STRUCTURE NO. 2440

MISSISSIPPI RIVER

JOB NO. 5473

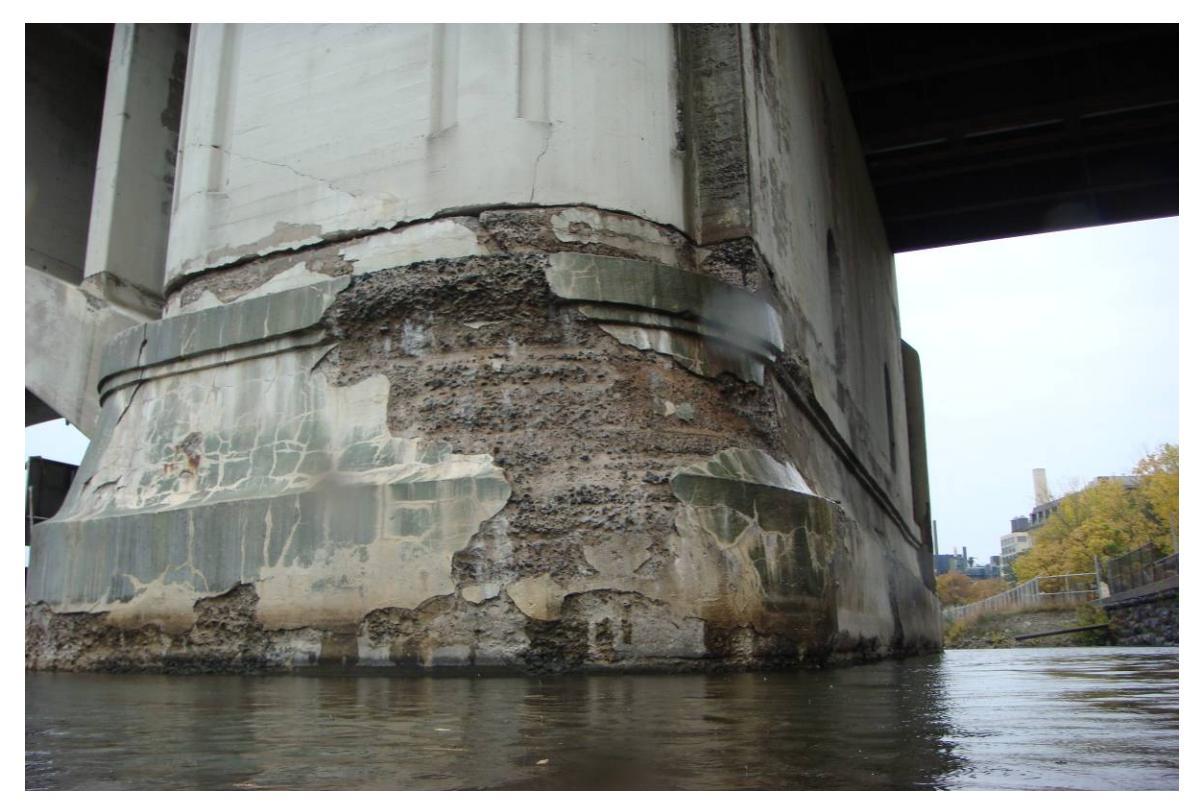
- (A) The concrete of Piers 1 and 2 exhibited widespread spalling and loss of section with typical penetrations of 6 inches to 1 foot and maximum penetrations at times reaching 2 feet. The deterioration was typically concentrated from 2 feet below to 4 feet above the waterline.
- (B) The footing at Pier 1 was exposed along the west face of the pier with 2 to 3 feet of vertical exposure. The concrete of the footing also exhibited moderate to heavy deterioration with 6 inch to 2 foot penetrations.
- (C) The footing at Pier 2 was exposed around the upstream and downstream nose with 3 to 4 feet of vertical exposure.
- (D) The concrete of Pier 5 exhibited random minor deterioration with 2 to 3 inch penetration.

Photograph 3. View of Pier 1, Looking Southeast.

- (A) The extent of concrete deterioration at Piers 1 and 2 does not pose an immediate threat to the structural integrity of those piers at this time, given the overall size of the piers. However, consideration should be given to repairing the deteriorated areas by removing all unsound concrete and replacing with new concrete designed to provide high durability and low permeability.

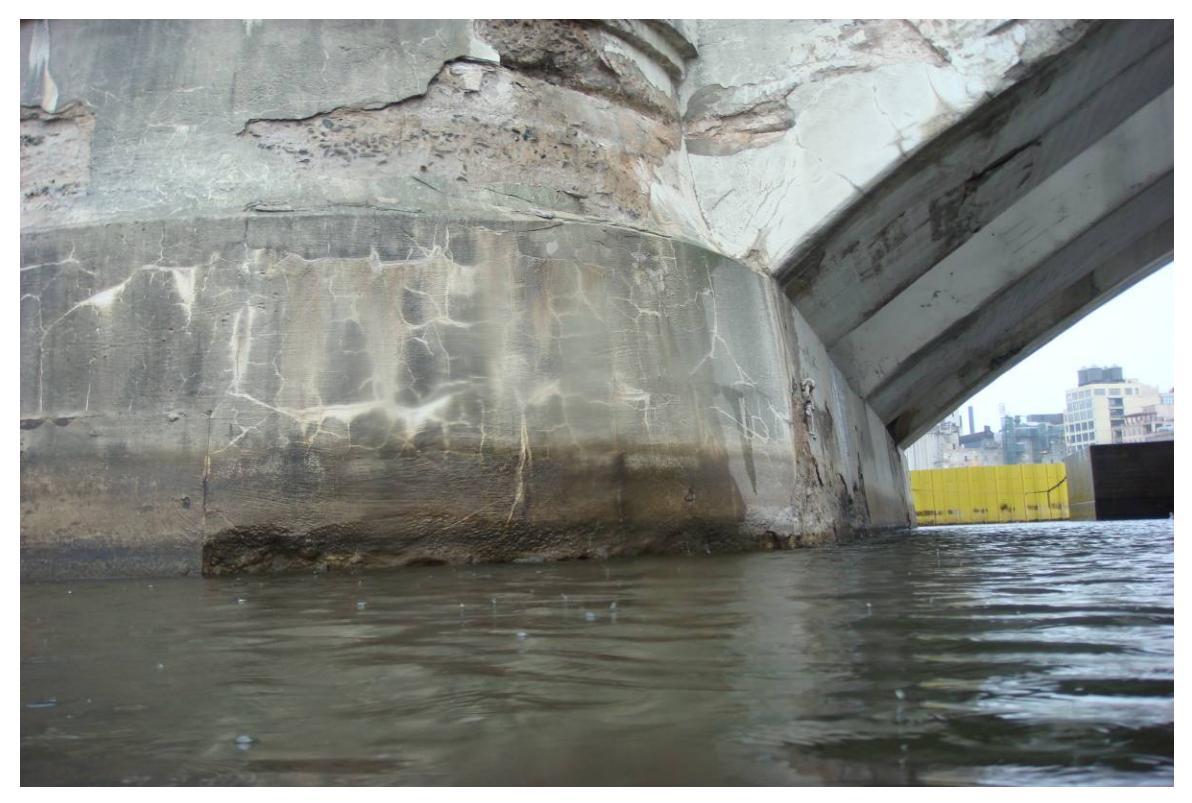
Photograph 4. View of Pier 2, Looking Southeast.

- The concrete of Pier 2 exhibited widespread spalling and loss of section with 6 inches to 1 foot deep penetrations, typically extending from 2 feet below to 4 feet above the waterline.

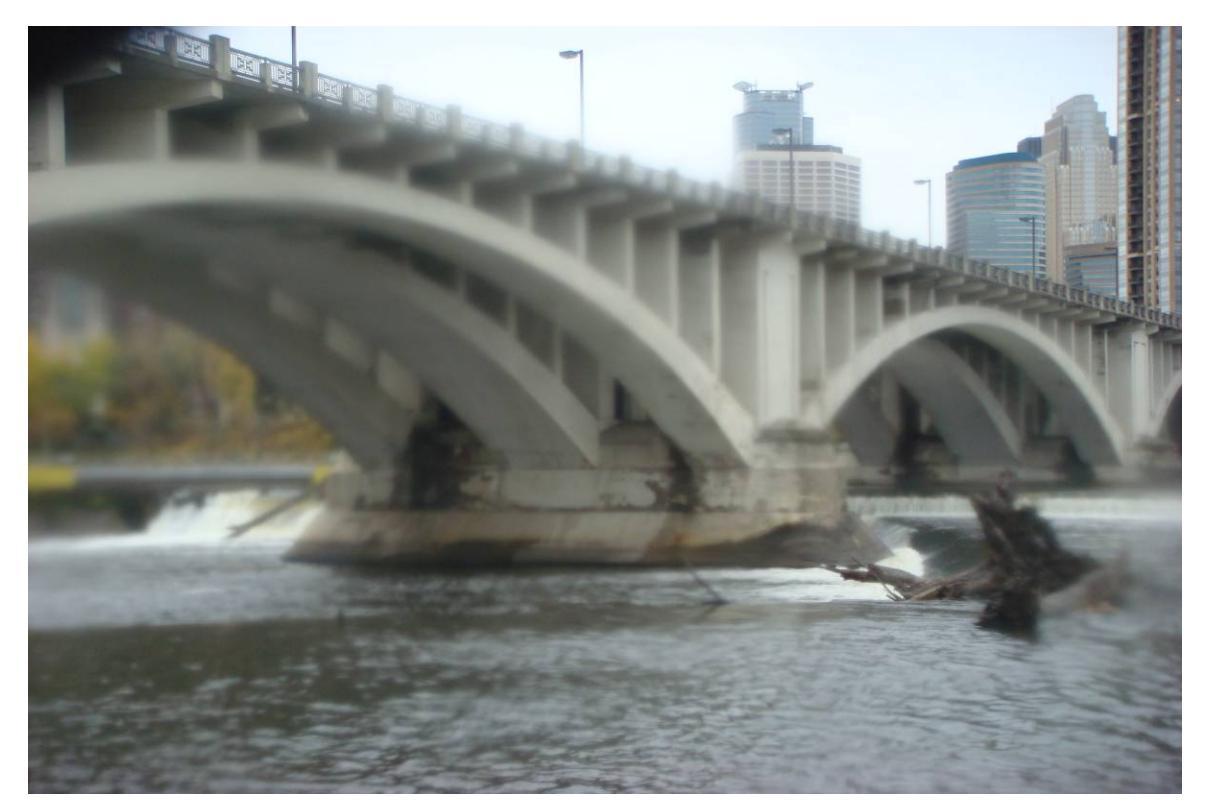
- (L) Pier 3 and 4 continue to be adequately founded in the concrete construction of the adjoining spillway.

Photograph 5. View of Pier 3, Looking Southwest.

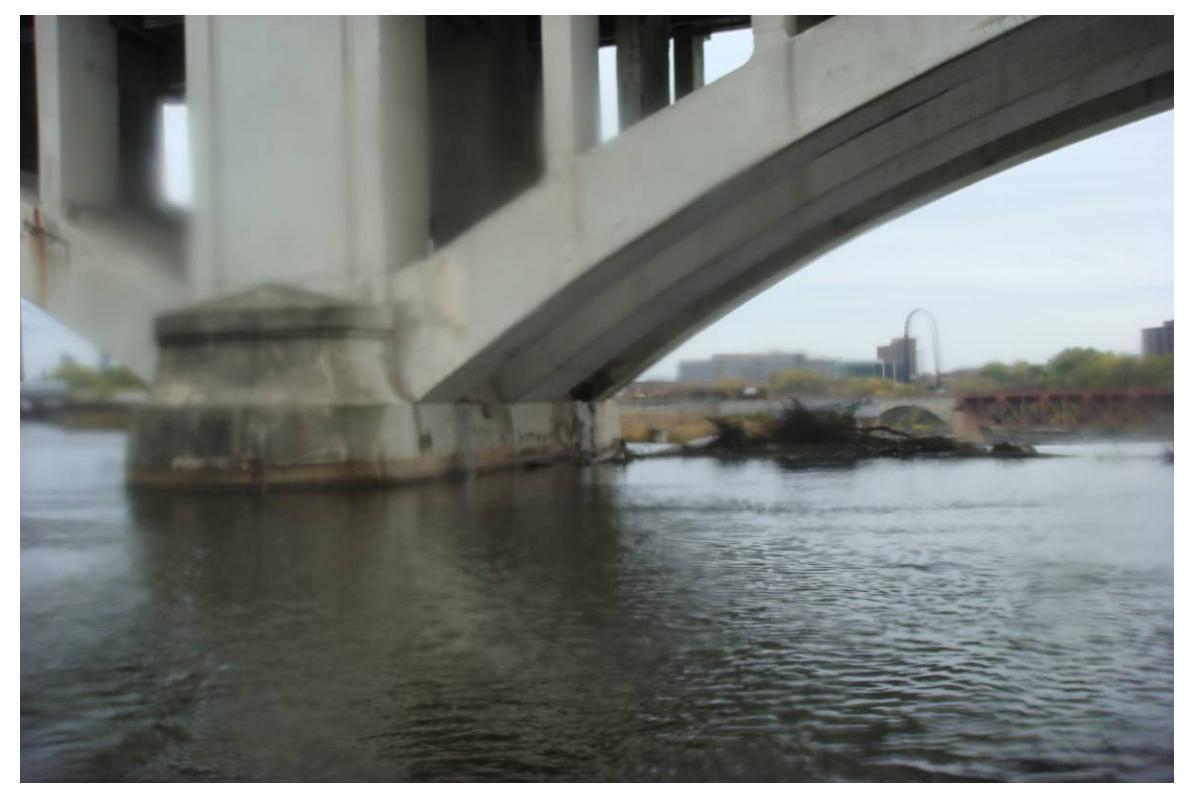
- (G) The footing at Pier 5 was exposed around the upstream 1/3 of the pier with 3 to 4 feet of typical vertical exposure. At the upstream nose of the pier, the footing was undermined (undercut from section loss) with a cavity measuring up to 2 feet in height with 2 to 3 foot penetration. The concrete of the footing also exhibited heavy deterioration with 2 to 3 foot penetration.

- (J) The footing step at Pier 8 was exposed along the west face of Pier 8 with up to 3.5 feet of vertical exposure.
- (K) Heavy accumulation of timber debris, consisting of up to 2 foot diameter drift pieces, was observed along the downstream half of the west face of Pier 5, extending from the channel bottom to 3 feet above the waterline.

Photograph 6. View of Pier 5, Looking East.

- (B) Monitor timber debris accumulation at Pier 5 during future inspections, and consider removal operations if debris is found to be increasing to an excessive extent.

- (C) Consideration should be given to implementation of scour countermeasures to address the undermined (undercut) foundation at Pier 5. The countermeasures could include the placement of riprap and/or pumped grout around the undermined/exposed footing.

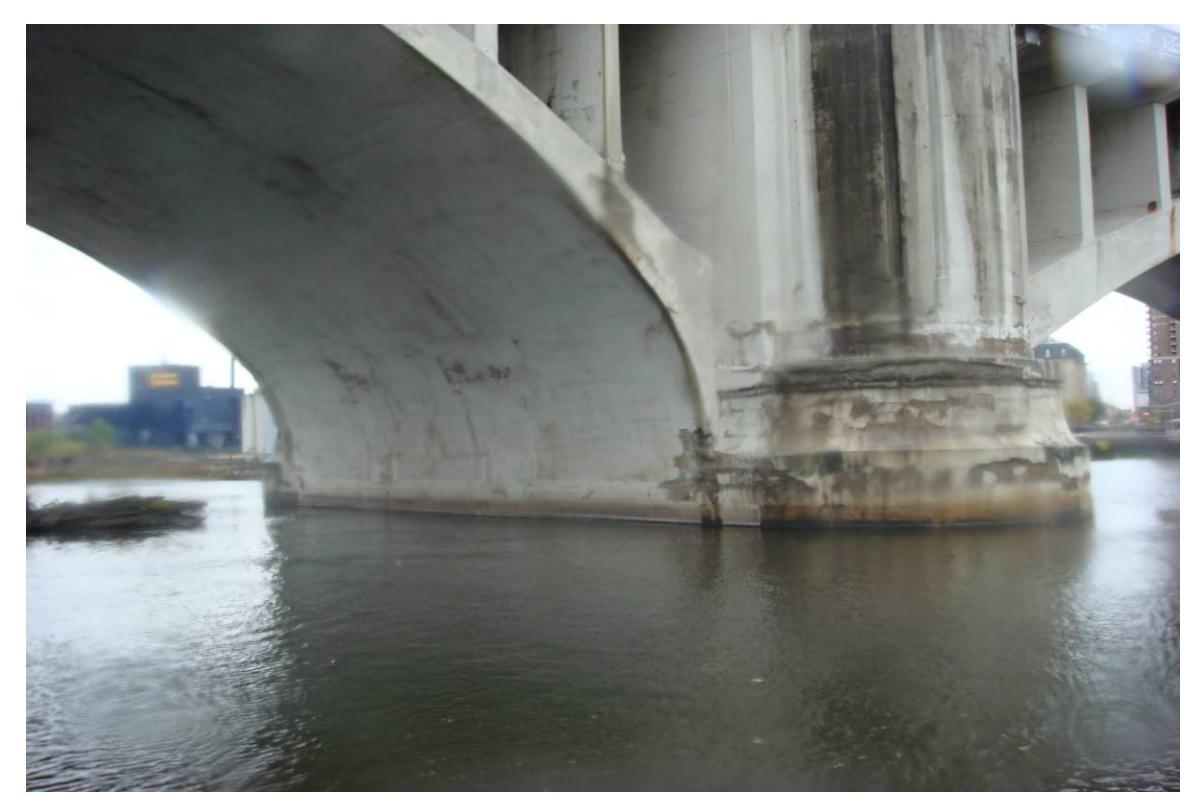
- (H) The footing at Pier 6 was exposed around the upstream nose with a maximum vertical exposure of 4 feet.
- The footing at Pier 7 was exposed along the west side of the pier with 1 to 3 feet of vertical exposure. The footing exhibited a 20 foot wide area of section loss and undercutting with 6 inch to 1 foot penetrations.

Photograph 7. View of Pier 6, Looking Southwest.

- (D) Monitor footing exposures at Piers 1, 2, 6, and 7 during future inspections, and if exposure is found to be increasing to a detrimental extent, implementation of scour countermeasures may become warranted at that time.

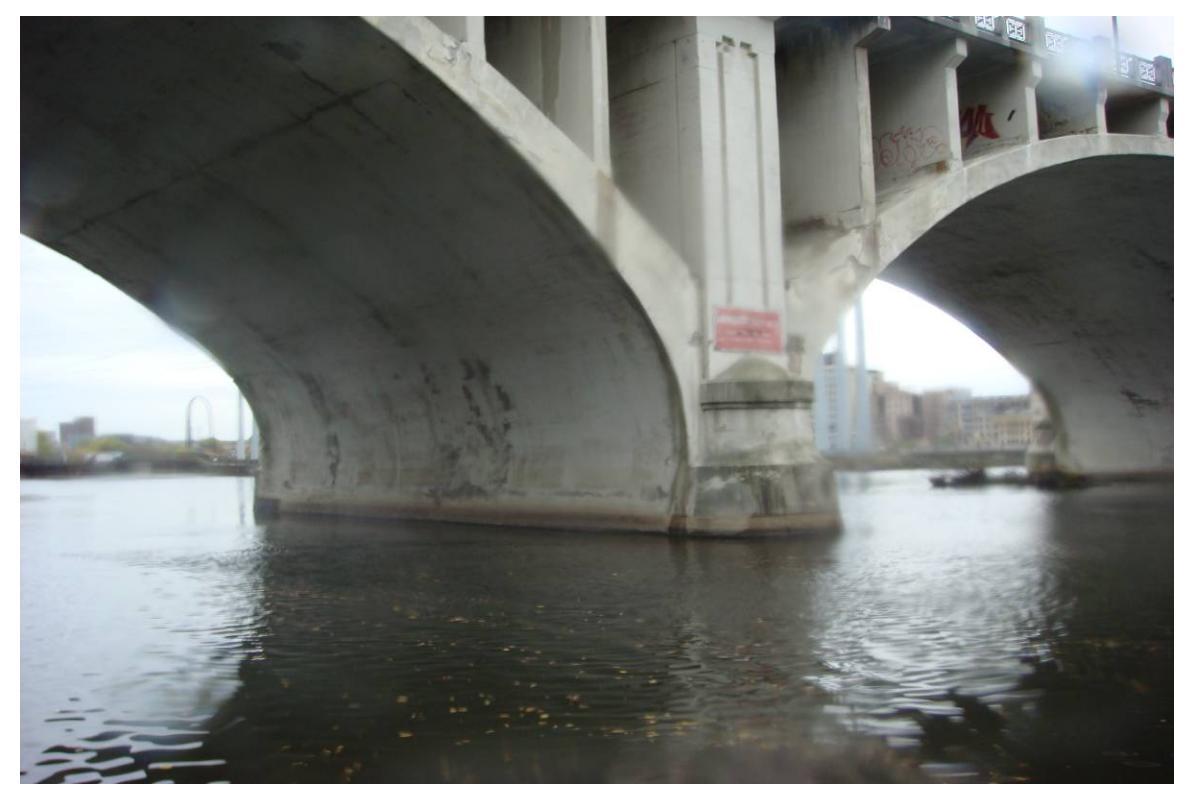
- (E) The concrete of Piers 7 and 8 exhibited a 1 to 1.5 foot high band of light to moderate scaling at the waterline with 1 to 3 inch penetrations.
- (F) An area of section loss, measuring 5 feet wide by 3 feet high with 2 to 3 foot penetration, was located on the east side of Pier 5 near the downstream 1/4 at approximately 3 feet below the waterline.

Photograph 8. View of Pier 7, Looking Southwest.

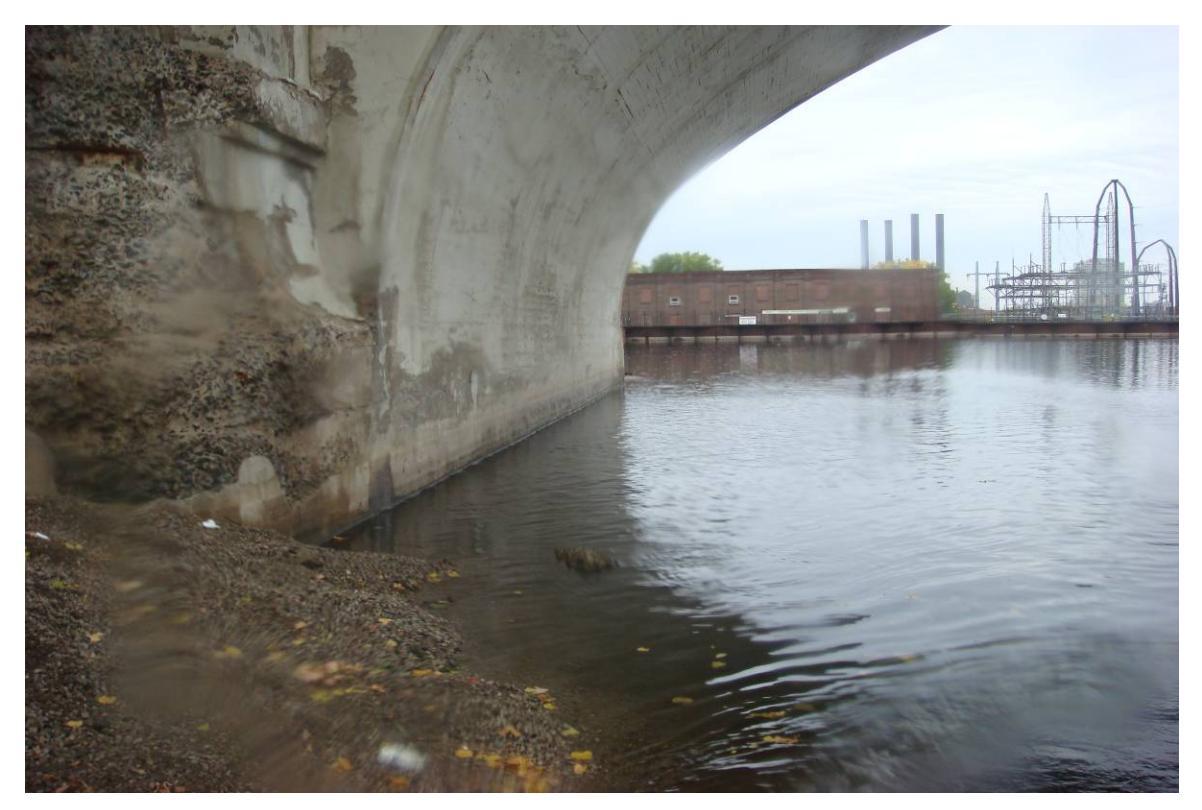
Photograph 9. View of Pier 8, Looking East.

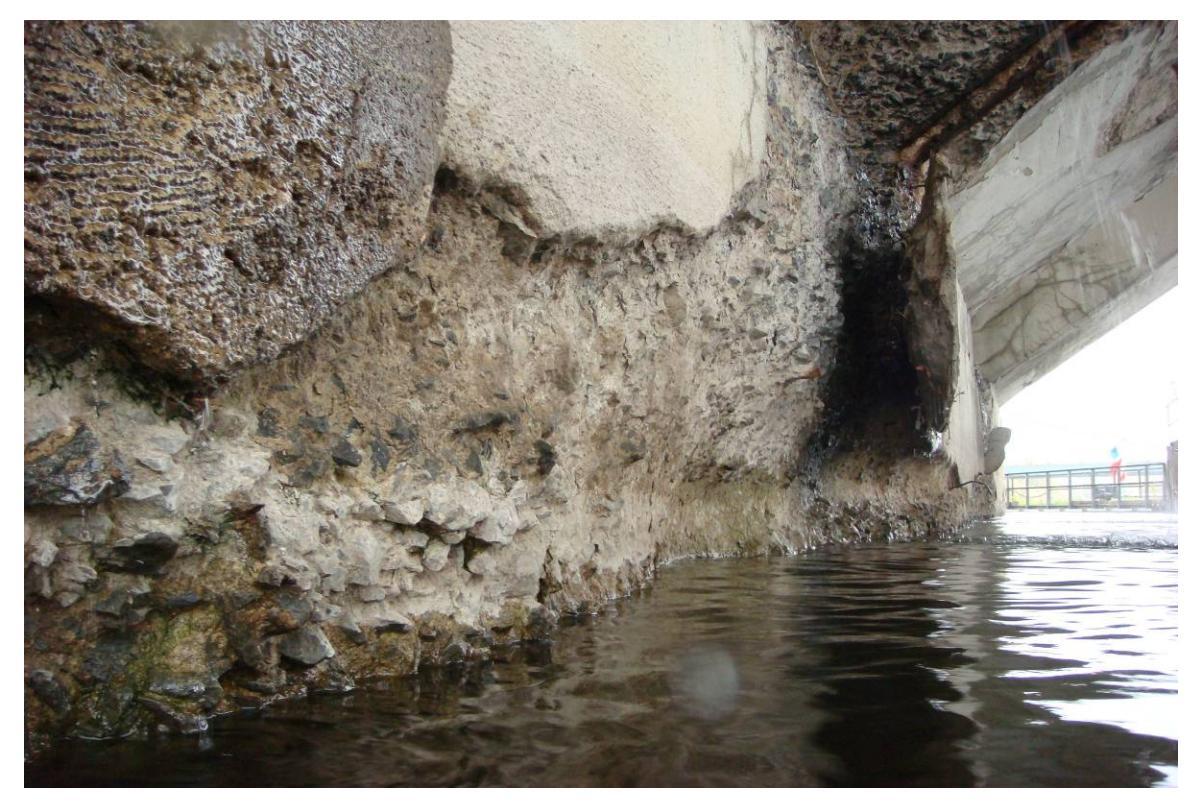
Photograph 10. View of typical concrete deterioration on the East face of Pier 1, Looking Northwest.

- (2)The concrete of Pier 1 exhibited widespread spalling and loss of section with typical penetrations of 6 inches to 1 foot and maximum penetrations of 2 feet, typically extending from 2 feet below to 4 feet above the waterline.

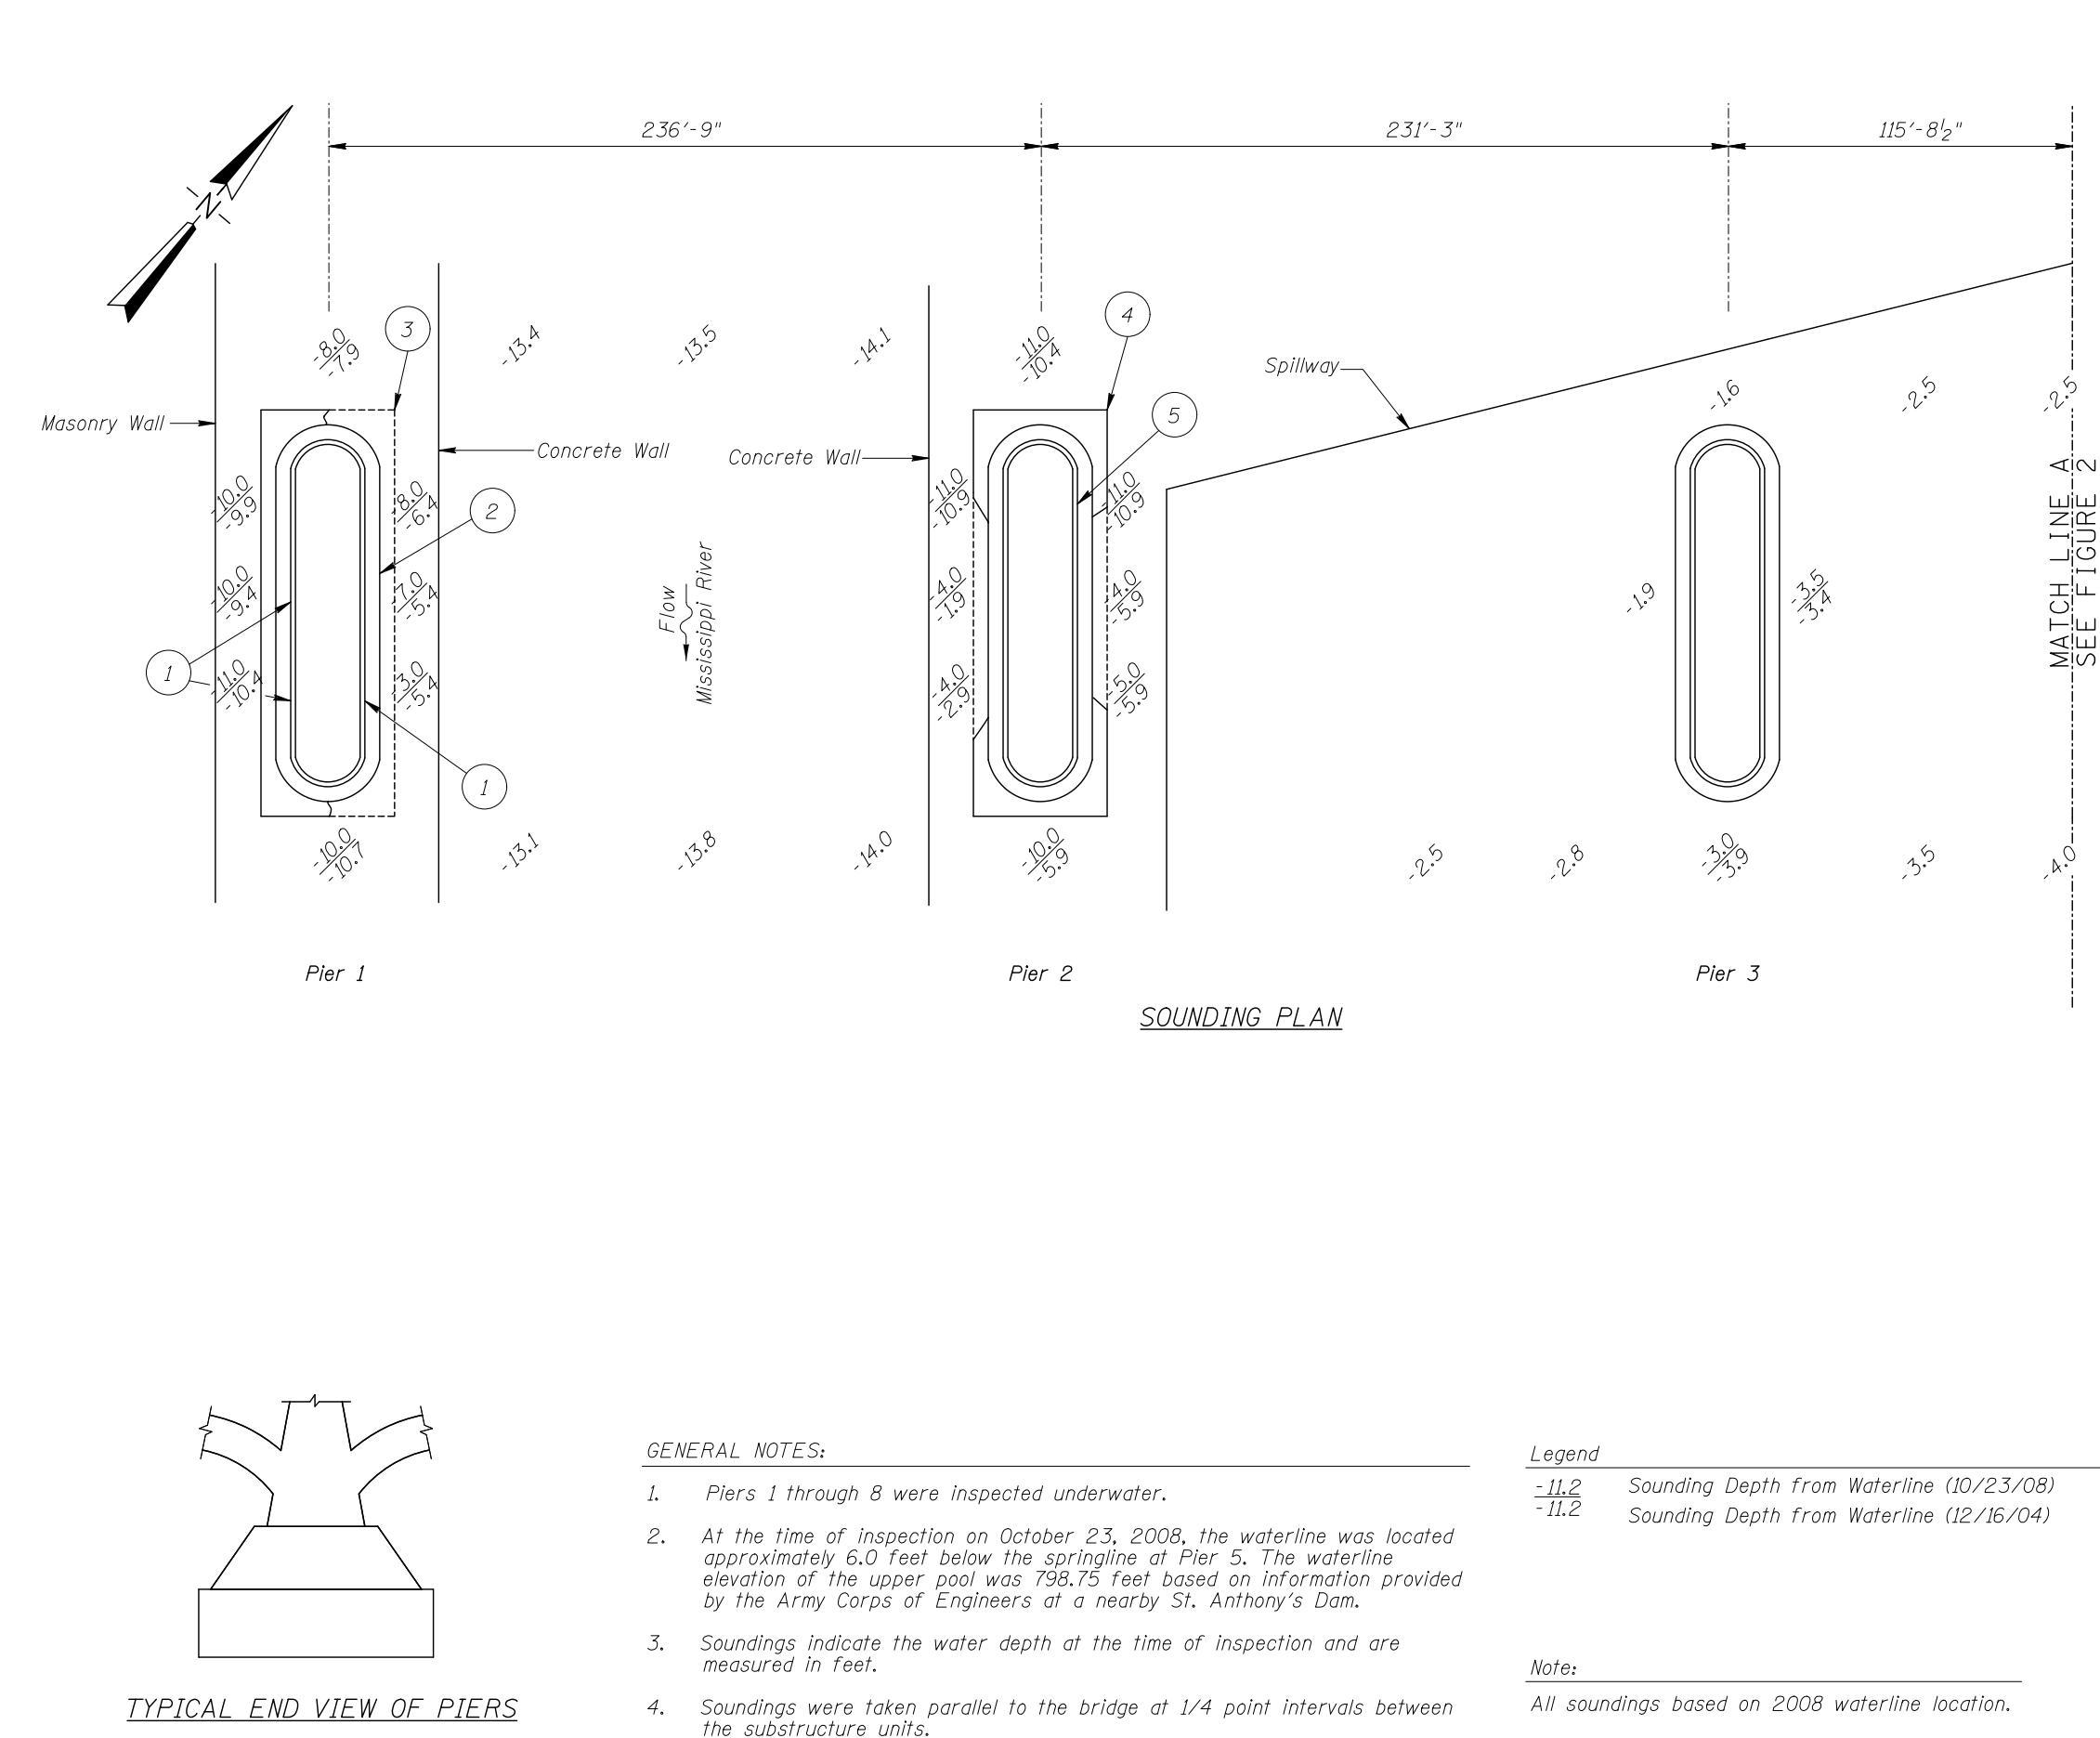
- Up to 1/4 inch wide vertical cracks were observed (1)at the midpoint and the downstream 1/4 point on the west face and near the 1/4 point on the east face of Pier 1, typically extending from 5 to 10 feet above the waterline to the top of the footing.

- (3) At Pier 1, the footing was exposed from the middle of the upstream nose, along the entire west face to the middle of the downstream nose. The vertical footing exposure ranged from 2 feet at the upstream corner to 3 feet at the downstream corner. The concrete of the footing exhibited moderate to heavy spalling and deterioration with 6 inch typical and up to 2 feet maximum penetration.

- (4)At Pier 2, the footing was exposed around the upstream 1/4 and the downstream 1/4 of the pier. The vertical footing exposure at both ends of the pier typically varied from 3 to 4 feet.

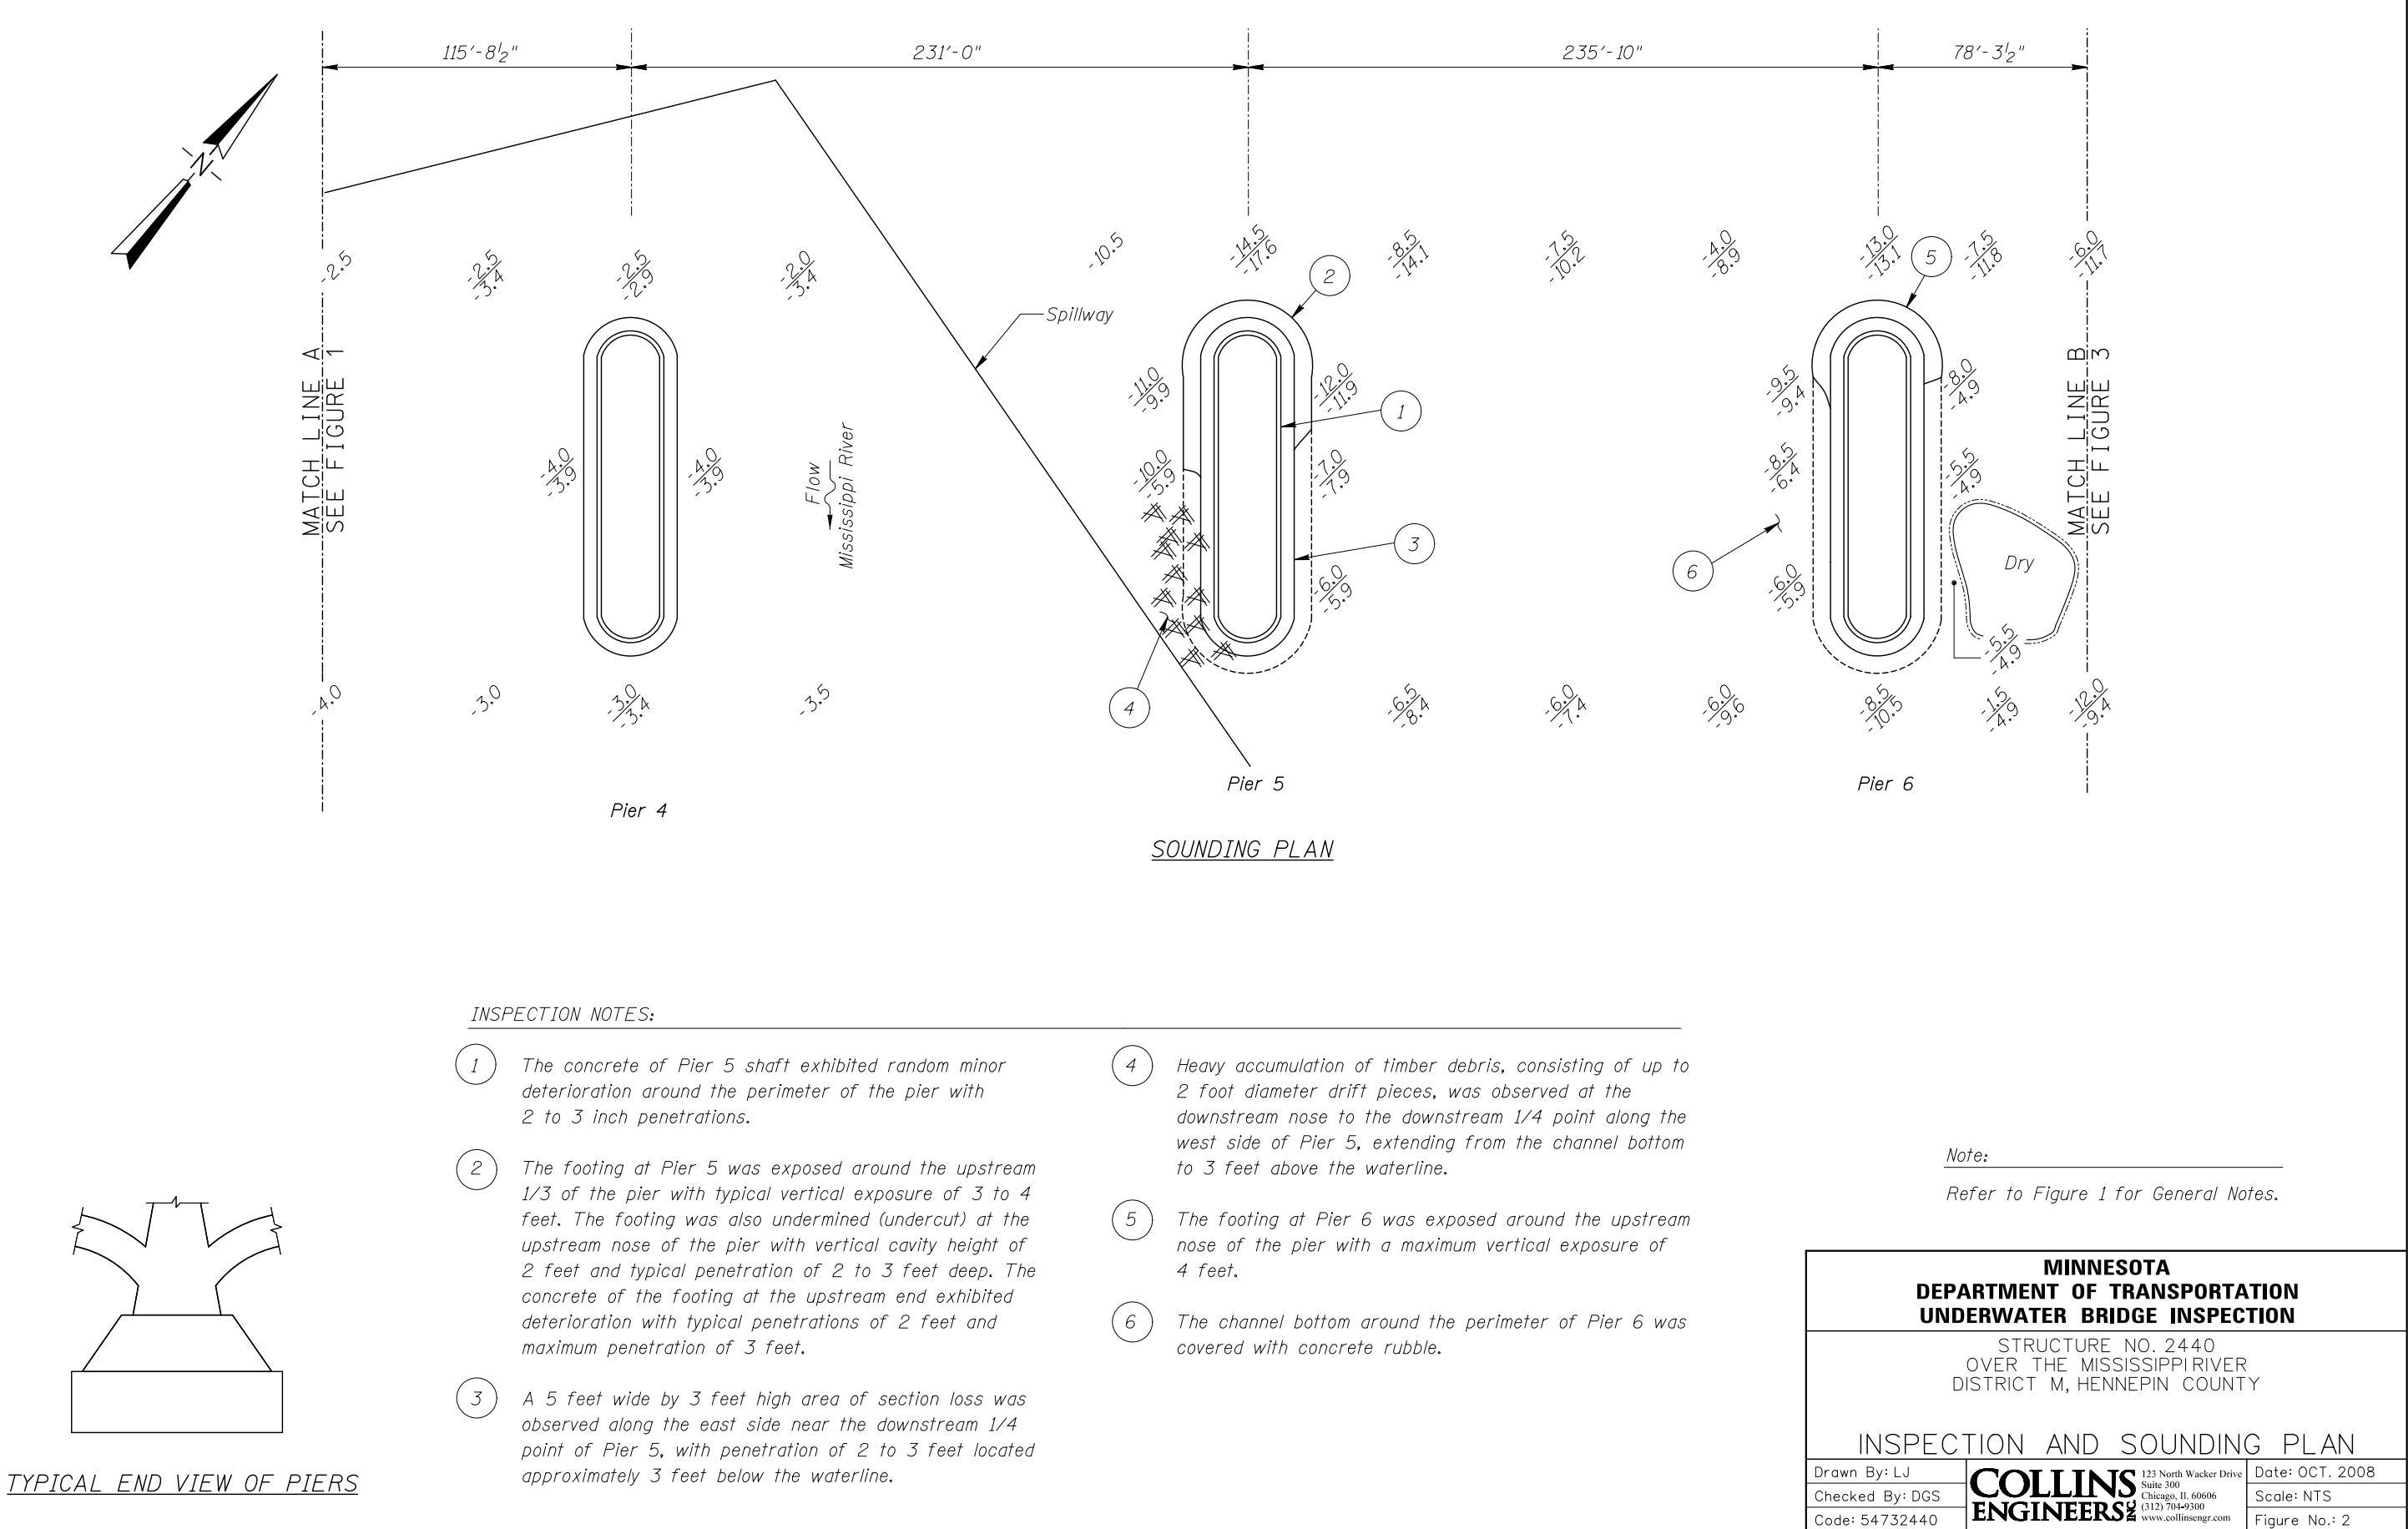
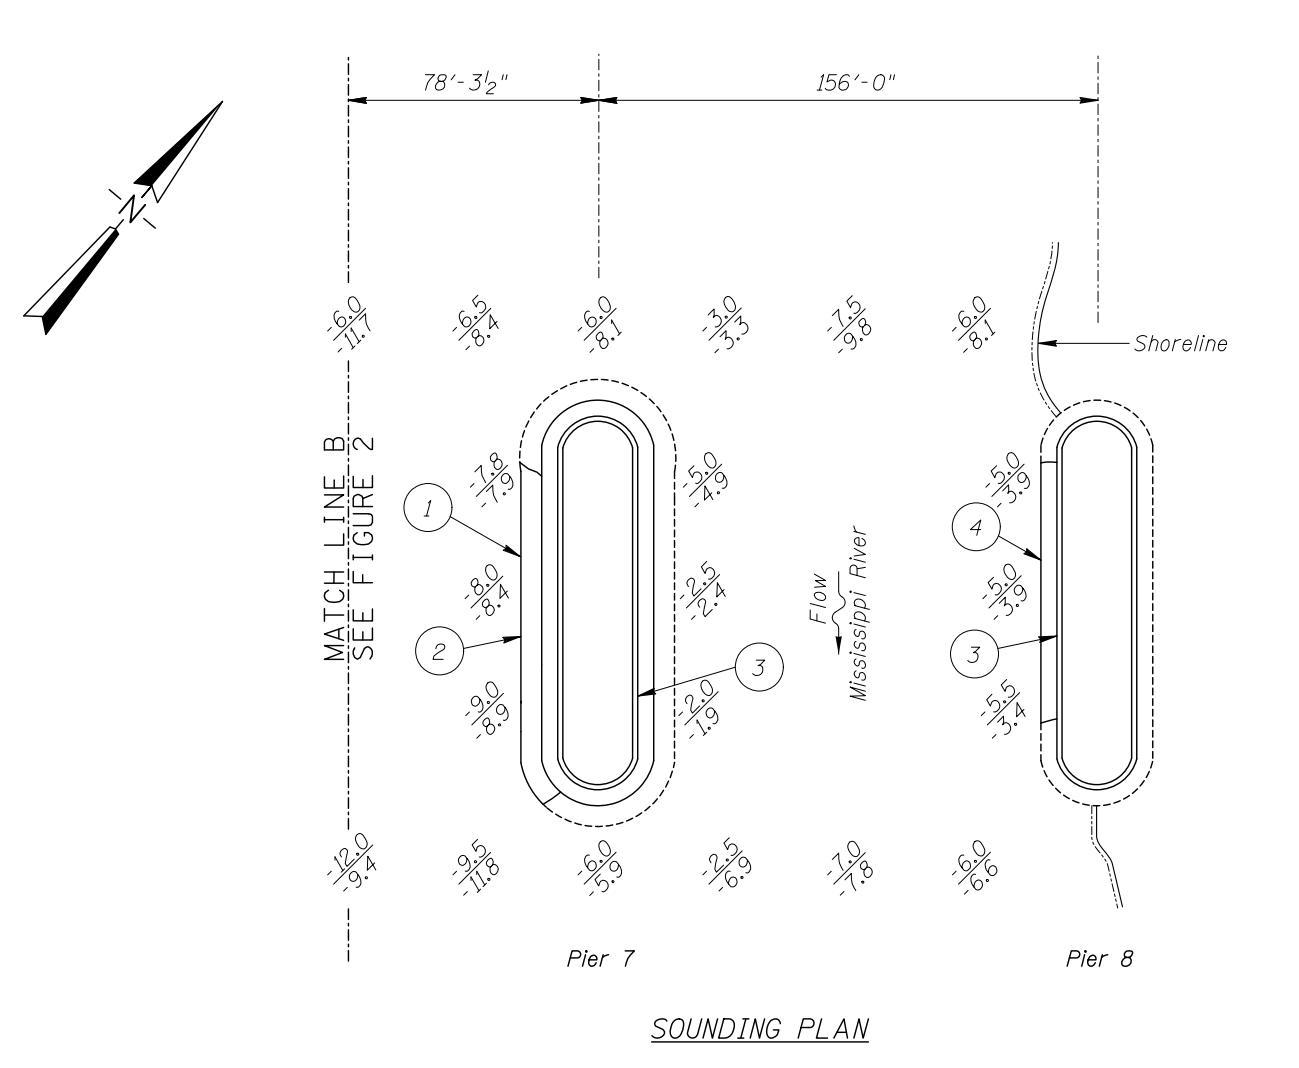
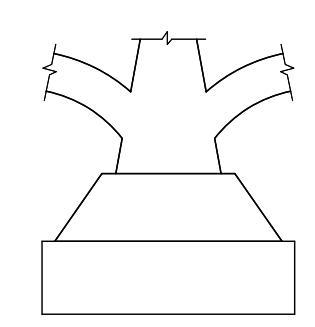
- (1) The footing at Pier 7 was exposed along the west face of the pier, with vertical exposure ranging from 1 foot at the upstream end to 3 feet at the downstream end.
- (2) The exposed footing at Pier 7 exhibited an approximately 20 foot wide area of section loss with undercutting and 6 inch to 1 foot deep penetrations.
- (3) Band of light to moderate scaling, 1 to 1.5 foot high with 1 to 3 inch penetration, was present at the waterline around perimeter of Piers 7 and 8.
- (4) At Pier 8, the footing (shaft step) was exposed along the west face of the pier with 3 to 3.5 feet of vertical exposure.
