UNDERWATER BRIDGE INSPECTION REPORT

STRUCTURE NO. 2440 TRUNK HIGHWAY NO. 65 OVER THE MISSISSIPPI RIVER DISTRICT 5 - HENNEPIN COUNTY

MINNESOTA DEPARTMENT OF TRANSPORTATION UNDERWATER BRIDGE INSPECTION

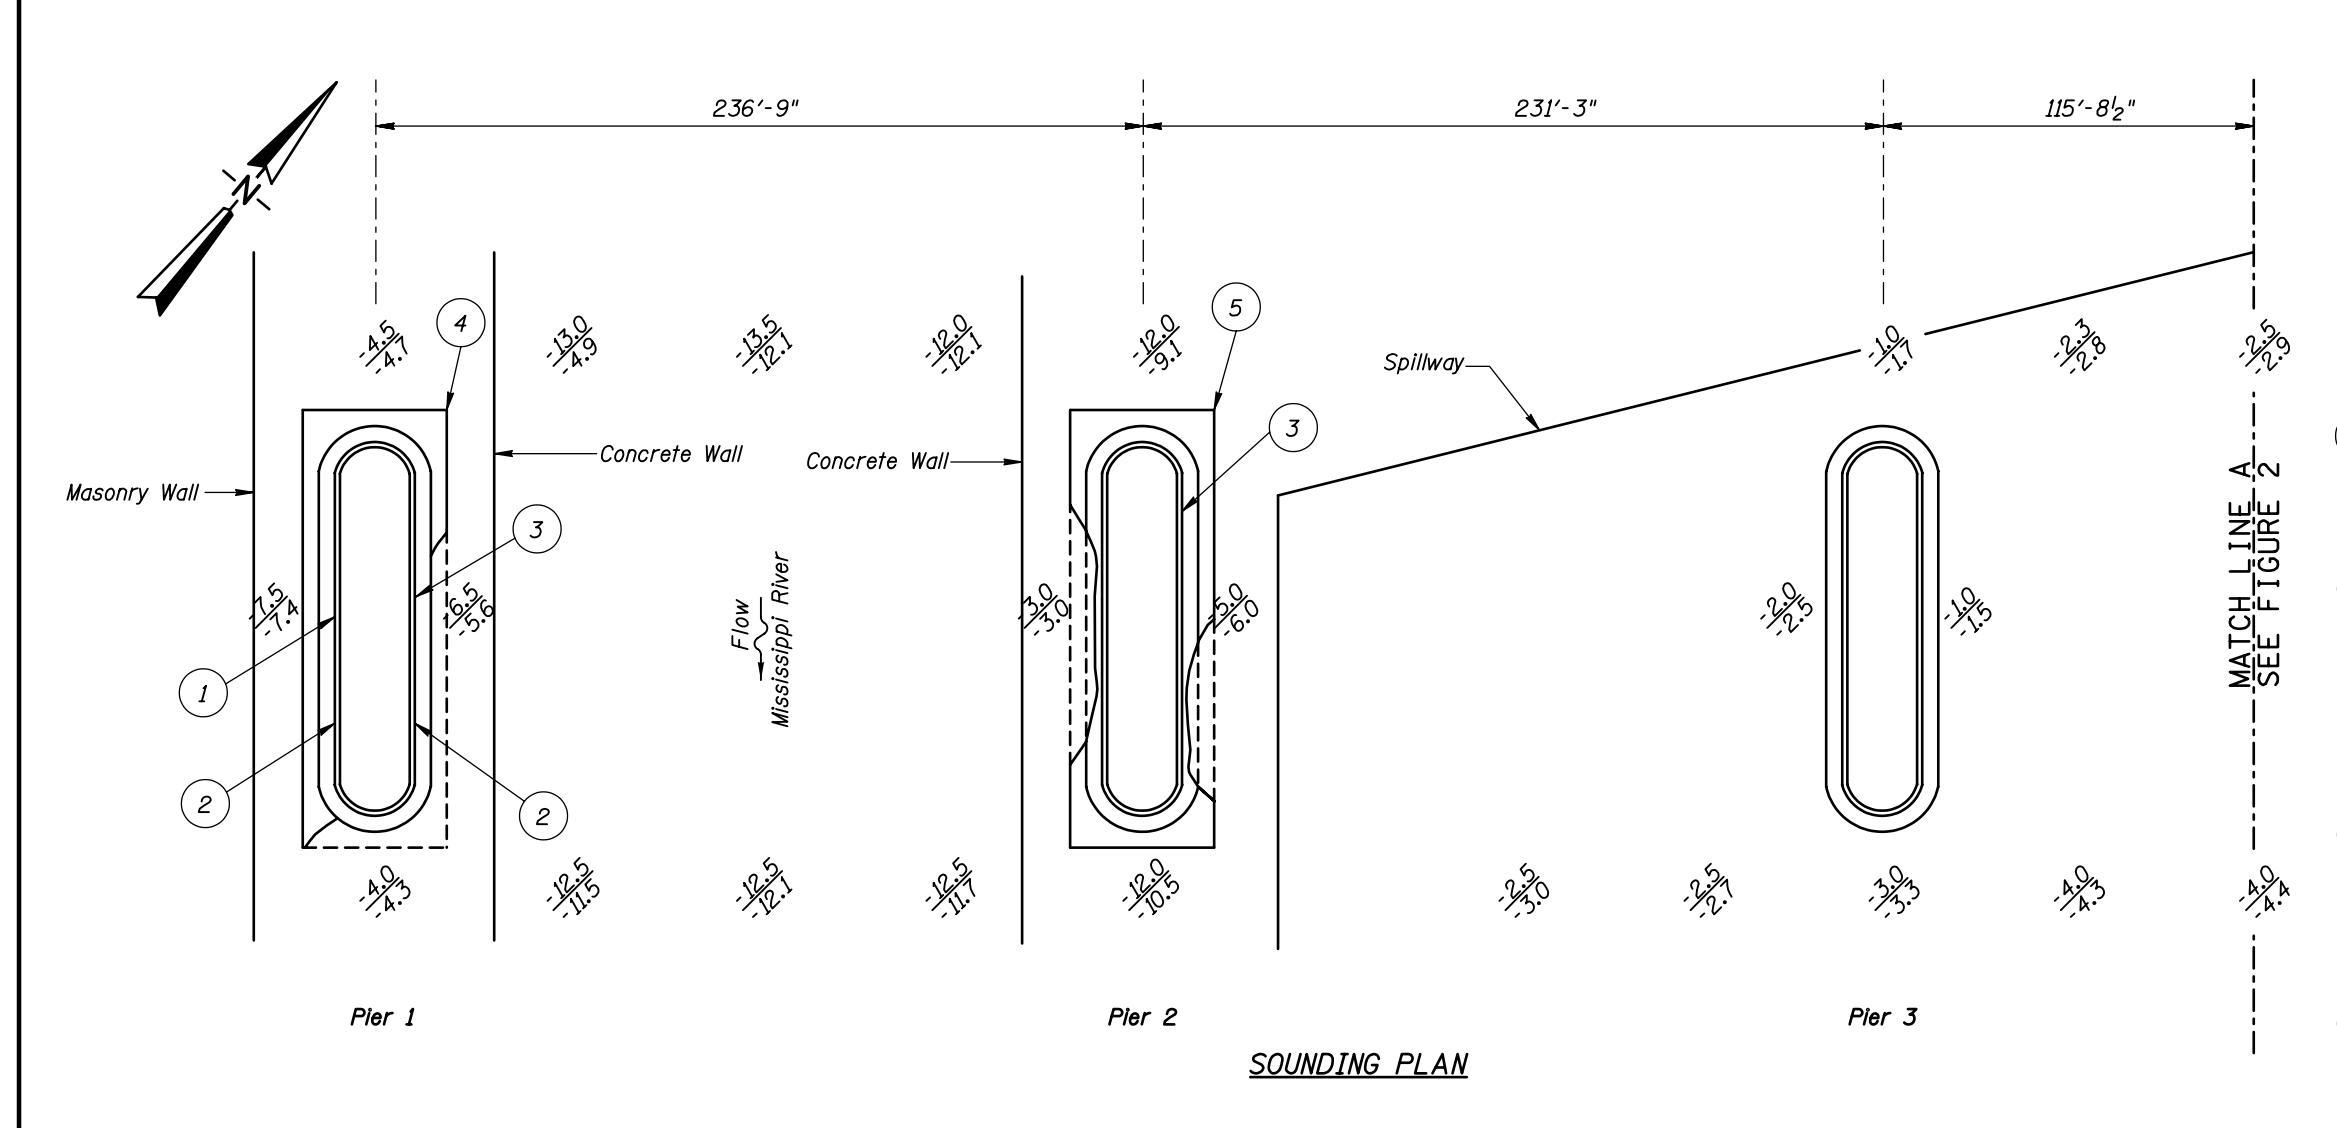
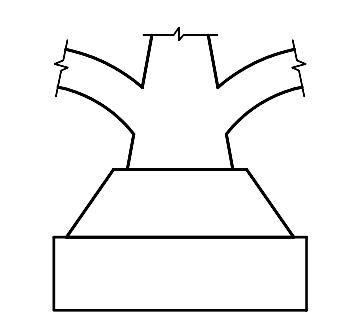
- 1) There was a 1/8 inch wide vertical crack near the midpoint of the west face of Pier 1, which extended from 5 feet above the waterline to the channel bottom.

- 2 There was an 1/8 to 1/4 inch wide vertical crack between the middle and downstream arches on both the east and west faces of Pier 1. The crack on the west face extended from the top of the pier to the top of footing and the crack on the east face extended from 10 feet above the waterline to the top of footing.

- Around entire perimeter of Piers 1 and 2 between 3 feet above and below the waterline, there was moderate to heavy scaling and loss of section with 2 to 9 inch penetrations and occasional exposed reinforcing steel.

- 4 The top of footing at Pier 1 was exposed from the upstream quarter point on the east face, around the upstream nose, and along the west face to the downstream nose, with 1 foot typical vertical footing exposure at the northwest side and 2 foot typical vertical footing exposure along the west face.

- (5) The top of footing at Pier 2 was exposed around the downstream nose and from the midpoint on the east face, around the upstream nose, to the upstream eighth point on the west face, with 5 foot typical vertical footing exposure.

are addressed. At Pier 5, the undermining at the foundation/channel bottom interface can be rectified with the placement of riprap and pumped grout (pre-placed aggregate repair). At Piers 1 and 2, as well at other piers with waterline deterioration, concrete patching/reforming repairs should be accomplished in conjunction with above water repairs.

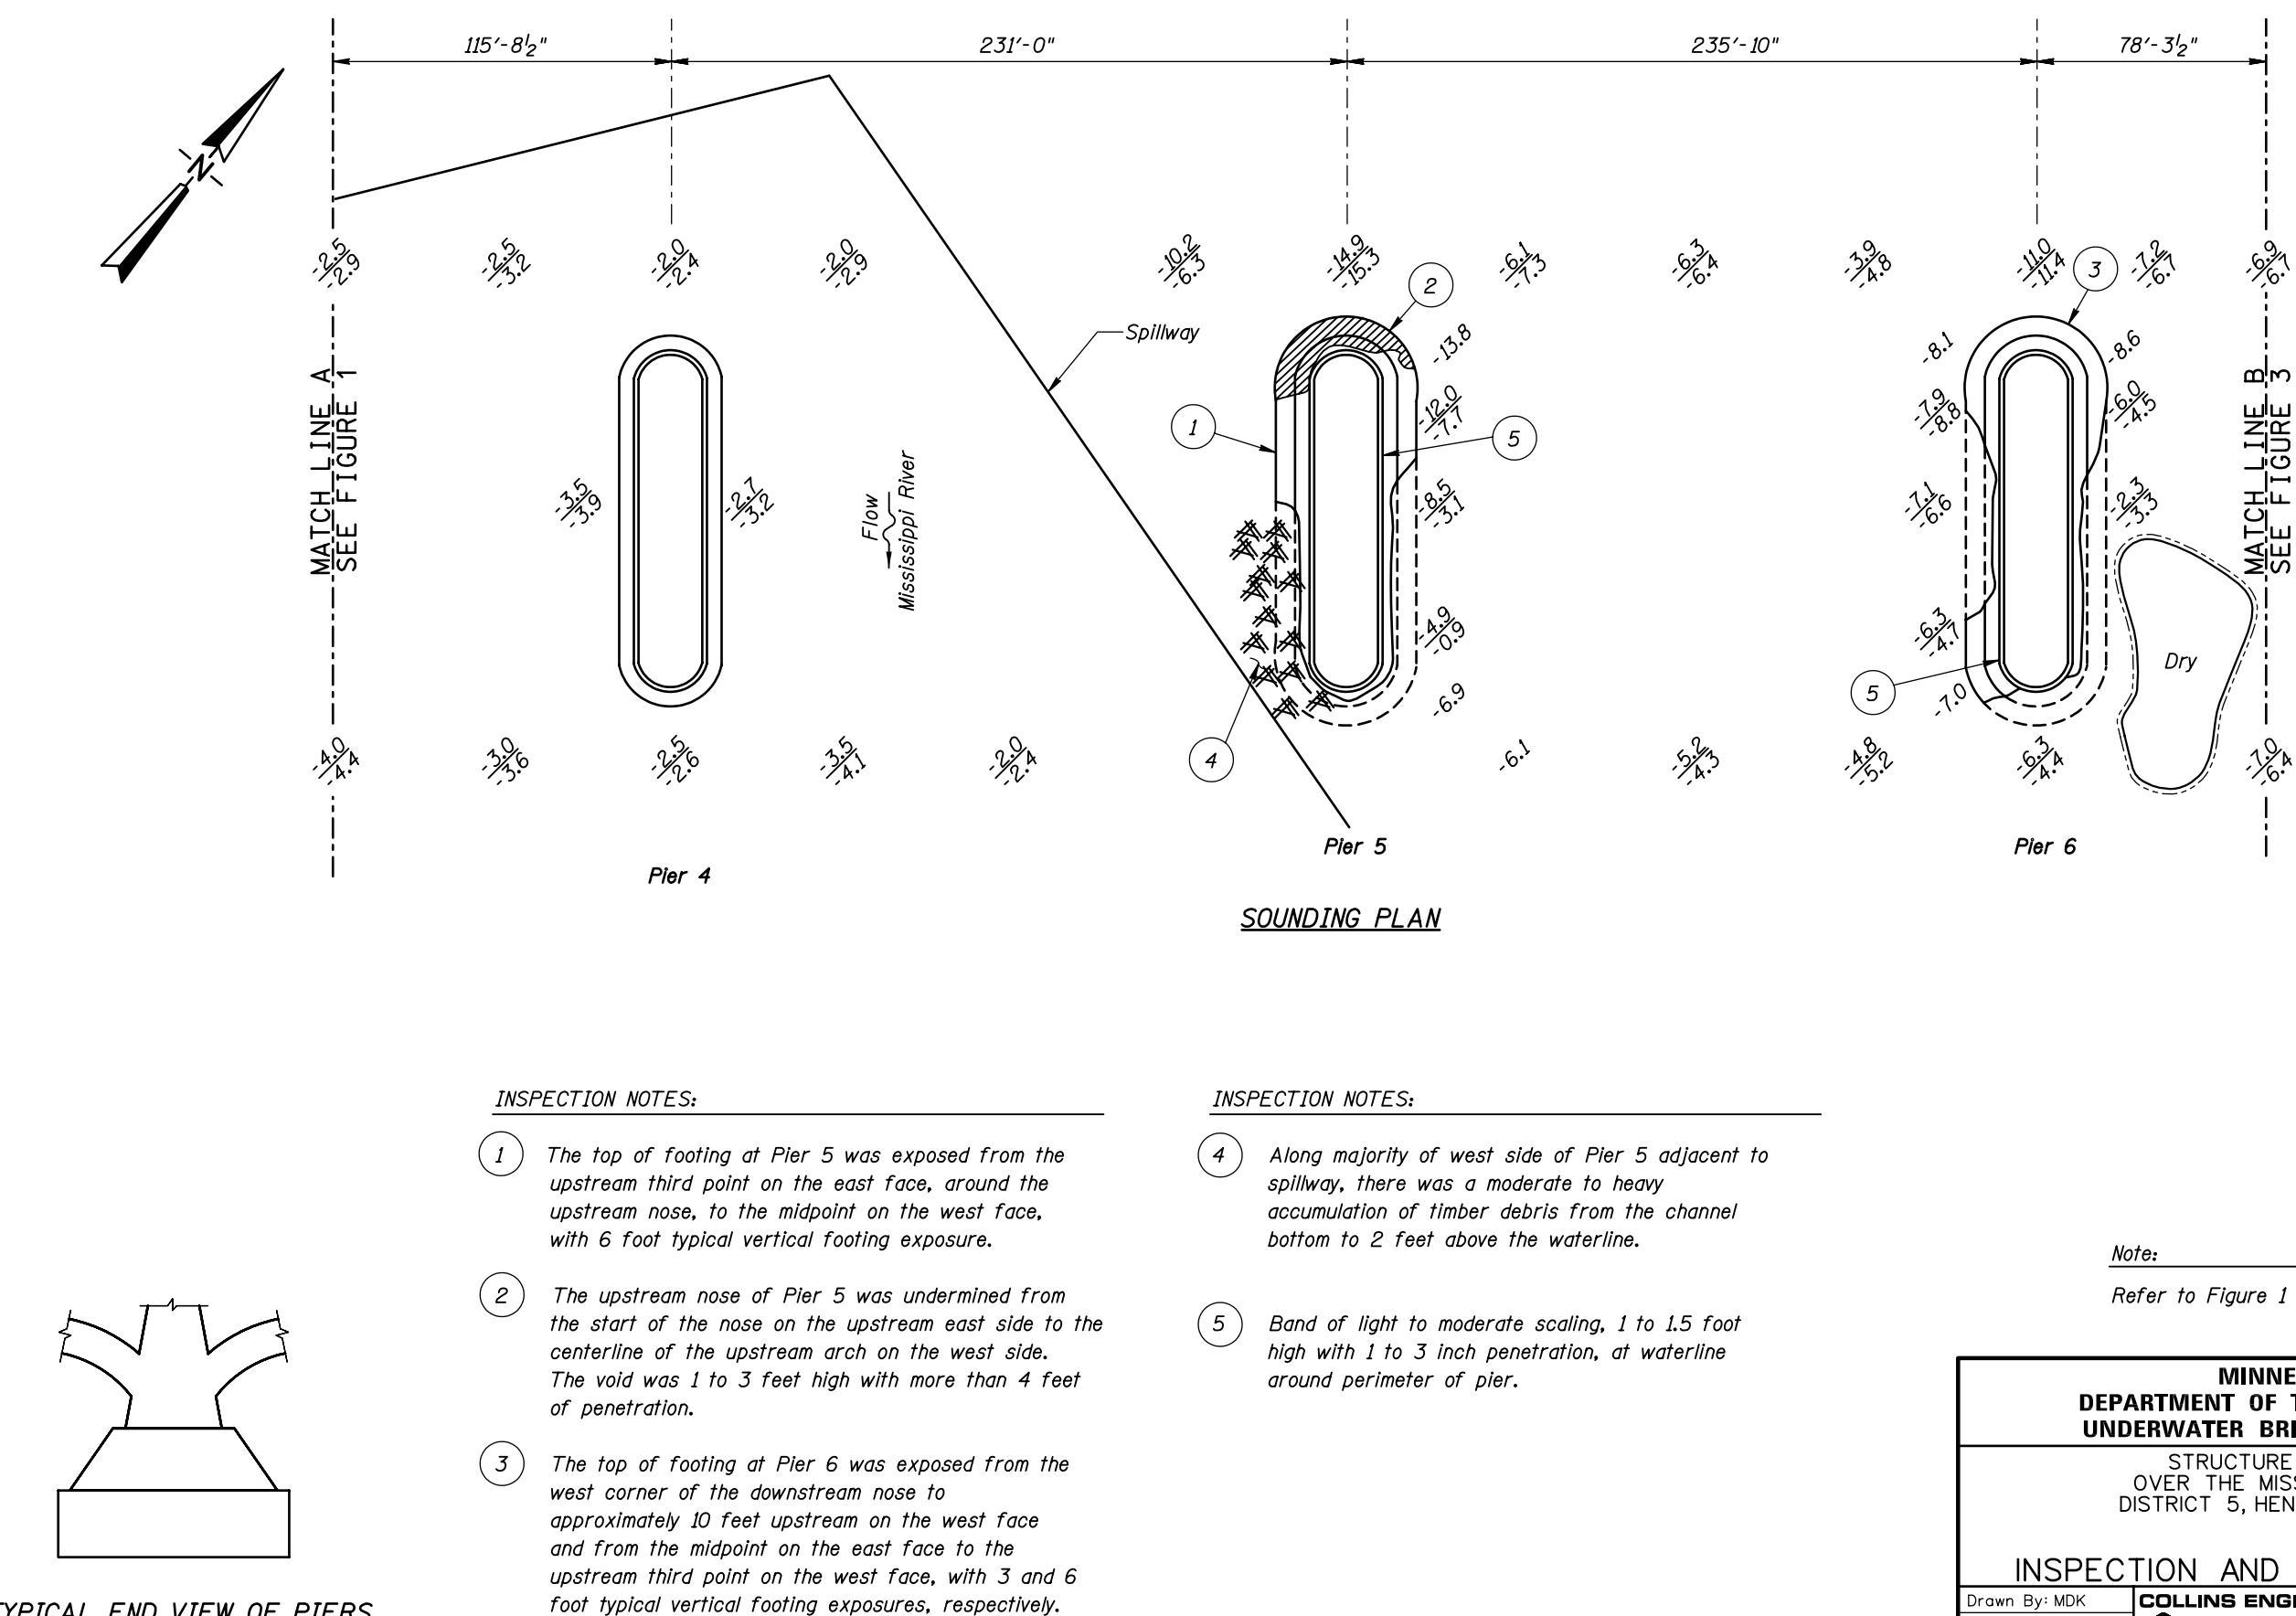
The top of footing at Pier 2 was exposed around the downstream nose and from the midpoint on the east face, around the upstream nose, to the upstream eighth point on the west face, with 5 foot typical vertical footing exposure.

The top of footing at Pier 5 was exposed from the upstream third point on the east face, around the upstream nose, to the midpoint on the west face, with 6 foot typical vertical footing exposure.

The upstream nose of Pier 5 was undermined from the start of the nose on the upstream east side to the centerline of the upstream arch on the west side. The void was 1 to 3 feet high with more than 4 feet of penetration back under the footing.

The top of footing at Pier 6 was exposed from the west corner of the downstream nose to approximately 10 feet upstream on the west face and from the midpoint on the east face to the upstream third point on the west face, with 3 and 6 foot typical vertical footing exposures, respectively.

Along the majority of the west side of Pier 5 adjacent to the spillway, there was a moderate to heavy timber debris accumulation extending from the channel bottom to 2 feet above the waterline.

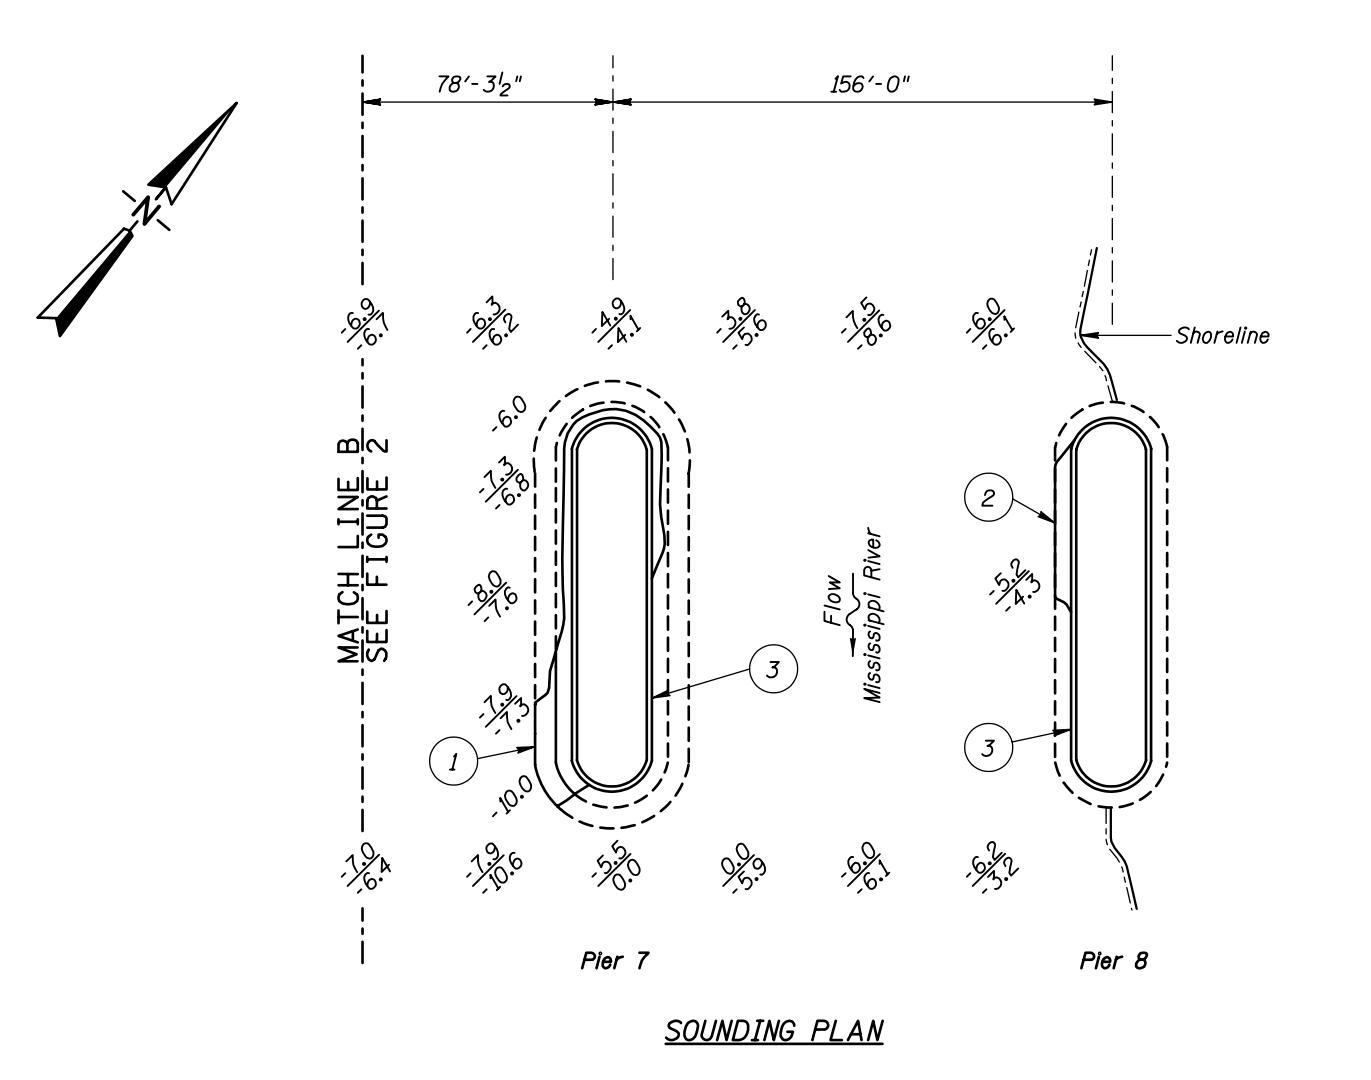
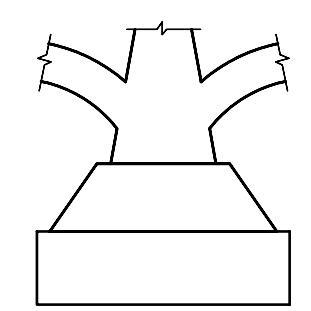
- 1) The top of footing at Pier 7 was exposed from the west corner of the downstream nose to approximately 10 feet upstream on the west face, with 5 foot maximum vertical footing exposure.
- 2) The top of footing (step) was exposed along a portion of the west face with 1 foot maximum vertical exposure.
- (3) Band of light to moderate scaling, 1 to 1.5 foot high with 1 to 3 inch penetration, at waterline around perimeter of pier.
