Michigan's Unbonded Overlay Experience

2011 Terra Pavement Conference February 10, 2011

Michael Eacker Pavement Design Engineer Michigan Department of Transportation

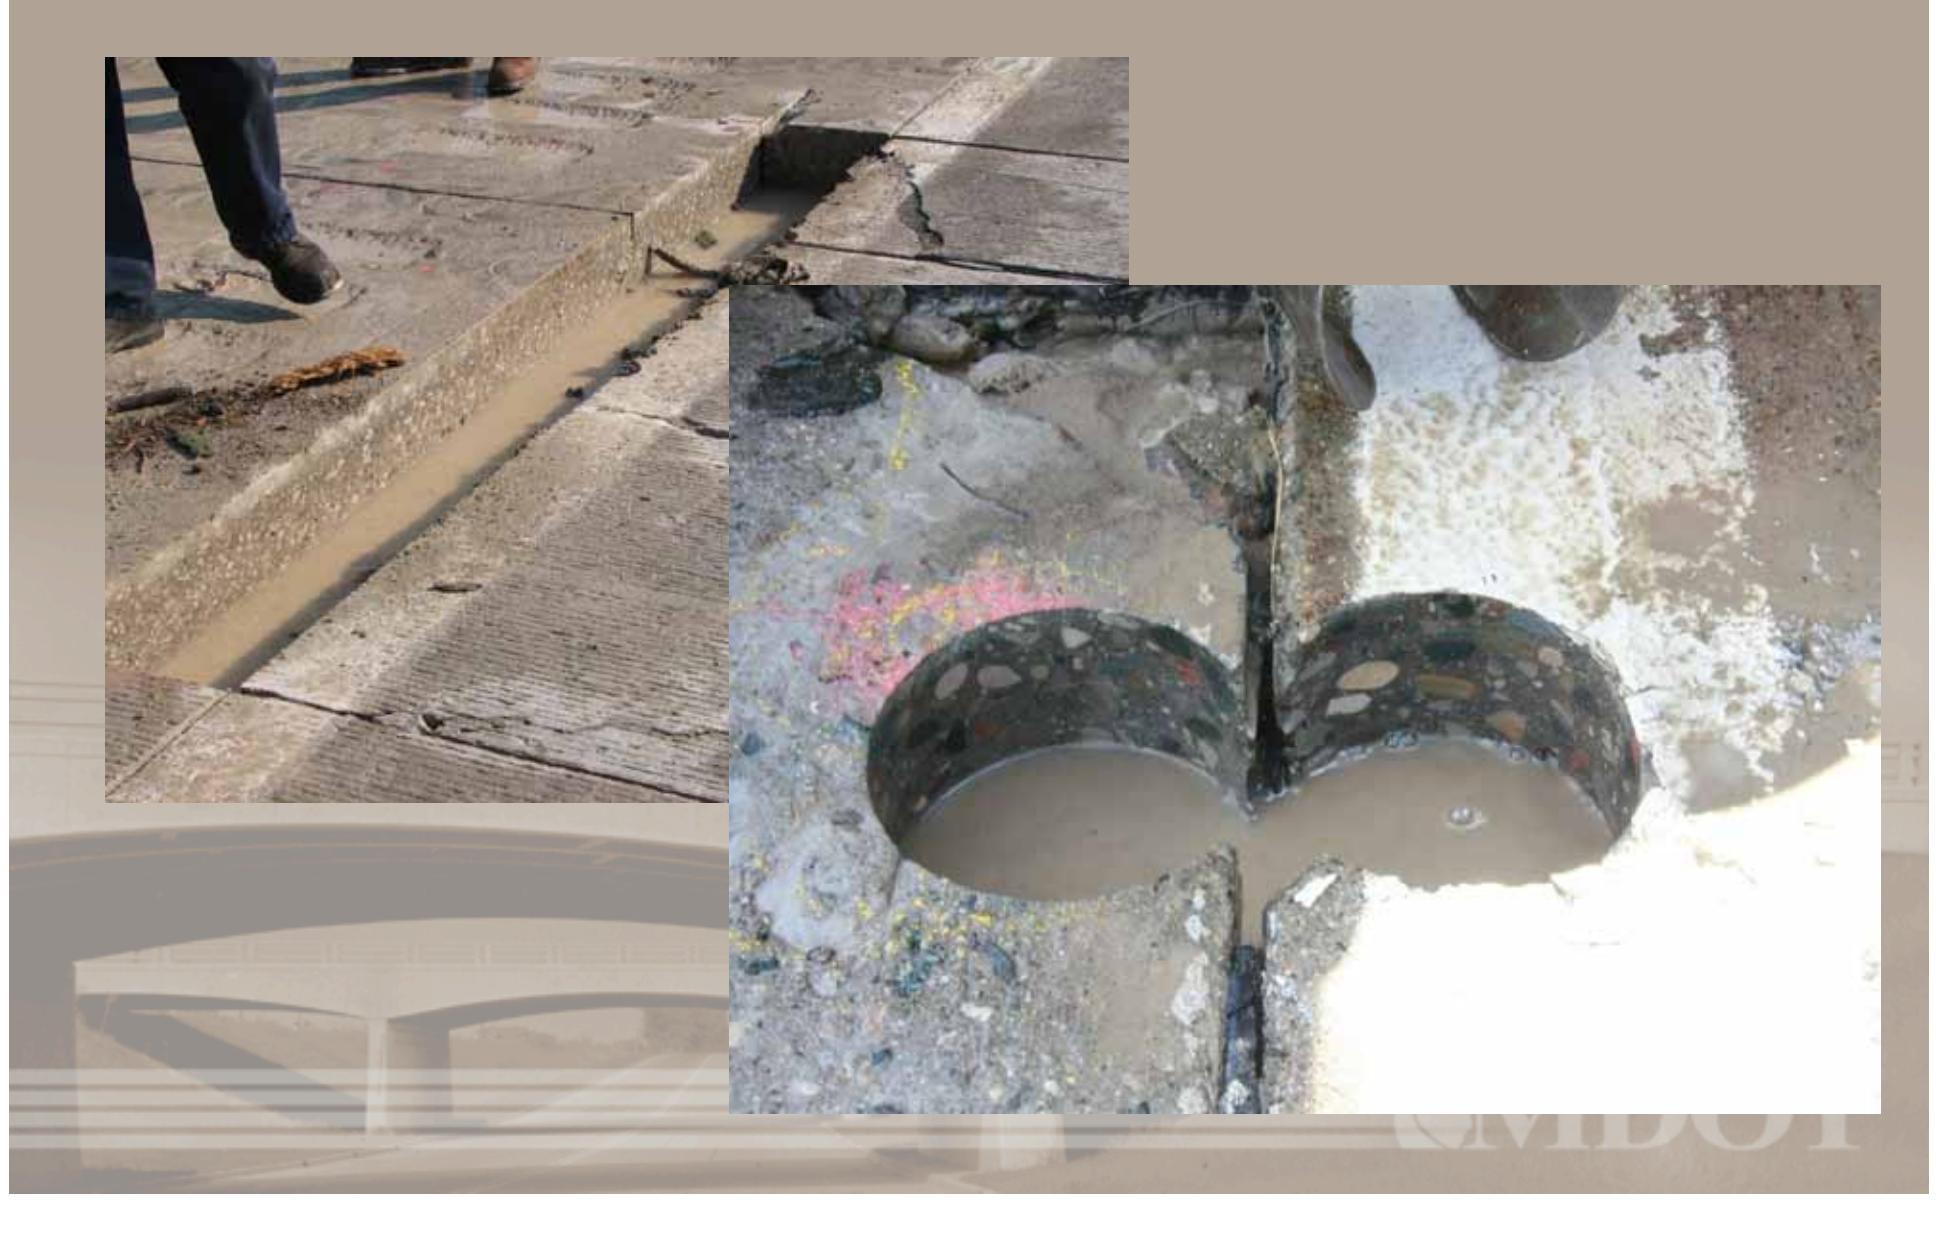
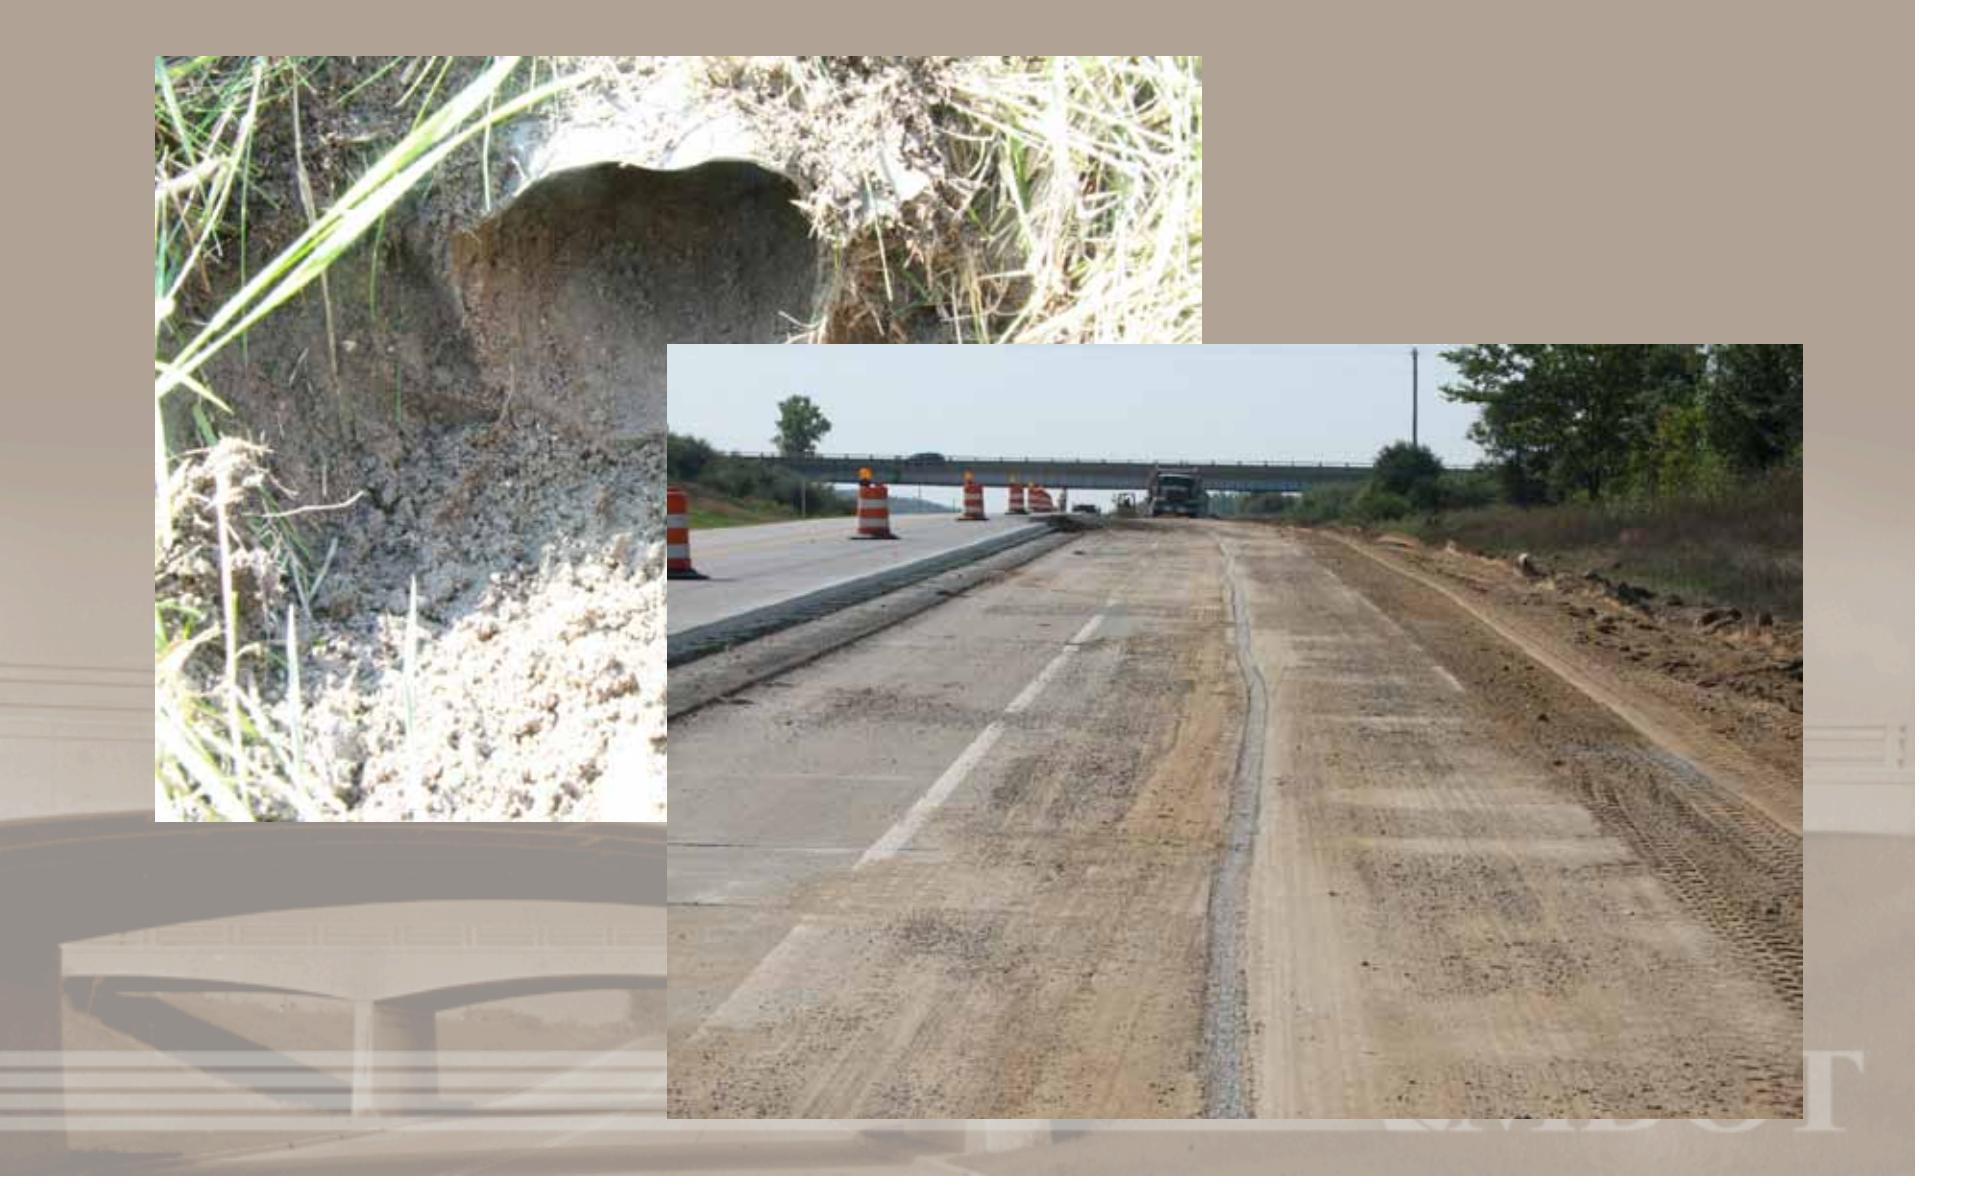
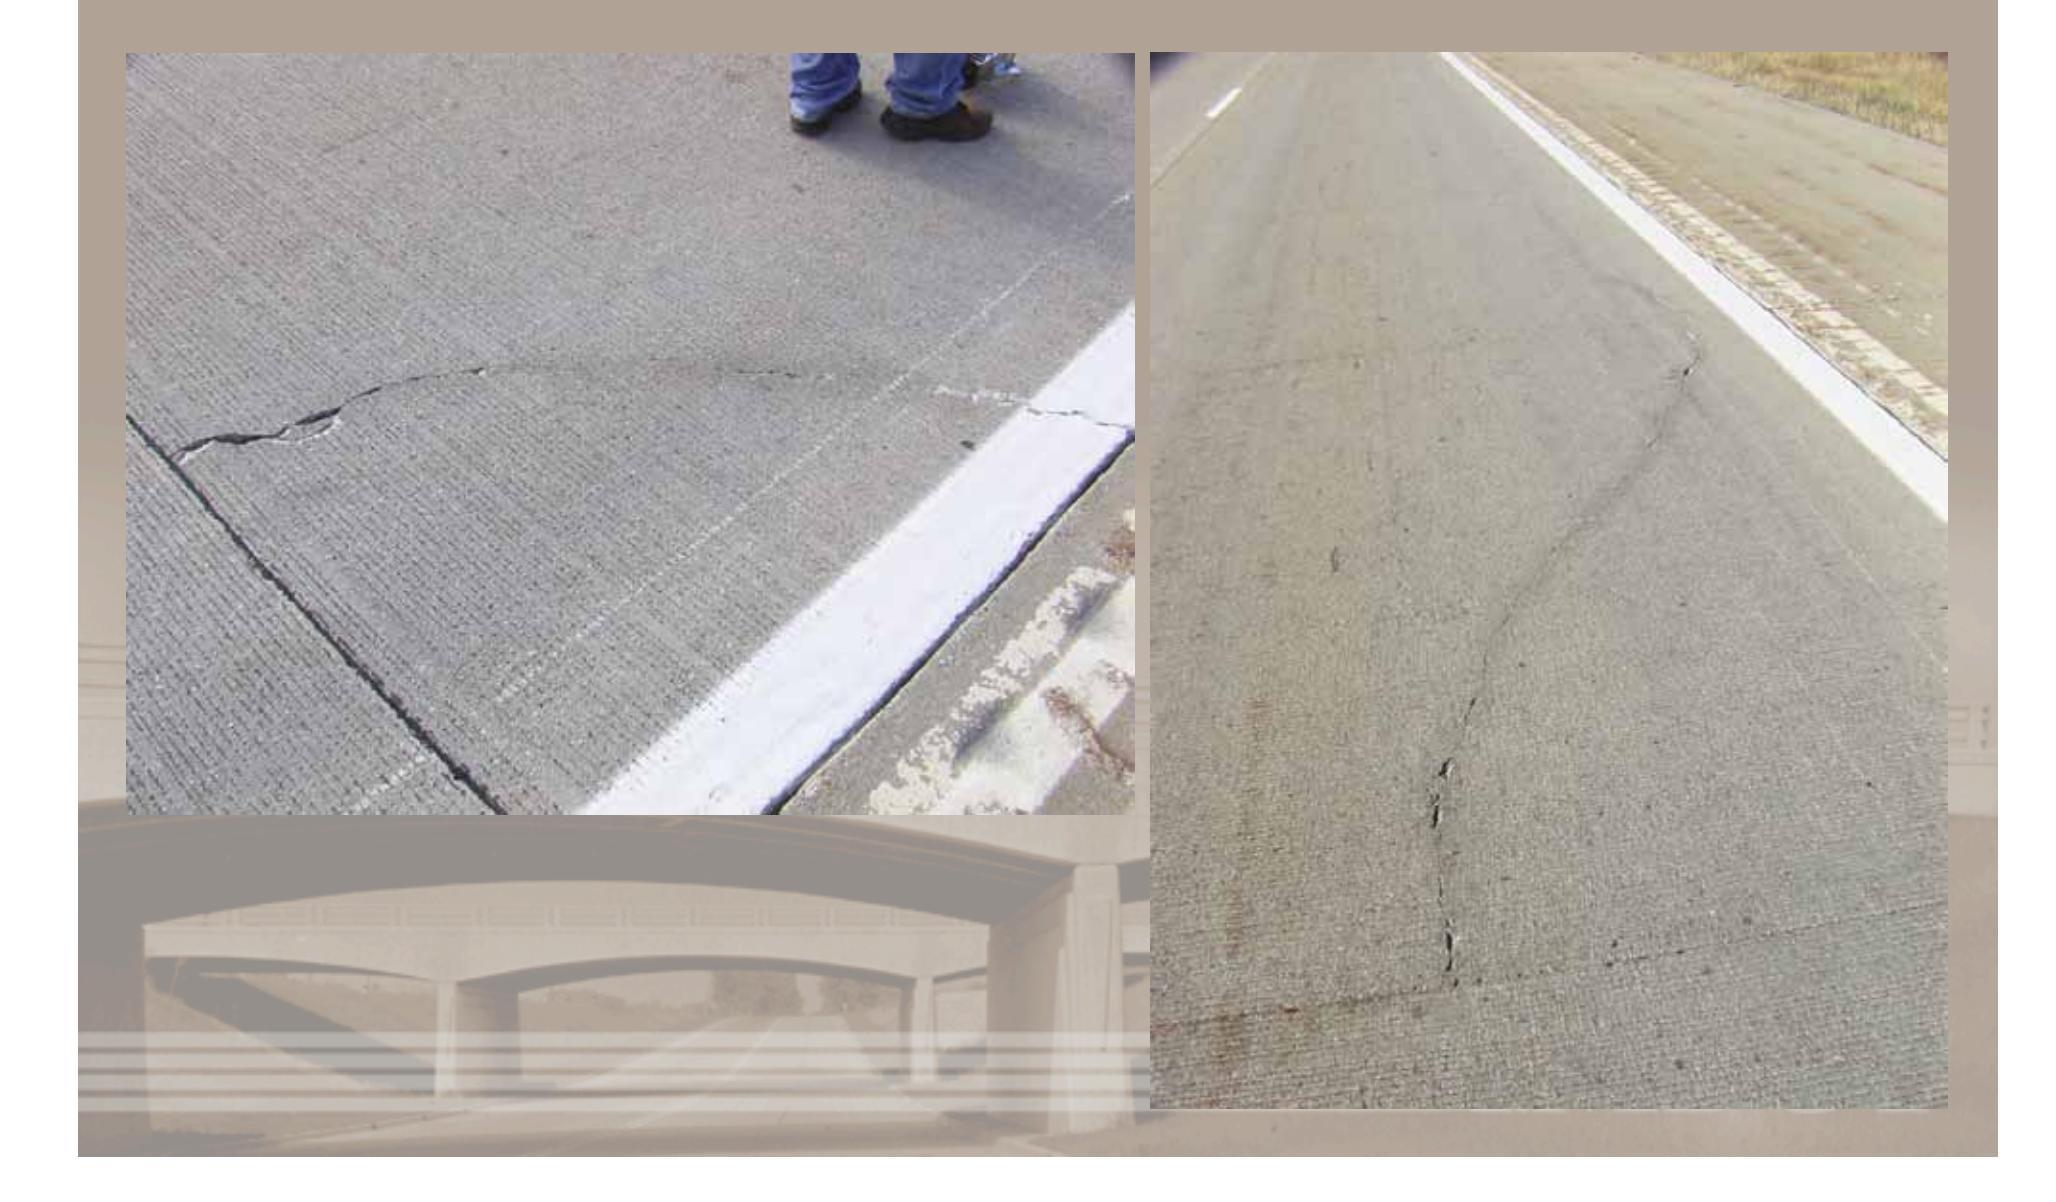
- Crown correction
 - Existing pavement = parabolic
 - New pavement = 2% cross-slope
- Initially corrected crown with HMA
- HMA separator layer was a fine mix
 - Edge distress due to HMA compaction under traffic
 - Moved to uniform 1" separator layer with crown correction in the concrete

- Poor drainage
 - Water sitting on the separator layer eroding the HMA

Edge distresses

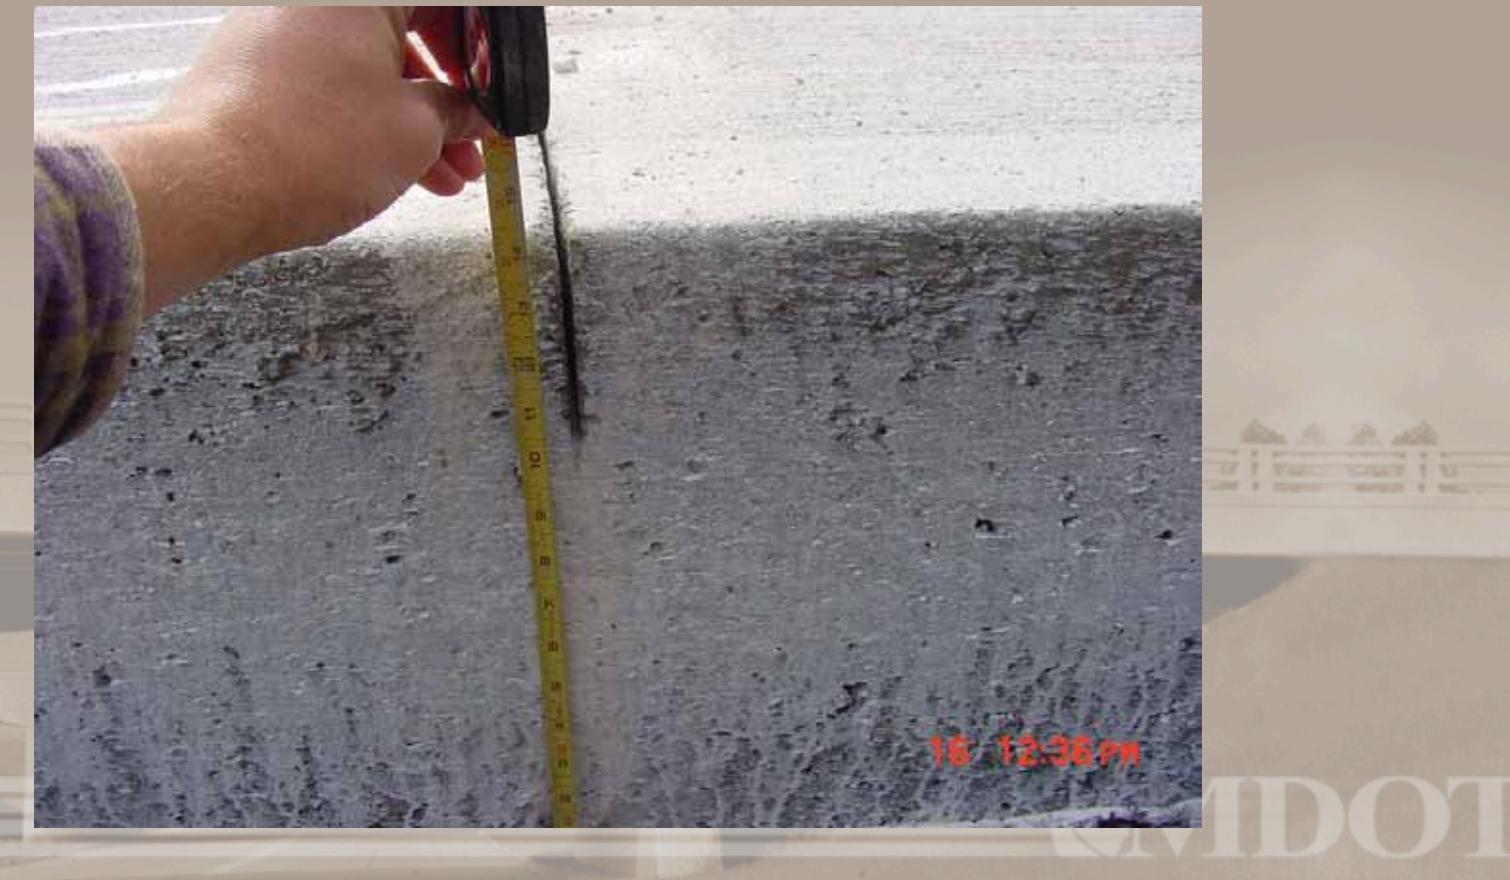
High side of superelevations very thick
due to crown correction

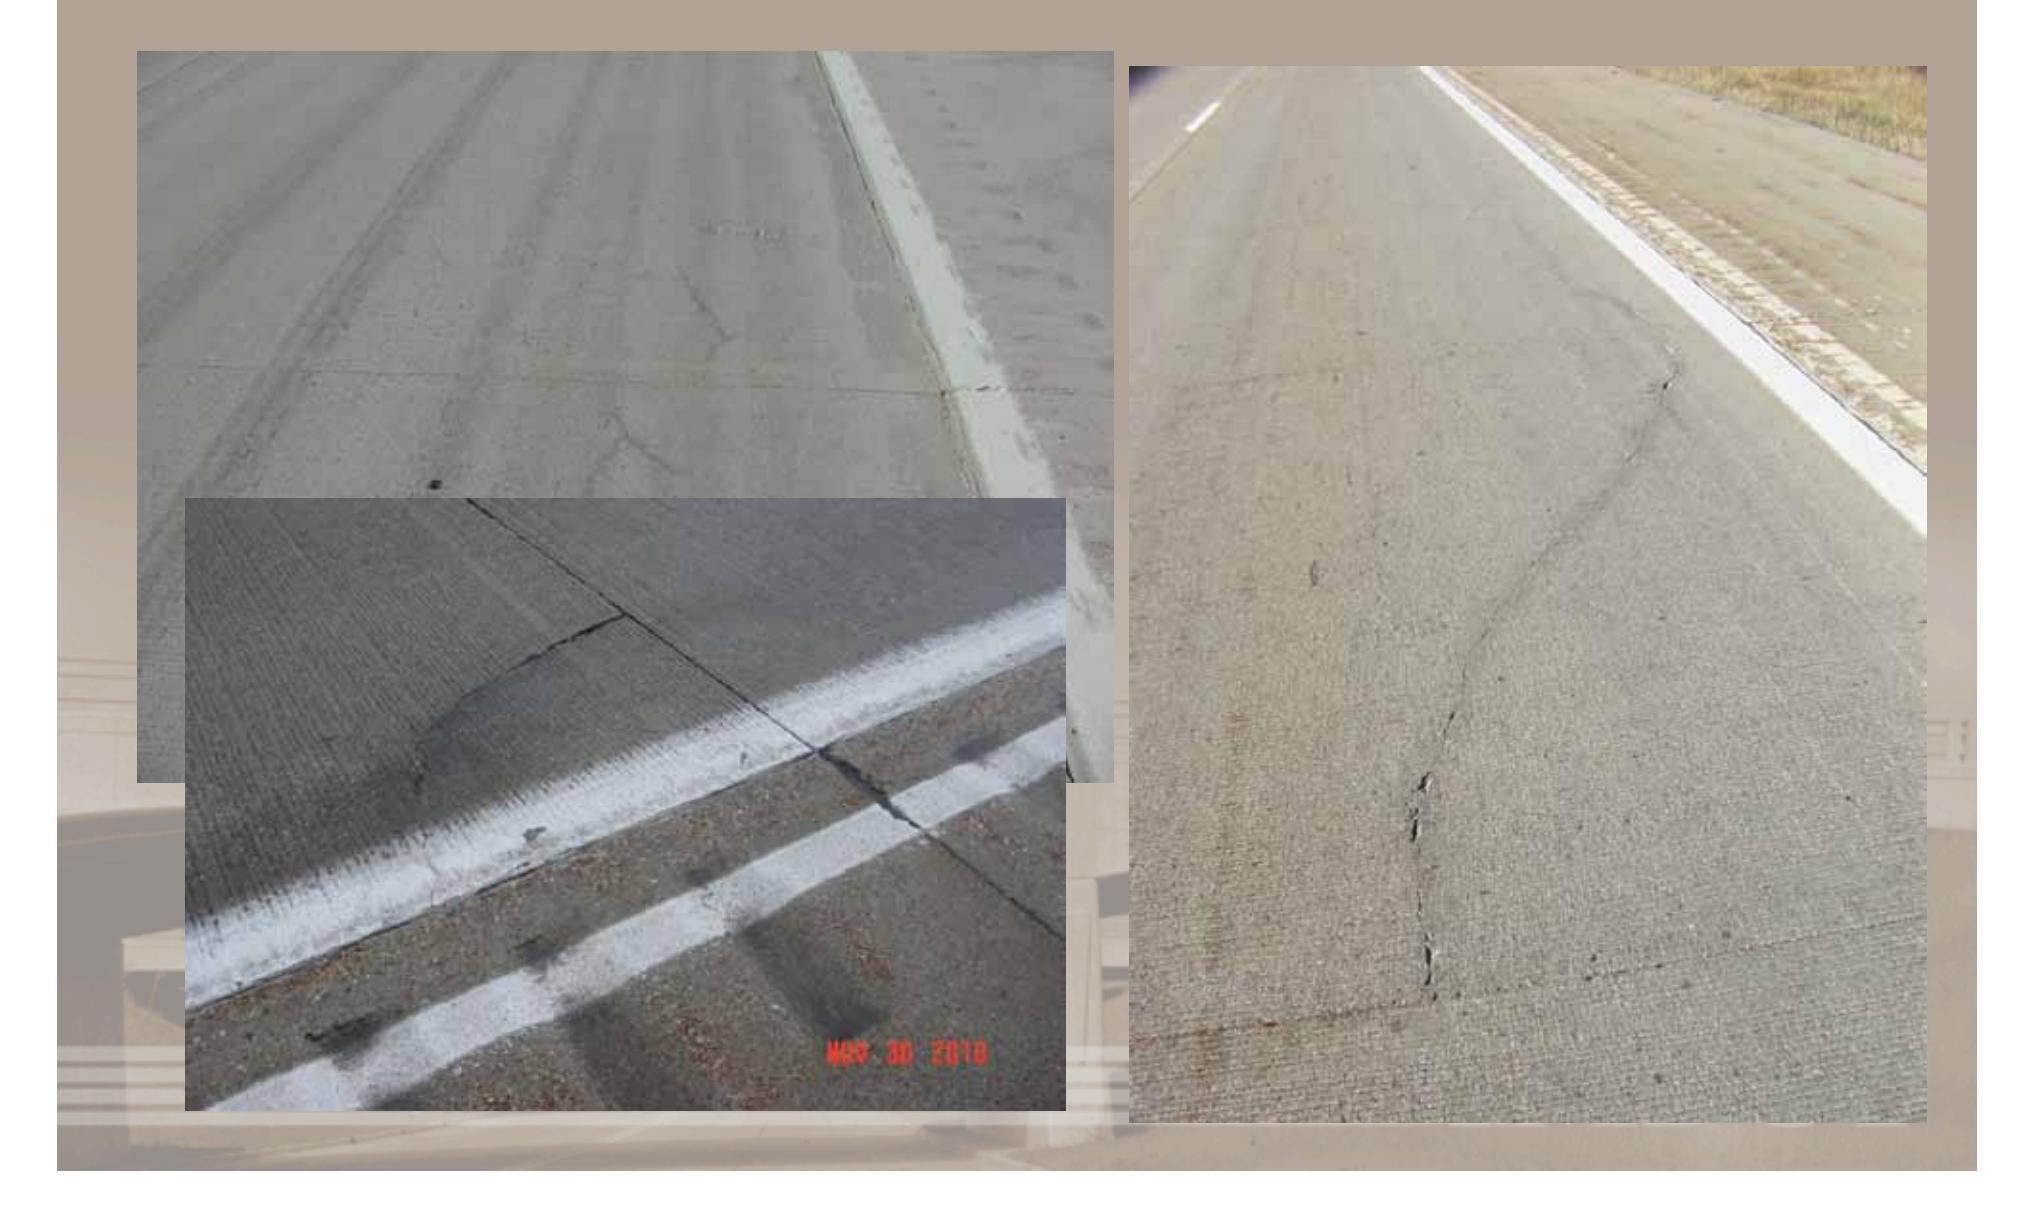
- Example of forensic study
 - I-75 near West Branch (built 2003)
 - 5 test sections
 - #1: 10' joint spacing, undoweled, unsealed
 - #2: 10' joint spacing, undoweled, sealed
 - #3: 12' joint spacing, undoweled, unsealed
 - #4: 12' joint spacing, undoweled, sealed
 - #5: 12' joint spacing, doweled, sealed
 - Sections 3 and 4 exhibiting longitudinal cracking and slightly more faulting

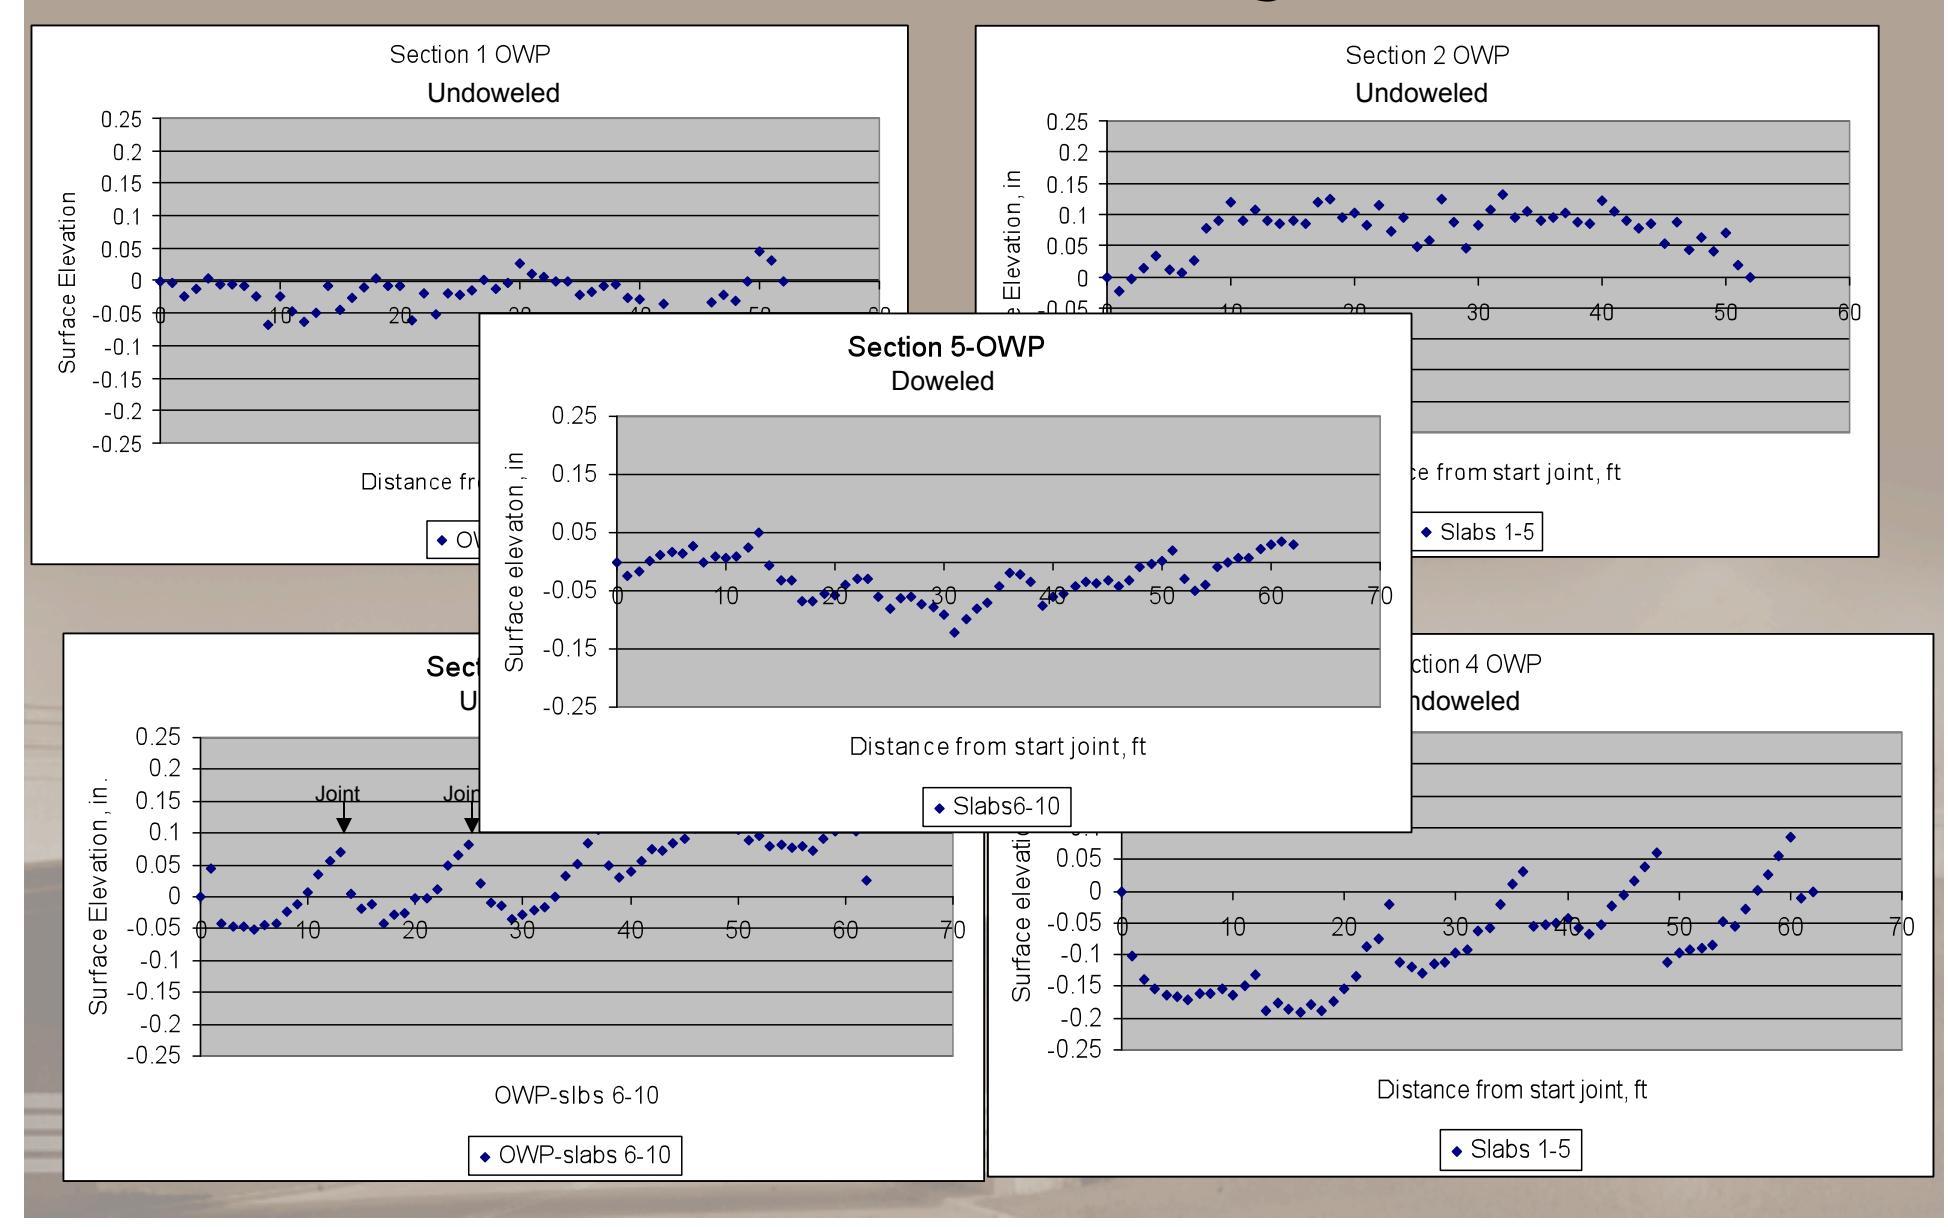
- FWD testing, Dipstick[®] profiling device, coring, pavement removal conducted
- Dipstick[®] found substantially more curl or warp at the joints in Sections 3 and 4
- Coring and pavement removal confirmed wet conditions in the HMA separator layer in those sections, and HMA stripping/erosion

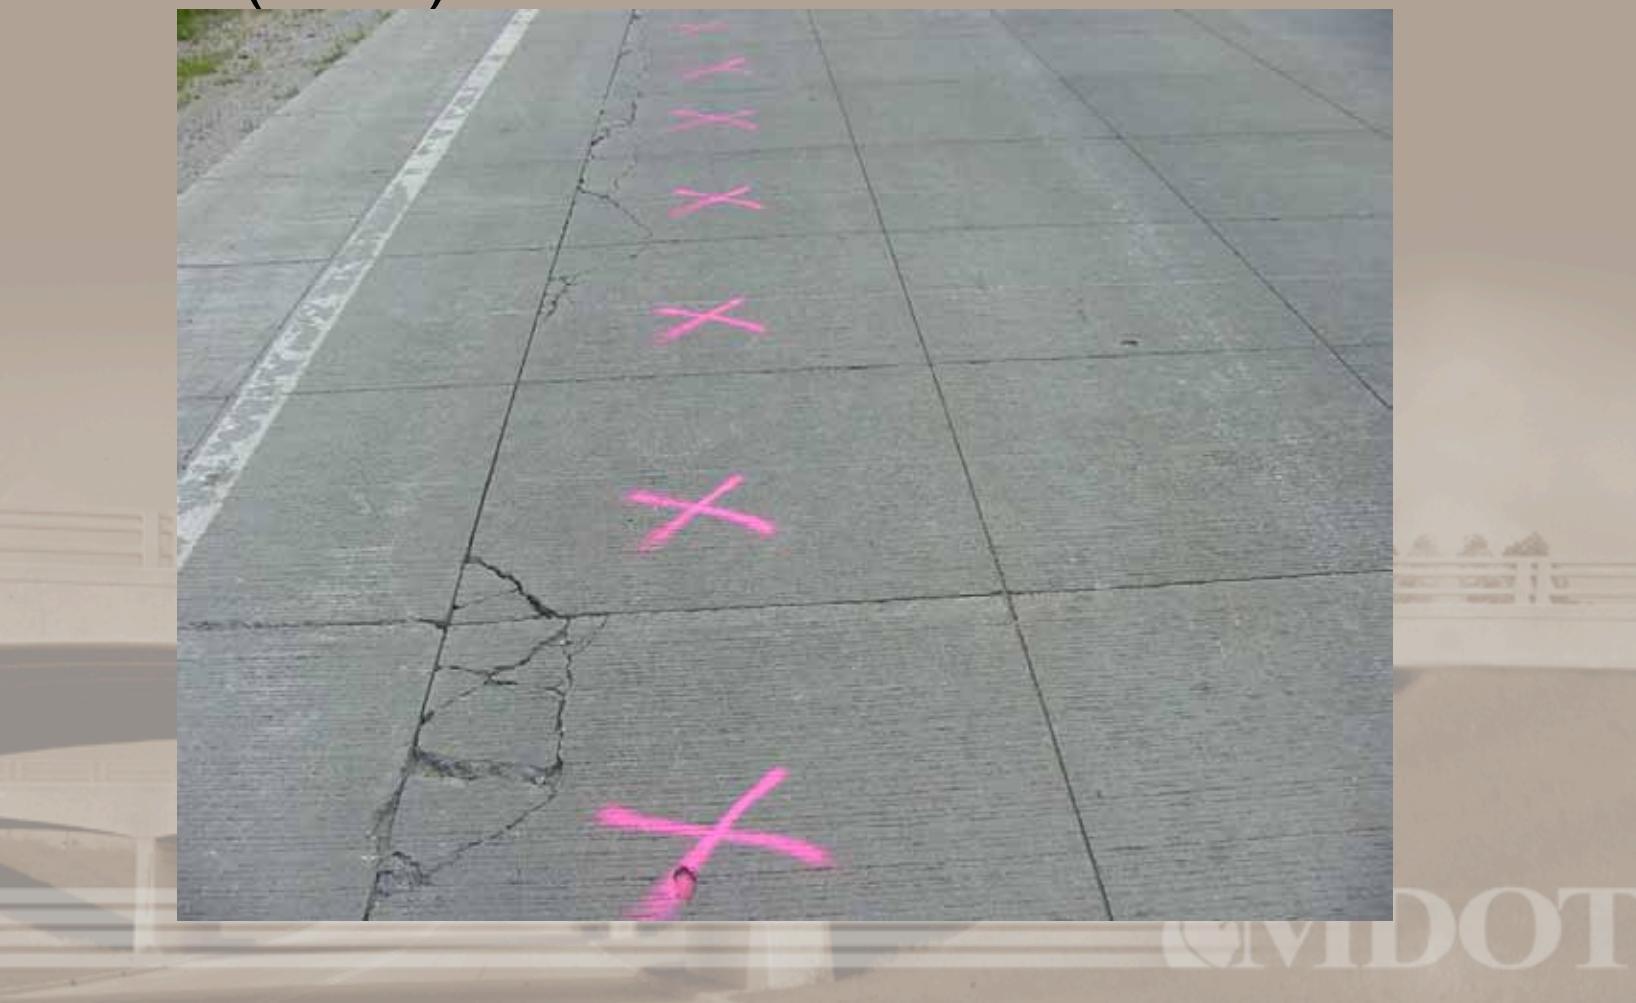
- M-46 (cont.)

- Ultra-thin performing poorly
- Large number of 1 meter X 1 meter panels replaced in 2004. Primarily over the edge of the old 20' wide concrete.
