MnDOT Contract, No. 1003325, Work Order No. 56

NRRA Long-term Research Project

Performance Benefits of Fiber-reinforced Thin Concrete Pavement and Overlays

Task-2: Second Year Annual Cell Performance Report (2018-2019)

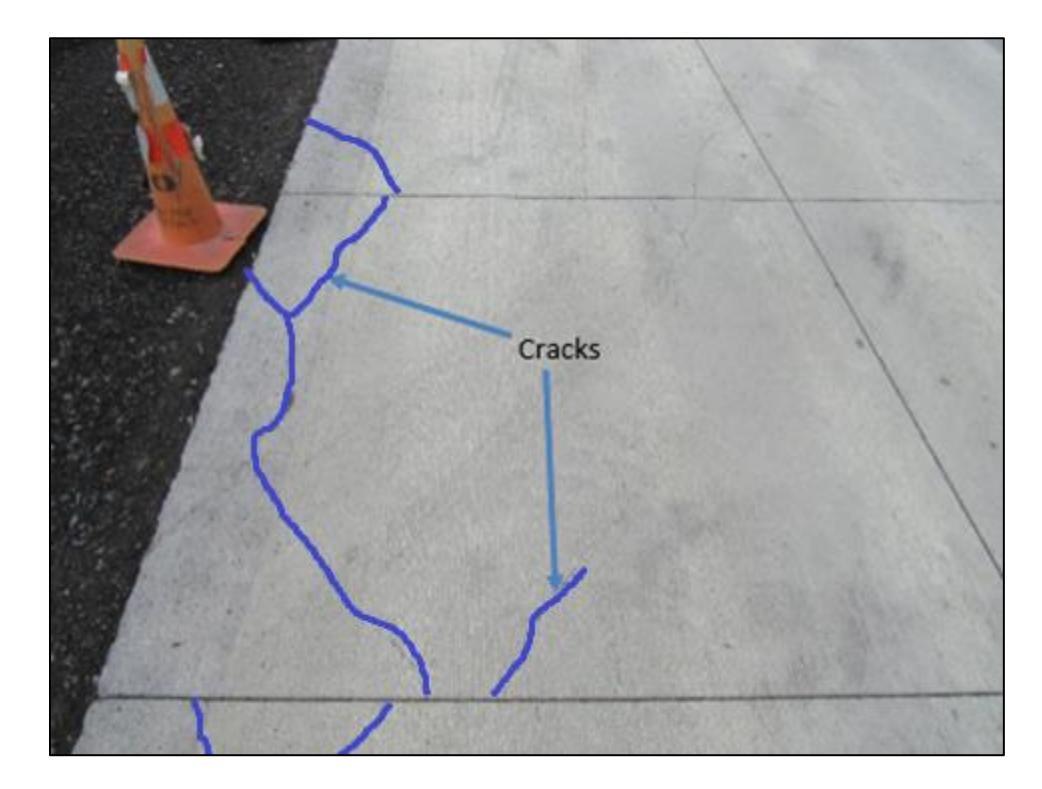
Cell 139 was constructed with a three-inch-thick (ultra-thin) concrete pavement on an unstabilized gravel base at the MnROAD low-volume test track. The size of the slabs of this cell was 6ft x 6ft and the number of the total slabs is 180. Cell 139 was inadvertently exposed to early loads from construction trucks that were using the crossover segment to access other cells under construction, which resulted in many early-age cracks. Figure 2-2 shows a picture of a couple of such early-age cracks in this cell. These types of cracks continued to develop, propagate throughout the first year of service, and eventually, many slabs of this cell were shattered by the end of the summer of 2018. Besides that, there was a considerable amount of depression along the outer wheel path at some locations; this distress looked similar to rutting that occurs in asphalt pavement. Figure 2-3 and Figure 2-4 show photographs of the abovementioned distresses. While the slab thickness limitation (only 3-inch thick) of this cell and early-age loading were the main reasons for the initiation of the distresses of Cell 139, a relatively weak base layer and some drainage issues were believed to have aggravated the distresses of this cell.

Figure 2-2. Cell 139 after exposure to construction trucks.

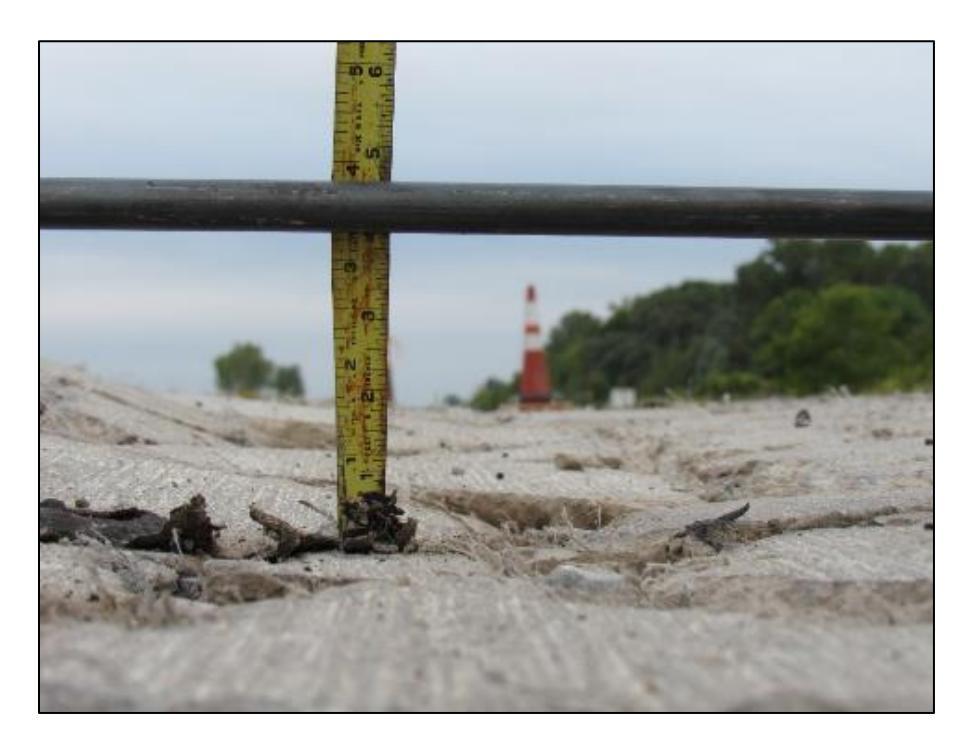
Figure 2-4. Depression along the wheel path in Cell 139.

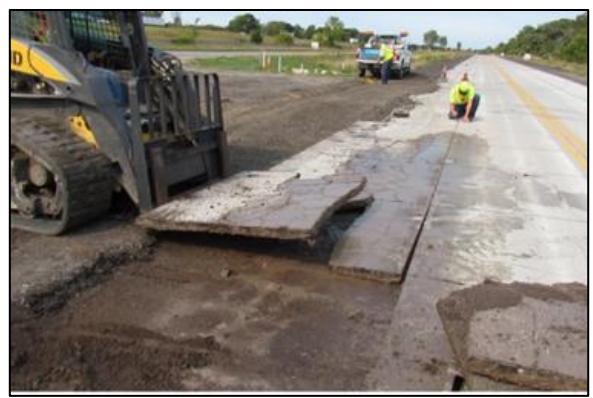
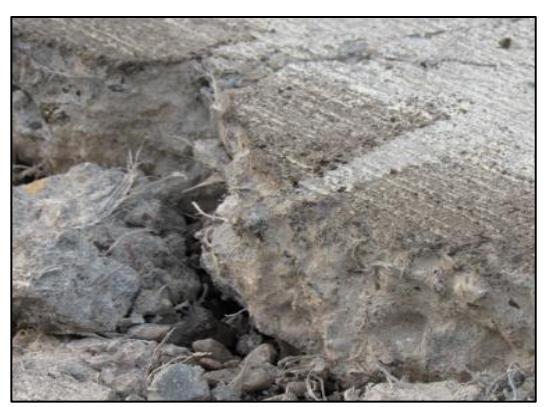
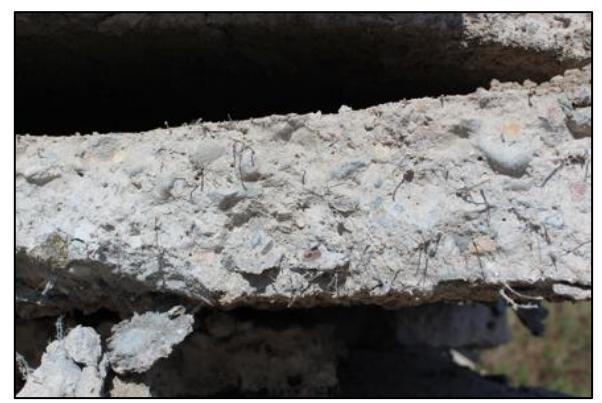
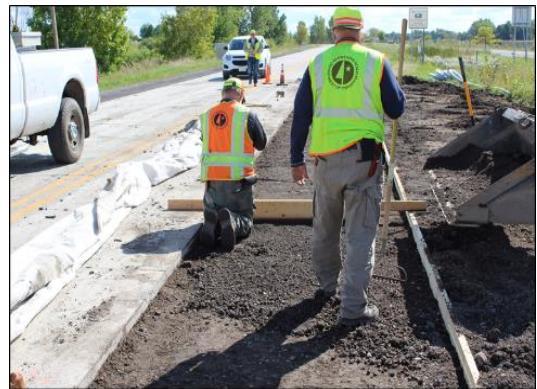
(2.5 a) Removal of broken slabs for Cell 139

(2.5b) Close shot of the broken concrete pieces

(2.5c) Fibers on the fractured face of a concrete piece.

(2.5d) Preparation of the base layer for reconstruction of the broken slabs.

Figure 2-5. Photographs of the replacement and reconstruction on Cell 139 (outer slabs, inside lane).

As many as 14 of the 44 slabs in the inside lane were replaced on September 27, 2018. Figure 2-5 shows a few ph collected during the removal of broken slabs and the construction of the replacement slabs. The replacement slabs are now 4-inch thick, with eight of them containing fiber reinforced concrete and the other six constructed with plain concrete. The fibers used in the replacement slabs are different and laterally stiffer than that used in 2017, as shown in Figure 2-6a. The dosage of the fiber was 5.5 lb/cy, which corresponds to a 30% residual strength ratio. Figure 2-6b shows the ASTM C1609 test results for the two numbers of beam samples prepared at the site during the construction of replacement slabs in Cell 139. The replaced slabs are performing well; no cracks have been found visible in a recent photographic survey conducted in October 2019.

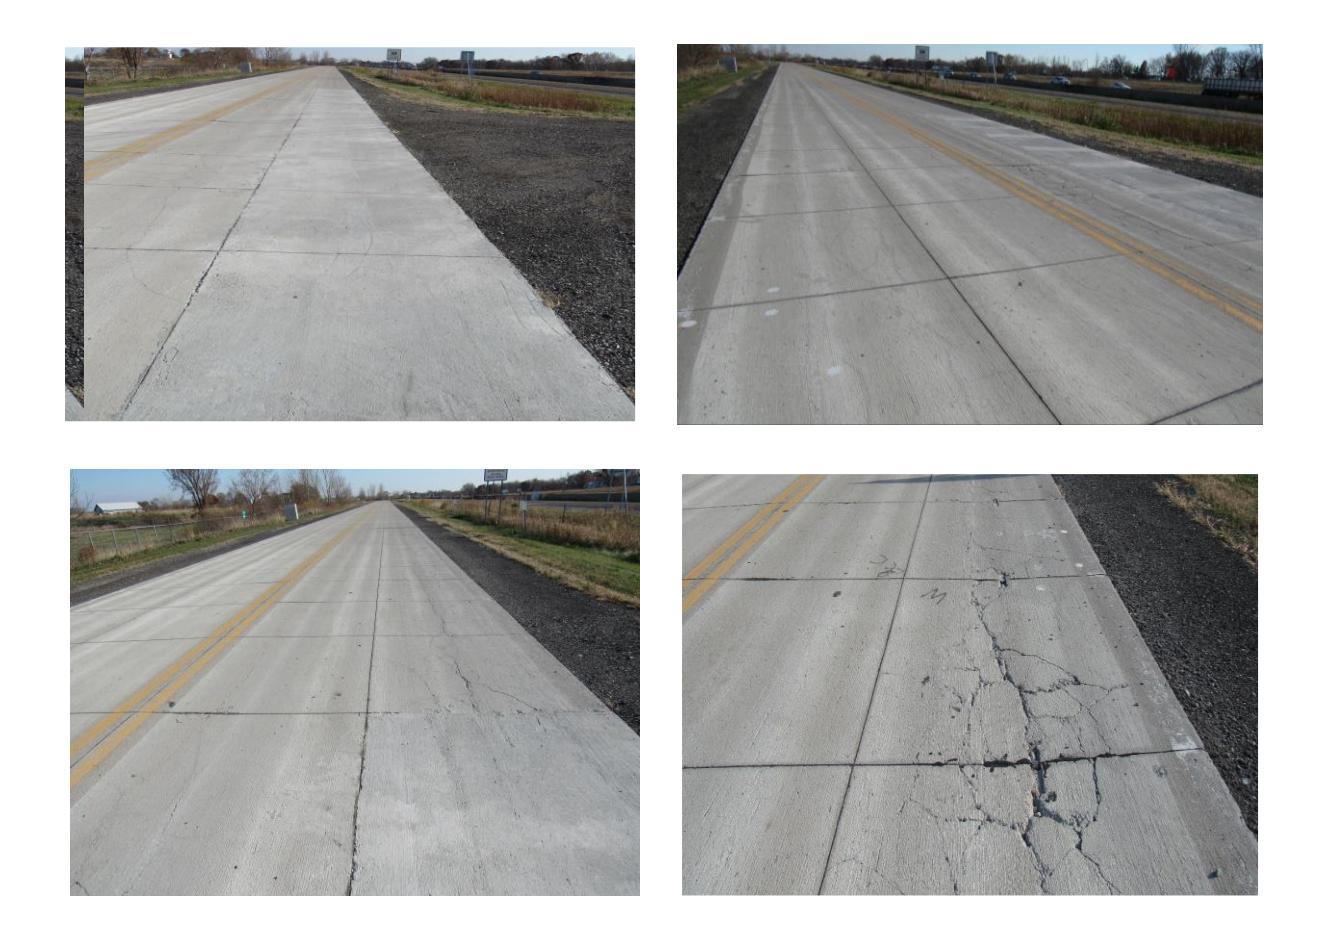
A large number of the unrepaired slabs of this cell, however, have cracked with longitudinal cracks (primary) that resulted in many secondary cracks in transverse and diagonal directions. Based on the December 2019 distress survey data, it was found that as much as 75% of the slabs have cracked in Cell 139 after 114,000 ESALs applied to them. Figure 2-7 shows four photographs of Cell 139 taken in October 2019. The distresses are continuously progressing in the older slabs, as shown in Figure 2-7; additional shattered slabs with multiple cracks can be noticed at some locations.

Figure 2-7. A few photographs of Cell 139 during October 2019.

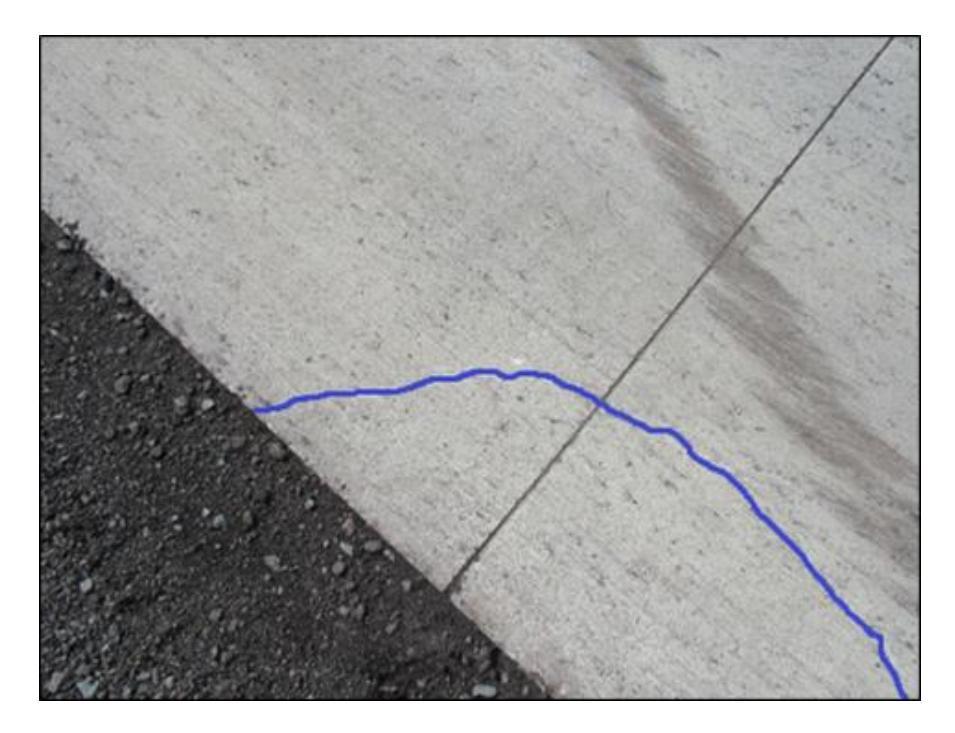
Cell 239 on the low-volume test track, which is a 4-inch thick concrete pavement on an unstabilized gravel base with 6ft x 6ft slabs, experienced longitudinal cracks and corner cracks. The total number of slabs in the cell is 176. Figure 2-8 shows a photograph of

Figure 2-8. Corner cracks in Cell 239 (2018)

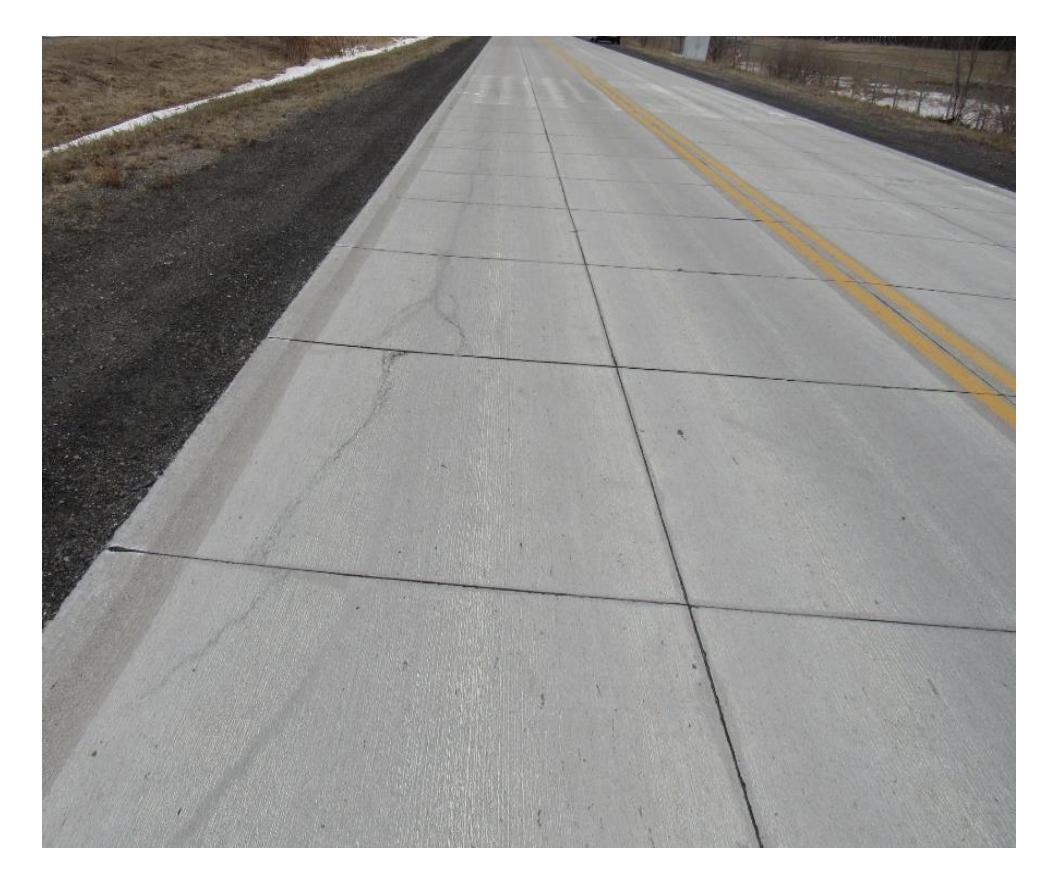
Nevertheless, it was found that Cell 239 performed better than Cell 139 throughout the last two years. Based on the distress survey data of December 2019, a total of 22 longitudinal cracks and 10 corner cracks have resulted in this cell, in other words, a total of 18% slabs have cracked after 85,000 ESALs.

Figure 2-9. Longitudinal cracks in Cell 239 (April 2019)

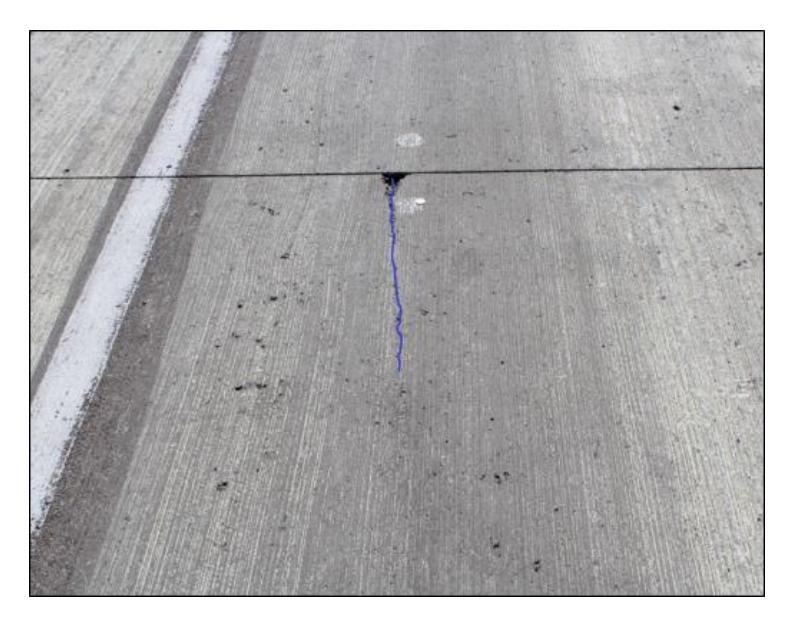
Figure 2-10. Longitudinal crack in Cell 705 (2018)

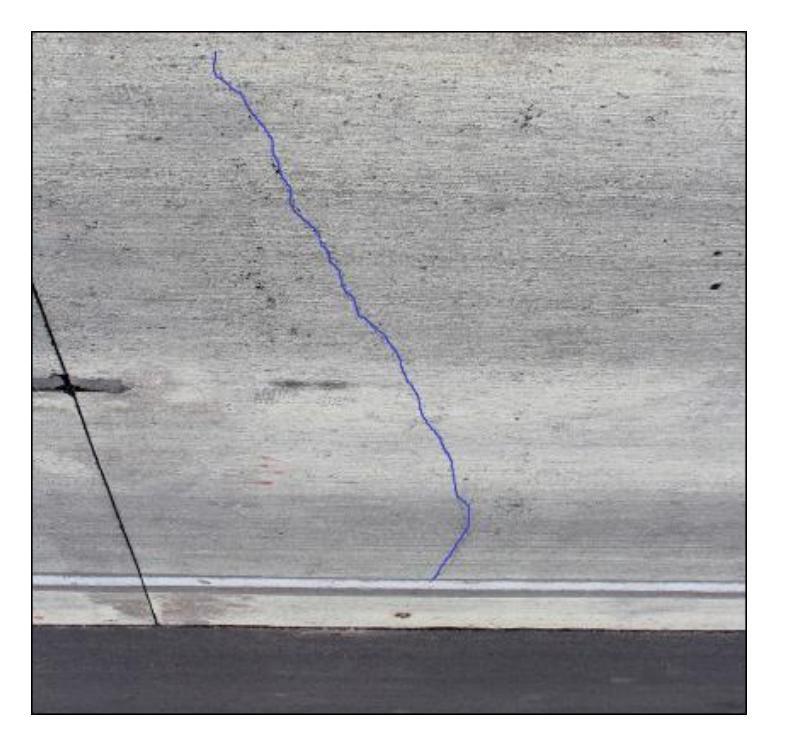
Figure 2-11. Transverse crack in Cell 705 (2018)

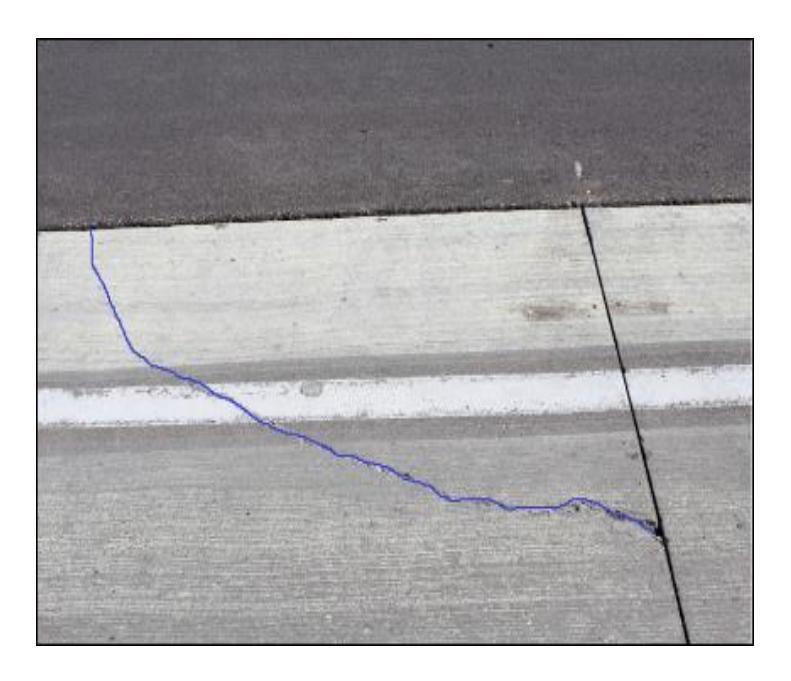
Figure 2-12. Corner crack in Cell 705 (2018)

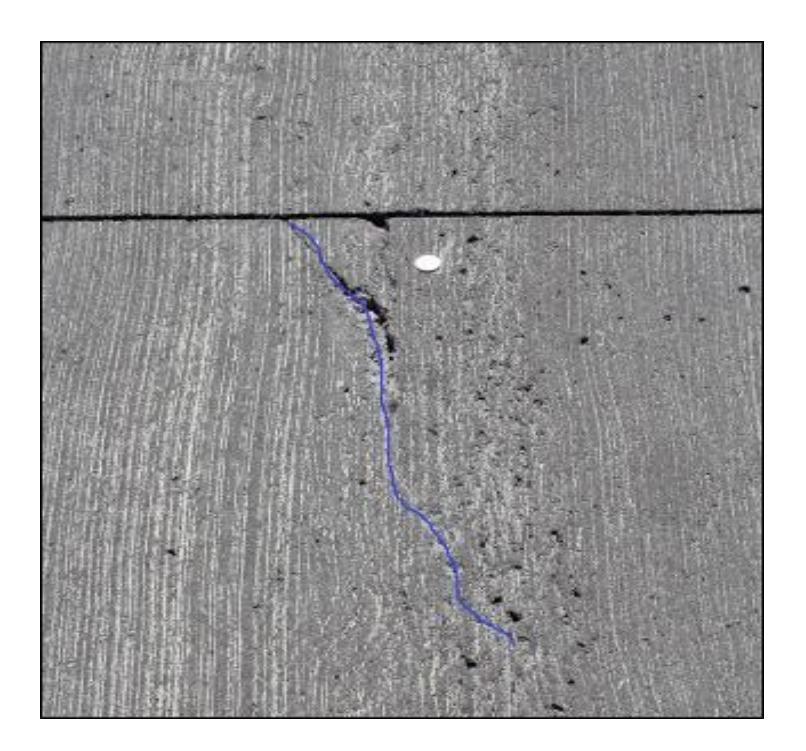
Figure 2-13. Longitudinal crack in Cell 805 (2018)

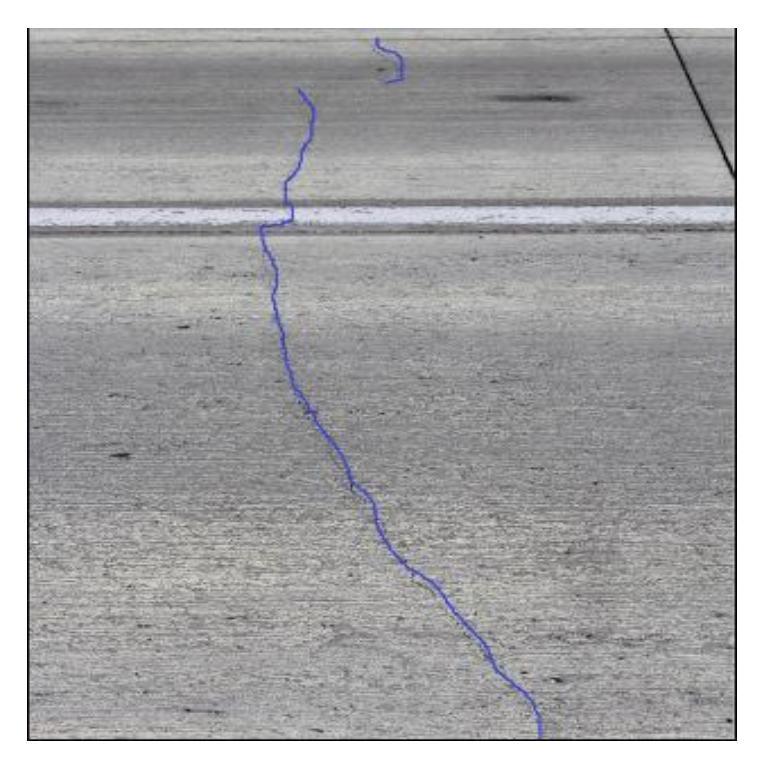
Figure 2-14. Transverse crack in Cell 805 (2018)

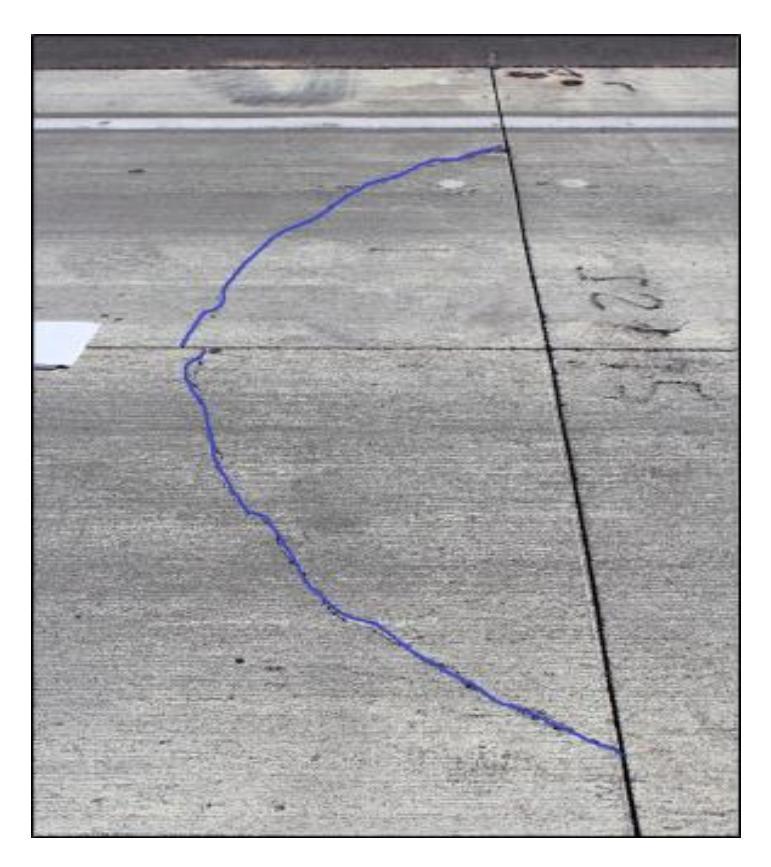
Figure 2-15. Corner crack in Cell 805 (2018)

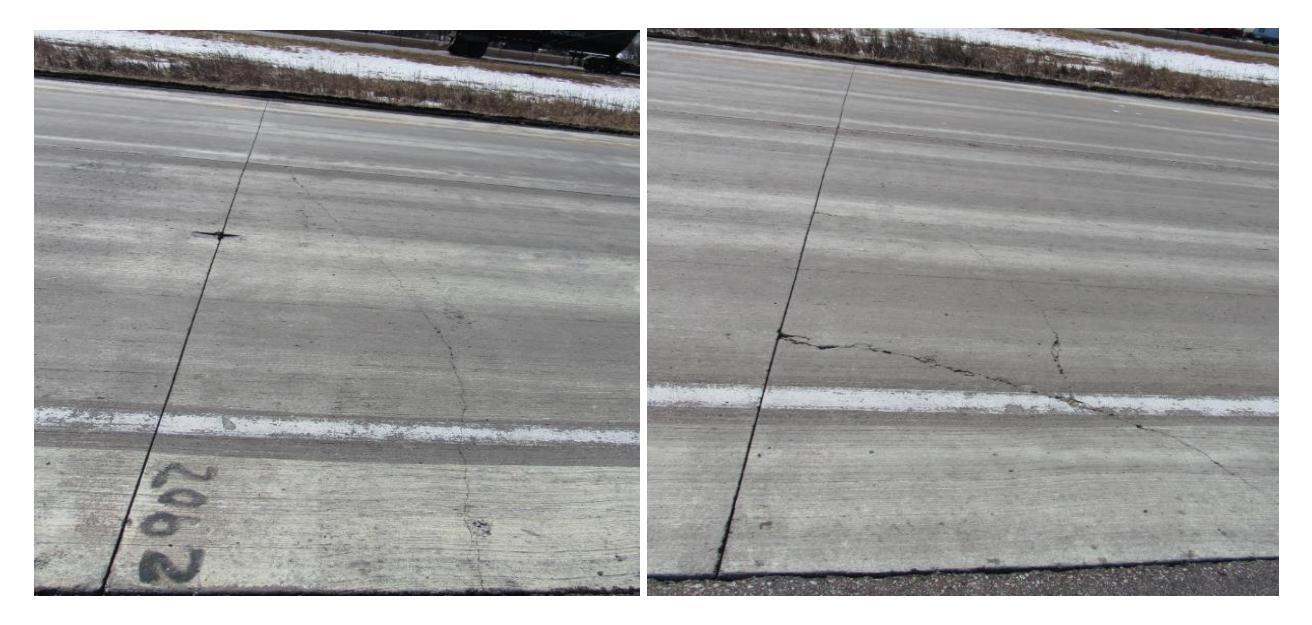
Figure 2-16. Photographs of transverse and corner cracks in Cell 705 as observed during April 2019

Based on the distress survey conducted in October 2019, Cell 705 has 11 longitudinal, five transverse and six corner cracks. Cell 805 has experienced a total of seven longitudinal, eight transverse and five corner cracks. It was found that as many as 55% slabs of Cell 705 and 28% slabs of Cell 805 have cracked after 2.4 million ESALs of traffic load on them.

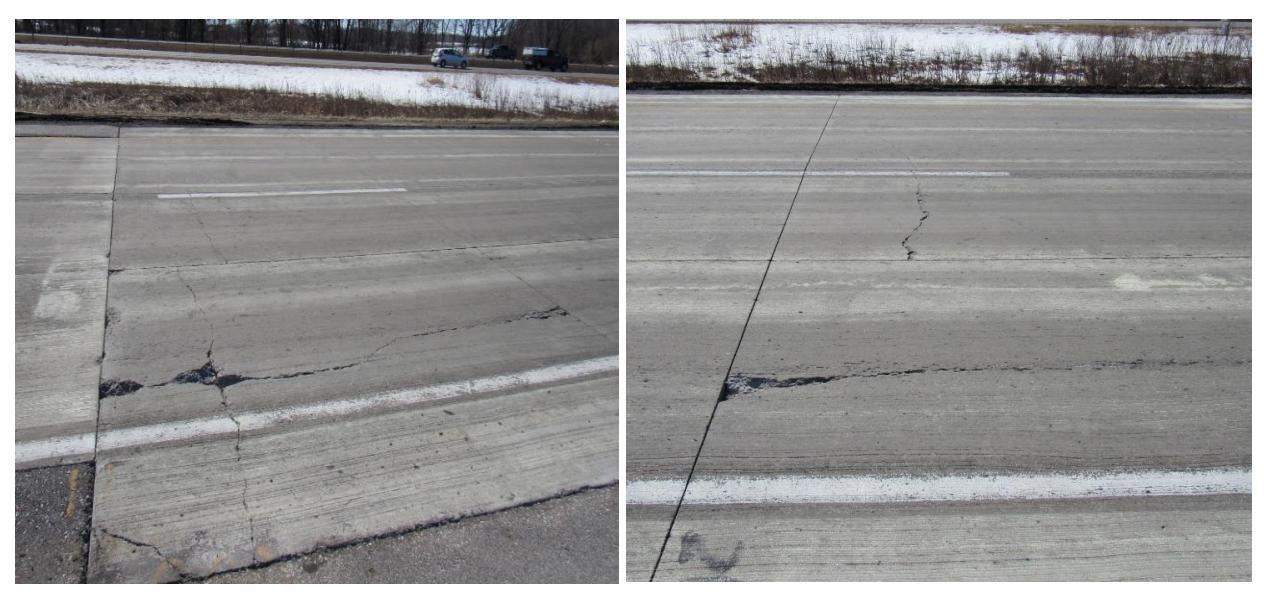
Figure 2-17. Photographs of observed cracks in Cell 805 during April 2019.

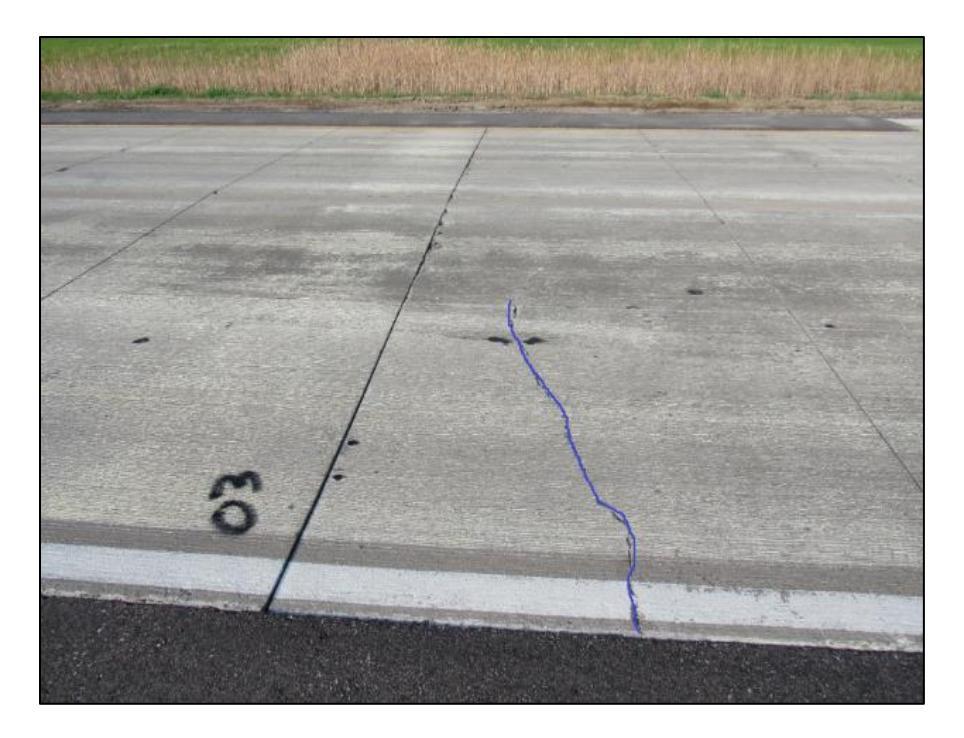
Figure 2-18. Transverse crack in Cell 506 (control, non-FRC) observed in the year 2018.

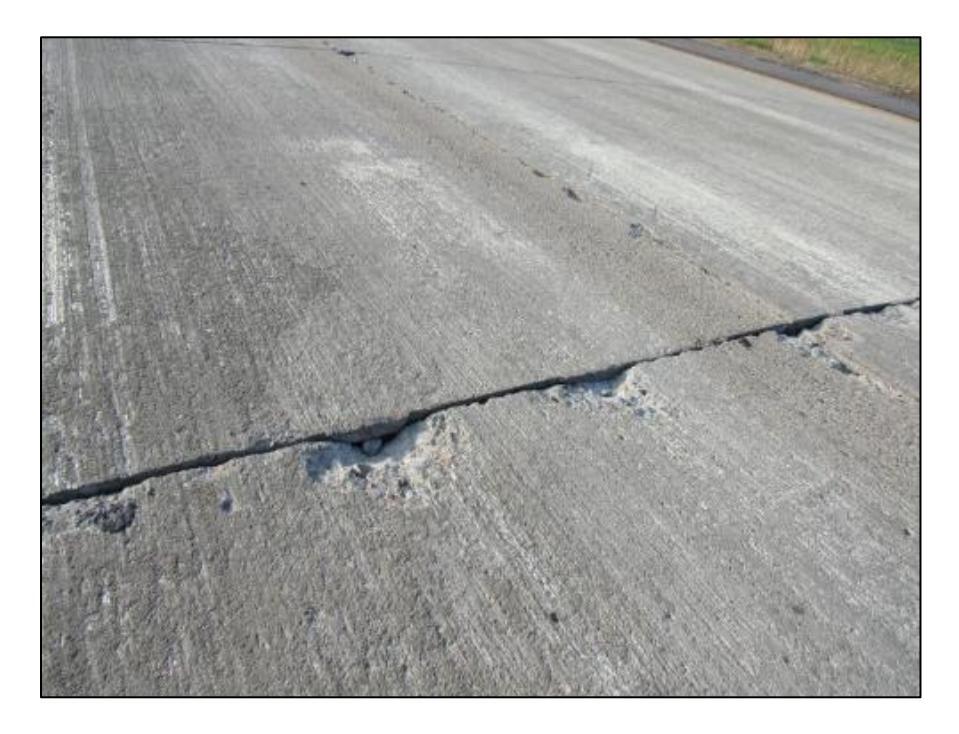
Figure 2-19. Spalling in Cell 506 (control, non-FRC) observed in the year 2018.

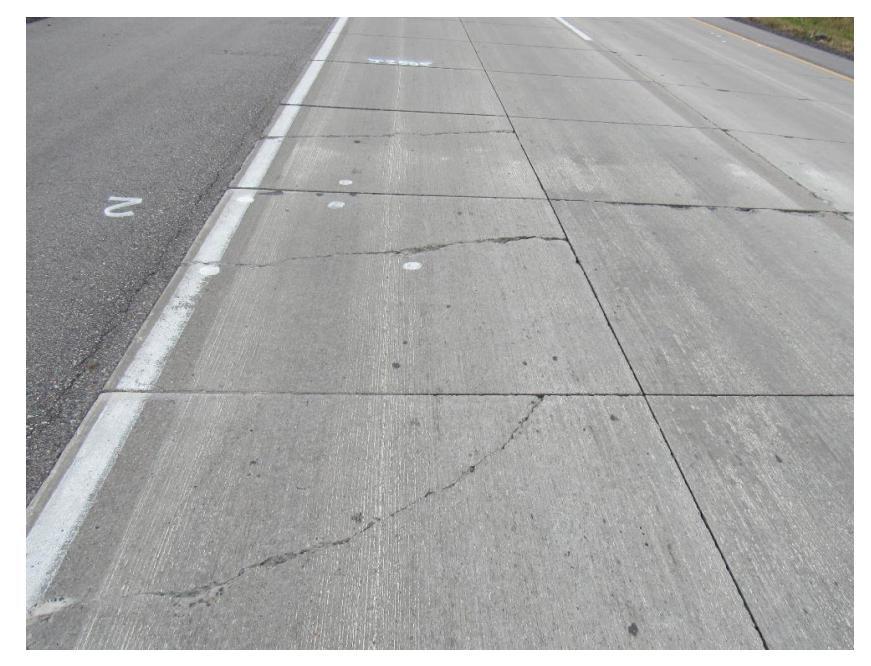
Figure 2-20. Photographs of transverse and diagonal cracks in Cell 506 (October 2019)

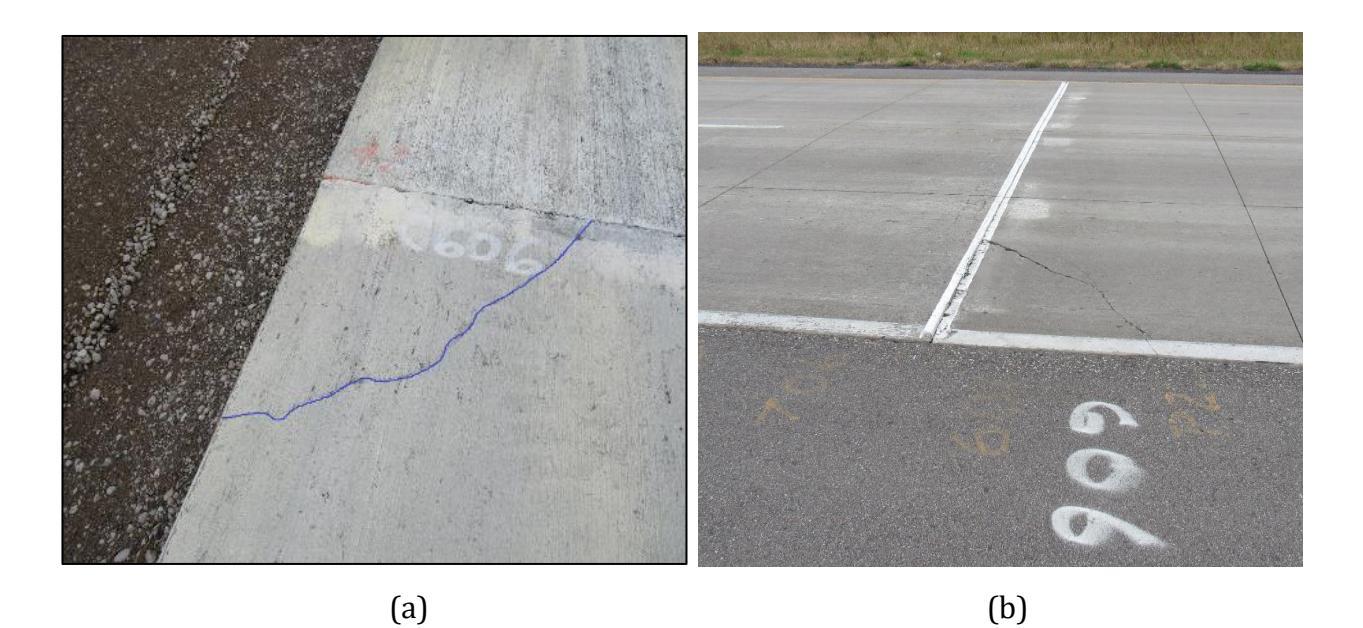
Cell 606, which was constructed with 5 lbs/cy (20% residual strength) of structural fibers, experienced one corner crack prior to April 2018. This corner crack was the only crack as observed during the 2019 distress survey as well. Figure 2-21 shows photographs of the crack in April 2018 and October 2019. It can be seen that the severity of this crack did not change much as compared to what has happened for the cracks in Cell 506 (Figure 2-18 vs. Figure 2-20). As this crack is located in the last panel next to a cell transition joint, it can be assumed that this crack is not a typical fatigue-related crack, it occurred because of a construction issue.

Figure 2-21. Corner crack (construction issue) in the last panel of Cell 606 observed (a)in the year 2018 and (b) 2019

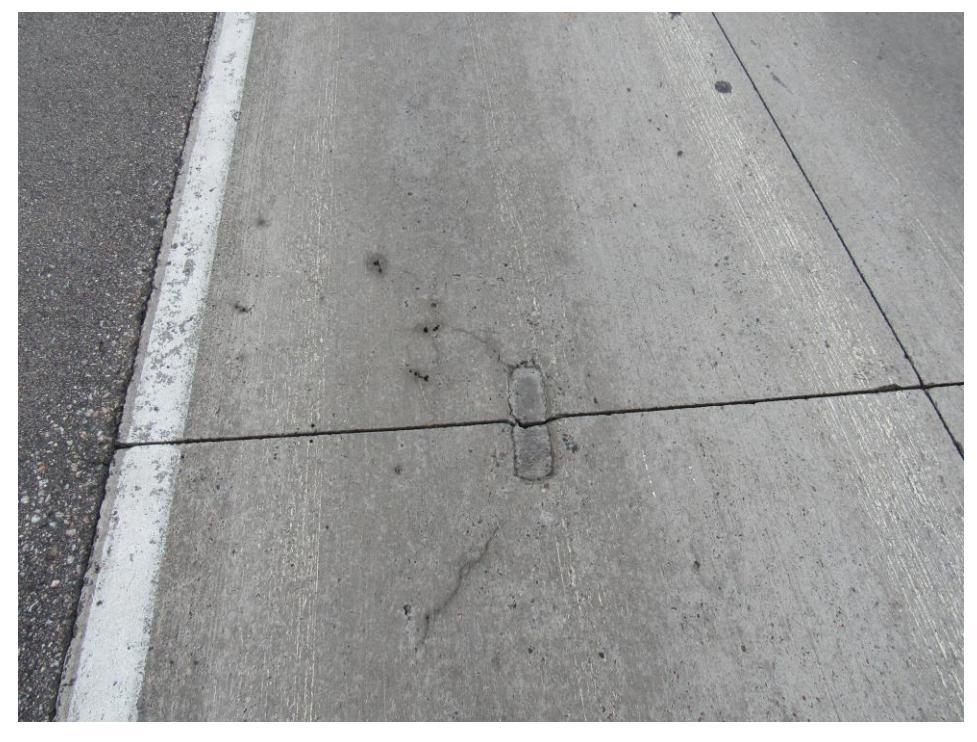
Cells 706 and 806, which were constructed with fiber dosages of 8 and 11.7 lbs/cy, respectively, did not experience any cracks or spalling prior to October 2019 except for a couple of narrow cracks in Cell 806 originated at the location of a joint opening sensor (Figure 2-22).

Figure 2-22. Narrow cracks in Cell 806, originated at the location of the joint opening sensor

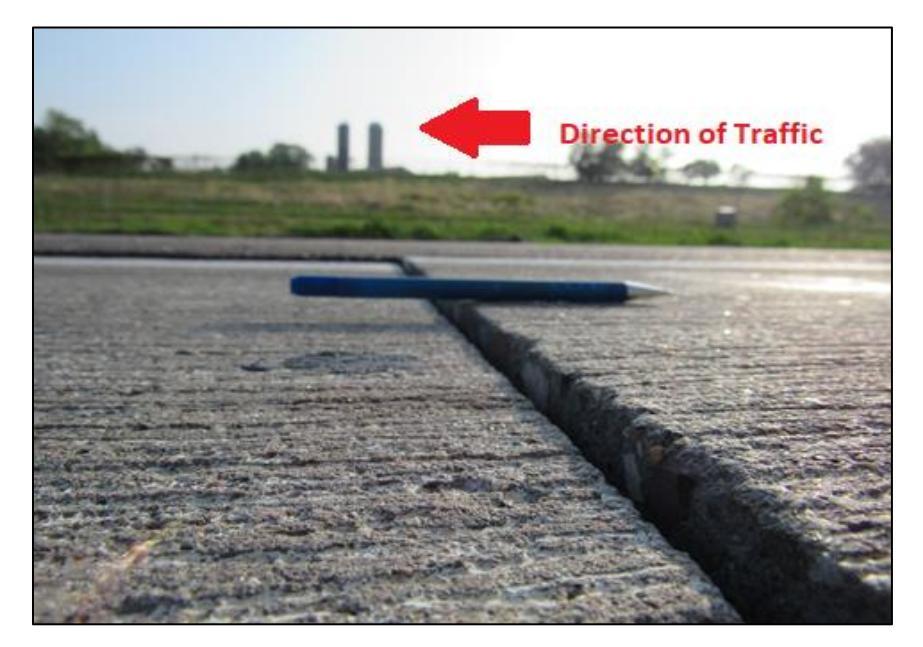
Figure 2-25. Photograph of faulting of Cell 506 (non-FRC). Note that faulting is exaggerated due to the broken corner in slab on leave slab.
