MnDOT ADA Training

Compliance Checklists 2017

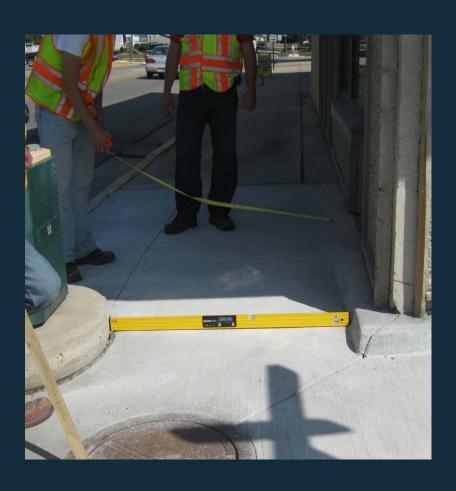
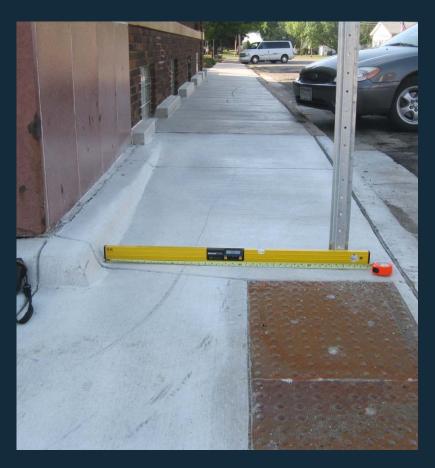
1) Minimum 4 ft. wide Pedestrian Access Route (PAR) with maximum cross slope of 2%

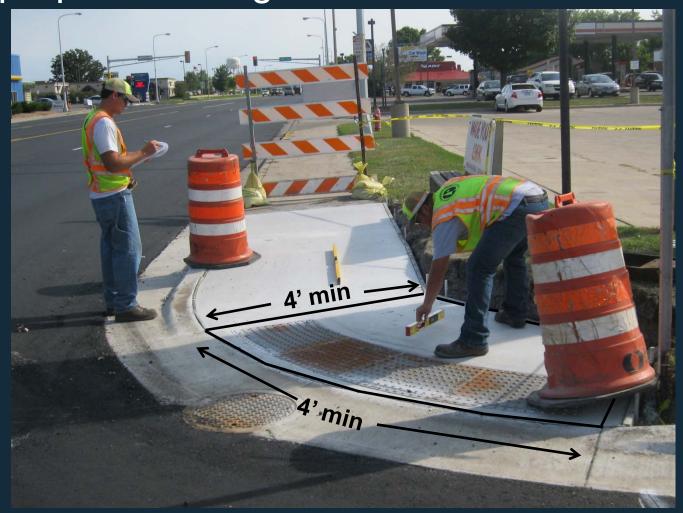
2) Landing dimensions are a minimum 4' x 4' and perpendicular grade breaks.

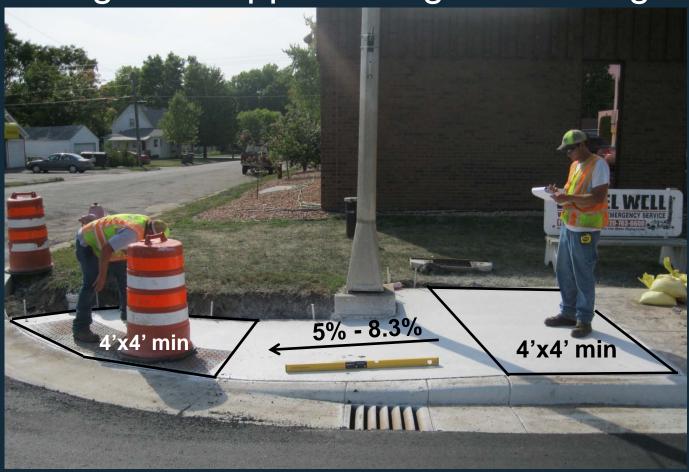
3) Landings are located at the top of each ramp. Is it over 5%? Is there a change in direction? Are there inverse grades approaching the landing?

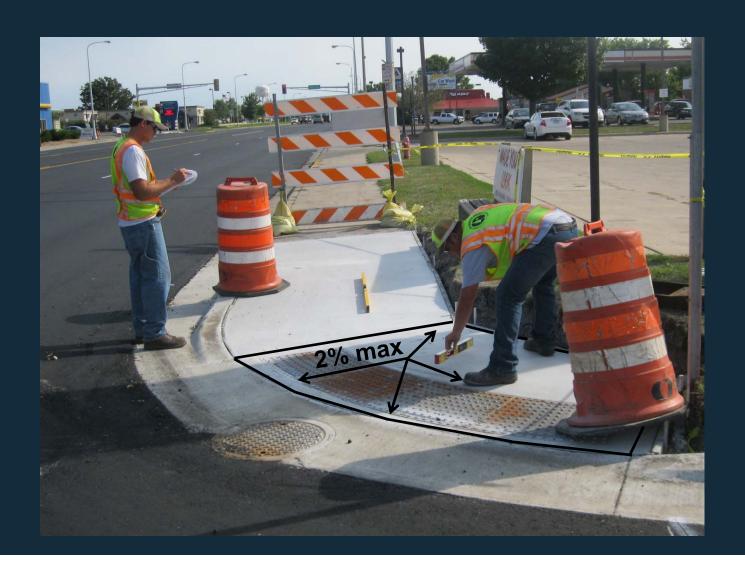
4) Record landing slopes (max. 2% in any direction)

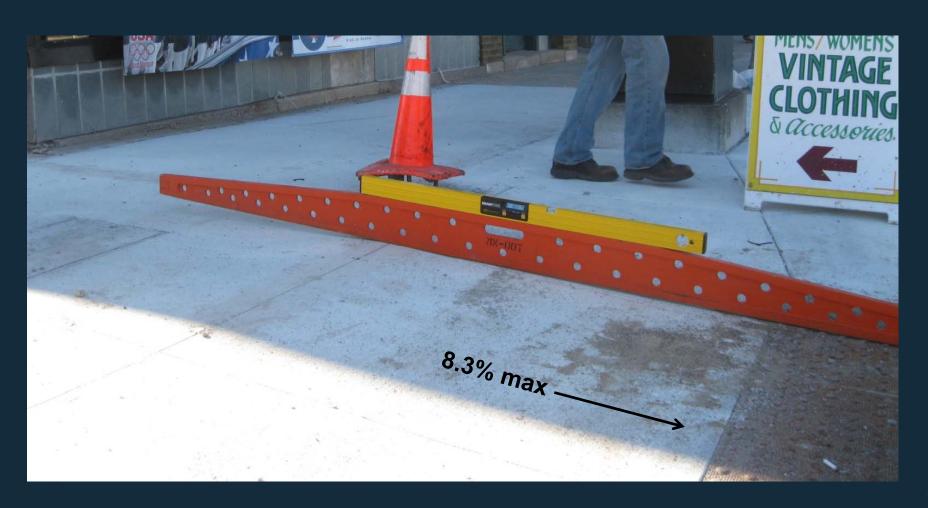
5) Ramp's running slope must be less than or equal to 8.3%.

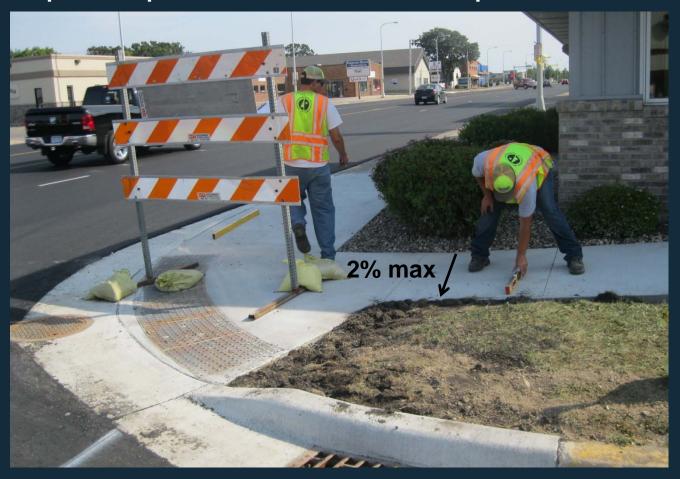
6) Ramp's cross slope must be 2% maximum. If secondary ramp is recorded do not record noncompliant portion of transition panel.

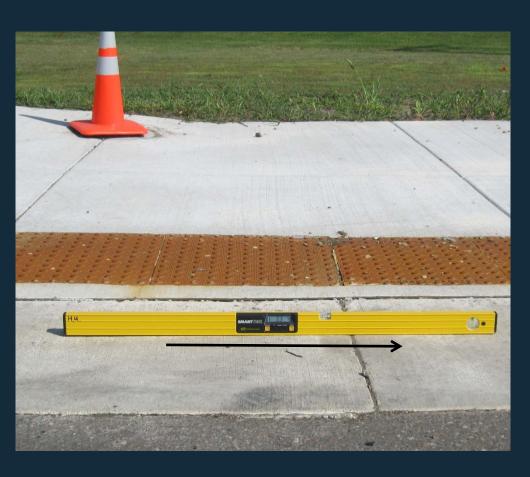
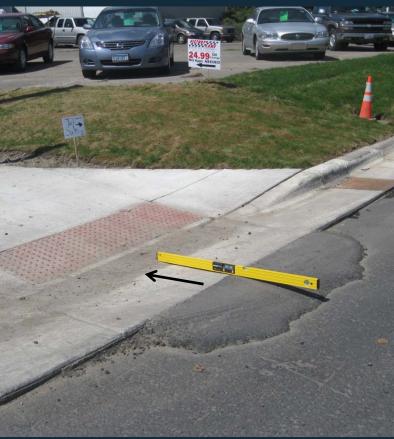
7 & 8) Record gutter flow line slope and inslope.

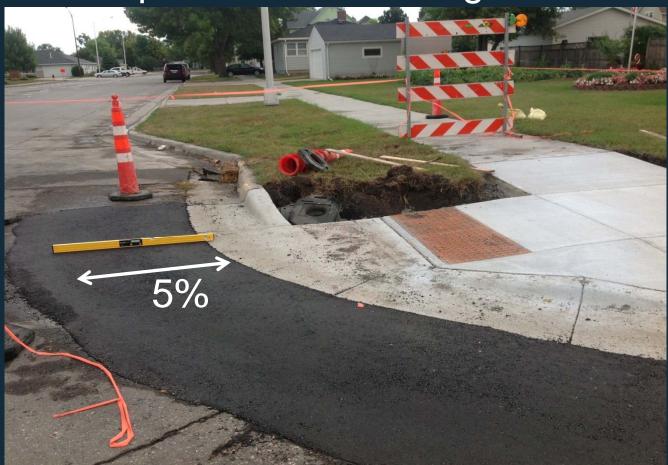
9) Roadway Cross slope is measured perpendicular to curb flow line or edge of roadway and should not exceed 5% at pedestrian crossings.

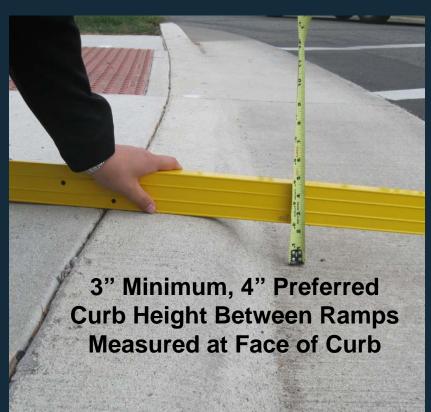
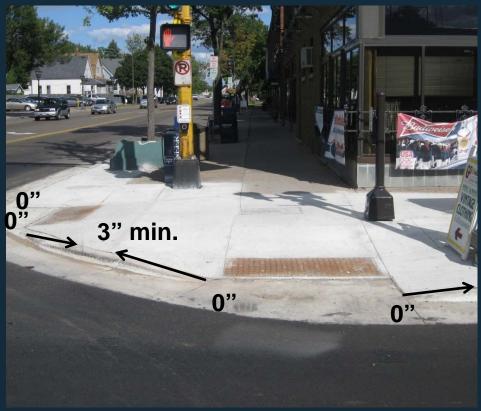
10) Curb tapers are considered a detectable edge when tapers start within 3" of truncated domes and rise to a minimum 3" curb height.

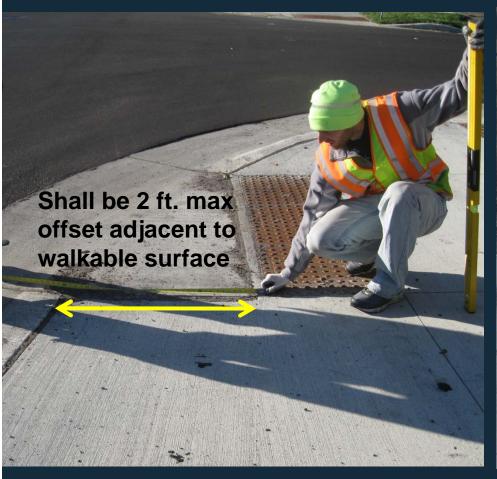
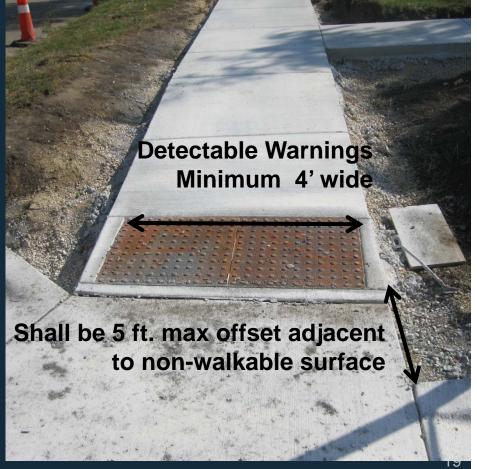
10) Truncated domes cover the entire curb opening and meet setback criteria.

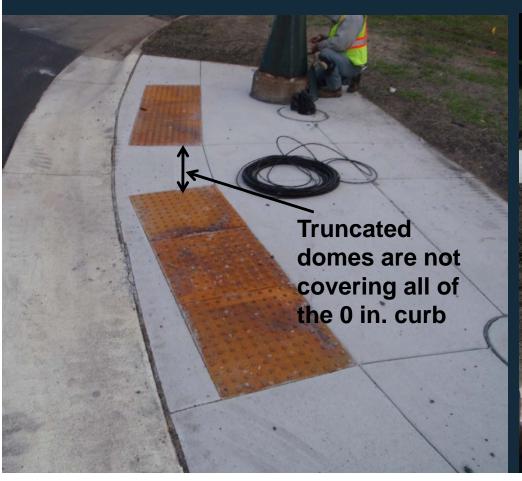
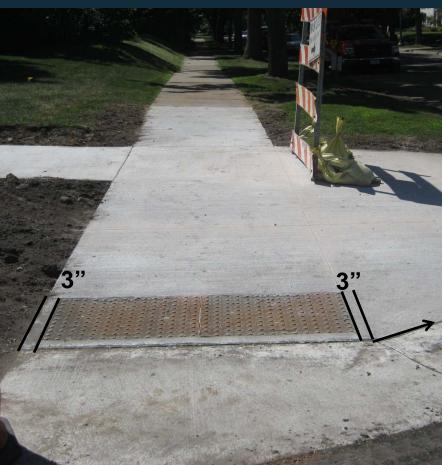
10) Truncated domes shall extend full width of the ramp landing or Blended transition within 3" on either end

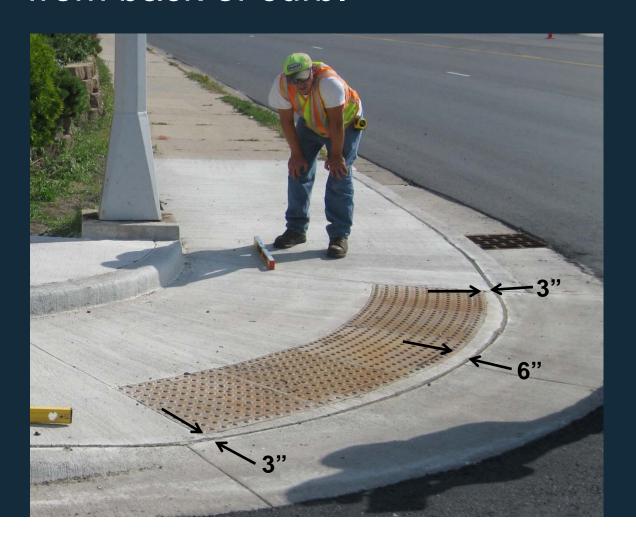
10) Radial Detectable warnings shall be set back 3" to 6" from back of curb.

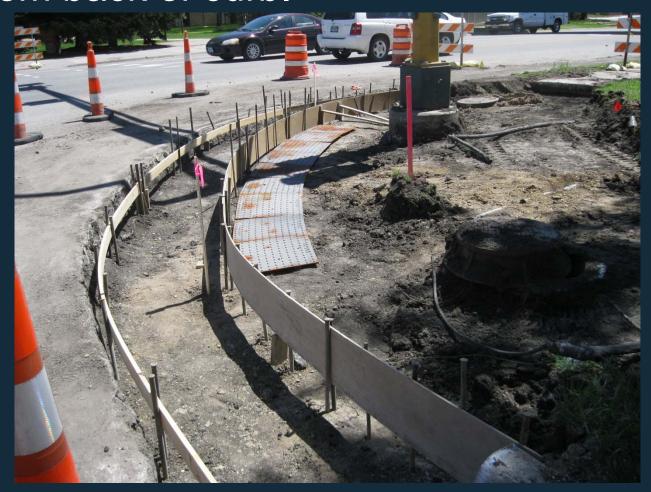
10) Radial Detectable warnings shall be set back 3" to 6" from back of curb.

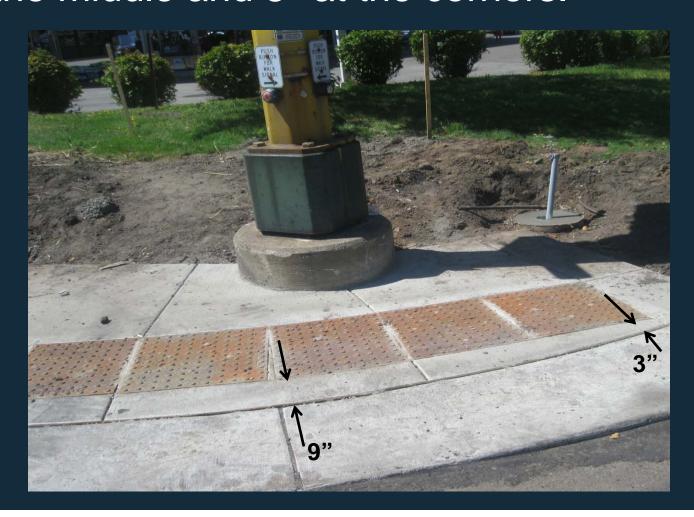
10) Whenever rectangular domes are placed around a radius, they may be set back up to 9" in the middle and 3" at the corners.

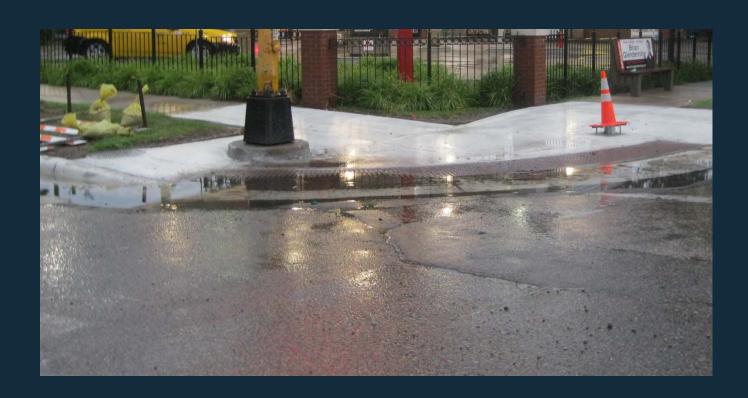
11) Check gutter line and ramps are draining properly and not holding water. Check after rain event.

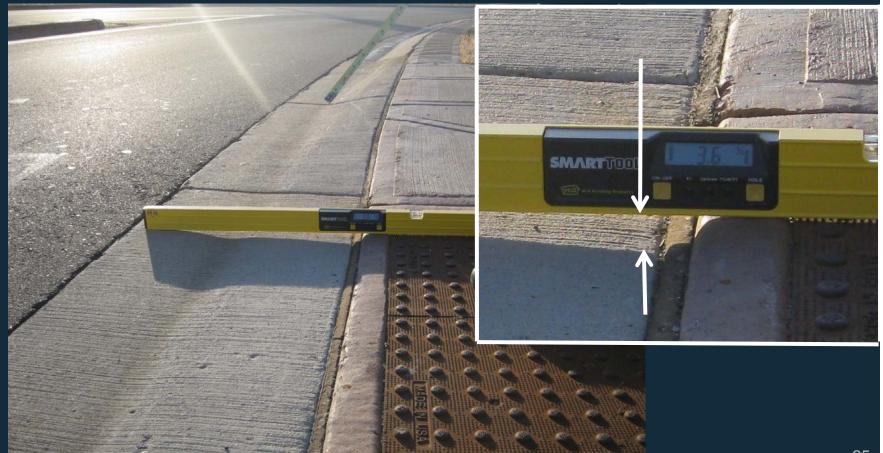
12) Prosecution of Work (ADA) No vertical discontinuities greater than ¼ inch anything over ½ inch and the panel should be replaced.

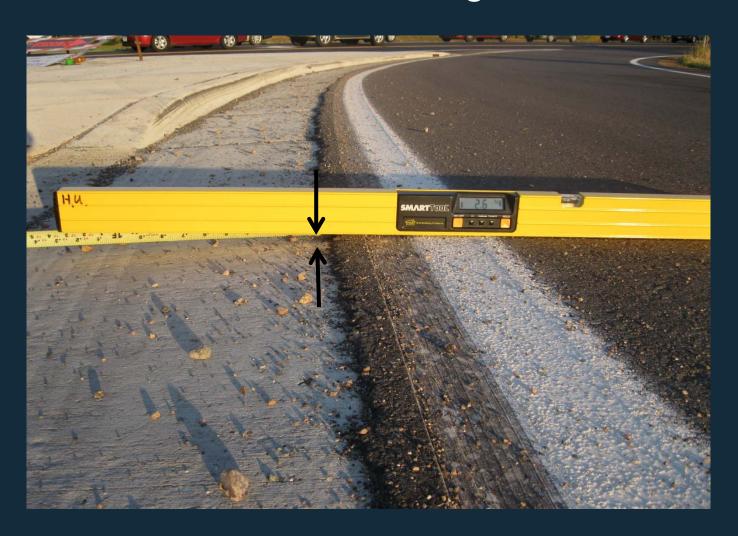
12) No vertical discontinuities greater than 1/4 inch

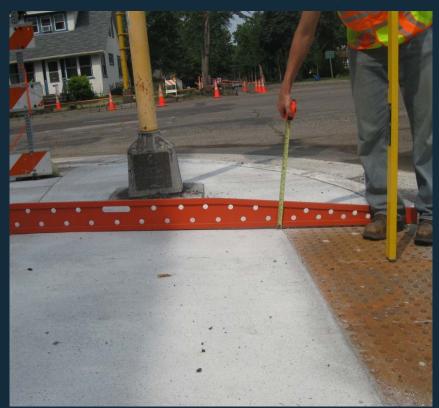
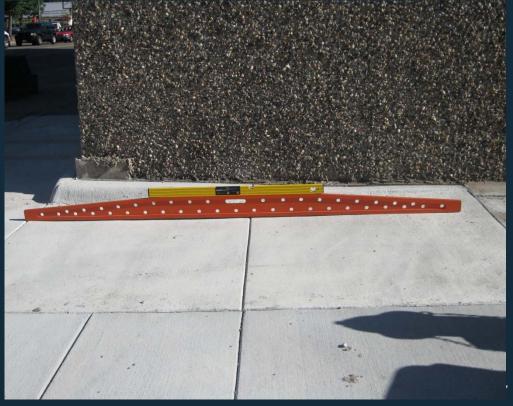
13) Spec 2521.3: The Engineer will use a 10' straight edge to measure the surface. The department considers deviations greater than 3/16 in. and deviations in formed concrete greater than ½ in. from the required location as unacceptable work. Remove and replace unacceptable work as directed by the Engineer.

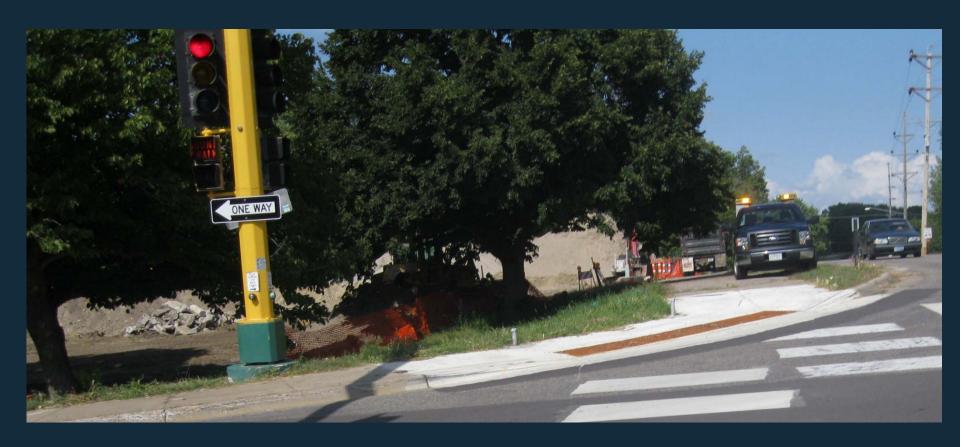
A) Topography: Elevated road slopes or steep existing flow lines. Secondary landing could not be constructed within 30 ft. of initial landing.

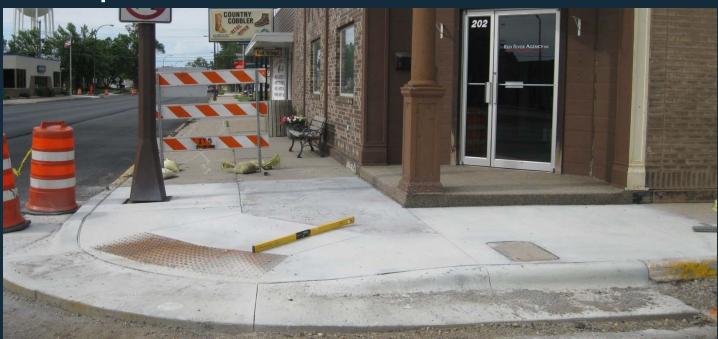
B) Structures: Ramp could not be constructed compliant due to existing structures such as buildings, steps, street signs ect...

Example: walkway attempting to tie into nearby entrance / steps and reducing space for compliant curb ramp construction.

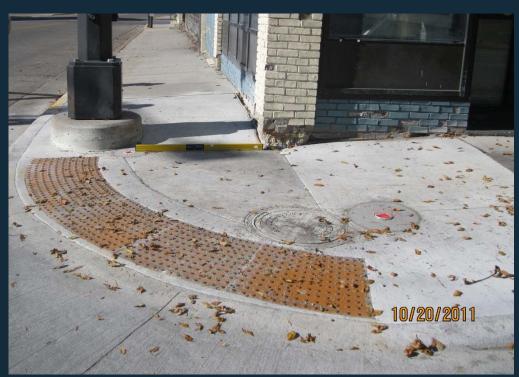
- C) Utilities: Existing utilities that could not be moved
- Both surface and underground utilities such as power poles, fire hydrants, street lights, signal poles, manholes, vaults ect...

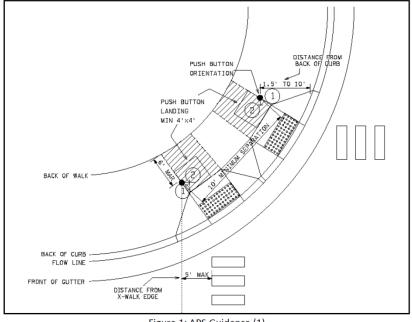
Figure 1: APS Guidance (1)

The bubble note in each figure represents the required data on the APS compliance checklist form.

Numbers on figure and on the APS form	DESCRIPTION
1	Push button orientation
2	Push button landing
3	Distance from crosswalk edge
4	Distance from back of curb
5	Distance between push buttons
9	Distance of push button(s) to front and back of landing
10	Maintenance access route (MAR)

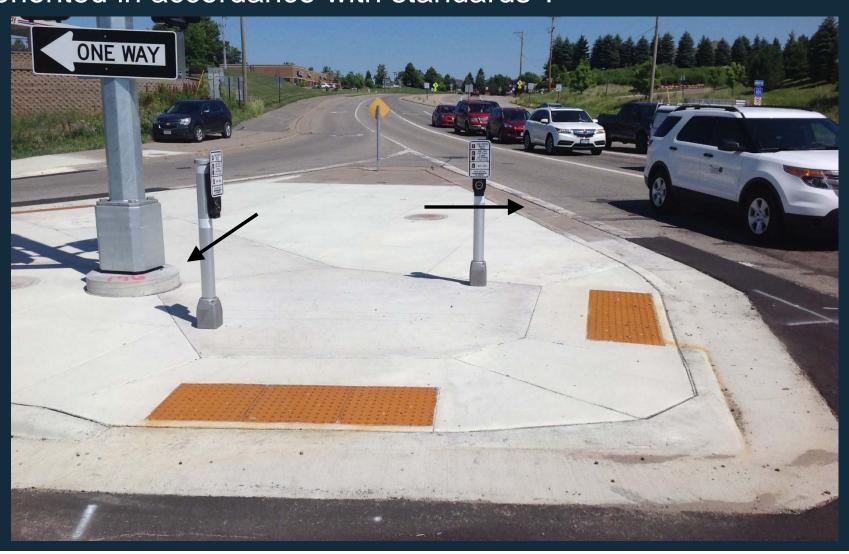
1) Are push button stations placed and push button faces oriented in accordance with standards?

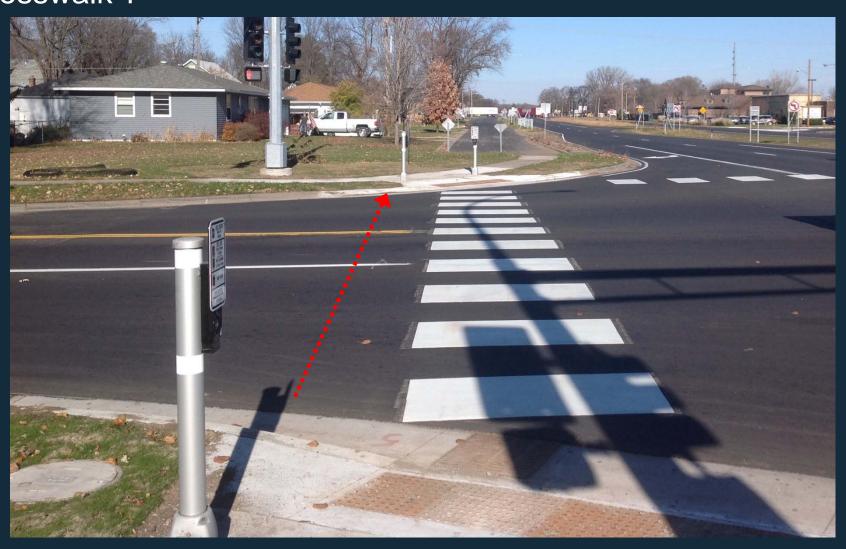
Are push button faces placed parallel to the outside edge of the crosswalk?

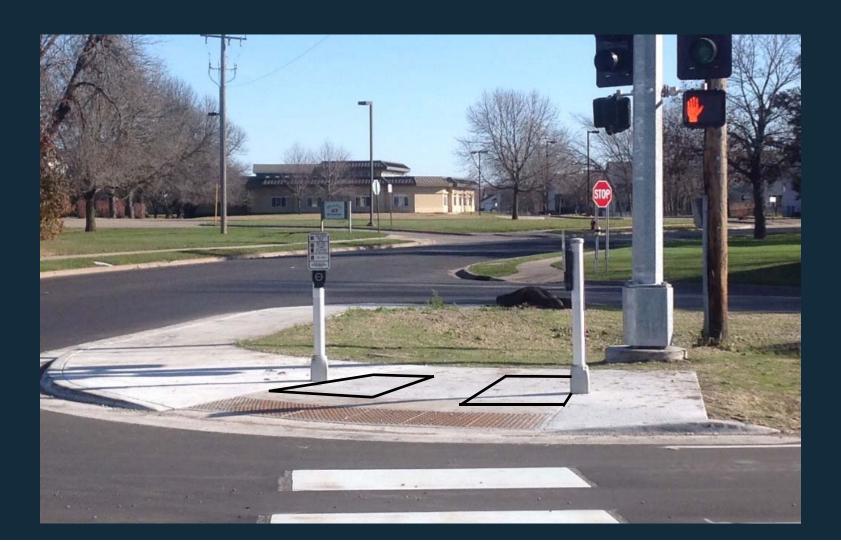
2) Is there a 4'x4' minimum landing adjacent to each push button?

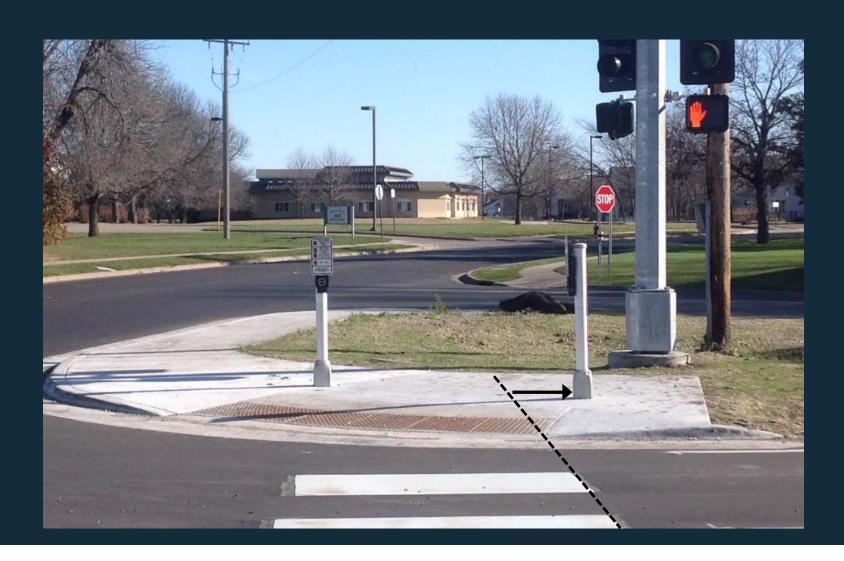
3) Distance from crosswalk edge to push button face (ft):

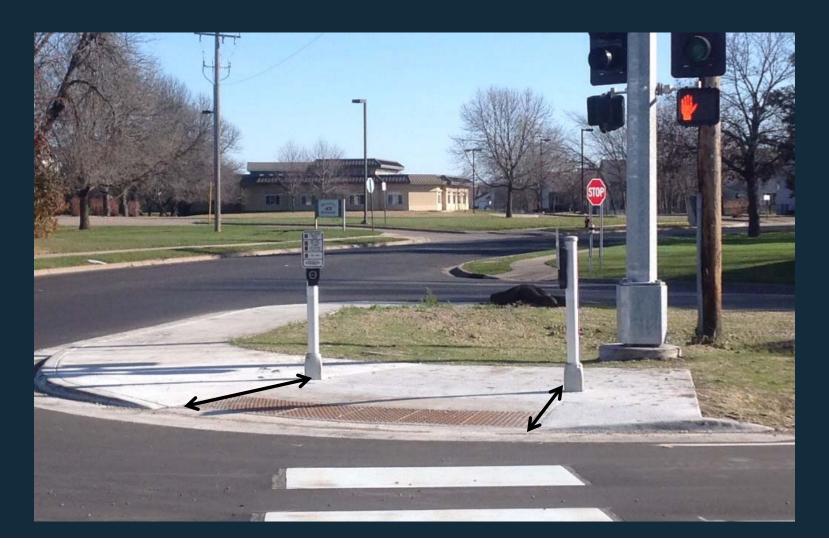
4) Distance from the push button to the back of curb (measured in the direction of pedestrian travel in ft.)

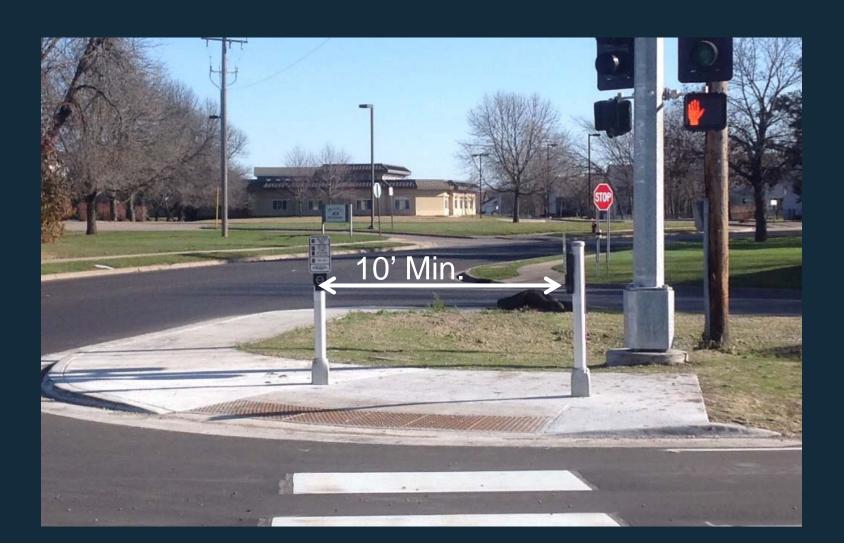
5) Distance between push buttons (ft.) ?

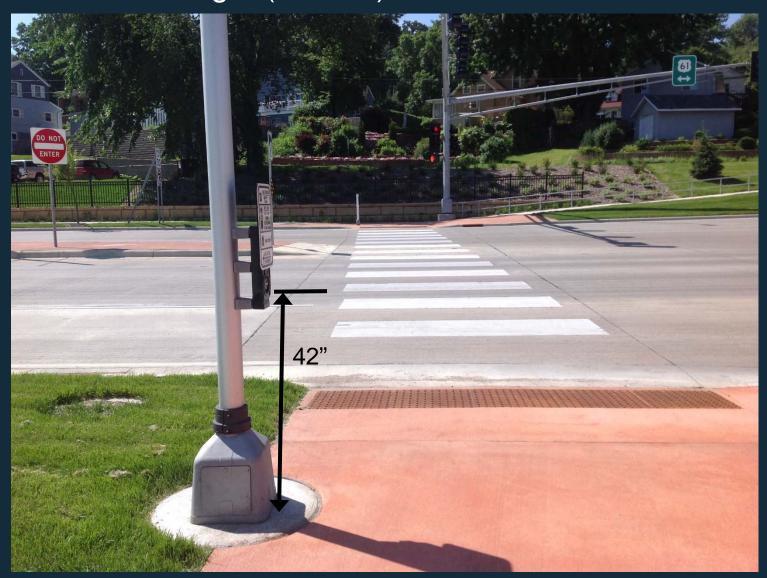
6) Push button height (inches)?

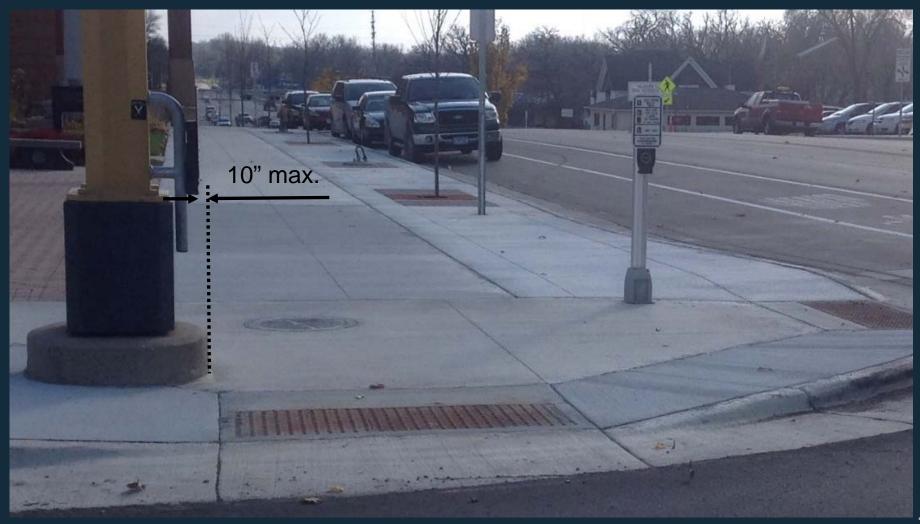
7) Push button side reach (inches).

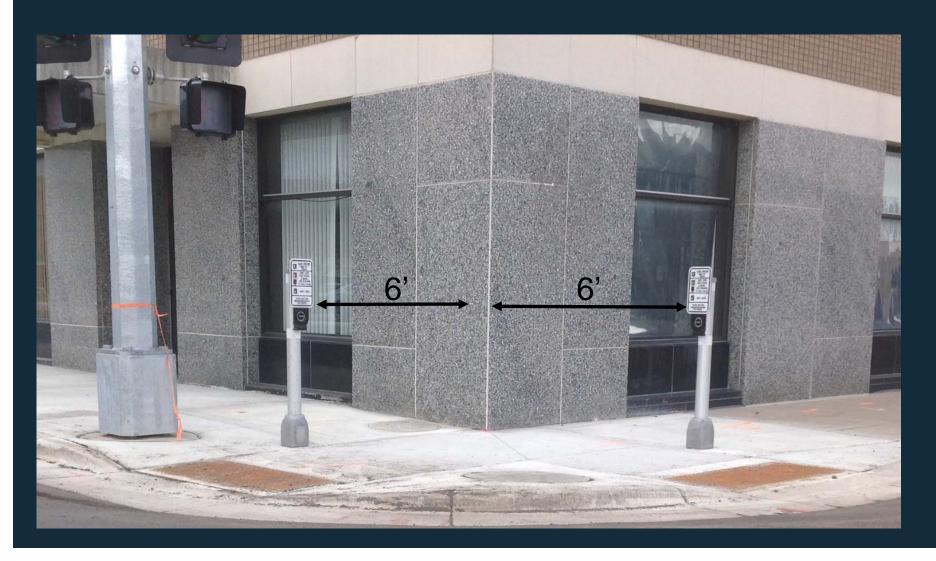
9) Has a 6' maintenance access route (MAR) been maintained?

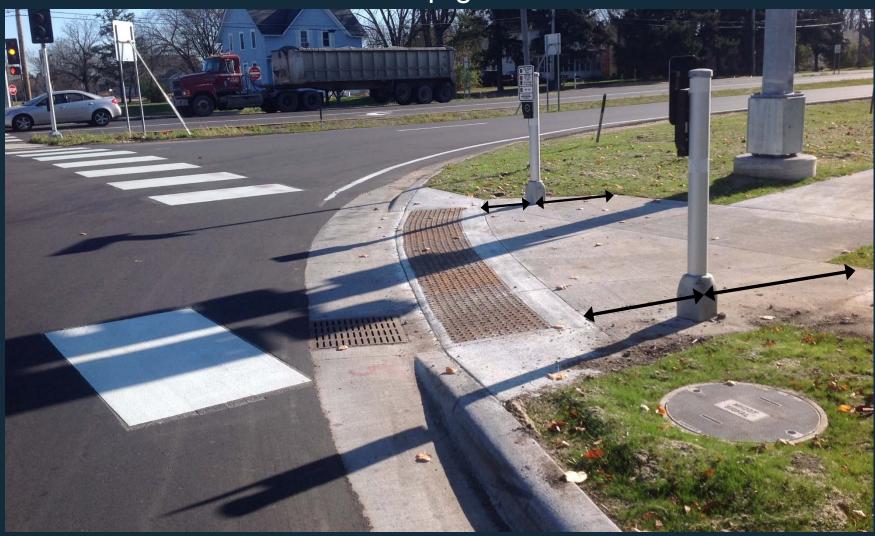
10) Are all push button stations situated at least 2' away from both the back of walk and ramp grade break?

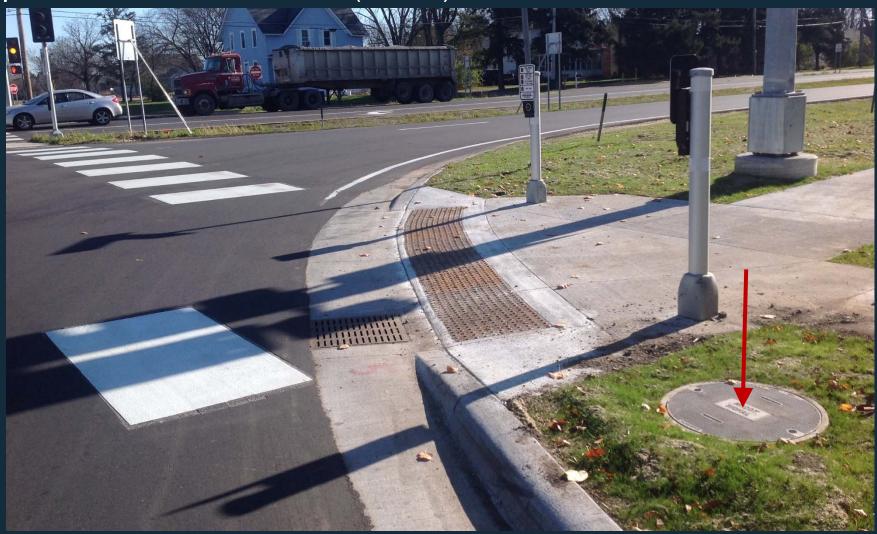
11) Are all newly constructed hand-hole(s) located outside of pedestrian access route (PAR)?
