Minnesota Airport System Pavement Evaluation 2010 Update

Bigfork Municipal Airport (FOZ)

Bigfork, Minnesota

December 2010

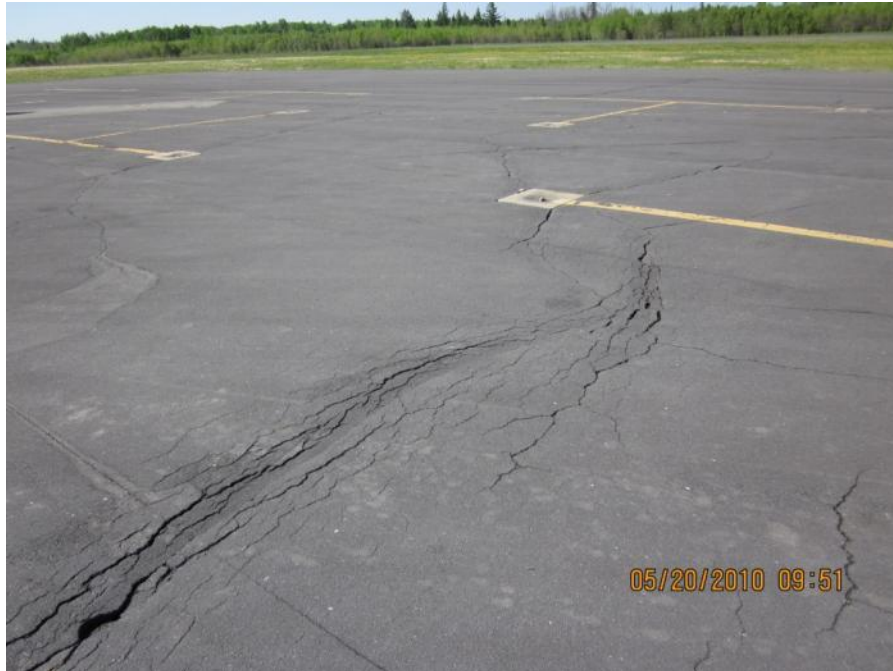
FOZ APA 001 (PCI = 54)

Conditions: PCI: 54.00

50	PATCHING	L	280.00	SqFt
41	ALLIGATOR CRACKING	L	55.00	SqFt
48	LONGITUDINAL/TRANSVERSE CRACKING	L	522.00	Ft
48	LONGITUDINAL/TRANSVERSE CRACKING	M	215.00	Ft
48	LONGITUDINAL/TRANSVERSE CRACKING	H	5.00	Ft
53	RUTTING	L	20.00	SqFt

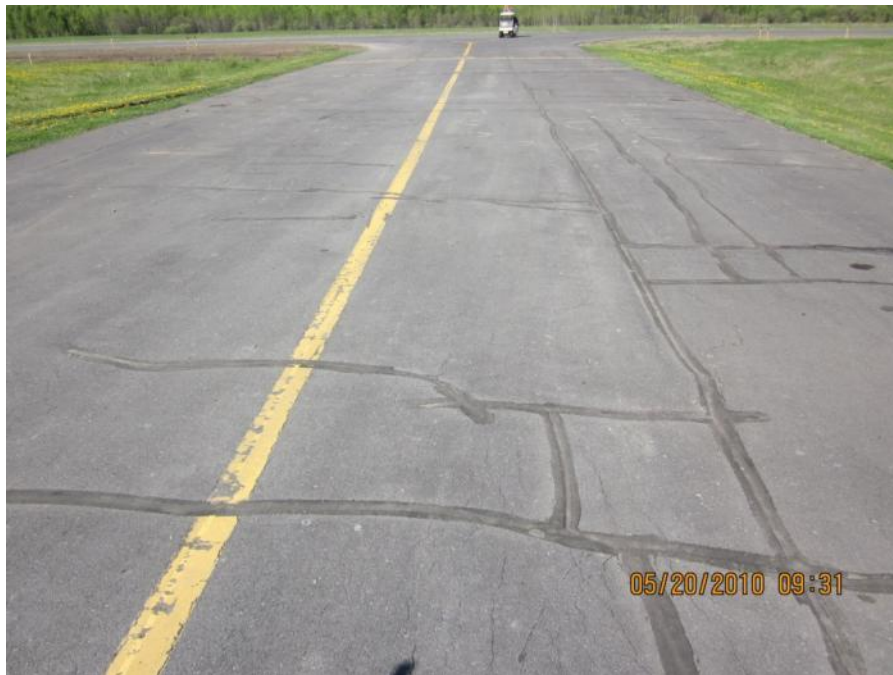
FOZ CTA 001 (PCI = 44)

Conditions: PCI: 44.00 |

48	LONGITUDINAL/TRANSVERSE CRACKING	L	563.00	Ft
48	LONGITUDINAL/TRANSVERSE CRACKING	M	10.00	Ft
48	LONGITUDINAL/TRANSVERSE CRACKING	H	11.00	Ft
41	ALLIGATOR CRACKING	L	26.00	SqFt
41	ALLIGATOR CRACKING	H	26.00	SqFt
45	DEPRESSION	L	10.00	SqFt

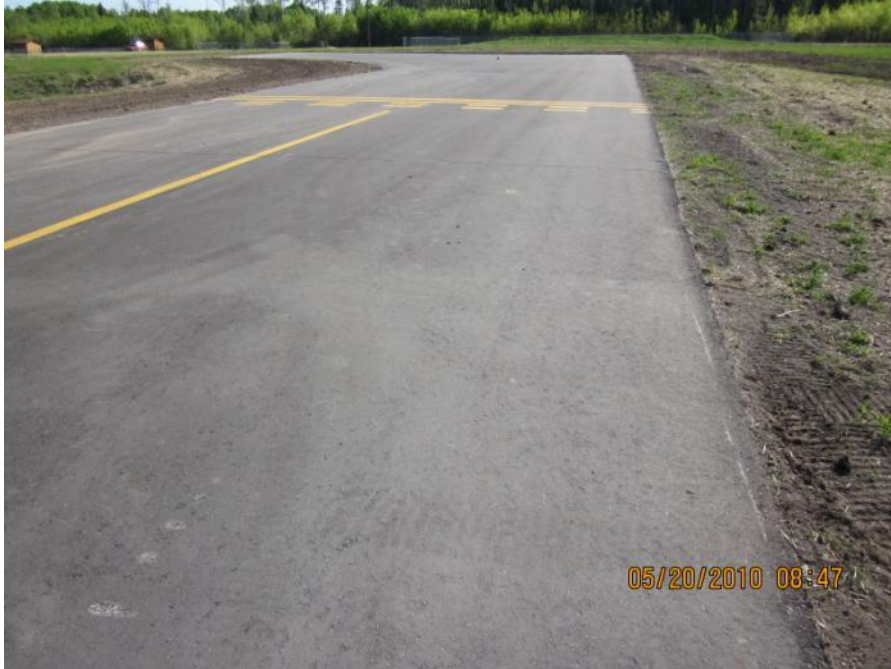
FOZ RTA33 001 (PCI = 100)

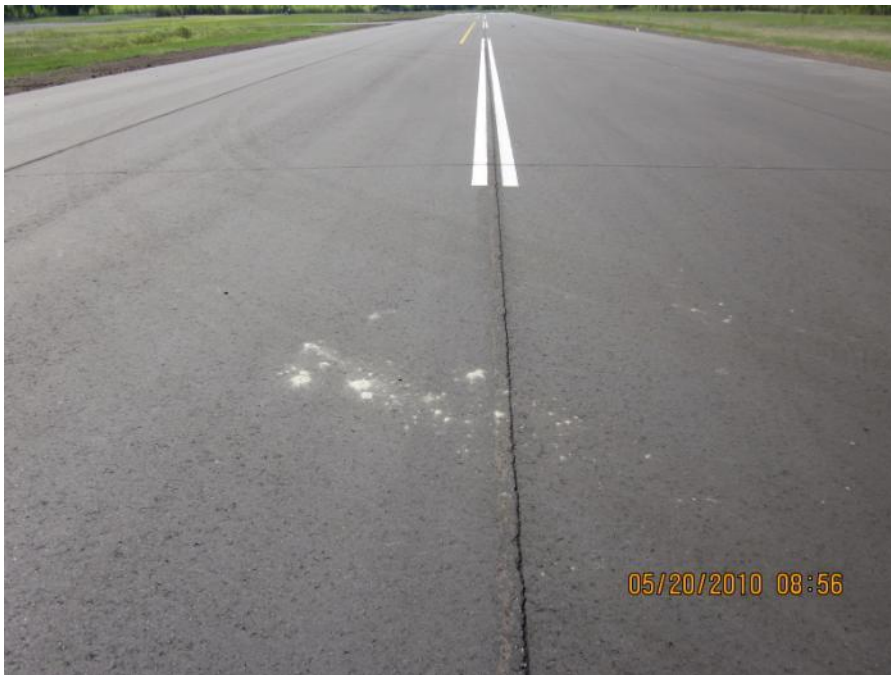
FOZ RY1533 001 (PCI = 100)

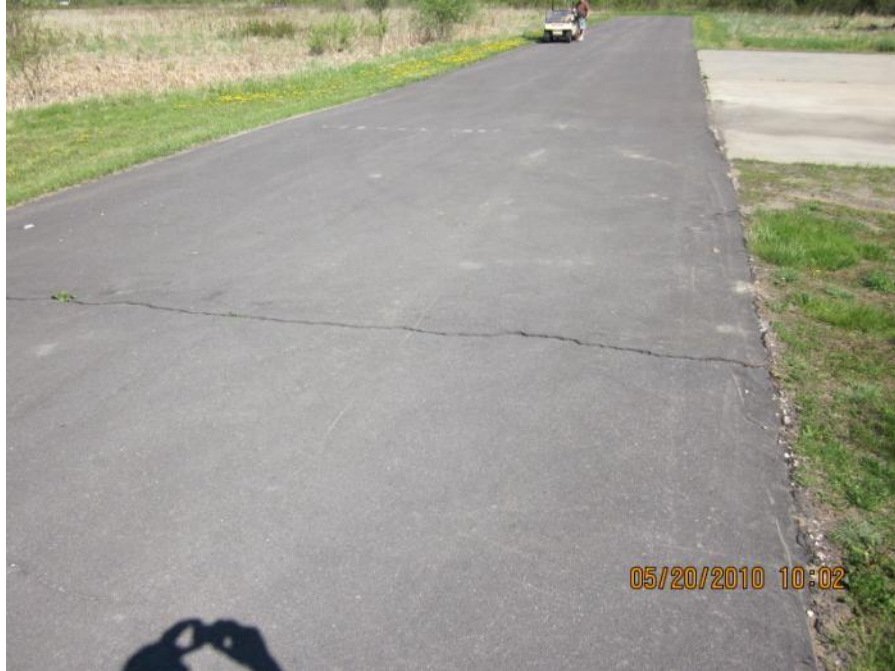
FOZ TLA 001 (PCI = 76)

Last Insp. Date: 5/20/2010 Total Samples: 3 Surveyed: 1
Conditions: PCI: 76.00 |

Sample Number: 101	Type: R	Area: 4,000.00SqFt	PCI = 76
48 LONGITUDINAL/TRANSVERSE CRACKING	L	189.00 Ft	
48 LONGITUDINAL/TRANSVERSE CRACKING	M	49.00 Ft	
48 LONGITUDINAL/TRANSVERSE CRACKING	H	2.00 Ft

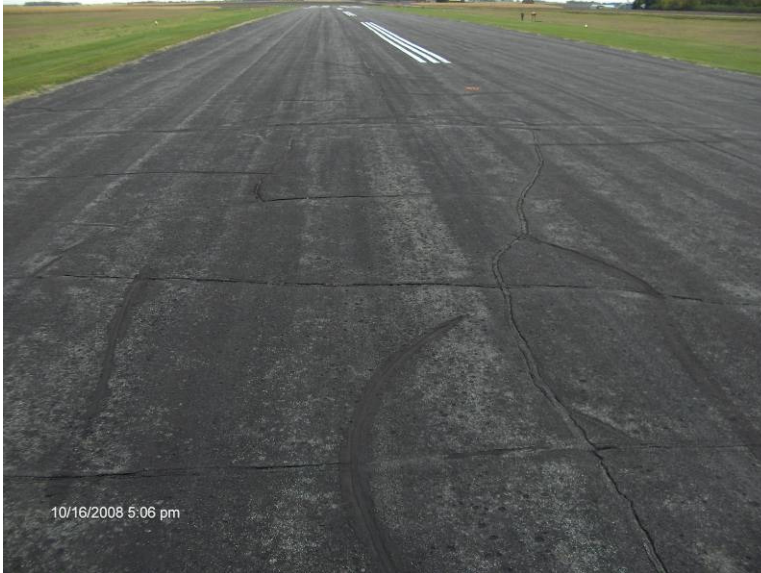
Example of Block Cracking

Block cracking is longitudinal and transverse cracking that has established a pattern of blocks ranging in size from 1ft x 1ft to 10ft x 10ft. This distress typically happens in older asphalt pavements and is an indication that the bituminous binder has lost most of its flexibility. The severity determination is basically determined by the crack width criteria defined for longitudinal and transverse cracking. Crack sealing typically is used to repair block cracking; however, the amount of required sealant can be extensive due to the high density of cracks.

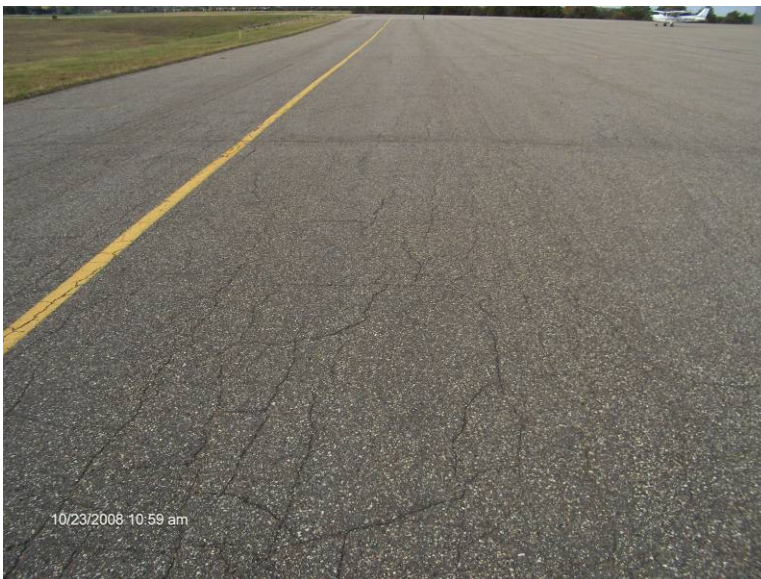
Example of Alligator Cracking

Alligator (or fatigue) cracks are a series of interconnected load-related cracks caused by fatigue of the asphalt surface. Alligator cracking is a significant structural distress and develops only in places subject to traffic loads. These cracks typically initiate at the bottom of the asphalt layer (where tensile strains are highest) and propagate upward - so once a fatigue crack is visible, significant damage has already occurred.

At low severity, alligator cracks are evidenced by a series of parallel hairline cracks (usually in a wheel path). Further traffic and deterioration leads to the interconnection of these cracks. Medium severity alligator cracking is a well-defined pattern of interconnected cracks, some spalling may be present. High severity alligator cracks have lost aggregate interlock between adjacent pieces, the cracks may be severely spalled with FOD potential, and most likely the pieces will move freely under traffic.

Alligator cracking is a structural failure and cannot be repaired with sealant, the proper repair is full-depth patching.
