Look Under the Pavement

It Lurks

Somewhere Under Your Roadway . . .

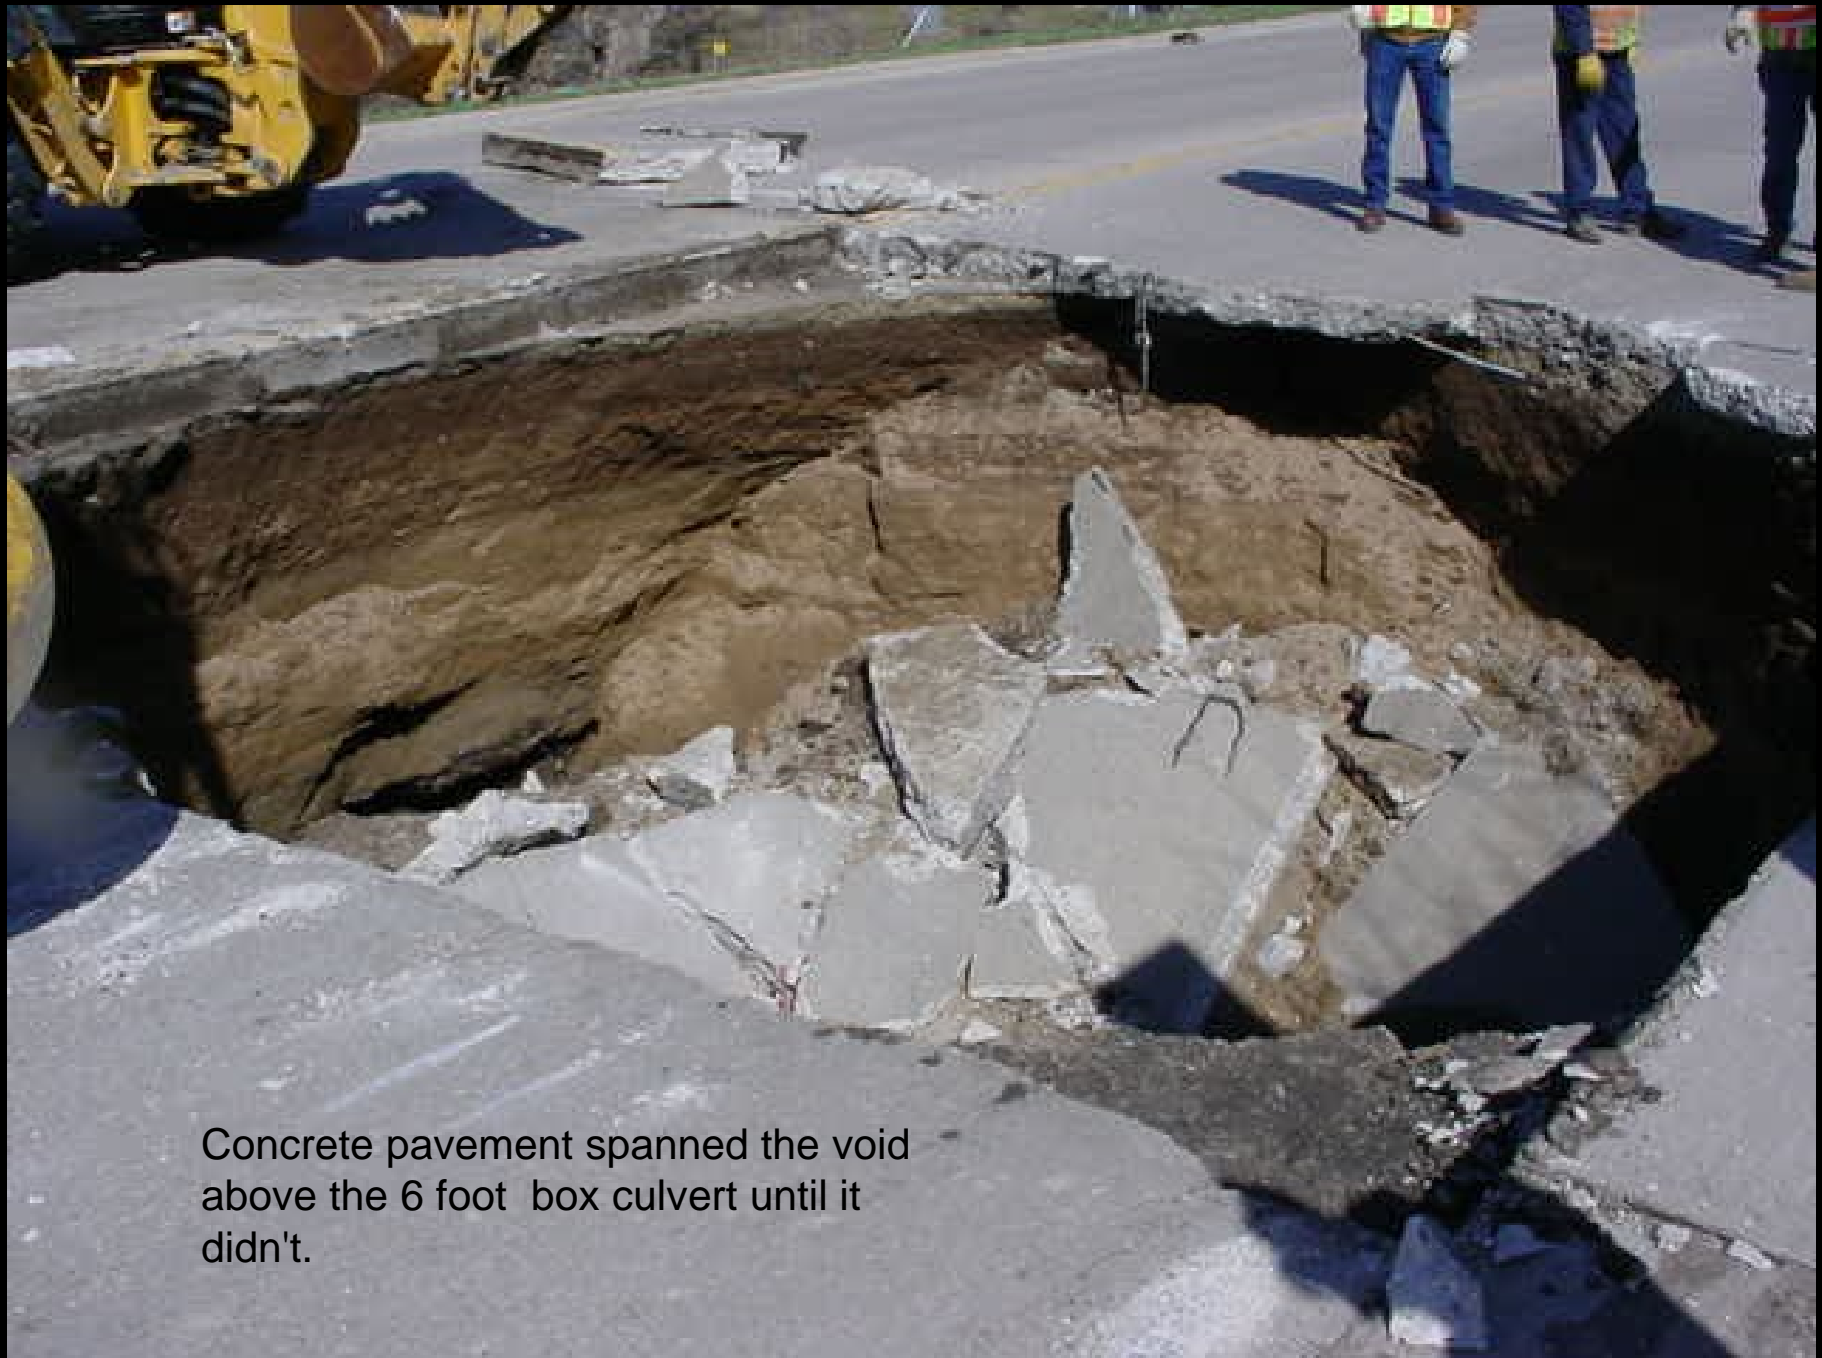
The hole developed because the roadway's foundation sifted through a crack in the top of a culvert creating a void. County Road 45 will be closed until late April to give [REDACTED] County crews time to replace the existing culvert and fix the road.

Concrete pavement spanned the void above the 6 foot box culvert until it didn't.

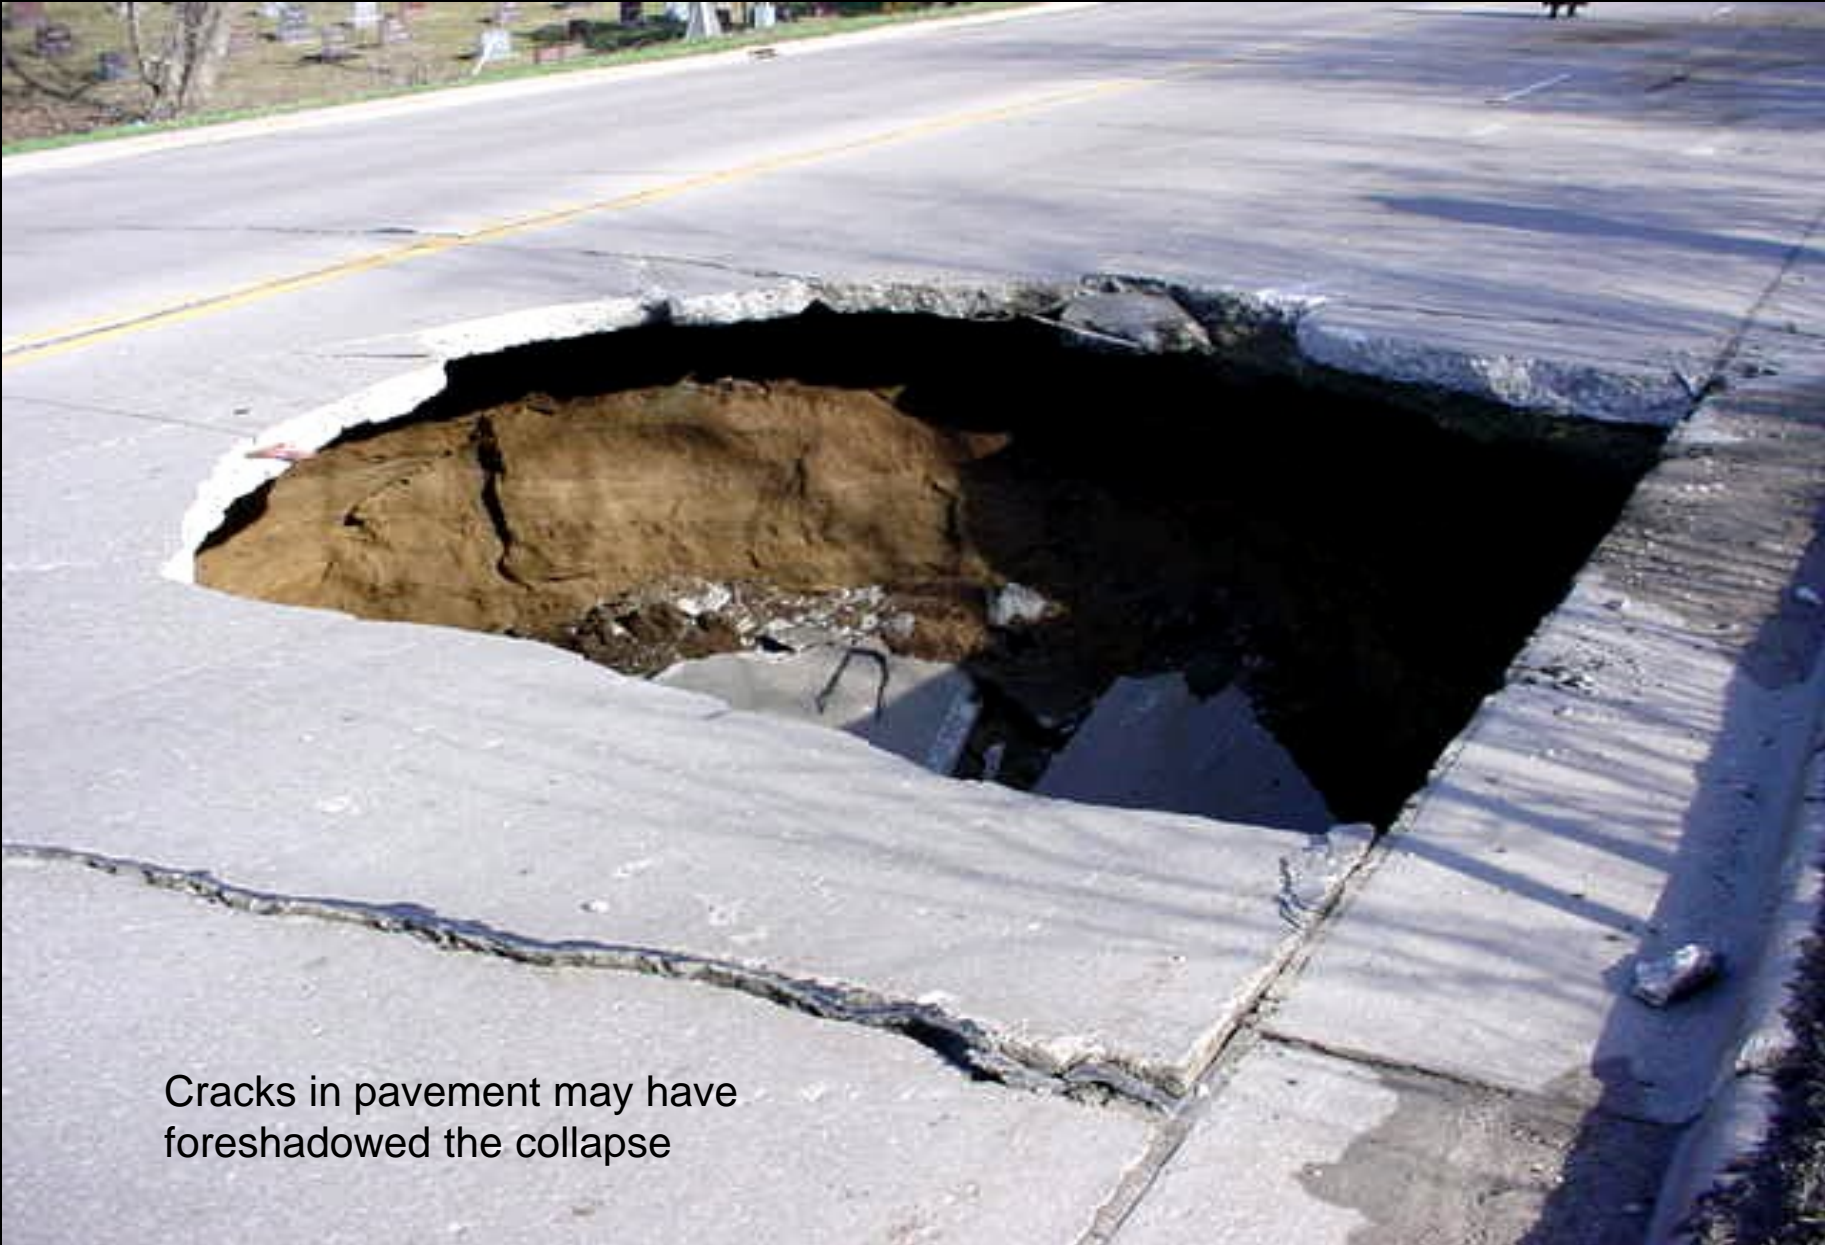
Cracks in pavement may have foreshadowed the collapse

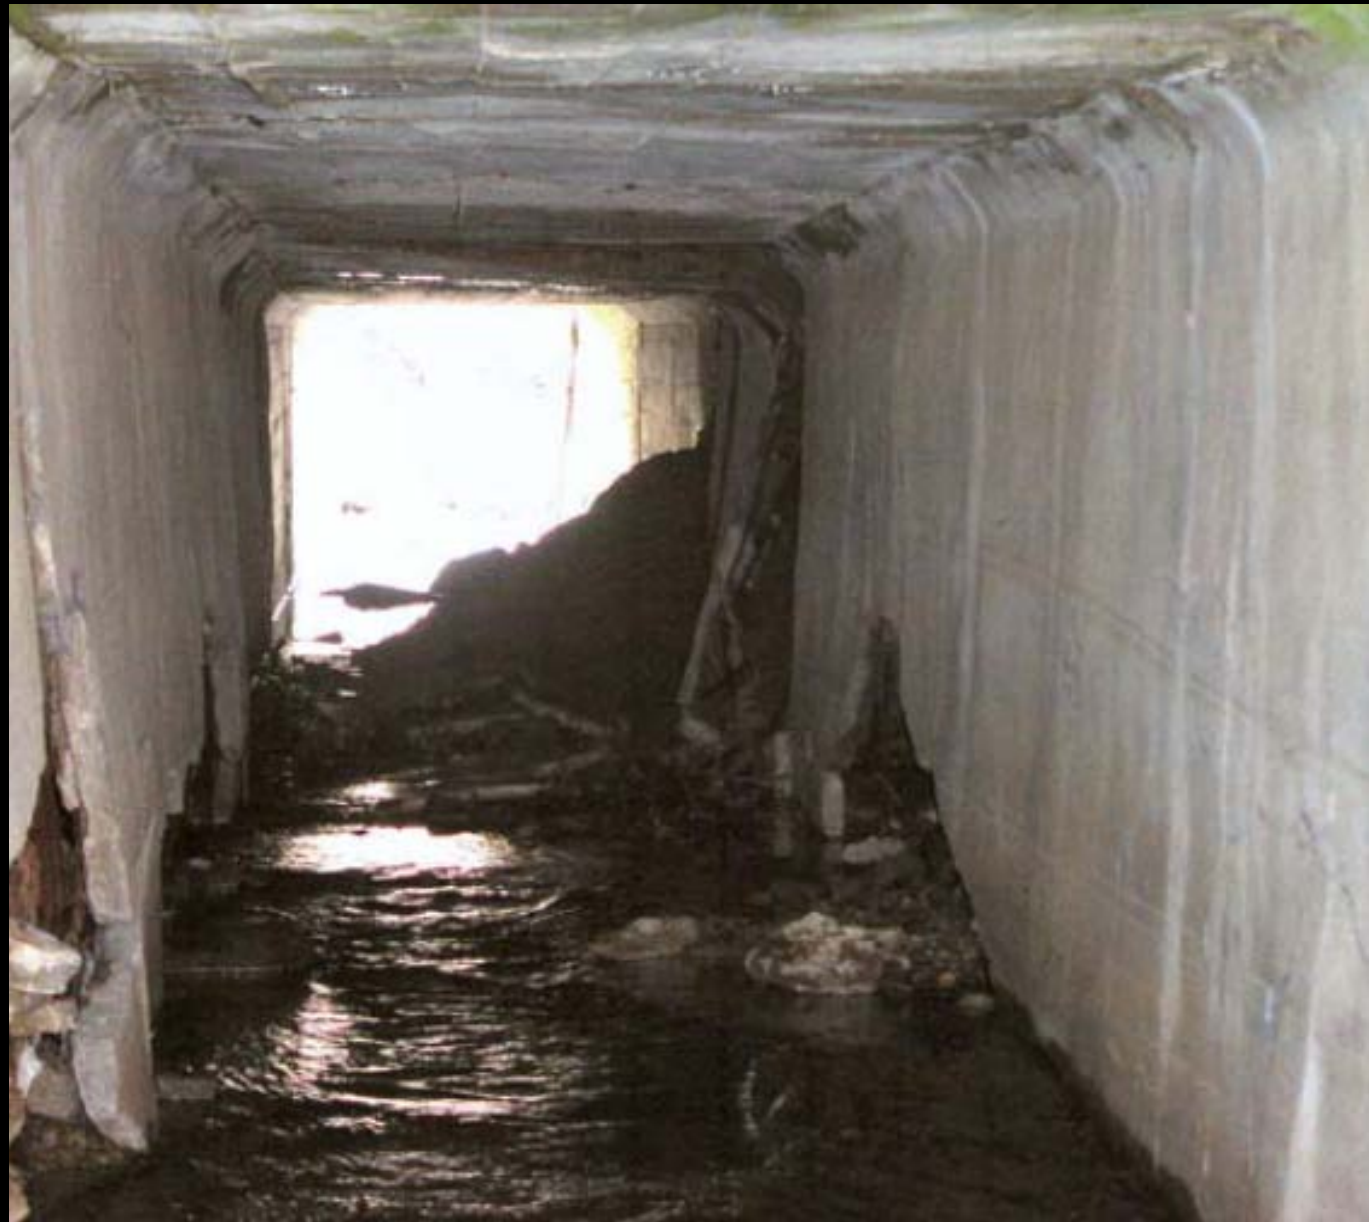
The 6 foot wide by 6 foot high box culvert had holes through the concrete along the bottom corners. Road fill was washed away through the holes, over time, and caused road collapse.

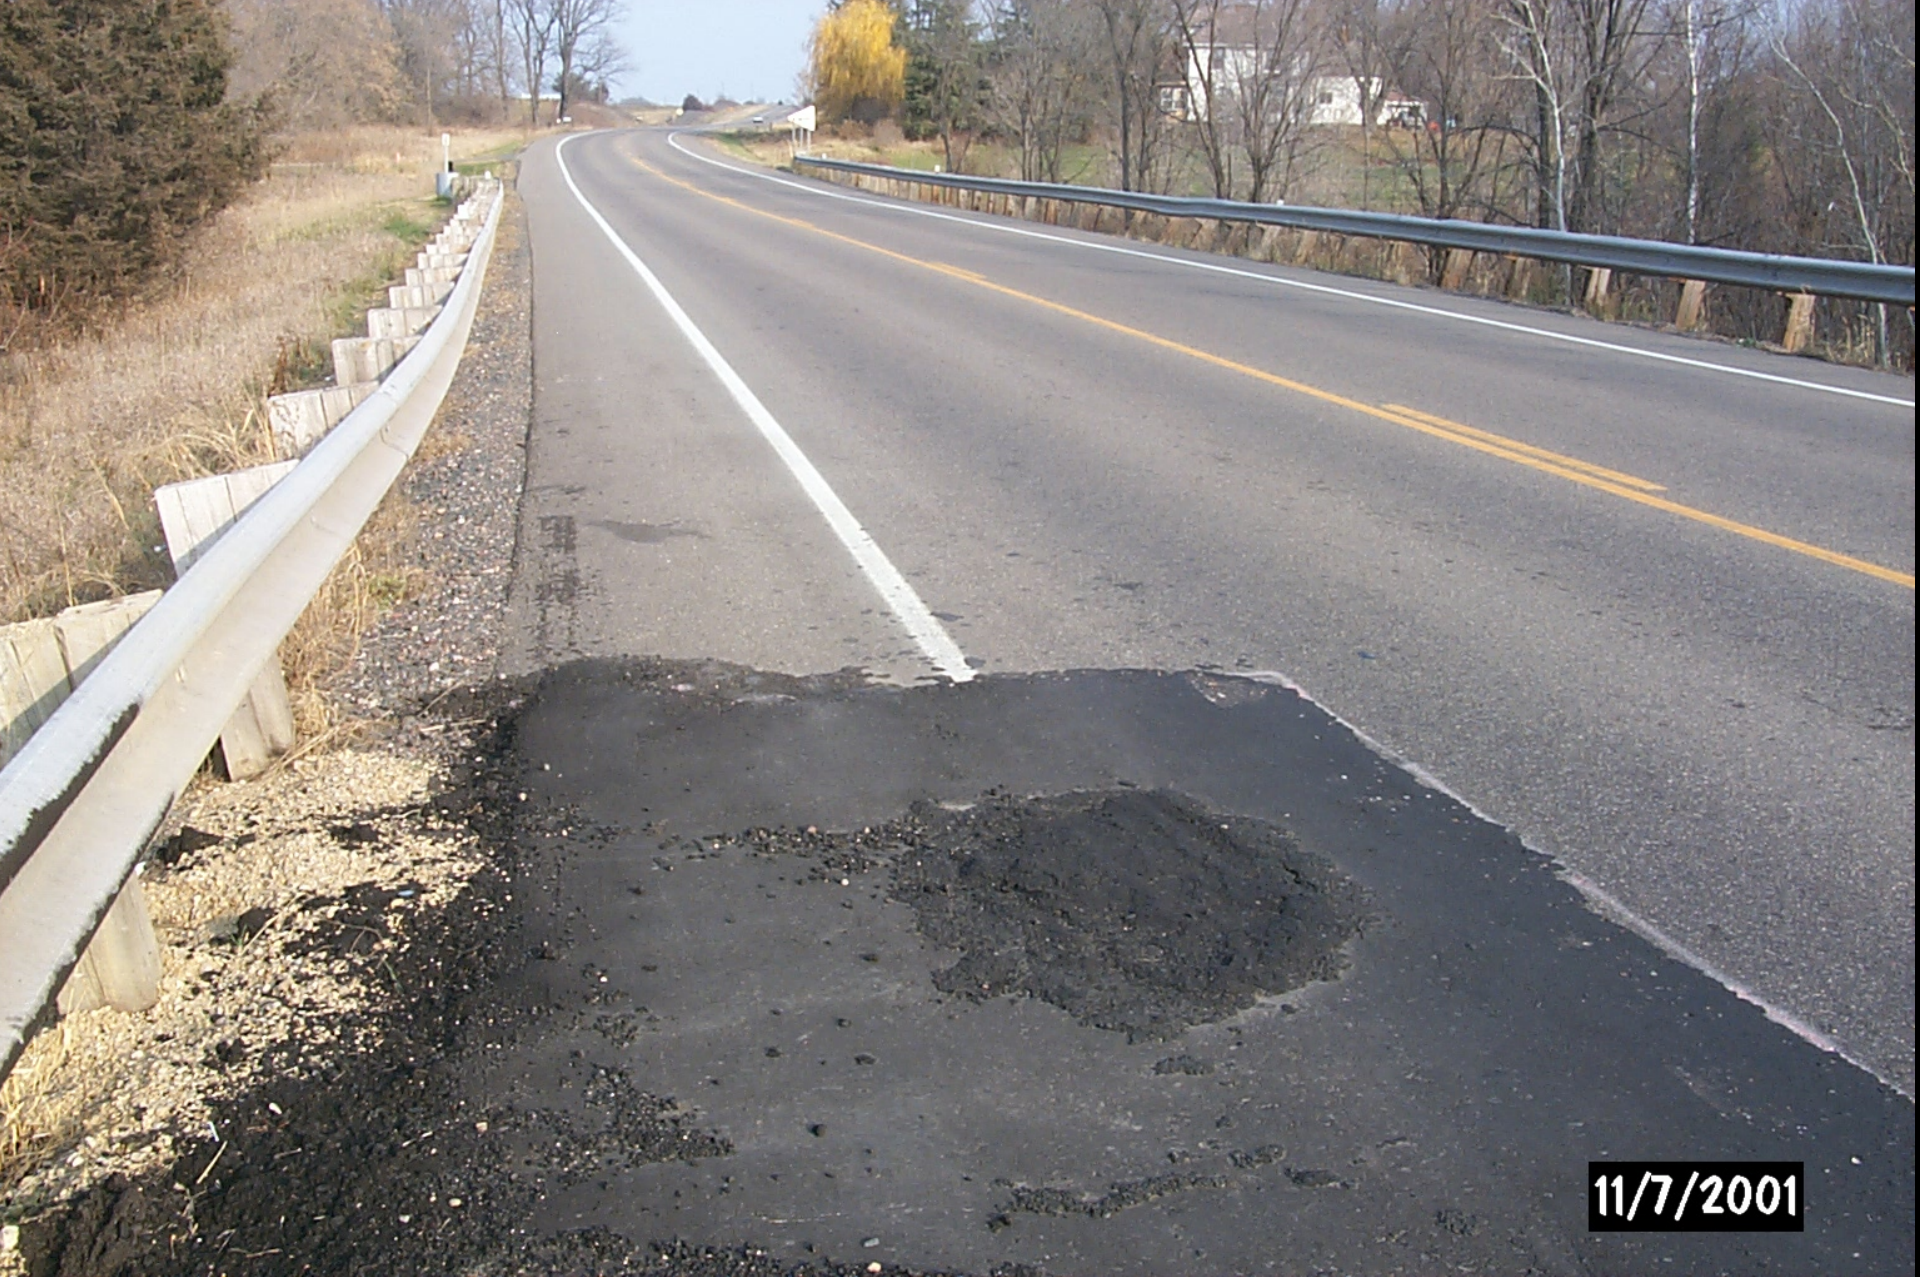
MN 95

2 successive patches on the bituminous pavement point to a problem below the road's surface.

Holes in the metal culvert allowed water to wash out soil from around the pipe and create a void under the pavement. The pavement patches masked the underlying problem.

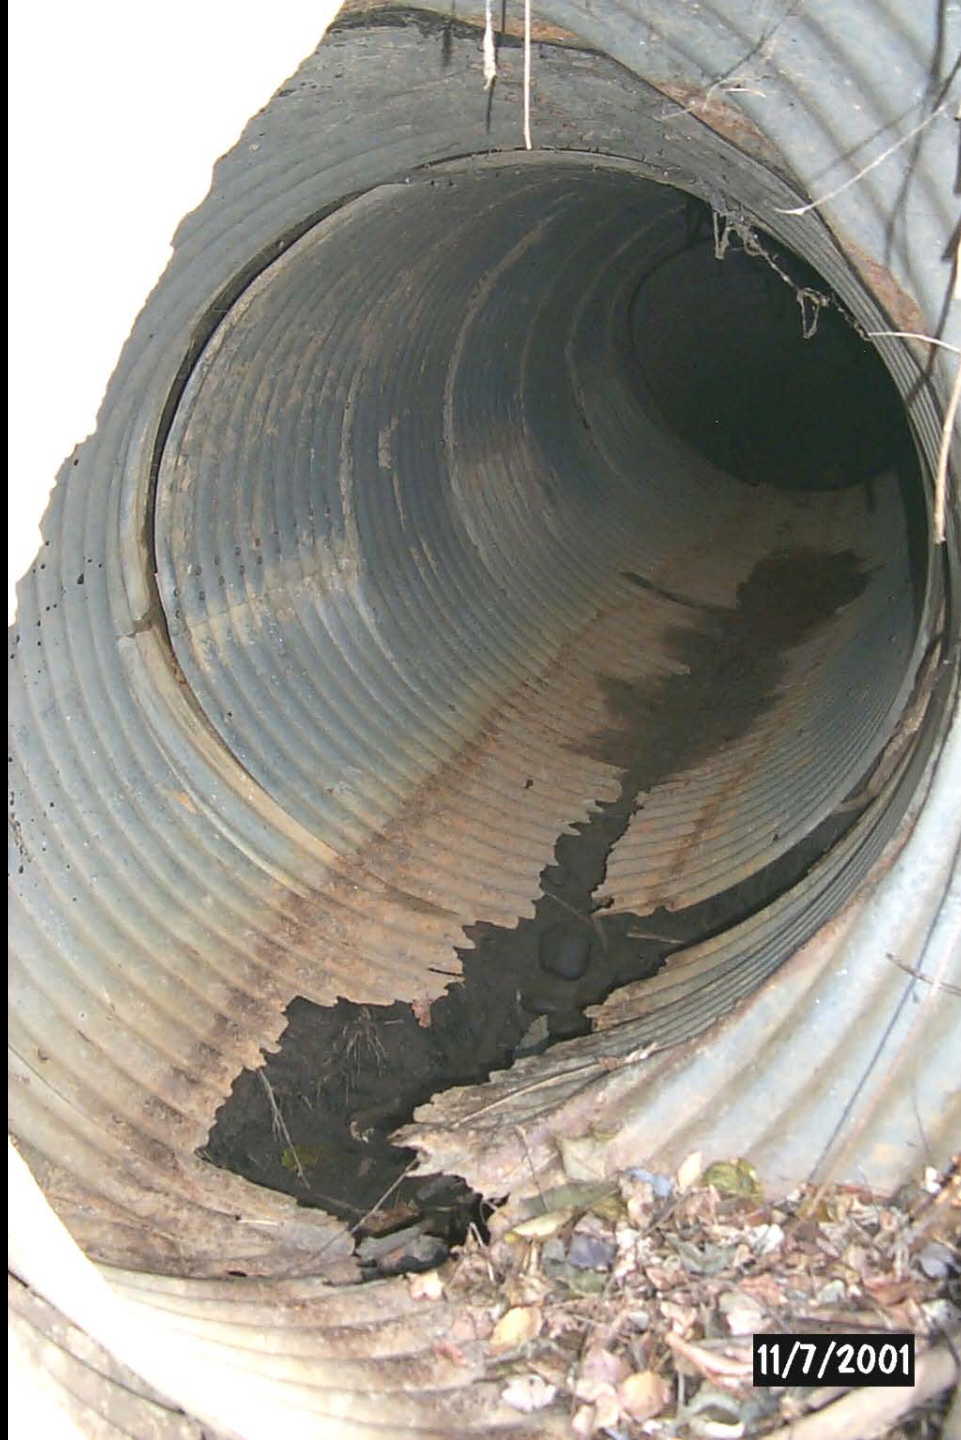
The hole in the pavement
may also show up
somewhere upstream of
the hole in the pipe.

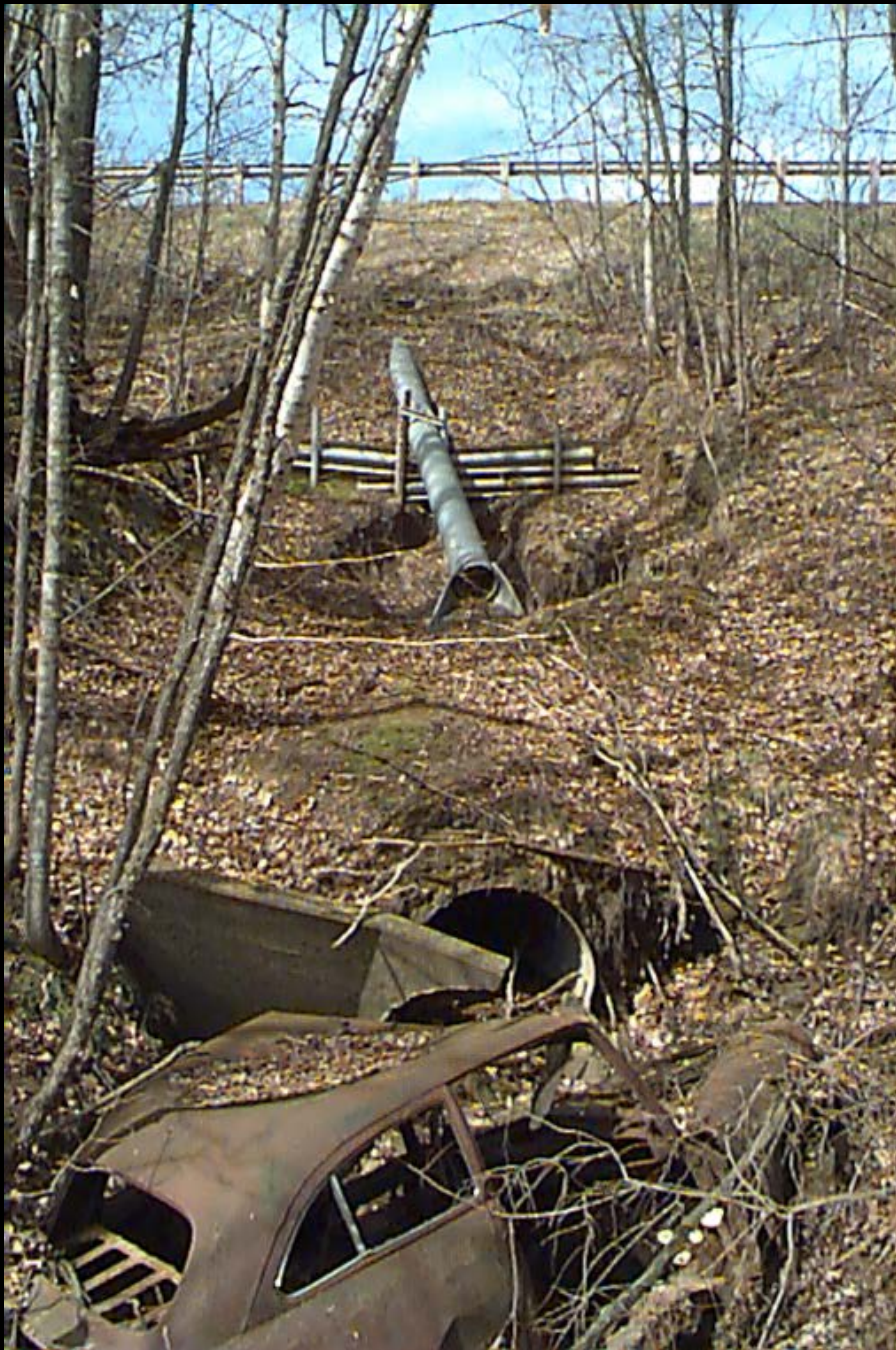
*Construction
saw a surface erosion
problem and tried to
fix it.*

A void had appeared high in the road embankment. A construction project installed a 24" pipe flume to carry drainage from the road surface and down over the eroded inslope. An old 36" metal culvert was underneath the void.

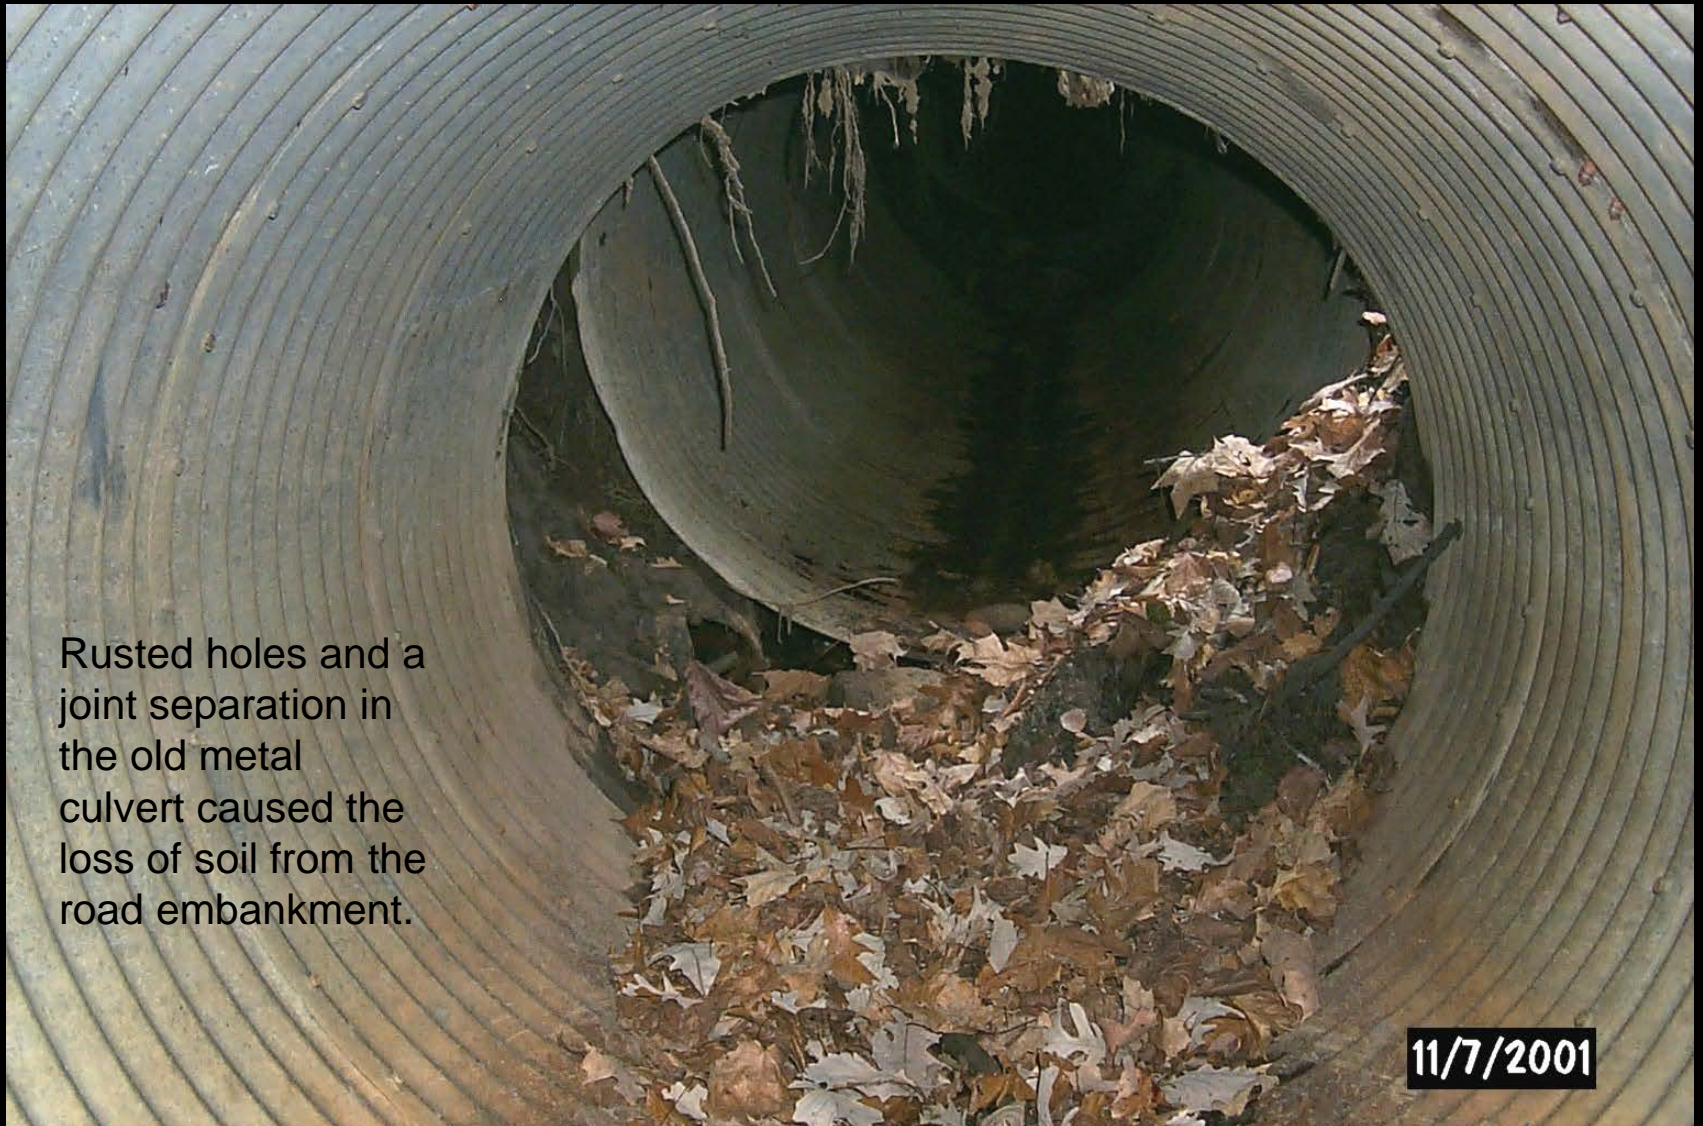
Rusted holes and a joint separation in the old metal culvert caused the loss of soil from the road embankment.

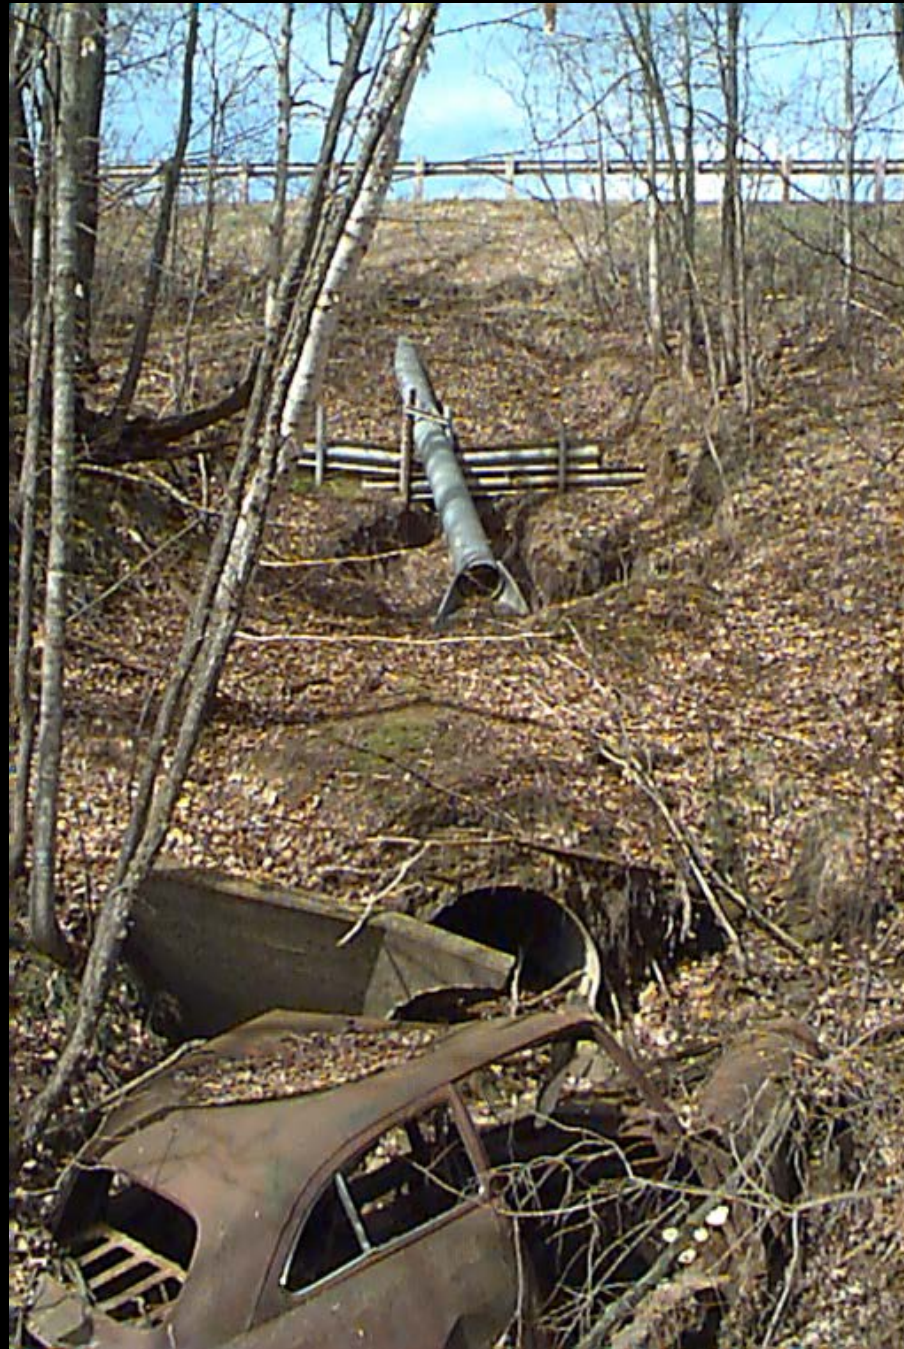
Look again at
the hole in
the slope
above the old
culvert.

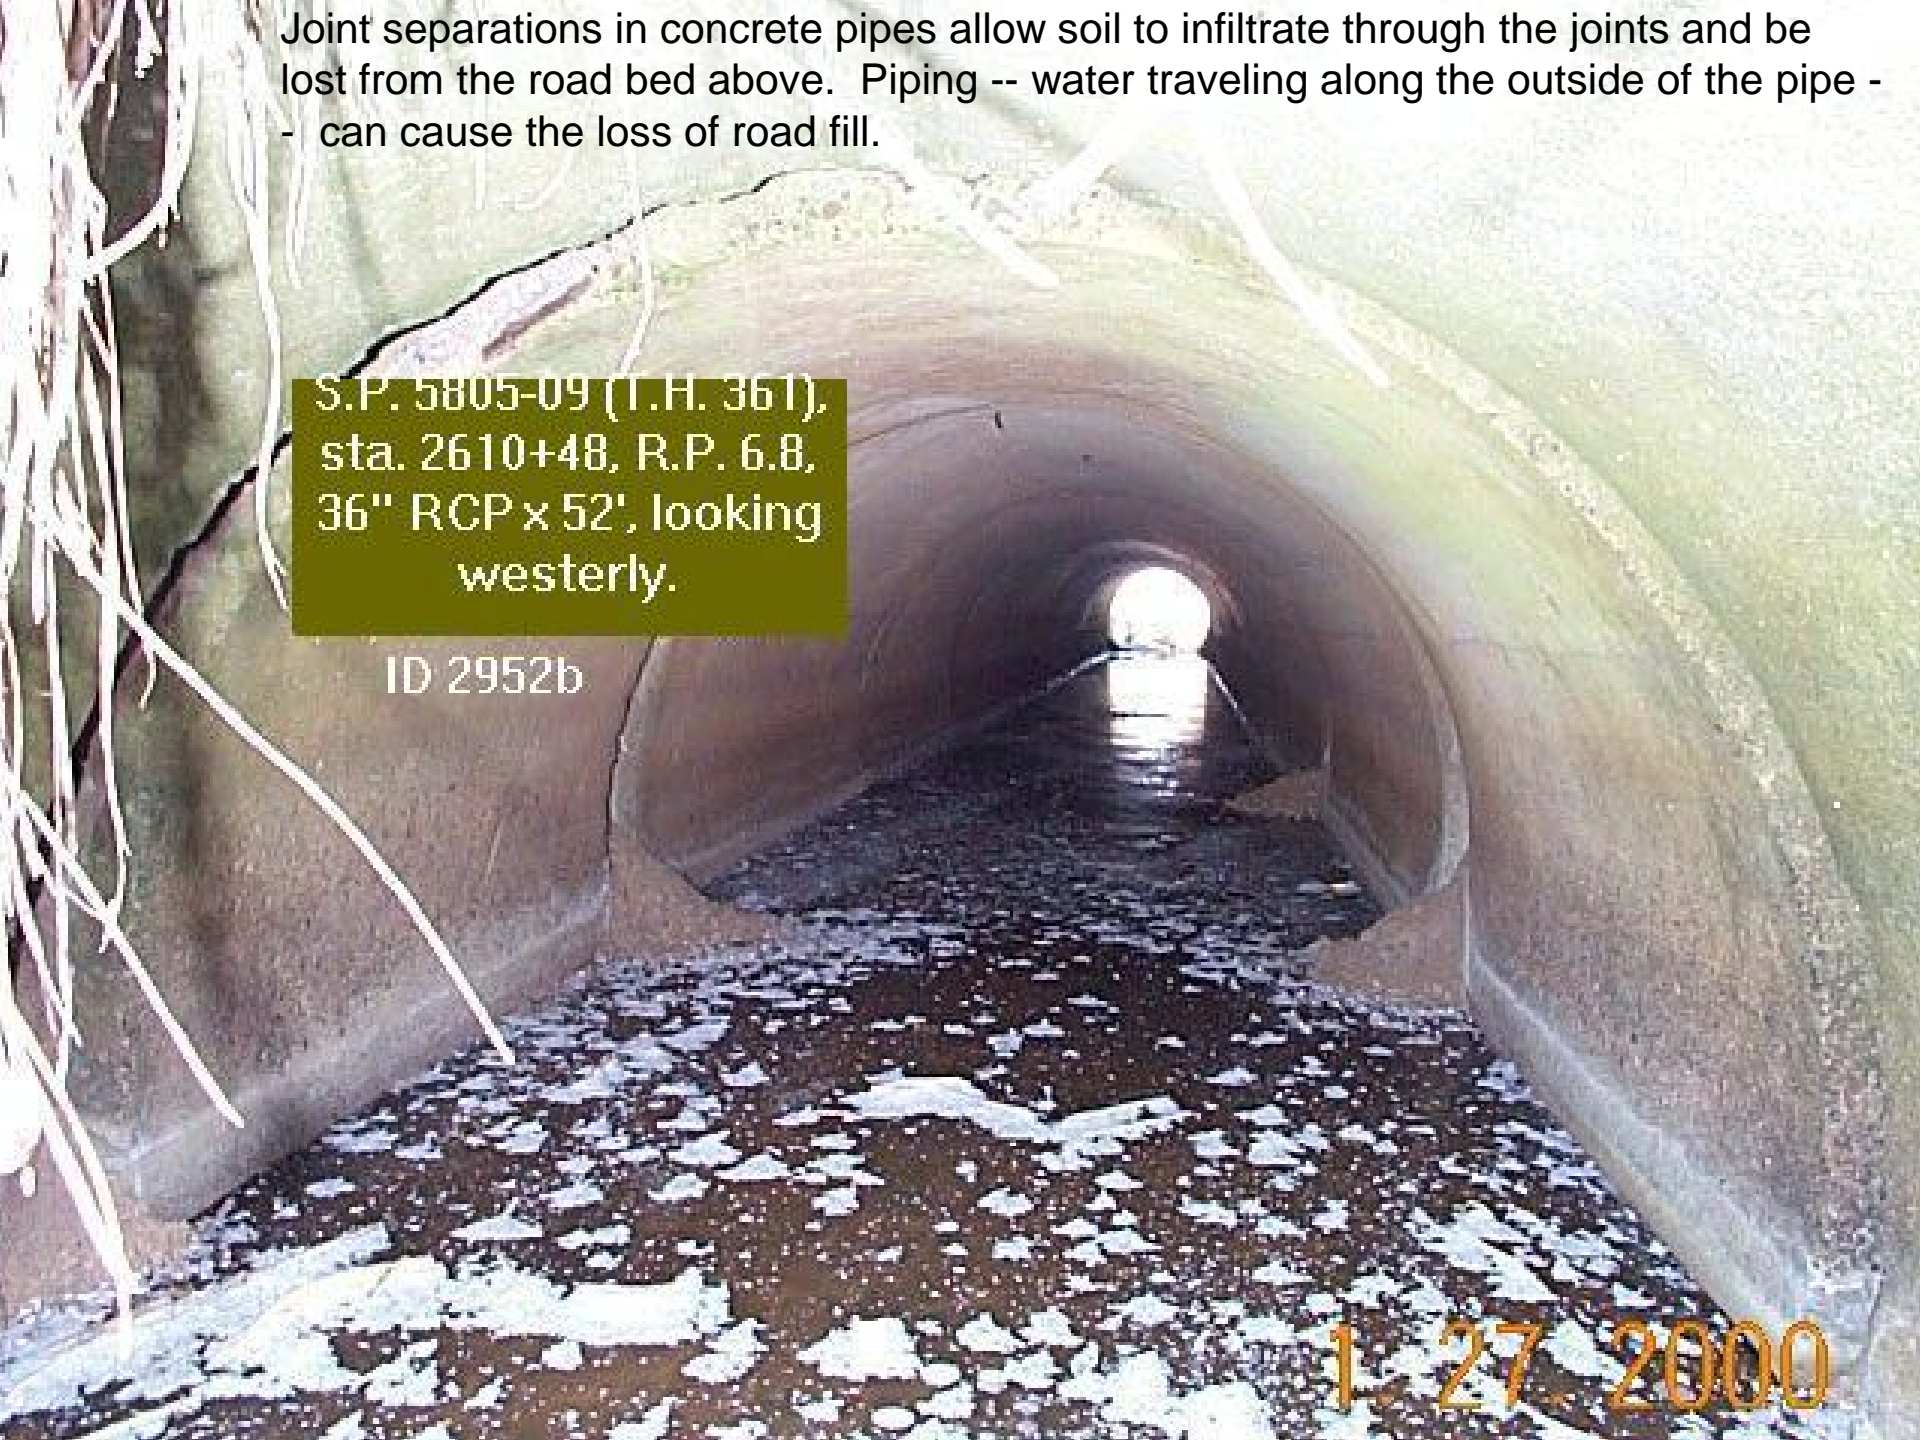
S.P. 5805-09 (I.H. 361),
sta. 2610+48, R.P. 6.8,
36" RCP x 52', looking
westerly.

Joint separations in concrete pipes allow soil to infiltrate through the joints and be lost from the road bed above. Piping -- water traveling along the outside of the pipe -- can cause the loss of road fill.

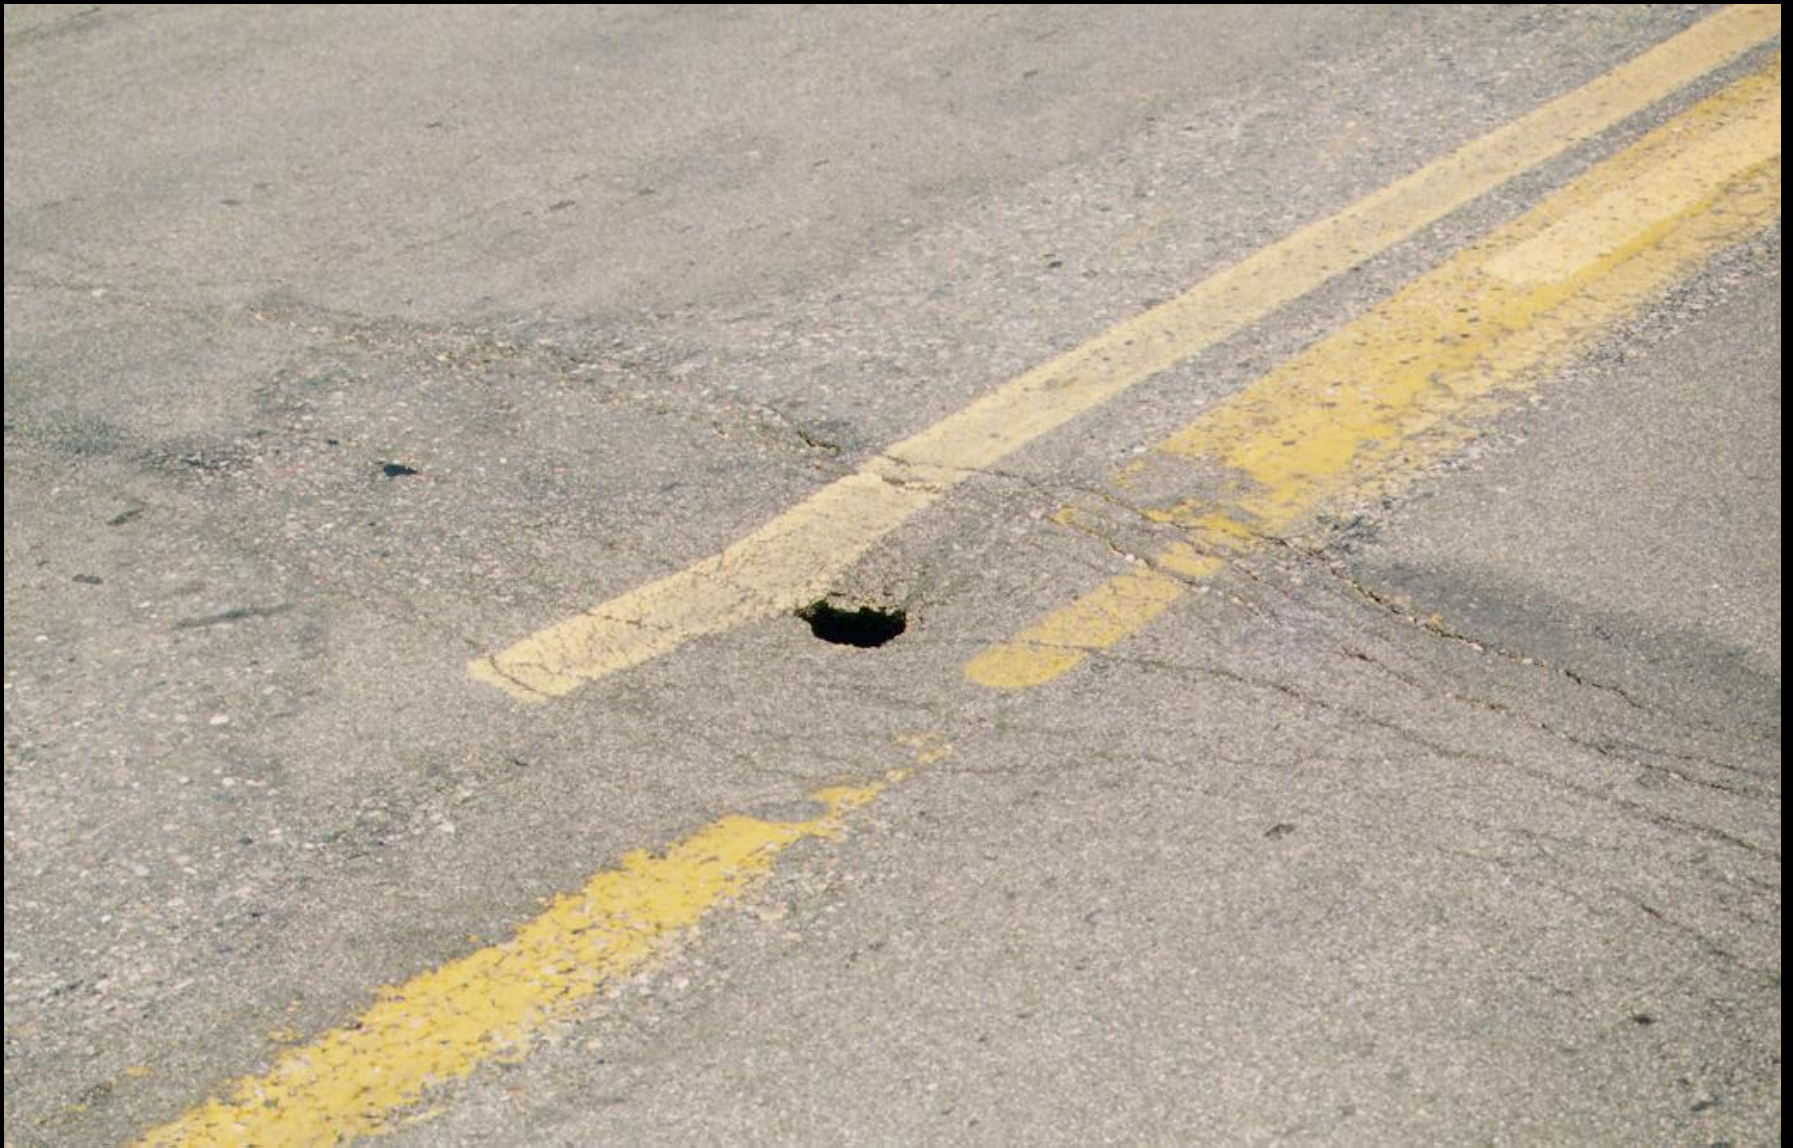
The hole in the pavement may look small. The void below it is the real concern. Holes, joint separations and piping in culverts and storm drain pipes cause voids under road pavement.

Look for
Pipes or Structures
with
Condition Rating 4
(*and maybe 3*)

and look for HydInfra inspection flags: Holes, Joint Separation, Piping, Road Void.
