# *Look Under the Pavement*

MN/DOT RETIREE

NARROWLY ESCAPES BIG HURT

AS ROAD CAVES IN

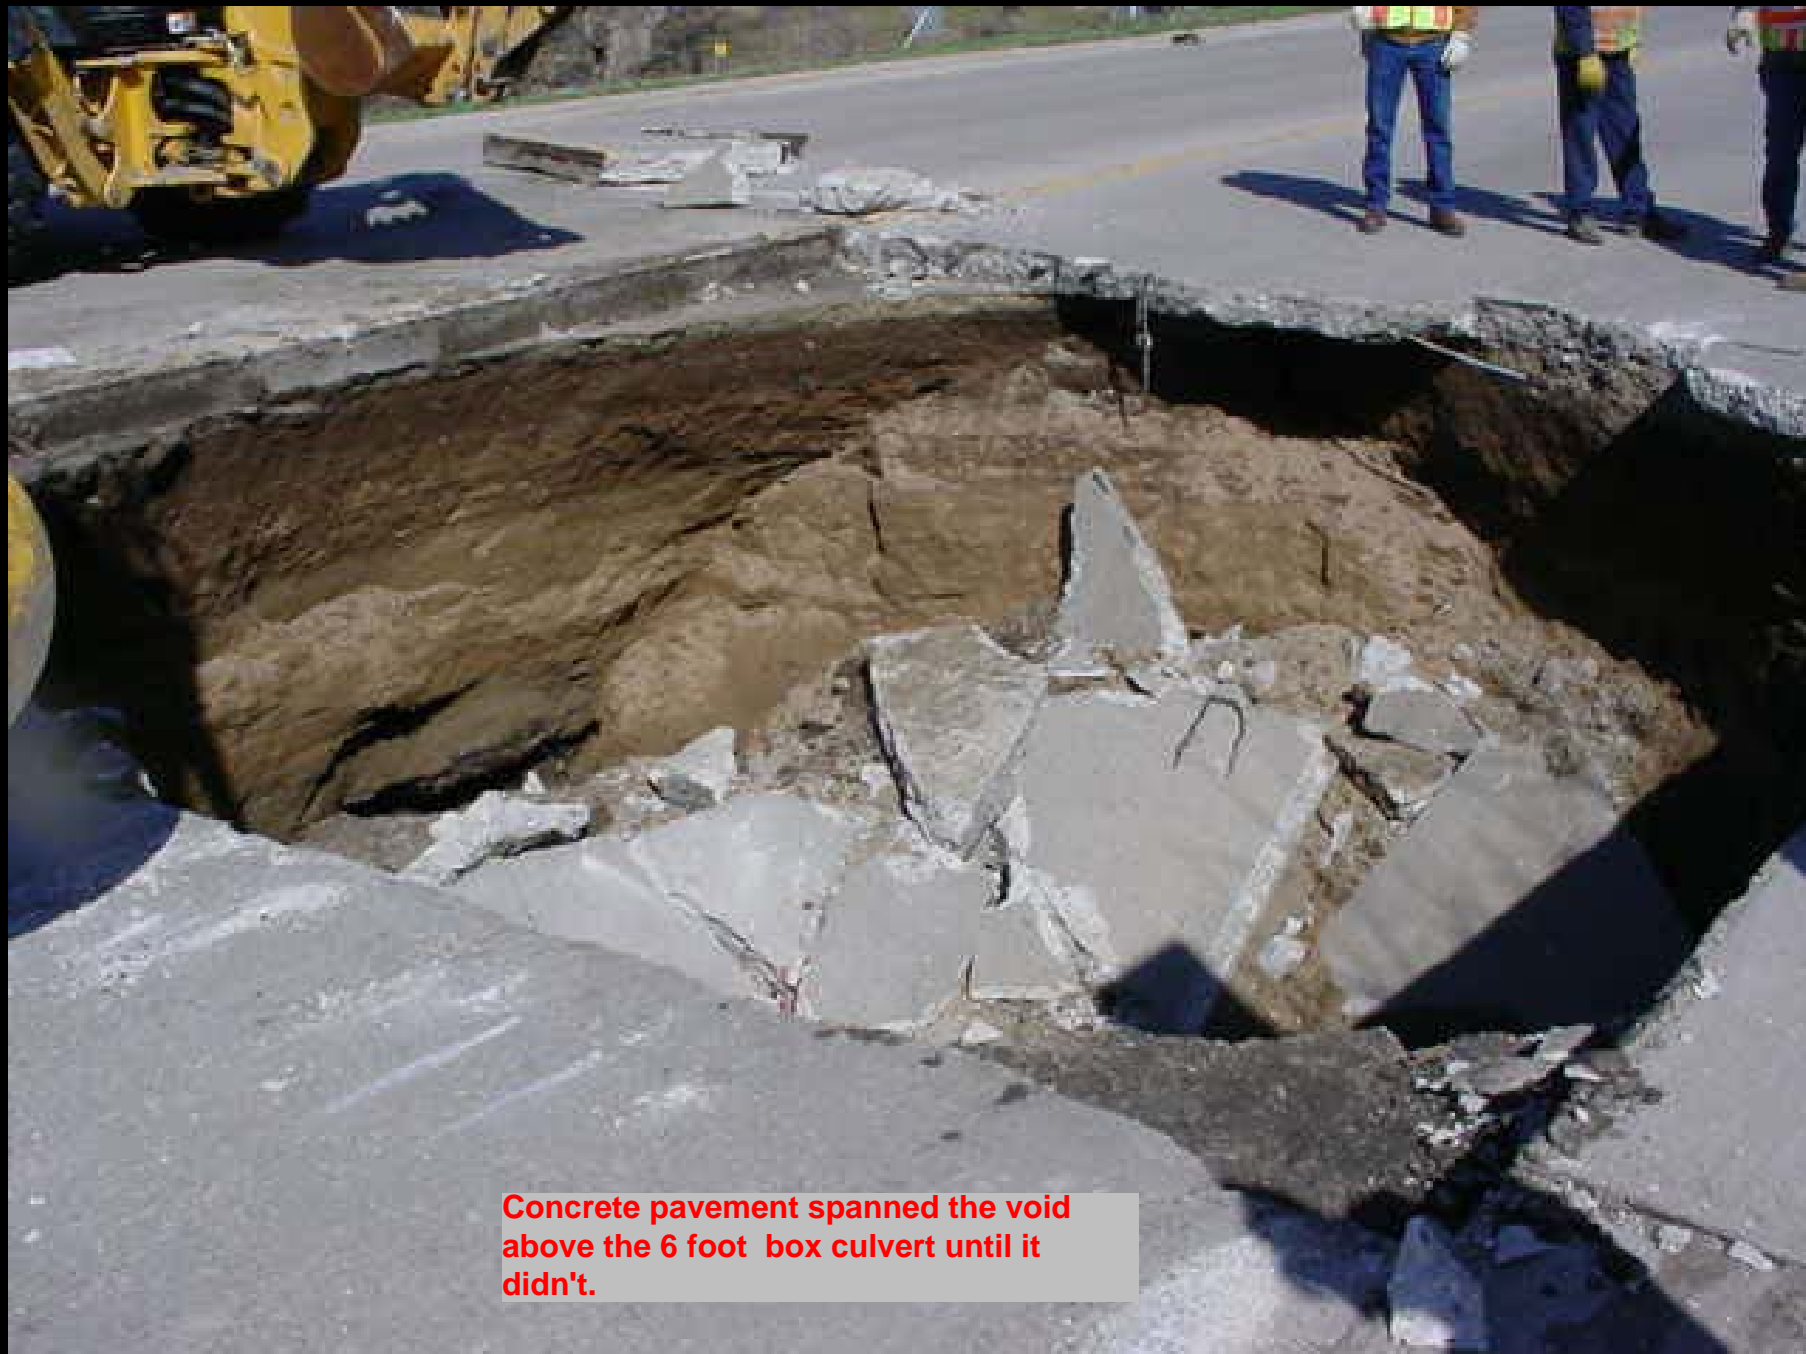
The hole developed because the roadway's foundation sifted through a crack in a culvert creating a void. County Road 45 will be closed until late April to give Steele County crews time to replace the existing culvert and fix the road.

Concrete pavement spanned the void above the 6 foot box culvert until it didn't.

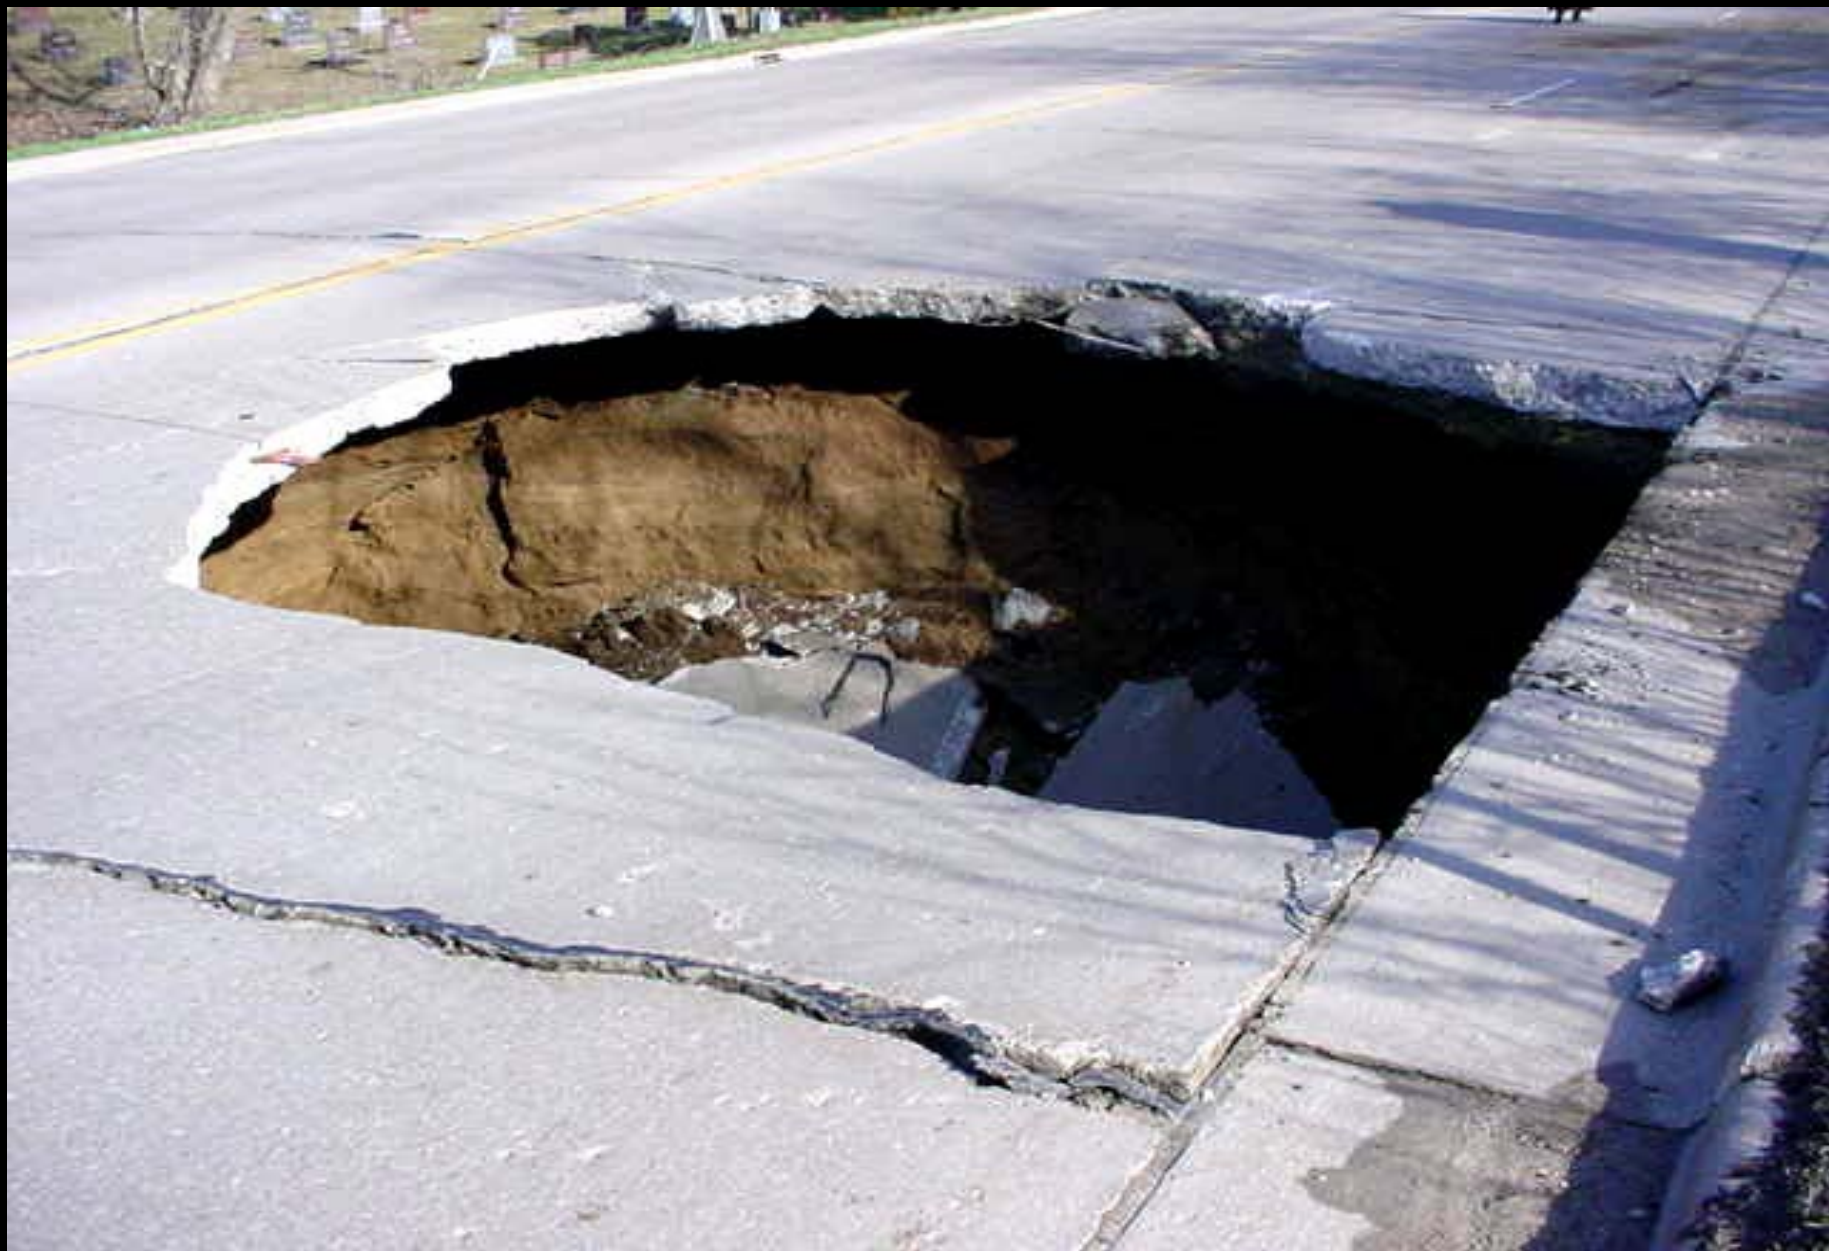
The 6 foot wide by 6 foot high box culvert had holes through the concrete along the bottom corners. Road fill was washed away through the holes, over time, and caused road collapse. The photo shows the exposed steel reinforcement where the concrete used to be.

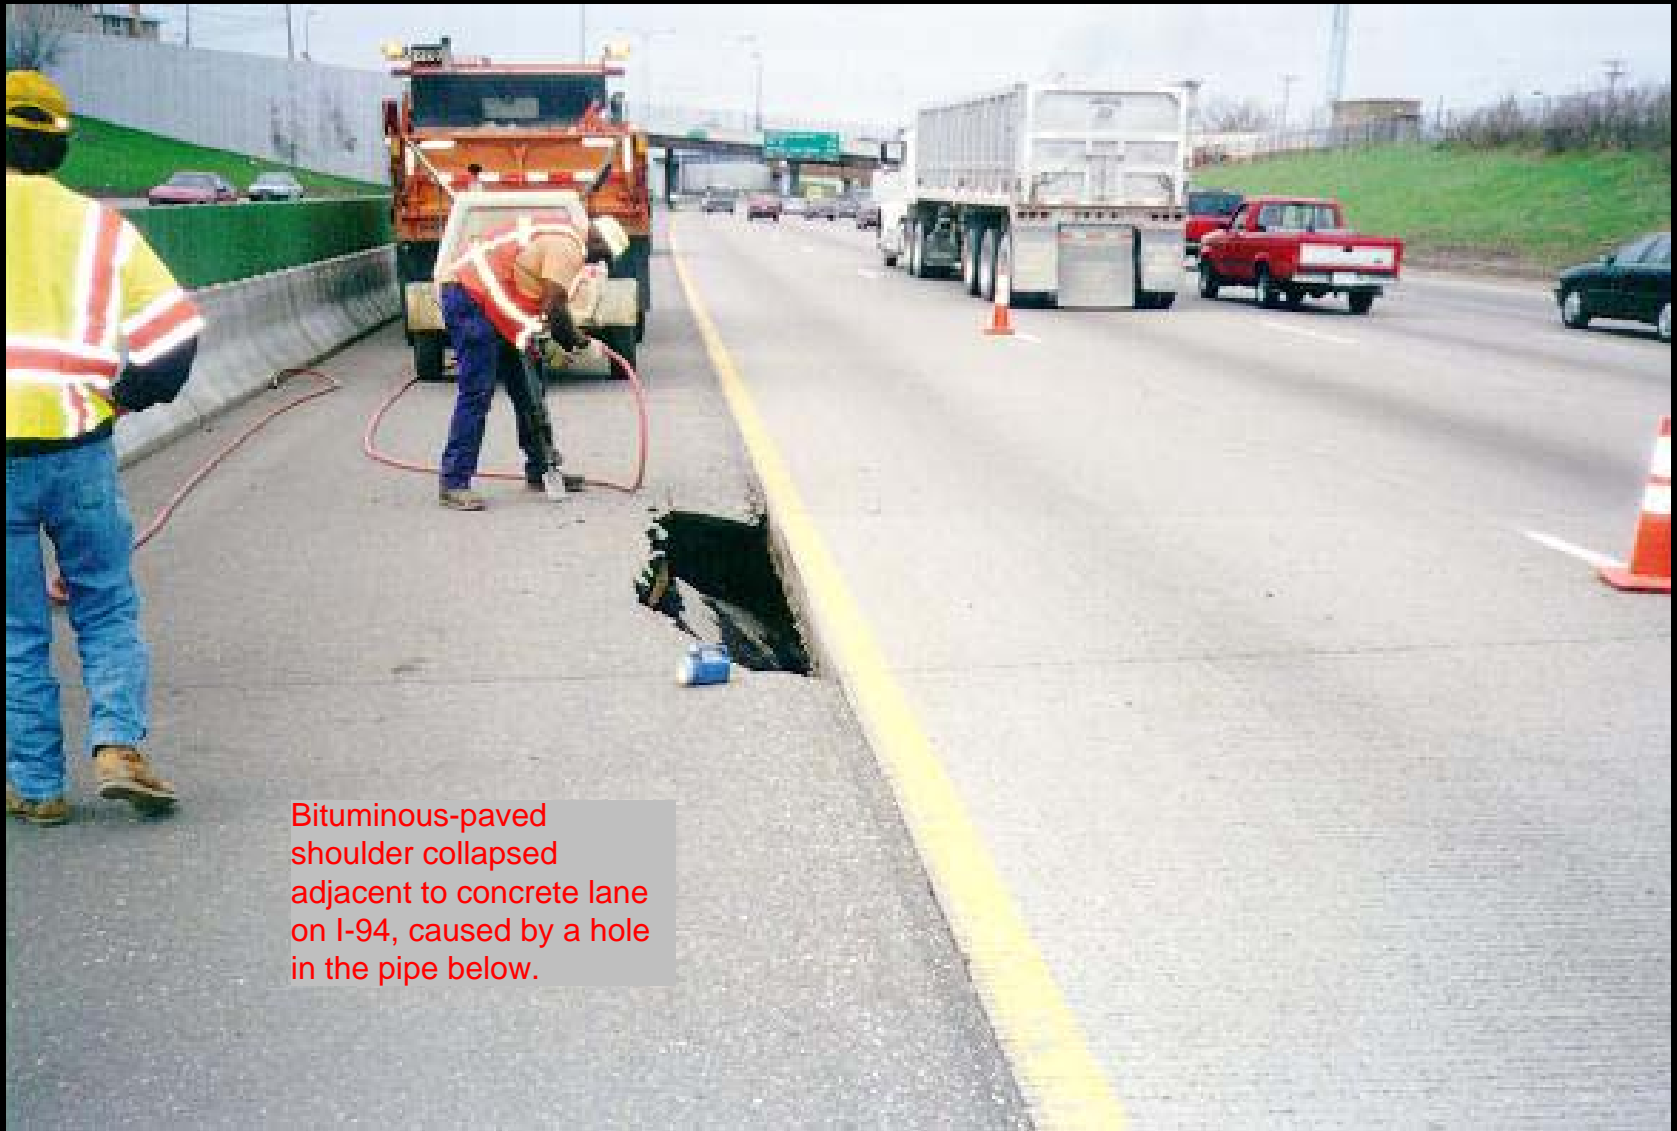
Bituminous-paved shoulder collapsed adjacent to concrete lane on I-94, caused by a hole in the pipe below.

The void was knee-deep where the pavement collapsed.

A view under the pavement showed the void extended under the freeway's concrete driving lane.

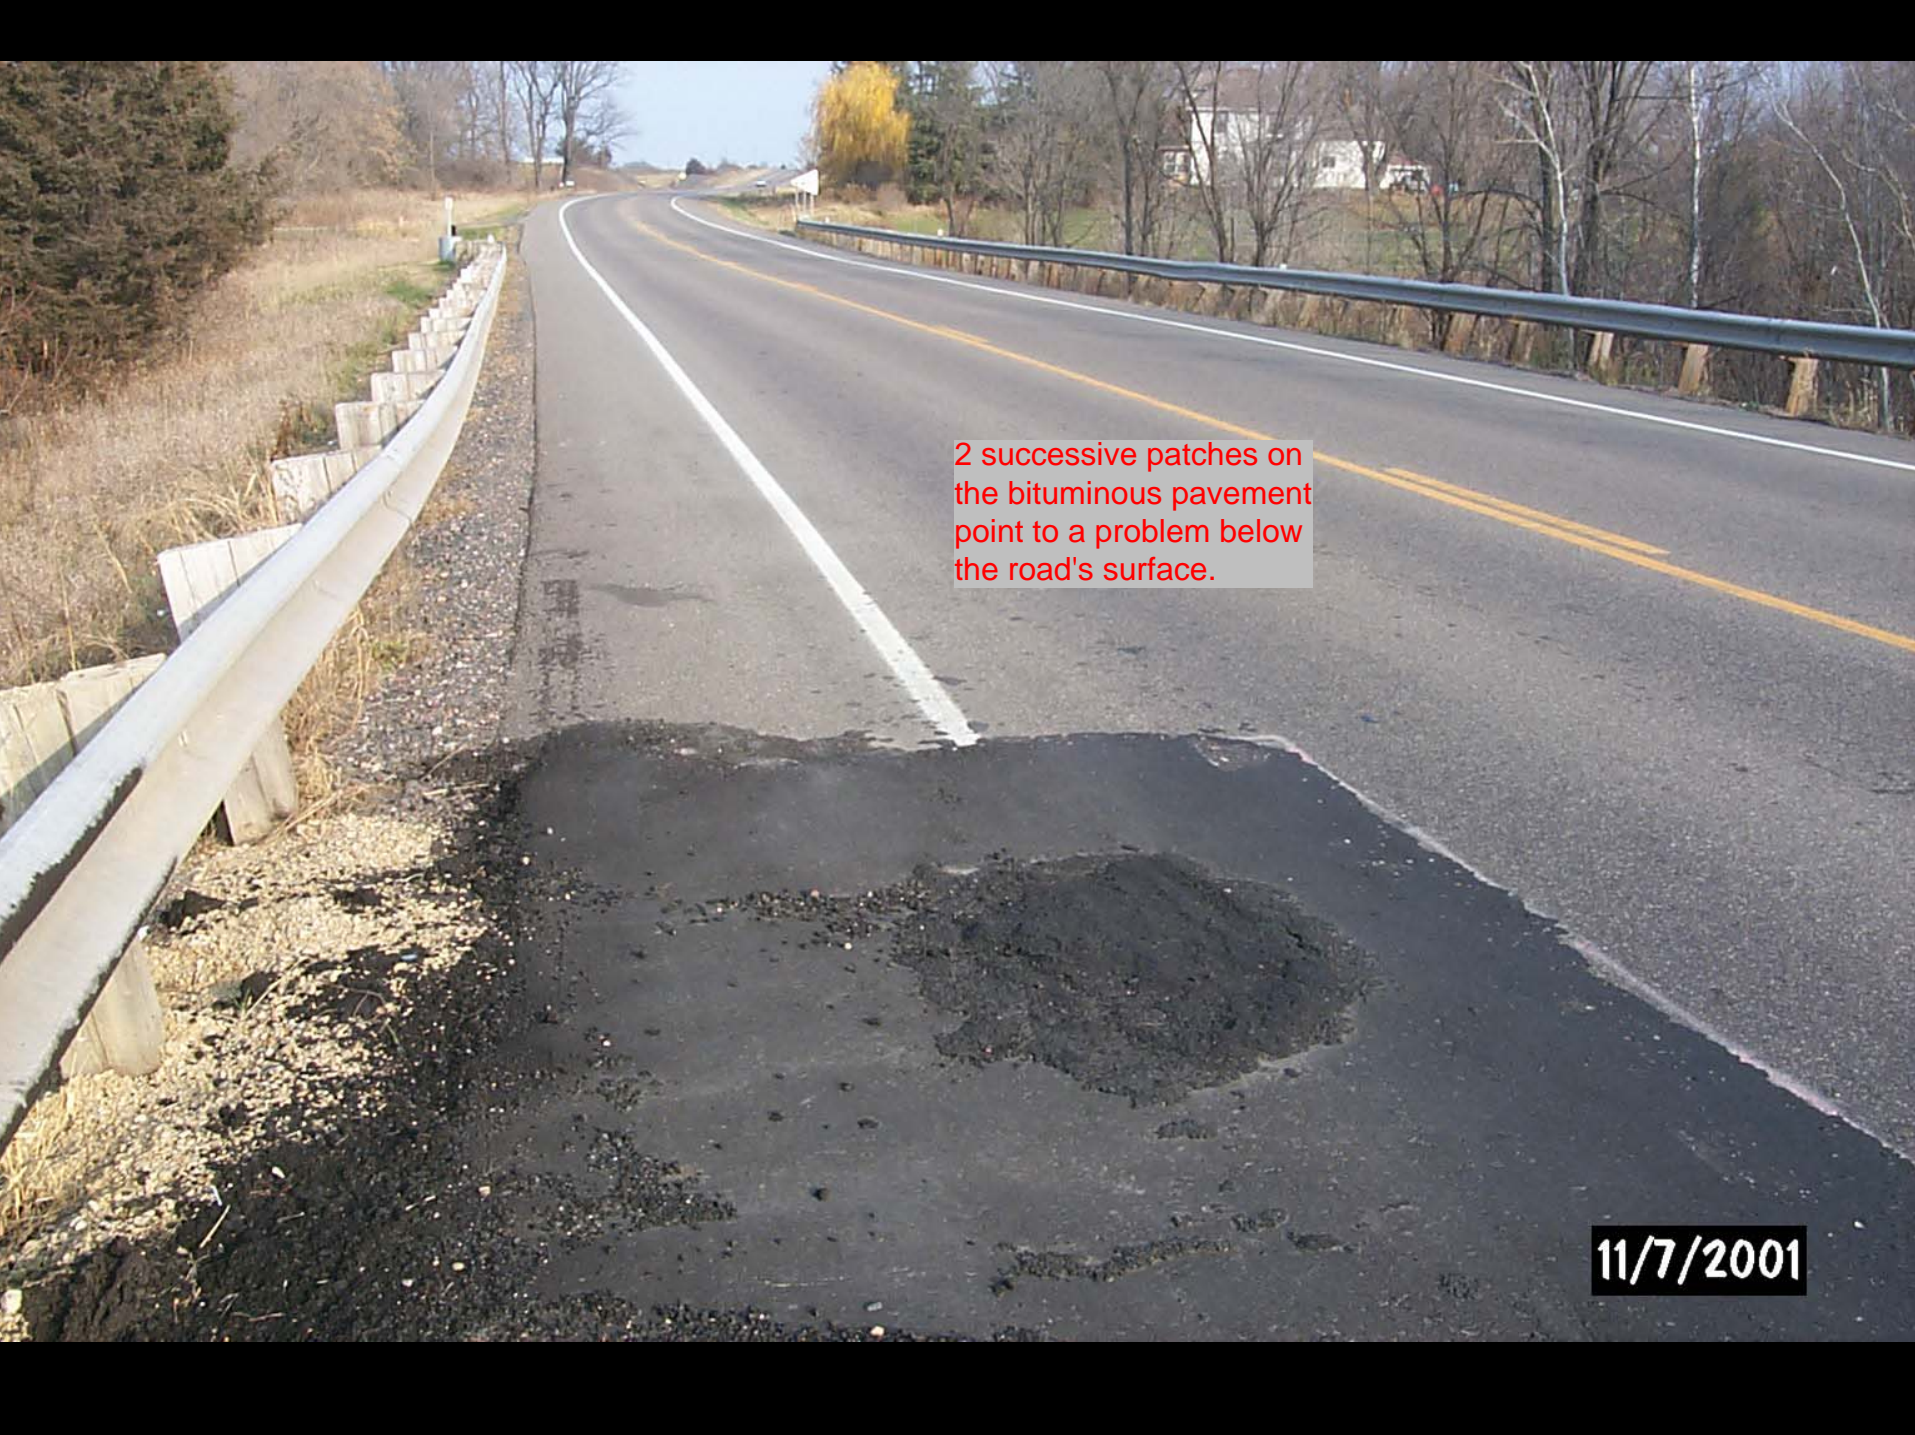
11/7/2001

2 successive patches on the bituminous pavement point to a problem below the road's surface.

Holes in the metal culvert allowed water to wash out soil from around the pipe and create a void under the pavement. The pavement patches masked the underlying problem.

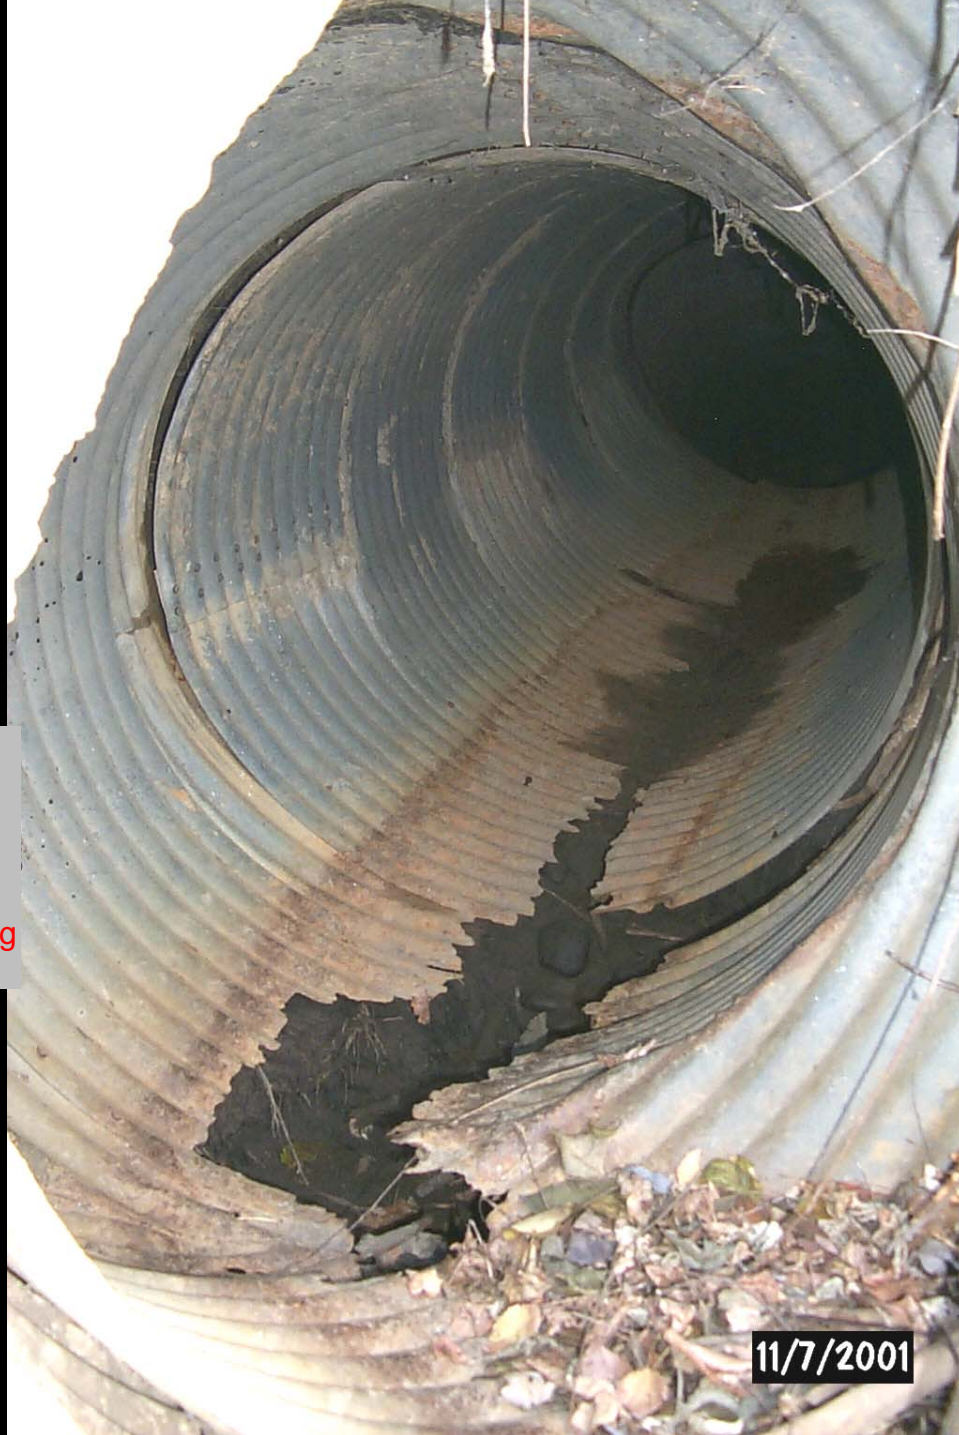
11/7/2001

The hole in the pavement  
may also show up  
somewhere upstream of  
the hole in the pipe.

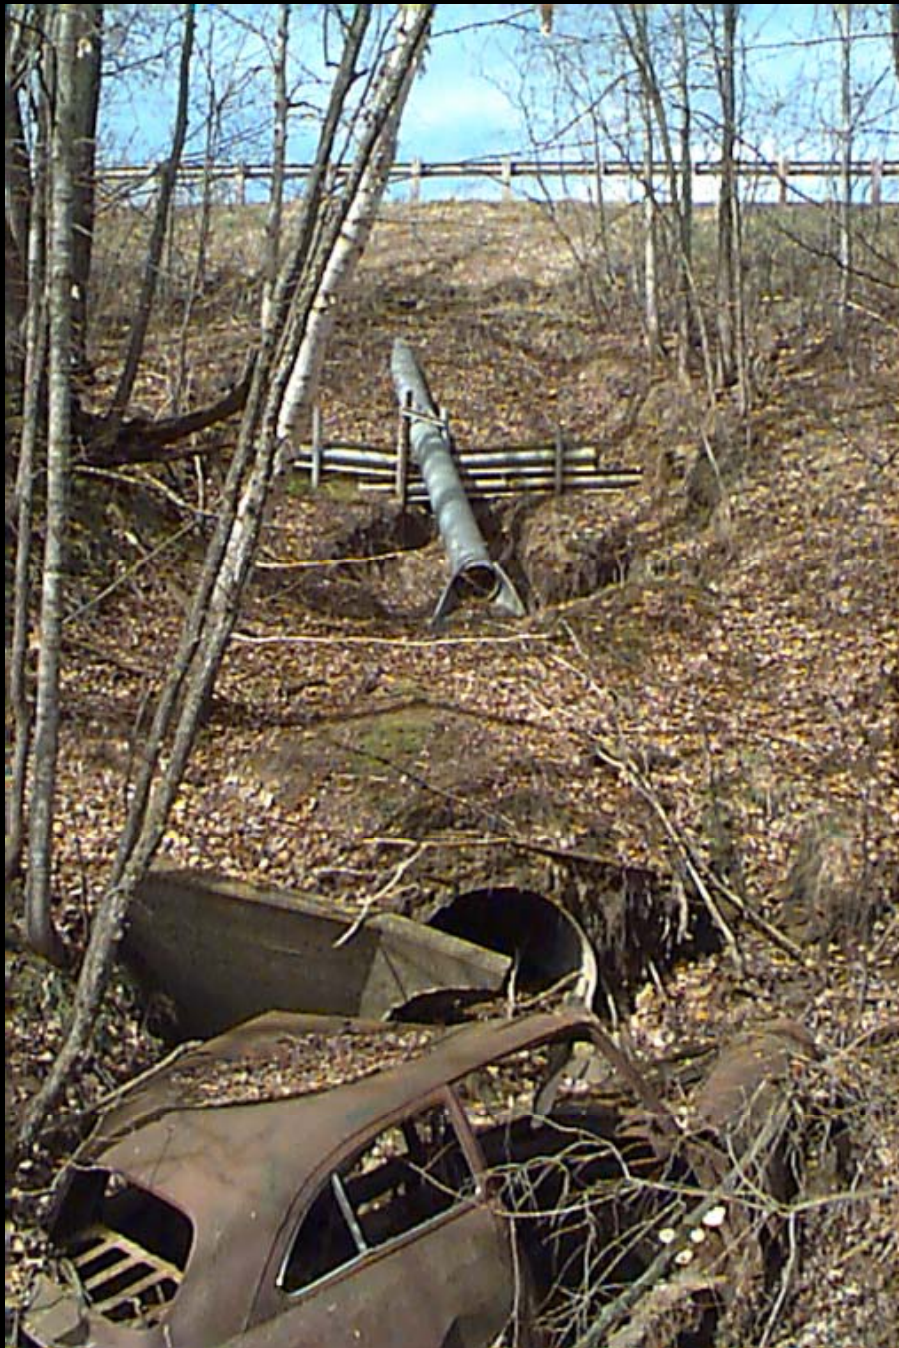
Construction saw a surface erosion problem and tried to fix it.

A void had appeared high in the road embankment. A construction project installed a 24" pipe flume to carry drainage from the road surface and down over the eroded inslope. An old 36" metal culvert was underneath the void.

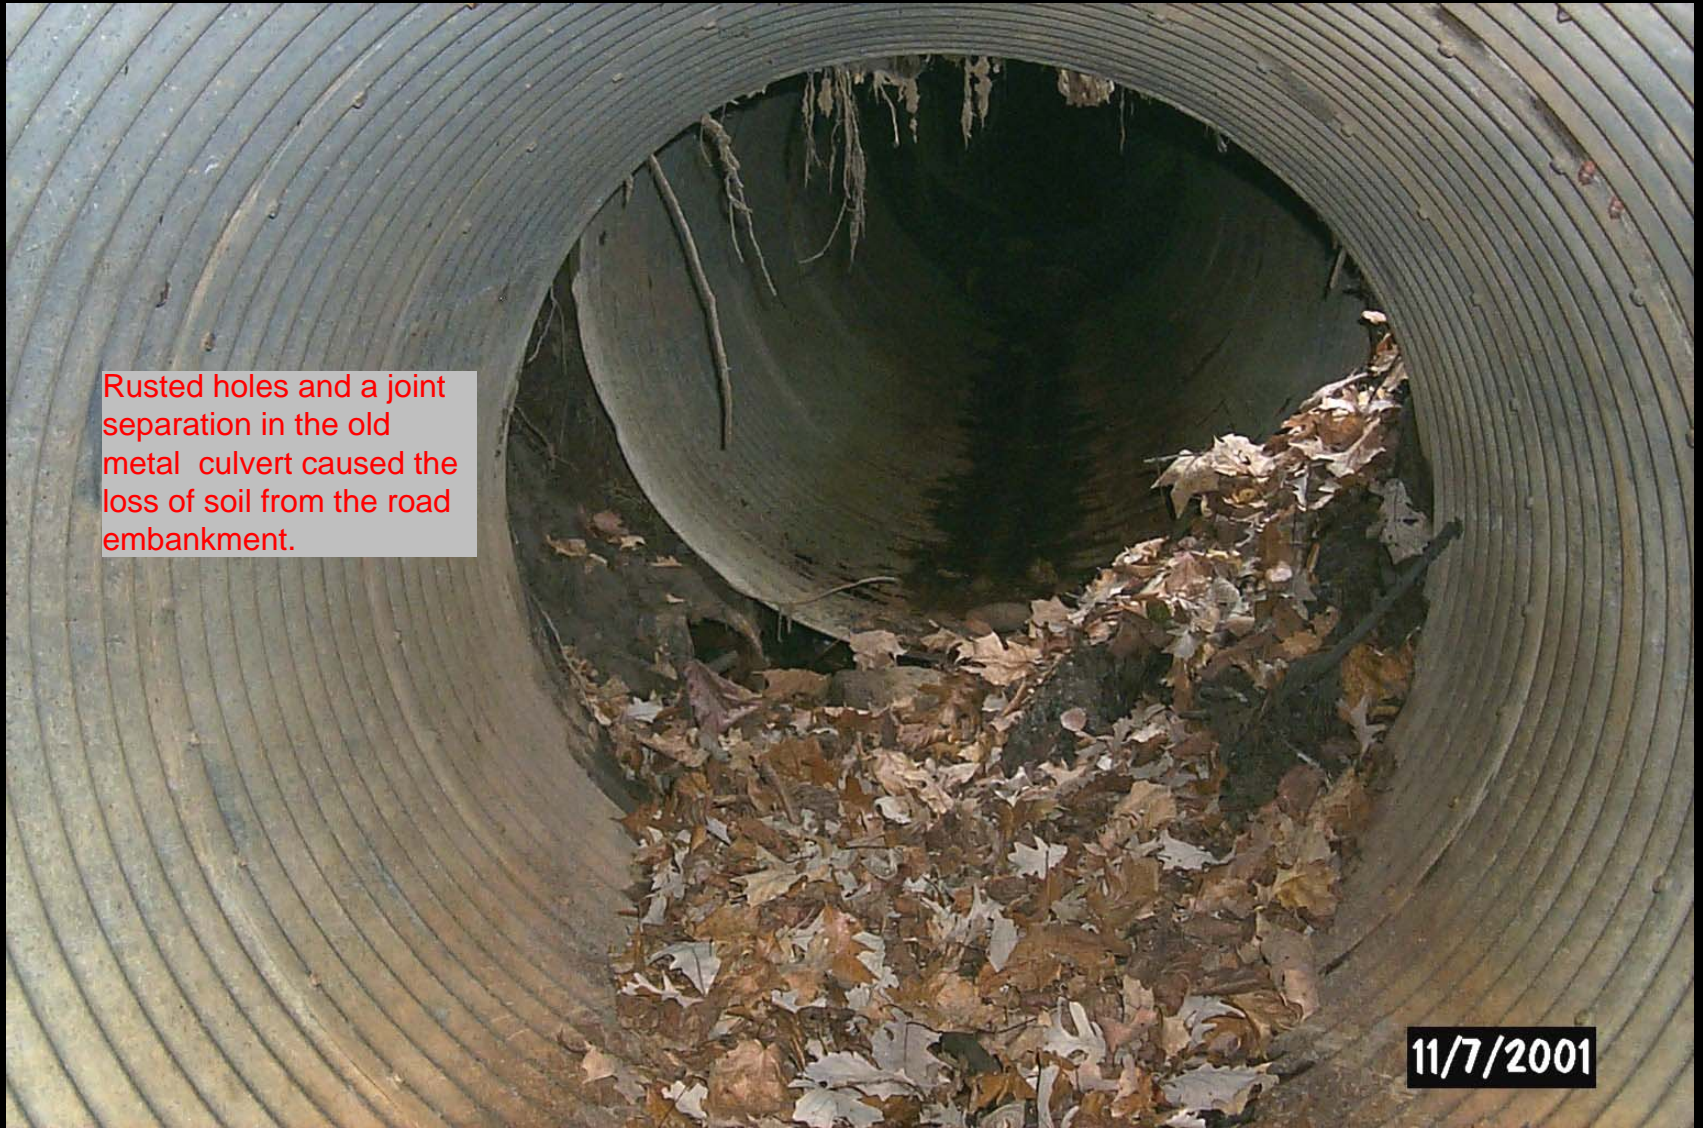
11/7/2001

Rusted holes and a joint separation in the old metal culvert caused the loss of soil from the road embankment.

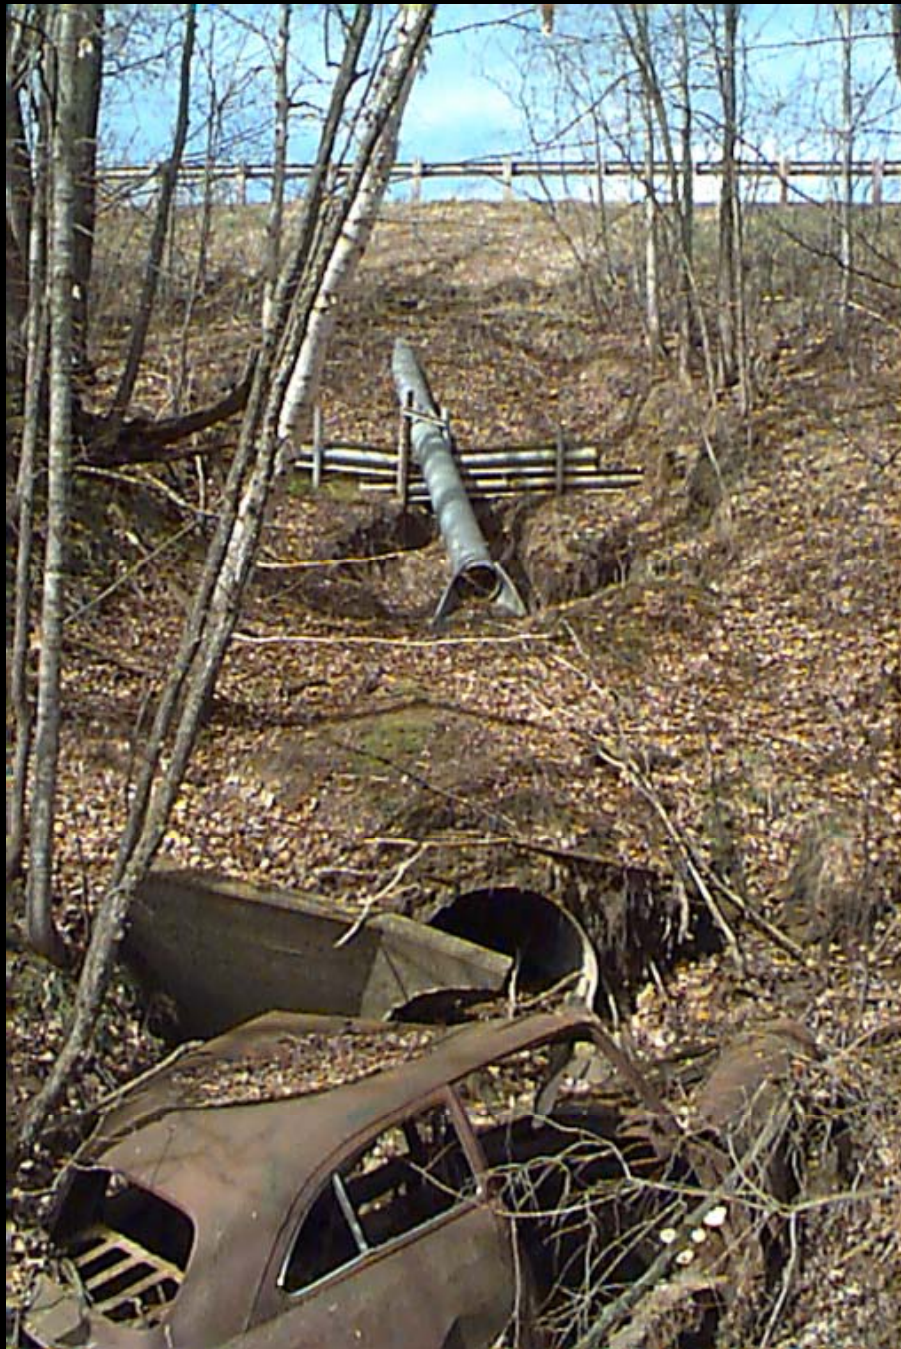
Look again at the hole in the slope above the old culvert.

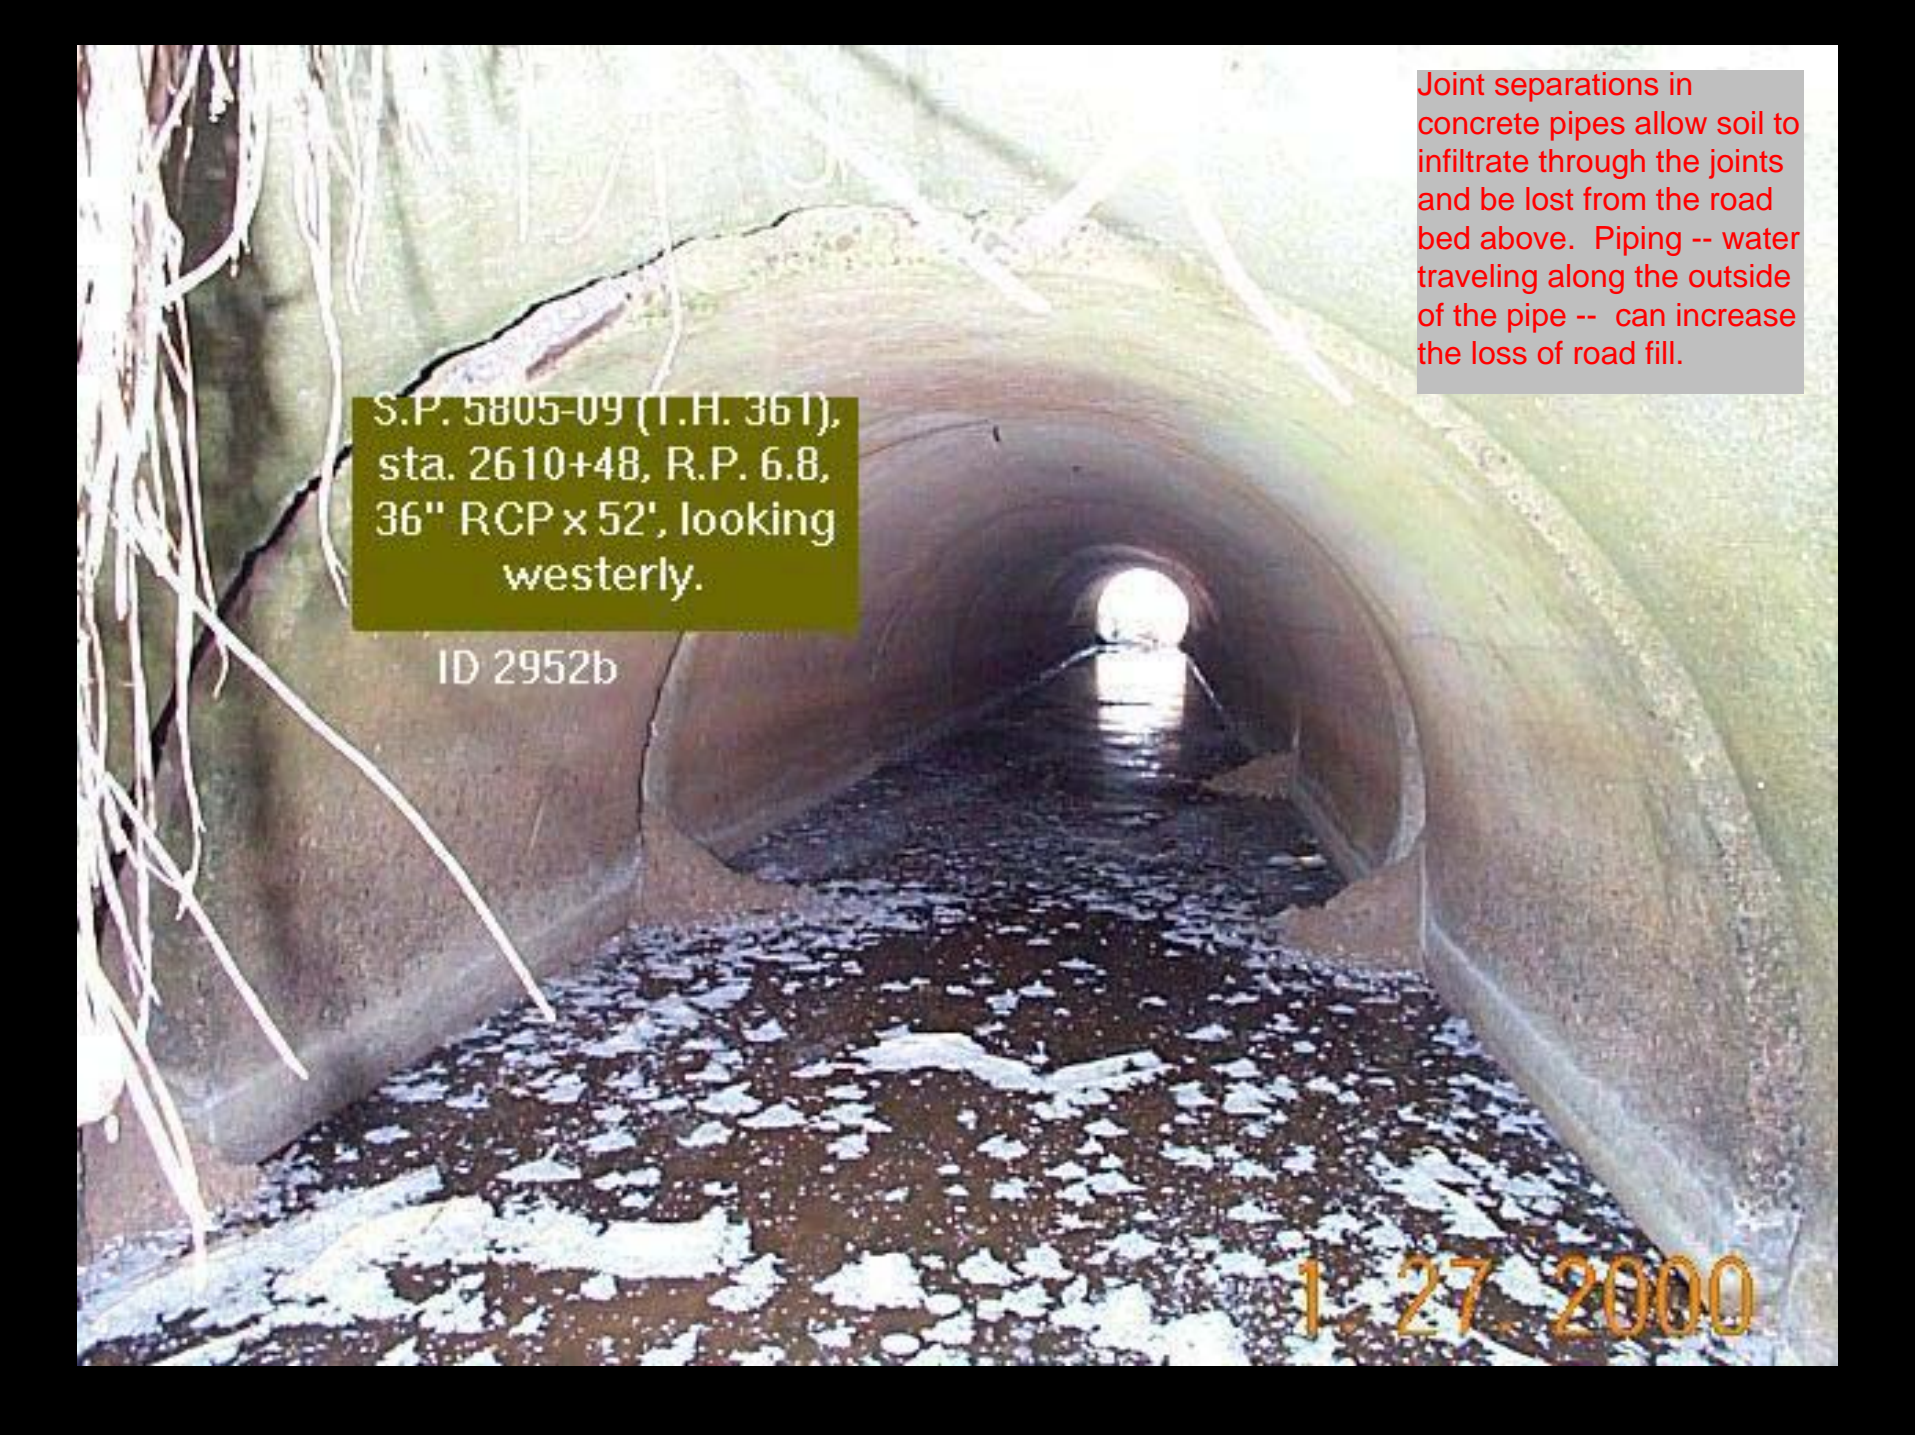
S.P. 5805-09 (I.H. 361),  
sta. 2610+48, R.P. 6.8,  
36" RCP x 52', looking  
westerly.

Joint separations in concrete pipes allow soil to infiltrate through the joints and be lost from the road bed above. Piping -- water traveling along the outside of the pipe -- can increase the loss of road fill.

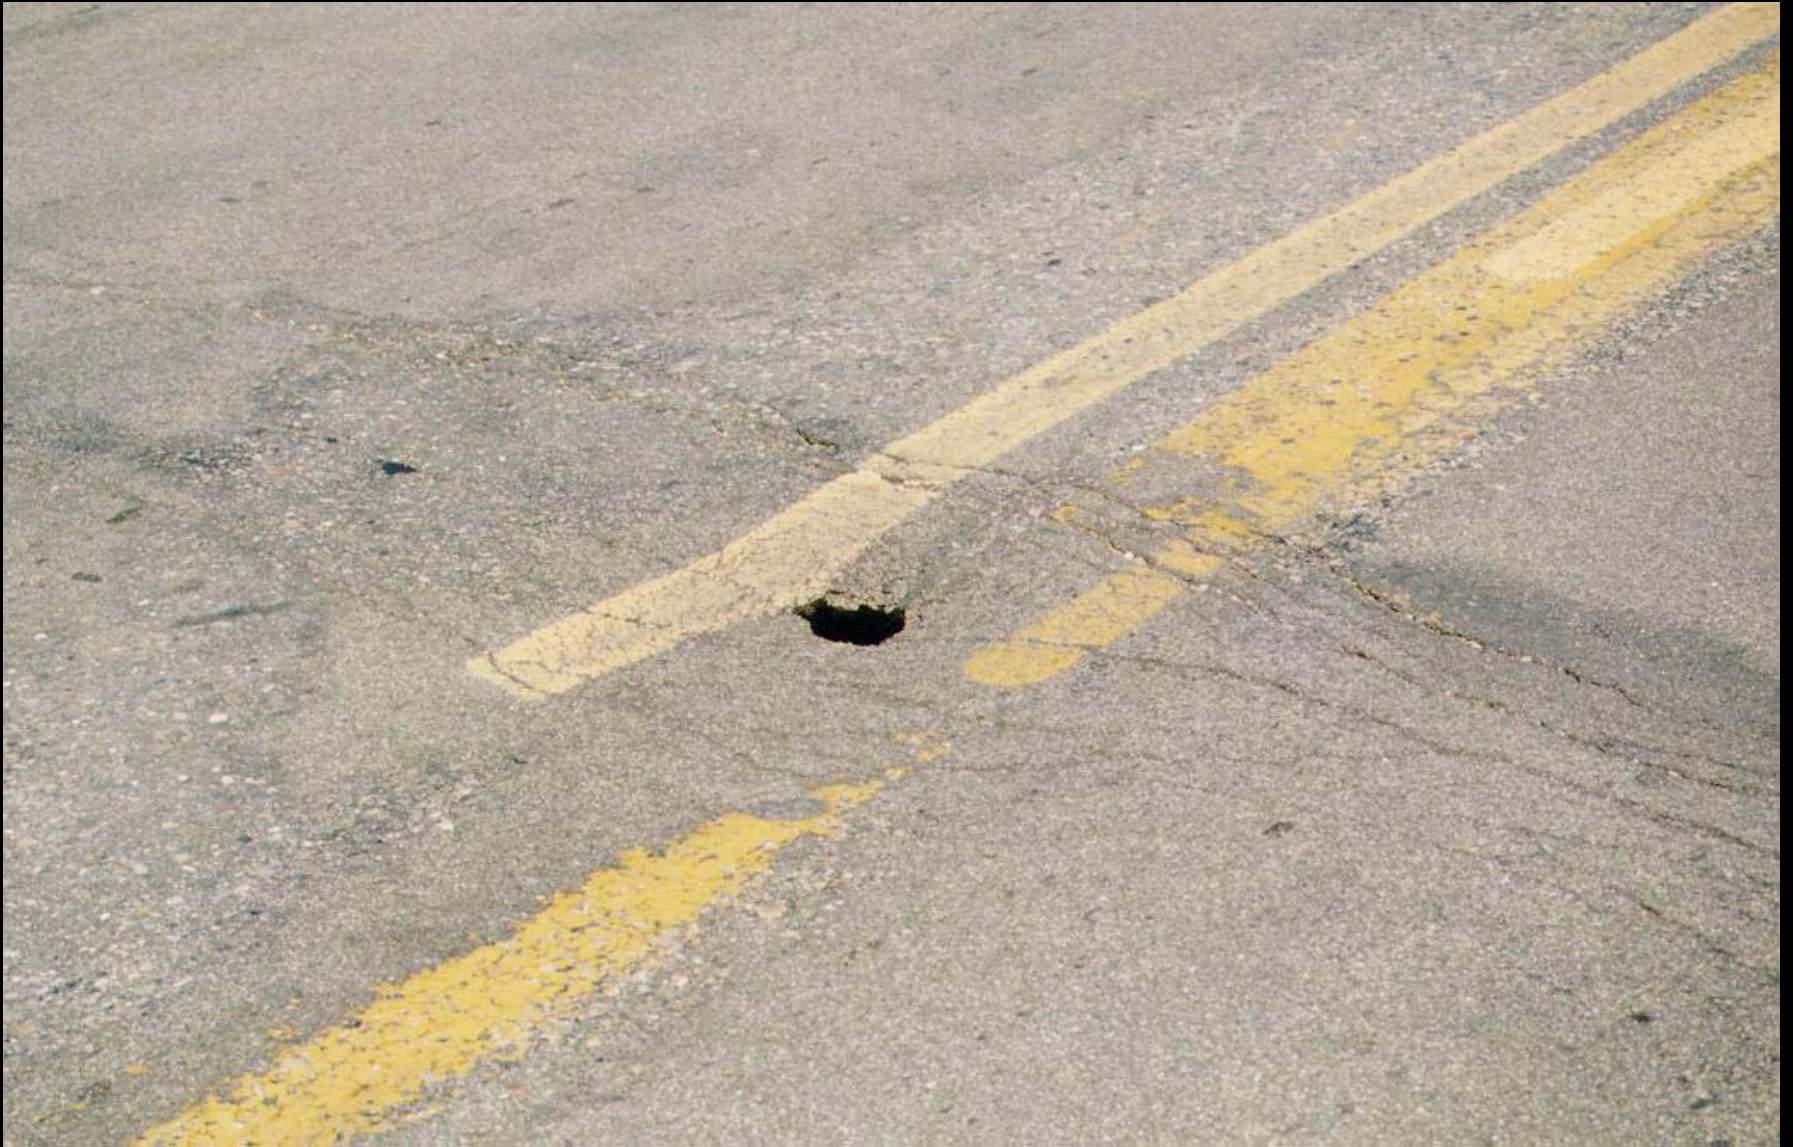
The hole in the pavement may look small. The void below it is the real concern. Holes, joint separations and piping in culverts and storm drain pipes cause voids under road pavement.

Look for  
Pipes or Structures  
with  
Condition Rating 4  
(*and maybe 3*)

and look for HydInfra inspection flags: Holes, Joint Separation, Piping, Road Void.
