Bridge Inspection Field Manual

May 2020

Chapter B of the Bridge and Structure Inspection Program Manual

DEPARTMENT OF
TRANSPORTATION

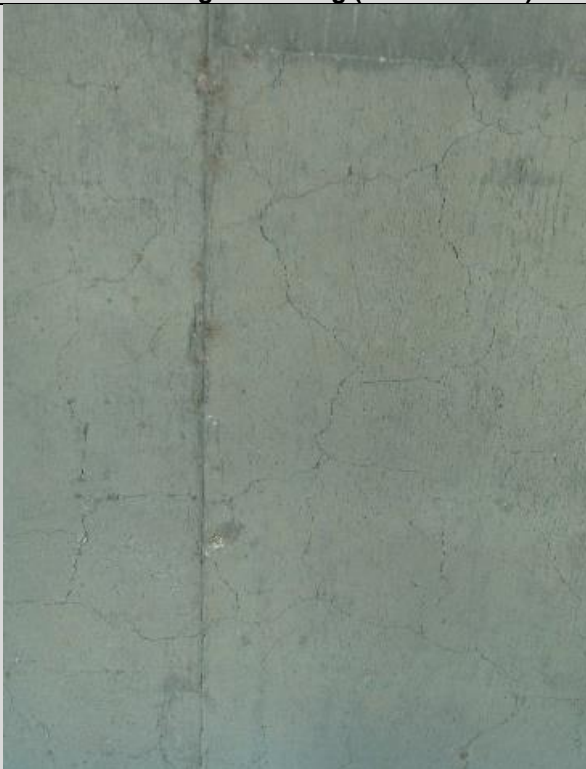
Condition State 2
Diagonal crack on the underside of a concrete deck with light leaching (efflorescence)

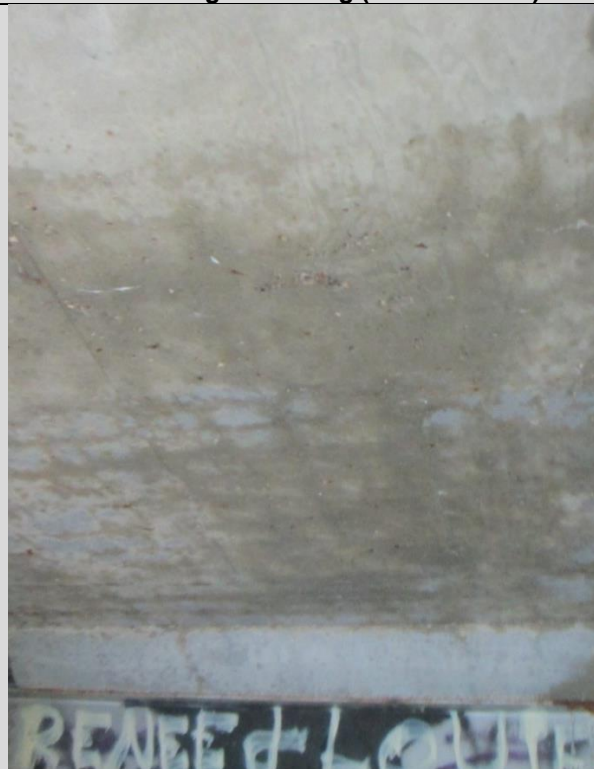
Condition State 2
Map cracking (moderate width) on the underside of a deck with no leaching or water saturation

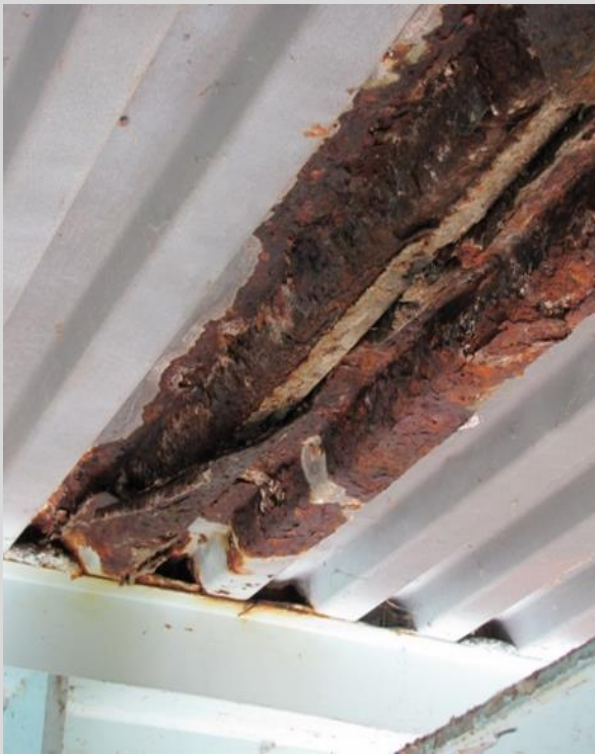
Condition State 3
Steel stay-in-place forms on underside of concrete deck rusted through

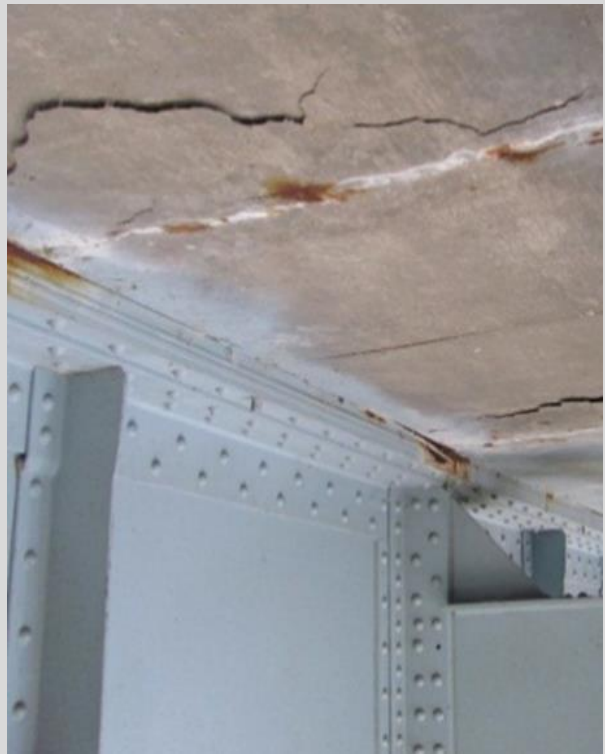
Condition State 4
Delaminated and loose concrete on the underside of a concrete deck (over traffic - safety hazard)

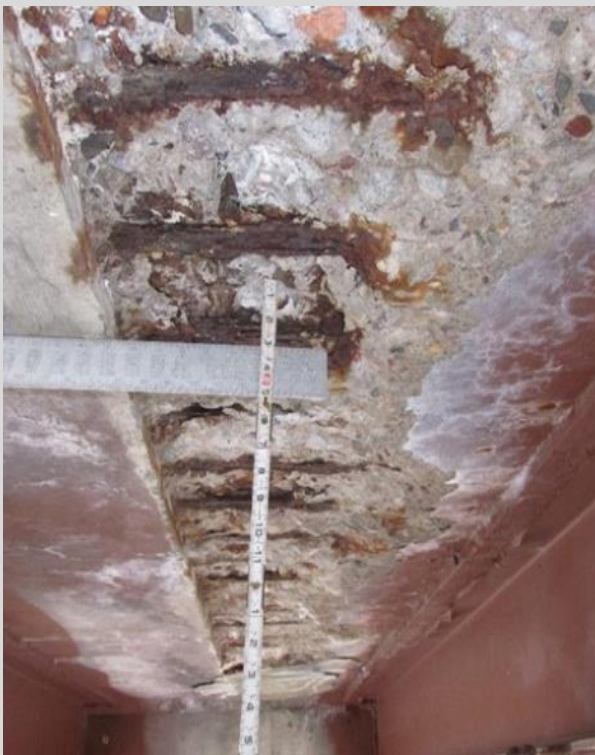
Condition State 4
Severe spalling (more than 3" deep) on the underside of a concrete deck

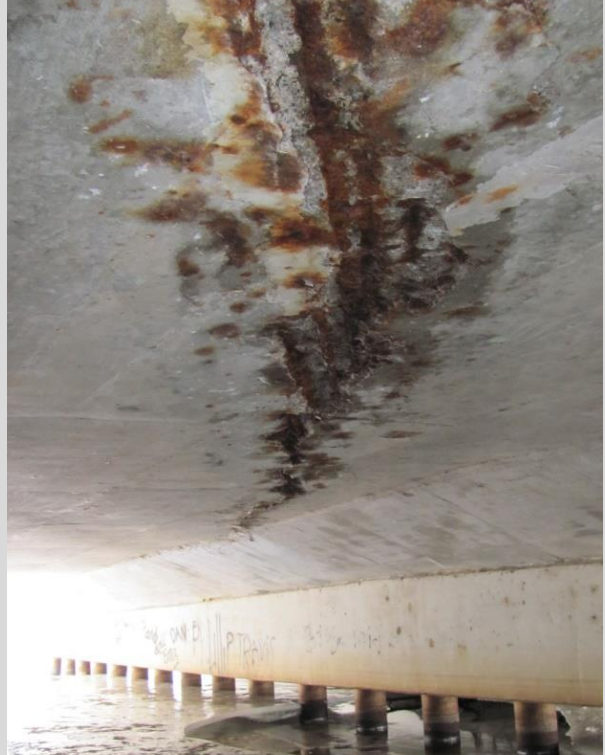
Condition State 4
Severe spalling (more than 3" deep) on the underside of a concrete deck

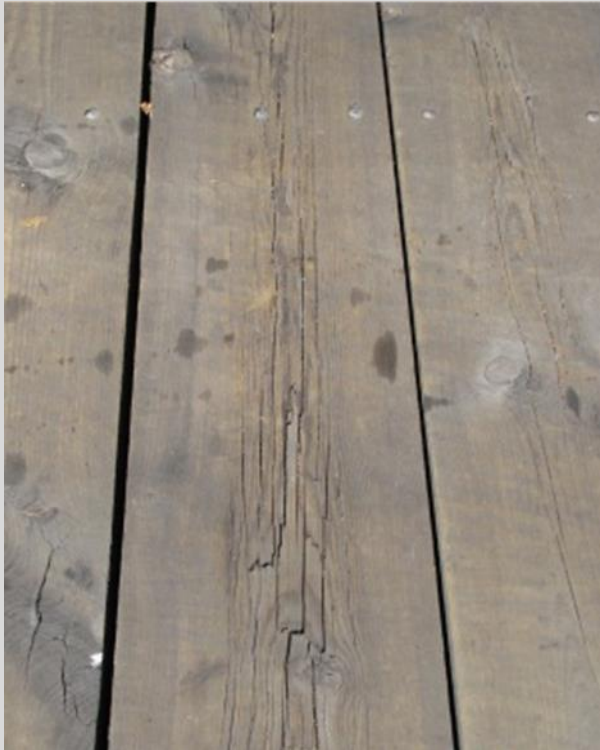
Condition State 2 Weathering (minor section loss) on a timber plank	Condition State 2 Staining on the underside of a timber slab

Condition State 3 Fire damage (significant charring) on a timber slab	Condition State 4 Hole in a timber plank deck

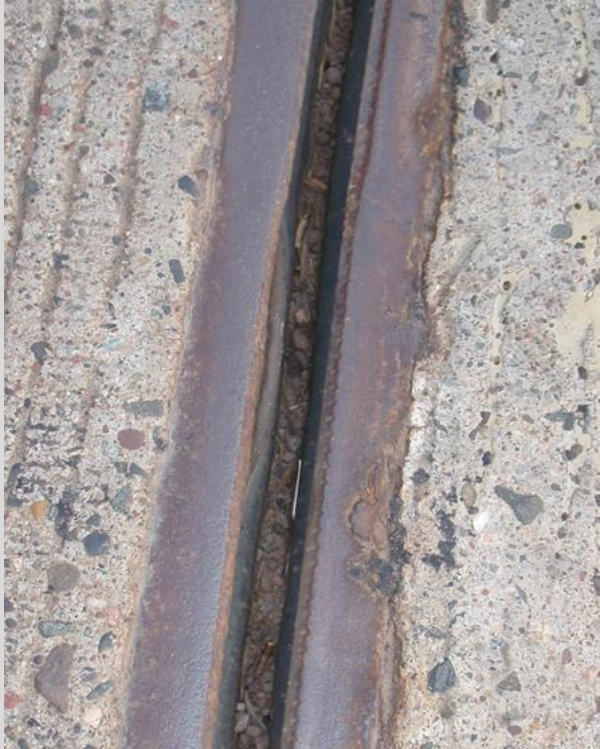
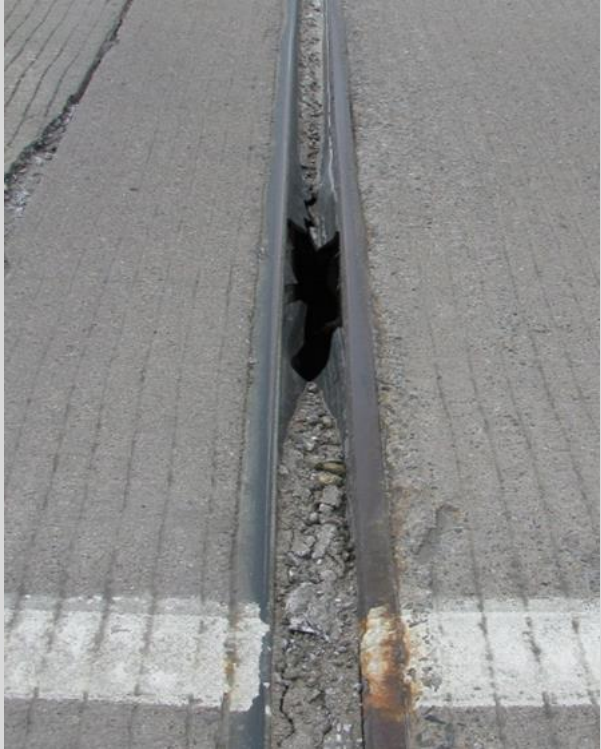
<p>Condition State 2 Strip seal gland partially pulled out</p>	<p>Condition State 3 Hole in strip seal gland</p>

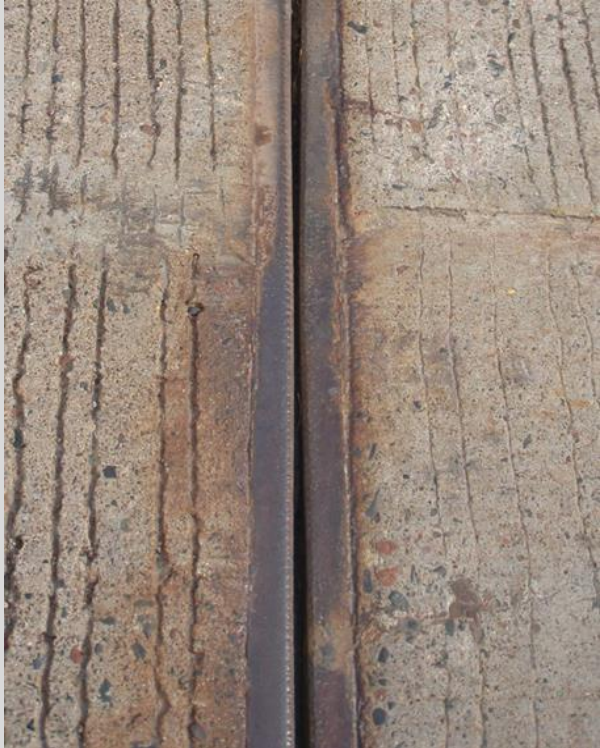
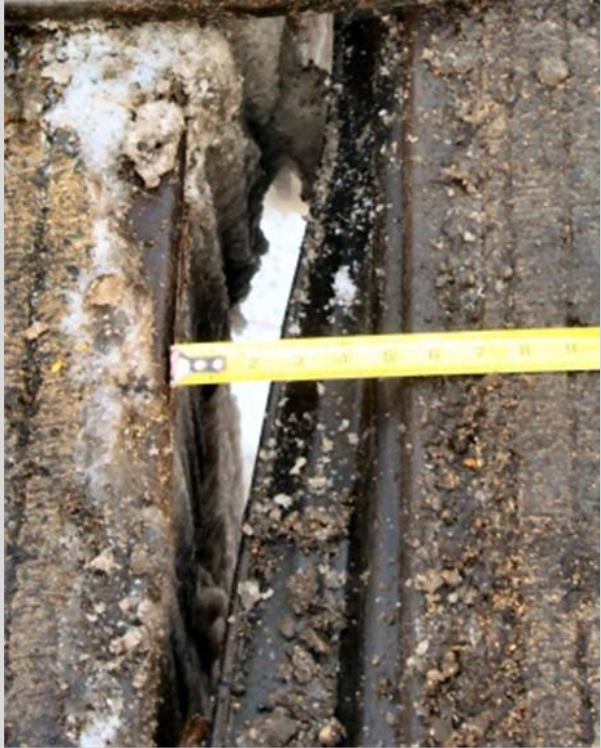
<p>Condition State 4 Strip seal deck joint closed to less than a 1/2" gap</p>	<p>Condition State 4 Joint open beyond design limits (5" gap) – the gland has pulled out of the steel extrusion</p>

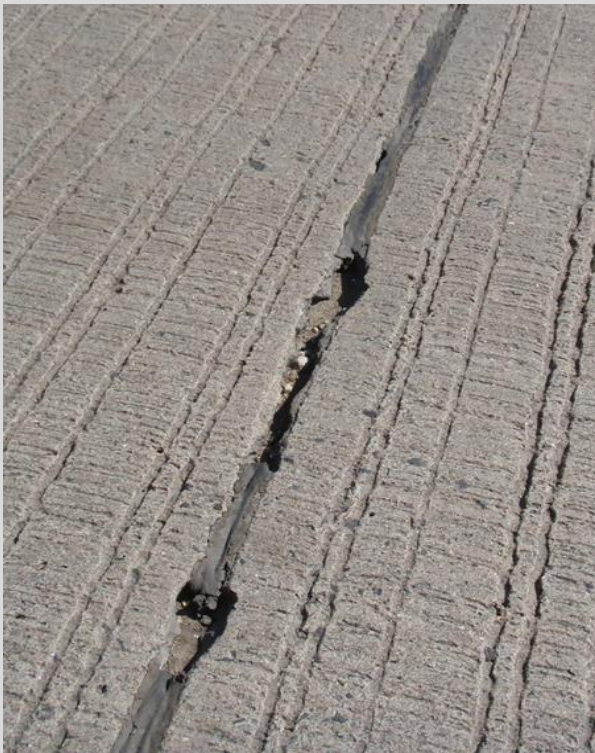
Condition State 3
Section of poured seal missing

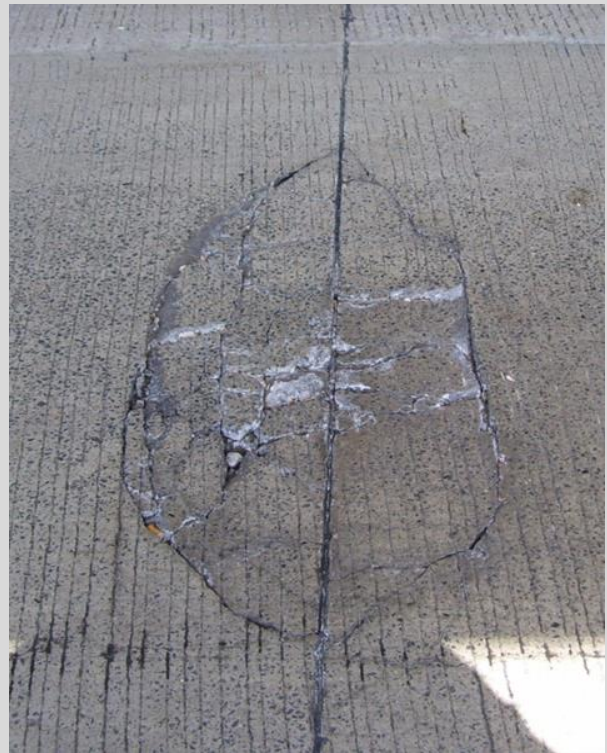
Condition State 4
Cracking and delamination adjacent to a transverse poured deck joint

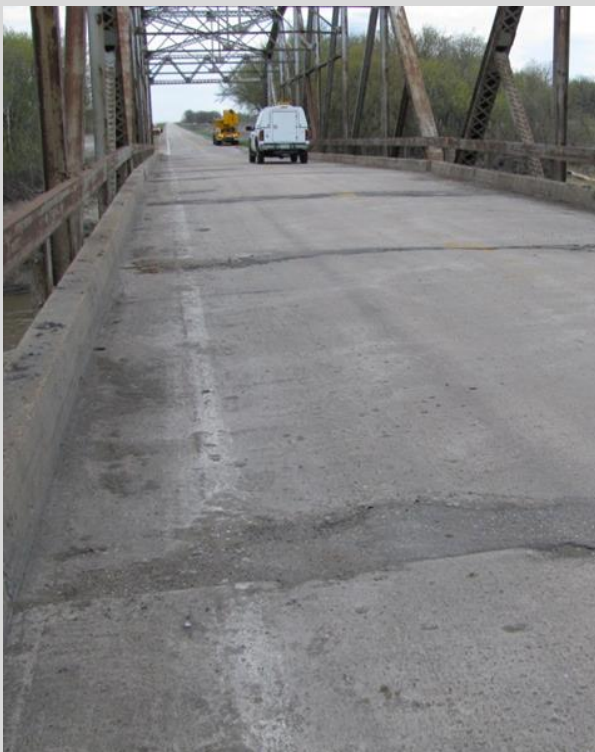
Condition State 4
Extensive deck deterioration (bituminous patching) along transverse poured deck joints

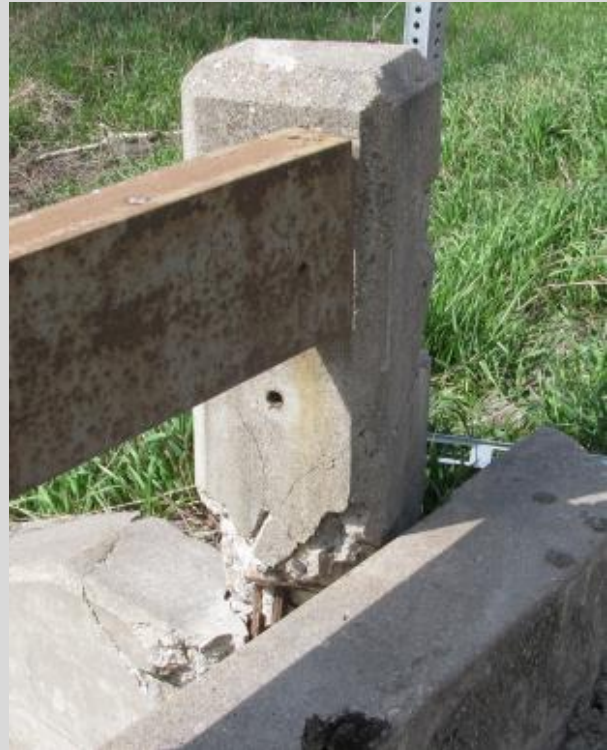
Condition State 4
Severe spall and fracture on a concrete end post

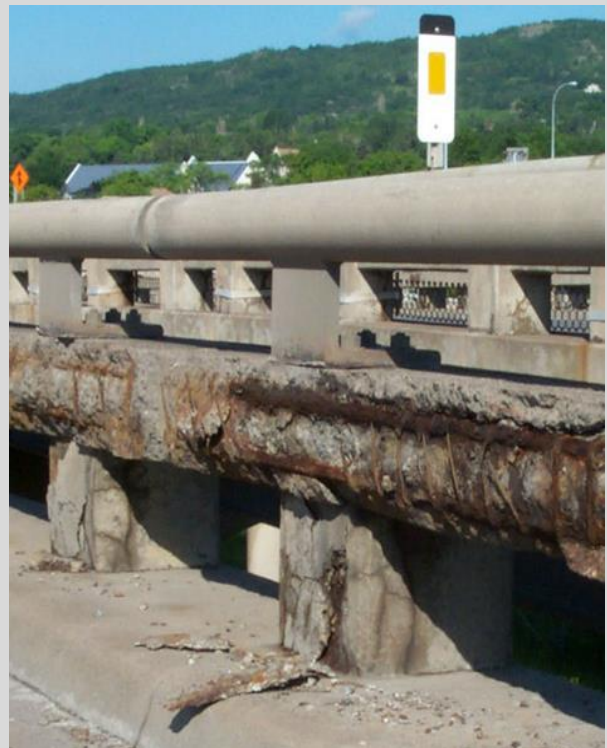
Condition State 4
Severe spalling on the concrete rail base of a combination railing

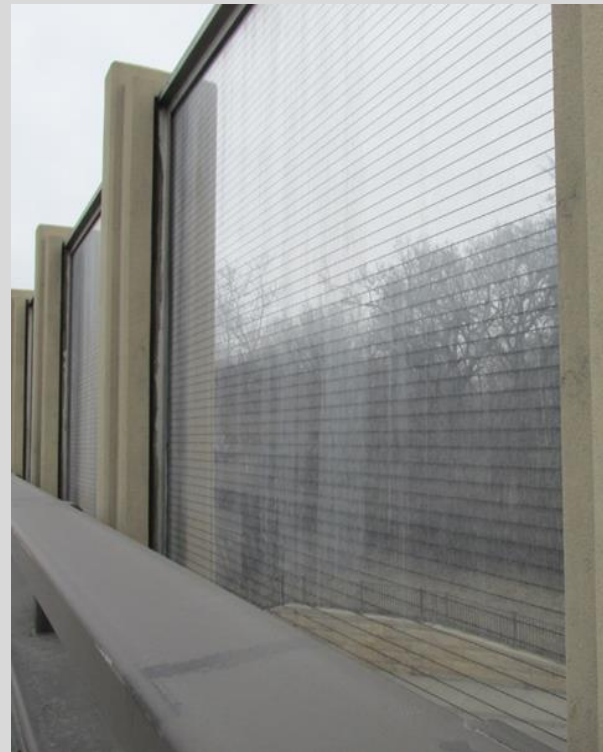
Condition State 1
Transparent Noise Barrier is dirty (no permanent loss of transparency)

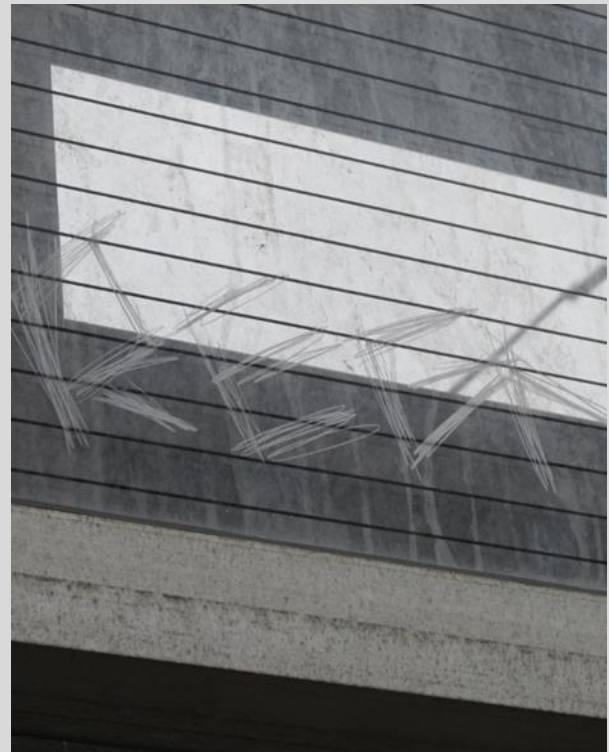
Condition State 2
Transparent Noise Barrier scratched by vandal.

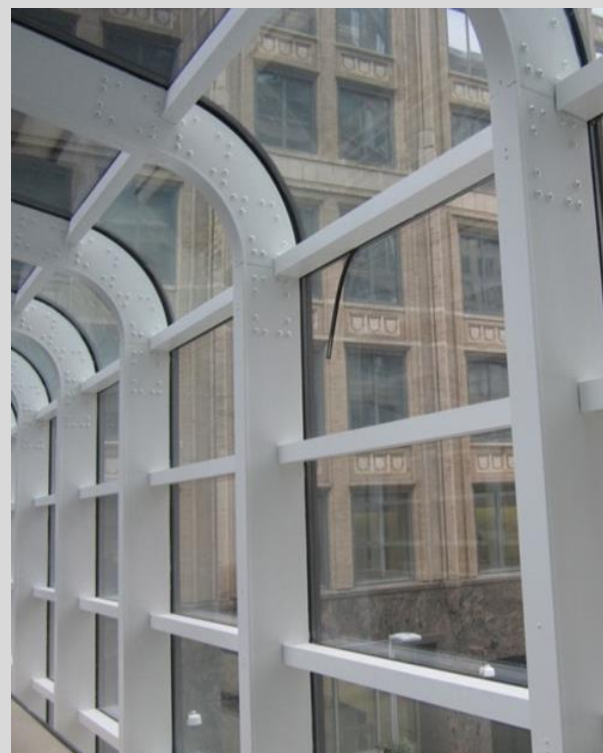
Condition State 2
Loose seal (no leakage) on an enclosed pedestrian skyway

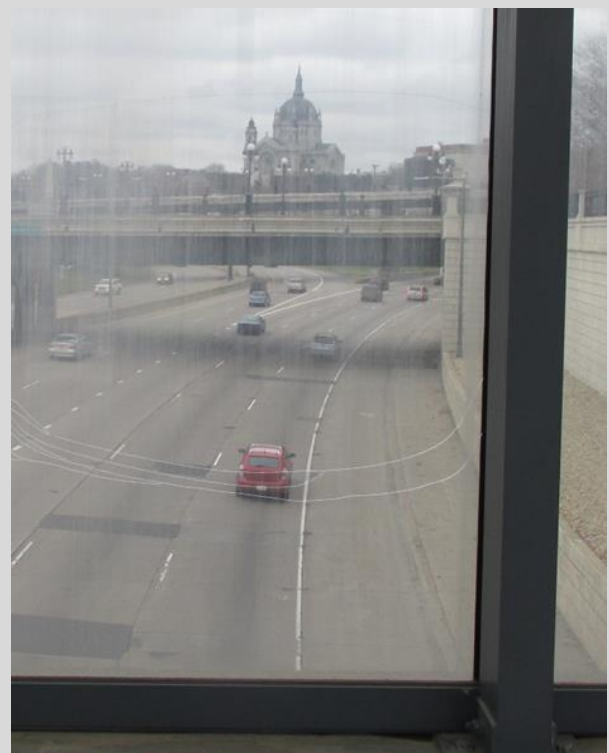
Condition State 3
Cracks in a transparent panel

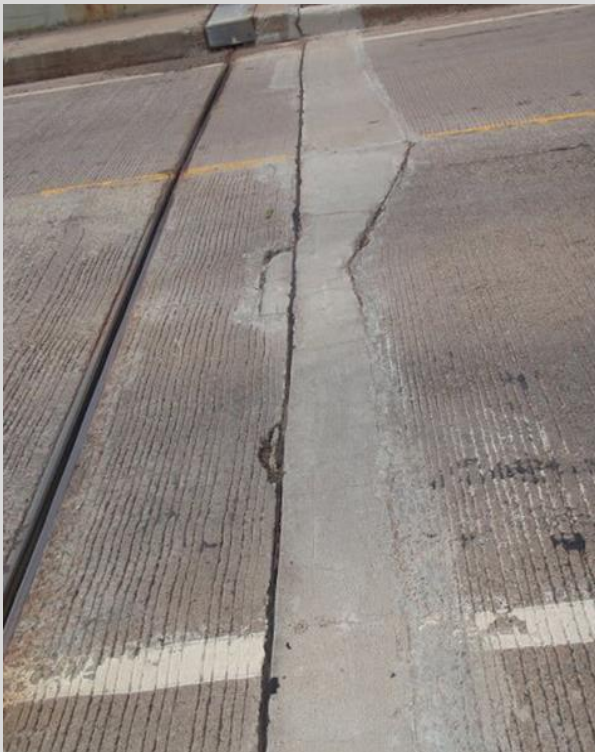
Condition State 2
Concrete patch on a concrete approach panel
(along the end block joint)

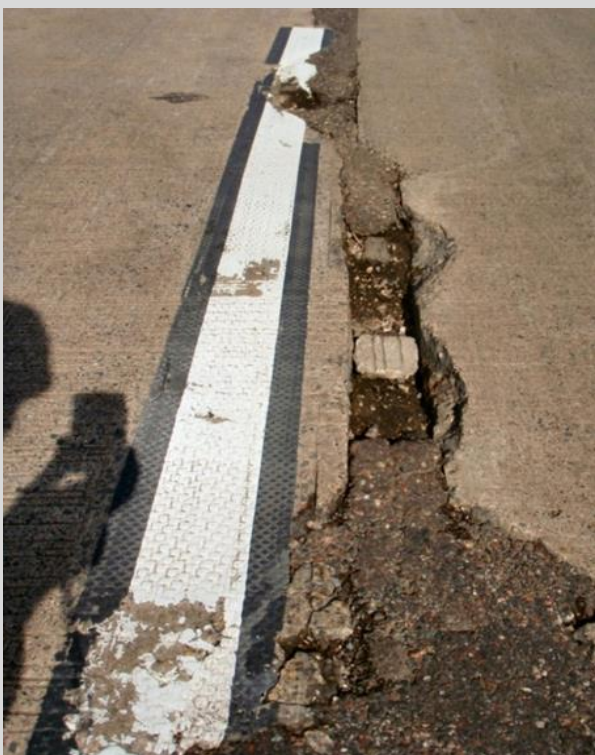
Condition State 4
Severe spall along centerline of a concrete
approach panel

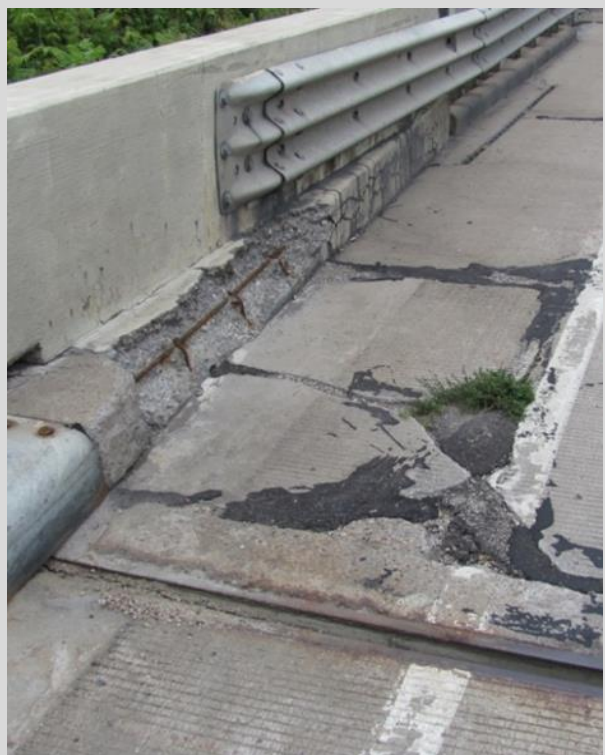
Condition State 4
Concrete approach panel fractured at the corner

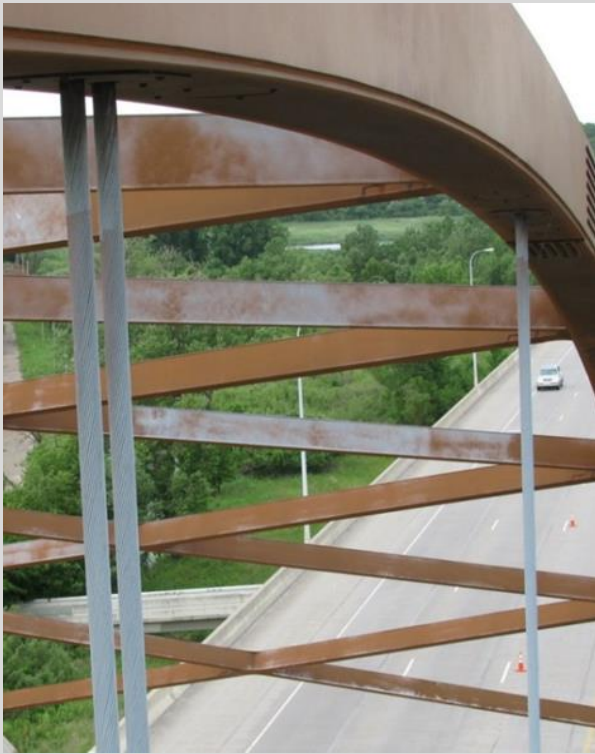
Condition State 2
Chalking paint on steel arch bracing members

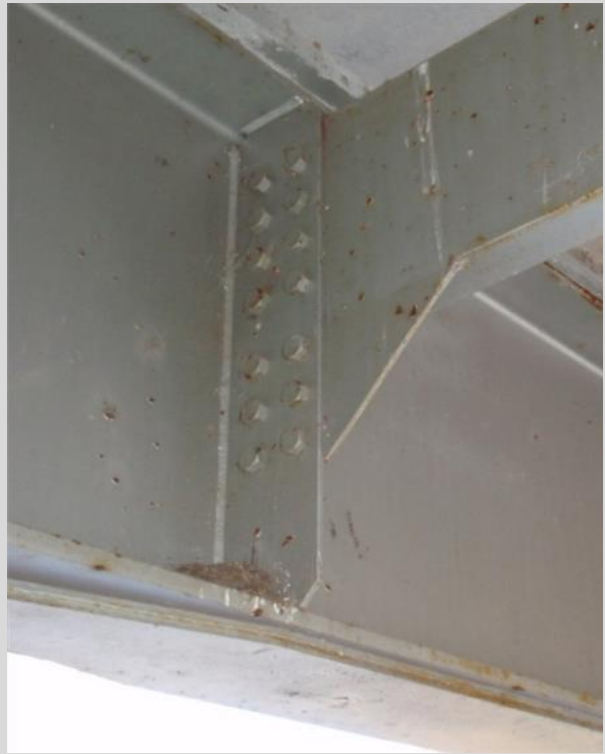
Condition State 2
Minor paint failure (Isolated – less than 3%)

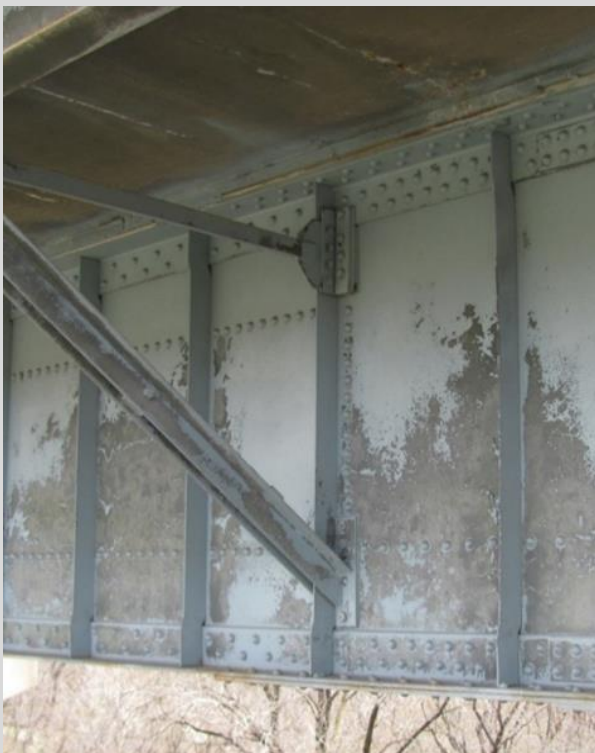
Condition State 3
Paint finish coat failure (primer coat remains intact)

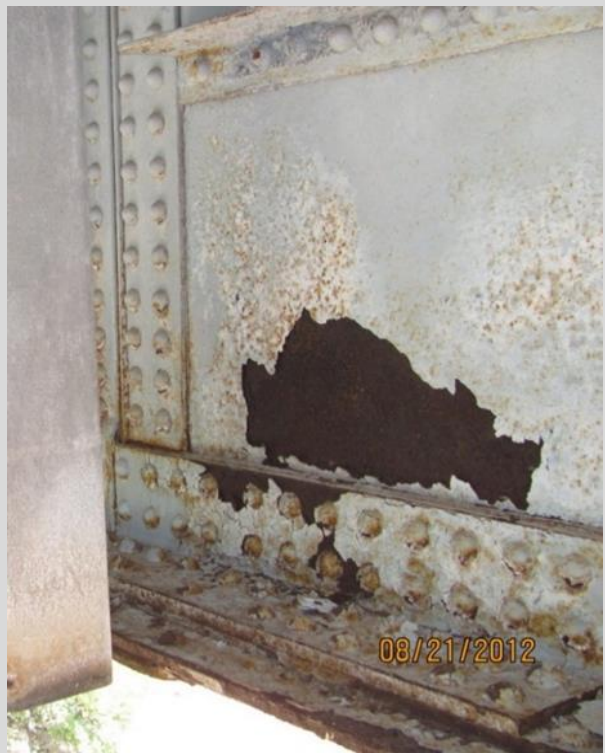
Condition State 4
Paint system failure (exposed steel)

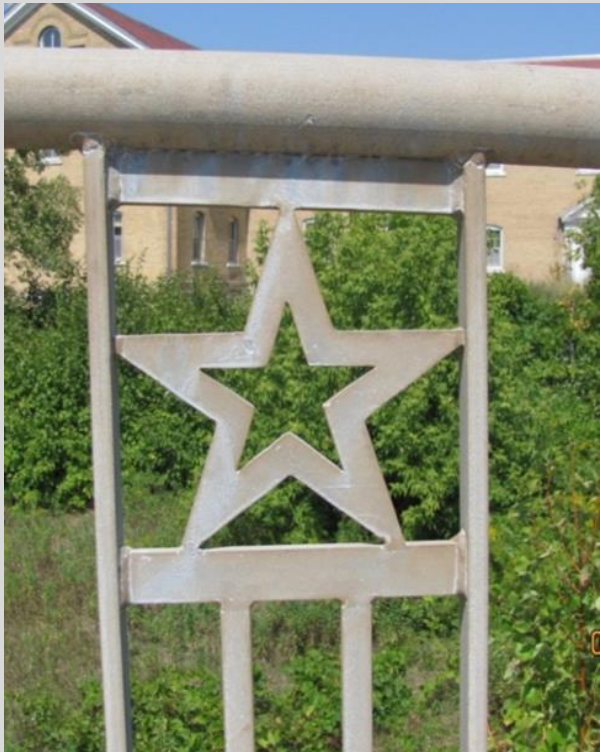
<p>Condition State 2 Galvanized coating on bridge rail is faded</p>

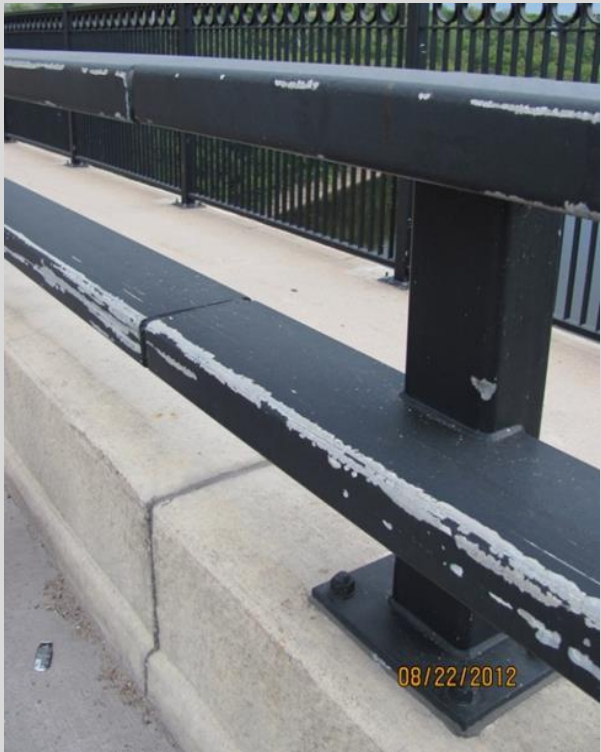
<p>Condition State 3 Finish paint coat (Duplex system) has been scraped off, the galvanized layer below remains intact</p>

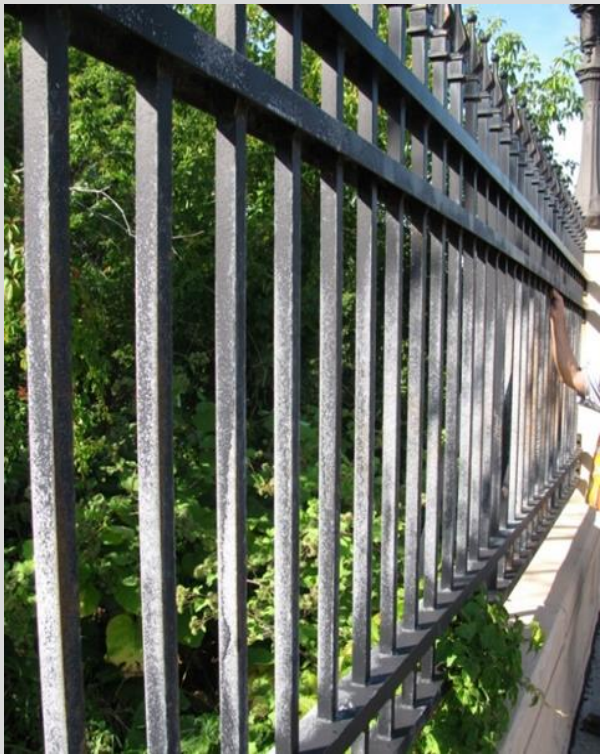
<p>Condition State 3 Finish paint coat (Duplex system) has extensive failure, the galvanized layer below remains intact</p>

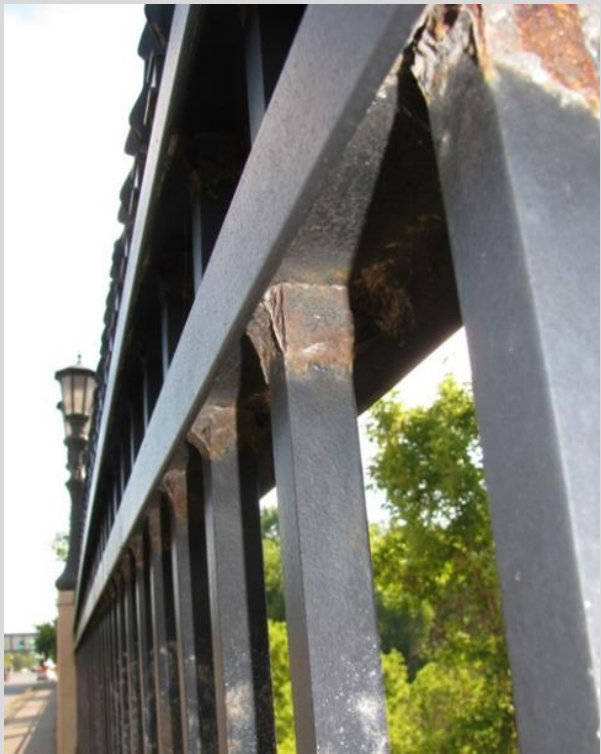
<p>Condition State 4 Complete failure of a Duplex system on a steel railing (isolated locations)</p>

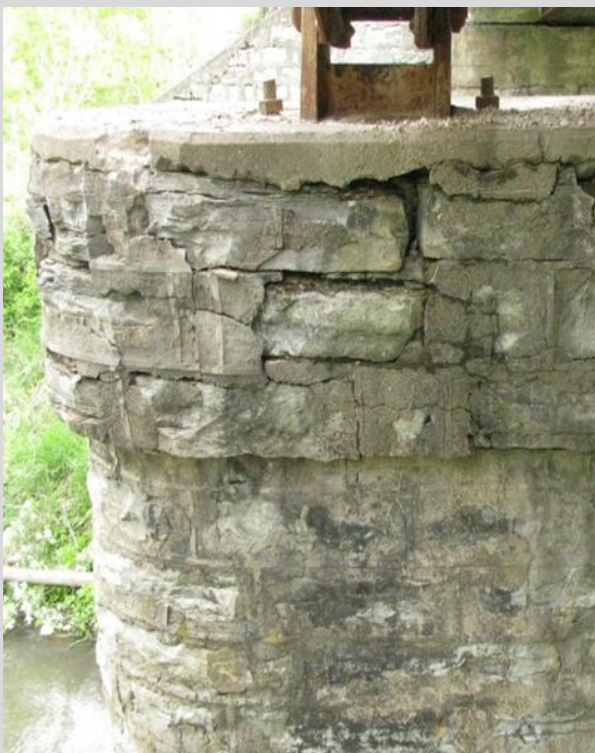
Condition State 4
Masonry pier wall severely deteriorated below a truss bearing

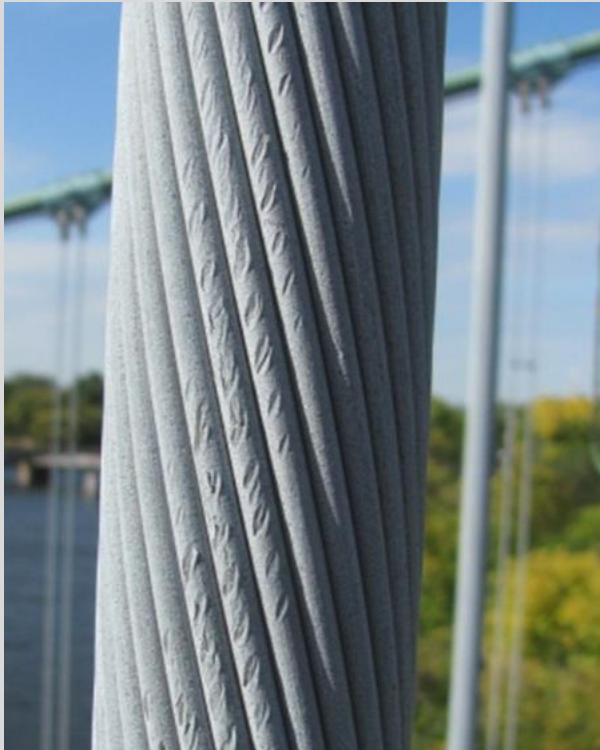
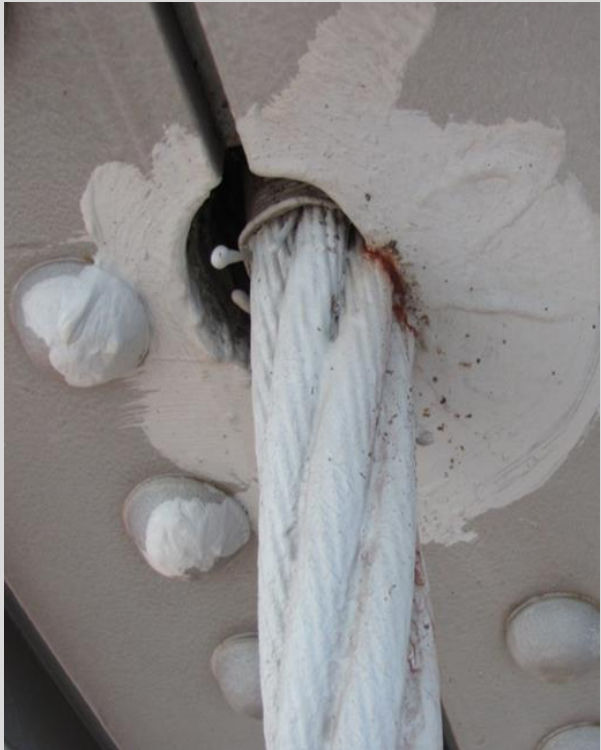
<p>Condition State 2 Minor wear on steel strand hanger cable</p>	<p>Condition State 3 Active abrasion at contact point (steel wire rope hanger cable wearing against a steel batten plate)</p>

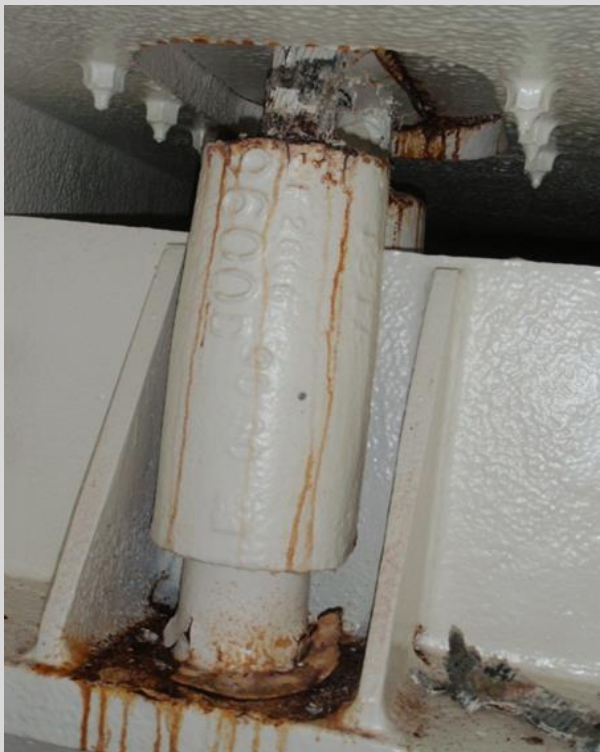
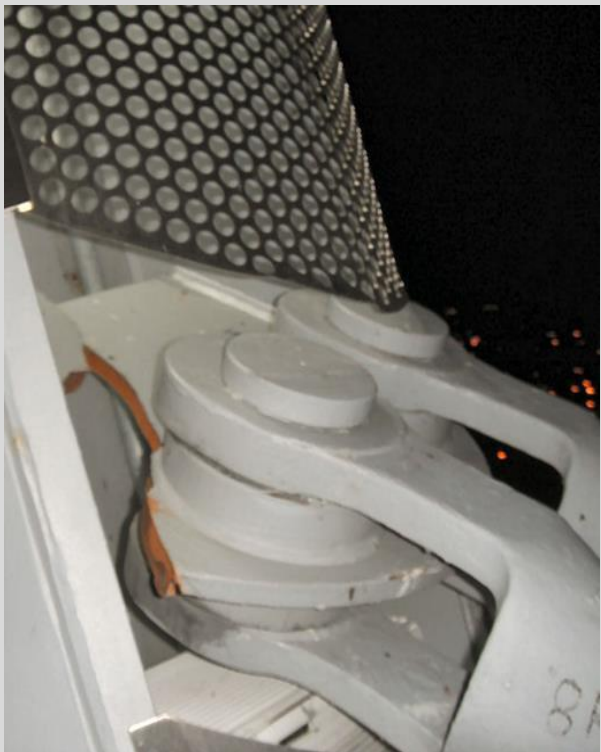
<p>Condition State 3 Corrosion on steel strand hanger cable just above the anchorage socket</p>	<p>Condition State 4 Cable failure due to fractured anchorage plate</p>

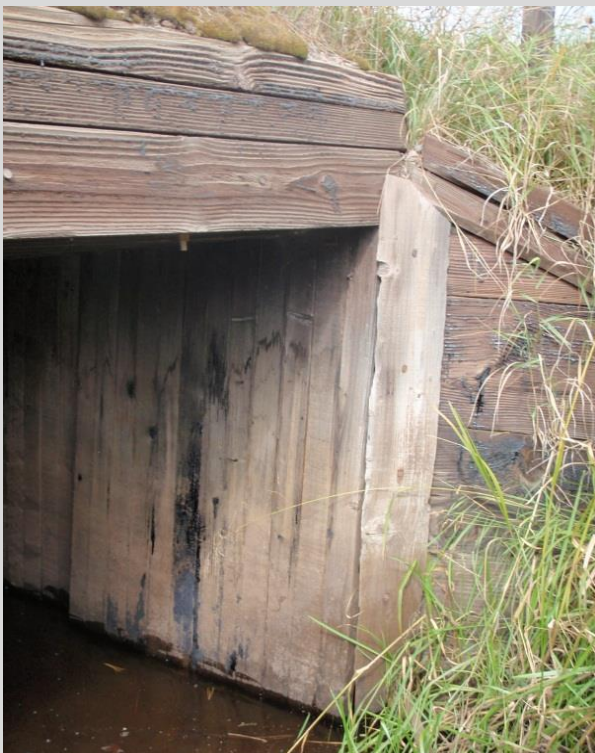
Condition State 3
Wall section misaligned on a timber box culvert

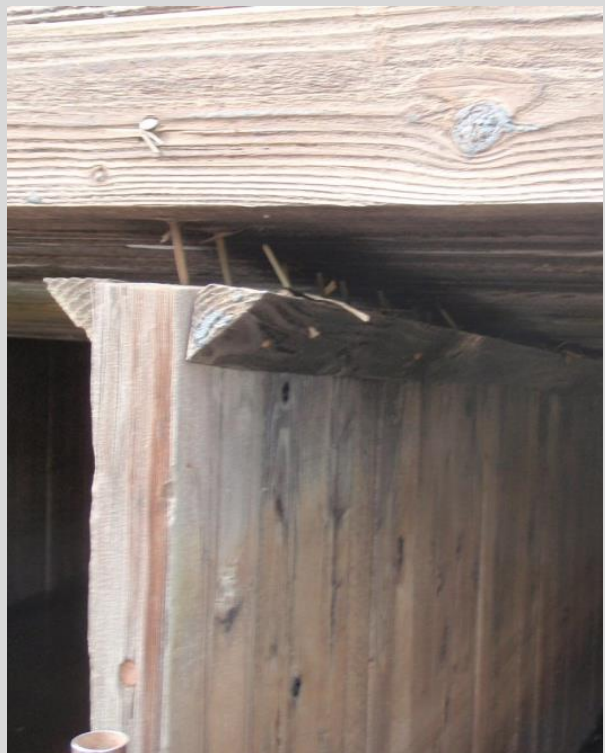
Condition State 4
Separation (connection failure) between wall and ceiling on a timber box culvert

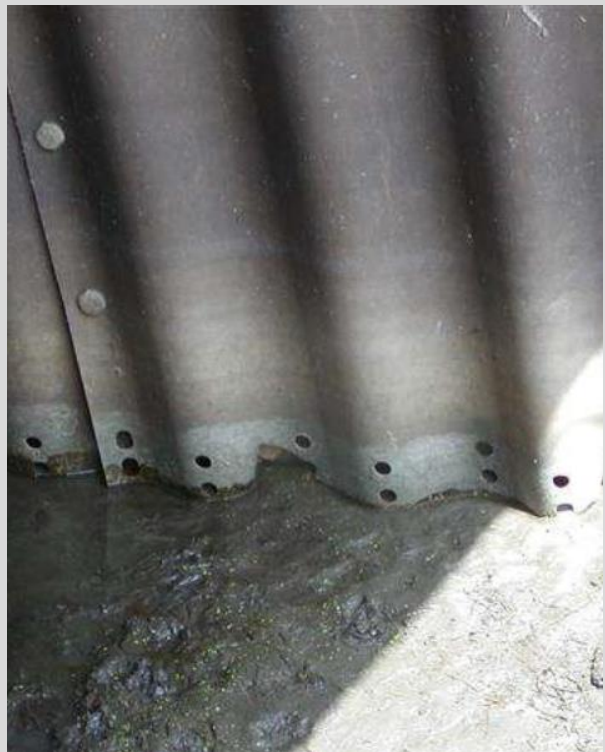
Condition State 4
Failed seam on an aluminum box culvert

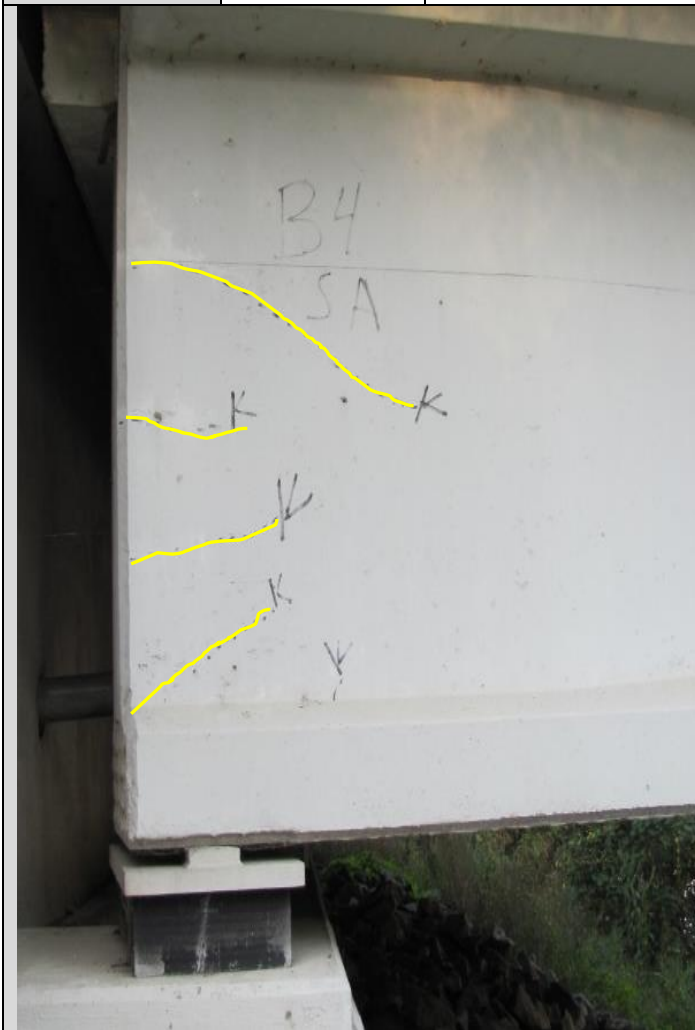
Draped strand cracks in prestressed beams are not shear cracks!

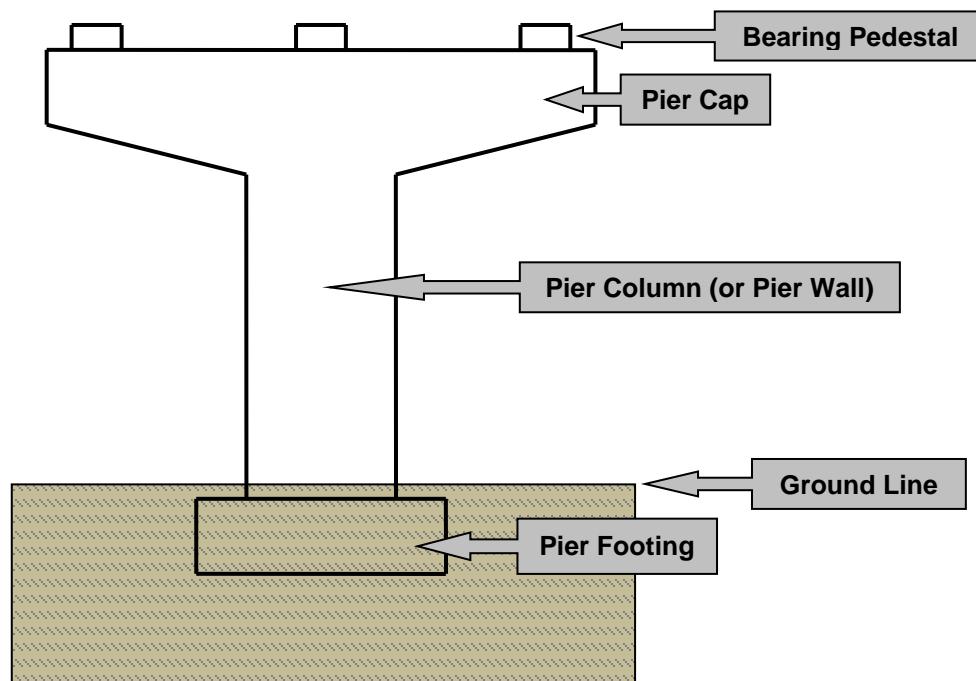
A reinforced concrete hammerhead pier consists of a single column with a relatively wide cantilevered pier cap (the cap is typically tapered in depth).

Typical “Hammerhead” Pier Configuration
