BRIDGE INSPECTION FOR DECAY AND OTHER DETERIORATION**13.1 INTRODUCTION**

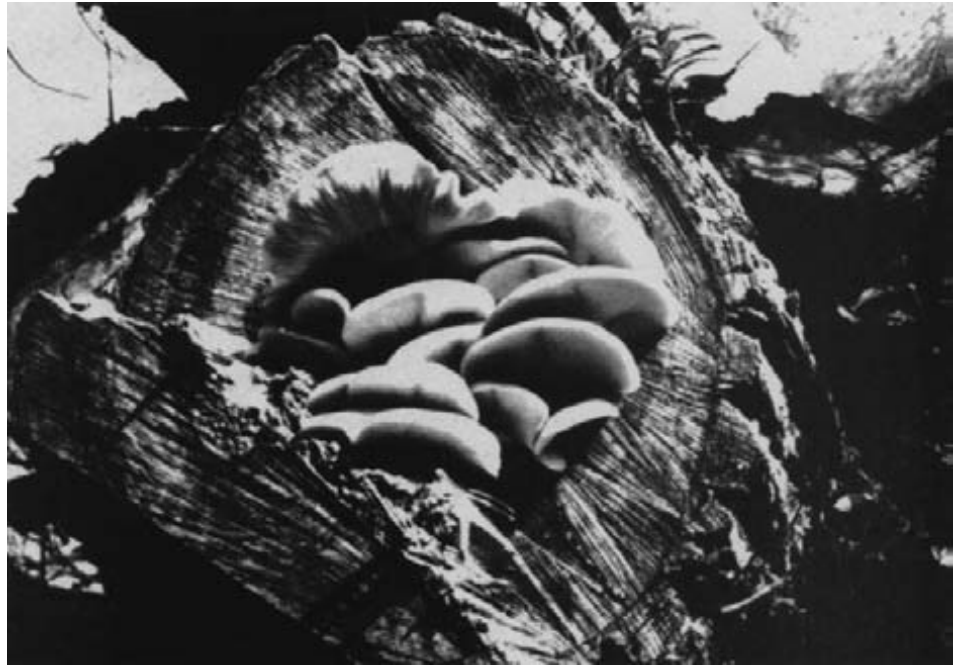
Figure 13-2. - A typical fungal fruiting body. Such growths vary considerably in size, color, and shape among species of fungi.

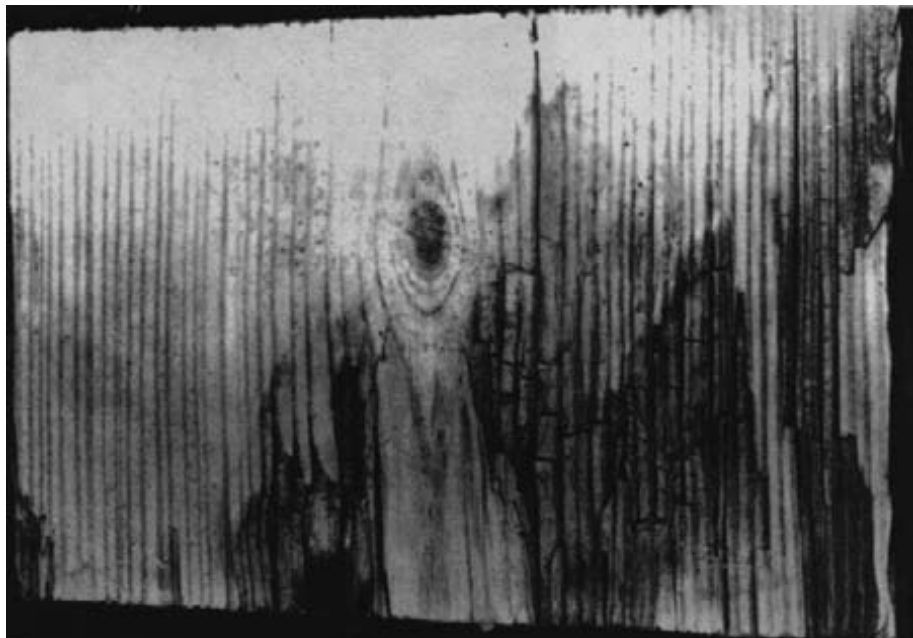
Figure 13-4. - Wood infected with brown rot fungi in an advanced stage. The decayed wood has a darkened color with a cracked, brittle surface that resembles charred wood.

Brown rot fungi, as the name implies, give decayed wood a brownish color. In advanced stages, brown rotted wood is brittle and has numerous cross checks, similar in appearance to the face of a heavily charred timber (Figure 13-4). In the 1700's, scientists examining brown rotted wood stated that the wood had cornbusted, and it was not until the latter 1800's that fungi were associated with this damage. The brown rots primarily attack the cellulose and hemicellulose fractions of the wood cell wall and modify the residual lignin, causing weight losses of nearly 70 percent. Because cellulose provides the primary strength to the cell wall, the brown rot fungi cause substantial strength losses at the very early stages of decay. At this point, the wood appears sound and the fungus may have removed only 1 to 5 percent of the wood weight, but some strength properties may be reduced by as much as 60 percent.⁵⁶

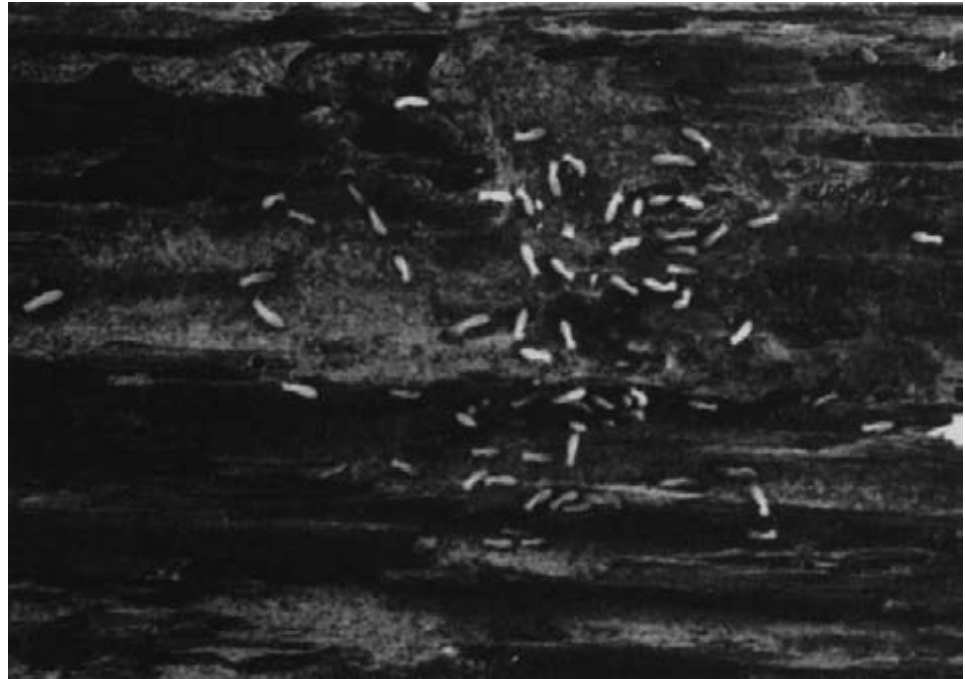
Figure 13-9. - Subterranean termites and the wood damage they cause. Note the frass and debris accumulations in the tunnels (photo courtesy of USDA Forest Service, Forest Sciences Laboratory, Gulfport, Mississippi).

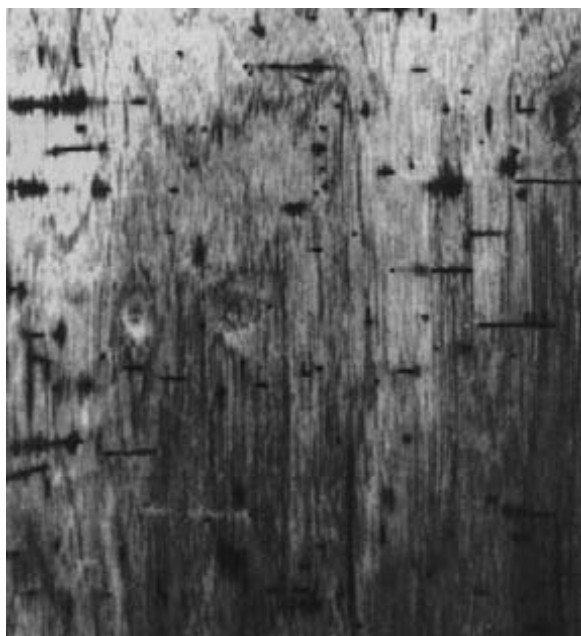
Figure 13-11. - Damage by Ambrosia beetles in green wood. The galleries are free of residue and the surrounding wood is darkly stained.

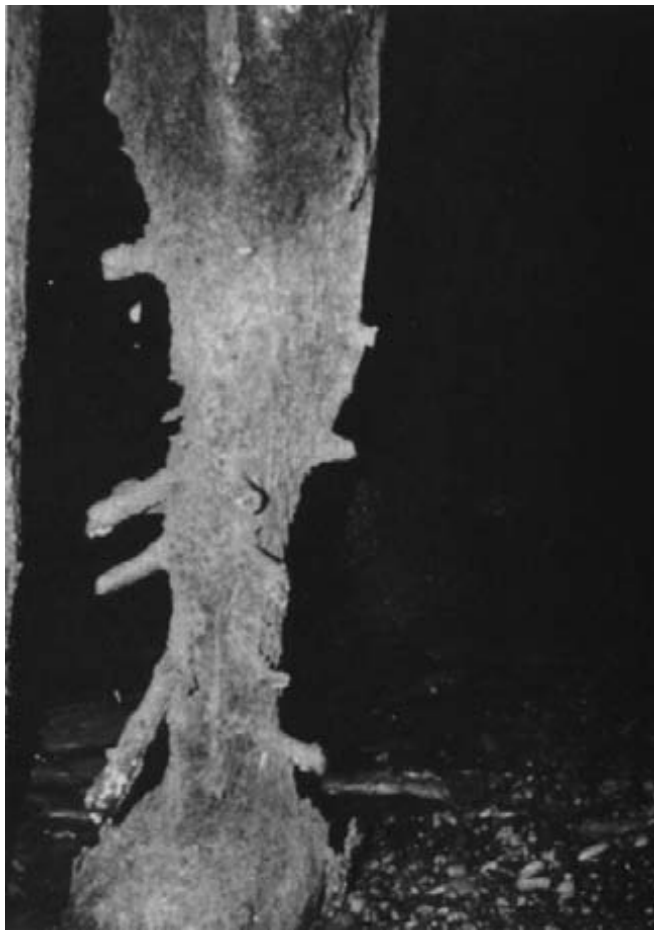
Figure 13-18. - Limnoria damage to a timber pile, evidenced by the characteristic hour-glass shape in the tidalzone.

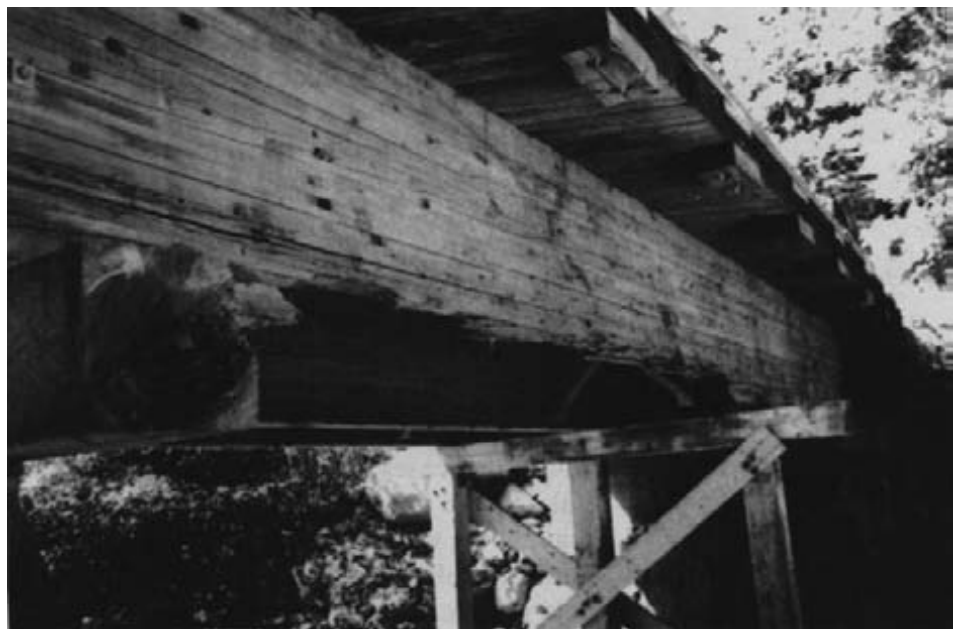
Figure 13-19. - Severe mechanical damage to a glulam bridge caused by debris flow during high stream levels.

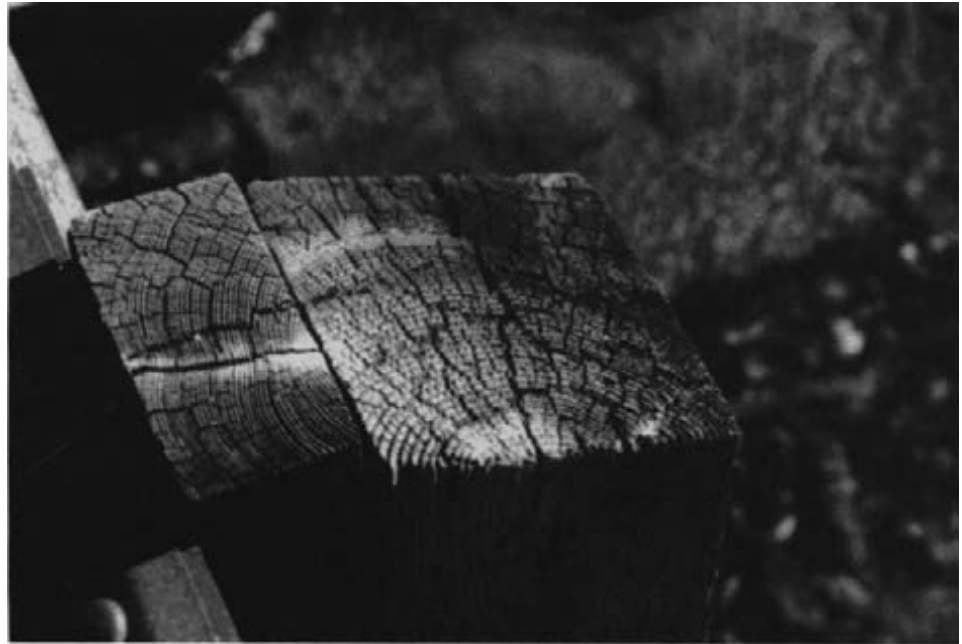
Figure 13-20. - Ultraviolet light degradation of the end grain of a guardrail post. Note the minor surface erosion of earlywood between the latewood (growth rings).

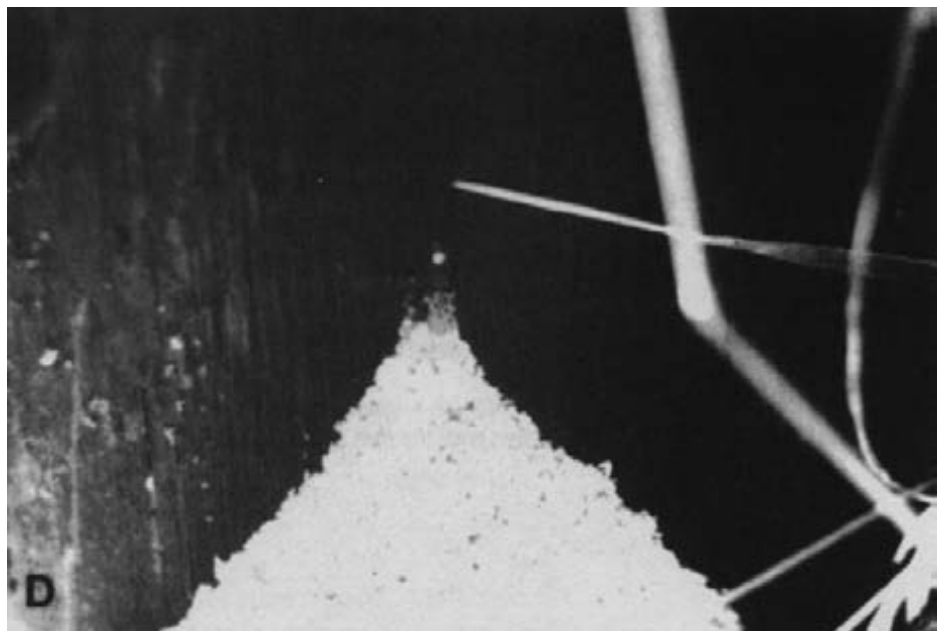
Figure 13-22. - Visual signs of potential deterioration (continued). (C) Water staining. (D) Insect activity (powder posting).

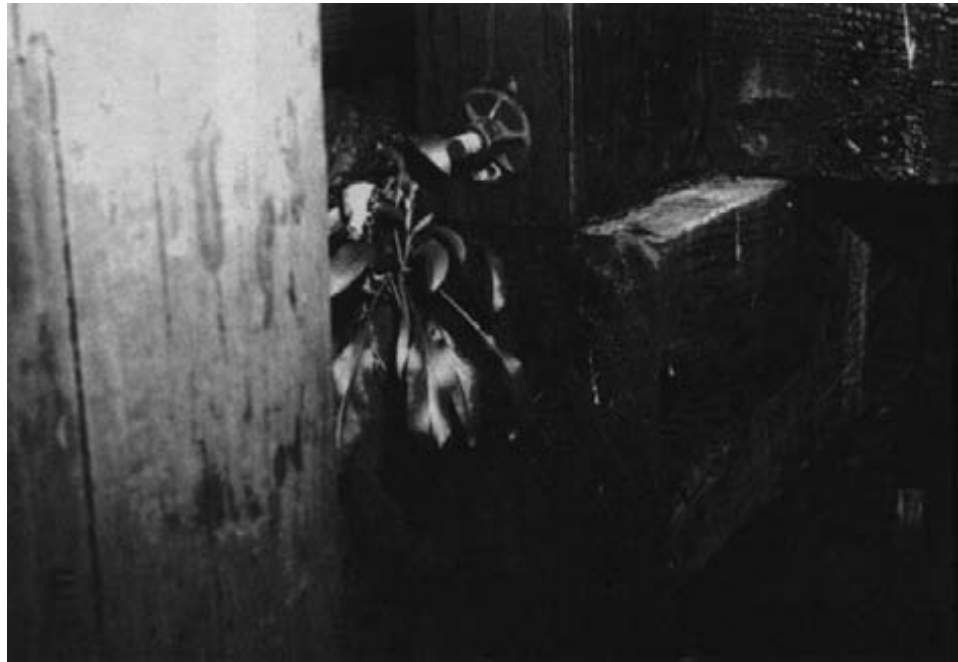
Figure 13-22. - Visual signs of potential deterioration (continued). (E) Plant growth.

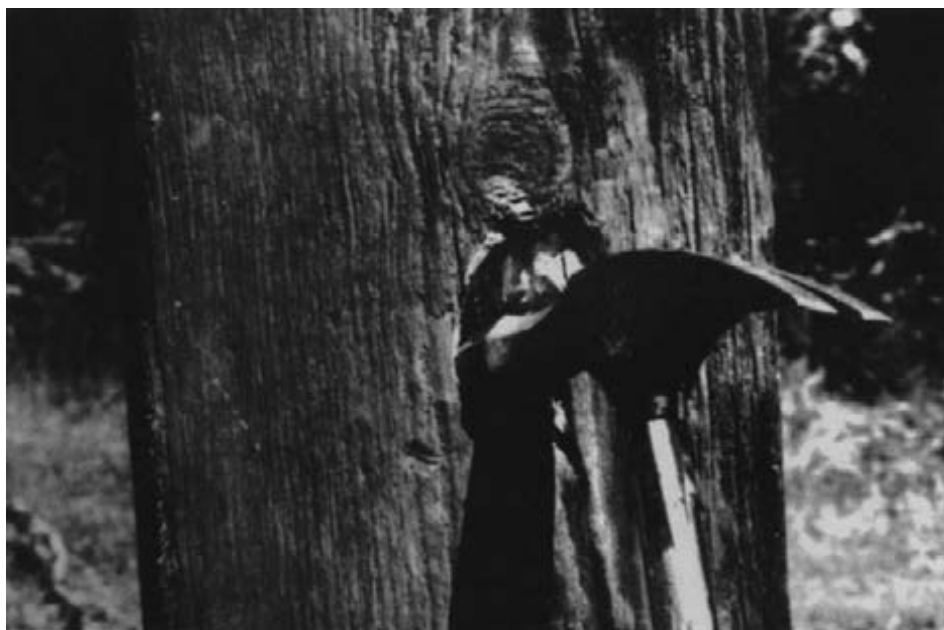
Figure 13-25. - A decay pocket near the wood surface is detected by sounding with a hammer.

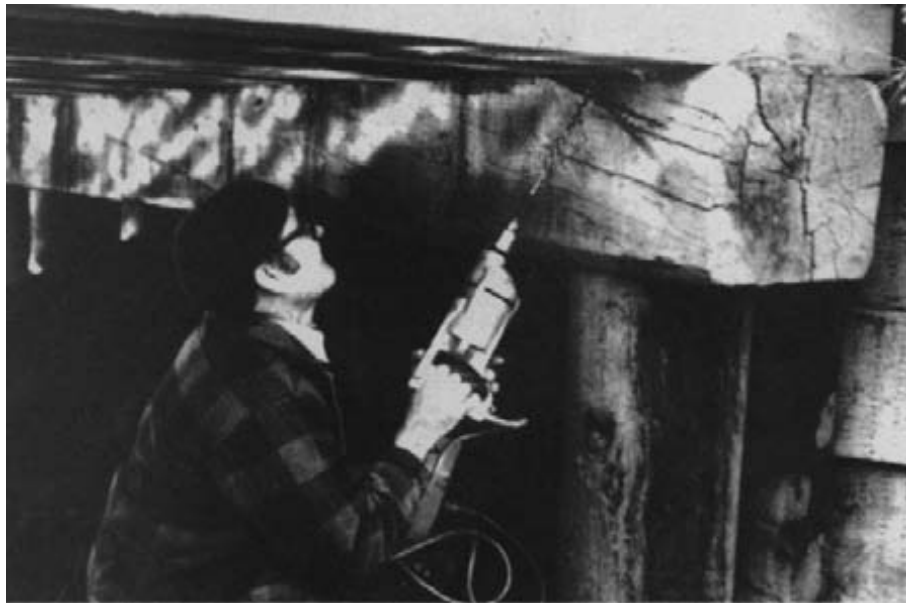
Figure 13-28. - Drilling the underside of a timber bridge beam to detect internal voids. The inspector feels and listens for torque release as the drill bit enters the wood, and examines shavings for evidence of decay.

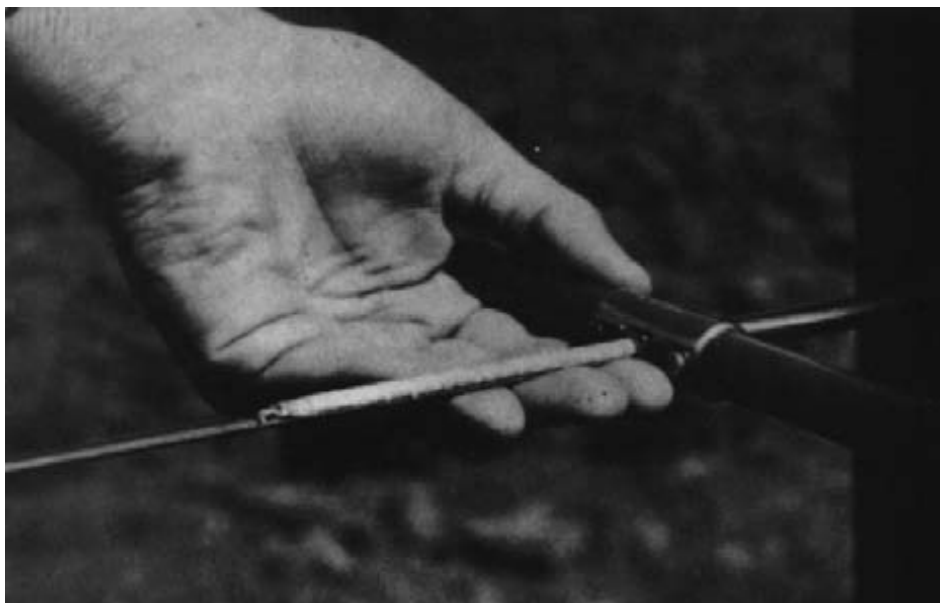
Figure 13-29. - Solid wood core removed with an increment borer. Such cores can be examined to determine the location and extent of decay.

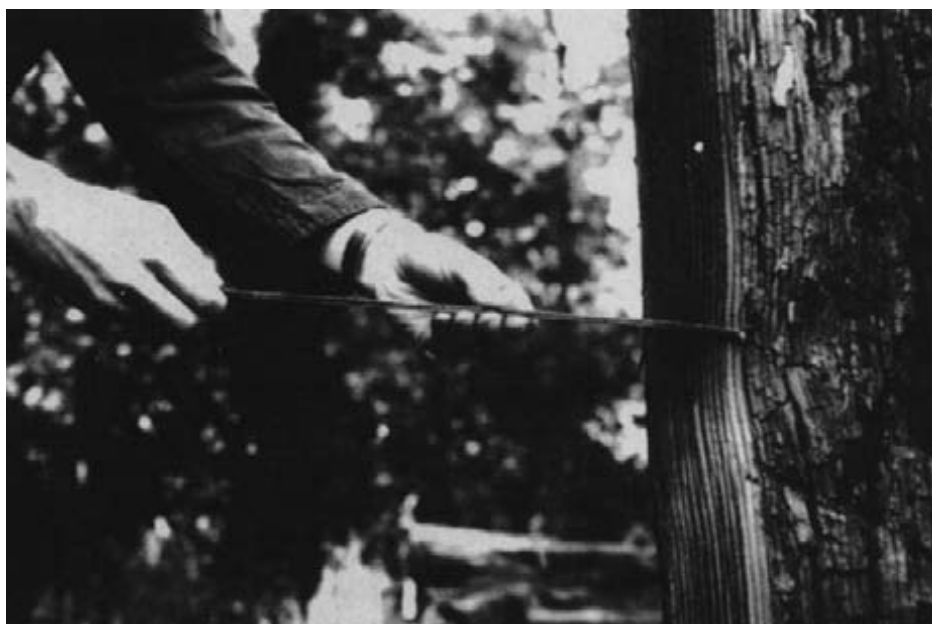
Figure 13-31. - Use of a shell depth indicator, illustrated with a portion of the member removed. The tool is inserted into an inspection hole and moved along the hole sides to feel for decay voids.

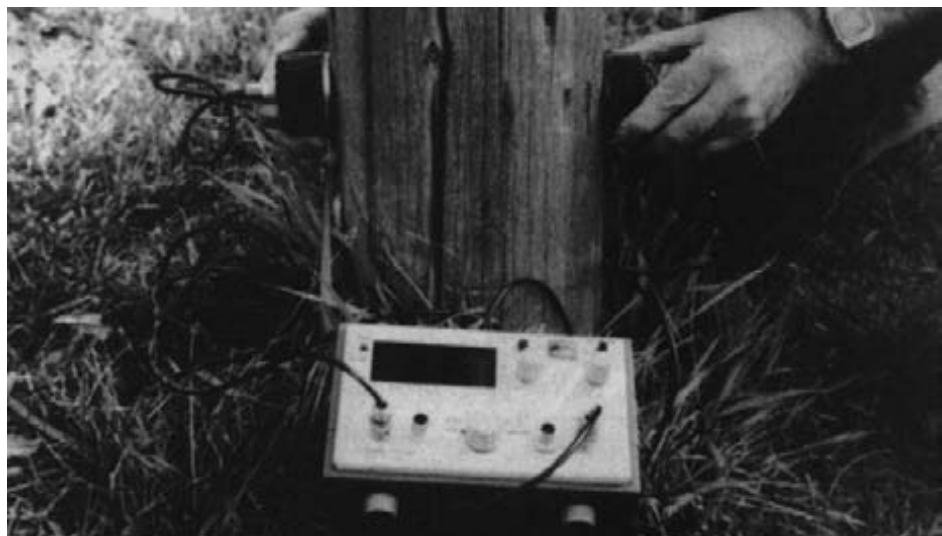
Figure 13-32. - A sonic inspection device for detecting internal defects in wood.

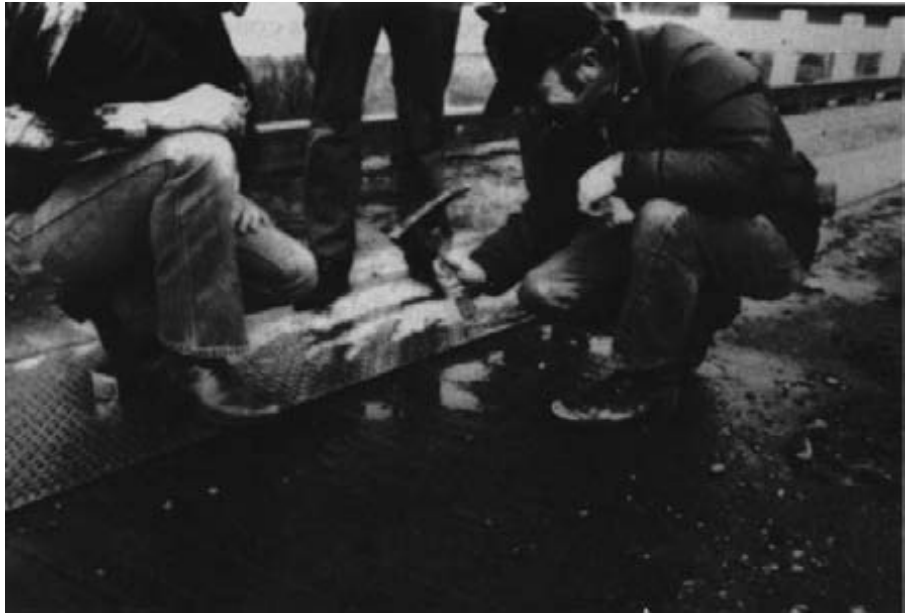
Figure 13-34.- After treating an inspection hole in a bridge deck with liquid wood preservative it is plugged with a treated wood dowel (photo courtesy of Frank Muchmore, USDA Forest Service).

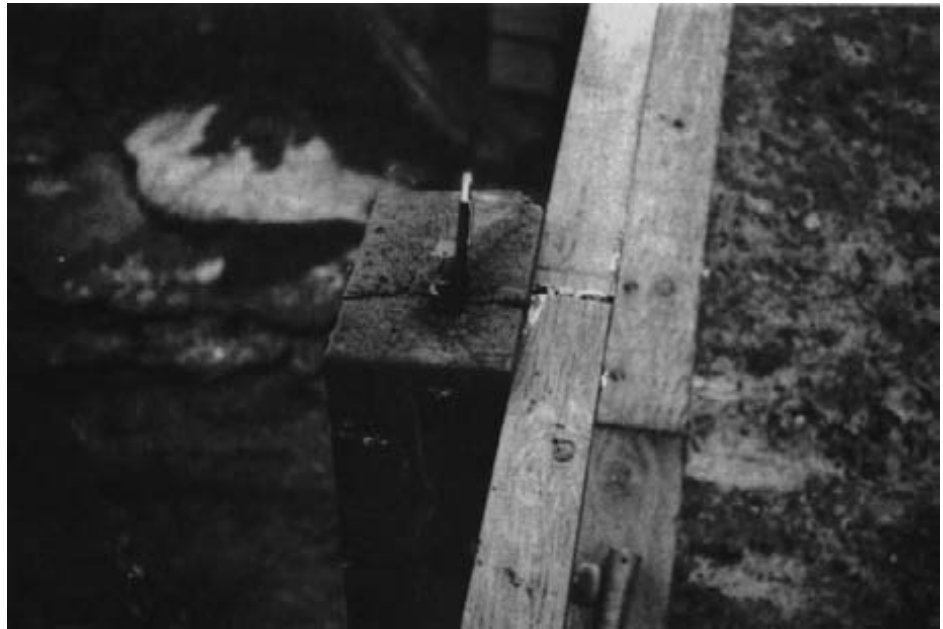
Figure 13-37. - Decay in the end grain of a timber rail post (photo courtesy of Duane Yager, USDA Forest Service).

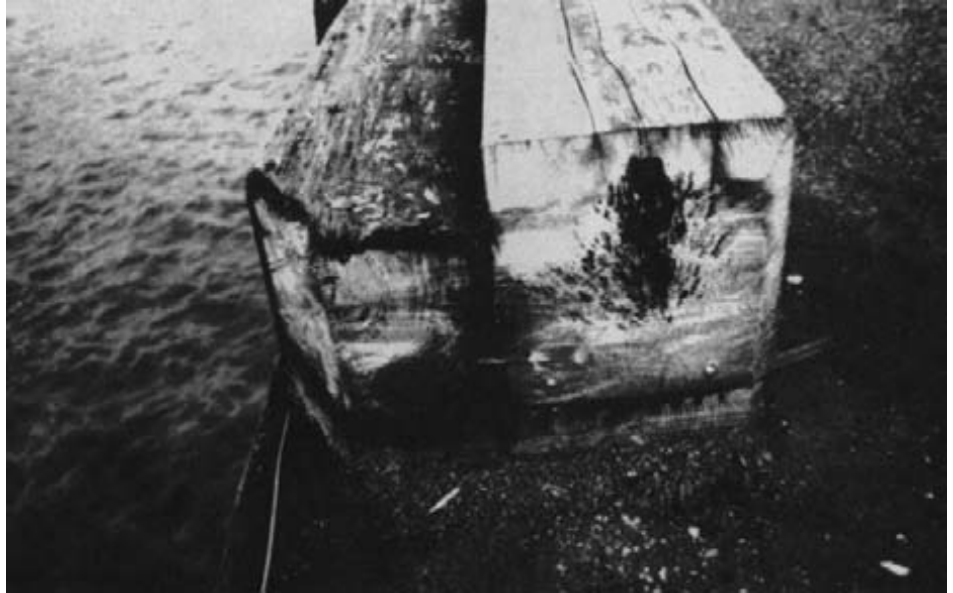
Figure 13-38. - Cross section of a timber curb, exposed by sawing, reveals interior decay resulting from seasoning checks in the upper surface.

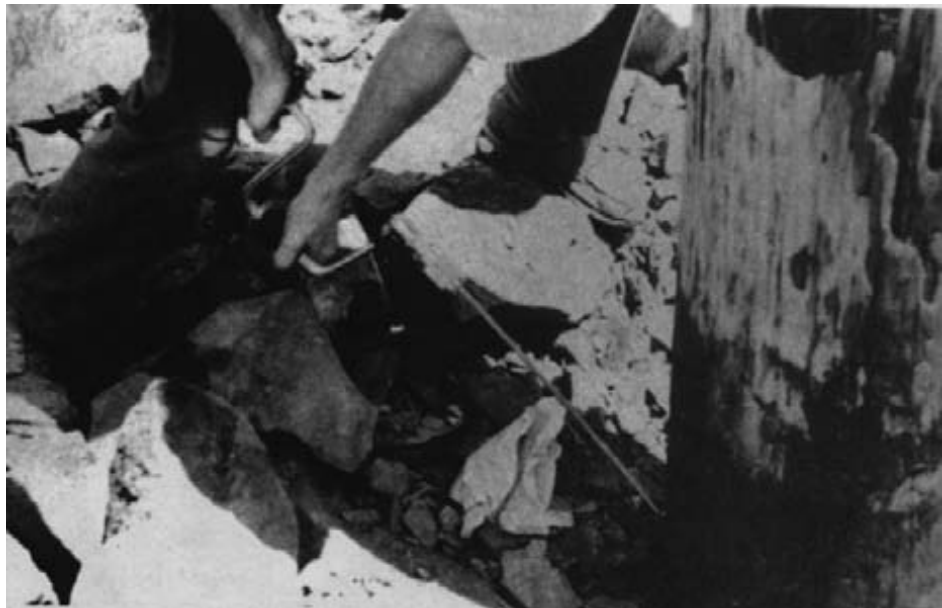
Figure 13-41. - Hand drilling at the base of a timber pile.

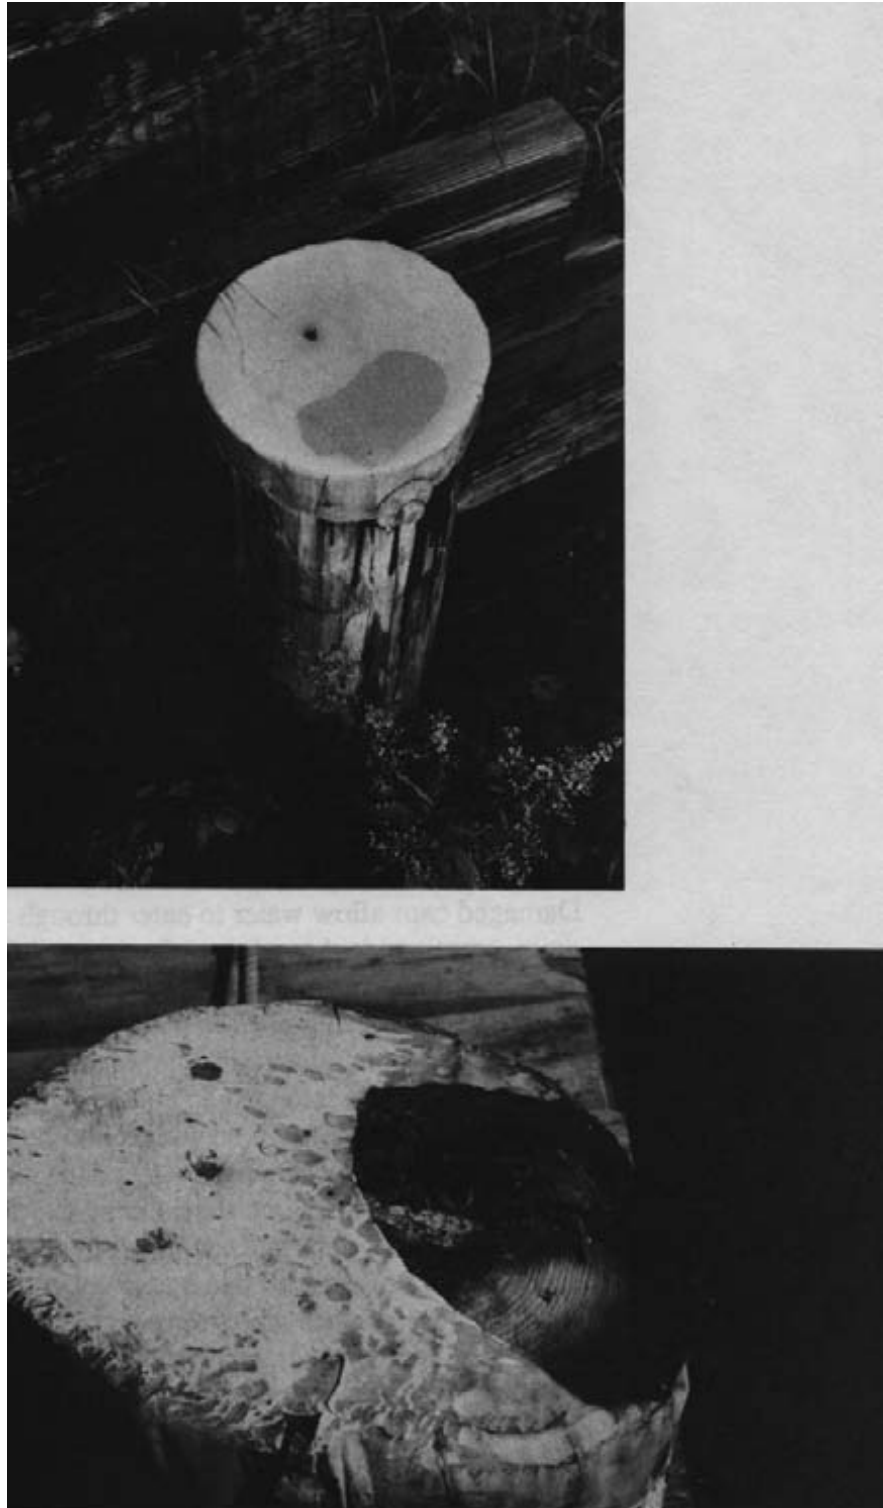
Figure 13-42. - (Top) Damaged metal pile caps allow water to enter, but restrict air circulation and drying. (Bottom) Pile decay is exposed when the damaged cap is removed.

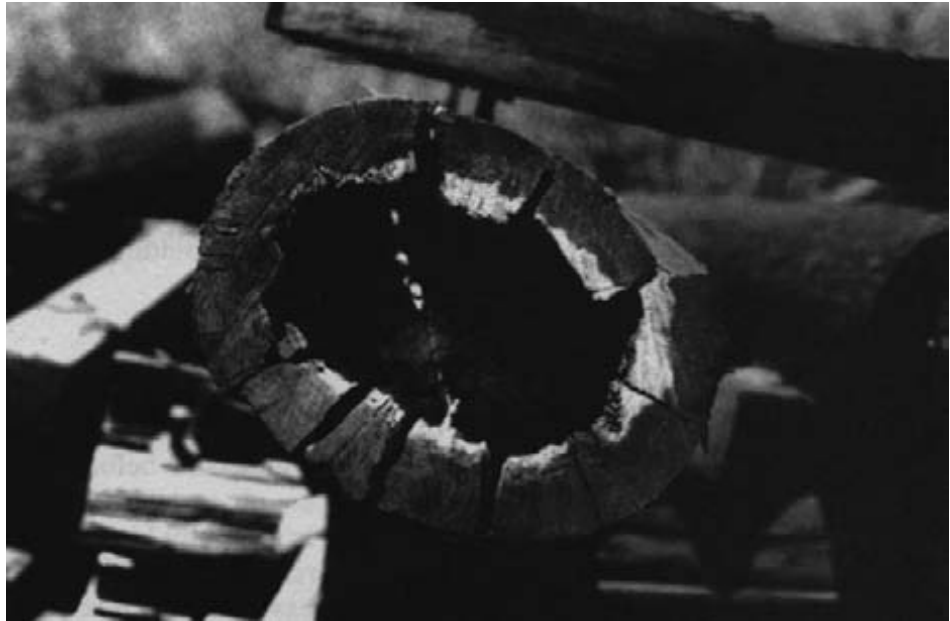
Figure 13-43. - Internal decay in a timber pile where it was drift-pinned to the cap. Before the breakage of the outside shell, caused by cap removal, the pile showed little exterior sign of the interior decay.

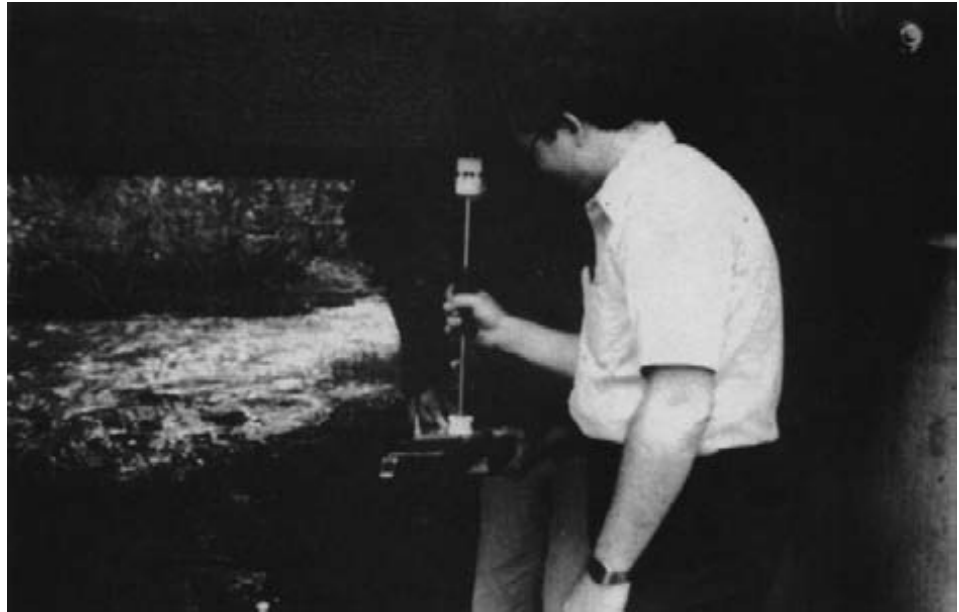
Figure 13-44. - The moisture content of a timber beam is measured with a resistance-type moisture meter.

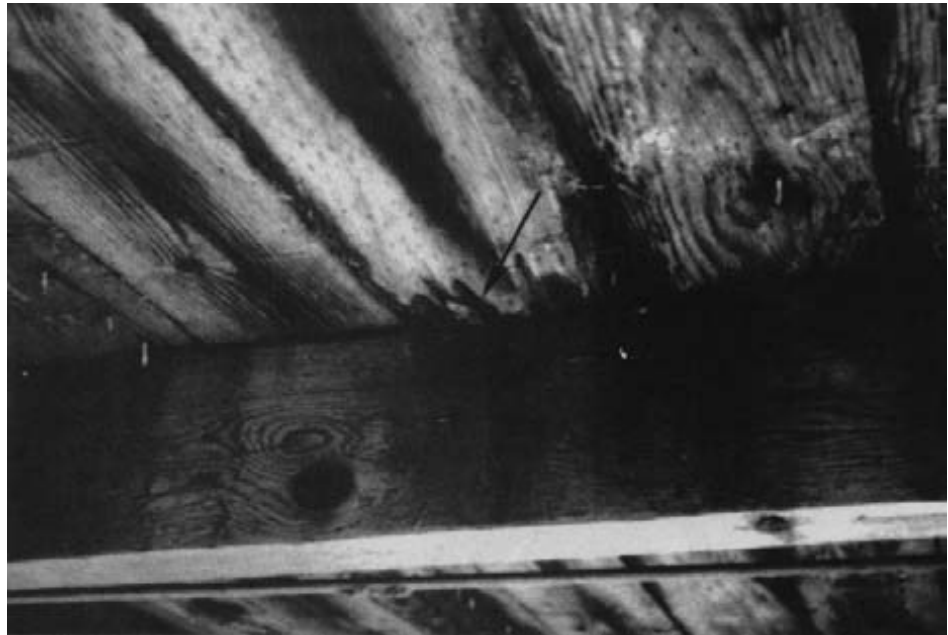
Figure 13-47. - Decay on the underside of a spike-attached lumber plank deck at the deck-beam interface (arrow).

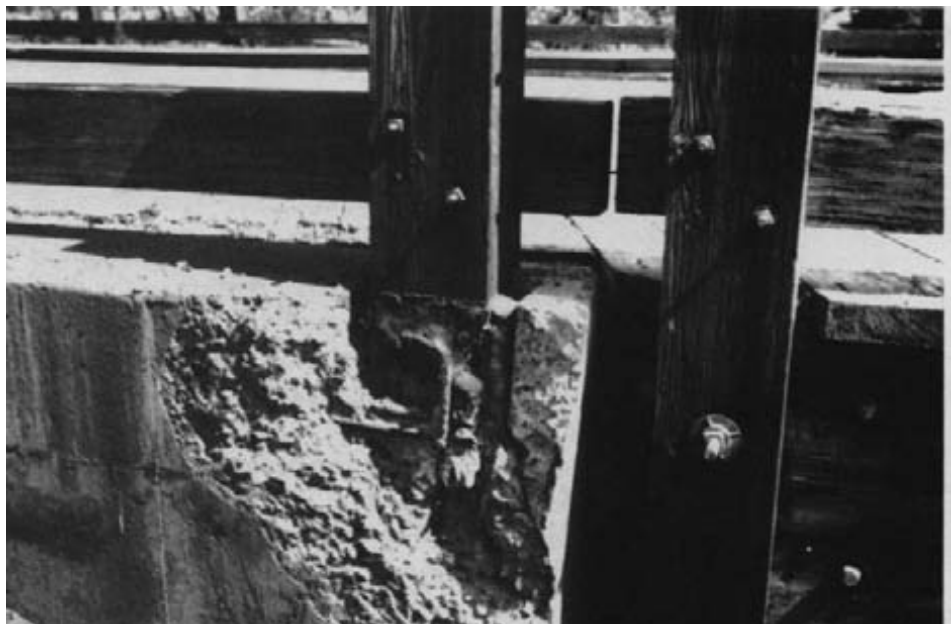
Figure 13-48. - Decay in a timber railpost embedded in concrete at the abutment. Concrete spalling was caused when water trapped in the post cavity was subjected to freeze-thaw cycles.
