# Third Avenue Bridge 2440

## Request for Proposals Information Meeting – 8/24/16

## Bridge 2440 – Historical Bridge Management Plan

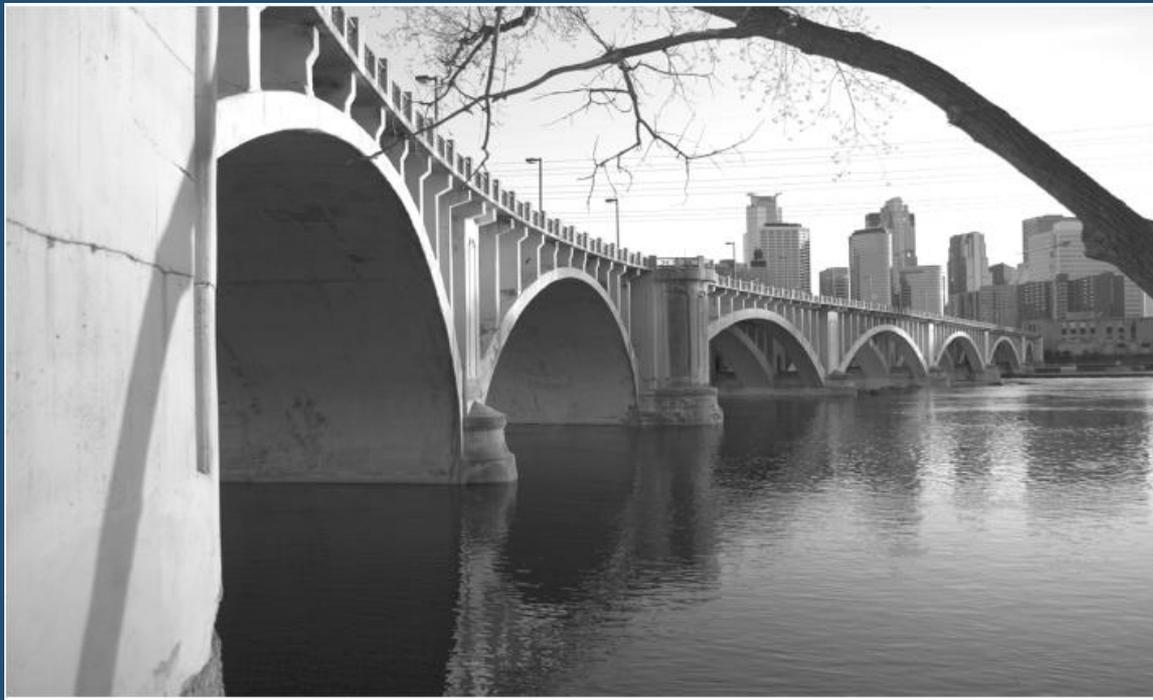
One of MnDOT's 24 bridges selected for long term preservation

Listed on the National Register of Historic Places

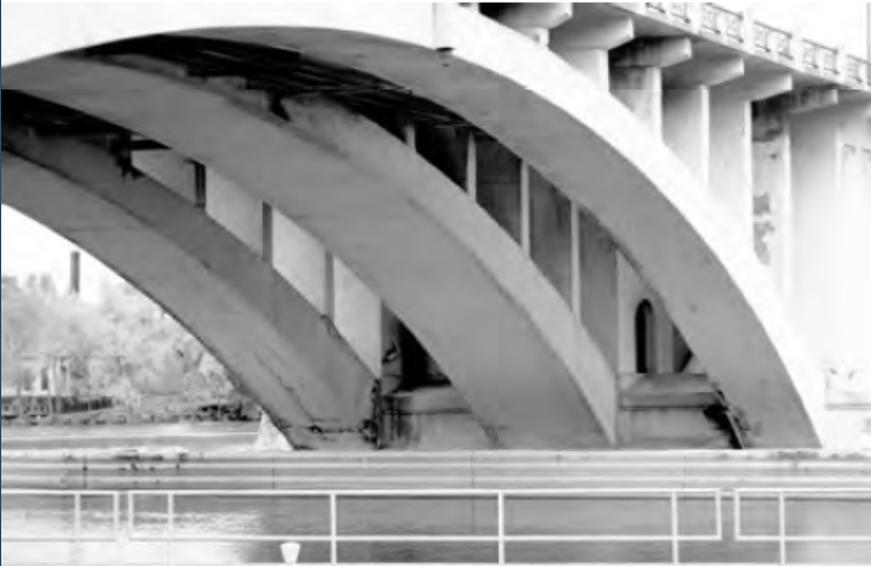
Feature 1. Melan-system reinforced-concrete arches. The Melan system, patented in 1894, uses steel I-beams bent approximately to the shape of the arch axis and laid in a parallel series near the undersurface of the arch. The Third Avenue Bridge has seven large Melan arches, including two barrel arches and five three-rib arches, including the example in this photograph. It is considered to be the last major reinforced-concrete bridge constructed in the Twin Cities using the Melan system.

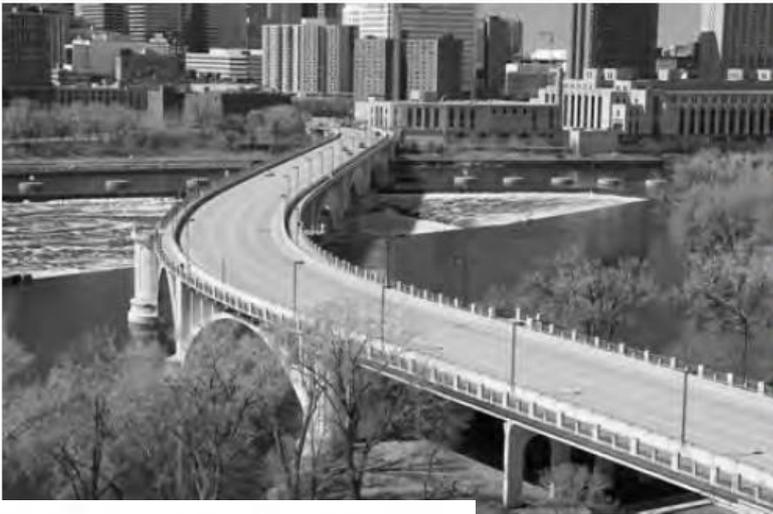
Feature 2. Reverse S-curve alignment. The bridge location lies in an area of the Mississippi River between Nicollet Island and St. Anthony Falls that has an irregular limestone base. The placement of piers and engineering of the spans required considerable engineering analysis to avoid unstable areas. The final plan resulted in a reverse S-curve alignment, which spanned the poor foundation sections and produced an aesthetic form that added to the bridge's overall image as a gateway to downtown Minneapolis.

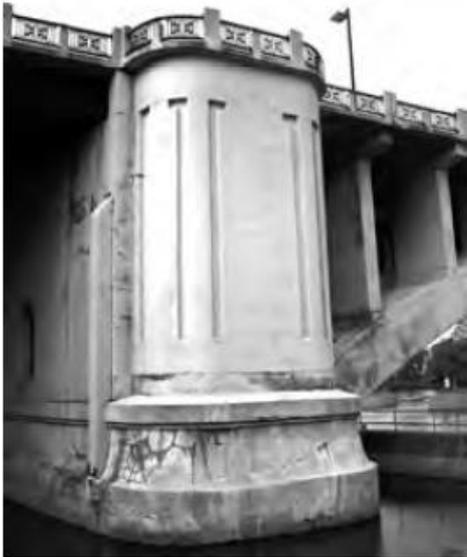
Feature 3. Classical Revival aesthetic treatment. A gateway structure, the Third Avenue Bridge received a Classical Revival aesthetic treatment. Classical elements include piers and the projecting pedestrian bays, which were restored or reconstructed in the 1979-80 deck-replacement project, and the 1939 ornamental railing.

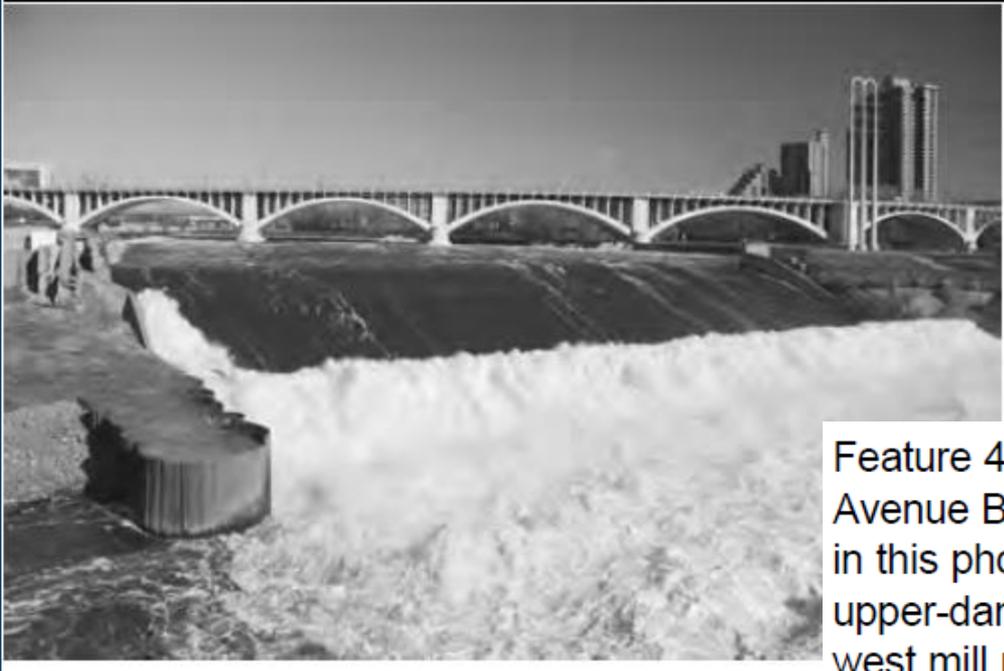
Feature 4. St. Anthony Falls setting. The Third Avenue Bridge is located just above the falls, as visible in this photograph. It spans elements of the V-shaped, upper-dam system that channeled water into east and west mill ponds on the east and west sides of the falls. The ponds provided water to the waterpower canals for the flour-milling district. The bridge is within the St. Anthony Falls Historic District (National Register of Historic Places).

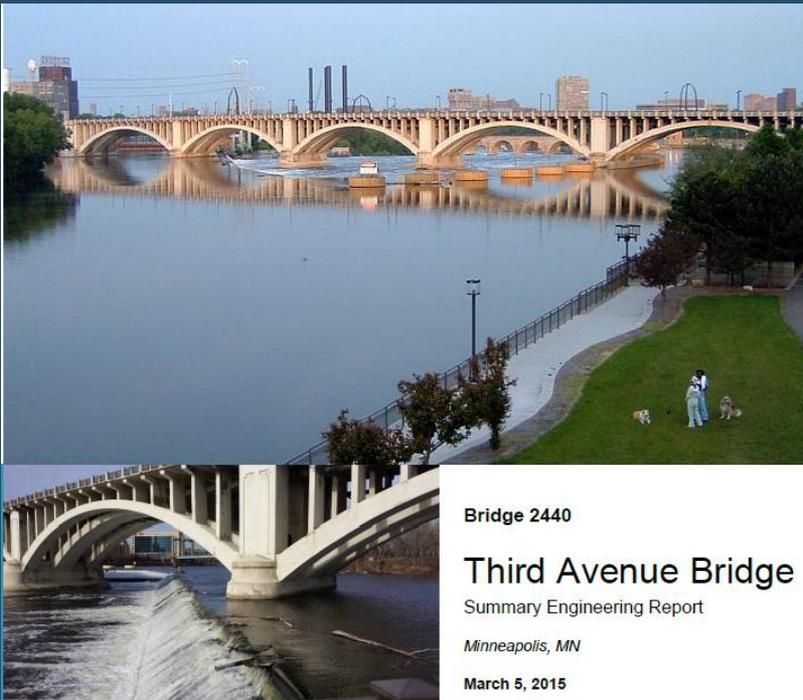
1	Introduction .....	1
2	Scope of the Report .....	1
3	Geological Setting .....	1
4	Relevant Site History .....	2
4.1	Eastman Tunnel.....	3
4.2	Saint Anthony Falls Spillway Protection .....	3
4.3	Upper and Lower St. Anthony Falls Lock and Dam .....	4
5	Pier 5 Available Data .....	4
5.1	Construction.....	4
5.2	1968 Repair Project and Associated Report.....	5
5.3	1993 Bridge Scour Investigation .....	6
5.4	Underwater Inspections .....	6
6	Subsurface Exploration .....	8
7	Potential Causes of Pier 5 Deterioration.....	9
8	Conclusion .....	10
9	Recommendation .....	11
10	References.....	11
	Appendix A Report Pictures .....	1
	Appendix B 1968 Bridge Inspection Report.....	29
	Appendix C Minnesota Historic Property Record.....	86
	Appendix D Engineering News Article .....	94
	Appendix E AET Subsurface Exploration Report.....	101
	Appendix F Blue View Screen Shots.....	137

REVISED: NO NEW BORINGS REQ'D – See updated Foundation Memo 10R

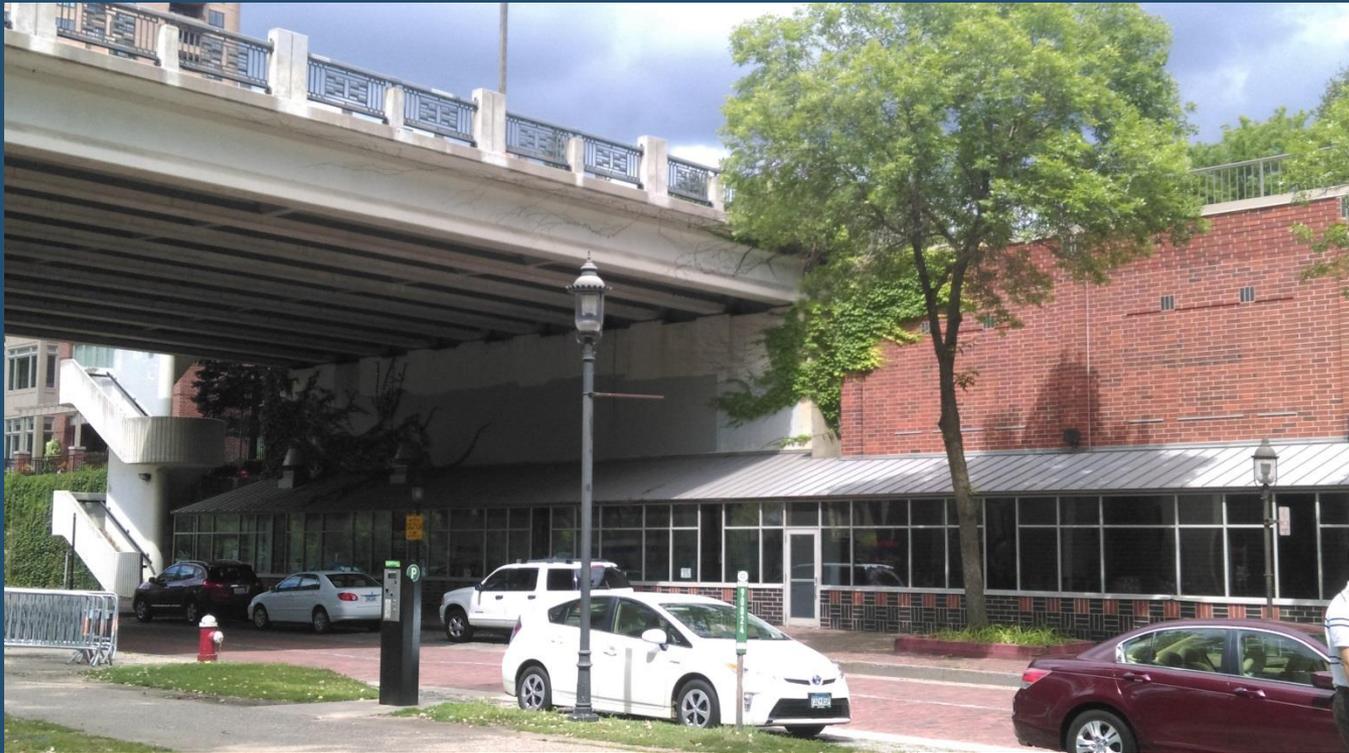
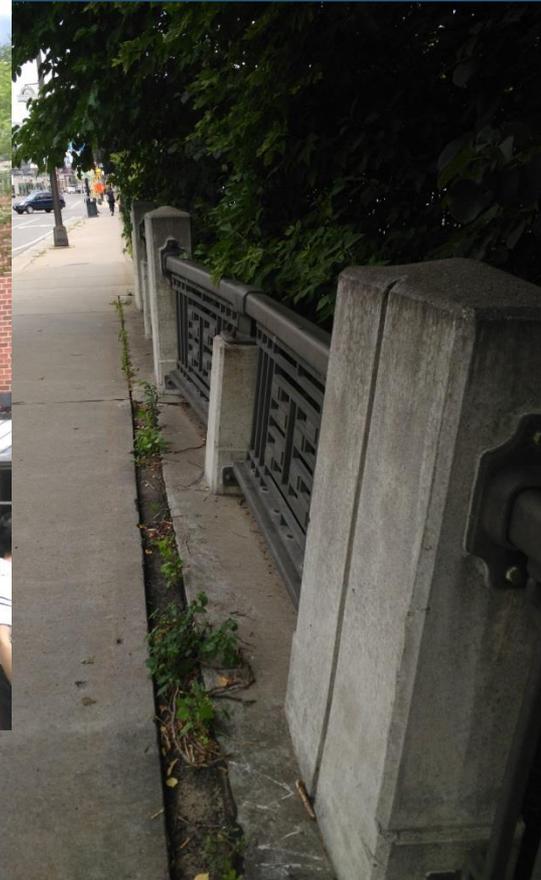
Wall Recs. (NE and NW on St. Anthony side)

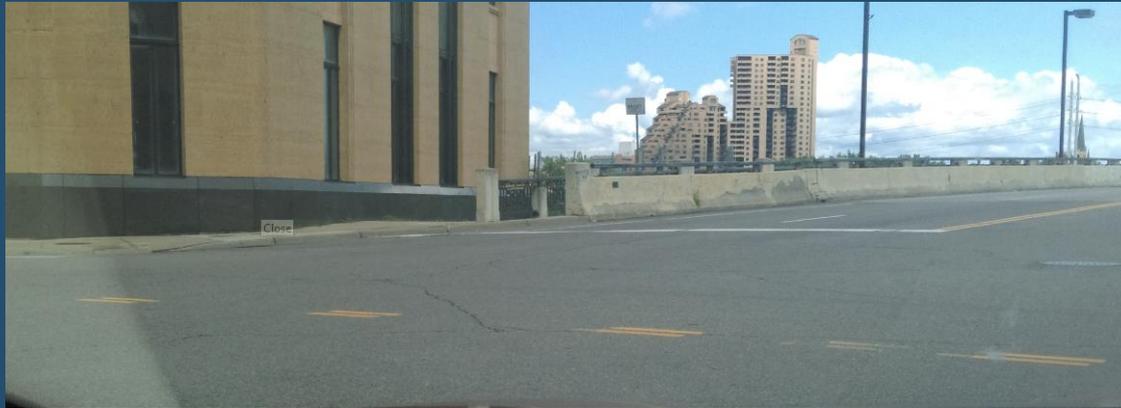
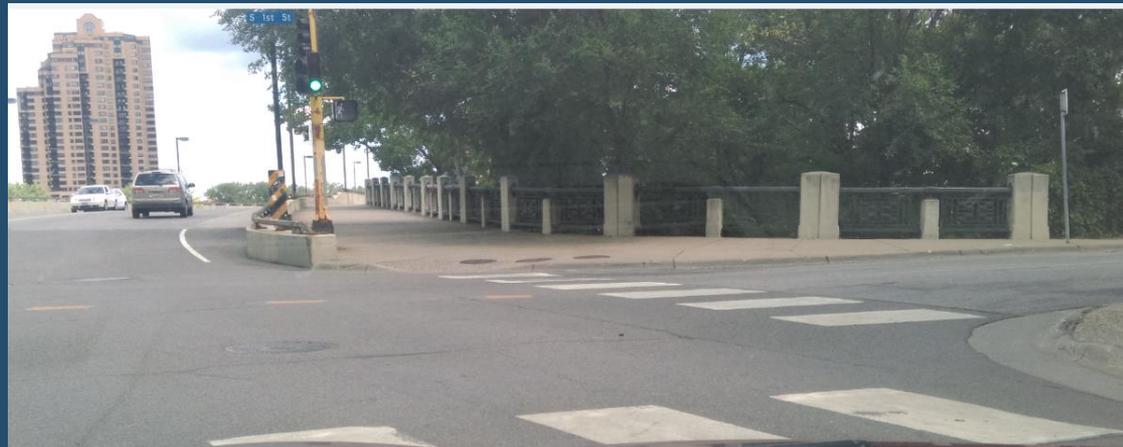
# Existing X-Section and Mod X-Section Type 1

Existing X-section  
Constrained at ends of  
Bridge and re-use of  
railing limits widening  
alternatives

Modified X- Section (Type 1):  
Same width = 81'-8" as  
existing, but consider use of  
11' lanes, 4'-2 1/2" shoulders,  
12' sidewalks

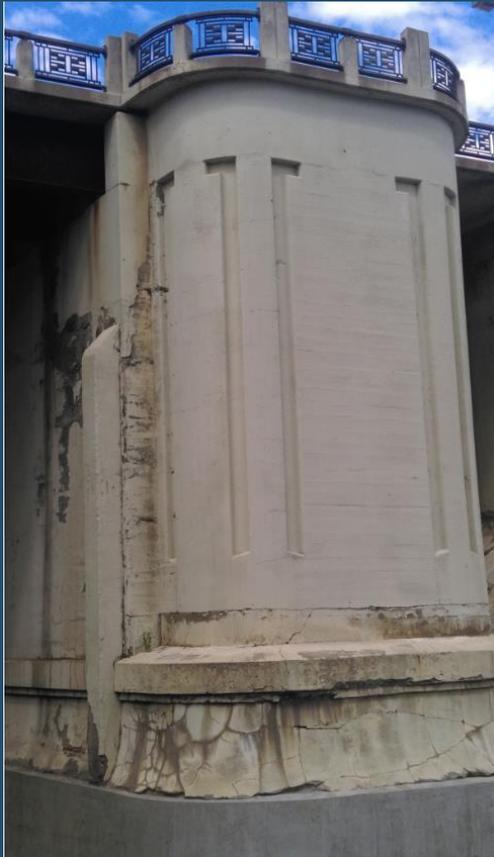
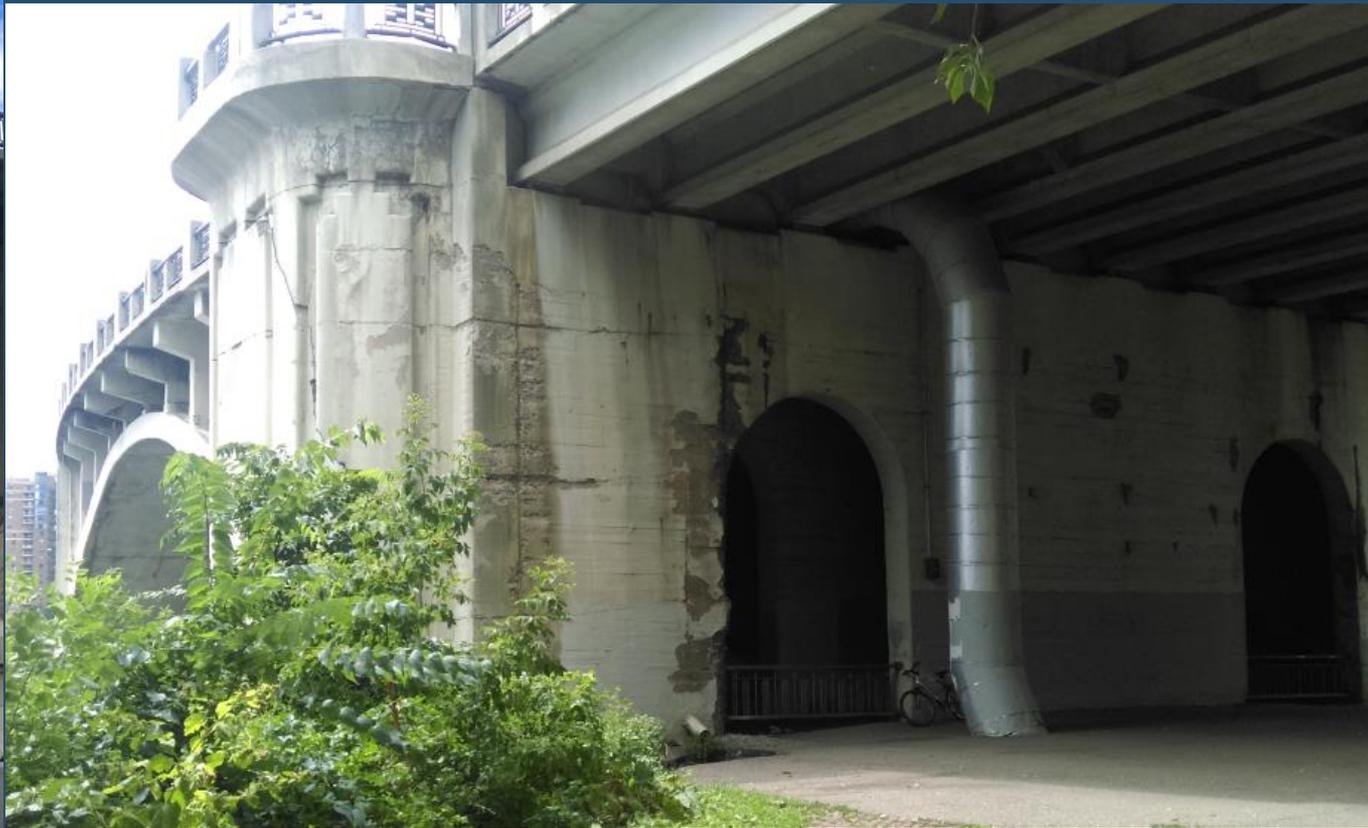
# *Bridge 2440 Historic Features Evaluation Report:* Entire bridge coated with Special Surface Treatment (previous repair projects)

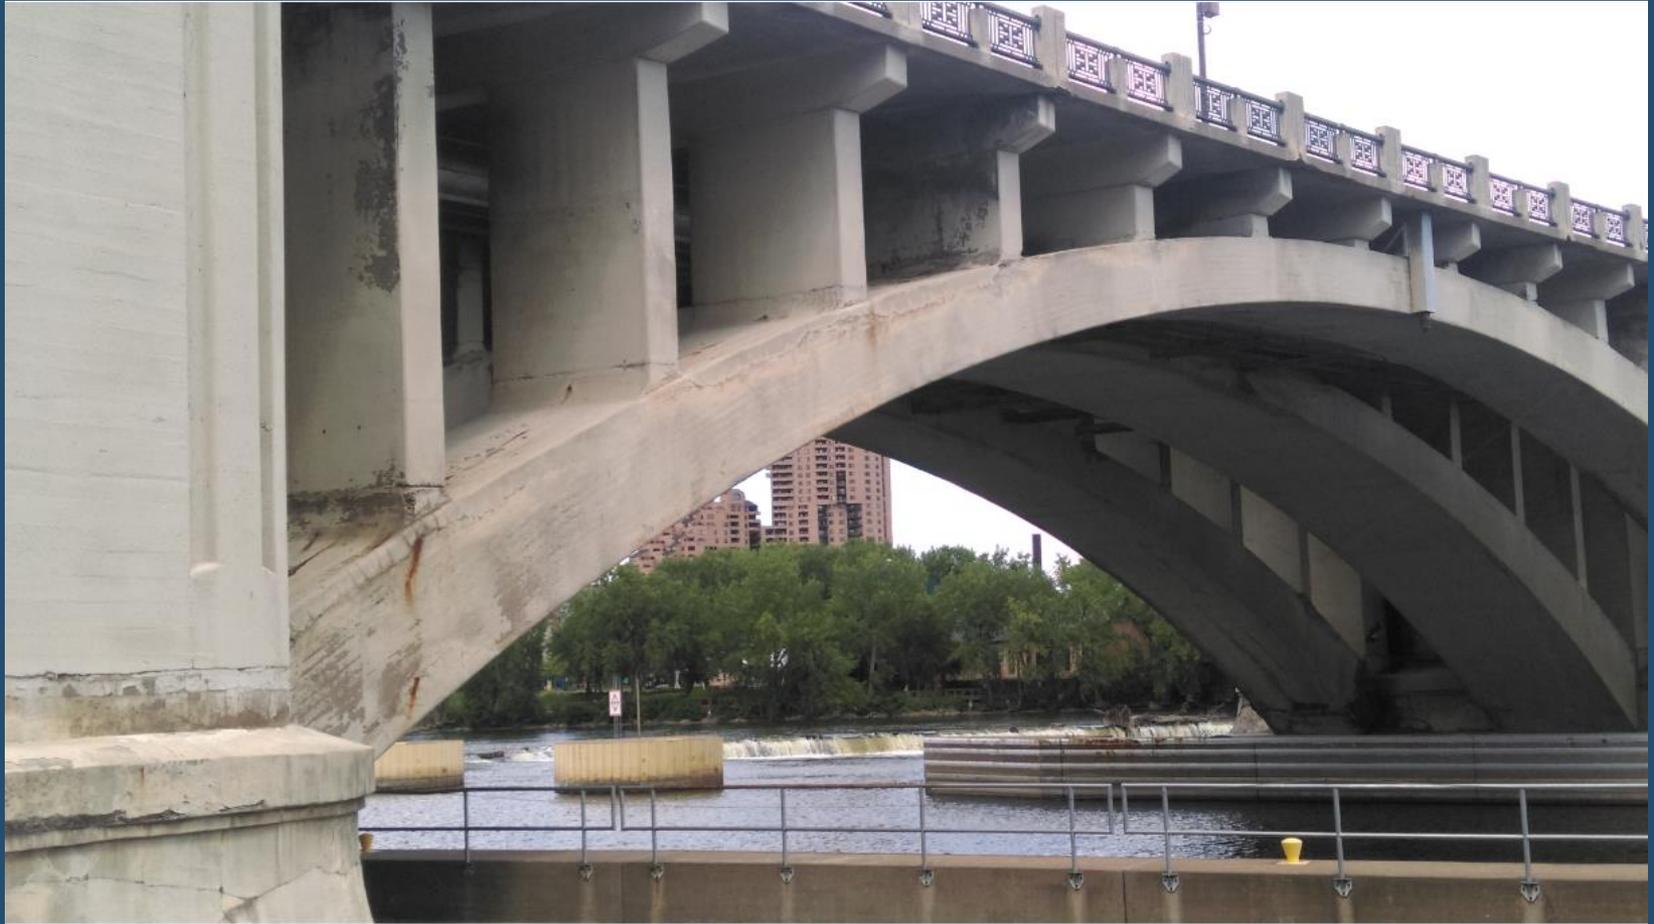
- Sampling/Testing will be focused on original concrete elements, but also include elements reconstructed in 1979-1980.
- Sampling/Testing must include assessment of condition of reinforcement and Internal Melan steel framework within the concrete arch spans for extent of corrosion and condition in the Element Level Insp'n
- List of in-depth field testing is included in the SOW
