Breakthrough Innovations

Project Title:
Bioengineering for Stabilization of
Critical Slopes

Project Team:
Lori Belz – Principle Investigator
John Benson
Steve Kortuem
Leo Holm

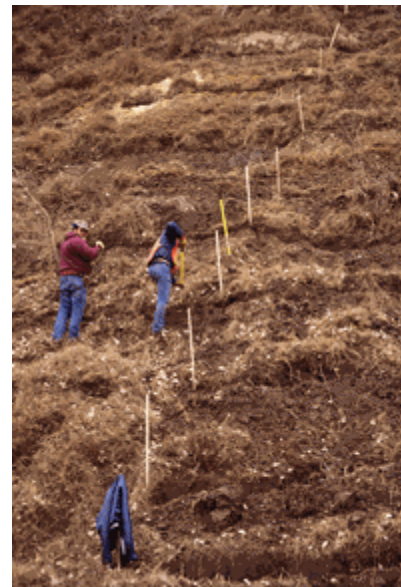
Two slopes were selected on T. H. 169 between Mankato and St. Peter, at milepost (M.P.) 56.750 and M.P. 56.859. Both sites are located on the west side of the highway. Site 1, the slope located furthest south at M.P. 56.750, is 60-70 feet high and 320 feet wide. The second site located at M.P. 56.859 is 50-60 feet high and 100 feet wide. Both sites have a 1:1 - 1.5:1 slope. The vegetation originally present consisted of brome grass and crownvetch with scattered deciduous trees; poplar, elm, willow, sumac, (as shown in the original site photos). The soils were sandy and platy clay. The clay soils had pH around 7.7 and the sandy soils were more alkaline around 8.2. Both sites were low in Phosphorous. Soluble Salts were at an acceptable low level. (Details can be found on the soil sample sheets taken on 4 October 1995). Both sites have seeps caused by subsoil layers of clay and sand, which cause the layers of sand to become saturated and lose their stability. Both sites have had stability problems since original highway construction in the mid 1960's.

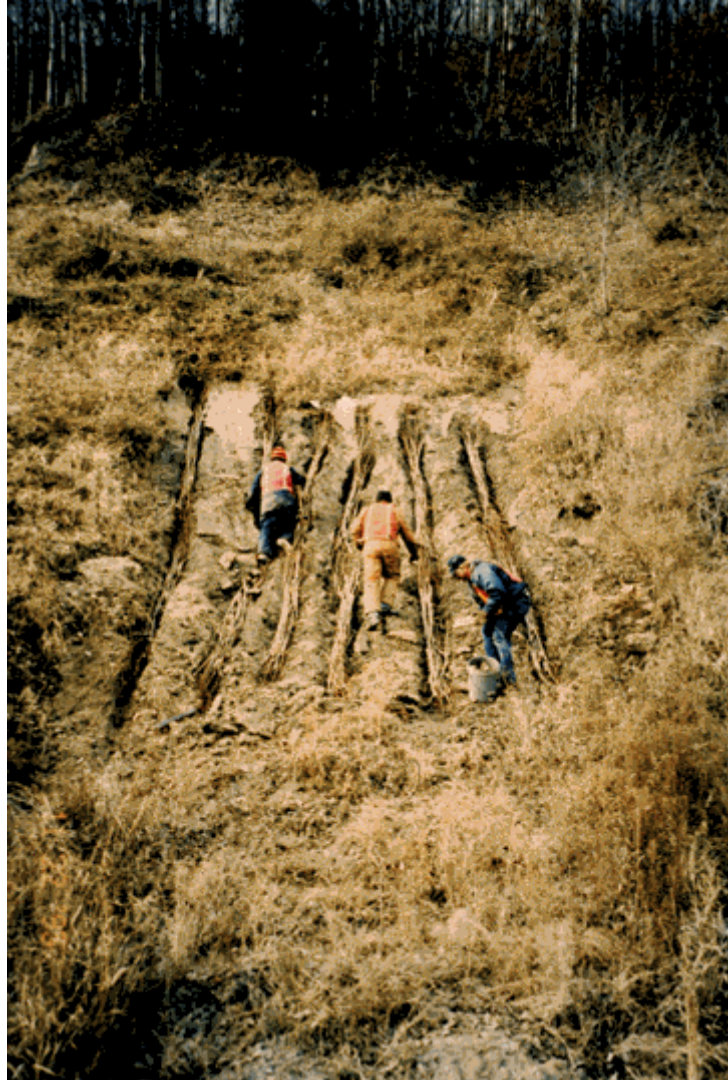
Placing wattles in the vertical drain trenches

The trench spacing, beginning at the toe of slope has two, 3 foot spaced rows; four, eight foot spaced rows; and four, twelve-foot spaced rows. Each of the two sites had a vertical drain; wattles placed vertically, verses on the slope contour, placed in a seep section of the slope. The trenches were being dug during an intermittent snowfall. This, along with the cool temperature (23 F), prevented the trenches from drying out. Once the workers finished trenching site 2, the workers cut the willows. Some willows were bundled into wattles and others were used for brushlayering. The willows for brushlayering were placed criss-cross in the trench, and then the trench was filled in by hand with shovels. The wattles were placed over lapping the ends in the trench and then were covered with soil. Site 1 was done in the same manner, the next day. Site 1 had a substitute of 15 lineal feet of 4 foot long Sumac (*Rhus glabra*) placed as brushlayering in a trench at the toe of slope.

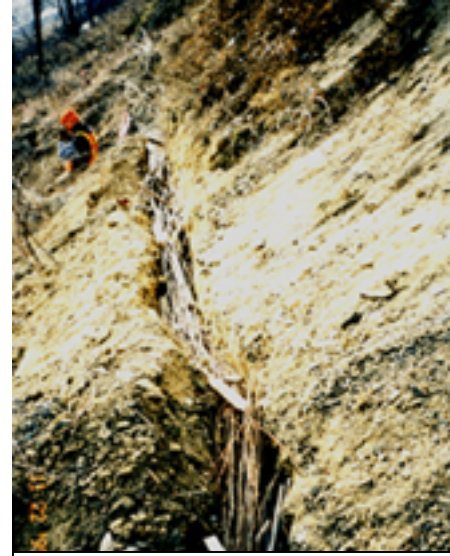
Willow wattles placed in trenches

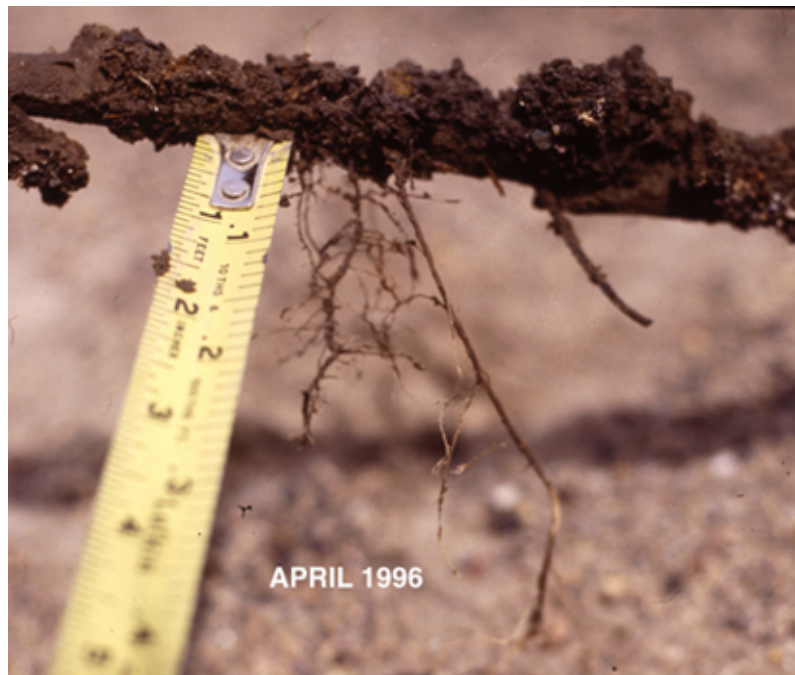
Root length of brushlayered willow

Site 2 was farther along with the longest length of new growth at 1". Roots were developing well, with brushlayering being slightly longer in length.

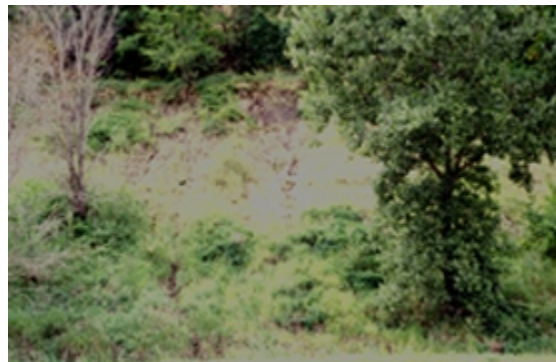
Brushlayer and Wattle Growth on Slope

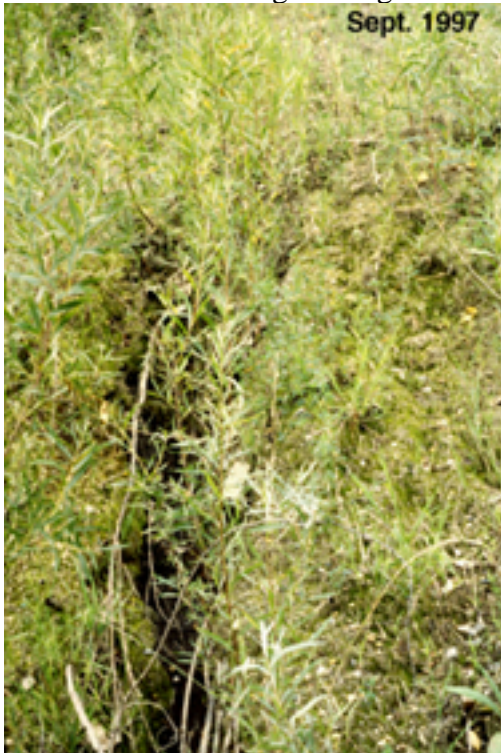
Willow growth in the vertical drain
Site 2 on August 1997

The wetter areas, where most of the seeps were located in the upper one third of the slopes, had the earliest, therefore the most growth of the willows and grasses. The vertical drain willows were effective in transferring water down the slope. At the end and between the wattles of most of the vertical drain some of the soil washed out. It was important to secure these wattles with long stakes due to the high mobility of the soil on the slope and forces from water flow through the wattles.
