**TO:** File: Research on Longitudinal Joint Deterioration

**SUBJECT:** Longitudinal Joint Fog Seal Test Sections

This memo describes the longitudinal joint fog seal treatment and documents the application and early performance of MnROAD test sections.

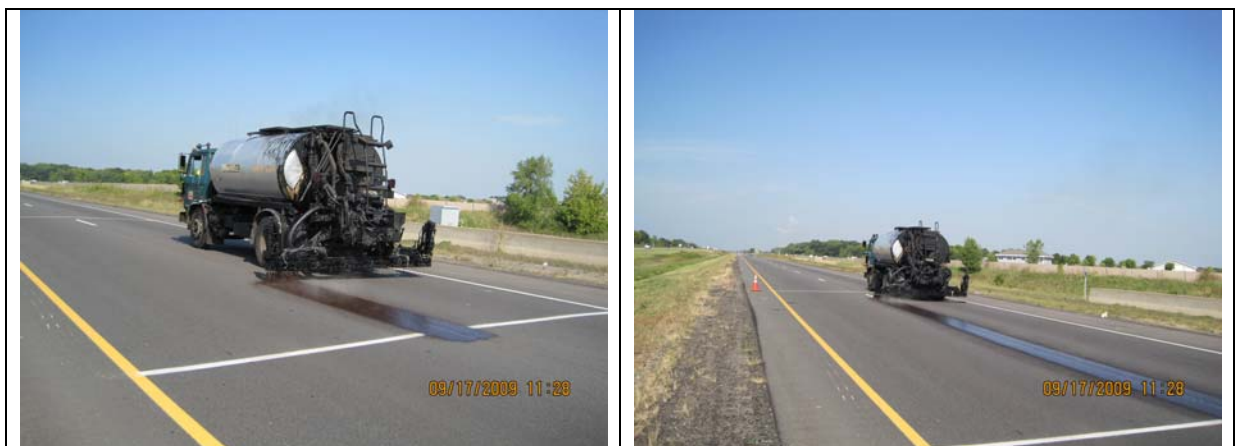
Figure 1. T.H. 94, September, 2009 – 0.10 gal/SY CSS-1h Fog Seal

- 0.10 gal/SY (2' wide by 50' long) in transition zone, between cells 19-18
- 0.15 gal/SY (2' wide by 50' long) in transition zone, between cells 18-17
- 0.20 gal/SY (2' wide by 50' long) in transition zone, between cells 17-16

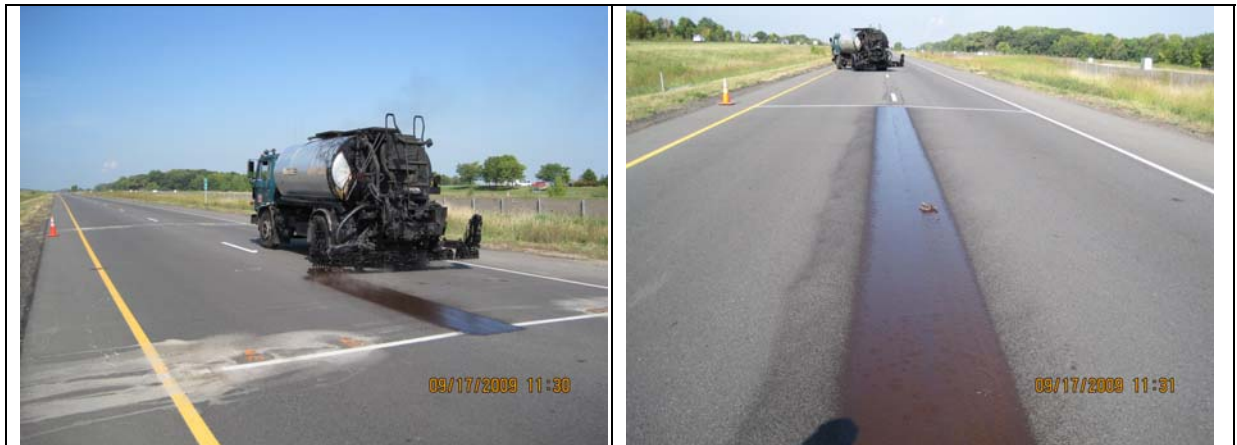
**Figure 2. T.H. 94, September, 2009 – 0.15 & 0.20 gal/SY CSS-1h Fog Seal**

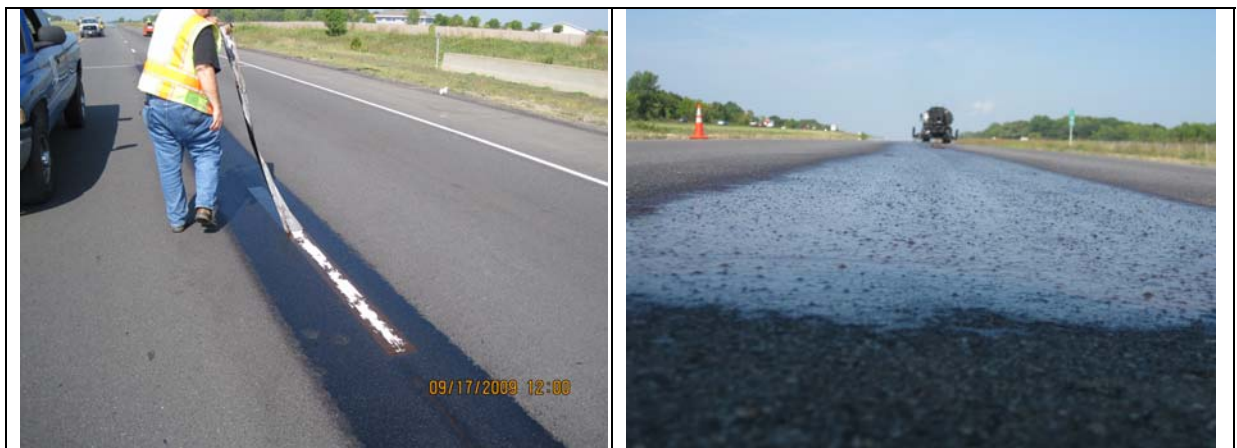
**Figure 3. T.H. 94, CSS-1h Fog Seal after 25+ minutes, September, 2009**

- Pavement striping was covered with special tape (3M Prespacing Tape SCPS-2), although effective for this project, this method may not be practical for larger projects. However, due to the quick cure time of the fog seal, the treatment could easily be coordinated with pavement striping
- A uniform application and coverage was critical to the success of this project (no dribbles)
- Proper material was also highly critical to the success of the project
- All three sections cured in approximately 25 - 30 minutes
- The application rate of 0.20 gal/SY may not be the upper limit of longitudinal joint fog sealing due to the low density and high permeability of the joint.

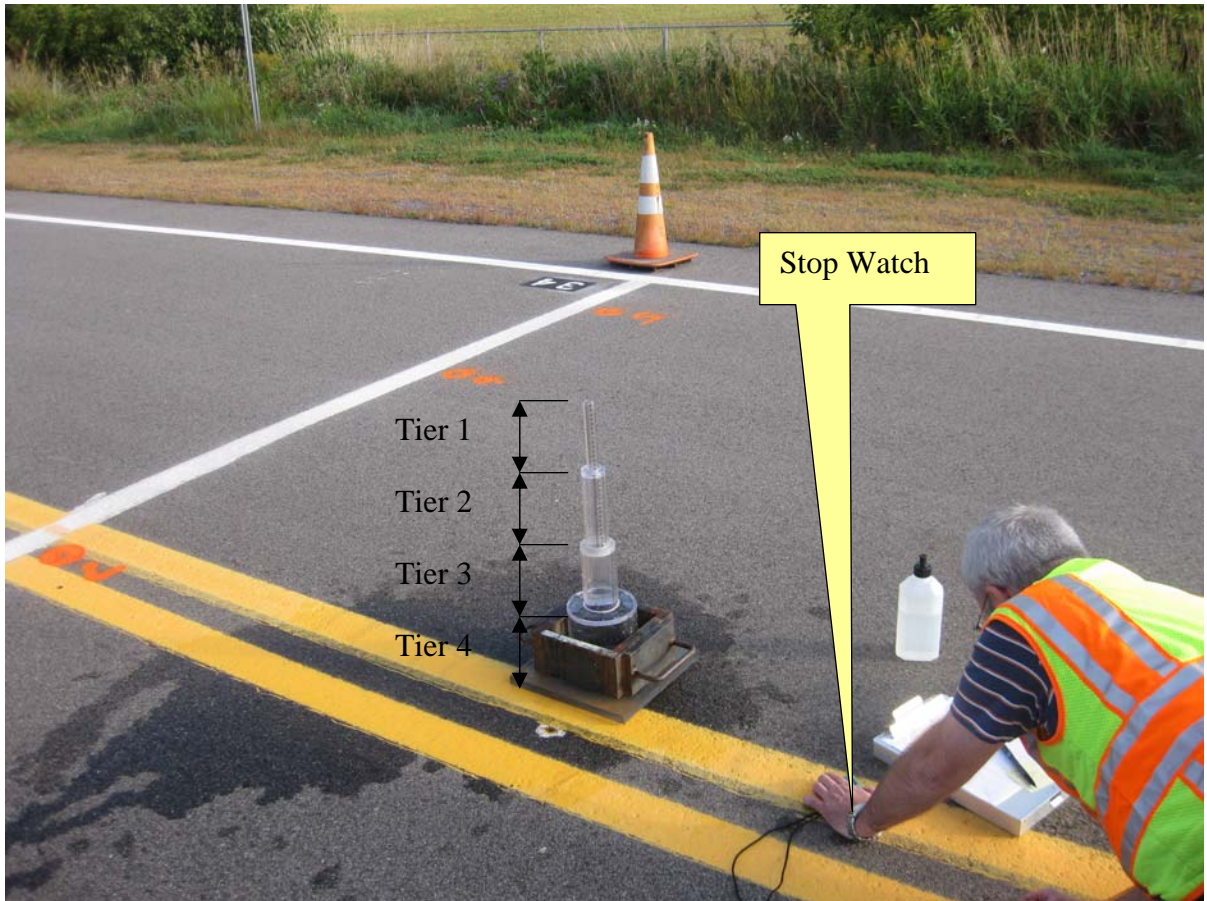
**Figure 4. Field Permeameter**

Figure 5 shows the permeability measurements taken directly over the centerline construction joint on the test sections the day prior to (Before) and the day after (After) the fog seal application. The two before measurements were located in the cell transition zones (between cells 18-17 and between cells 17-16). Note that there wasn't a before measurement for the transition zone between cells 19-18, so it was assumed to be equal to the transition between cells 18-17 due to similar conditions. The coefficient of hydraulic conductivity was measured using a falling head Permeameter as shown in Figure 4. This test involves sealing

the Permeameter to the ground, then filling it with water and measuring the time it takes for water to “fall” from one level (tier) to the next. The hydraulic conductivity measures the ease with which water can travel through the pavement, higher values denote less resistance to flow and lower values denote greater resistance to flow. Note the dramatic reduction in permeability as a result of the fog seal treatments. The fog seal hydraulic conductivity values are still higher than the permeability of cell 19 (not in the transition zone) measured in the right wheel path; this value ( $6.5 \times 10^{-5}$  cm/sec) is shown with a red line near the bottom of Figure 5 for comparison purposes.

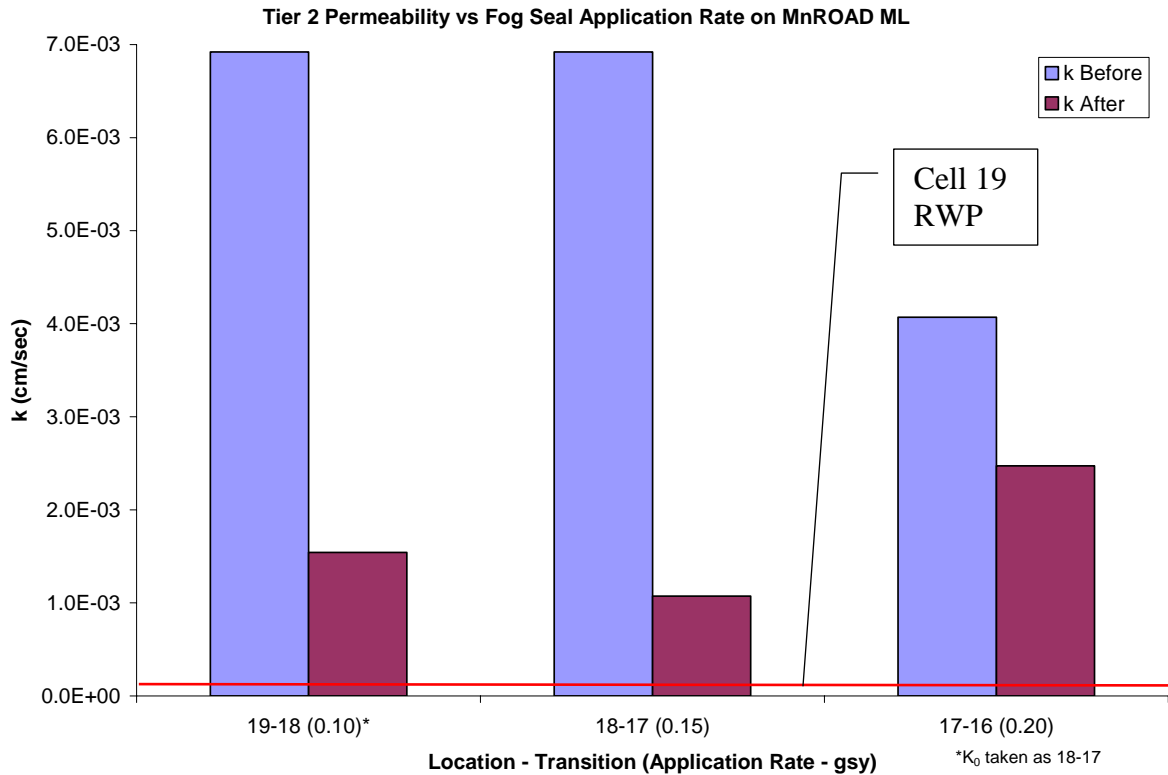
**Figure 5. Before and After Hydraulic Conductivity Measurements**

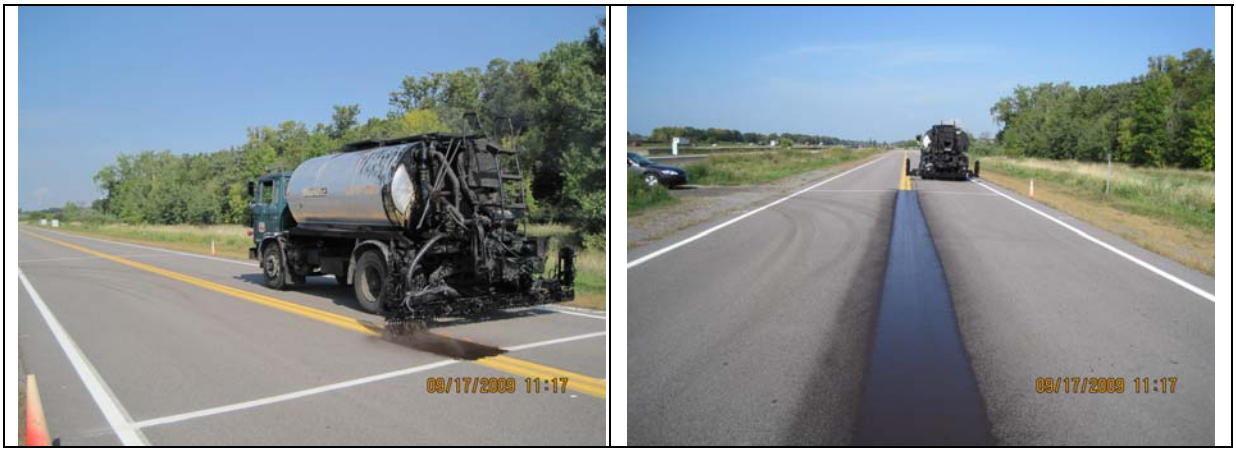
Figure 6. MnROAD CSS-1h Fog Seal applied at 0.10 gal.SY, September, 2009

- Pavement striping was obliterated with the treatment, but new latex paint was applied shortly afterwards.
- A uniform application and coverage was critical to the success of this project (no dribbles)
- The test section cured in approximately 25 minutes, longer over the centerline paint stripes

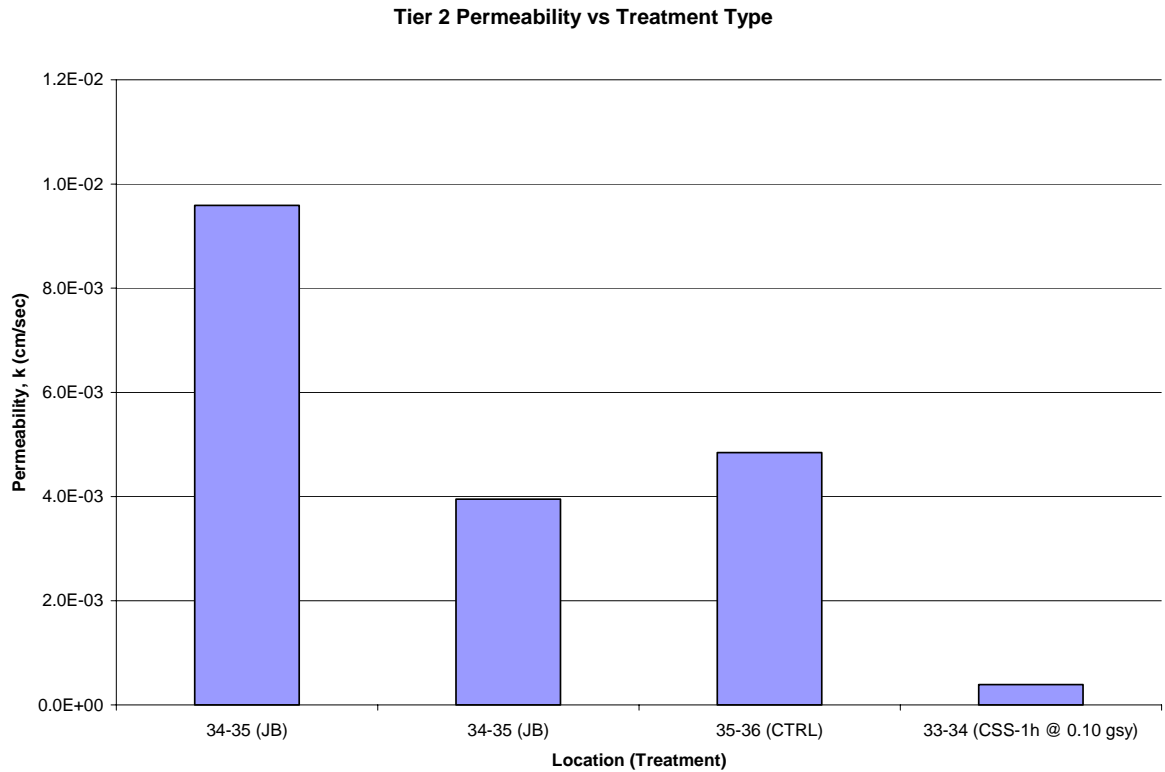
**Figure 7. Hydraulic Conductivity Measurements of LVR Test Sections**

Figure 7 shows the permeability measurements taken on the MnROAD low volume road test sections. There is a dramatic reduction in permeability as a result of the fog seal treatments, and the JointBond results appear to be inconclusive with one measurement slightly lower than the control and another significantly higher. Note that the joint bond treatment has been in-place for 1-year at the time of measurement, but the CSS-1h fog seal was applied the day prior.
