Memo

Office of Materials

SUBJECT: Joint Stabilization (JointBond®) Lab Study

This memo describes the lab study undertaken to evaluate the effect of joint stabilization (JointBond®) treatment on pavement marking retro-reflectivity.

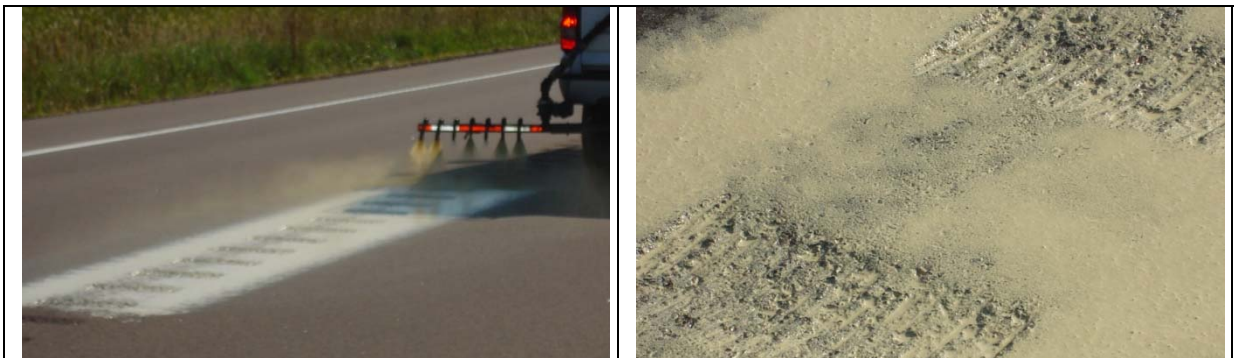
Figure 1. T.H. 95, September 8, 2008 – JB Application

JointBond was applied on an experimental basis on September 8, 2008 at T.H. 95 (5.75 miles east of TH 169 (Princeton)). This section of roadway had received an overlay one year prior (2007).

- Started at Reference Point (RP) 28.0 and applied the product as described below:
 - 0.10 gallons per square yard (gsy) for 90 ft
 - skip 45 ft
 - 0.08 gal/SY for 250 ft
 - skip 240 ft
 - 0.07 gal/SY for 210 ft

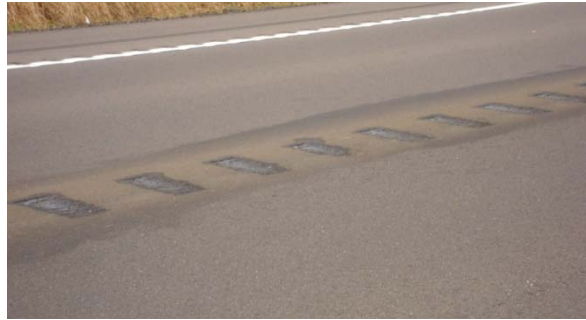
Figure 2. T.H. 95, November, 2008 –After JB Application

A field visit was made by Patti-Wallin Johnson of D3 on 11-6-2008 (2 months after application) after maintenance reports of color change from clear to brown. This color change prompted the question as to whether or not the retro-reflectivity was reduced. In addition, Pavement marking retro-reflectivity was measured by Dave Gustafson using a hand held LTL-X device shortly after application in 2008 (Table 1). Note that the measurements

were made because of a visible difference between the sealed and unsealed sections on a routine marking evaluation, and not by special request. The results in Table 1 show that retro-reflectivity measurements are reduced by approximately 30 MCD's (29.9 and 33.4% difference for the west bound and east bound centerline, respectively) between the sealed and unsealed sections.

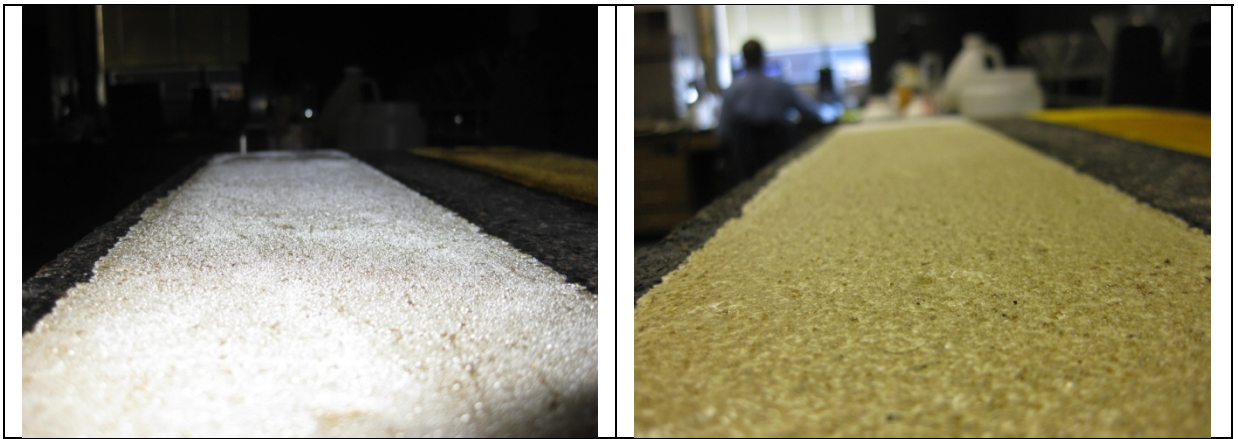
Figure 3. White Stripe, Before (Left) and After (Right) – JB Application

A plant produced HMA specimen was cut from a MN state highway and used for this laboratory evaluation. Two pavement stripes (one white and one yellow) were applied 18 inches long by 4 inches wide in a high humidity environment (to facilitate glass bead embedment), using standard laboratory procedures. The pavement markings were then allowed to cure over the weekend, and the initial retro-reflectivity measurements were taken, denoted “before” in table 1. The JB treatment was applied with a paint brush, at an amount of not more than 15 ml. This corresponds to an equivalent rate of not more than .07 gsy, the smallest rate applied on the TH 95 test section. After the treatment was allowed to cure, retro-reflectivity measurements were taken again, denoted “after” in table 1.

Both treated stripes have approximately 50% of their pre-treatment retro-reflective values. The JointBond treatment appeared to turn the pavement markings brown, and was tacky. It is possible that with time and traffic that this material on the surface could fade away and retro-reflectivity numbers could improve, however it is uncertain how long this process would take.

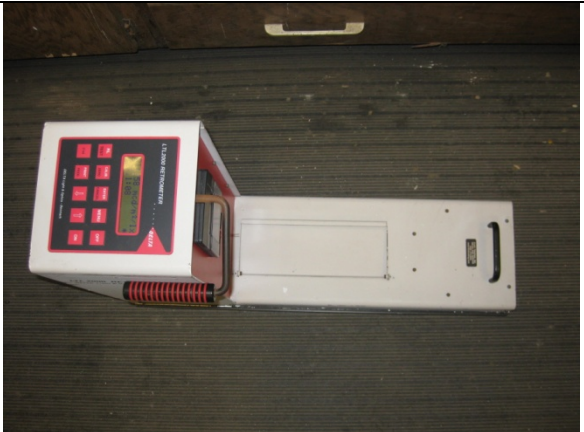
Table 2. Before and After Retro-Reflectivity Measurements

White	Yellow
Before (mcd)	1	345	183
	2	355	194
	3	333	206
	Average	344.3	194.3
After (mcd)	1	181	69
	2	164	102
	3	169	81
	Average	171.3	84.0

The JB treatment was applied on two test sections in 2008. Upon construction the product penetrated into the pavement surface. On TH 95 there were reports that the pavement surface had turned brown, this was not permanent. Initial measurements of retro-reflectivity indicated a difference of 30 mcd between the control and the treated section. A laboratory evaluation of retro-reflectivity found that the JB treatment reduced retro-reflectivity values significantly (post treatment values were ½ of pre-treatment values). The difference between pre-post retro-reflective measurements of the laboratory and field results seems to suggest that time, weather and traffic may help to remove the JointBond product from the pavement markings and allow the retro-reflectivity to partially recover. It is not clear at this time if a full recovery is possible, or how long it would take.
