**TO:** File: Research on Longitudinal Joint Deterioration

**SUBJECT:** Joint Stabilization (JointBond®) Test Sections

## T.H. 95 Test Section:

**Minnesota Road Research Project (MnROAD) Test Section:**

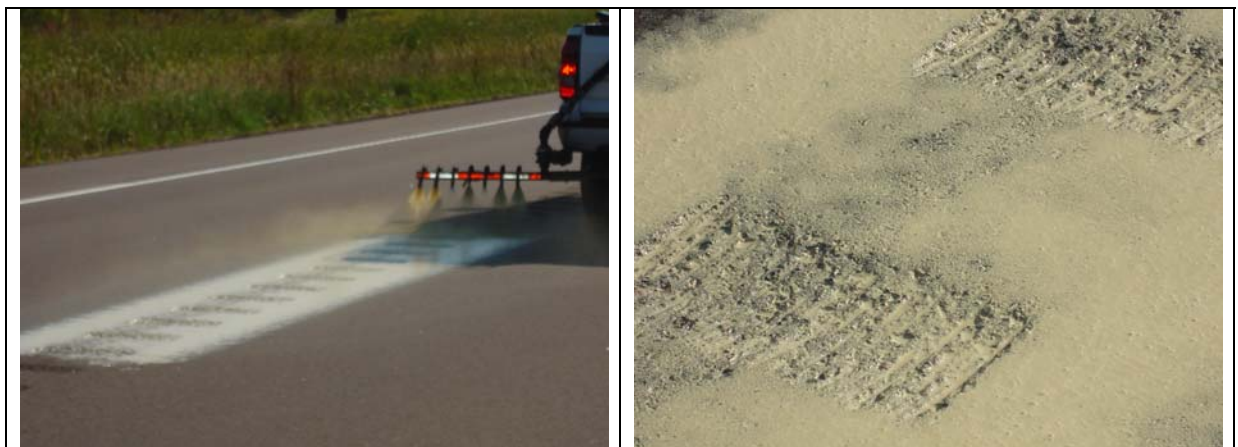
**Figure 1. T.H. 95, September 8, 2008 – JB Application**

- Started at Reference Point (RP) 28.0 and applied three closely spaced 100 ft long test sections at varying application rates
- Figure 1 shows the application of JointBond over the longitudinal joint, and Figure 2 shows the completed test section (Note the relatively short length). Note how the product penetrated the pavement leaving a dark black color.

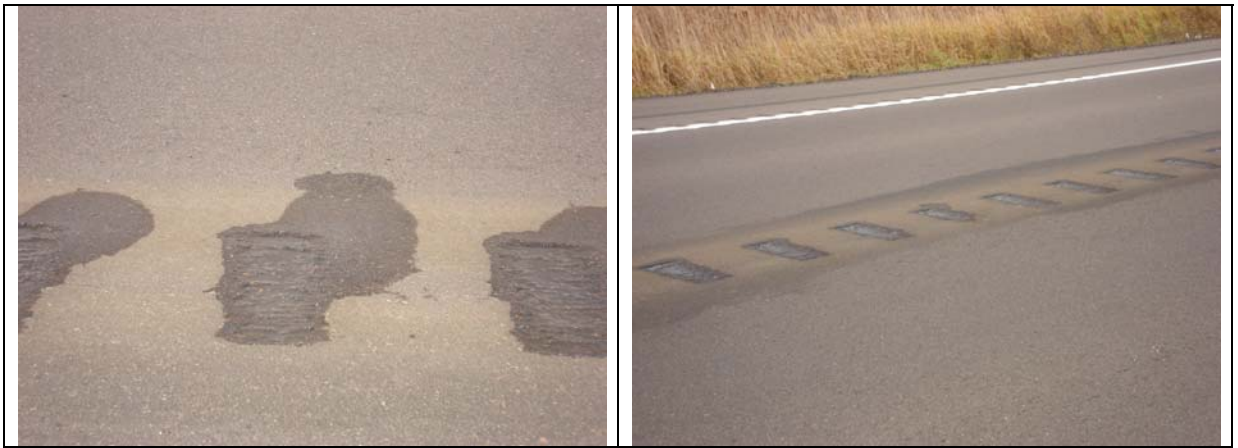
**Figure 3. T.H. 95, November 11, 2008 – 2 Months After JB Application**

- A field visit was made by Patti-Wallin Johnson of D3 on 11-6-2008 (2 months after application) after maintenance reports of color change from clear to brown as shown in Figure 3. Note that the photos were taken after a rain, as shown by the retained water in the centerline rumble strips.

- Although the brown color has faded, an evaluation of pavement marking reflectivity **has not** been performed.
- The 2009 field visit did not observe a difference in field performance between the treated and untreated sections

- Continue monitoring the field performance of the test section
- Perform reflectivity measurements
- Perform permeability measurements

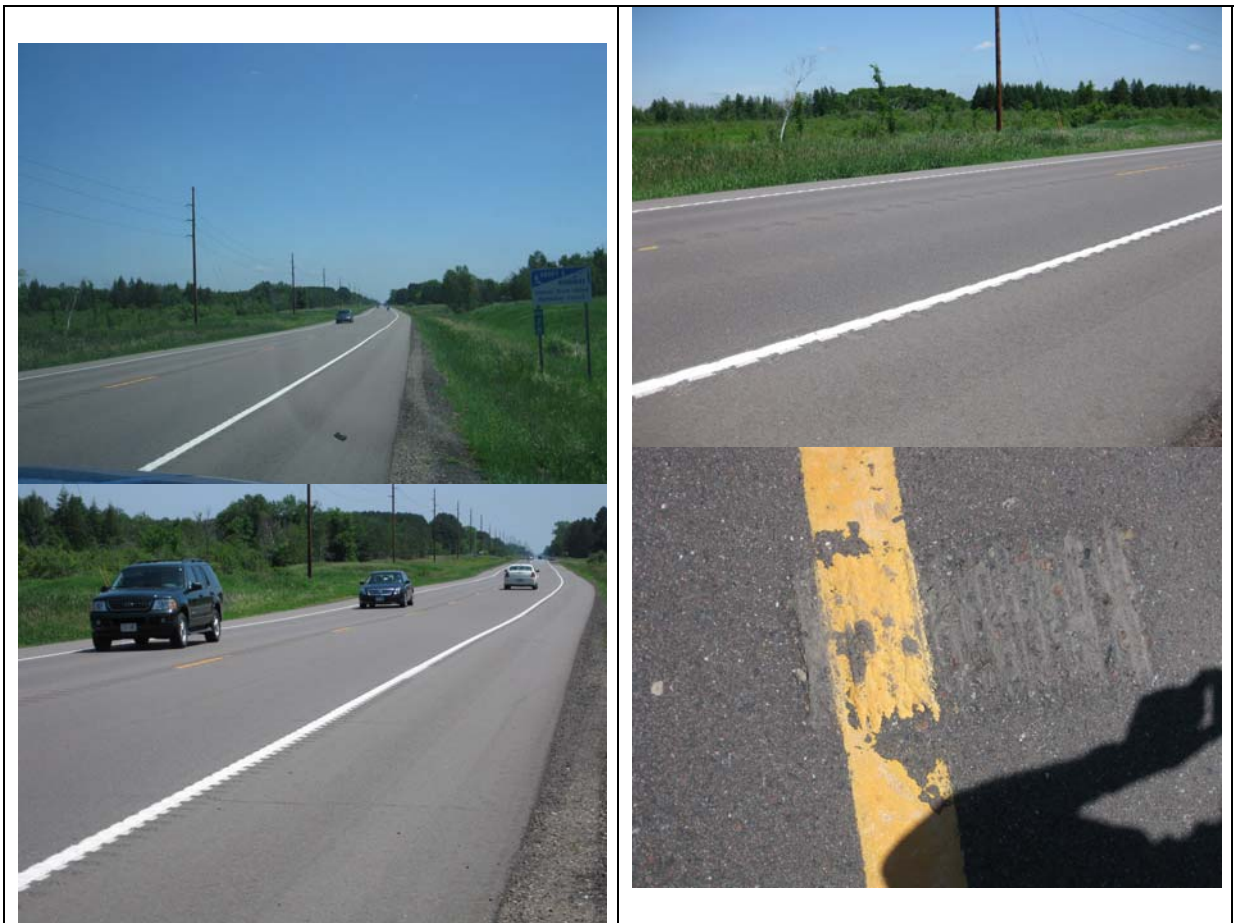
**Figure 4. T.H. 95 JB, August, 2009 – 1 Year After JB Application**

- A field visit was made in 2009 by Mark Watson and John Pantelis of CO MRR (nearly 1 year after construction). This visit did not find evidence of discoloration in the application area as shown in Figure 4. Note that the photos were also taken after a rain, however there was no retained water in rumble strips in the JointBond section, but there was retained water in the chip seal section as shown in Figure 5.

- After one year, there is no discernable difference in pavement performance between the JointBond Section and the control based on visual observation alone.

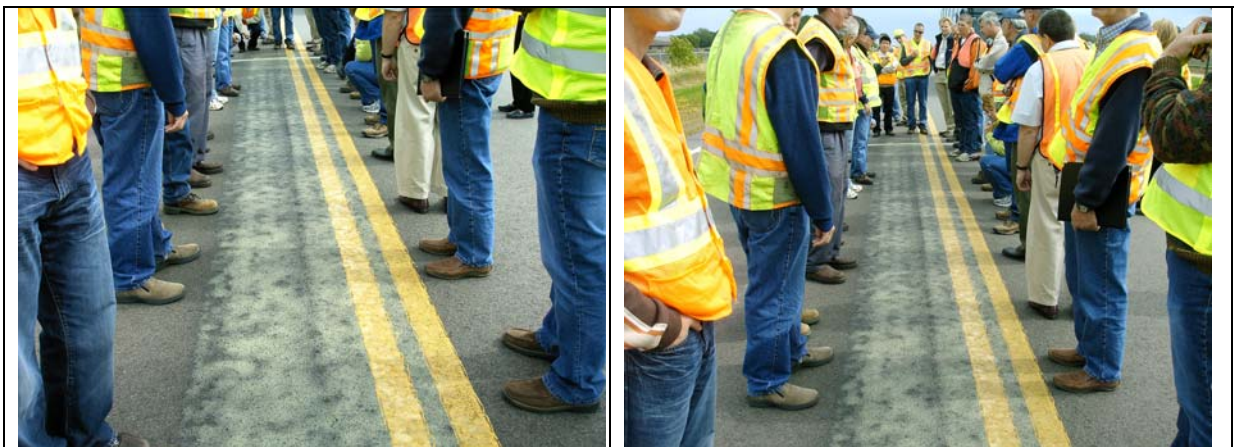
**Figure 6. MnROAD, September 10, 2008 – JB Application**

- Applied in the transition zone between cells 34-35 (Sta 7445 – 7495 dist. of 50')
- Figure 6 shows the application of JointBond over the longitudinal joint at MnROAD during the Midwestern Pavement Preservation Partnership (MPPP) Meeting.
- Figure 7 shows photos of the completed test section taken in August 2009, after a rain event (Note the relatively short length). Note how the product penetrated the pavement).

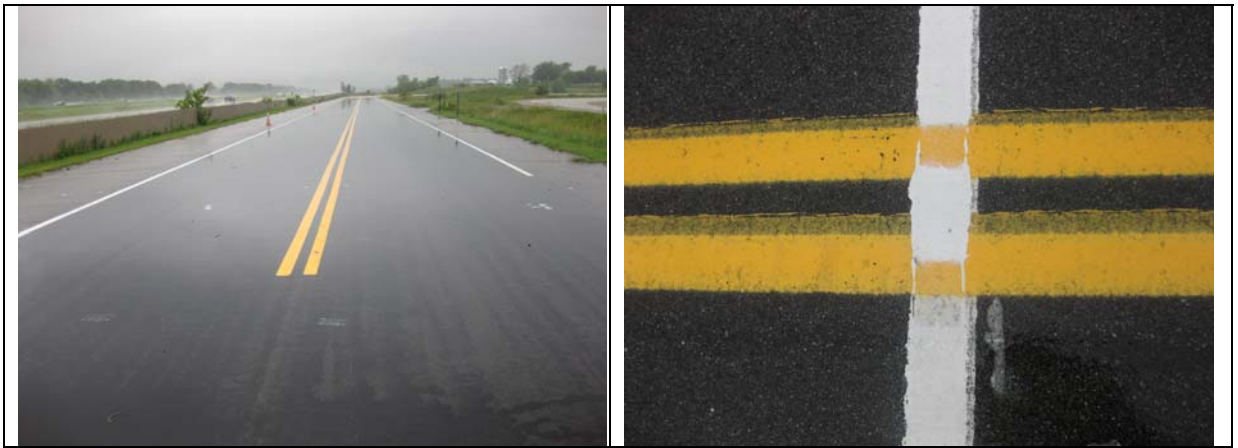
**Figure 7. MnROAD JB, August, 2009 – 1 Year After JB Application**

- After one year, there is no discernable difference in pavement performance between the JointBond Section and the control based on visual observation alone.

- Continue monitoring the field performance of the test section
- Perform reflectivity measurements
- Perform permeability, friction and texture measurements (MnROAD location will facilitate testing and evaluation due to the controlled traffic environment which can be challenging on a higher volume 2-lane rural highway)
