Non-Destructive Testing in Civil Engineering

Herbert Wigggenhauser

BAM- Federal Institute for Materials Research and Testing
Berlin, Germany

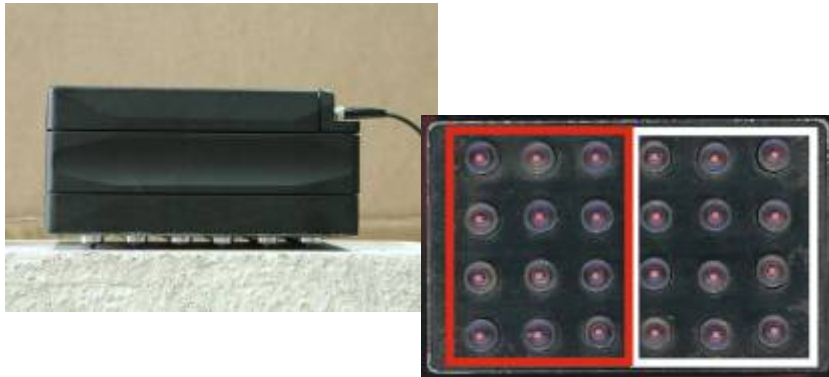
Ultrasonic Measurement Device

- **Shear waves**
 - center frequency of 50 kHz
- **Measurement head**
 - 24 point-contact transducers
 - without coupling agent

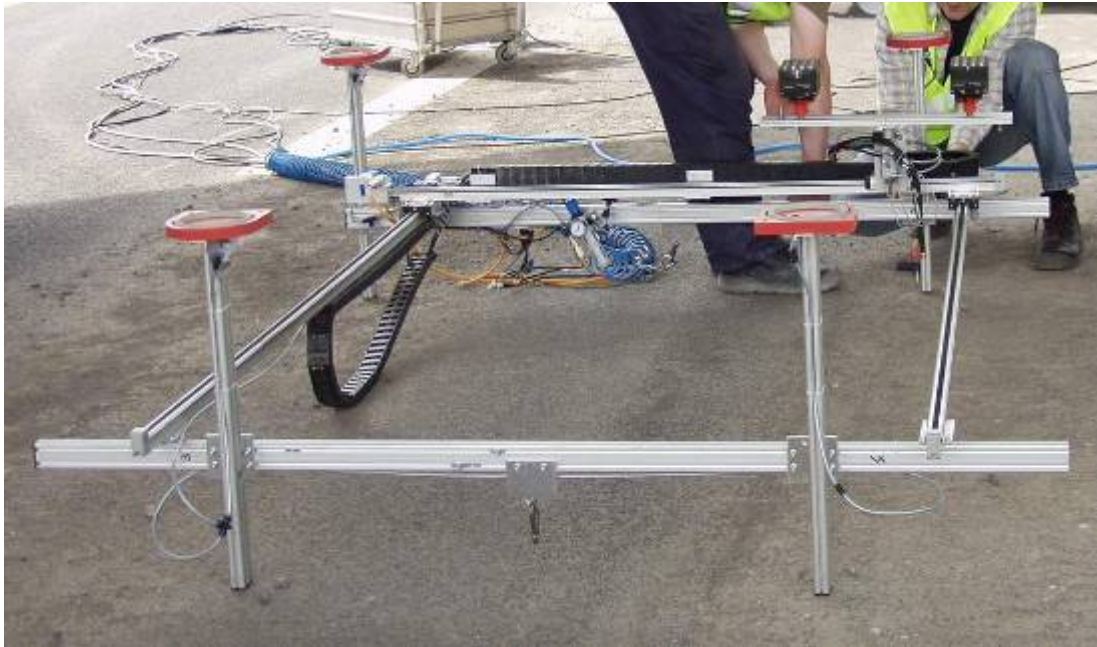
Scanner Systems

- ▶ Small lightweight scanner with vacuum attachment
- ▶ Two ultrasound sensors (dry coupled) to reduce measurement time

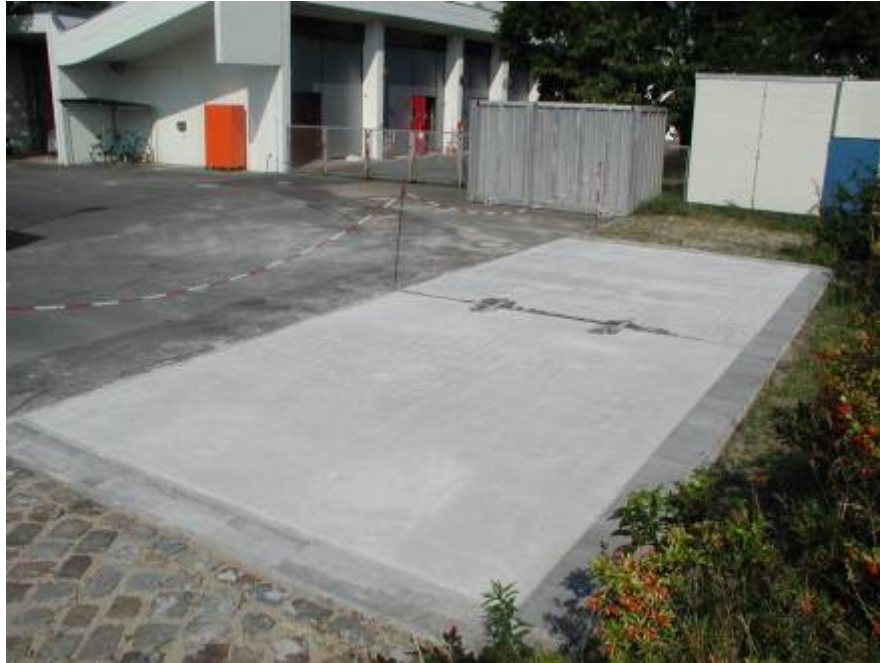
Large Concrete Slab (LCS) at BAM

Facility for various tests and measurements for the improvement of NDT-CE methods

Reference specimen for comparison of different methods (=>validation)

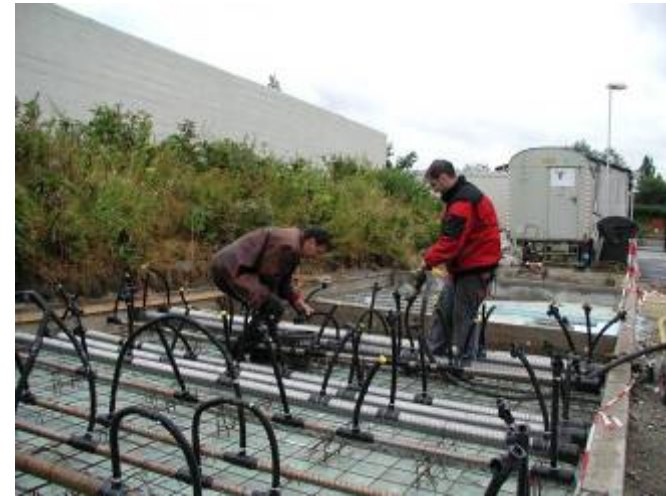
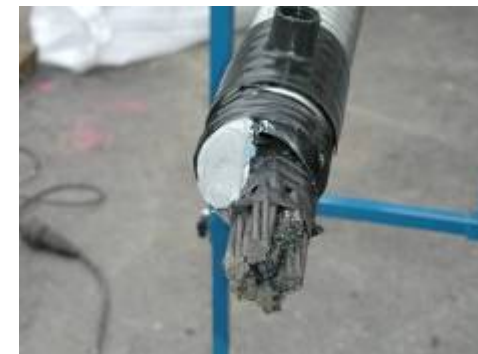
1. Section - Tendon ducts

11 Tendon ducts with strands
(length 4 m, diameter 40 ... 100 mm)
Grouting defects, Grouting by DSI

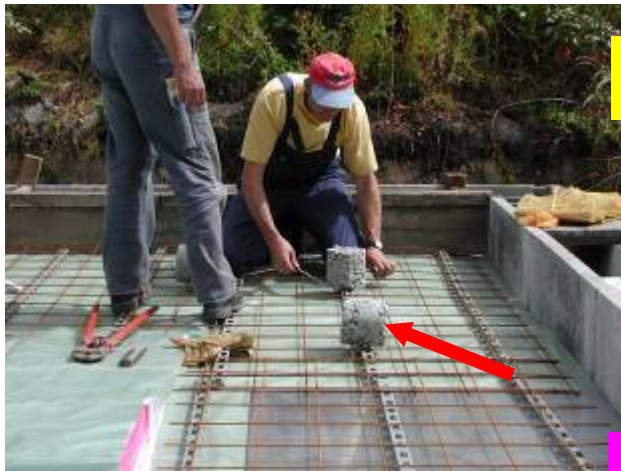
2. Section - Voids and auxiliary devices

- Compaction faults (gravel pockets)

Steel-plate

Thermoelements

Honeycombs

Water inlet

- Inlet for water and salt-solution through a tube from the bottom side into high porosity structure
- Thermoelements (for Thermography)
- Stainless steel-plate for backside reflection calibration
- Plastic tubes (for Radiography)

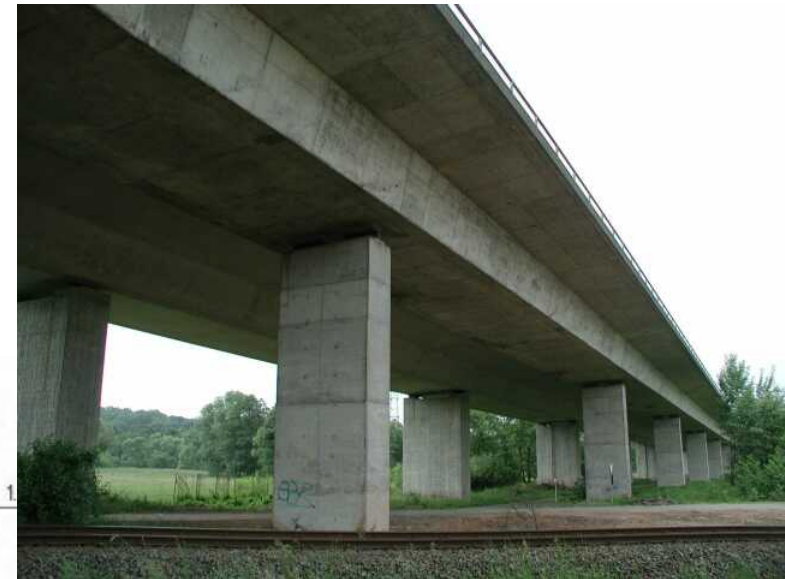
Construction

Cantilever unicellular box bridge

Length: 480 m

Prestressed in longitudinal and transversal direction

Constructed 1966, deconstruction 2004

- Radar
- Impact-Echo
- Ultrasonic Echo

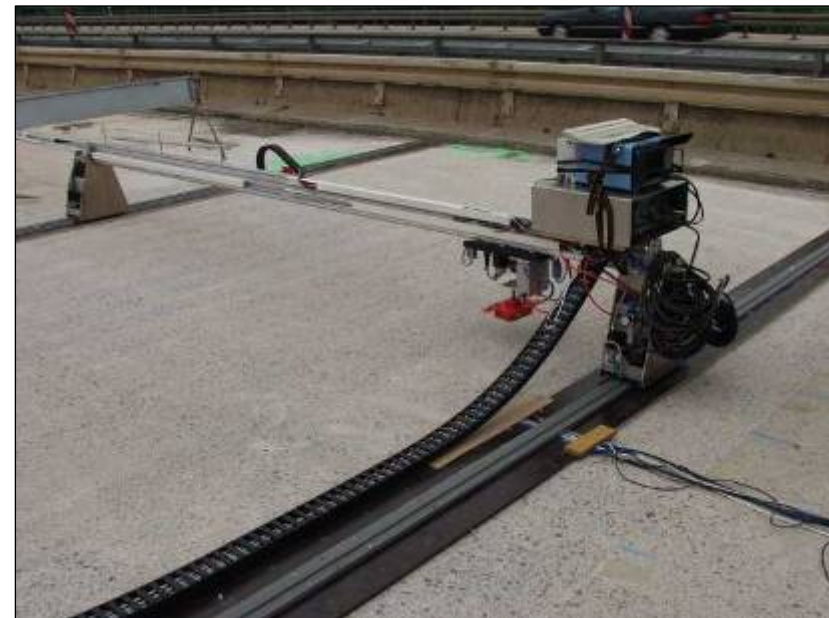
Measurements on a post-tensioned bridge deck

Test Area on the top: 4.0 m x 10.0 m

Test Area on the bottom: 3.0 m x 10.0 m

- tendon ducts with diameters of 45 mm, each with 6 wires
- thickness of the deck 23 - 38 cm

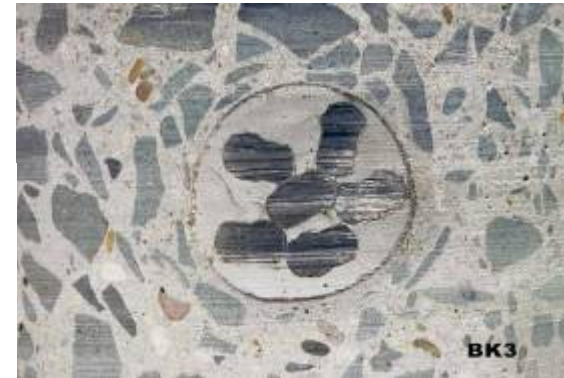
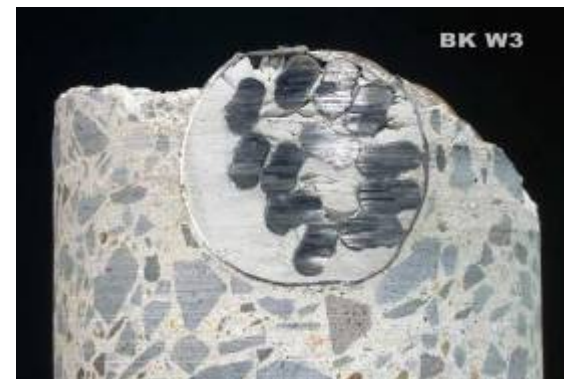
Bridge-deck: Destructiv testing: 35 cores, endoscopy

Bridge deck (transverse tendon ducts):
Very good grouting condition

Box girder wall (longitudinal tendon ducts)

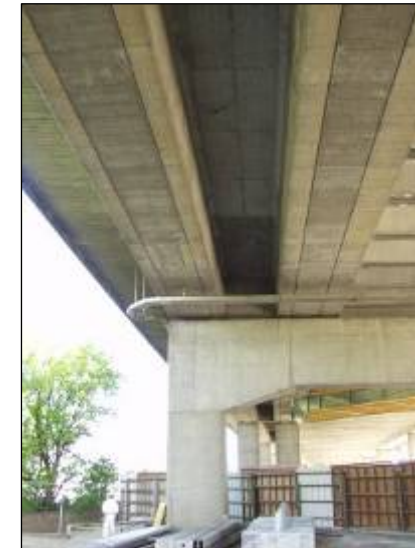
Measurements on webs of box girder bridges

- thickness of the web 50 cm
(83 cm in the area of anchoring of the pre-stressing)

- bridge under unaffected traffic

Test Area: 10 m (length) x 1.5 m (height)

- simultaneous mounting of the impact-echo and ultrasonic sensors on the scanner

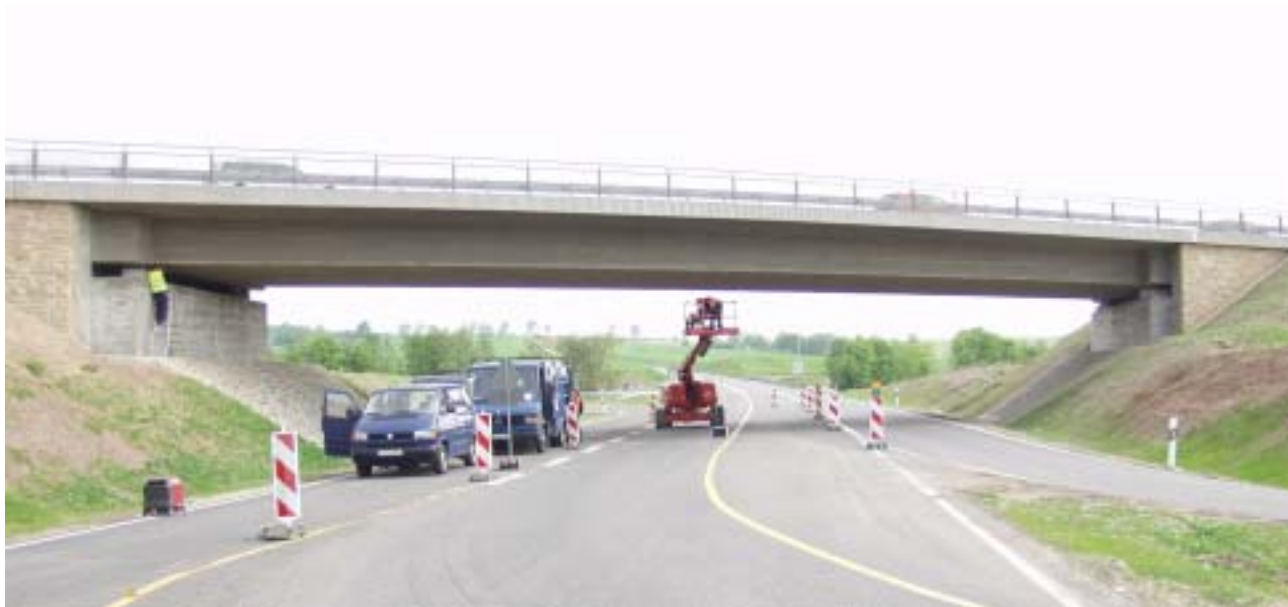
Measurements on a bridge deck, pre-stressed in longitudinal direction

Test Area on the bottom side of the deck, 0.96 m x 18.40 m:

ultrasonic echo measurements were done in 23 scanning areas length of 2 m x 0.40 m

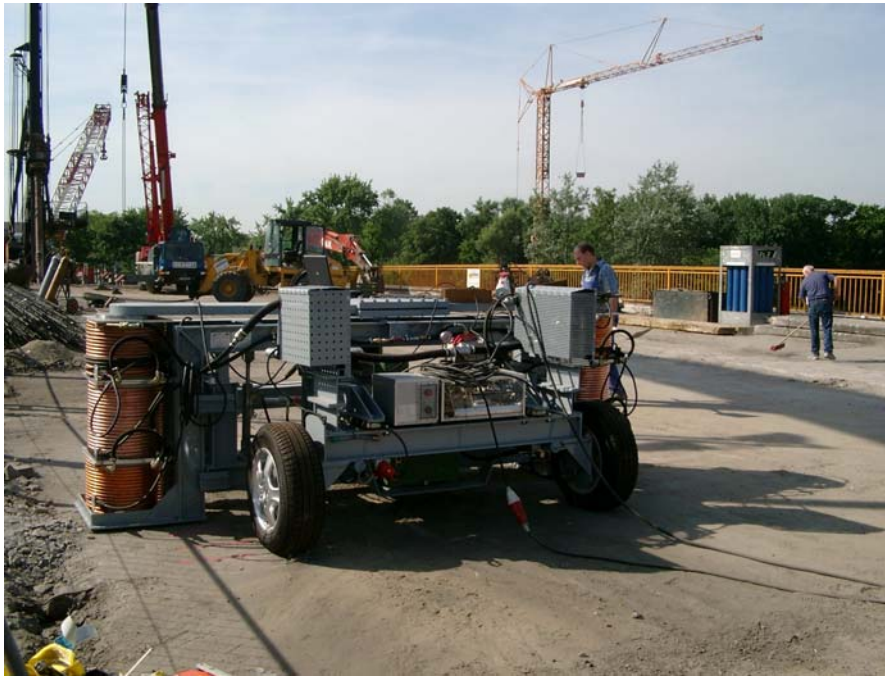
Locating tendon cracks in PT Concrete

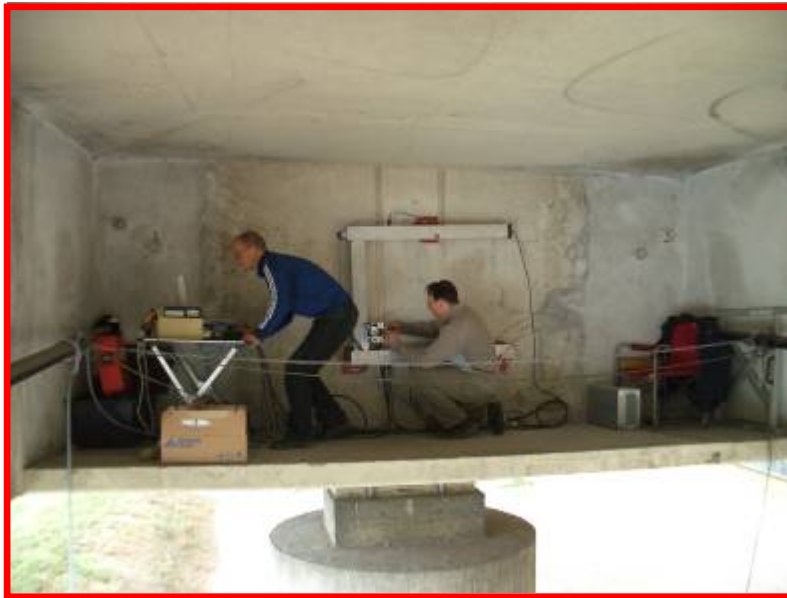
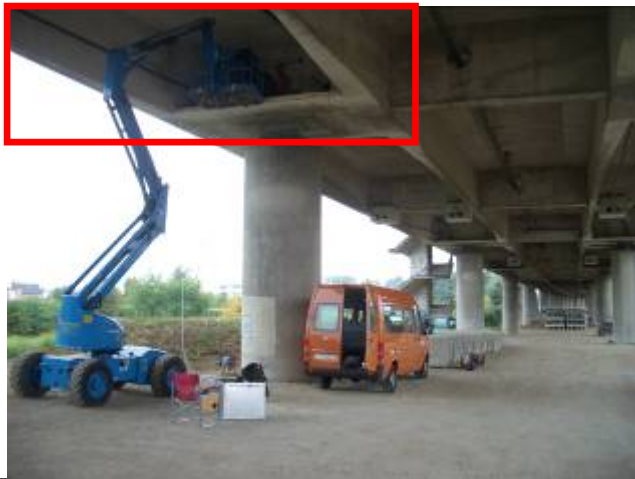
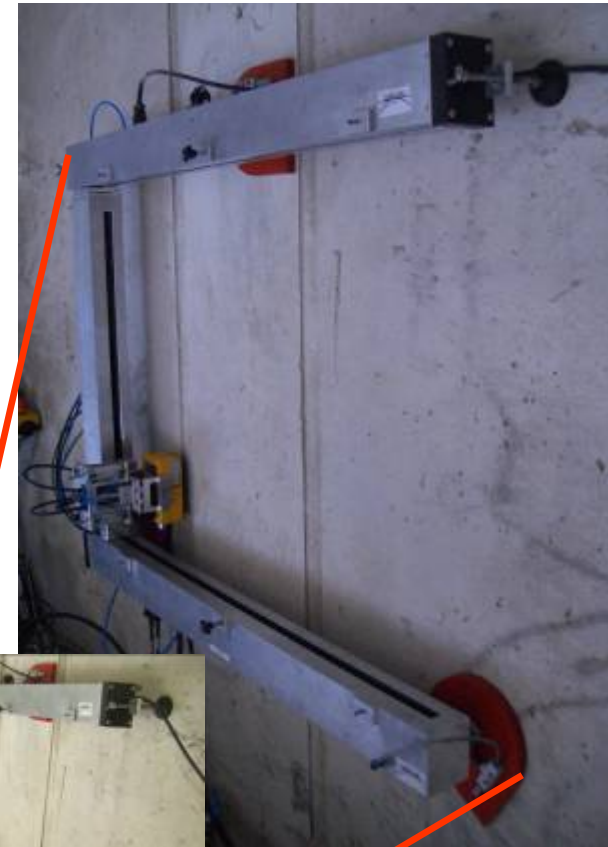
First on-site application

- Bridge close to Frankfurt over the river *Main* (2009-Sep)

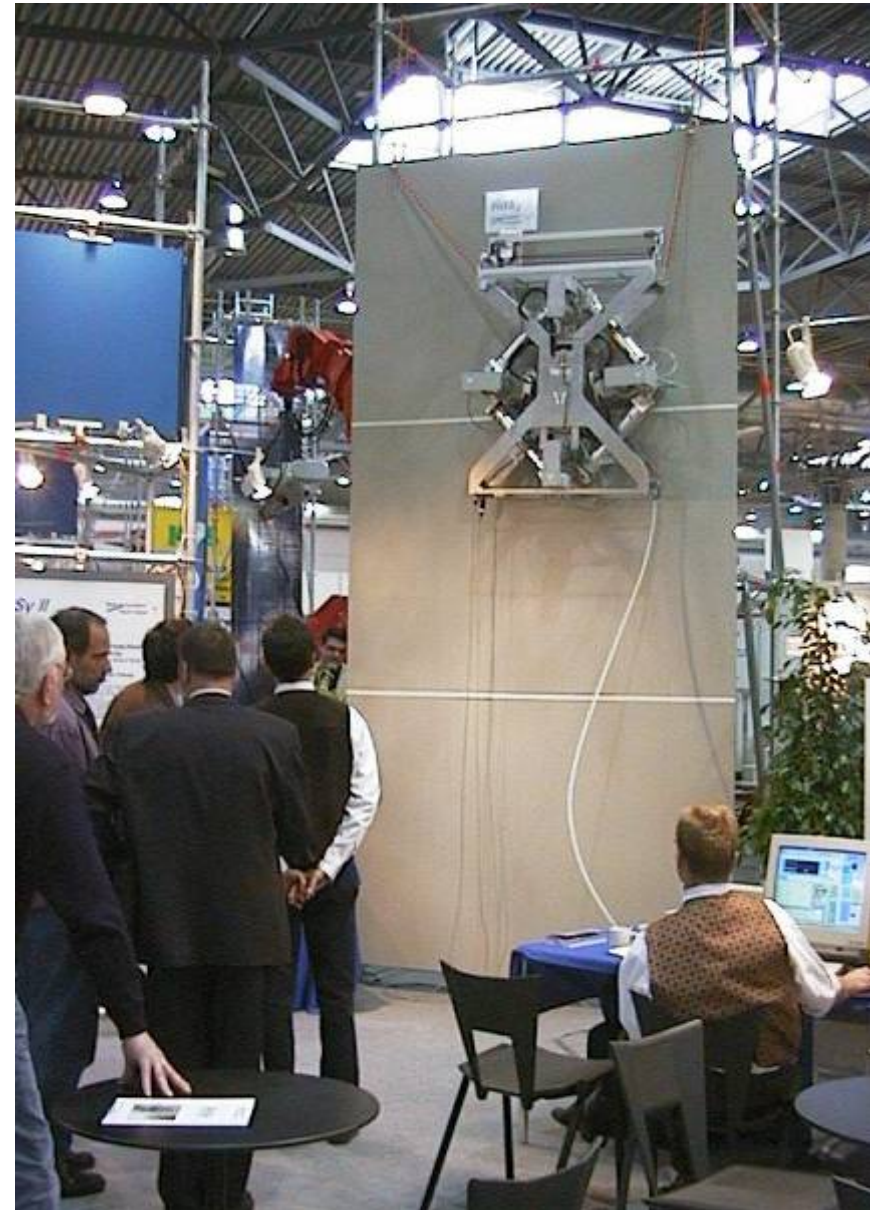
- **Climbing machine equipped with**
 - camera
 - radar
 - impact-echo
 - ...

ROSY climbing machine (Yberle)
