Fatigue Evaluation of  
Stillwater Bridge  
(Bridge 4654)

1. Report No. MN/RC - P99-1		2.		3. Recipient's Accession No.	
4. Title and Subtitle FATIGUE EVALUATION OF STILLWATER BRIDGE (Bridge 4654)				5. Report Date December 1998

Final Report

December 1998

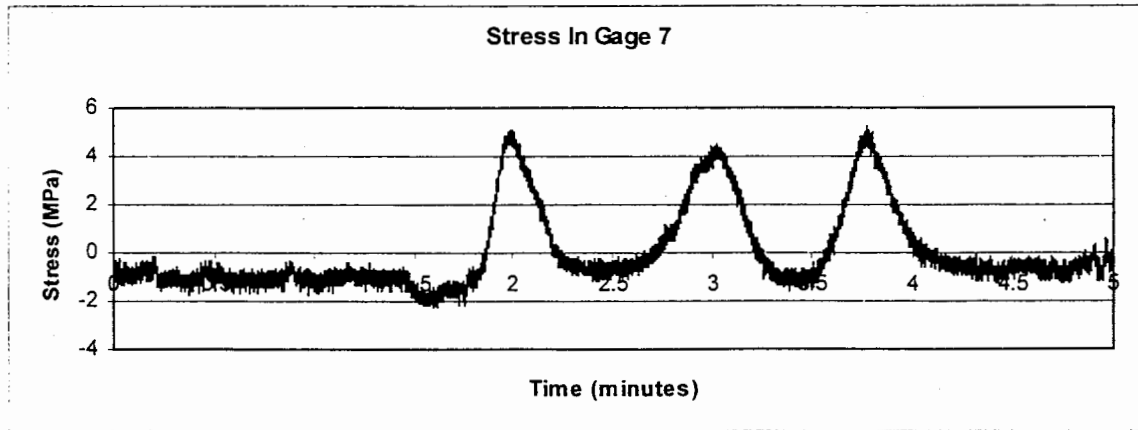
Figure 5: Time Histories of the Response during the Static Test

Figures 5a-i show five minute segments of the time histories of the strain gages during the static tests. The time scales are identical for all of these graphs in Figure 5. The peaks from each pass of the trucks line up on each page, indicating the peaks occurred at the same time. Gages 0 and 1 are on the top flange, while gages 2 and 3 are on the bottom flange. Since the pairs of gages on each flange give almost identical results, it is concluded that there is no weak axis bending of the floorbeam. Also, since the magnitudes of the stress peaks in compression in gages on the top flange are essentially equal to the magnitudes of the stress peaks in tension on the bottom flange, it can be concluded that the slab is not acting compositely with the beam for transverse bending.

All four gages show that the stress induced in the second peak is greater than in the first or third peak. The maximum stress range the floorbeam experiences during the second peak is 26 MPa. The trucks were backing up during the second peak, however there is no good explanation for the increase in stress range relative to the forward motion.

Because the floorbeam response is symmetric, the absolute values of gages 0-3 were averaged to determine a bending stress. This average bending stress will be the focus of the data reduction rather than describe all four gages individually. The average will further reduce noise and error. The average bending stress for the static test case is shown in Figure 5e.

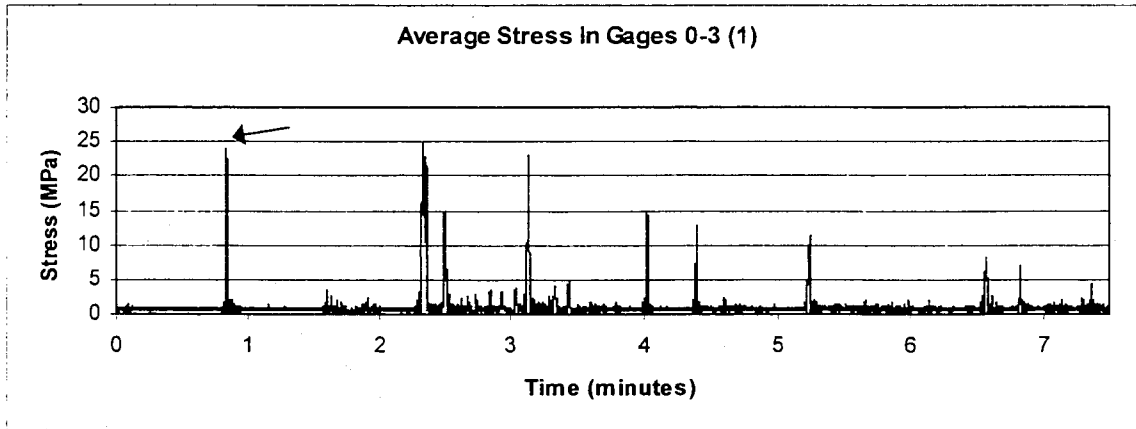
The five-minute stress histories for the single-truck dynamic test are shown in Figures 7a-7c. The two trucks passed over the floorbeam at about 4.0 and 4.6 minutes, respectively, as indicated with arrows on Figure 7a. The peak stress range recorded for gages 0-3 near the middle of the floorbeam is 18.4 MPa for the second truck.

Theoretically, the peak stress range from two trucks (26 MPa) should have been about twice this 18.4 MPa peak stress range from one truck. This discrepancy is discussed again with respect to the analysis in Chapter 4, where it is noted that the measured stress range for one truck is relatively close to the predicted stress range, whereas the measured stress range for two trucks is much less than predicted. Thus, the fact that the measured response for two trucks is less than twice the measured response for one truck indicates nonlinearity in the strain response to increasing load. This nonlinearity probably has to do with increasing significance of alternate load paths at the higher load levels. The increasing difference between the measured and predicted stress ranges indicate that these alternate load paths are not considered in the analysis.

The peak stress range in gage 5 near the end of the floorbeam was 2.5 MPa from the second truck. Note that the first truck caused no noticeable response at all in gage 5. This may indicate that the partial fixity in the end of the floorbeam may have slipped as the first truck passed over.

The peak stress range in the tension chord (gages 7 and 8) was 4 MPa, as compared to 6.2 MPa for the two-truck dynamic test. The ratio of the response to one truck to the response to two trucks was expected to be about 71 percent due to the load distribution between the two trusses.
