**Historic Stillwater Lift Bridge
Management Plan and Repair Project**

Character-Defining Features

Lift Bridge Condition

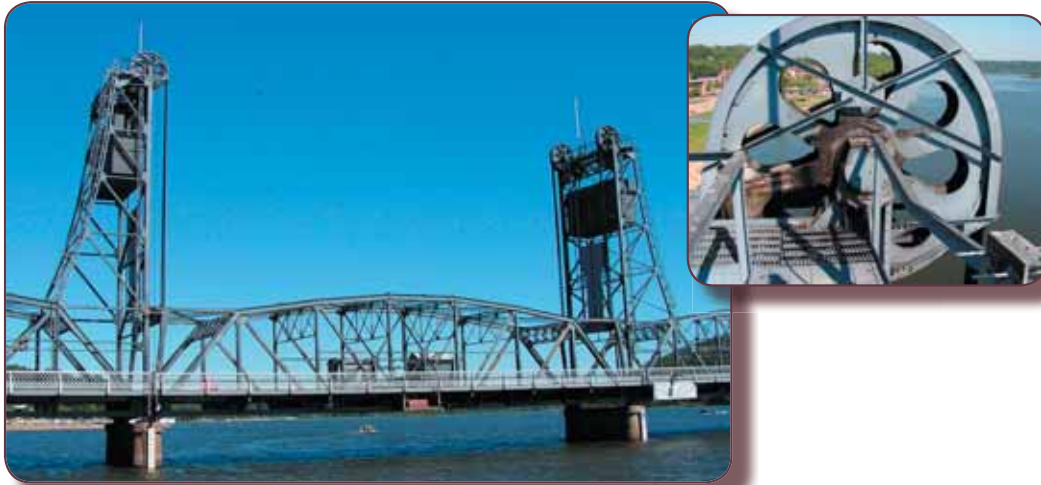
1. Vertical lift span and details.

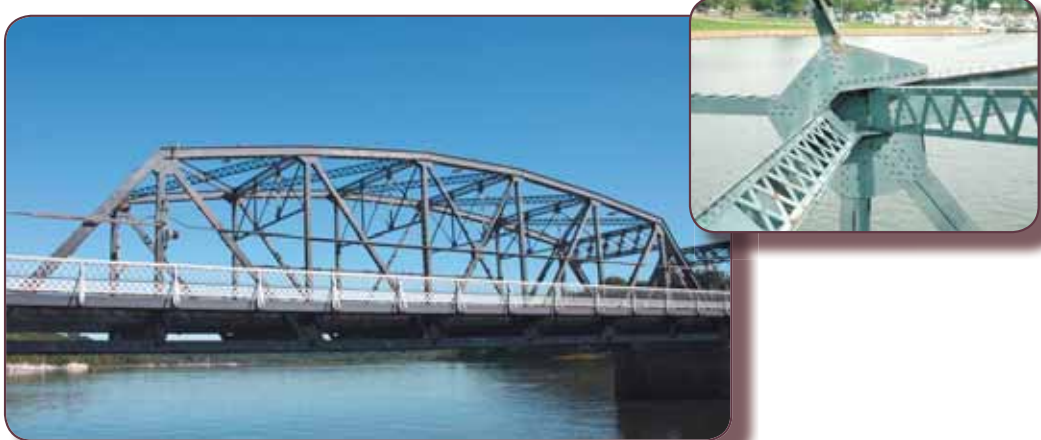
2. Parker truss spans and details.

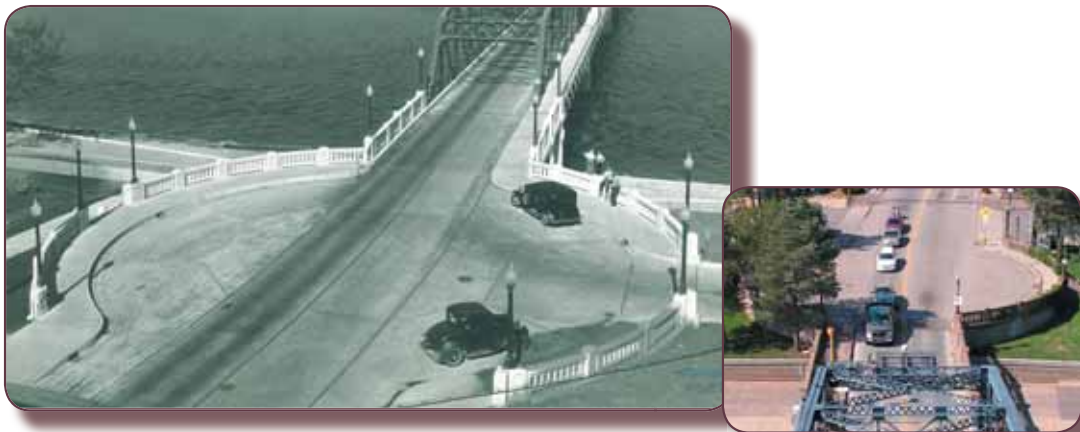
3. Concourse, spans 1 and 2.

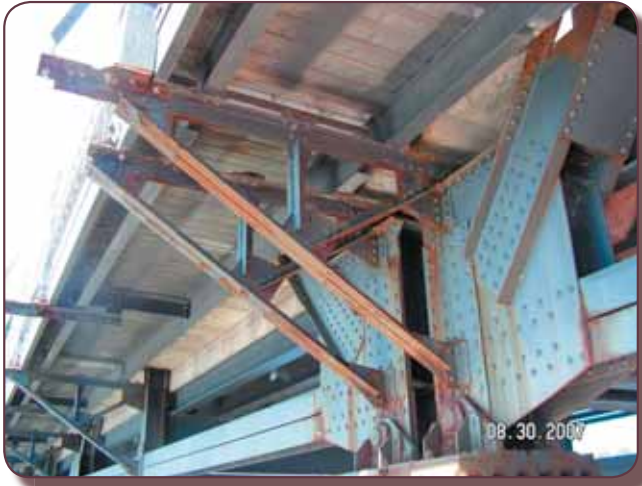
Corroded Sidewalk Support Bracket

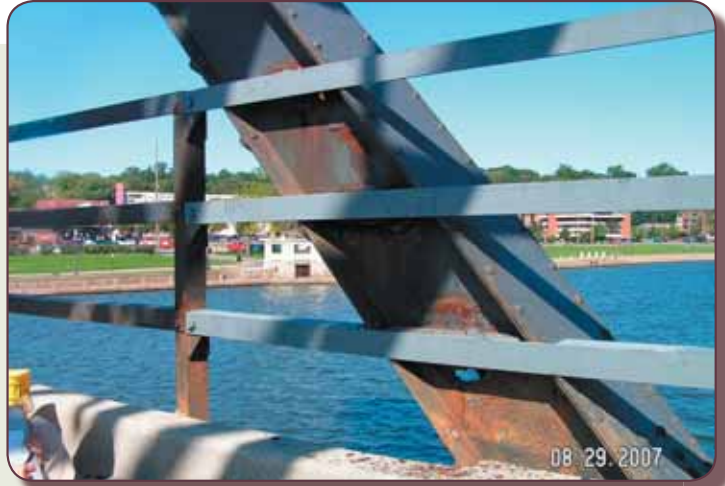
Truss, Portal Member—Steel Section Loss

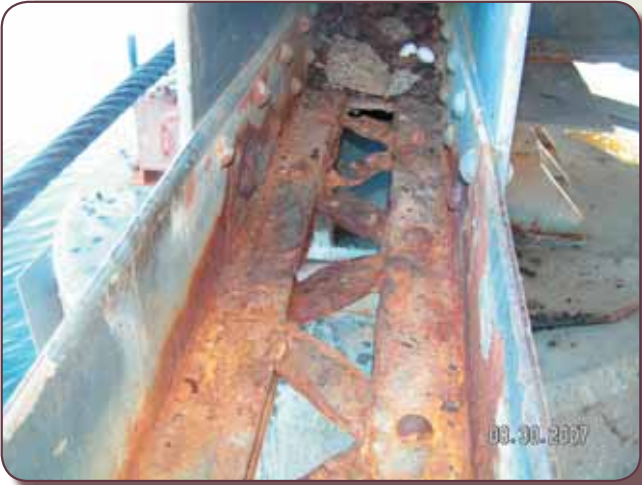
Corroded Areas of Lower Truss Chord

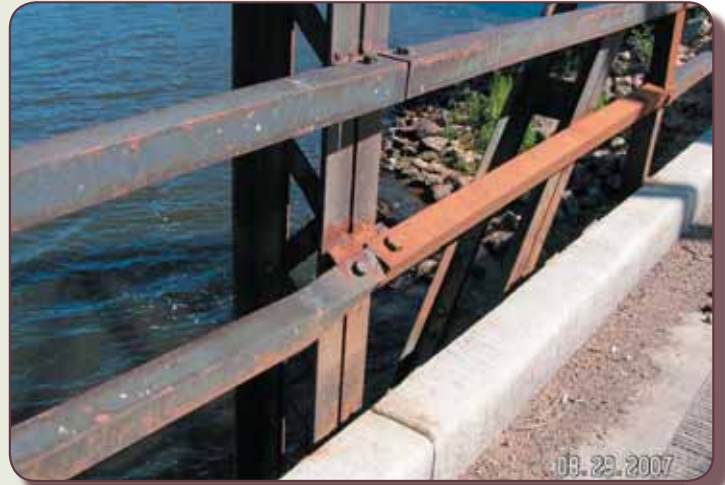
North Railing—Bent and Corroded Members

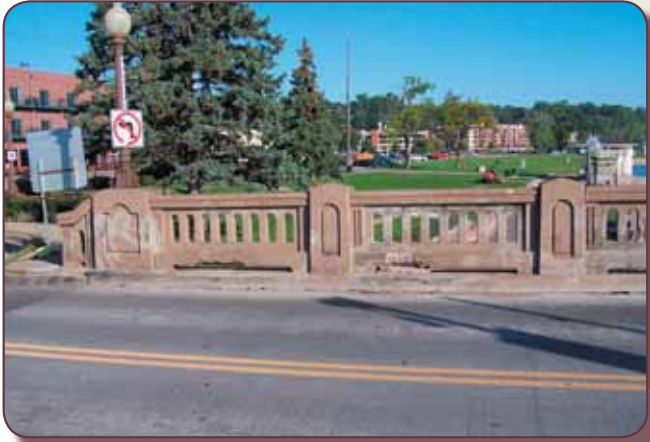
Span 1 Ballustrade—Concrete Spalling

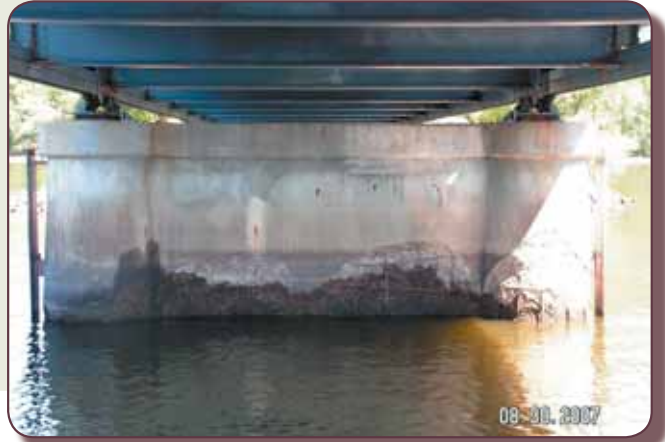
Pier 8—Concrete Deterioration

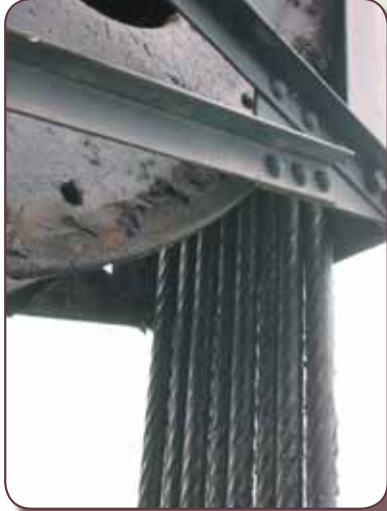
Worn Counterweight Cables

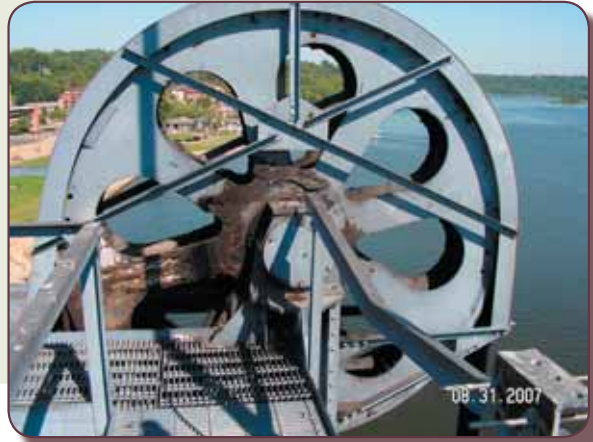
Counterweight Sheave

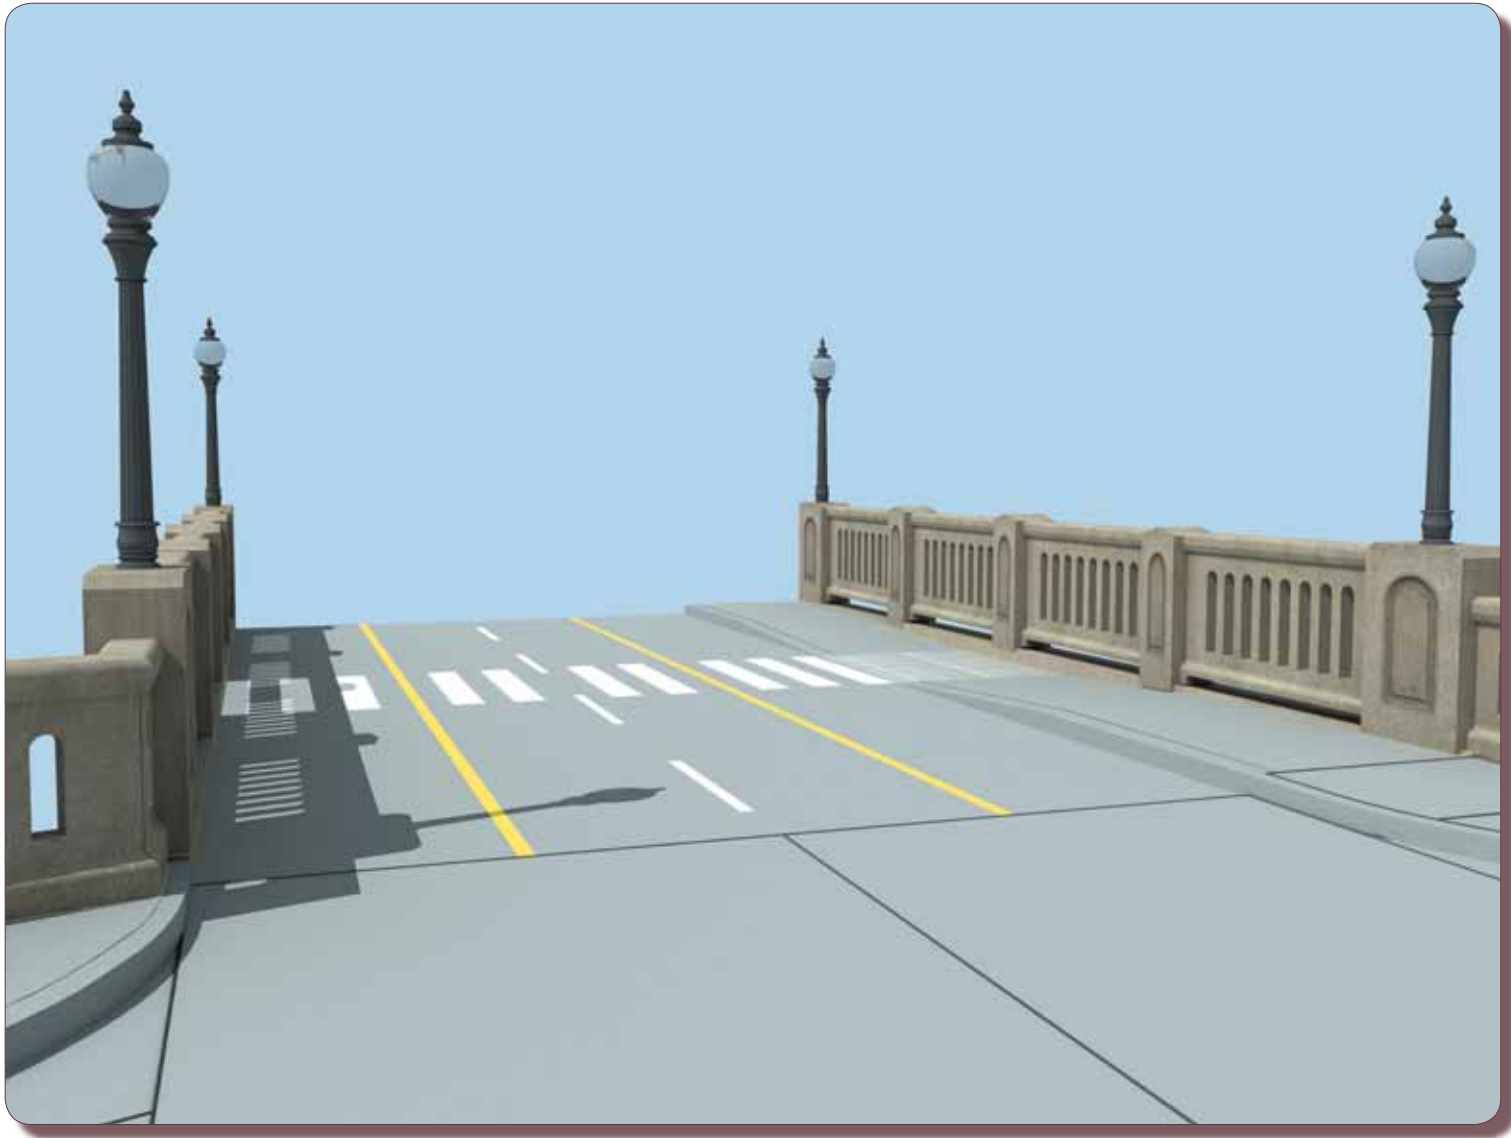
Approach Span View

South Sidewalk Lowering Visualization

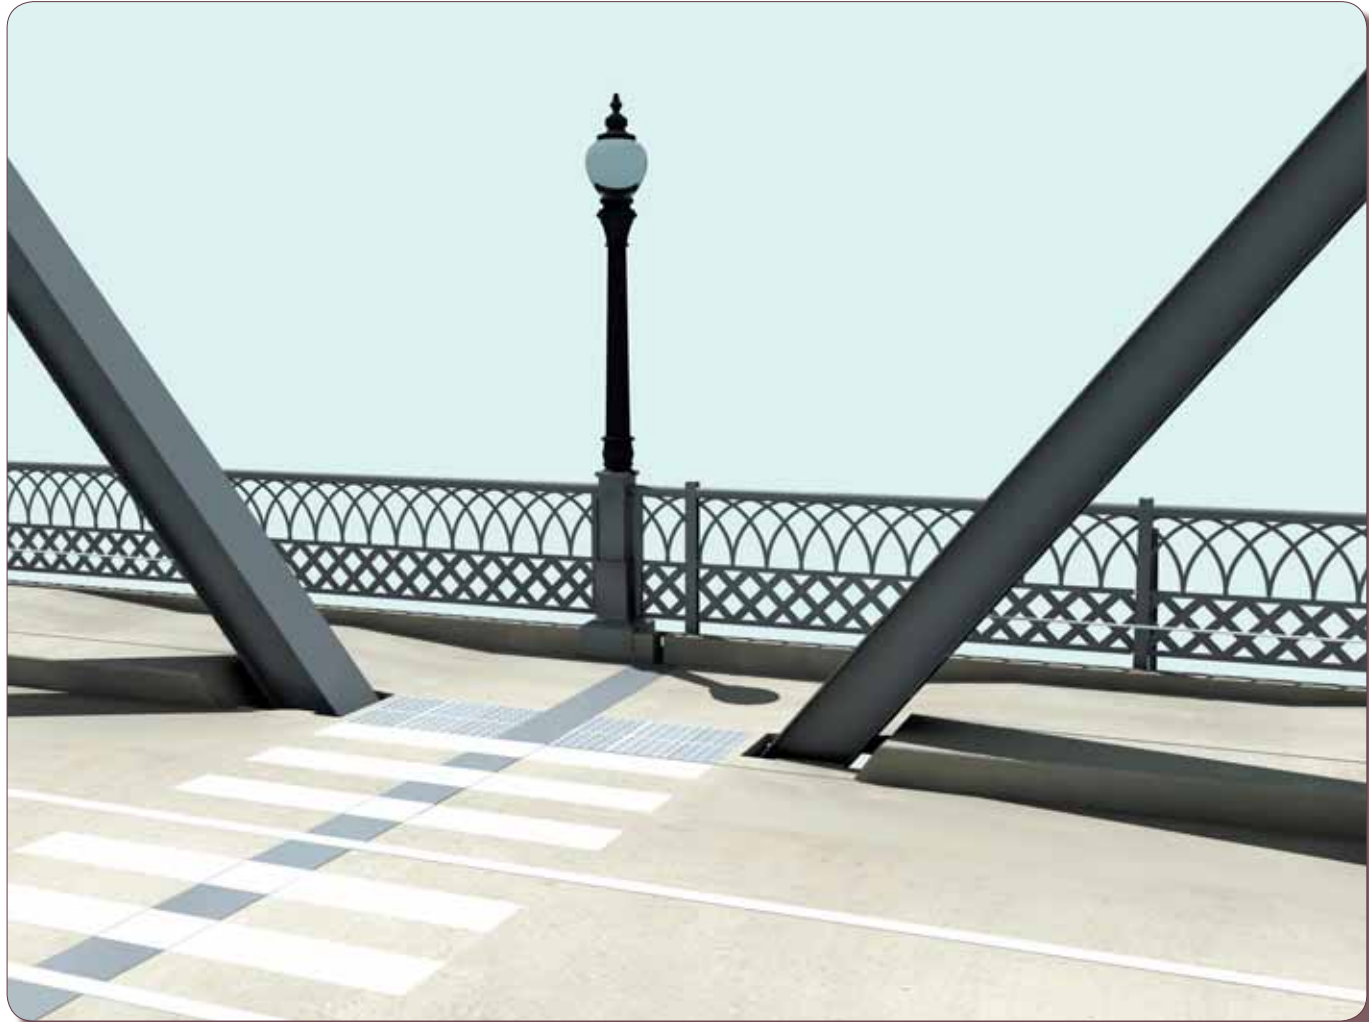
Deck View

South Sidewalk Lowering Visualization

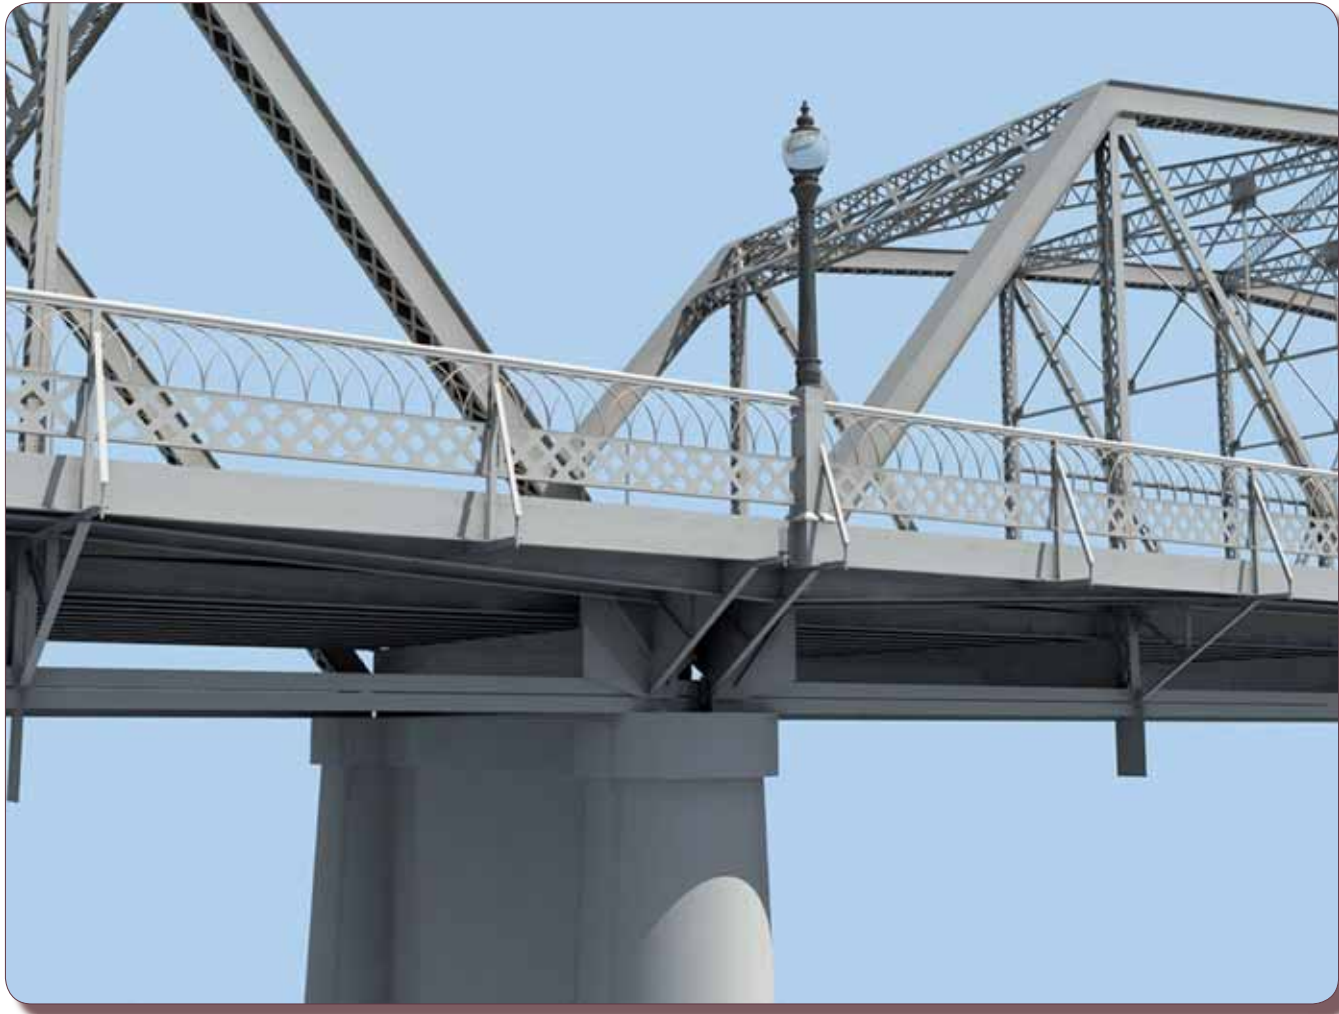
River View

South Sidewalk Lowering Visualization

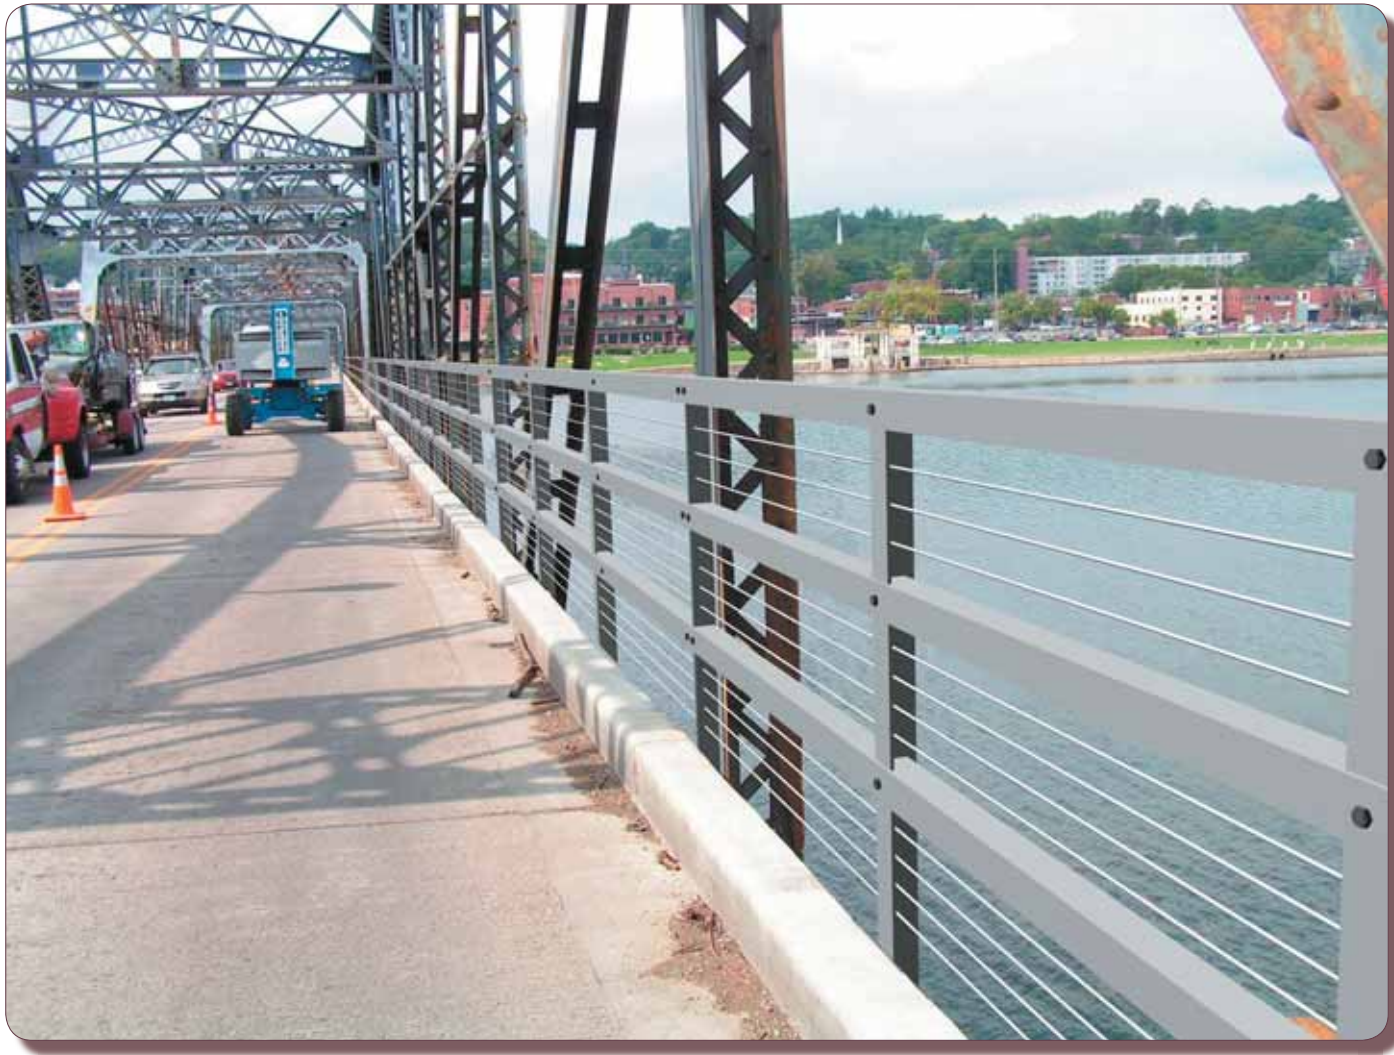
North Railing Visualization
