**2016 MnROAD/NCAT Cracking Group Construction
Weekly Construction Update
For the week of August 15, 2016**

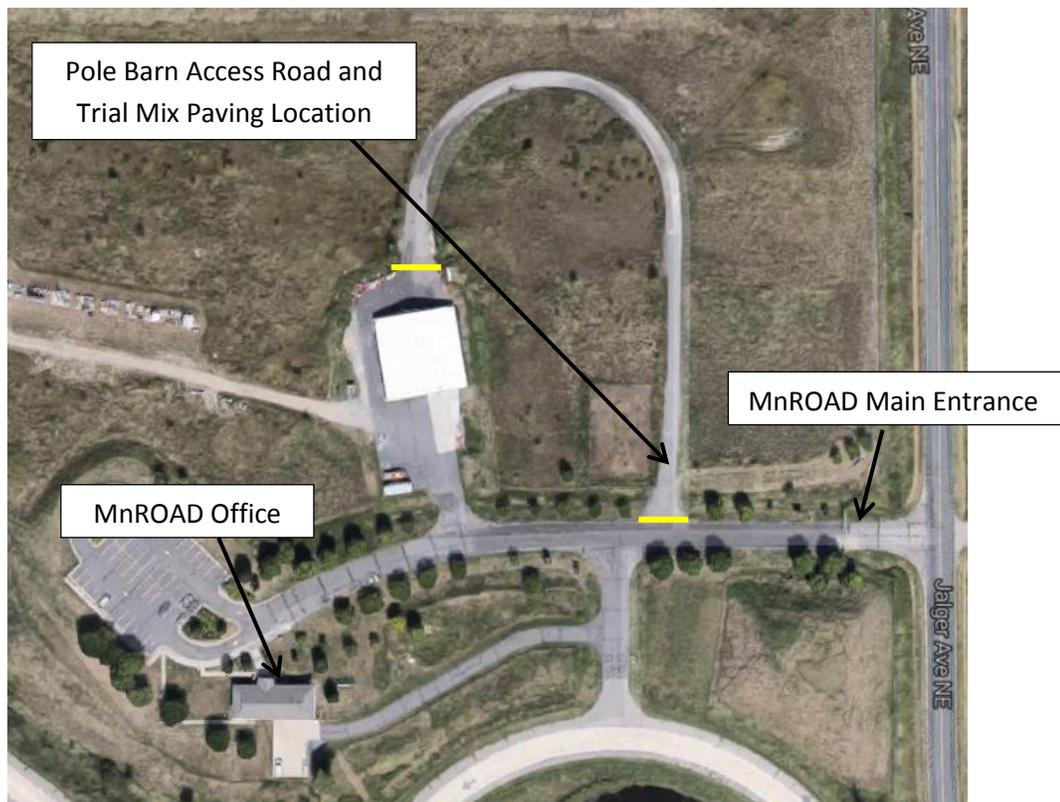
Figure 1: Trial Mix Paving Location

Thursday, August 18 was a busy day as it was the start of sensor installation in Cells 17 and 19, as well as the weekly construction meeting. An updated schedule was distributed at the meeting. The new schedule included sensor installation continuing through Monday, August 22, with trial mix paving and a pre-activity meeting for test section paving to occur on Tuesday, August 23. MnDOT personnel will prep the area of the access road behind the MnROAD pole barn for trial mix paving.

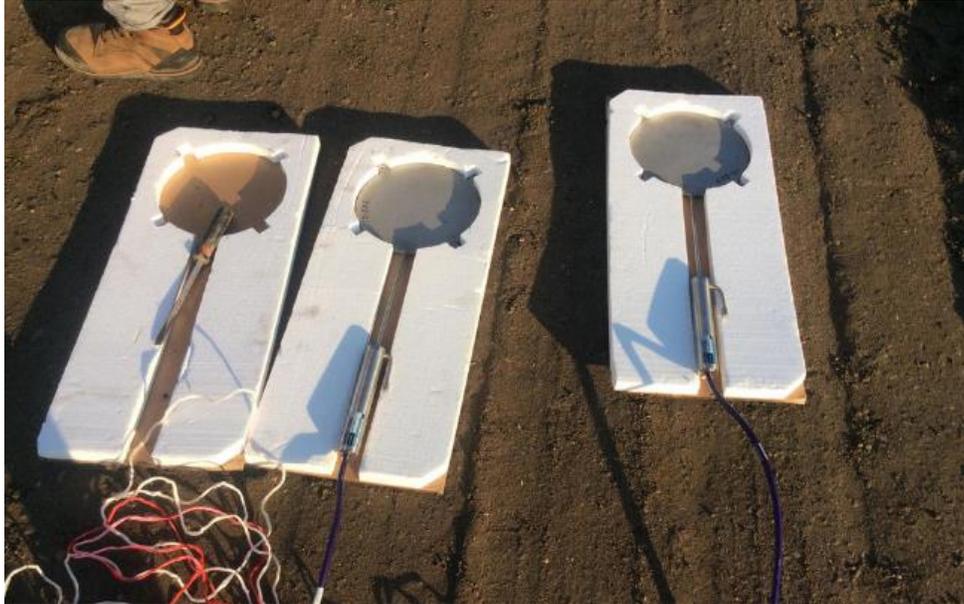
Figure 2: Organizing Pressure Gauges Before Installation

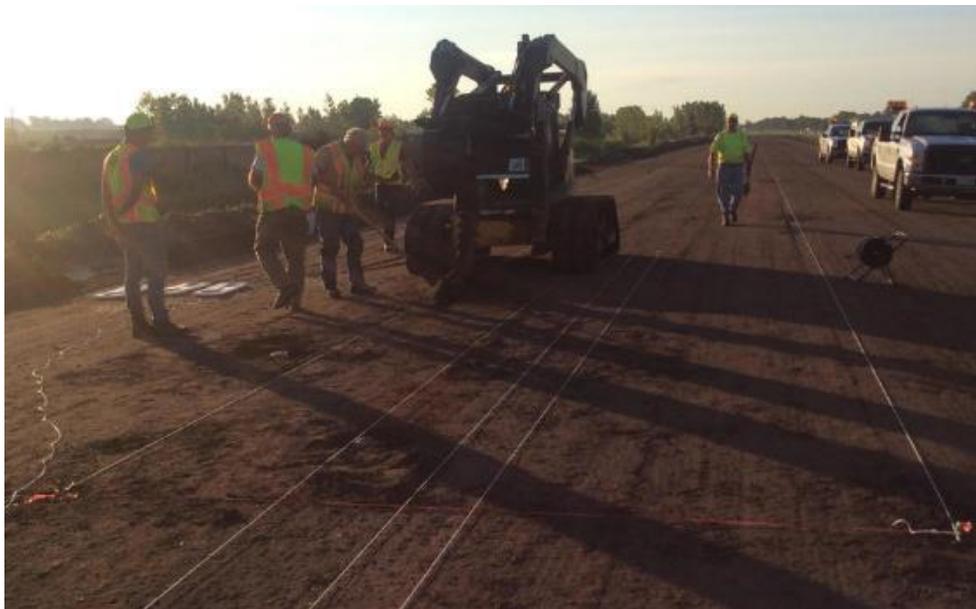
The first day of sensor installation began on Cell 17 by pulling a string line grid to establish the installation area. Locations for pressure gauge, thermocouple, and moisture sensor installation were then measured out and marked with spray paint. A trenching tool attached to the skid loader was brought in and used to cut areas where the pressure gauges would be installed.

Figure 3: String Line Layout and Trenching for Pressure Gauge Installation

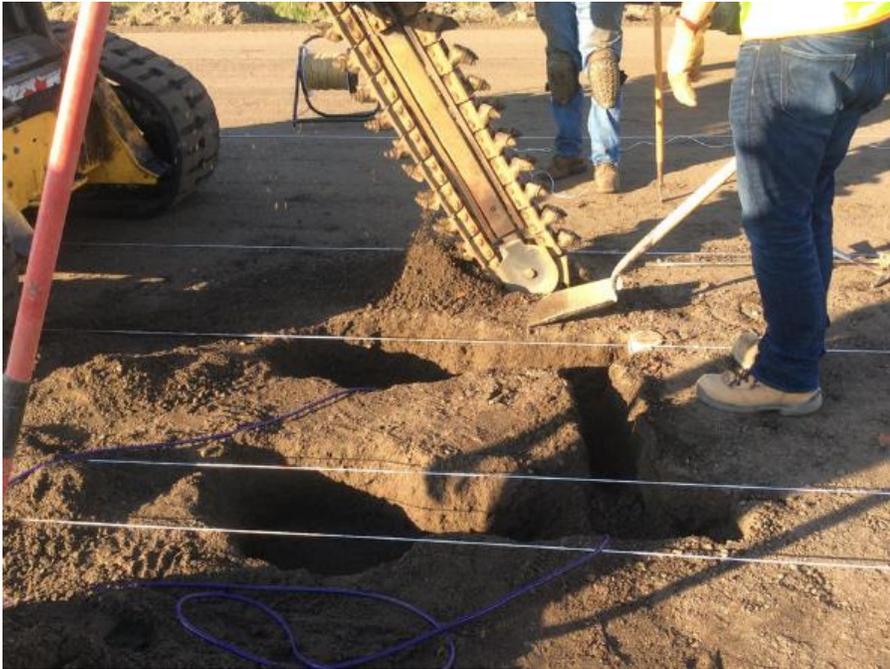
Figure 4: Pressure Gauge Installation

After trenching of pressure gauge areas, base material was sieved to obtain fine aggregate that would be used to level pressure gauges in both lateral and transverse directions. Pressure gauges in Cell 17 were installed 10.5 inches to top of base, while gauges in Cell 19 were installed at 10.75 inches to top of base. After pressure gauges were found to be level, additional sieved material was brought in several lifts and hand tamped. Holes were also drilled into the in-place conduit for pressure cell wires to be pulled into each Cell's respective vault.

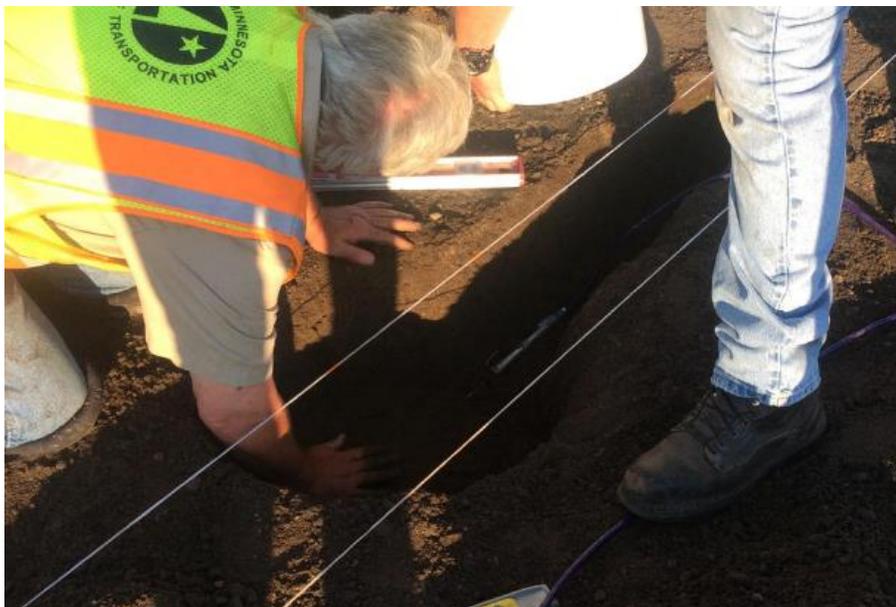
Figure 5: Levelling of Pressure Gauge

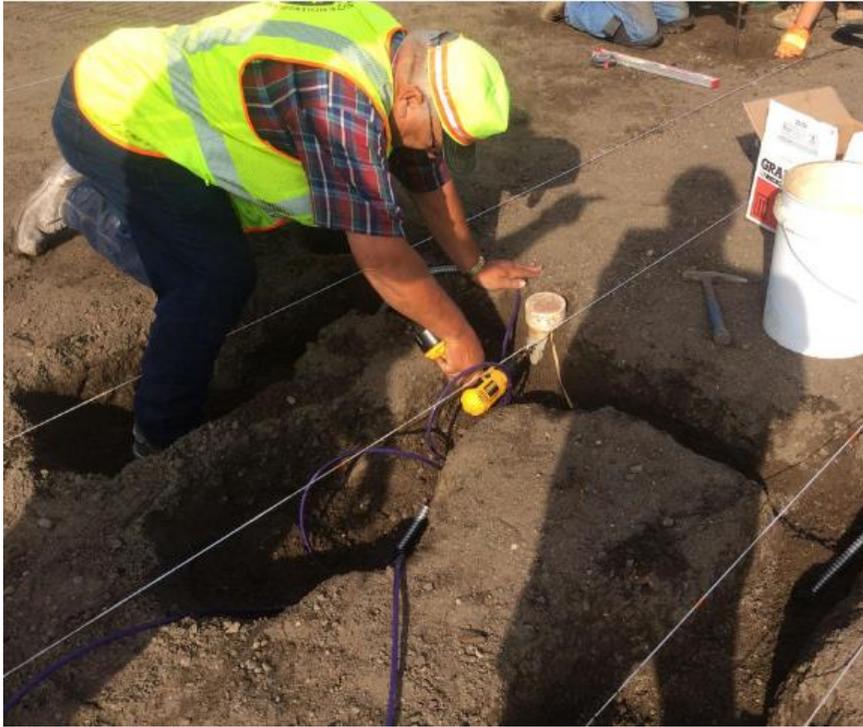
Figure 6: Drilling Hole into Conduit

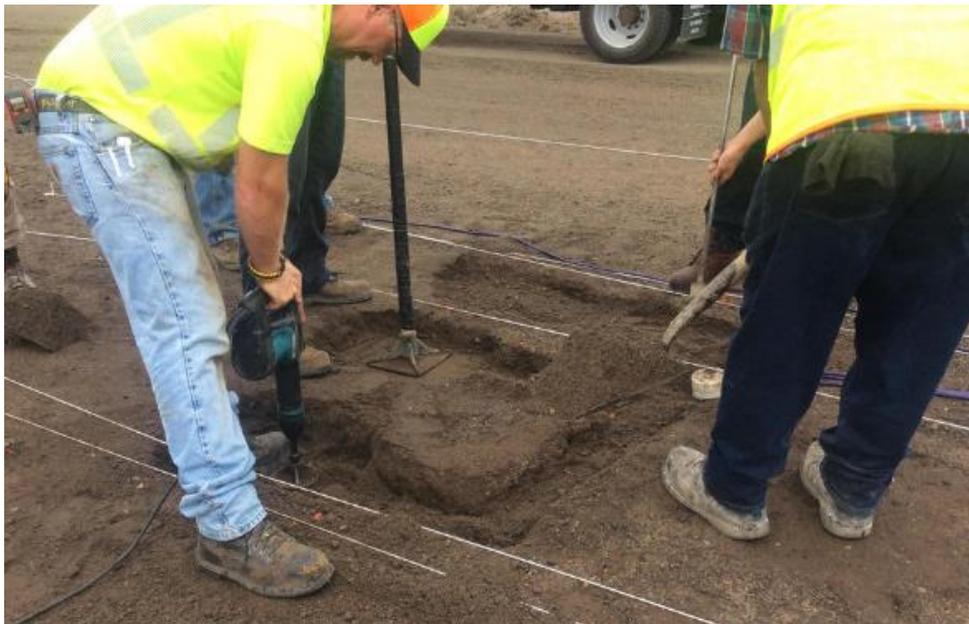
After gauges were installed and hand tamping was finished, a mechanical tamper was used to ensure good compaction above all pressure gauges.

Figure 7: Compaction of Base Above Pressure Gauges

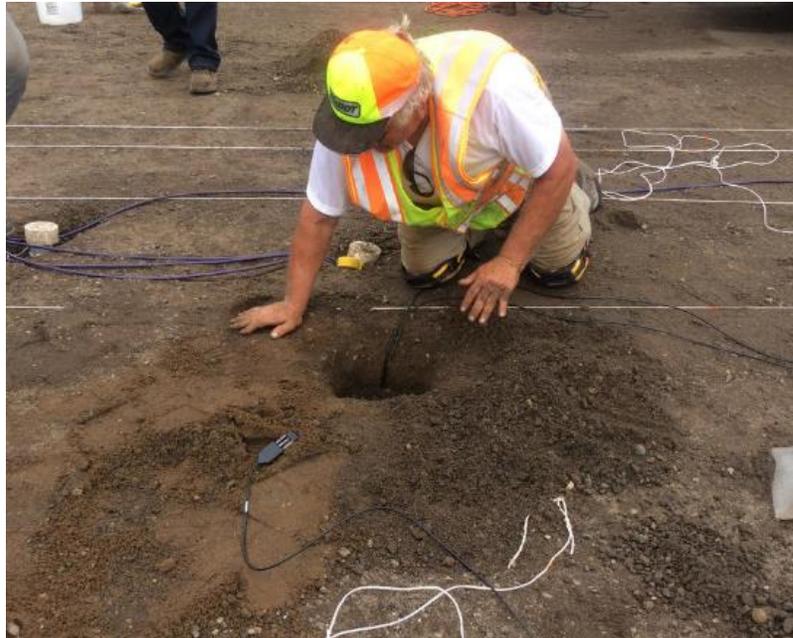
While pressure gauge installation was happening, an auger was brought in for both moisture sensor and thermocouple installation. Moisture sensors were installed at 2 locations in Cells 17 and 19 at 3 different depths. Two thermocouples were also installed in both cells, with one extending from bottom of HMA into the existing sub-grade, and the other extending from the HMA to the top portion of Class 6 aggregate base.

Figure 8: Moisture Sensor Installation

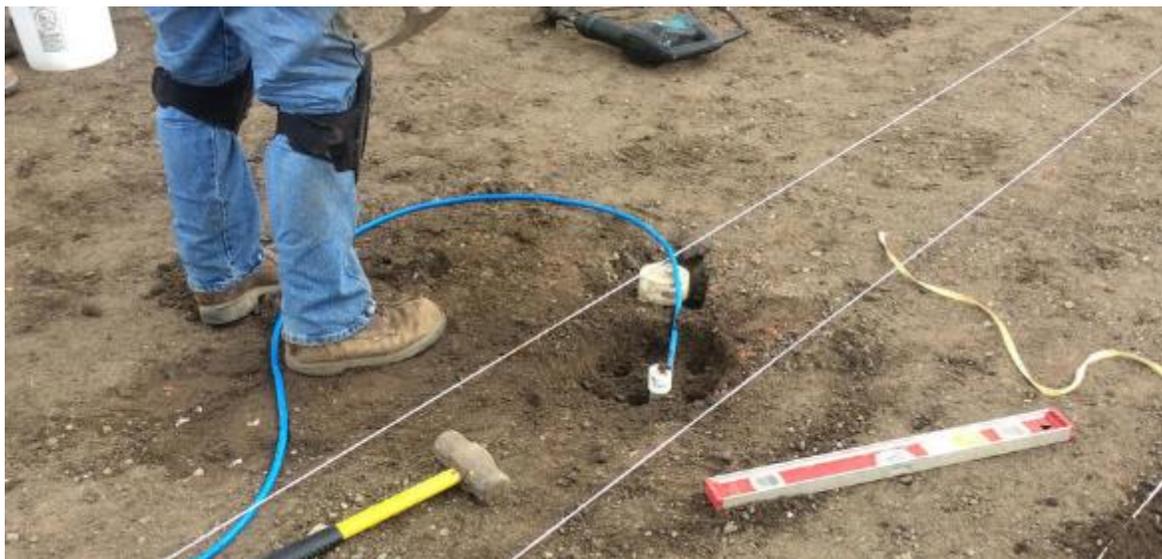
Figure 9: Thermocouple Installation

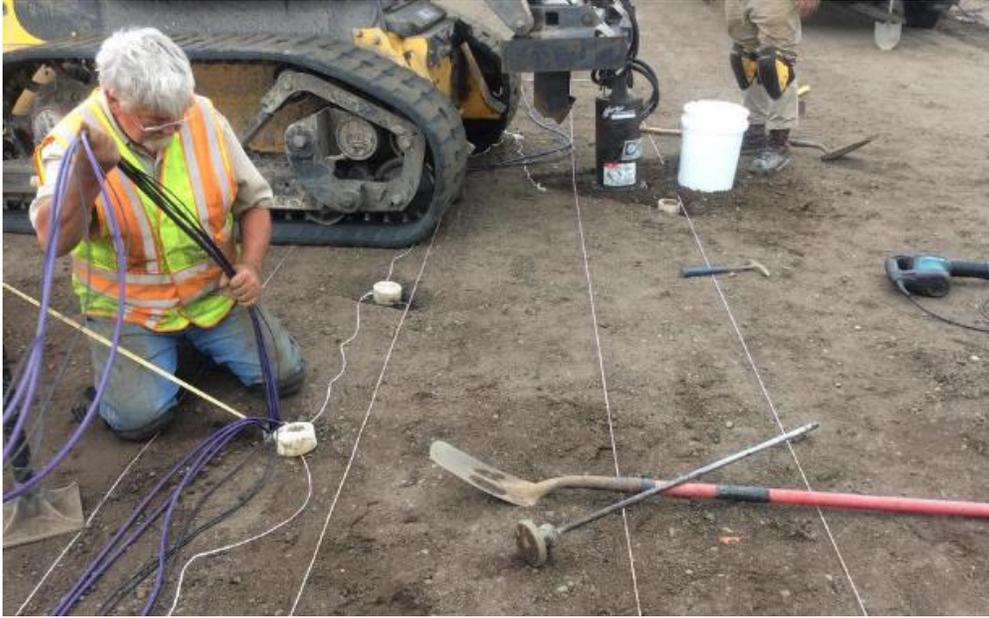
Once all sensors and gauges were installed, wires were pulled from their respective conduit locations into the vault. It was critical to keep all wires labeled, organized, and straight during this process to avoid getting caught in the conduit. Thankfully this process went smoothly and all wires were successfully pulled from the installation area to the vaults, and finally to the hand holes located near the Cell cabinets.

Figure 10: Placing Wires into Conduit

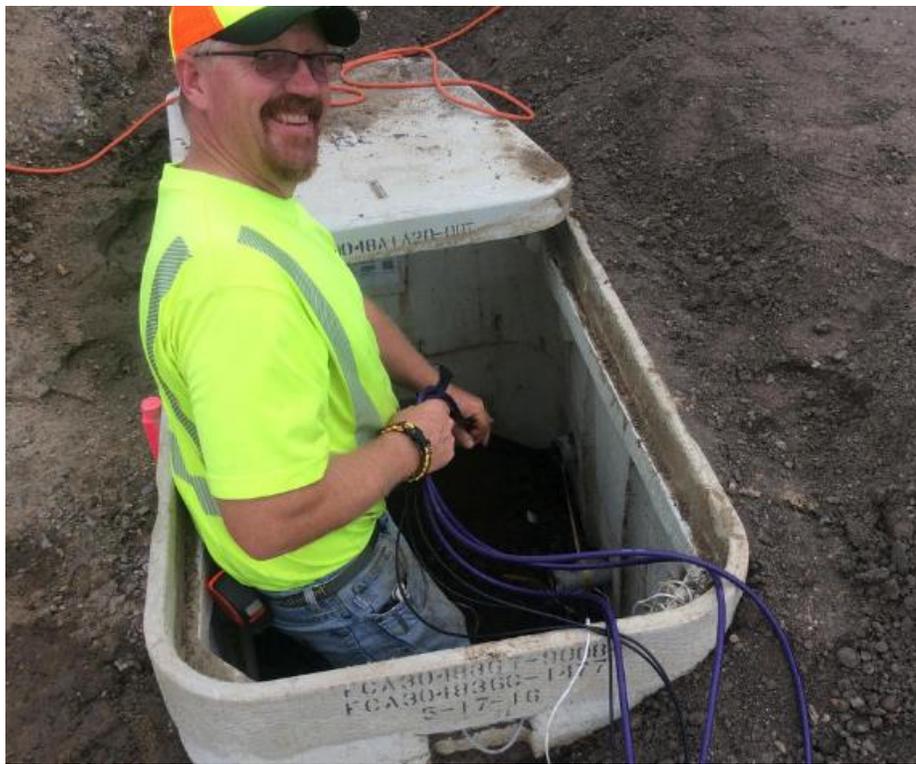
Figure 11: Pulling Wires from Conduit into Vault

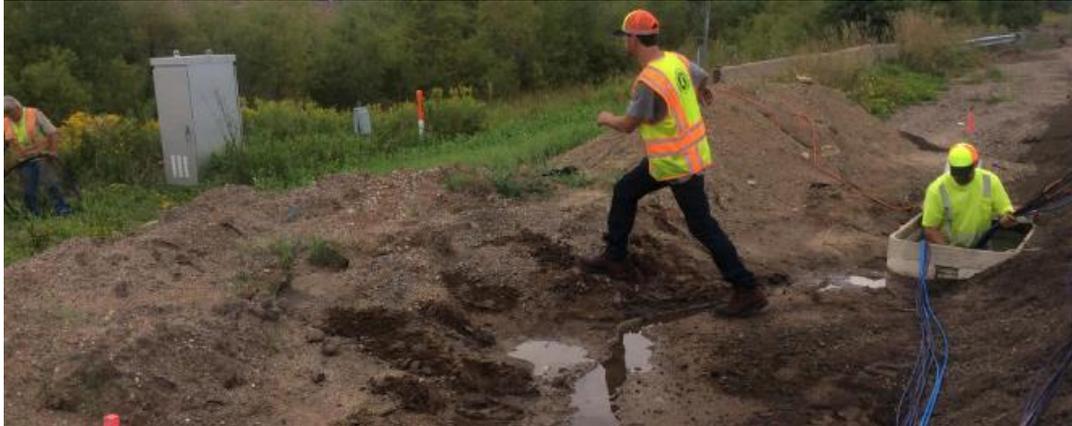
Figure 12: Pulling Wires from Vault to Hand Hole

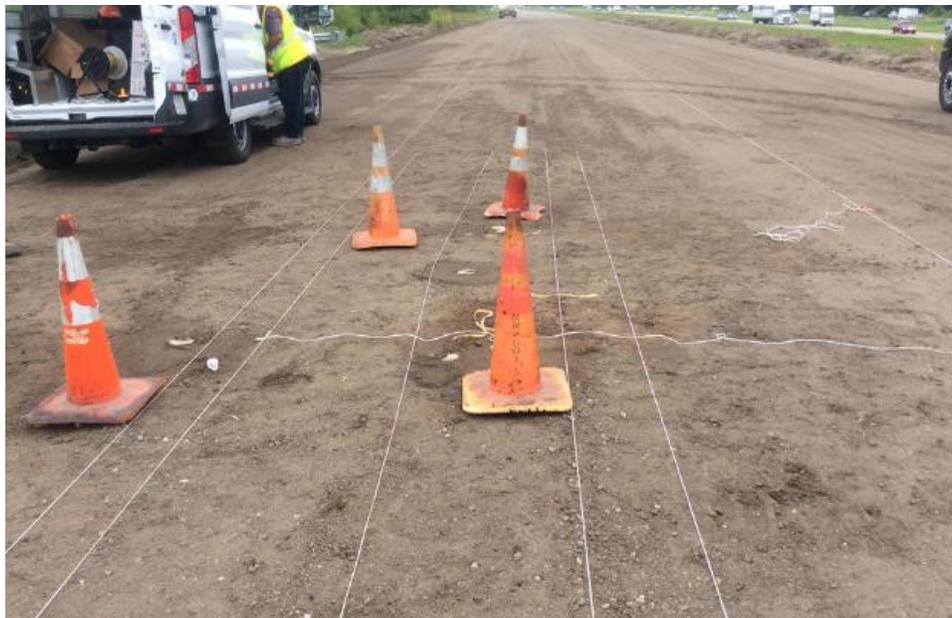
Cones were placed around completed sub-surface sensor and gauge installation areas in Cells 17 and 19 to ensure no equipment would disturb instrumentation before strain gauge layout and paving.

Figure 13: Completed Sub-surface Sensor Installation in Cell 19

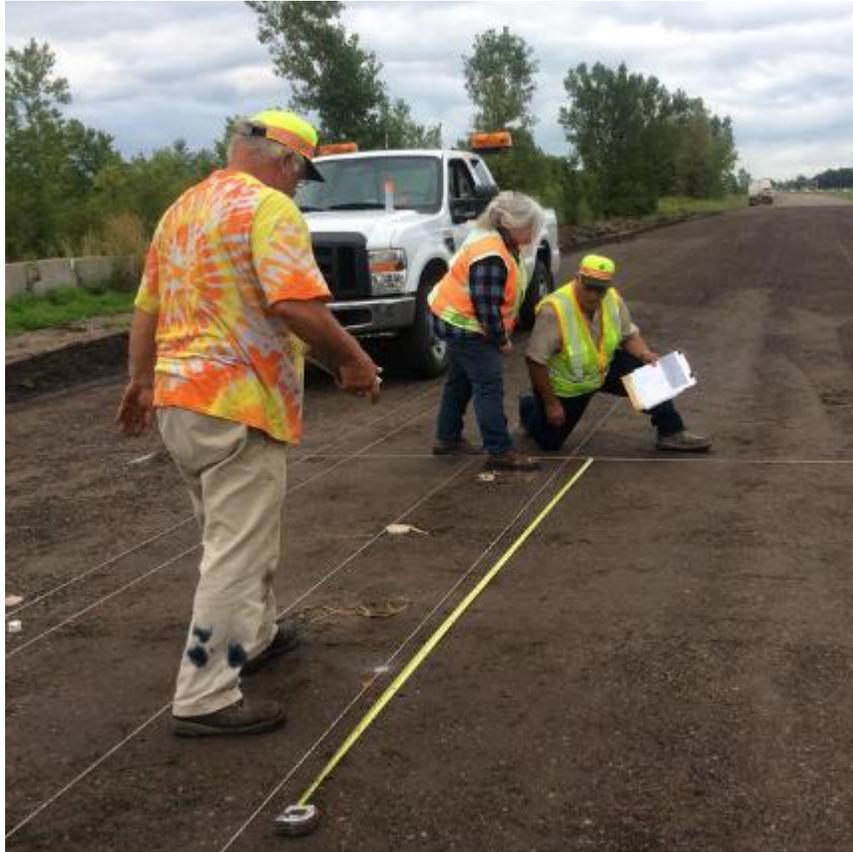
Work on Friday, August 19 consisted of organization and placement of strain gauges in Cell 19. There are a total of 15 strain gauges that will be placed in Cell 19 with 9 in the longitudinal direction and 6 in the transverse.

Figure 14: Marking Strain Gauge Locations

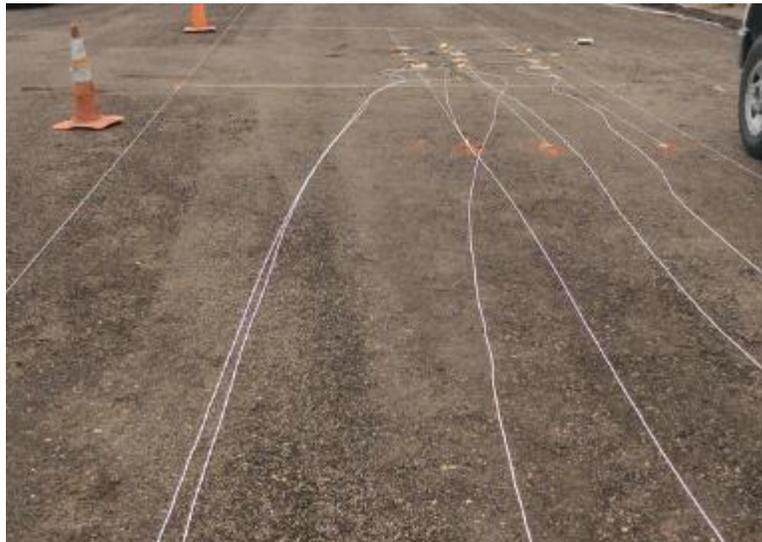
Figure 15: Unrolling of Strain Gauge Wires

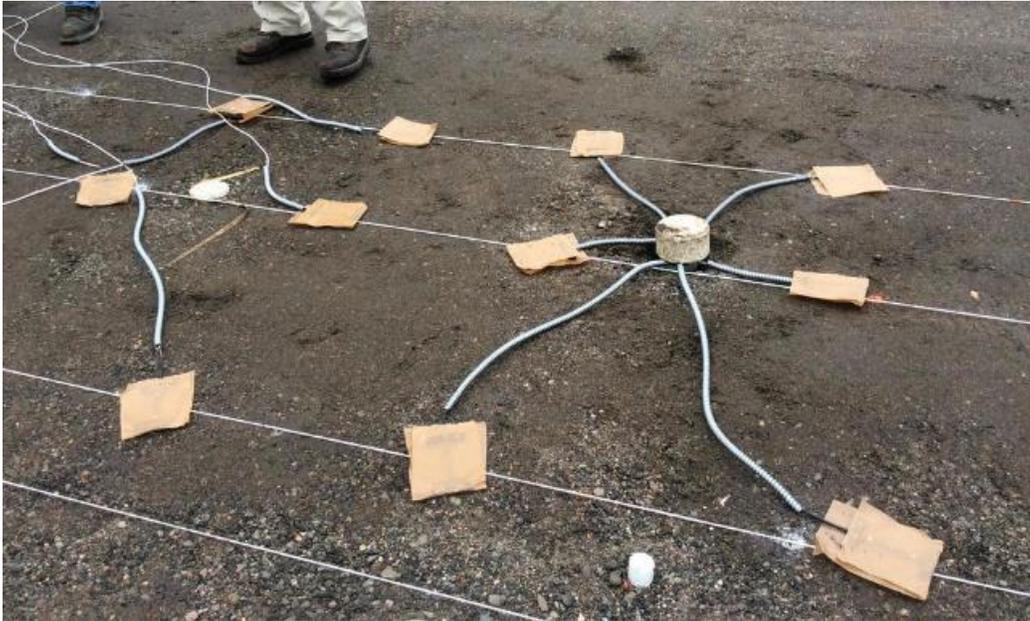
Figure 16: Strain Gauge Wires Placed in Conduit and Pulled to Vault
