Asphalt Aging and its Impact on the Timing of Preventive Maintenance

Mike Anderson

Asphalt Institute

19th Annual TERRA Pavement Conference

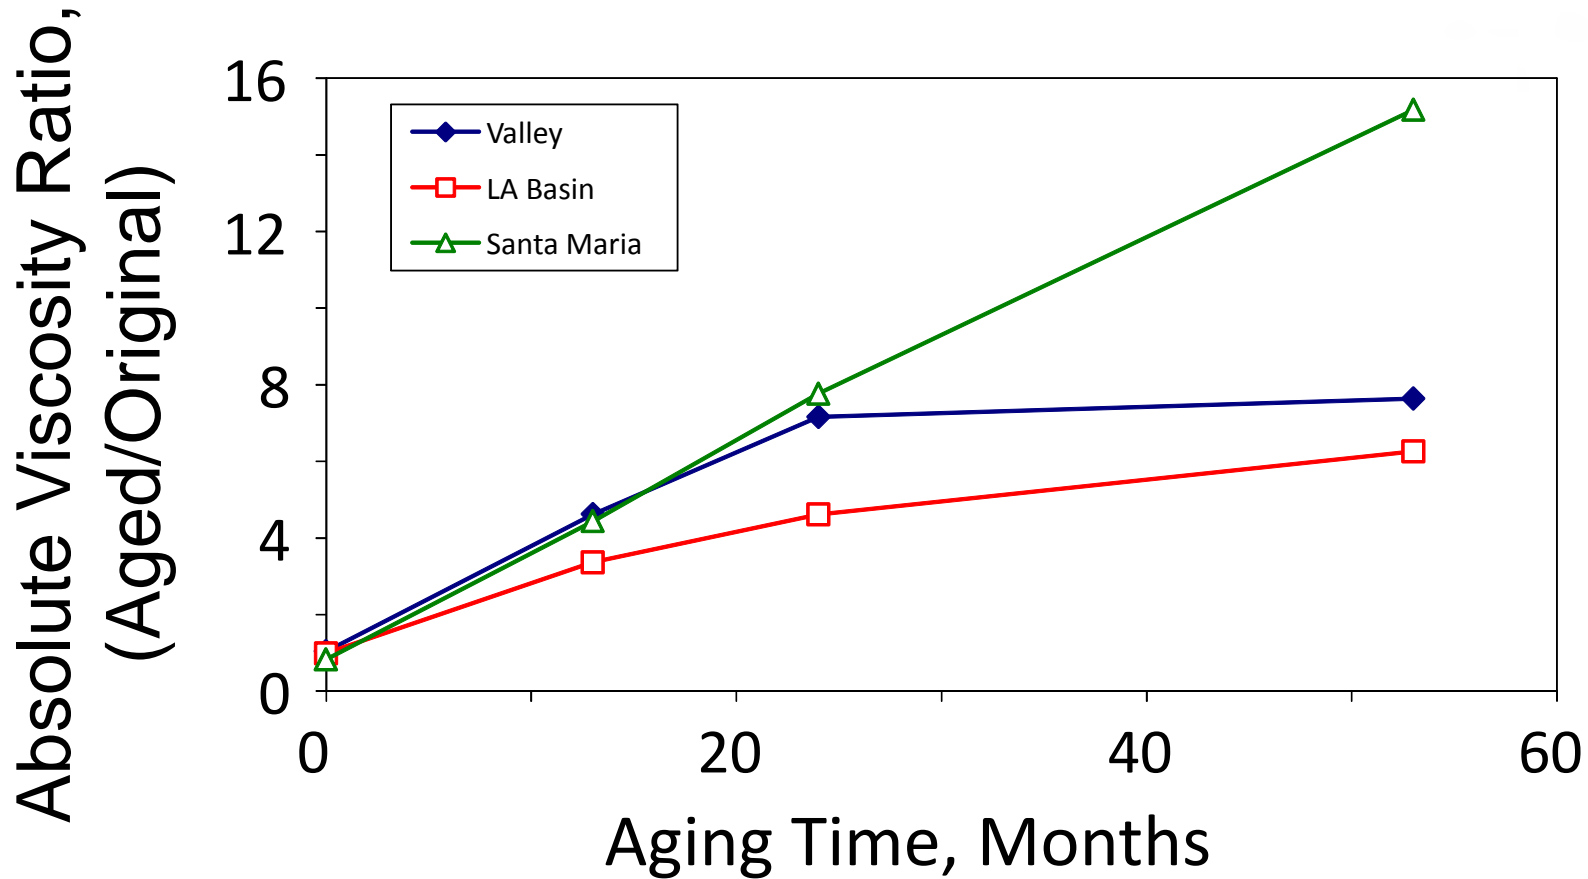
1981 CA Durability Study

Kemp, et.al.

Sacramento (62.9C), 7-9% Air Voids, Non-Absorptive Aggregate

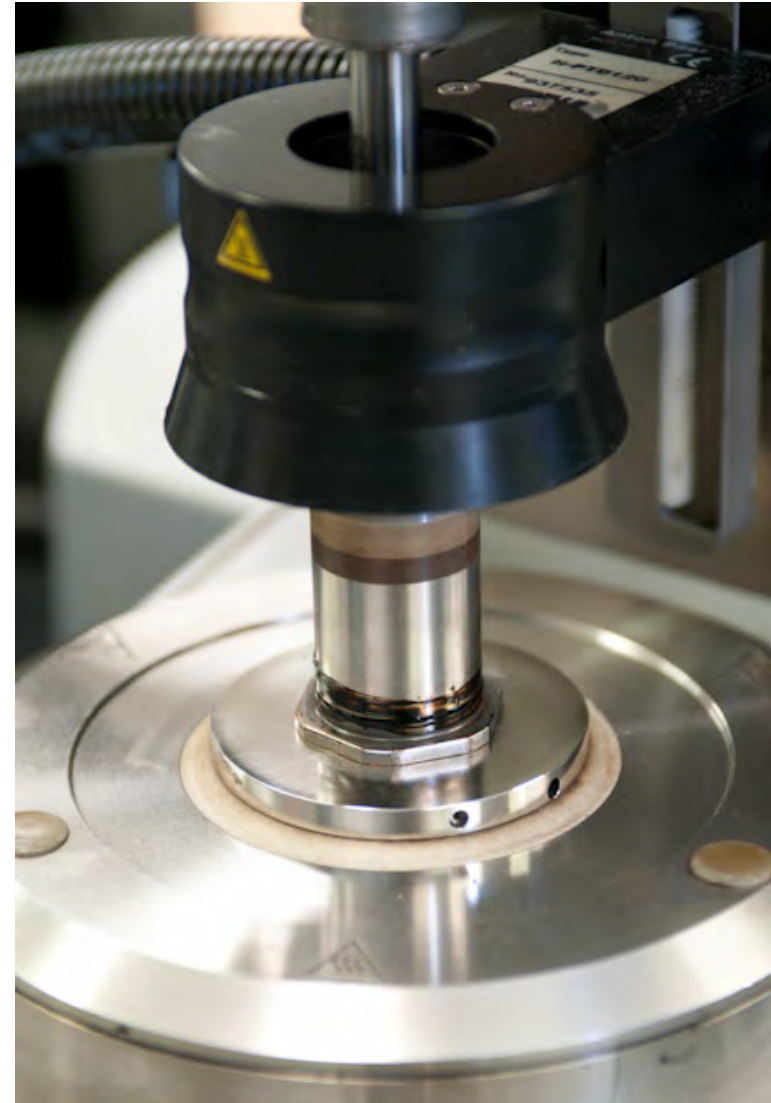
Dynamic Shear Rheometer

- Mastercurve at 15°C
 - 8-mm parallel plate
 - 5, 15, and 25°C
 - Frequency sweep (0.1 to 100 rad/s)
 - Obtain Texas A&M parameter at 0.005 rad/s
 - $G' / (\eta' / G')$
 - Related to ductility at 15°C and 1 cm/min.

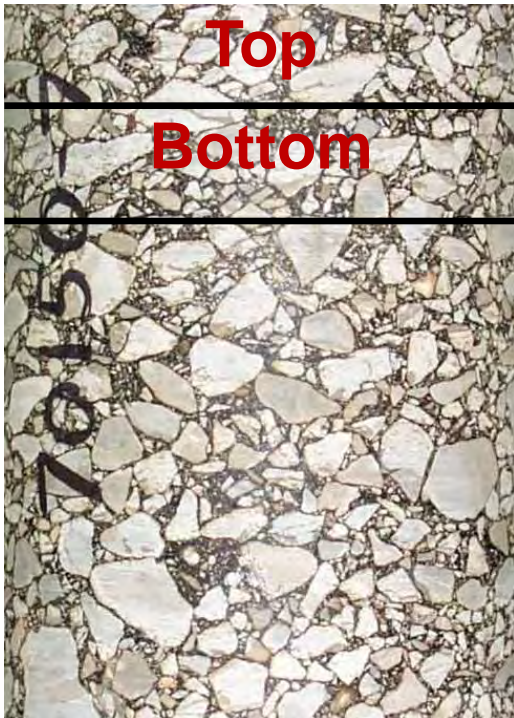
- Cores
 - Remove chip seal (if any)
 - Cut into two 25-mm layers
 - Test for fracture energy (cracking potential)
 - Recover component asphalt to check aging
