Concrete Repair Best Practices: A Series of Case Studies

Final Report

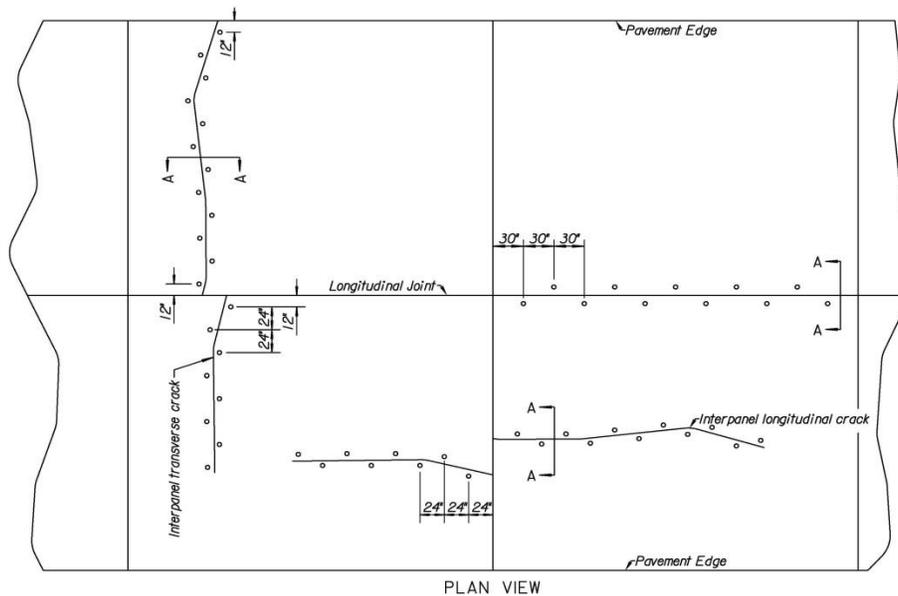
Figure 1. Kansas DOT, concrete pavement details, cross-stitching of joints and cracks.

Figure 1 shows a diagram of the Kansas cross-stitch specification standard for different joints and cracks, as summarized above. Figure 2 shows a diagram of the actual cross-stitching bar with various dimensions. Note that the goal is to place the tie bars at mid-depth of the slab.

The Kansas cross-stitching design is specified in Kansas DOT “Concrete Pavement Details, Tiebar Insertion RD723” (see Figure 1 and Figure 2). Holes are drilled on alternating sides of joint or crack at the following spacing:

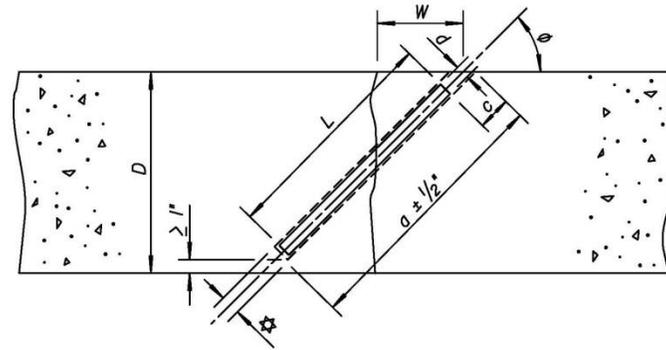
SECTION A-A
TIE BAR INSERTION DETAILS

☆ Drill diameter will be not less than $\frac{1}{4}$ " larger than the tie bar diameter and no more than $\frac{3}{8}$ " larger than the tie bar diameter.

Note that all of the dimensions depend on slab thickness. Thus, it is important to determine the slab thickness, as this will directly affect the length of the rebar required in the hole, the angle with the horizontal and other dimensions. This is an interesting rebar design specification in that it provides increased reinforcement to help ensure that the most critical crack/joint is held tightly together, providing strong reinforcement to maintain a very tight joint or crack and even good load transfer under heavy truck wheels.

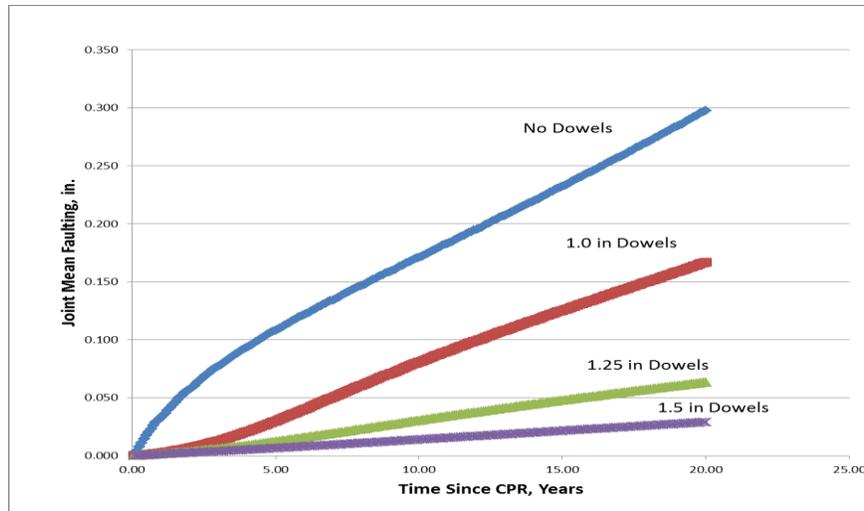
One tool that is now available to predict future joint faulting after an existing JPCP has been diamond ground is the AASHTOWare Pavement ME Design software. The “Restoration” pavement type must be chosen and the required data entered to run the program to estimate mean joint faulting over the next 10 to 20 years. Figure 3 shows the projected joint faulting for a JPCP over a future 20 years, both with and without DBR of varying diameters. This is a valuable tool to provide another estimate of what will happen if no dowels are installed versus a full DBR installation with varying diameters. Figure 3 shows the potential for extra life until critical faulting is reached. Note the impact of dowel diameter on mean joint faulting, which is due to lower dowel/concrete bearing stress under load. The Pavement ME Design software also calculates slab fatigue transverse cracking and IRI, given the after-grind slab thickness.

Figure 3. AASHTOWare Pavement ME Design example output for a JPCP CPR grinding project, with and without DBR.

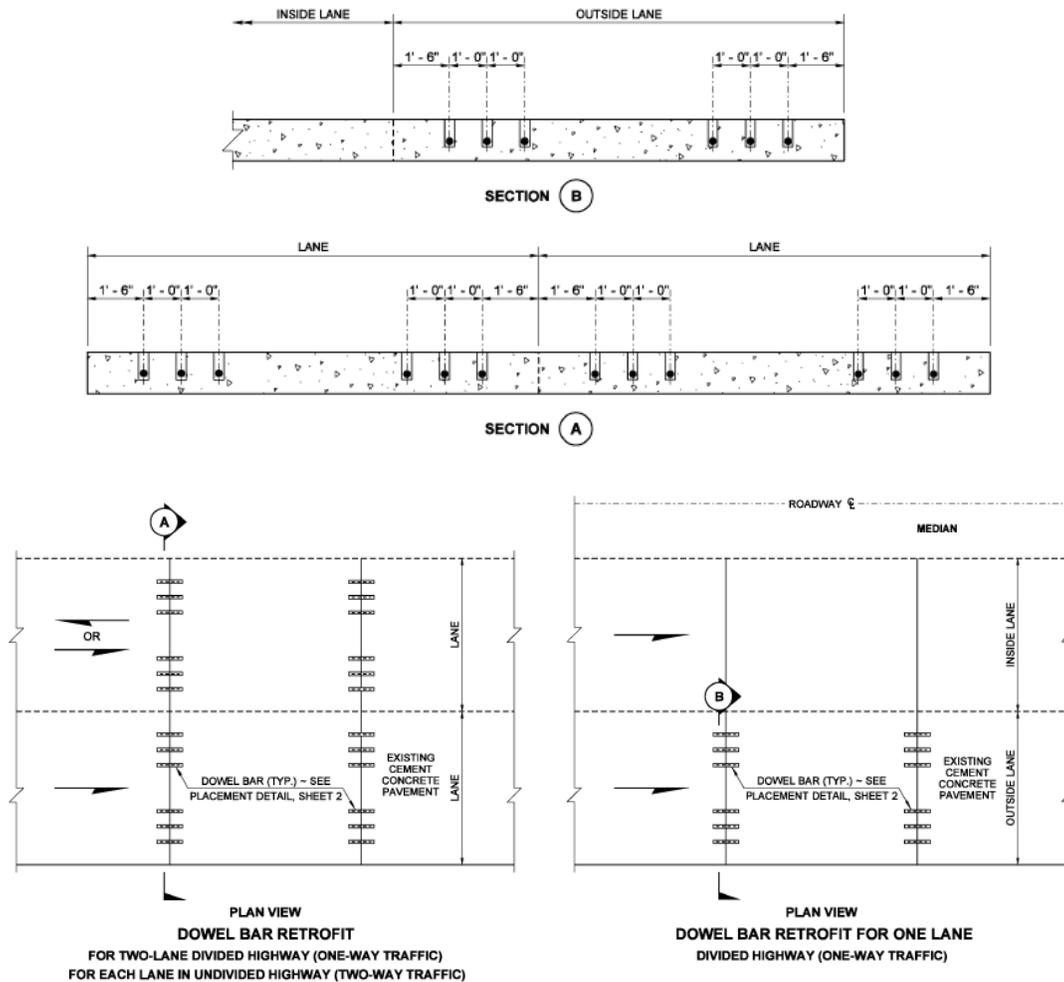
Figure 4. Washington State DOT DBR design and plan layout diagram for perpendicular joints. (Washington State DOT Standard Plan for DBR, A-60.20-03)

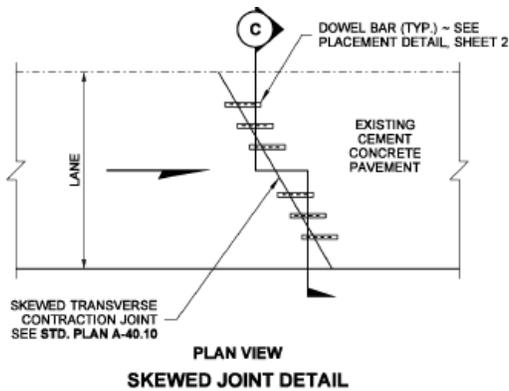
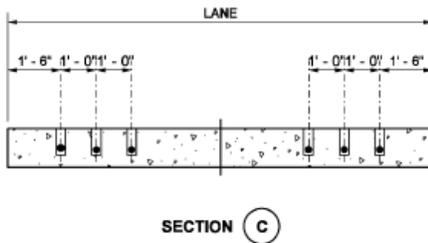
Figure 5. Washington State DOT DBR design and layout diagram for skewed joints.
(Washington State DOT Standard Plan for DBR, A-60.20-03)

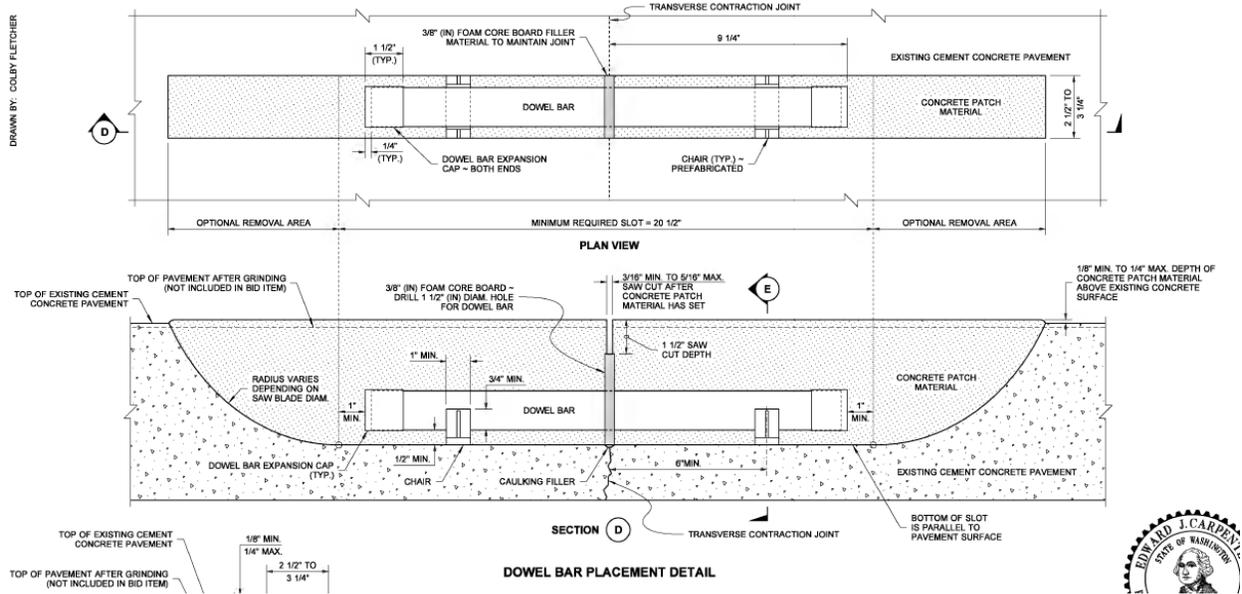
Figure 6. Washington State DOT DBR placement detail.
(Washington State DOT Standard Plan for DBR, A-60.20-03)

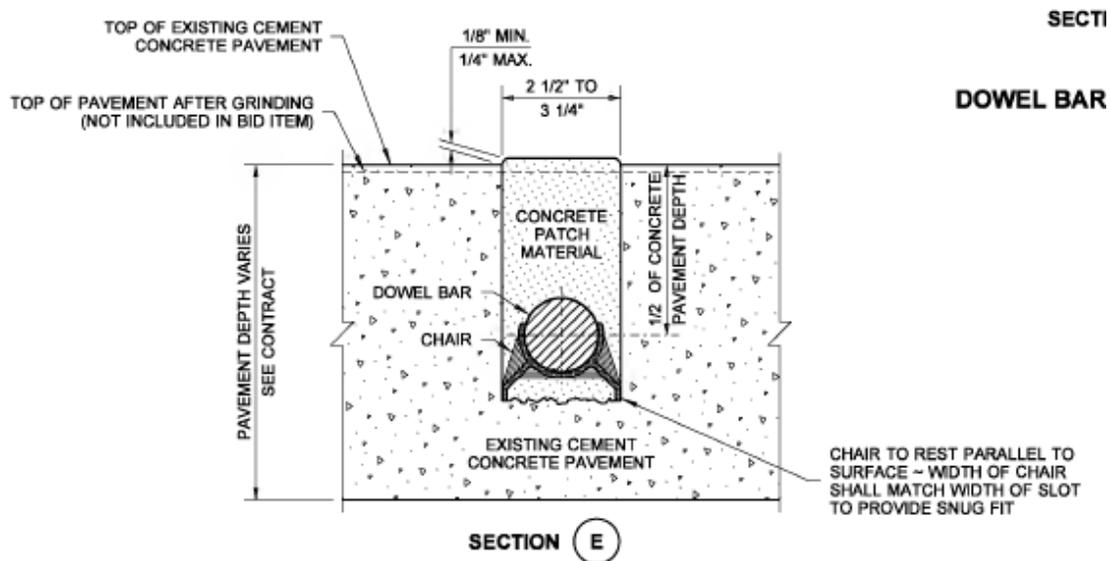
Figure 7. Washington State DOT DBR cross-section layout diagram.
 (Washington State DOT Standard Plan for DBR, A-60.20-03)

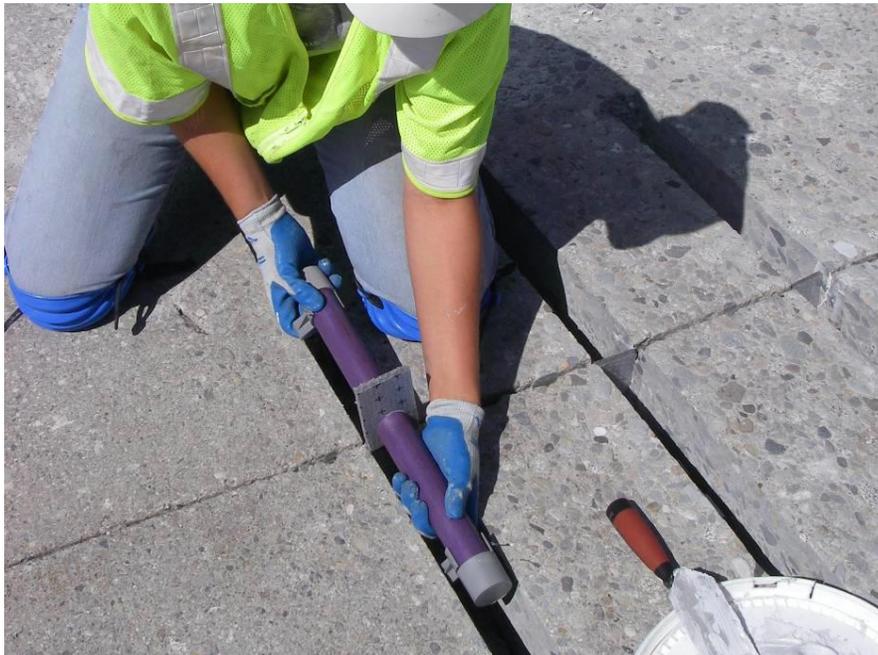
The lubricated dowel bar assembly is placed into the slot as shown in Figure 8. The assembly is placed in the center of the slot. Other States utilize a very similar approach to that of Washington.

Figure 8. Inserting dowel bar assembly into slot. (Photo Courtesy of Jeff Uhlmeyer, WSDOT)

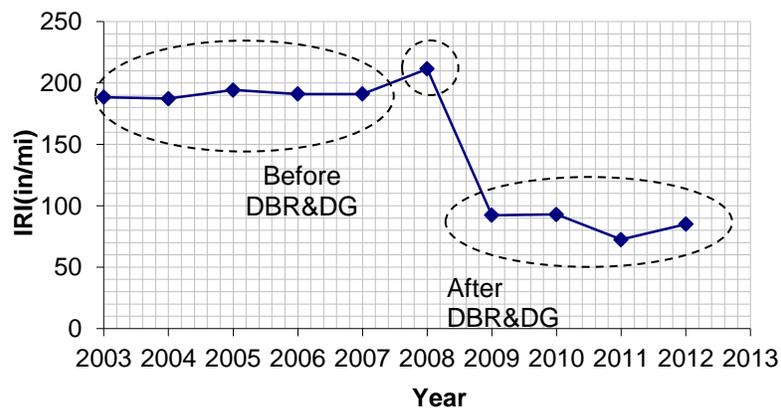
Figure 9. Texas US 69 JPCP diamond grinding (52% reduction).

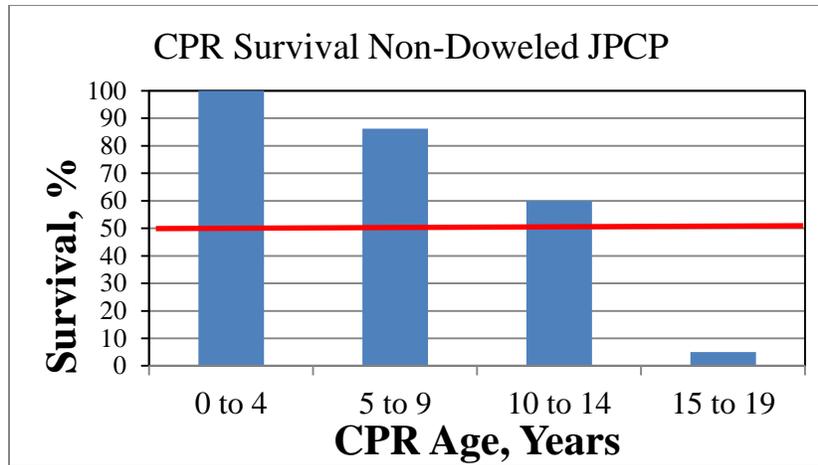
Figure 10 shows the results of a survival analysis of 60 diamond ground largely non-doweled JPCP (about 10 had received DBR). At 10 to 14 years, 60 percent of these diamond ground JPCP had received no CPR, overlays, or reconstruction, but from 15 to 19 years nearly all had received CPR, overlays, or reconstruction. Thus, the 50th percentile CPR survival age is approximately 15 years for these non-doweled JPCP. The faulting of these DBR projects is significantly lower, and they are expected to have a much longer life than those without dowel bars because faulting has not returned.

Figure 10. Survival analysis of diamond grinding of Utah non-doweled JPCP.

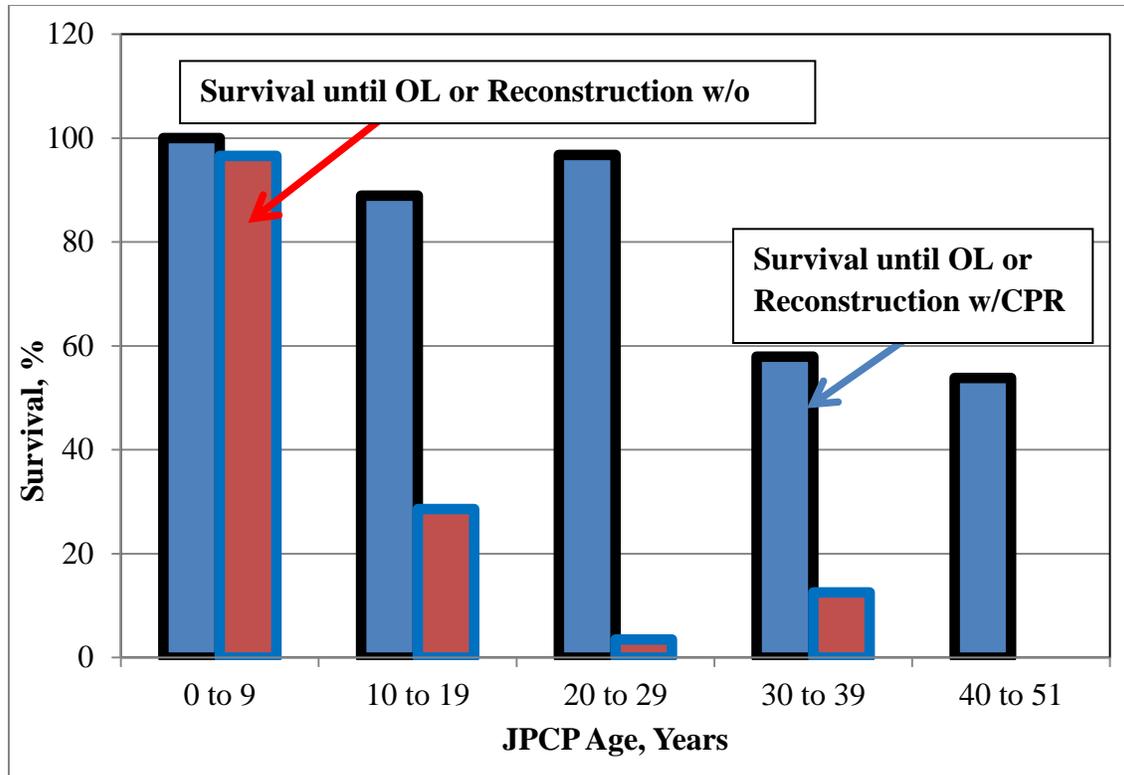
What about life extension of these non-doweled JPCP beyond their 20-year design life? Analysis results of all 108 JPCP projects in Utah are shown in Figure 11. Two sets survival results are illustrated:

These results indicate that the application of CPR with diamond grinding preservation program extended the life of JPCP significantly until a much more costly application of overlay or reconstruction was needed.

These results show that the service life of non-doweled JPCP (until an overlay or reconstruction) can be more than doubled by applying CPR including diamond grinding as needed. Diamond grinding has thus been an effective preservation treatment in Utah. Note also that, in terms of meeting the 20-year design life of these JPCP, the timely application of CPR with diamond grinding made it possible for over 95 percent of these projects to achieve the 20-year design life.

Figure 11. Comparison of service life of non-doweled JPCP with and without CPR in Utah.

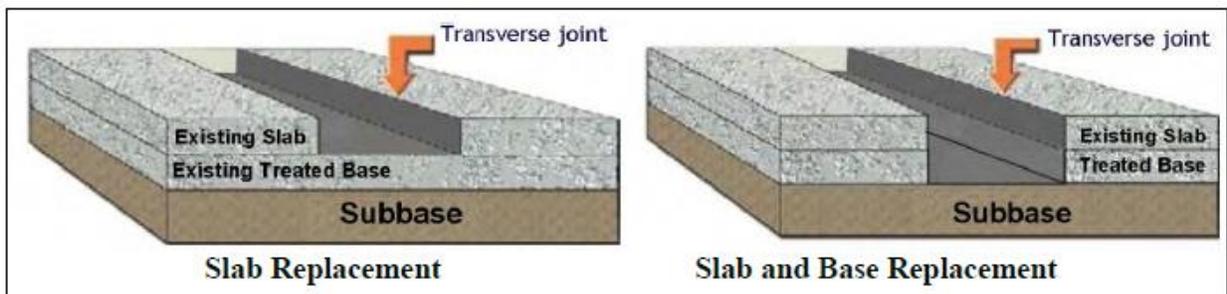
Figure 12. Slab and base replacement. (Caltrans Concrete Pavement Guide, 2015)

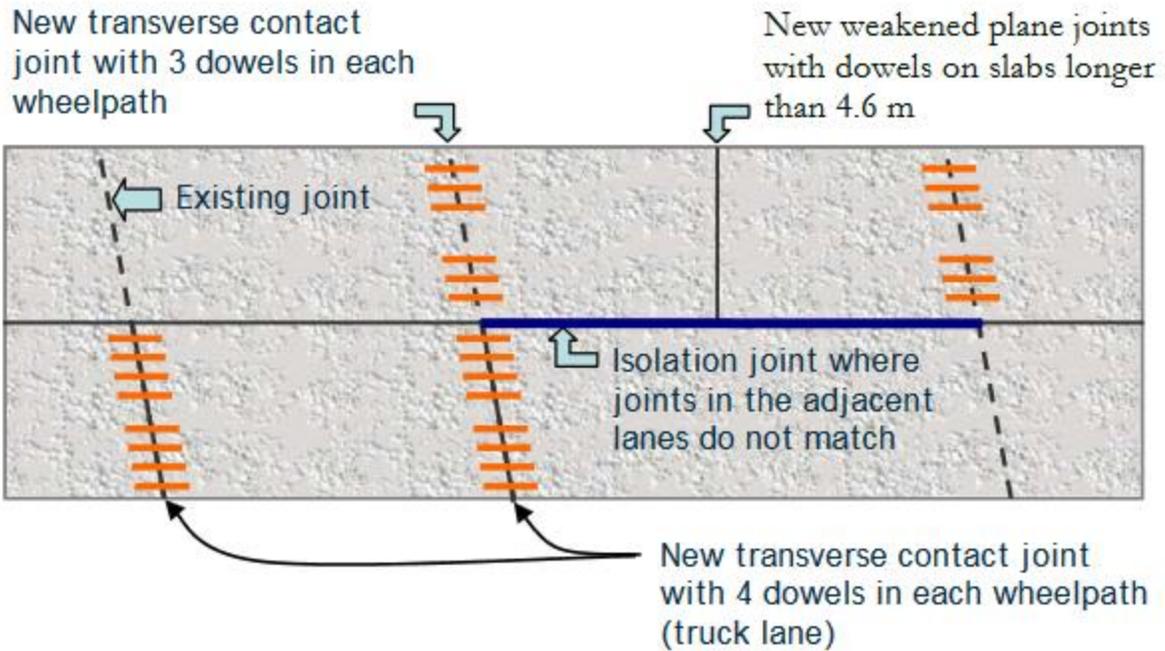
Figure 13. Plan showing number of dowel bars per joint in California. (Caltrans Slab Replacement Guidelines, 2004). Note that perpendicular joints are used with dowels.

California. Standard Specifications 2015 Section 41-9.01C (3), Revised Standard Plan: RSP P10 and P8. For non-truck lane, three dowels per wheel path are used, and for truck lane, four dowels per wheel path are used. Dowels are spaced at 12 inches. For slab thickness ≤ 9 inch, 1.25-inch dowel diameter is used, and for slab thickness ≥ 9 inch, 1.5-inch dowel diameter is used. The minimum FDR length is 6 feet, and the lane width is 12 feet. Figure 13, Figure 14, and Figure 15 provide plan and layout of FDR with dowel bar retrofit. Note the isolation longitudinal joint where transverse joints in the adjacent lane do not match to avoid reflection cracking. Half lane widths are not allowed due to instability of the FDR under loading. Maximum length is 15 ft.

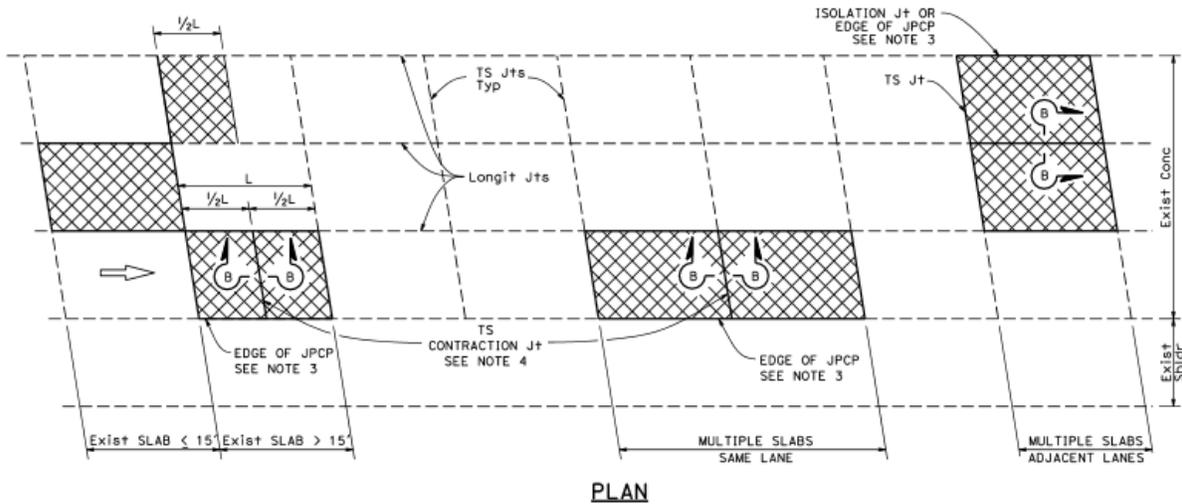
Figure 14. Plan showing individual slab replacement in California. (Caltrans Standard Plans, P8, 2015). Note that perpendicular joints are used with dowels.

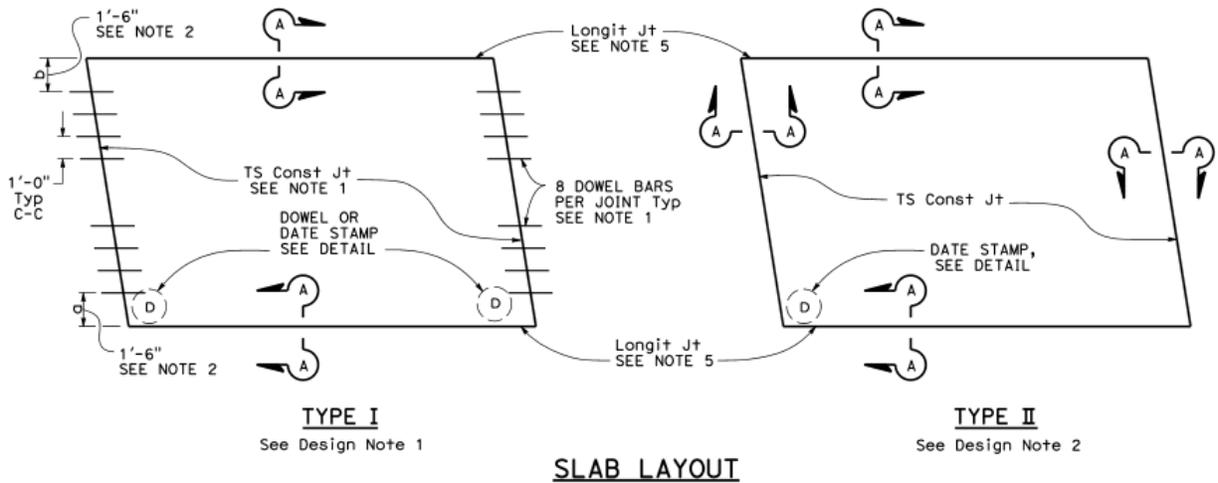
1. For concrete slab repair with > 5 years design life.
2. For short term repairs with 5 yrs or less design life or for slab replacements with cracking and seating.

Figure 15. Slab layout showing individual slab replacement with number of dowels per joint in California. (Caltrans Standard Plans, P8, 2015). Note that perpendicular joints are used with dowels.

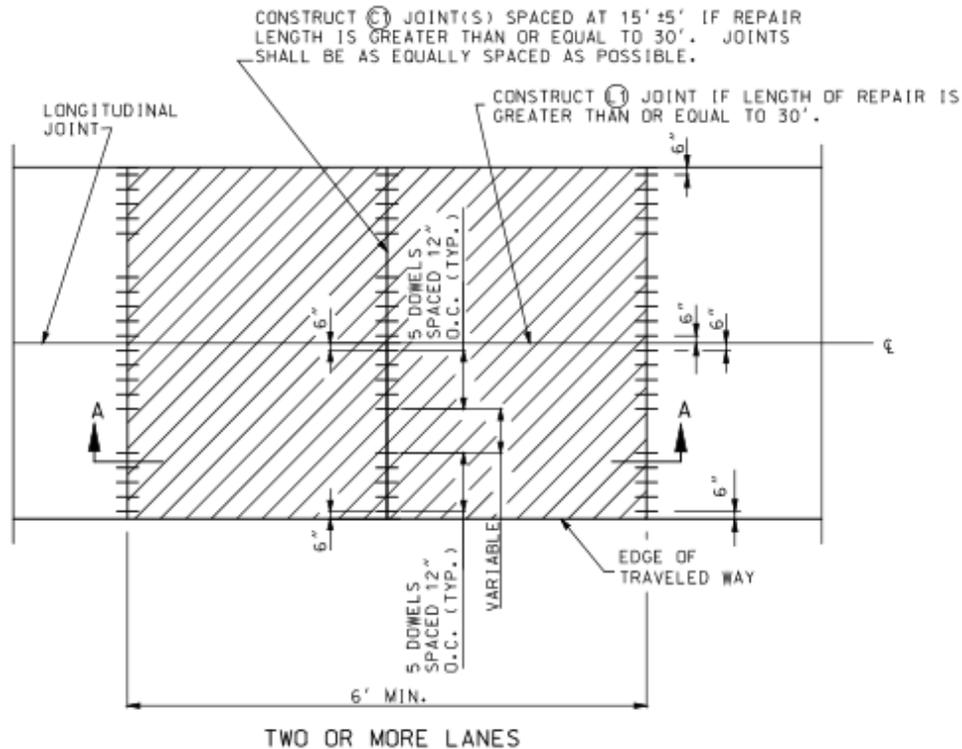
Figure 16. Plan showing number of dowel bars per joint in Missouri. (MoDOT Standard Plans, 2017)

Missouri. Five dowels per wheel path, 12-inch spacing, and a 1.0-inch dowel diameter are specified. The minimum FDR length is 6 feet and the width is 12 feet. FDR of JRCP is typically done at transverse joints and at transverse deteriorated cracks that are the weak points in JRCP design. Both of these areas can be fully repaired with an FDR. Figure 16 shows plan and profile layout for JRCP in Missouri. Repair lengths ≤ 30 feet are not tied to the adjacent lane. Note the transverse joints spacing requirements (15 ft +/- 5 ft) if repair length is ≥ 30 ft.

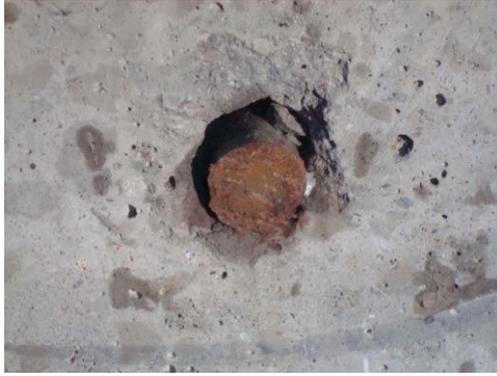
Figure 17. Poor anchoring of dowel into hole that resulted in faulting of the transverse FDR joint. (Photo Courtesy of Mark Snyder)

Anchoring of the dowel bars into the existing slab is the critical construction step for FDR. If this is not done adequately, the dowels will eventually become loose, the FDR joint will lose joint LTE, and pumping and faulting will develop along with cracking and settlements. Figure 17 and Figure 18 show one of many poor anchoring examples, where the grout or epoxy material was not properly surrounding the dowel bar and the continual pounding of loads has completely eroded it away.

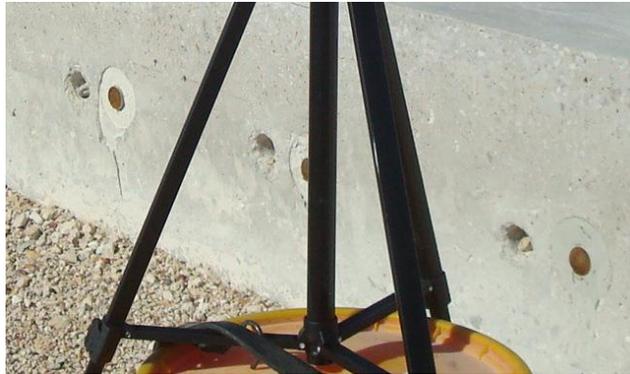
Figure 18. Use of grout retention disks provides good coverage. (Photo Courtesy of Mark Snyder)

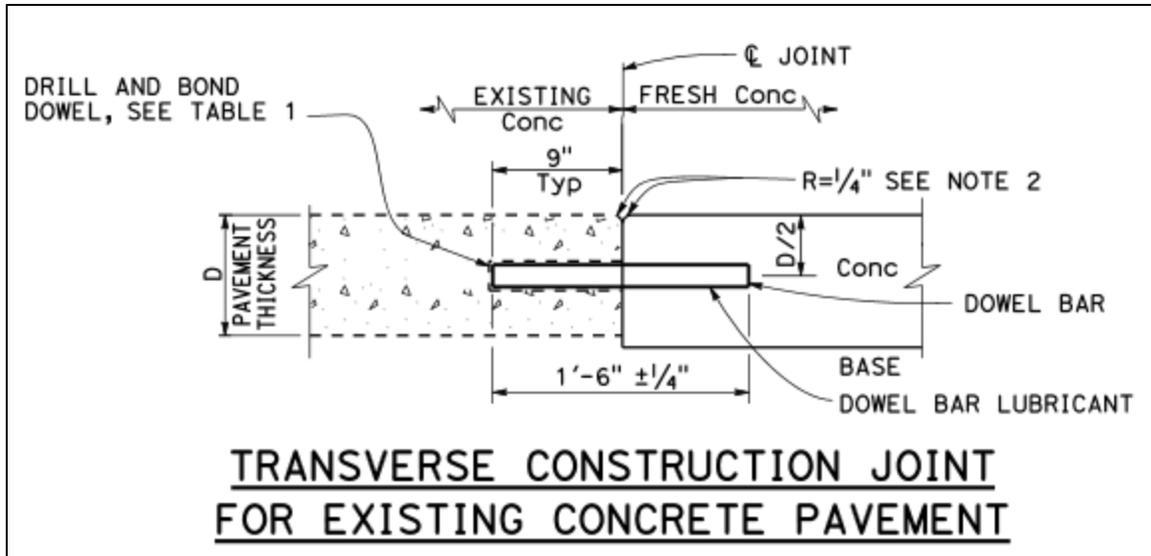
Figure 19. Dowel bar anchoring in California. (Caltrans Standard Plans, P10, 2015)

California. Drilled hole is $\frac{1}{4}$ inch larger than dowel. Bars are anchored with epoxy and no grout retention disks are used. Figure 7 shows the dowel bar anchoring requirements in California.

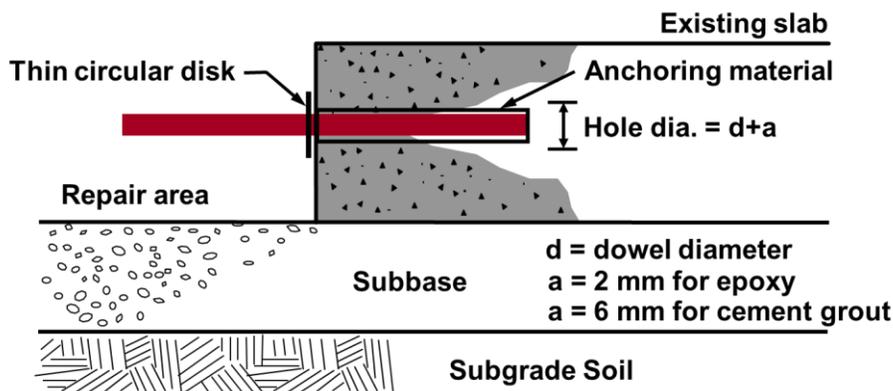
Figure 20. Dowel bar anchoring in slab face with grout retention disk. (FHWA, 1998)

Missouri. Drill holes, clean, inject epoxy resin into hole, rotate bar during insertion, use grout retention rings, end caps on protruding dowels, coat bars with lubricant. The grout retention rings are an important part of a system of anchoring dowels, and that system includes the proper consistency and strength of anchor materials (cementitious grout or epoxy-based material), the right annular gap for the material being used, the proper injection of the material into the drilled hole, proper technique for inserting and rotating the dowel for good filling of the gap and the grout retention ring to force full grout coverage at the joint face and hold it all in place until it sets. Figures 8 and 9 show a typical dowel bar anchoring with a grout retention disk.

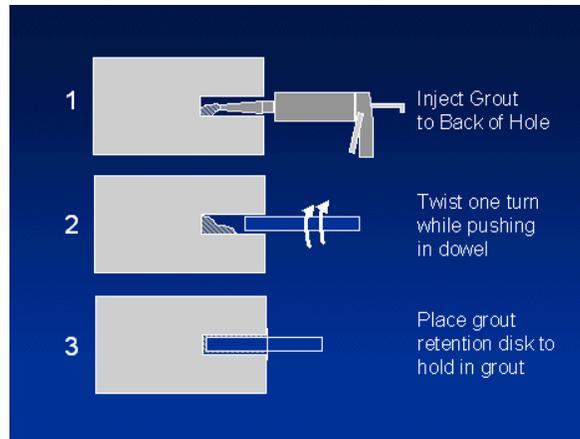
Figure 21. Illustration of recommended procedure to anchor dowels securely into face of slab.
(Courtesy of Mark B. Snyder)

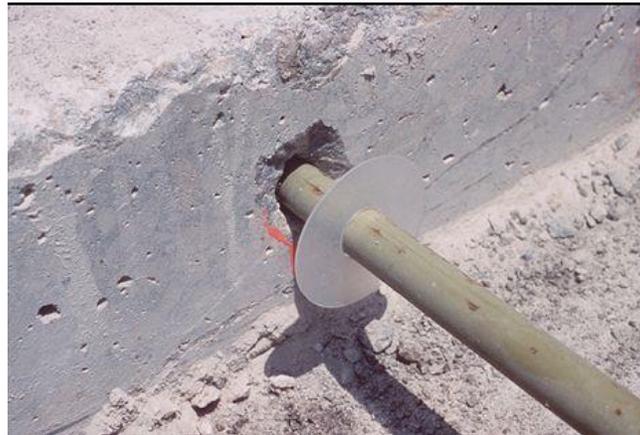
Figure 22. Grout retaining disk. (Photo Courtesy of Mark B. Snyder)

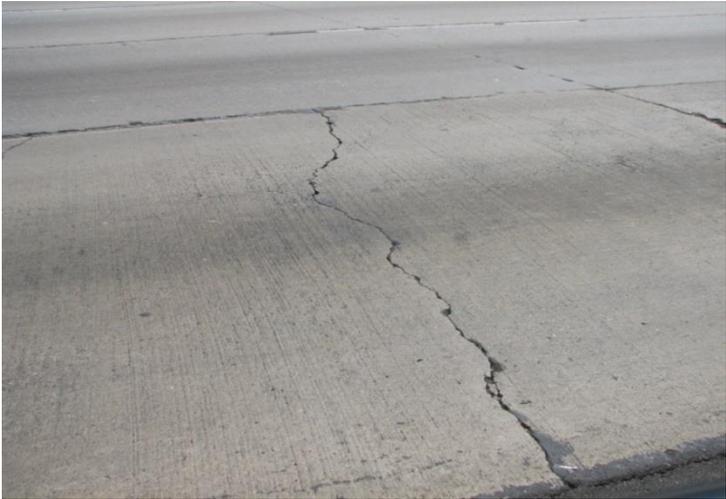
Figure 24. Midpanel cracking on an RSC slab on I-5 in Los Angeles County.

Of the few RSC FDR that were distressed, the majority exhibited midpanel and surface cracking as shown in Figure 24. Distresses in the FDR included spalls and corner cracking, midpanel and surface cracking, shrinkage cracking, aggregate pockets, and moving slabs. Figure 25 shows the percent distressed slabs on surveyed RSC projects.

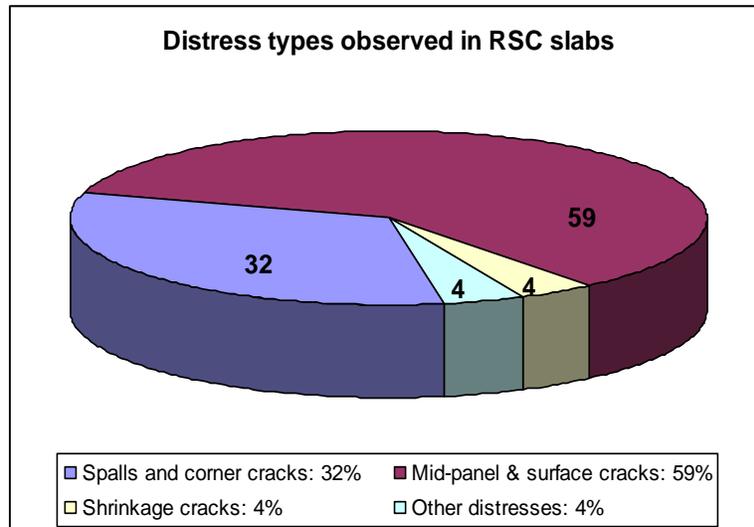
Figure 25. Distribution of distress types observed in the distressed slabs on RSC projects.

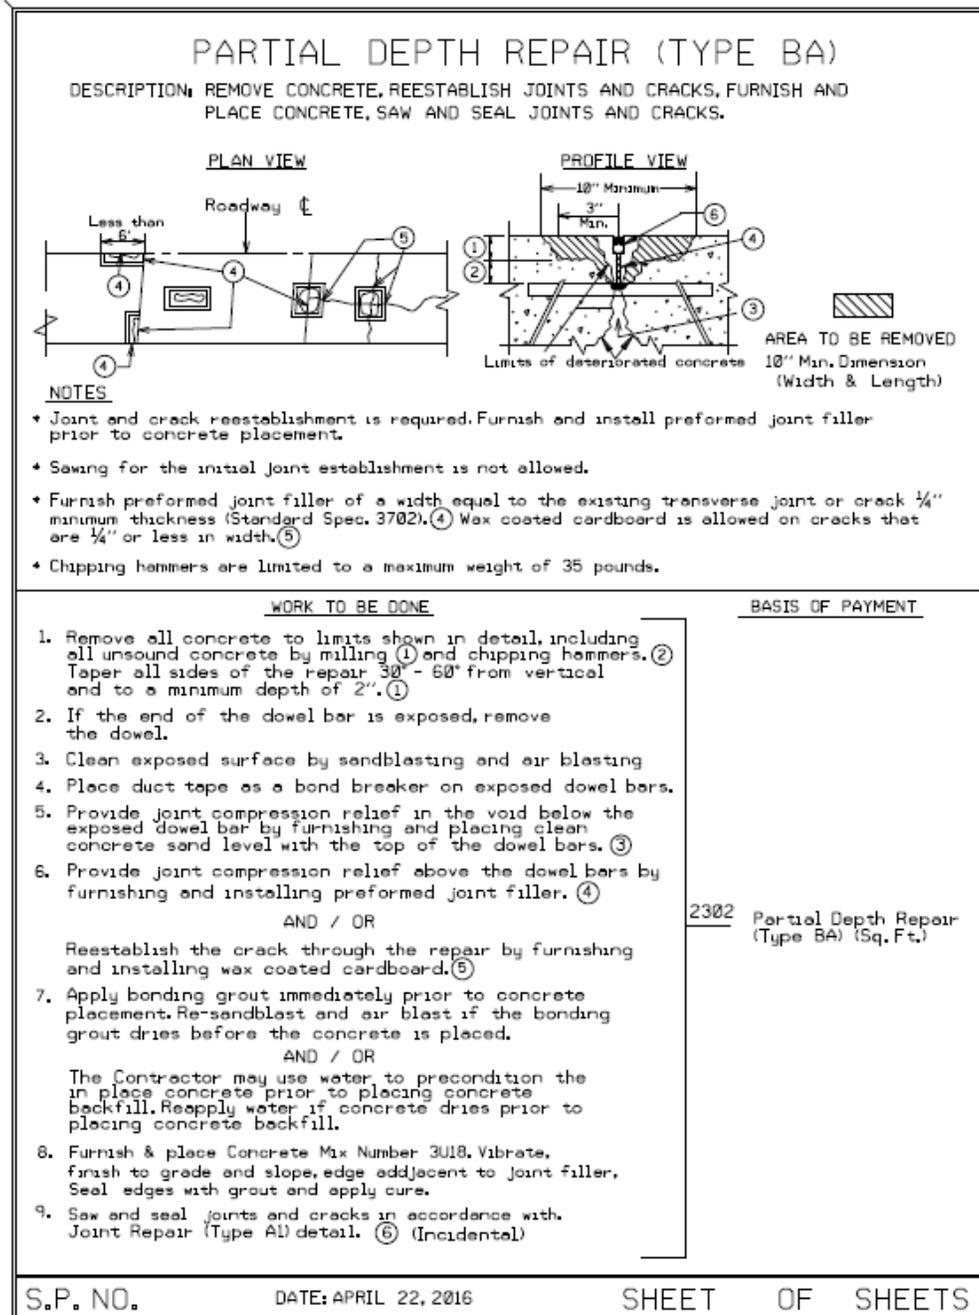
Figure 26. Minnesota PDR BA diagram for milling. (MnDOT, 2017)

MnDOT does the coring to determine if a pavement is a good candidate for a CPR project. If it is a CPR candidate, then the cores are used to estimate PDR/FDR quantities. If MnDOT finds the lower portion of the PCCP is unsound they will then skew the repairs more towards FDRs. A sample graphic and instruction sheet for PDR is shown in Figure 26.

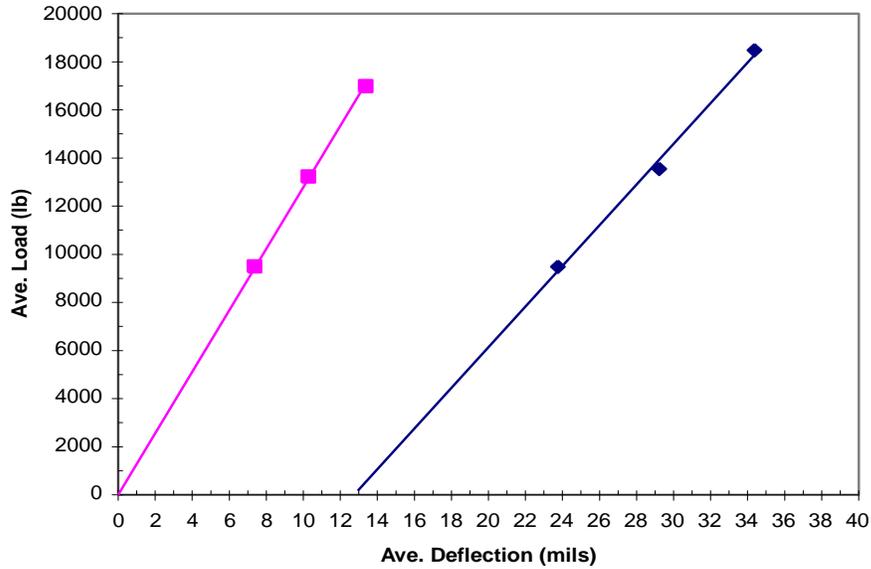
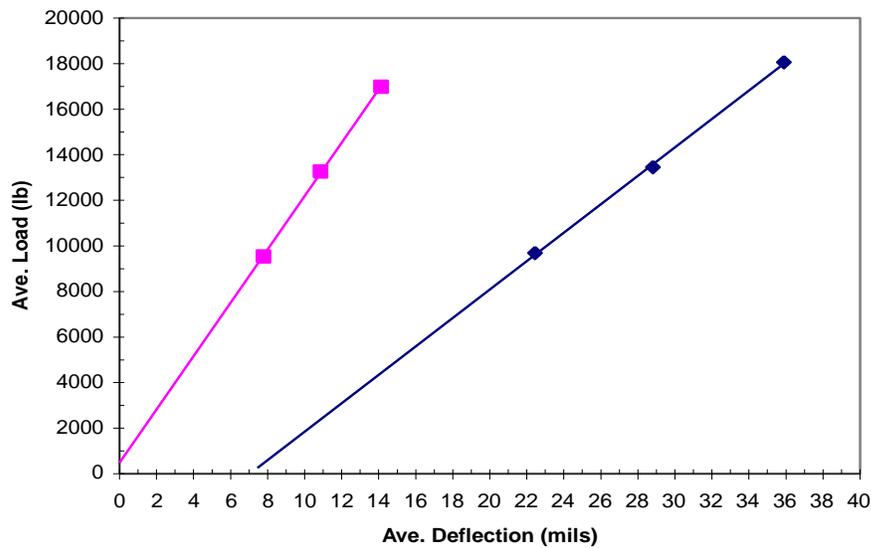
US 71 NB at
 Bridge A-2022
 in Jasper Co.
 3rd Approach Slab

Although it is the primary intent of another study to evaluate the effectiveness of the polyurethane undersealing process, it can be concluded from the FWD tests that a positive improvement in support did occur under most of the slabs. It may be a more reliable process than grout undersealing, which, although cheaper, has in the past on occasions caused uneven filling of voids, because of its high viscosity, and created greater support problems than existed before.

Figure 27. One Missouri slab corner tested by FWD at 9,000, 13,000, and 16,000 lb before and after slab stabilization showing impact of stabilization to restore support.
