Performance Benefits of Fiber-reinforced Thin Concrete Pavement and Overlays

MnDOT Contract No. 1003325; Work Order 56

TAP MEETING # 1

Thin Concrete Pavement/ Overlay

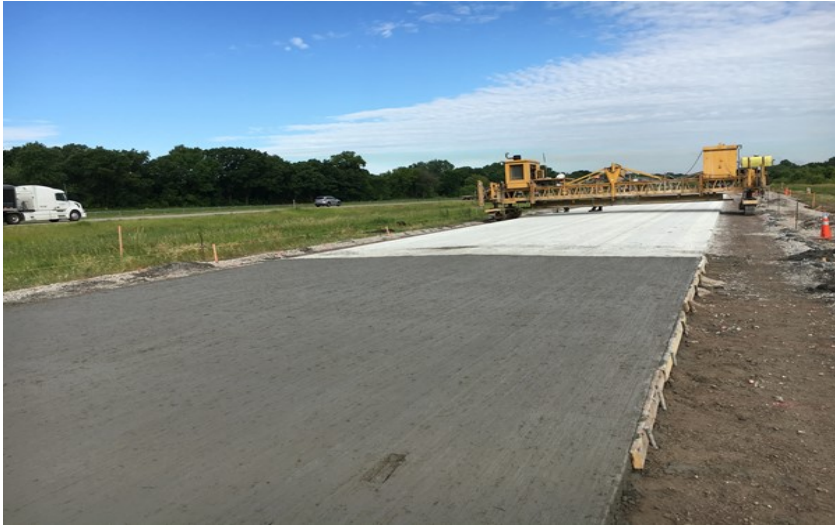
Thin conc. Pavement

Over agg. base

Thickness: 3 to 6 inches

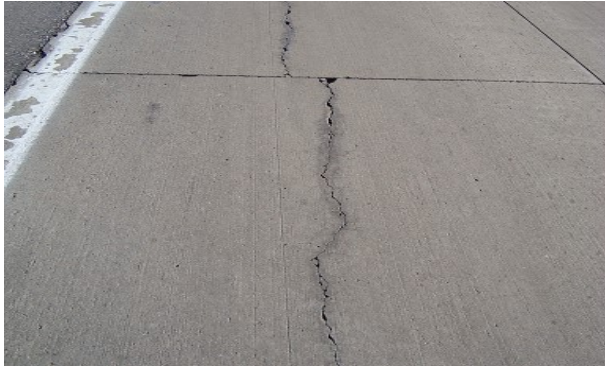
Cracks

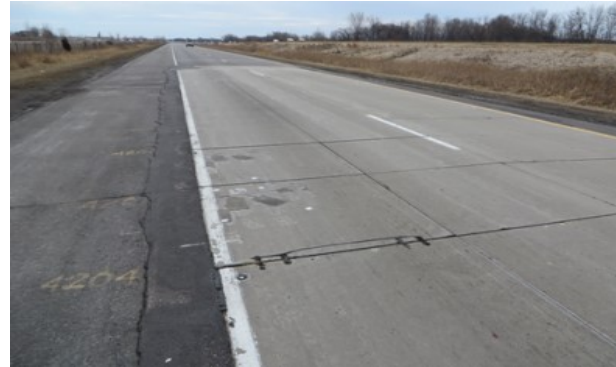
Joint faulting

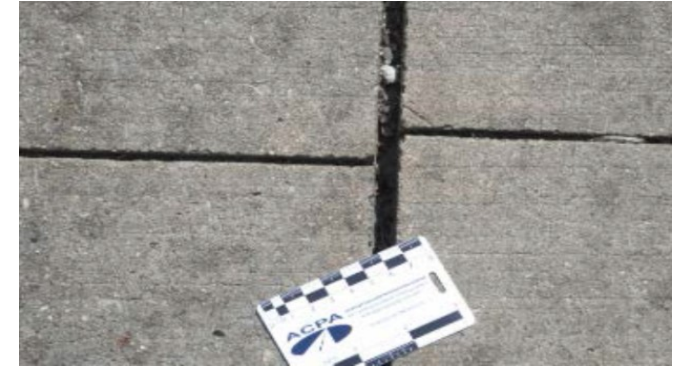
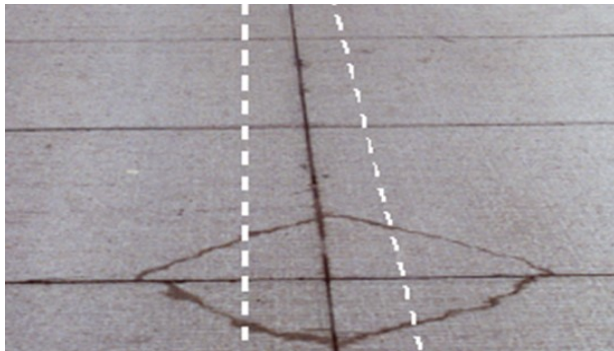
Slab migration

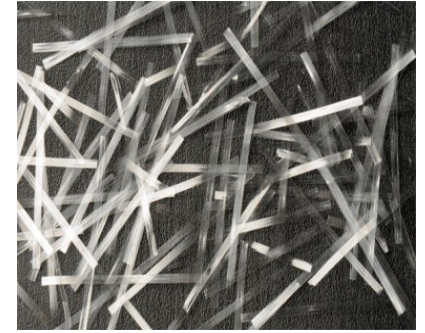
Materials (ASTM C1116)

Type I: steel
Type II: glass
Type III: synthetic
Type IV: natural fibers

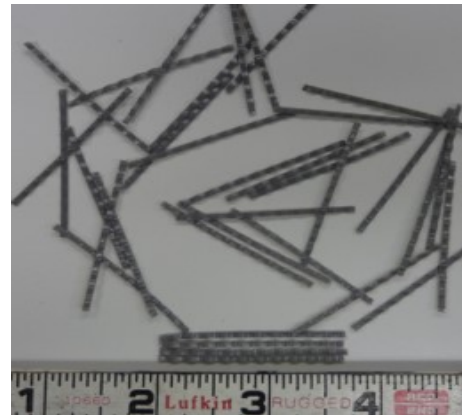
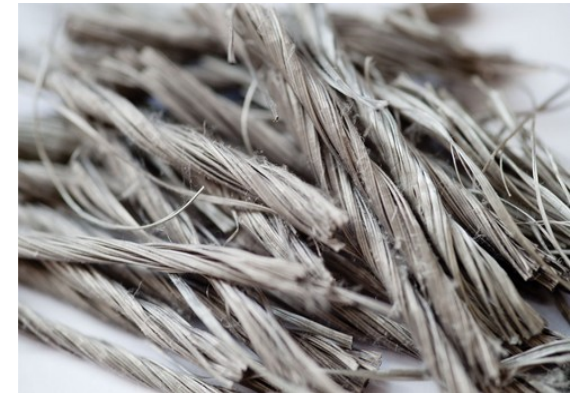
Geometry/texture

Straight
Crimped
Hooked end

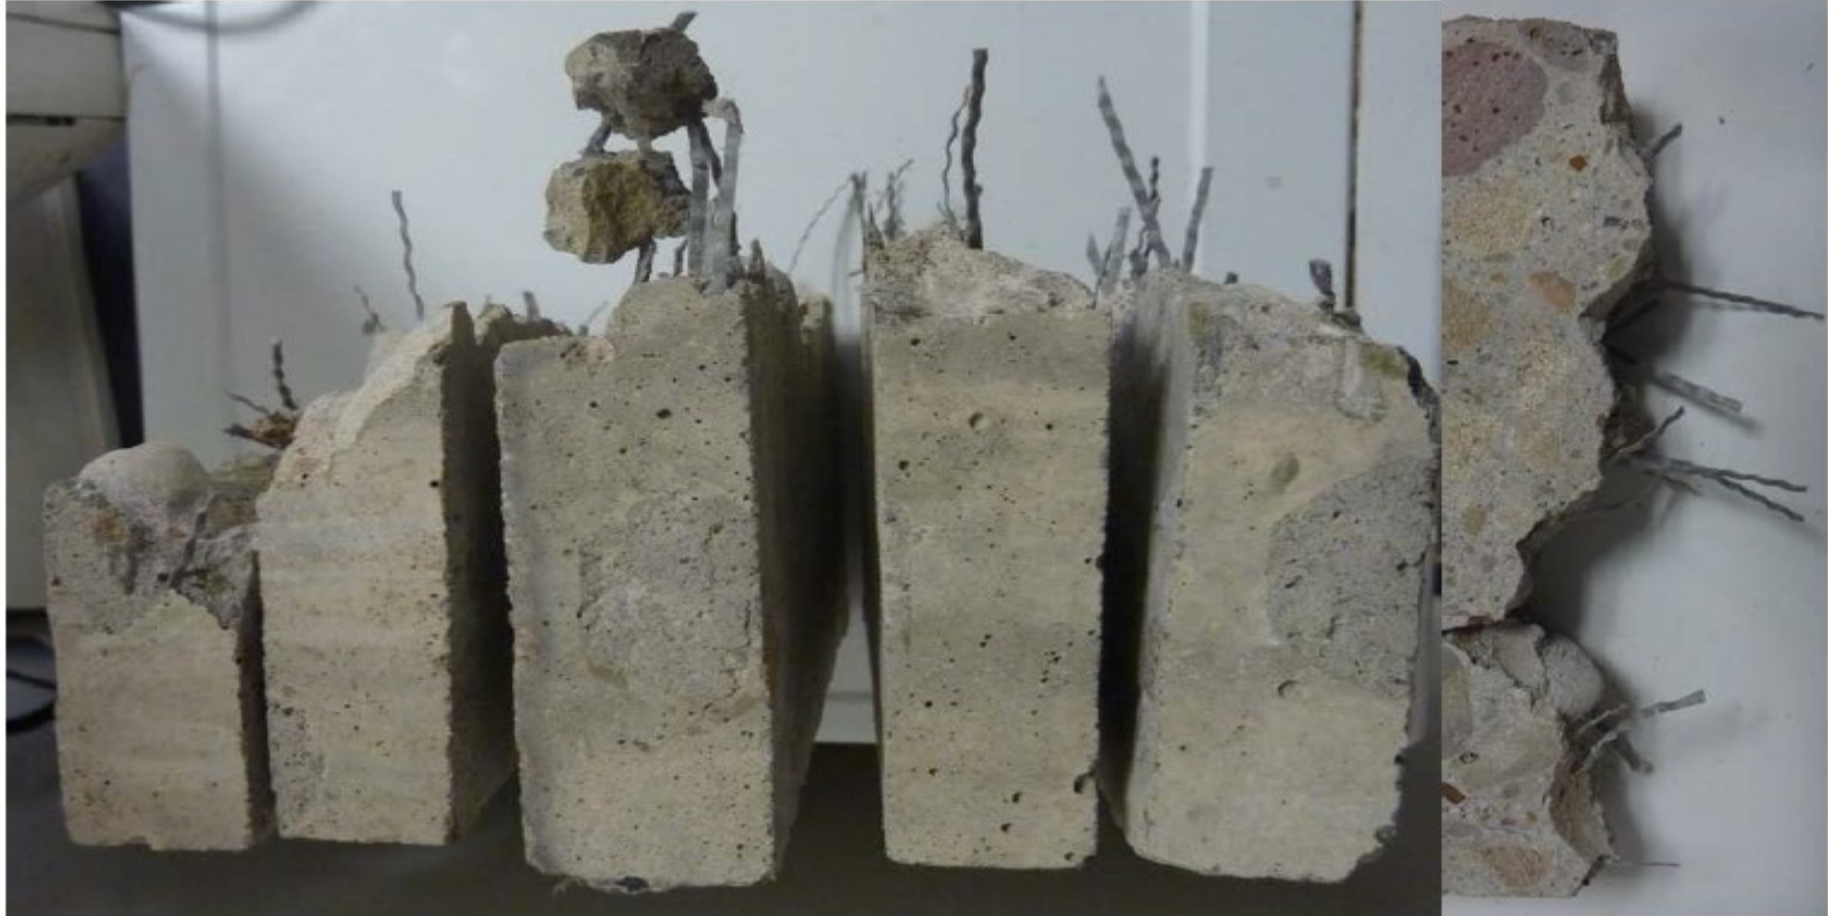
Pictures of Enduro 600 fibers after fatiguing with 10 million load cycles.

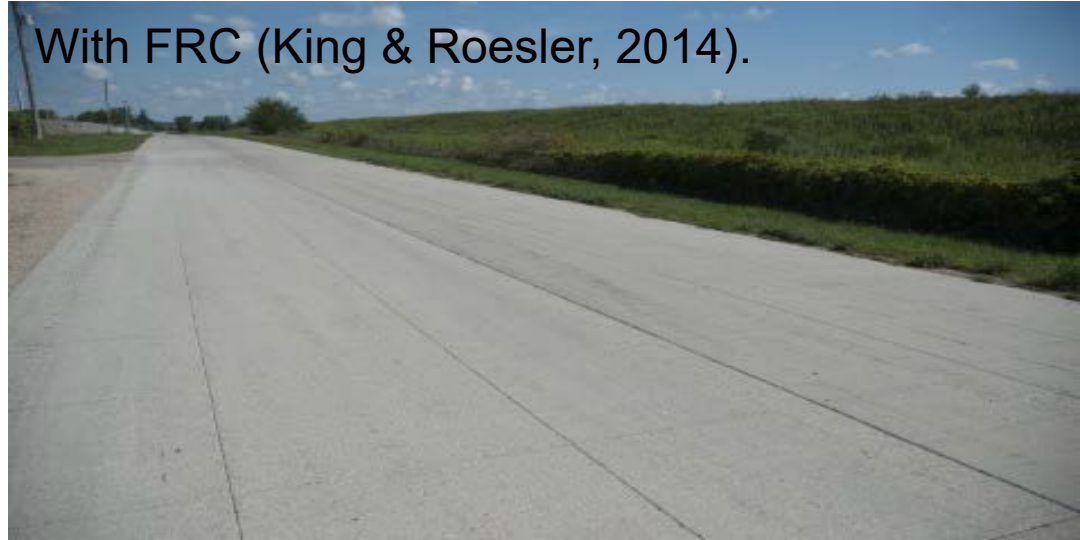
With FRC (King & Roesler, 2014).

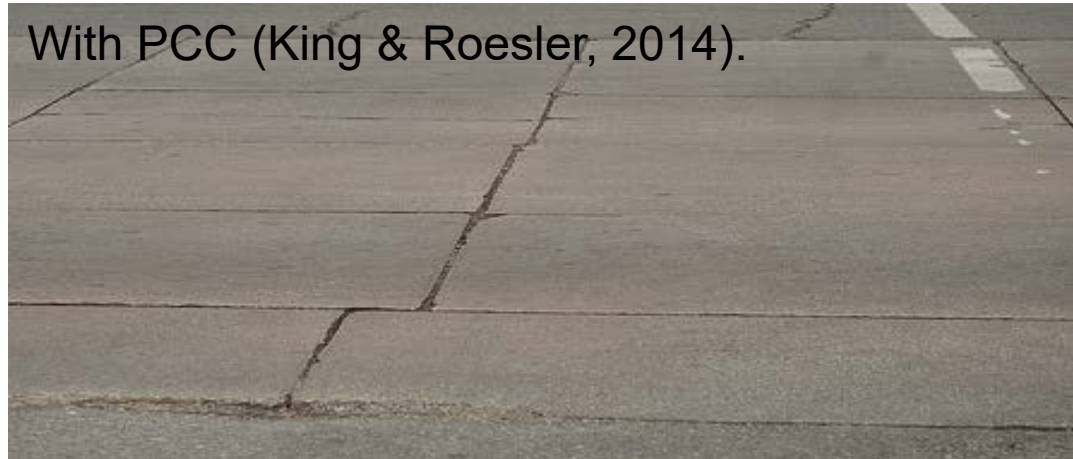
With PCC (King & Roesler, 2014).

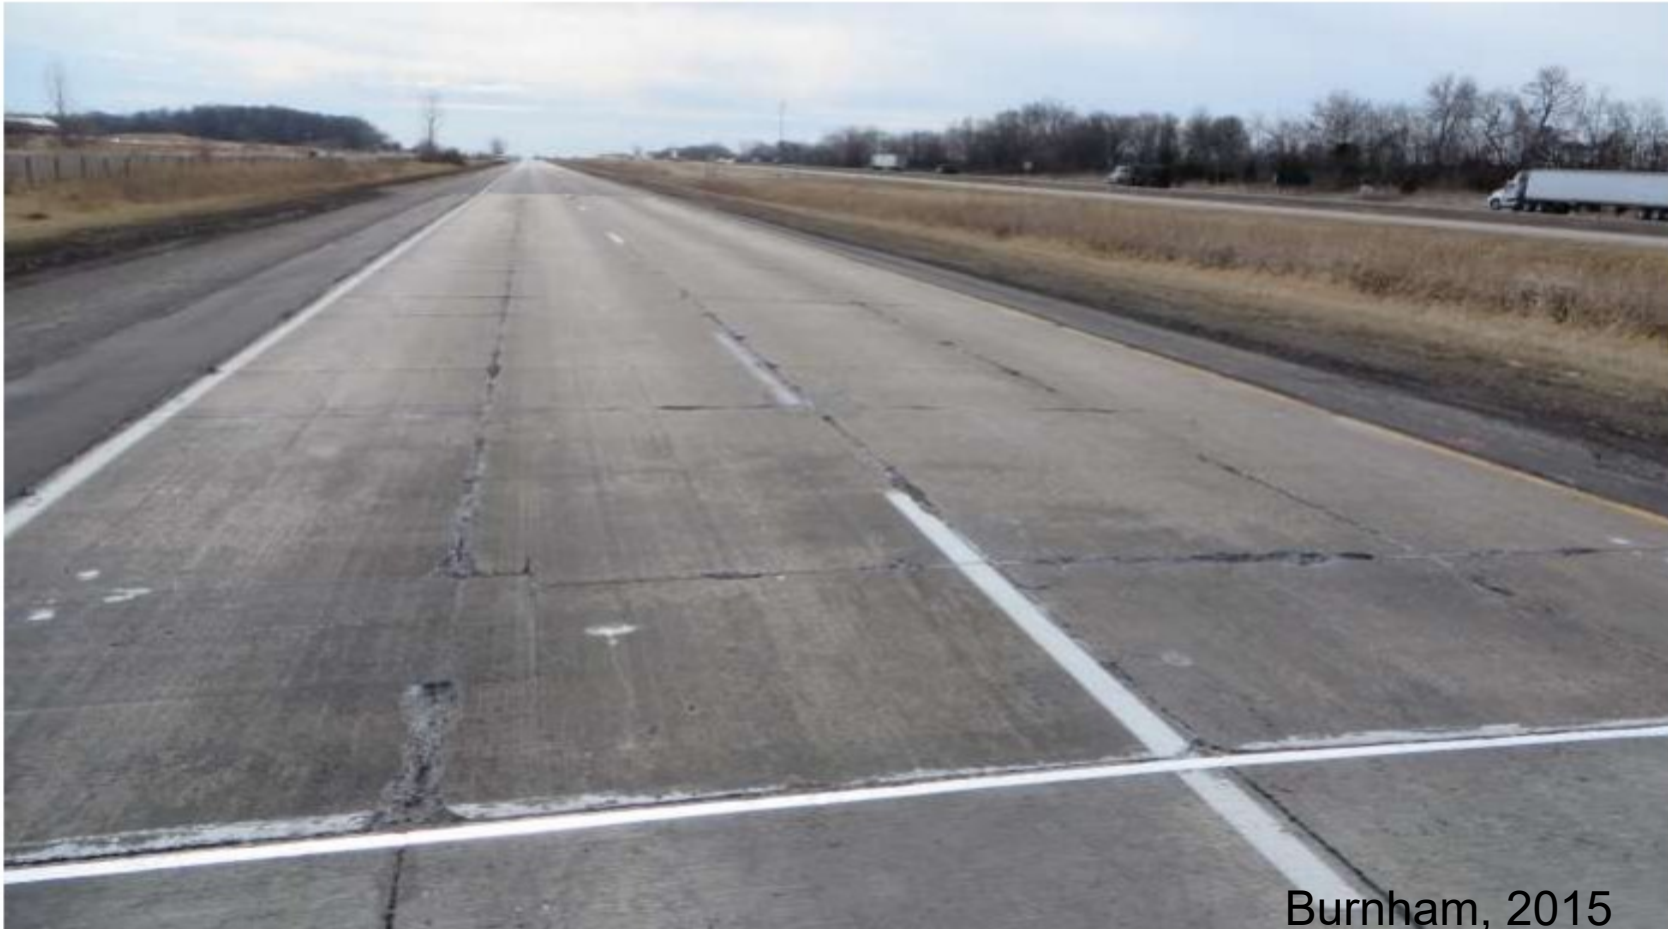
Burnham, 2015

- Cell 96, No cracked panels, joint deterioration (too many fibers)

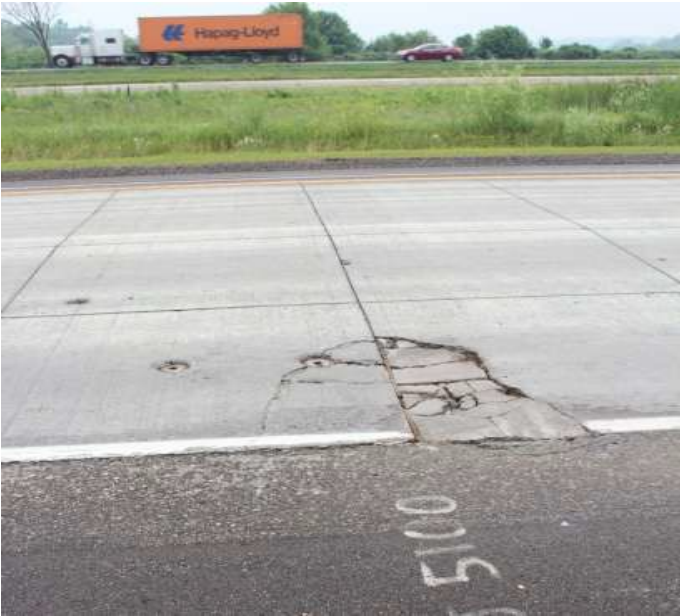
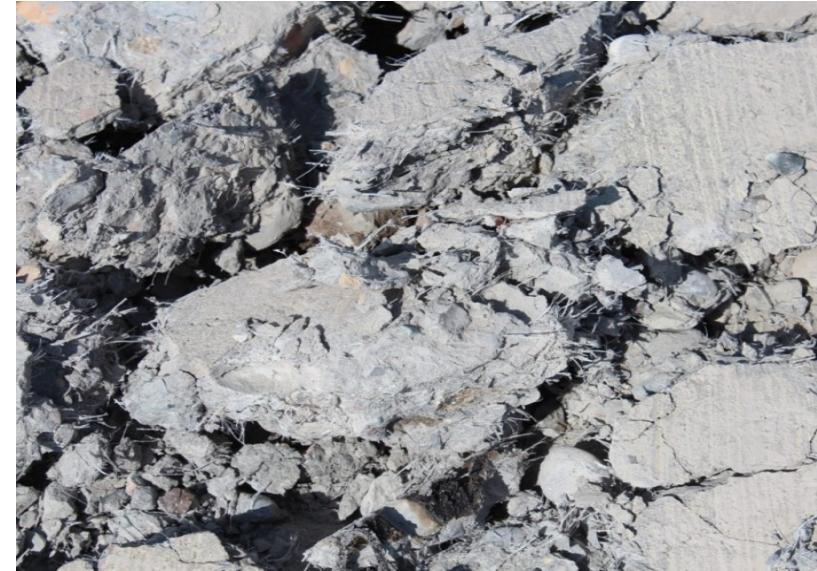
Localized distress in Cell 162, (b) concrete broken to replace the slab (Burnham & Andersen, 2015).

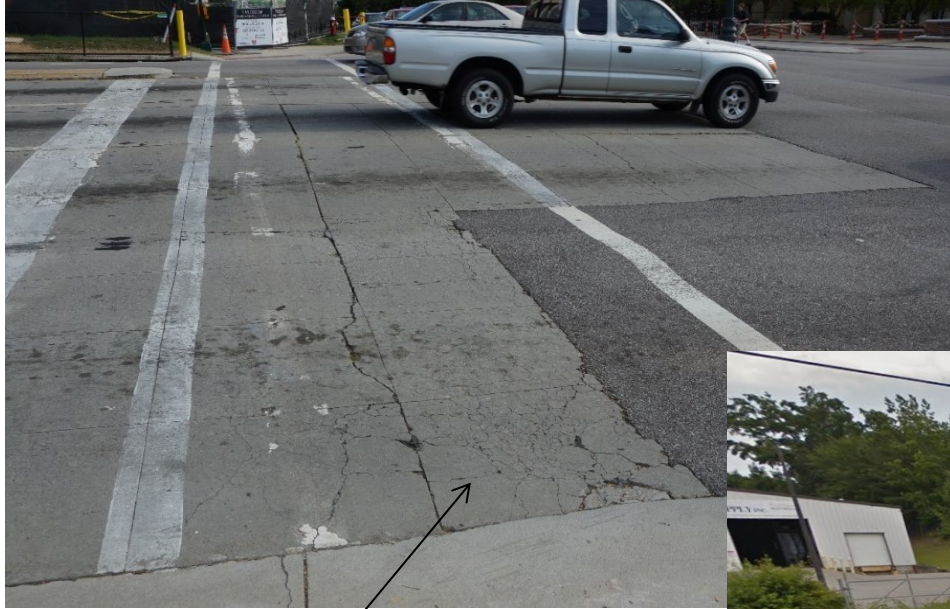
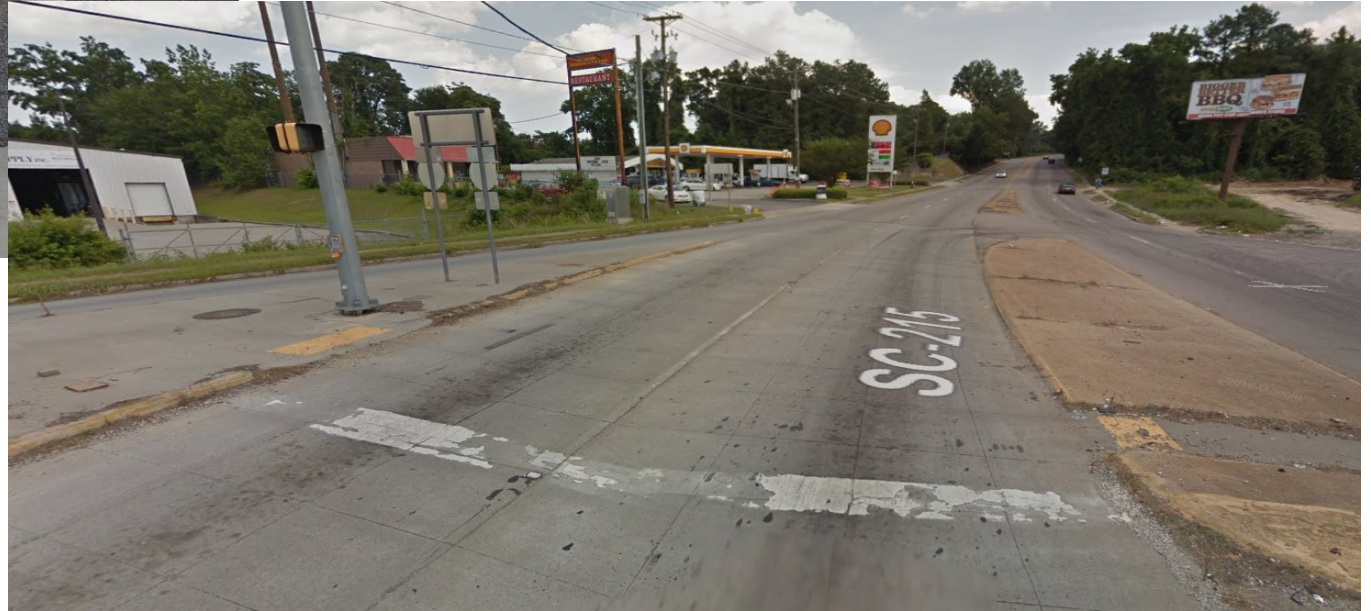
Fibers holding shattered slab pieces

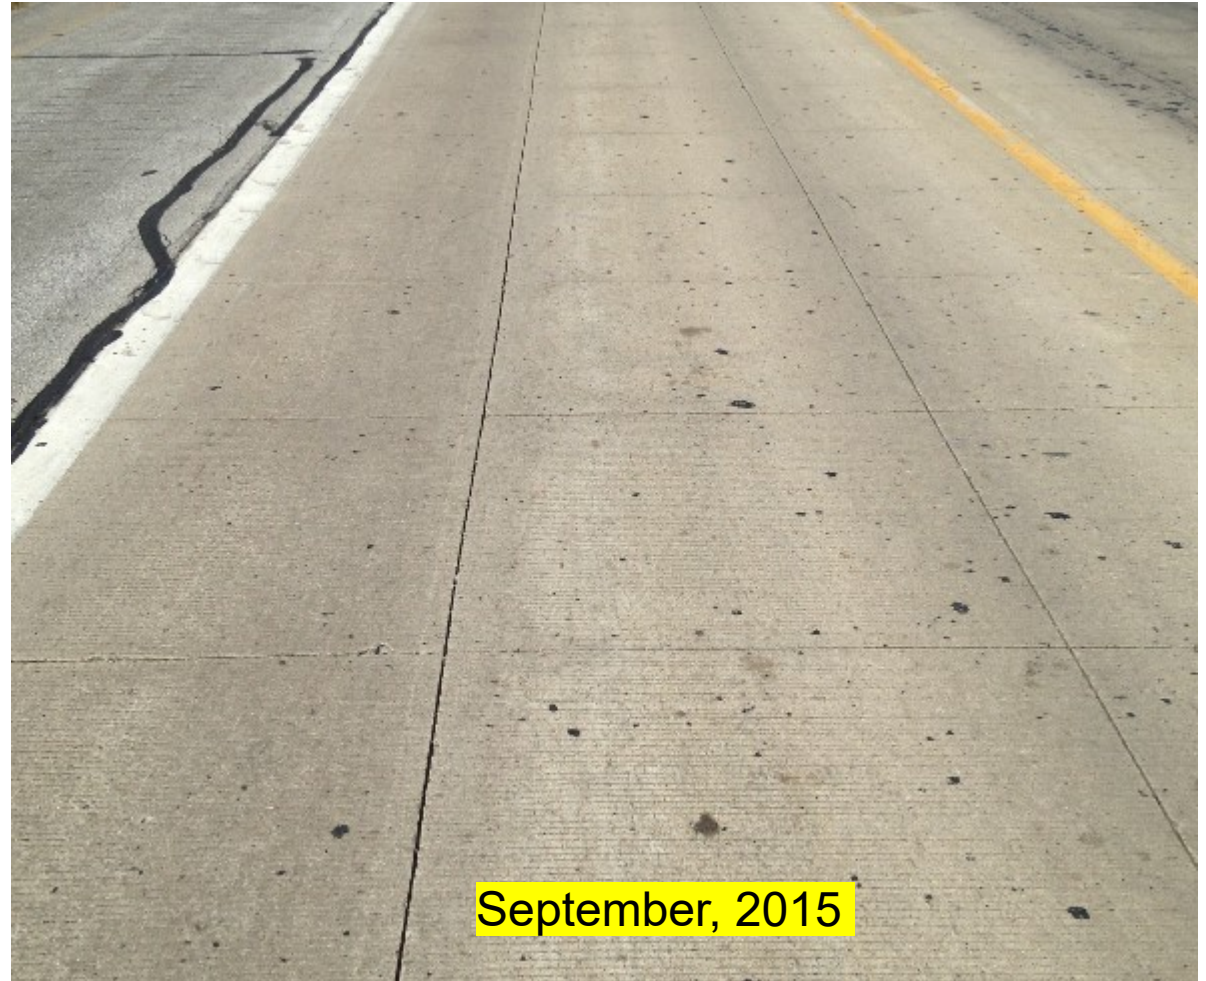
- US 60: A bonded concrete overlay project (1999)
- polypropylene fibers - 3 lb/yd³; 4 inches thick and included 3 ft x 3 ft and 4 ft x 4 ft panel sizes
- Fibers **did not reduce panel cracking but did reduce crack widths and joint degradation. No faulting** was observed on this project and may be related to the use of fibers.
