NRRA Long-term Research Project

**Performance Benefits of Fiber-reinforced Thin Concrete
Pavement and Overlays**

**Task-2: First Year Annual Cell Performance Report
(2017-2018)**

**Prepared by:
Manik Barman and Corey Crick, UMD
and
Tom Burnham, Minnesota Department of Transportation**

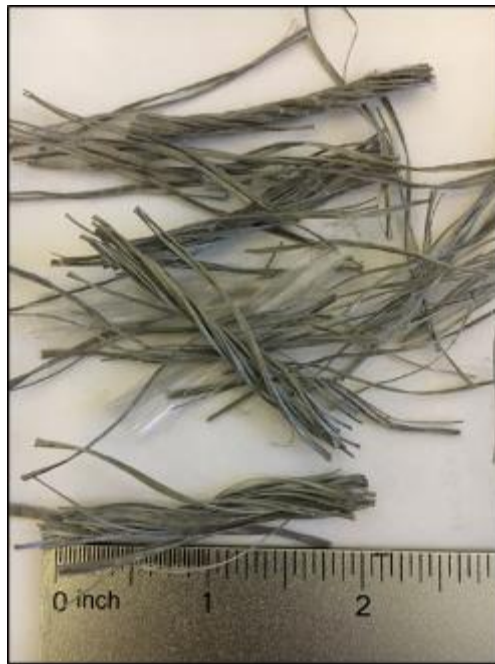
Figure 2: Photograph of the fiber used in MnROAD 2017 FRC research cells.

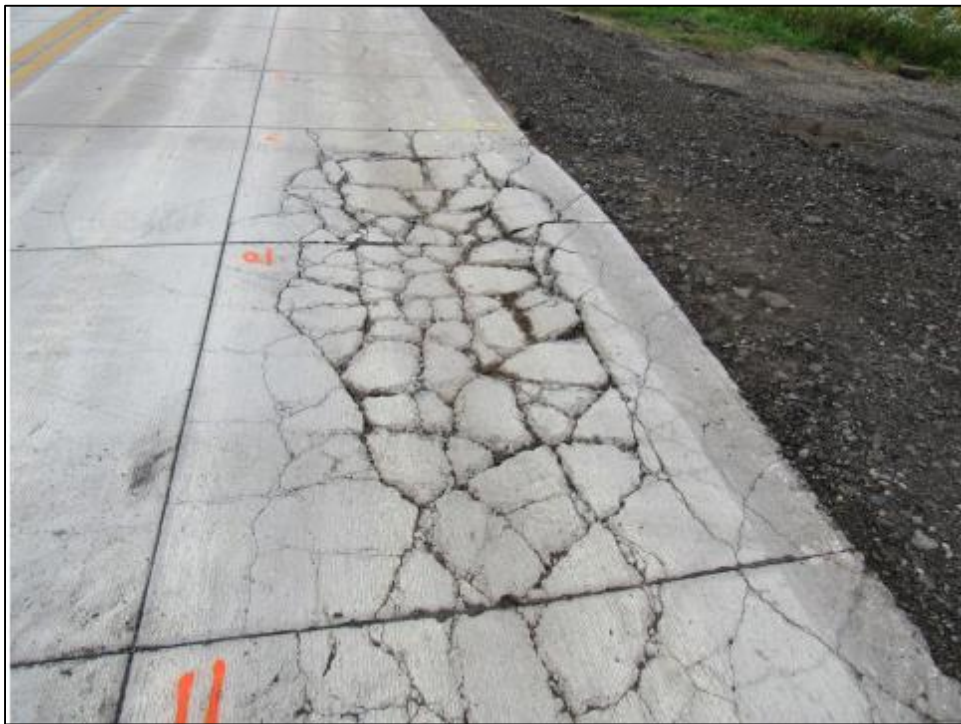
Figure 5. Shattered slabs in Cell 139.

Cell 139 was constructed with a three-inch-thick (ultra-thin) concrete pavement on gravel base at the MnROAD low-volume test track. The slab size of this cell was 6ft x 6ft. Cell 139 was inadvertently exposed to early loads from construction trucks that were using the crossover segment to access other cells under construction, which resulted in many early-age cracks. Figure 4 shows a picture of a couple of such early-age cracks in this cell. These types of cracks continued to develop, propagate throughout the first year of service, and eventually, many slabs of this cell were shattered by the end of the summer of 2018. Besides that, there was a considerable amount of depression along the outer wheel path at some locations; this distress looked similar to rutting that occurs in asphalt pavement. Figure 5 and Figure 6 show photographs of the abovementioned distresses. While the thickness limitation (only 3-inch thick) of this cell and early-age loading were the main reasons for initiation of the failure of Cell 139, a relatively weak base layer and some drainage issues were believed to have aggravated the distresses of this cell. Based on the distresses observed in Cell 139, it can be stated that the type and quantities of the fibers used in the experiment may not be helpful when the

pavement is too thin (like 3 inches) and rested on a relatively weak unstabilized base layer. As many as 14 of the 44 slabs in the inside lane were eventually had to be replaced on September 27, 2018. Figure 7 shows a few photographs collected during the removal of broken slabs and construction of the replacement slabs. The replacement slabs are now 4-inch thick, with eight of them containing fiber reinforced concrete and the other six constructed with plain concrete. The fibers used in the replacement slabs are different and laterally stiffer than what was used in 2017, as shown in Figure 8a. The dosage of the fiber was 5.5 lb/cy, which corresponds to a 30% residual strength ratio. Figure 8b shows the ASTM C1609 test results for the two beam samples prepared at the site during the construction of replacement slabs in Cell 139.

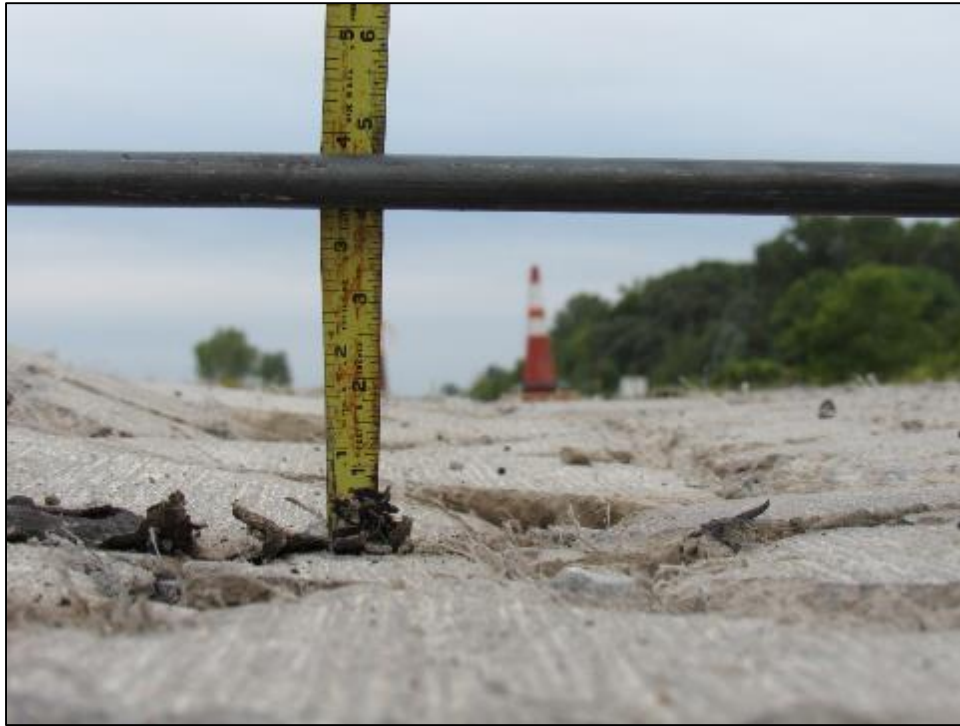
Figure 6. Depression along with the wheel path in Cell 139.

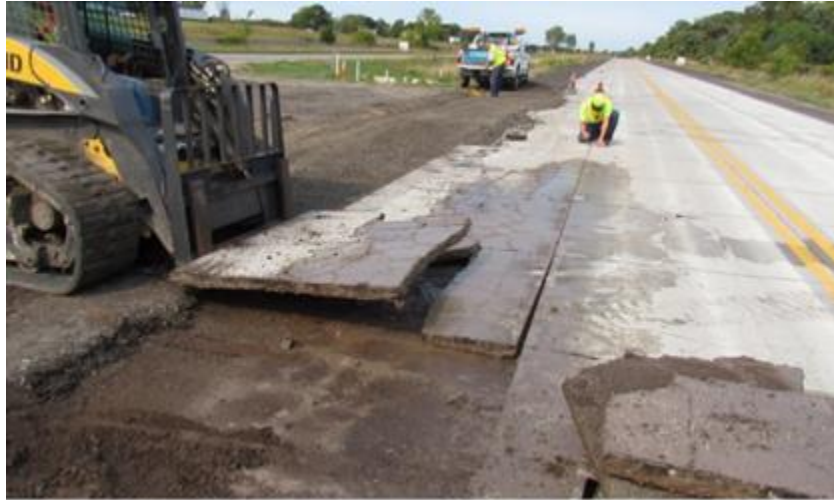
(7a) Removal of shattered slabs

Figure 7. Photographs of the replacement and reconstruction on Cell 139 (outer slabs, inside lane).

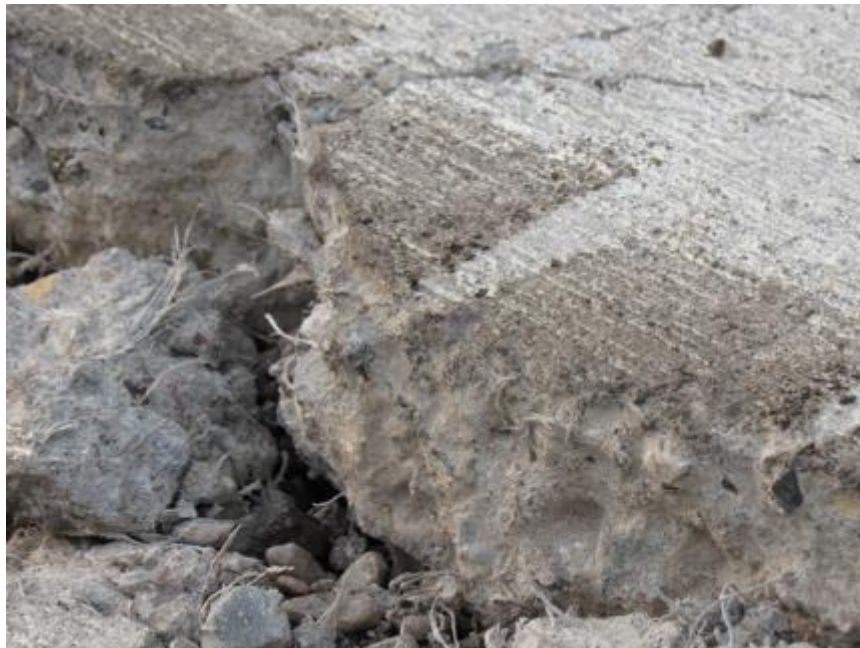
(7b) Close shot of the broken concrete pieces.

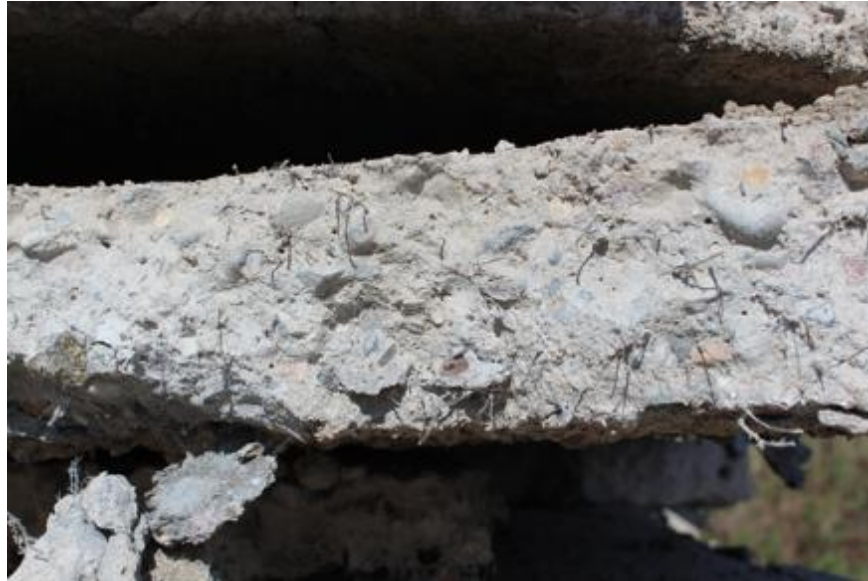
(7c) Fibers on the fractured face of a concrete piece.

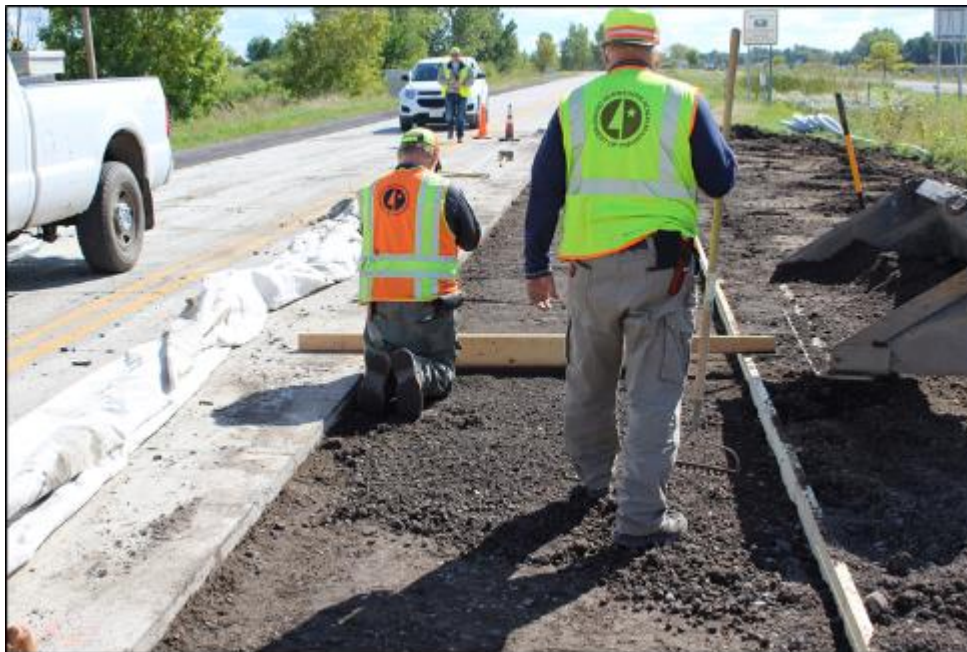
(7d) Preparation of base layer during the construction of replacement slabs.

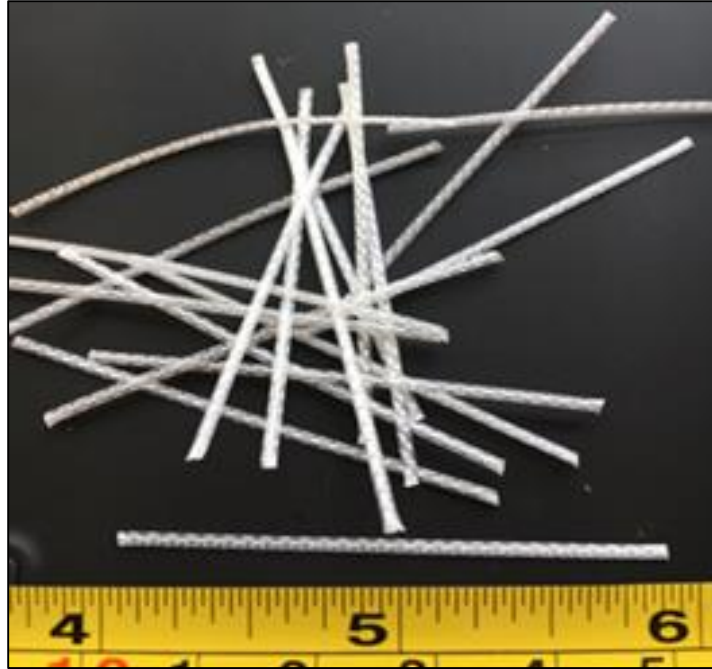
(8a) Fibers used in new slabs of Cell 139.

Figure 8. Photograph of fibers used in the reconstruction of Cell 139 and ASTM 1609 test results for the FRC samples.

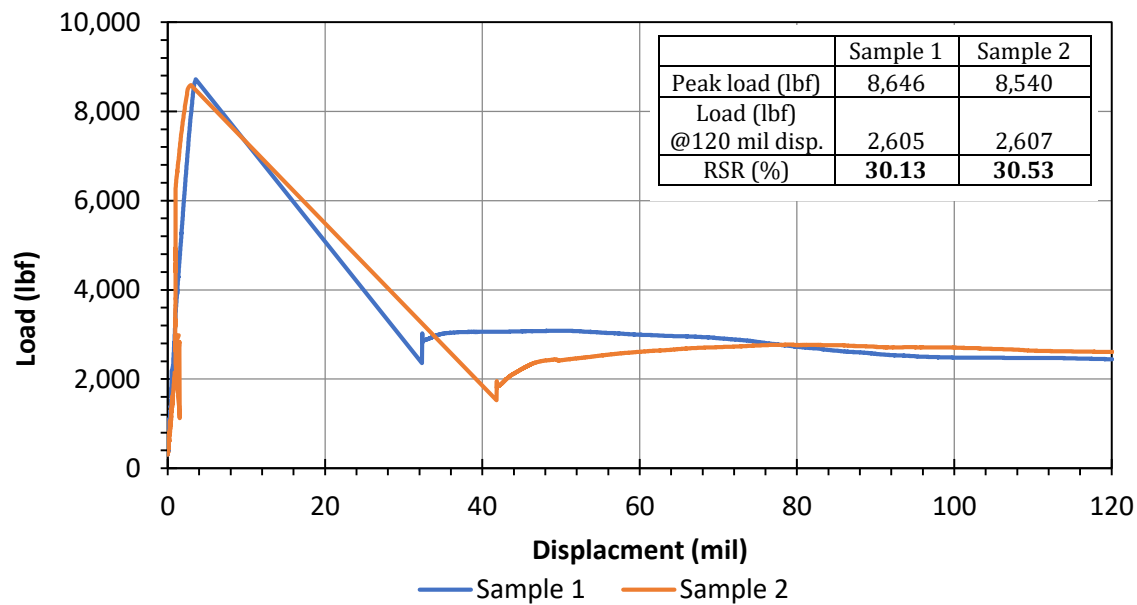
(8b) ASTM C1609 test results of the FRC concrete samples prepared during the construction of replacement slabs for Cell 139.

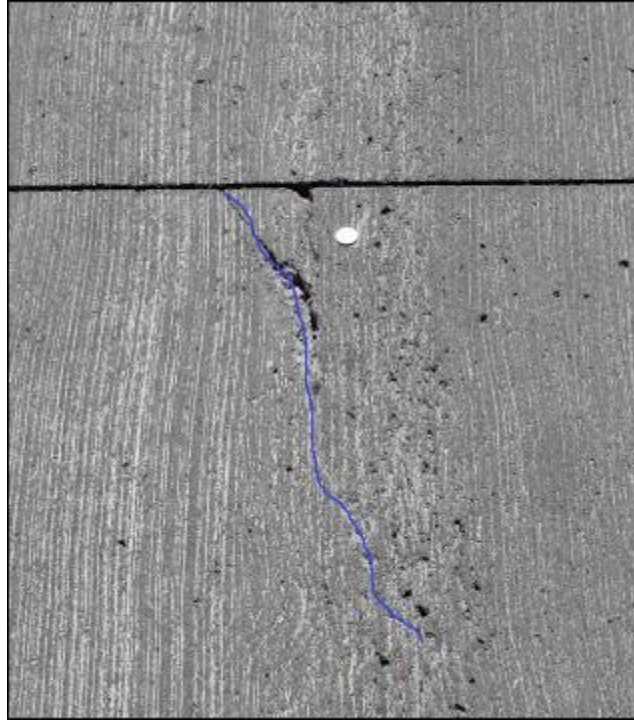
longitudinal, transverse and corner cracks that occurred in Cell 705. Cell 805, which was also constructed with a 5-inch thick unbonded concrete overlay, has smaller slabs compared to Cell 705, as shown in Table 1. This cell experienced three longitudinal cracks, four transverse cracks, and two corner cracks prior to April 2018. Figure 13 to Figure 15 show photographs of typical cracks in Cell 805. A close investigation of the distresses observed in Cells 705 and 805 reveals that both cells had the same number of transverse and corner cracks on March 13, 2018, with the only difference being that Cell 705 had one longitudinal crack and Cell 805 had none. By April 25, 2018, the number of transverse cracks sharply increased in Cell 805. Also, by that time Cell 805 had experienced three longitudinal cracks. Based on the first-year distress data alone, even though the Cell 705 had shown slightly better performance than the Cell 805, it is too soon to draw a strong conclusion that larger FRC slabs outperform the smaller FRC slabs, in terms of cracking.

Figure 13. Longitudinal crack in Cell 805.

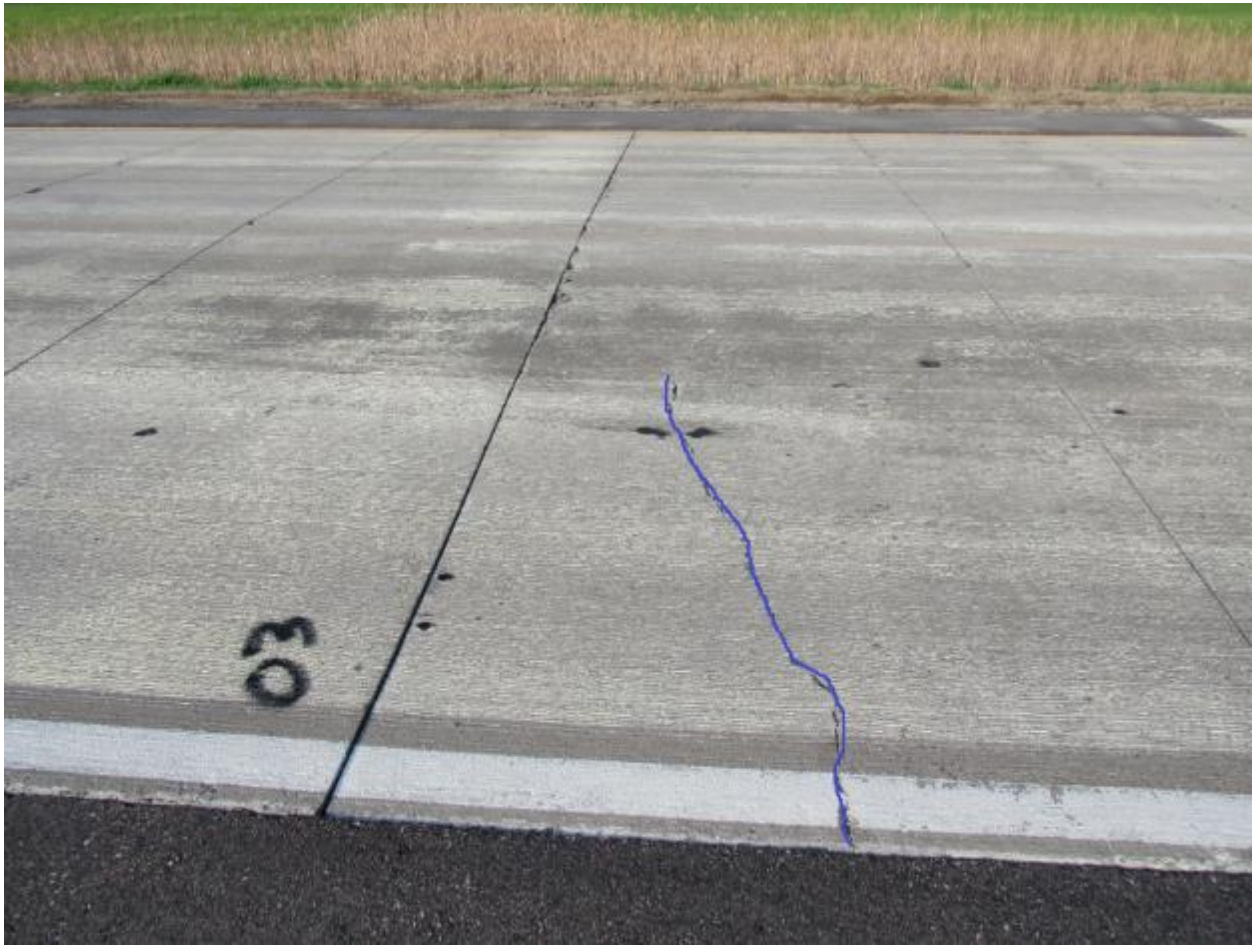
Cells 506, 706 and 806 were constructed with 5-inch thick 6ft x 6ft size slabs on a gravel base. Cell 606 was constructed with 6-inch thick 6ft x 6ft size slabs. All of these cells were constructed on the Mainline test track. Cell 506, which is the control cell constructed without any fibers, experienced one transverse crack and 15 area of spalling prior to April 2018. The spalling in Cell 506 was found to be noticeably higher than other FRC cells. Figure 16 and Figure 17 show photographs of typical transverse crack and spalling that occurred in Cell 506. A comparison of the spalling in this cell with other FRC cells poses an interesting question on whether fibers help mitigate spalling. Similar findings were reported by Barman (2014). In that study, based on the laboratory test results of 4-inch-thick 5ft x 6ft size slabs, it was found that plain concrete slabs experienced significantly greater amount spalling of than the FRC slabs.

Figure 16. Transverse crack in Cell 506 (control, non-FRC).

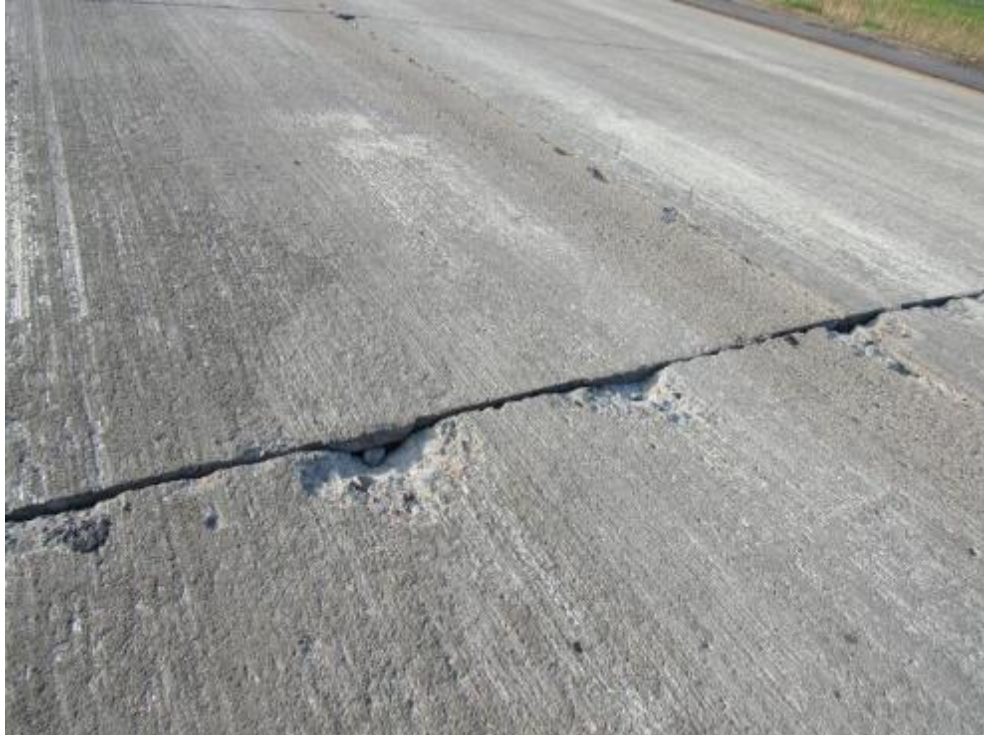
Figure 17. Spalling in Cell 506.

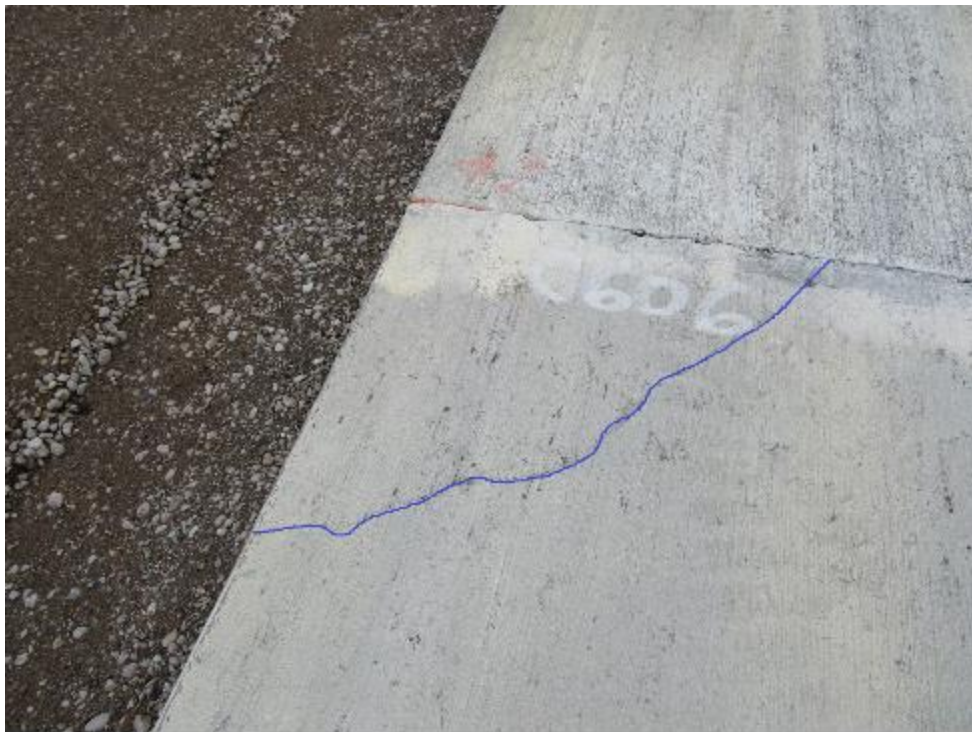
Cell 606, which was constructed with 5 lbs/cy of structural fibers, experienced one corner crack prior to April 2018. Figure 18 shows a photograph of a corner crack that occurred in the end panel of Cell 606. Cells 706 and 806, which were constructed with fiber dosages of 8 and 11.7 lbs/cy, respectively, did not experience any cracks or spalling prior to April 2018. Overall, the distress data of these four cells show that increasing the amount of fibers may decrease cracking and spalling.

Figure 18. Corner crack in the last panel of Cell 606.

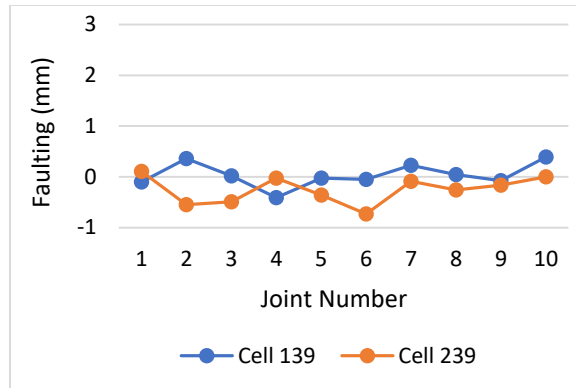
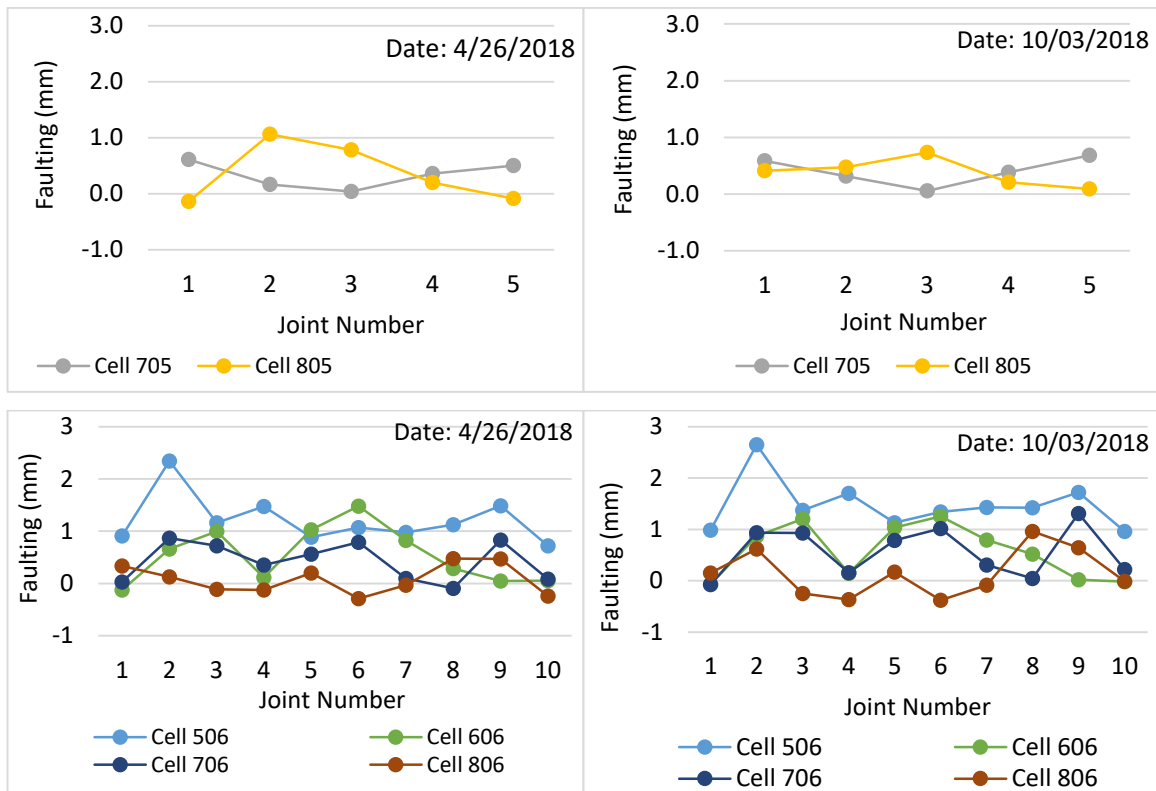
Figure 19 shows the faulting measured at various transverse joints of Cells 139 and 239 prior to April 2018. It should be noted that the surface texture depth is usually around 1 mm on average; therefore, any faulting readings below 1 mm may not be indicating any notable faulting. As previously mentioned, Cell 139 had experienced depression along the wheel path, so, it may not be appropriate to compare the faulting results between Cells 139 and 239. Interestingly, faulting results for Cell 239 showed negative values at almost every joint (where measured), except joint number 1. In general, a negative faulting value indicates that the leave side of the joint is at a higher elevation than the approach side. Negative faulting is usually not typical (Selezneva et. al., 2000), but since the magnitude of the faulting in Cell 239 is below -1 mm, it can be stated that there was not any notable faulting in the first of service, at least at the joints where the faulting values were recorded.

Figure 19 also shows the faulting at each joint that was measured for Cells 705 and 805 for two dates: April 26, 2018, and October 03, 2018. Both Cells 705 and 805 had shown mostly positive faulting. One noticeable observation was that the faulting at Joint number 2 of Cell 805 was higher in April 2018 than what was measured in October 2018. Even though the maximum measurements in these Cells were around 1 mm, in general, Cell 805 was closer to developing noticeable faulting.

Figure 19 shows the faulting magnitude at each joint that was measured for the Cells 506, 606, 706 and 806 for two dates: April 26, 2018, and October 03, 2018. Cell 506, which was

Figure 19. Faulting of different cells measured in April and October 2018.

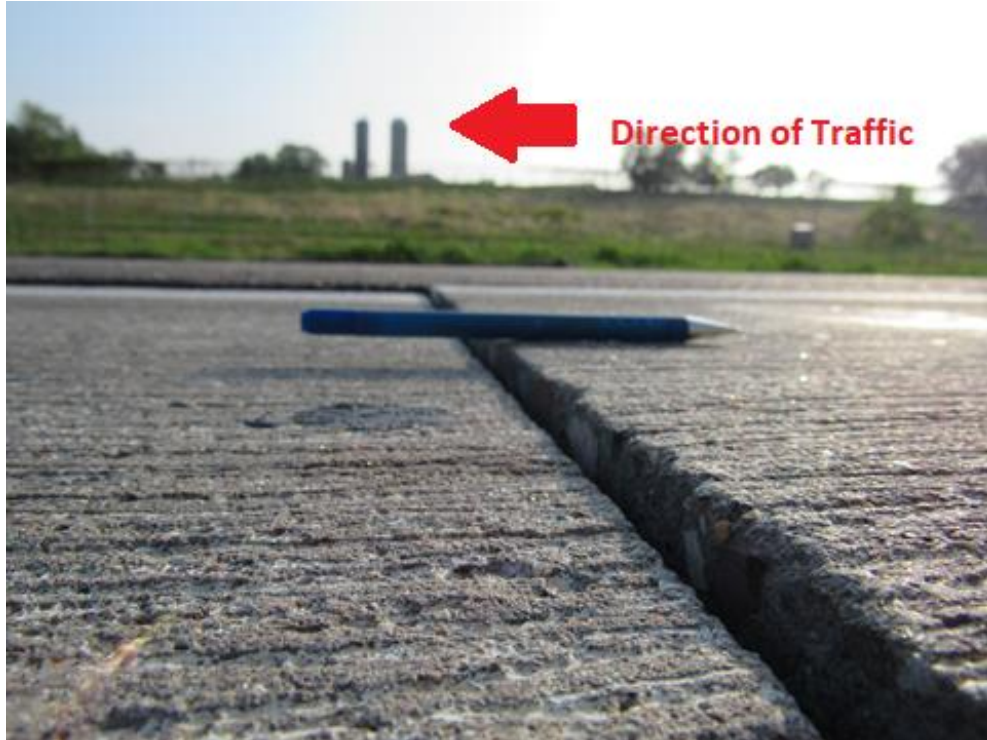
constructed with plain concrete, experienced higher faulting compared to the other three cells that had fibers. Figure 20 shows a photograph of noticeable faulting in Cell 506. (note that there is a sunken corner crack in the leave slab which exaggerates the faulting in the photo.) Figure 21 shows the trend of average faulting versus fiber dosage. It can be seen that Cell 606, which was constructed with a fiber dosage of 5 lbs/cy experienced approximately 60% less faulting than the Cell 506 until October 2018. Cell 706, with a fiber dosage of 8 lb/cy, also experienced less faulting than Cell 06. Cell 806 which had the highest fiber dosage at 11.7 lbs/cy, experienced significantly lower faulting compared to any other FRC cell. Based on the designs considered in this study, early indications are that an adequate dosage of fibers is likely to reducing faulting.

Figure 20. Photograph of faulting of Cell 506 (non-FRC). Note that faulting is exaggerated due to broken corner in slab on leave slab.

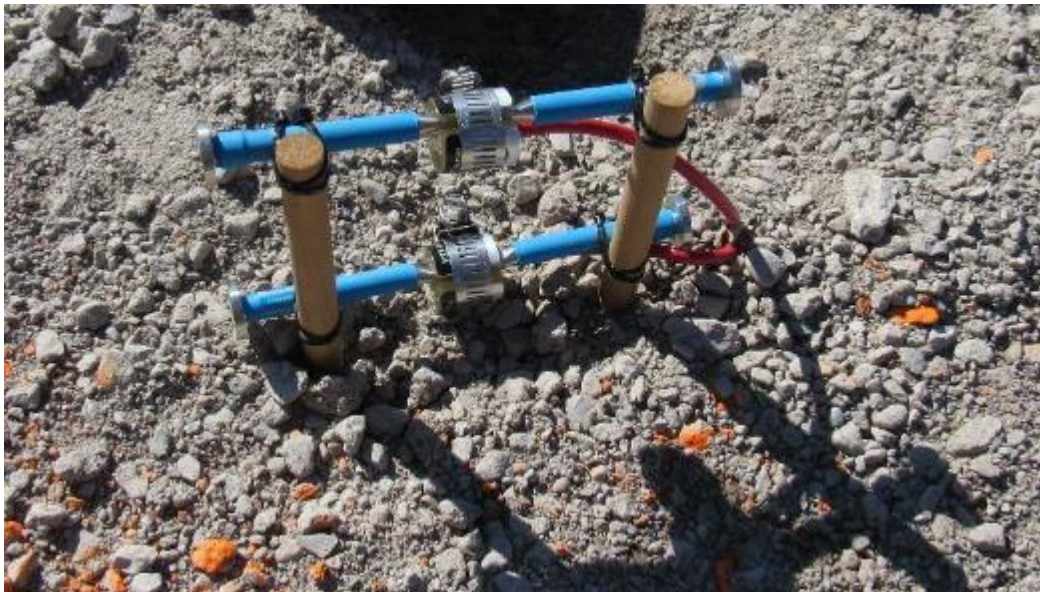
Figure 43. Photograph of a vibrating wire sensor.

Vibrating wire sensors were installed in all of the MnDOT 2017 FRC research cells to measure the environmental strain that occurs in the slabs and to investigate the trends of this strain with respect to fiber dosage and pavement design features. A photograph of a vibrating sensor is shown in Figure 43. The raw data from this type of sensor are converted to estimate the environmental strain that is exerted on the concrete as a result of the change in the moisture state, temperature and temperature gradient, freezing of underlying layers, and joint locking. MnDOT has an established procedure for converting the raw vibrating wire data into a meaningful strain. One of the important steps in the vibrating wire data analysis procedure is to determine the initial strain value, which corresponds to the first reading when the concrete has hardened sufficiently to fully engage the sensor, and the temperature gradient between the nearby top and bottom temperature sensors is approximately 0. This serves as the initial or baseline value for subsequent readings. In order to determine the above-mentioned initial strain value, temperatures at the top and bottom of the slab and the raw frequency data are plotted together. An example of such plots is provided in Figure 44; these plots are related to one of the vibrating sensors of Cell 139 (Sensor 1, longitudinal direction). Using these plots, the time of the first 0 temperature gradient after the raw frequency data started proper cycling is determined; the

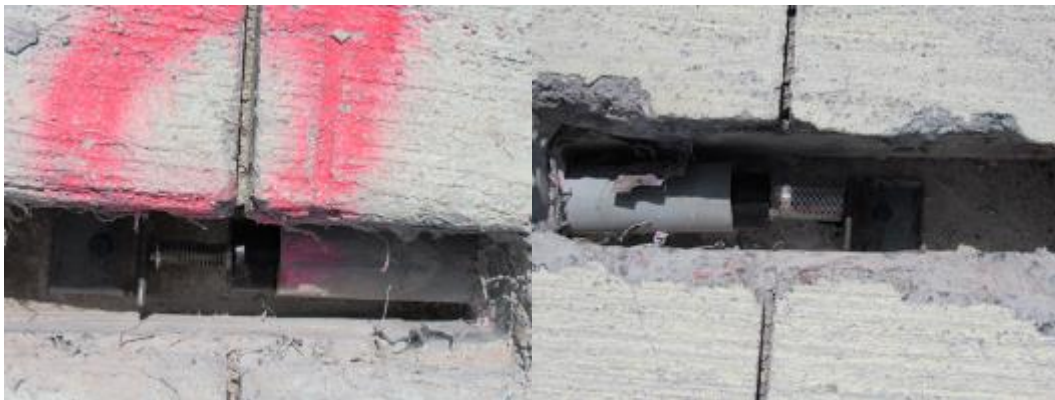
Figure 55. Sketch and photographs of joint opening sensors before installation of protective covering.

A new type of joint opening sensor (spring-loaded potentiometer) was installed in MnROAD 2017 FRC research cells. A sketch and two photographs of such a joint opening sensor is provided in Figure 55. The goal of using this type of sensor is to track joint movement constantly throughout the year rather than manually measuring at certain time intervals. Figure 56 shows a plot of relative joint opening recorded by a joint opening sensor in Cell 506. The first reading was used to zero the subsequent joint opening readings. In this figure, it can be seen that there are two jumps in joint movement data, one in August of 2017 and the other one was in around October of 2017. The second jump is related to the reinstallation of the sensor.
