# **REDUCED CEMENTITIOUS MATERIAL IN OPTIMIZED CONCRETE MIXTURES: ANNUAL CELL PERFORMANCE REPORT**

**Task 2B: Annual Cell Performance Report**

National Concrete Pavement Technology Center

National Road Research Alliance Transportation Pooled Fund

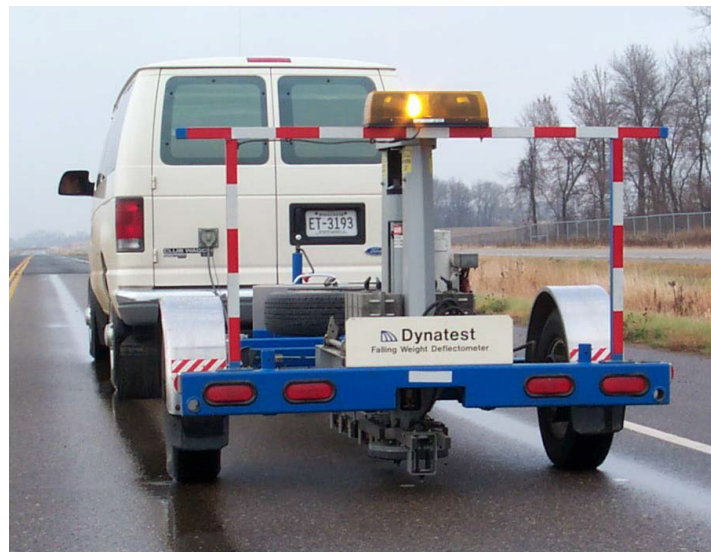
Figure 3- MnDOT's FWD tester

Falling weight deflectometer (FWD) test was conducted on pavement cast with reduced cement content and reference mixture according to the following matrix. Note that the reference cell (Cell 524) is 6.0 in. thick, while the 138 and 238 Cells were 8.0 in. thick. MnDOT's FWD tester, conforming to requirements of the ASTM E2583 was used for testing the cells. The test setup is shown in Figure 3 .

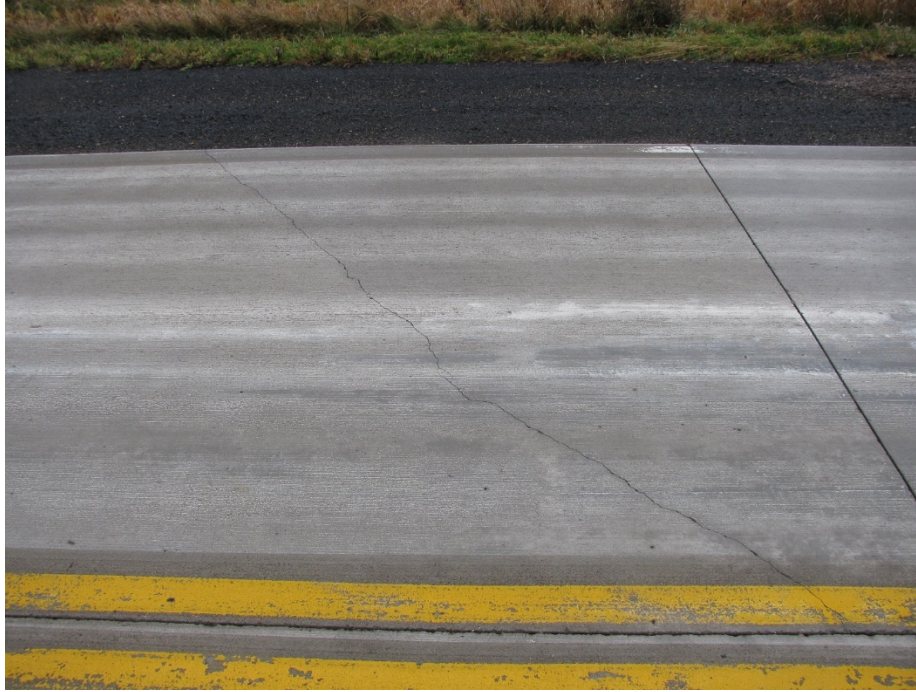
Figure 22- Cracking occurred on inside lane at Cell 138

During the distress survey conducted in November 2018, a diagonal crack was observed in the traffic lane of Cell 138. The crack starts about 1.0 ft. from the intersection of the transverse and longitudinal joints and continues with an almost 45 degrees angle towards the shoulder of the inside lane as presented in Figure 22. Potential problems with base and/or subgrade may have contributed to formation of the cracks. Stresses caused by traffic loading can be another reason for cracking in this panel. The research team will monitor the crack and further investigate the potential cause for distress.

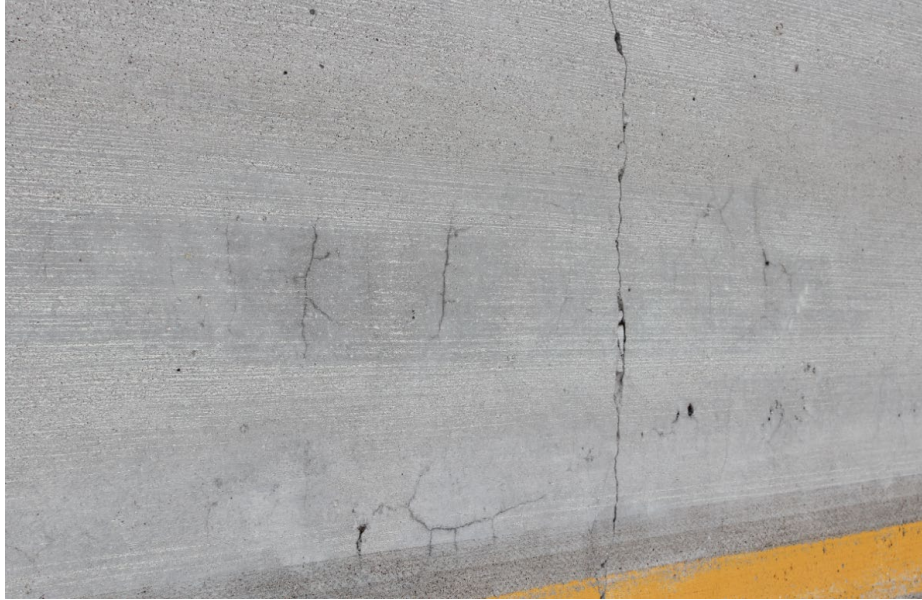
Figure 24- Further distress in form of cracking near the wheel path at Cell 238

Site visit and coring was conducted on November 6, 2018 to further elucidate the reason for progressive cracking at Cell 238. In-situ investigations suggested that the main transverse cracking at this location was induced by the utility line underneath the pavement (Figure 25).

In collaboration with staff at MnROAD, the research team obtained four cores from Cell 238 to further investigate the reason for the observed distress. Two of these cores (C-1 and T-1) were extracted from the concrete adjacent to the transverse crack as shown in Figure 25. Core C-1 was obtained from the outside lane and core T-1 was obtained from the inside lane (exposed to traffic). Moreover, two cores were extracted (C-2 and T-2) from a panel with no cracking to serve as the reference (Figure 26). It should be noted that in each location, cores were obtained from both the inside and outside lanes to understand the potential effect of traffic loading (if any) on the observed distress. The pavement thickness at the distress area was about 8.0 in. compared to 9.0 in. for the panel with no sign of distress.

- In-situ inspection indicated proper performance of the investigated cells during the first two years. Distress observed at Cell 238 was attributed to the segregation of concrete that caused further cracking adjacent to the existing transverse crack induced by utility line.

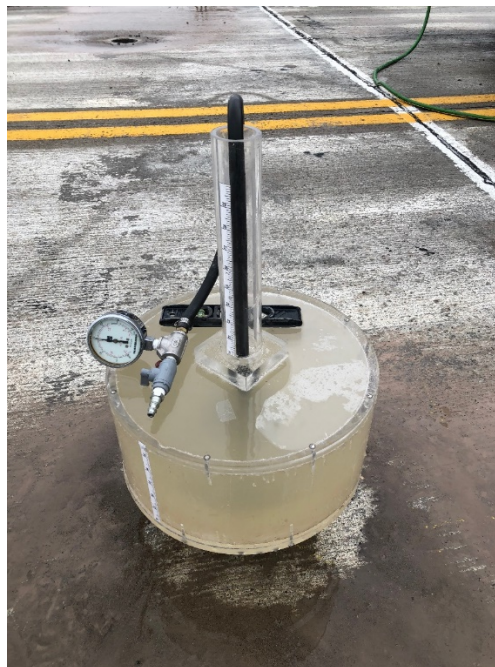
Figure 27- Borehole permeability test setup

Borehole permeability test was also conducted to compare the permeability of the base layer at the coring spots (ASTM D6391). This test involves monitoring the rate of water infiltration through the base layer using a standpipe with a falling head. The test setup is presented in Figure 27.

Drop in water level was monitored over time and the average rate of flow during periods of stable measurements was reported for each coring spot. Stable readings were obtained for core holes number T-1, T-2, and C-2. However, the run off through concrete cracks made it impossible to obtain stable readings for the C-1 location. Higher base permeability was observed for the area with no distress as presented in Table 15.

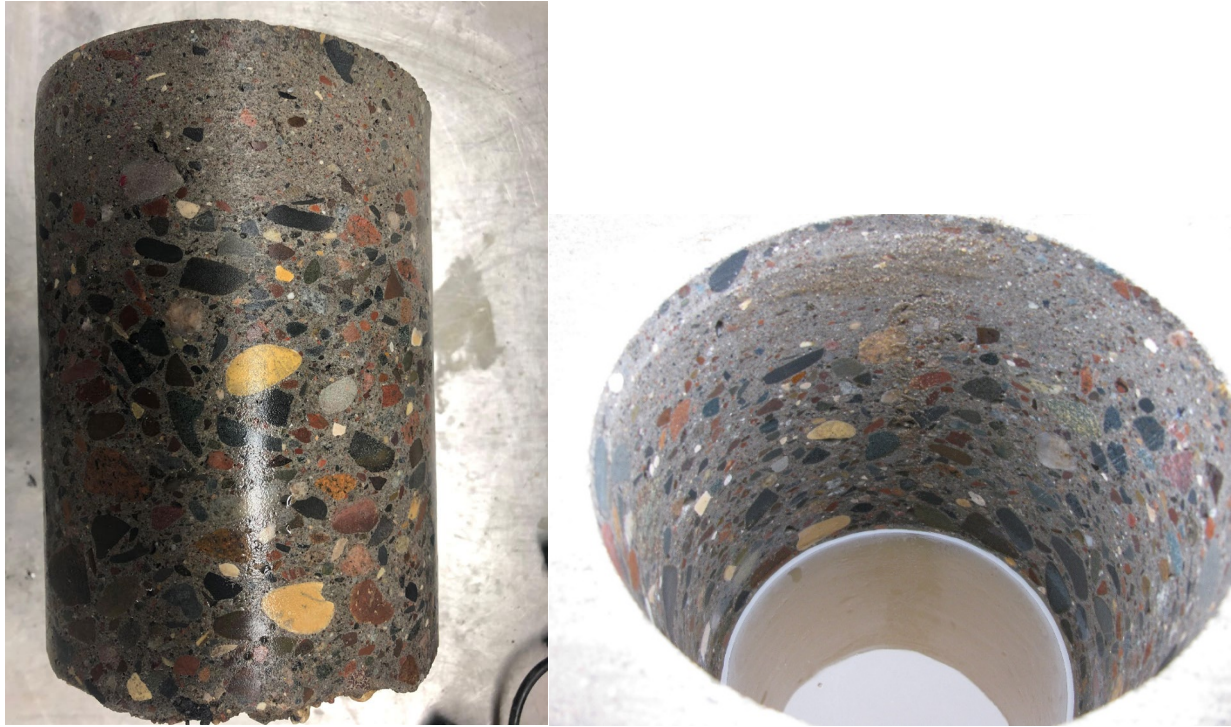
Figure 28- Segregation of coarse aggregate in distress area; Core T-1 (Left) and corresponding core hole (Right)

The visual inspection of the Core T-1, extracted from the main distressed area revealed segregation of coarse aggregates from mortar as presented in Figure 28. No such problem was observed for the rest of the cores. Such a segregation can lead to limited contribution of coarse aggregates in restraining the mortar during shrinkage. Moreover, reduced local modulus of elasticity, along with the stresses exerted by traffic loading in the area adjacent to the transverse crack can be considered as the other contributors to the distress observed in Cell 238. Potential problems with base and/or subgrade can also contribute to formation of the cracks as a result of punching forces exerted by the traffic load.

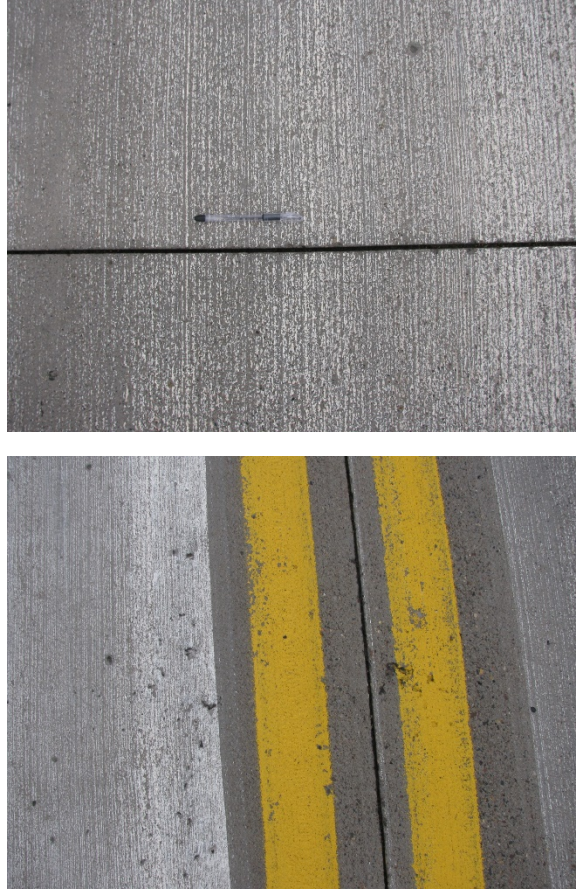
Figure 29- Typical surface quality at Cell 138 (top), and finishing issues observed at Cell 238 (Bot.)

As of November 2018, the distress in Cells 138 and 23 was limited to the reported cracks. So far the in-situ inspection of the cells exposed to environmental conditions and traffic loading, indicated proper quality of the pavement surfaces at both cells. No issues were observed for the surface texture at Cell 138. Finishing problems were occasionally observed at pavement surfaces in Cell 238. This is believed to be due to the lower workability of the mixtures with lower cementitious materials content as stated in previous reports. Figure 29 presents examples of typical surface quality at Cell 138, along with the observed finishing problems at Cell 238.

- Finishing problems were observed in some areas of Cell 238 which is in agreement with data obtained from workability measurements during the paving. The mixture prepared with low cementitious materials content of  $500 \text{ lb}/\text{yd}^3$  exhibited acceptable workability based on VKelly and Box test results. Slight workability problems were observed for the mixture with lower cementitious materials content of  $470 \text{ lb}/\text{yd}^3$ .
