# **REDUCED CEMENTITIOUS MATERIAL IN OPTIMIZED CONCRETE MIXTURES: ANNUAL CELL PERFORMANCE REPORT**

**Contract Number:** (C) 1003320 (WO) 3

**Task 2C: Annual Cell Performance Report**

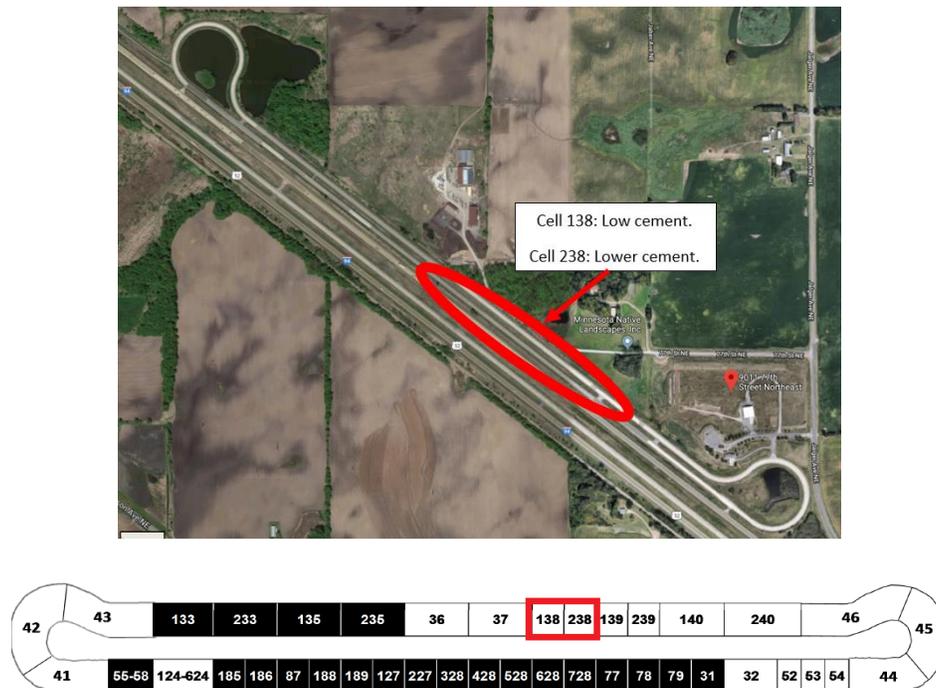
Figure 1- Aerial photo (top) and schematic view (bot.) of the investigated cells

The low cementitious test cells 138 and 238 are contiguously located on the LVR as presented in Figure 1. A concrete mixture with 500 lb/yd<sup>3</sup> of cementitious materials was used for building cell 138 and designated as the low cementitious mixture, while another similar mixture proportioned with 470 lb/yd<sup>3</sup> of cementitious materials content was used for cell 238 and designated as the lower cementitious mixture in this report. Data obtained from these two cells were compared to those gathered from testing the cell 524 proportioned with 570 lb/yd<sup>3</sup> of cementitious materials that serves as the reference cell in this study.

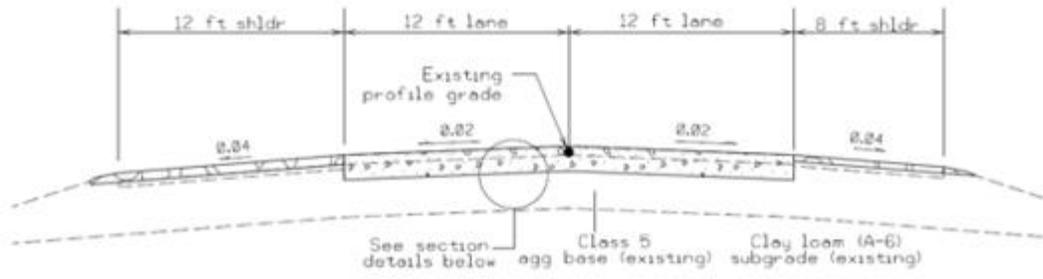
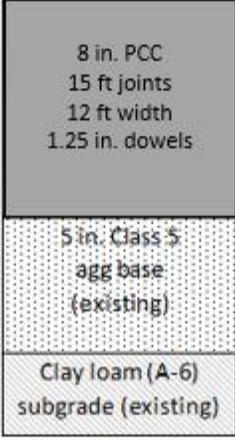
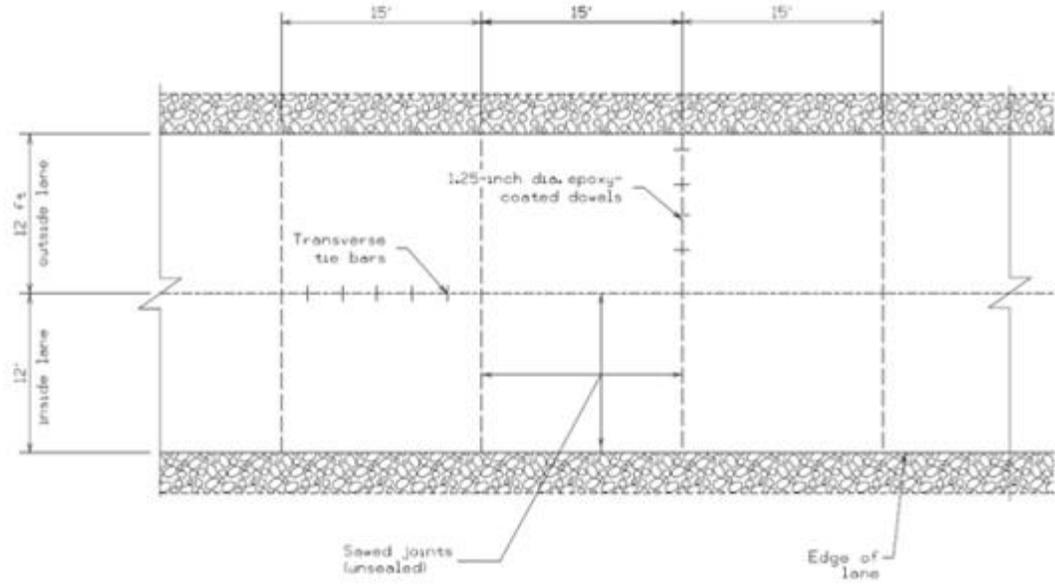
Figure 2- Pavement construction details

- Base: 5.0 in. Class 5 aggregate base
  - Subgrade: Clay loam (A-6)

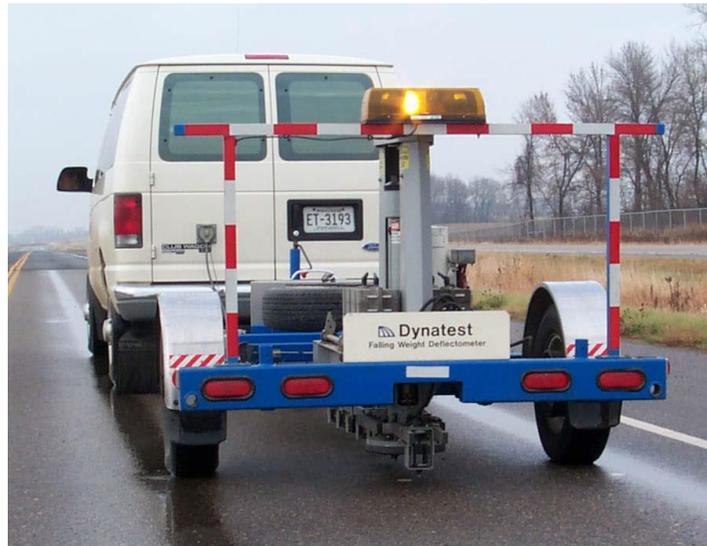
Figure 3- MnDOT's FWD tester

Falling weight deflectometer (FWD) test was conducted on pavement cast with reduced cement content and reference mixture according to the following matrix. Note that the reference cell (cell 524) is 6.0 in. thick, while the 138 and 238 cells were 8.0 in. thick. MnDOT's FWD tester, conforming to requirements of the ASTM E2583 was used for testing the cells. The test setup is shown in Figure 3 .

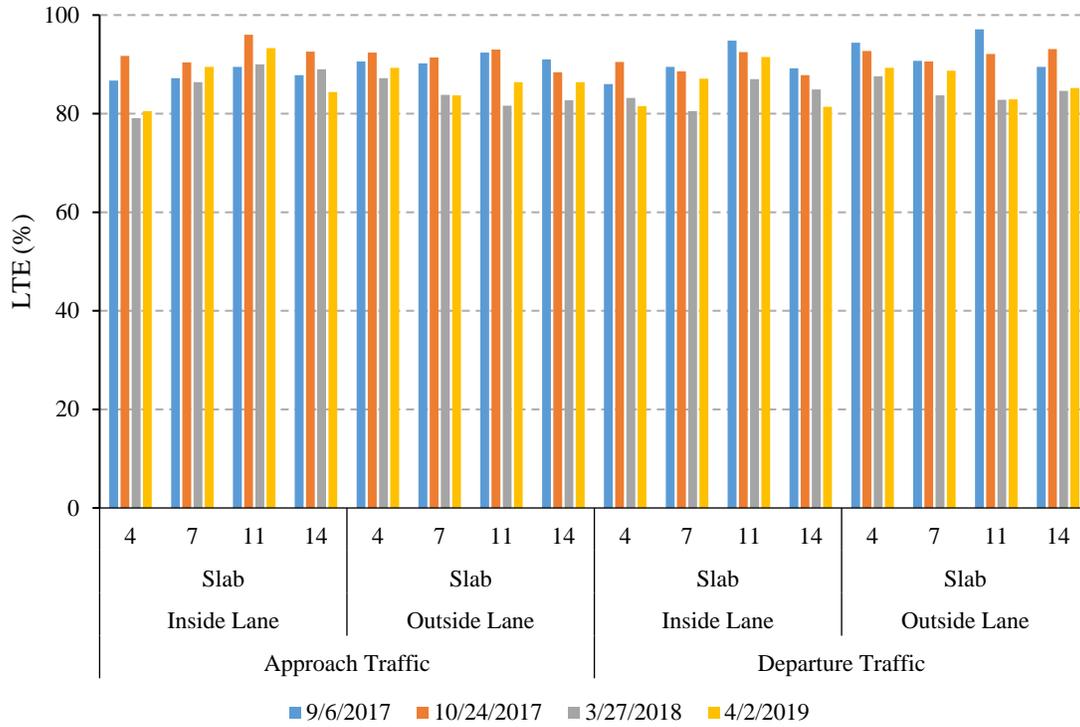
Figure 4- Average LTE data obtained for concrete with low cement content (cell 138)

Results are summarized in Figures 4 to 6 for the pavement cast with low cement, lower cement, and reference concrete mixtures, respectively. The values reported in these figures summarize the data obtained for both inside and outside lanes exposed to approach and departure traffic, also known as “Before Joint” and “After Joint” measurements, respectively. Scatter in data makes it difficult to draw trend lines. However, a general trend of slight reduction in LTE values can be observed over time.

- Test slab: P-value = 0.0019. In other words, the variations in LTE results obtained for different slabs were statistically significant.
- Traffic lane: P-value = 0.190. In other words, the variations in LTE results obtained for different traffic lanes were not significant.
- Traffic direction: P-value = 0.754. In other words, the variations in LTE results obtained for different traffic directions were not significant. This is in agreement with the linear correlation previously observed for the approach and departure traffics in Figure 4-a.

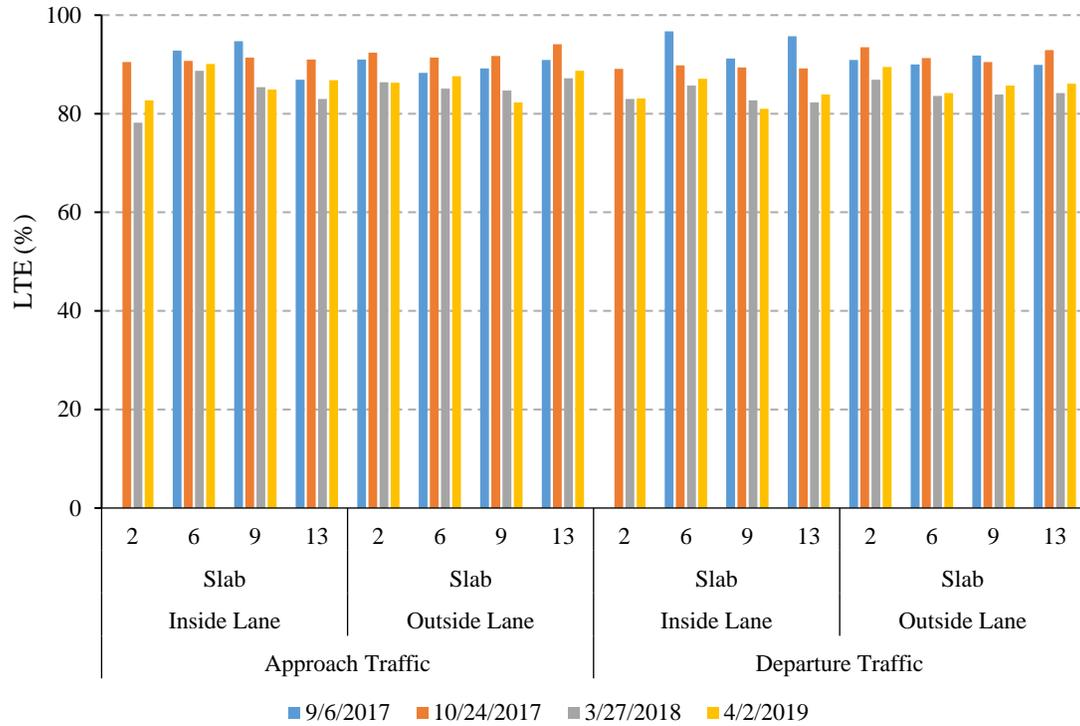
Figure 5- Average LTE data obtained for concrete with lower cement content (cell 238)

Similar data were obtained from cell 238, indicating comparable LTE for the departure and approaching traffics for both lanes. For the inside lane, the LTE ranged from 78% to 95% for the approaching and from 81% to 97% for the departure traffic, respectively. LTE results were between 83% and 94% for the outside lanes, regardless of the traffic direction.

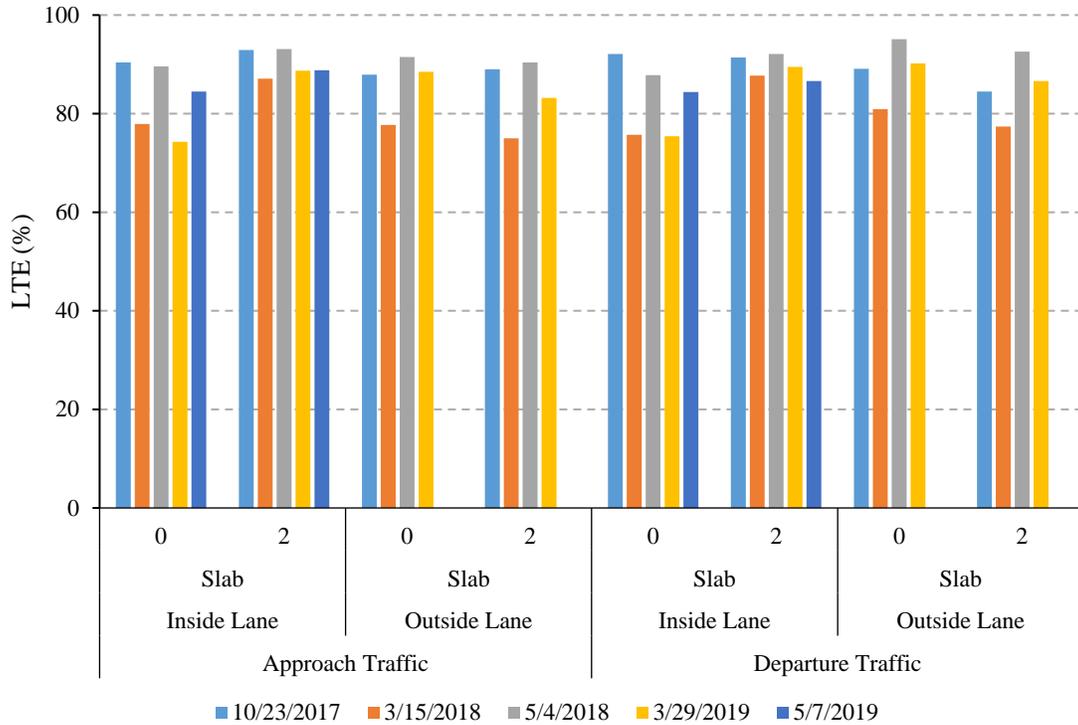
Figure 6- Average LTE data obtained for reference concrete (cell 524)

Slight reduction in LTE was observed for the reference pavement with average data between 85% and 91%. This can be due to the lower thickness of the reference cell compared to the low cement sections.

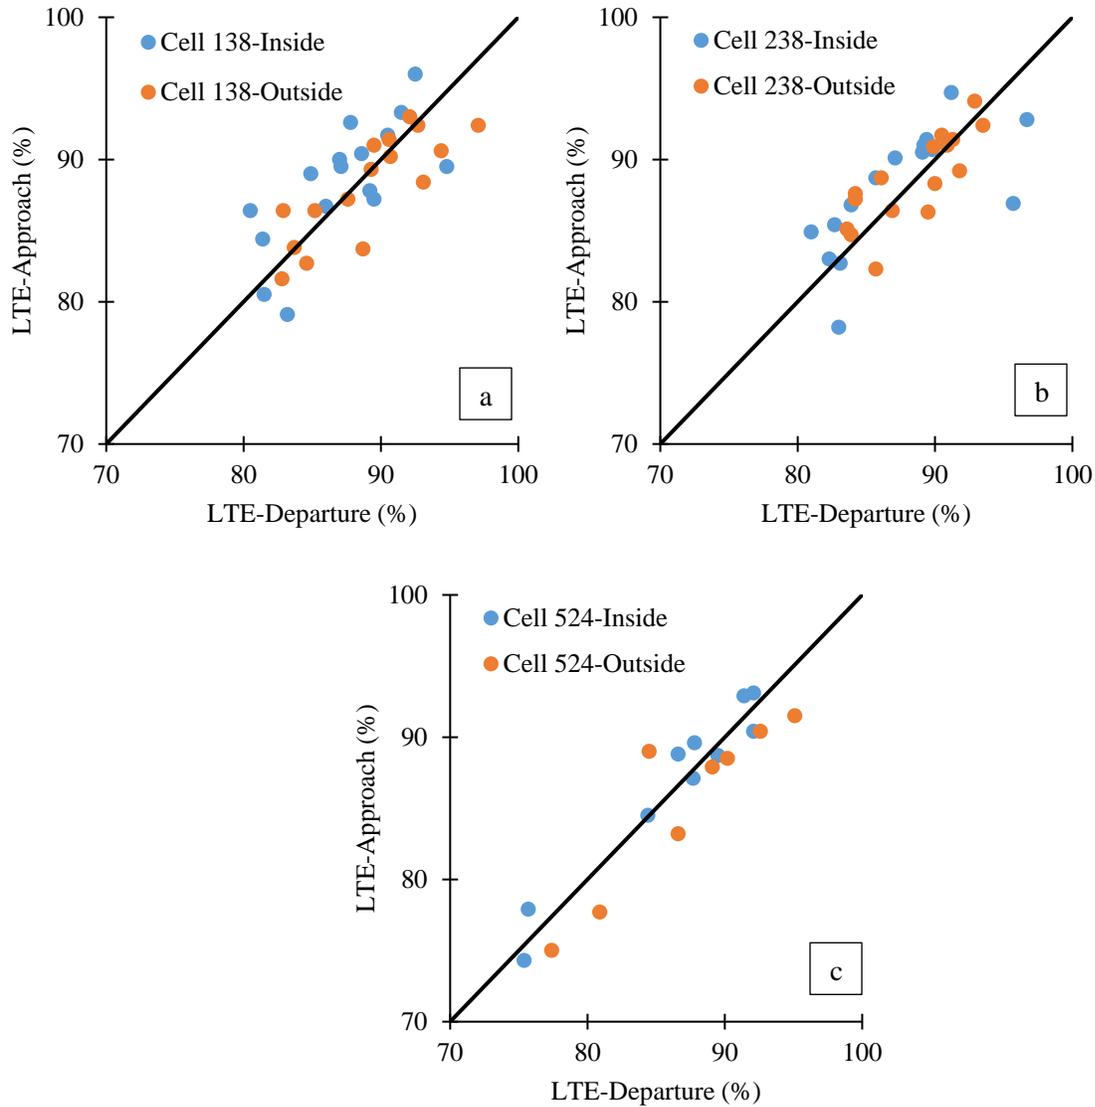
Figure 7- Variation in LTE as a function of traffic direction for low cement concrete (a), concrete with lower cementitious content (b), and reference mixture (c)

The LTE data as a function of traffic direction are summarized in Figure 7. In general a linear correlation was observed for the LTE values obtained for the approaching and the departure traffic. In general the LTE values obtained for cells 138 and 238 were comparable, indicating similar load transfer characteristics for these two cells. For both cells, the comparison between the LTE values for departure and approaching traffic indicated higher scatter in LTE values for the inside lane exposed to regular traffic loading. In summary, the LTE values obtained for cells 138 and 238 suggested uniform performance during the first three years.

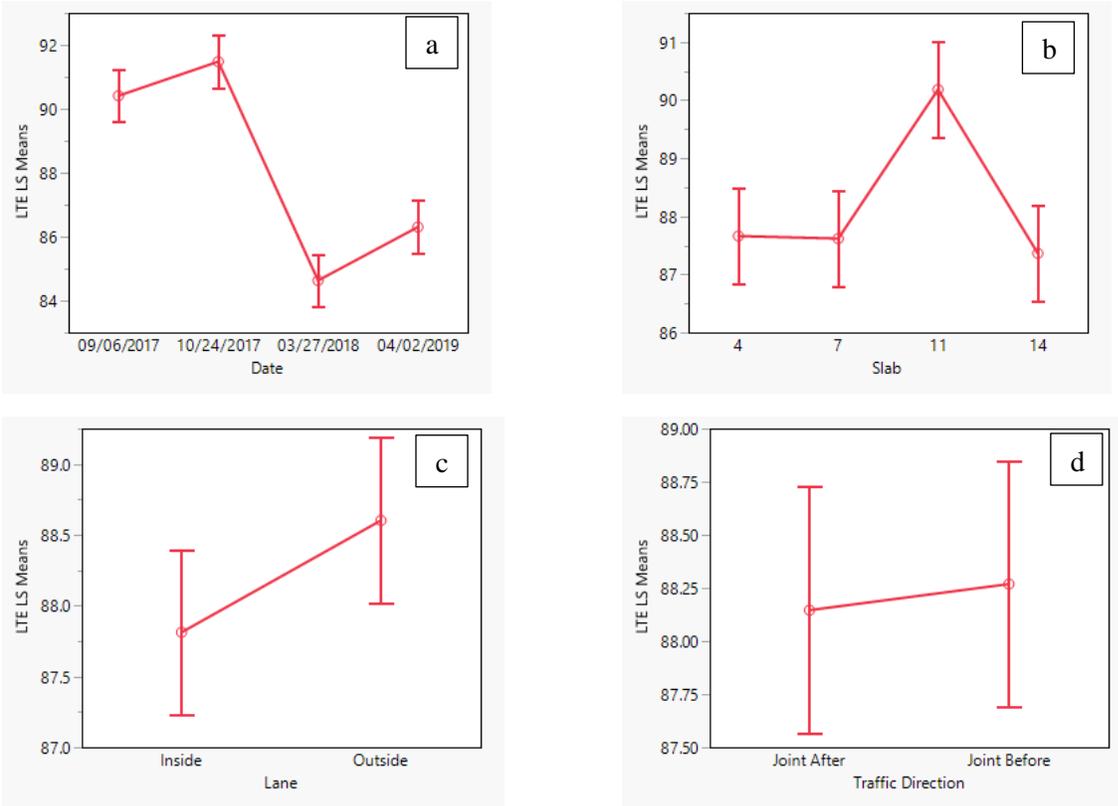
Figure 8- Least square means plots for LTE values of cell 138 as a function of test date (a), slab number (b), lane (c), and traffic direction (d)

Given the fact that over 190 data points were included in these comparisons, which was more than the typically recommended limit of 30 points, it was also considered to assume normal distribution of the LTE data and perform additional parametric testing. Results were in agreement with findings of the non-parametric comparisons, as summarized in Table 2. Test date and slab number were proved to have significant effects on LTE data with P-values lower than 0.05. The least square means plots obtained for different input factors are summarized in Figure 8. Tendency for reduction in LTE over time was observed. Results also exhibited higher LTE values for the outside lane (not exposed to traffic).

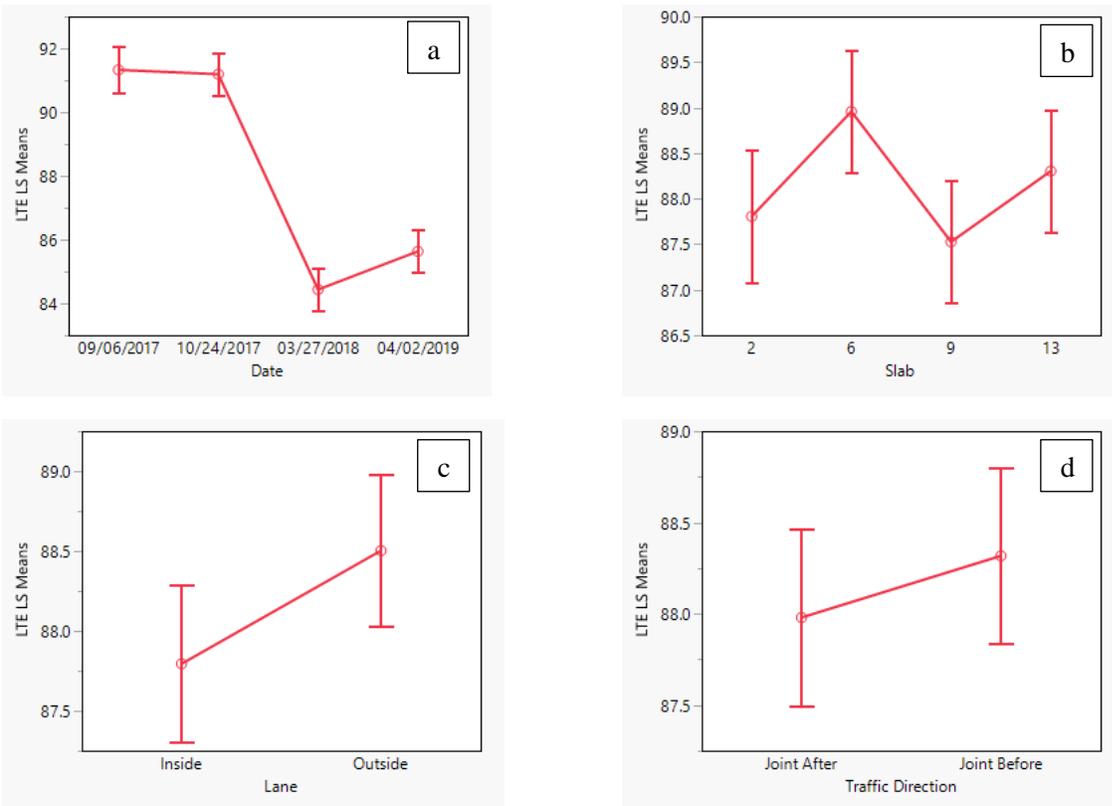
Figure 9- Least square means plots for LTE values of cell 238 as a function of test date (a), slab number (b), lane (c), and traffic direction (d)

cell 138, tendency for reduction in LTE over time was observed. Results also exhibited higher LTE values for the outside lane.

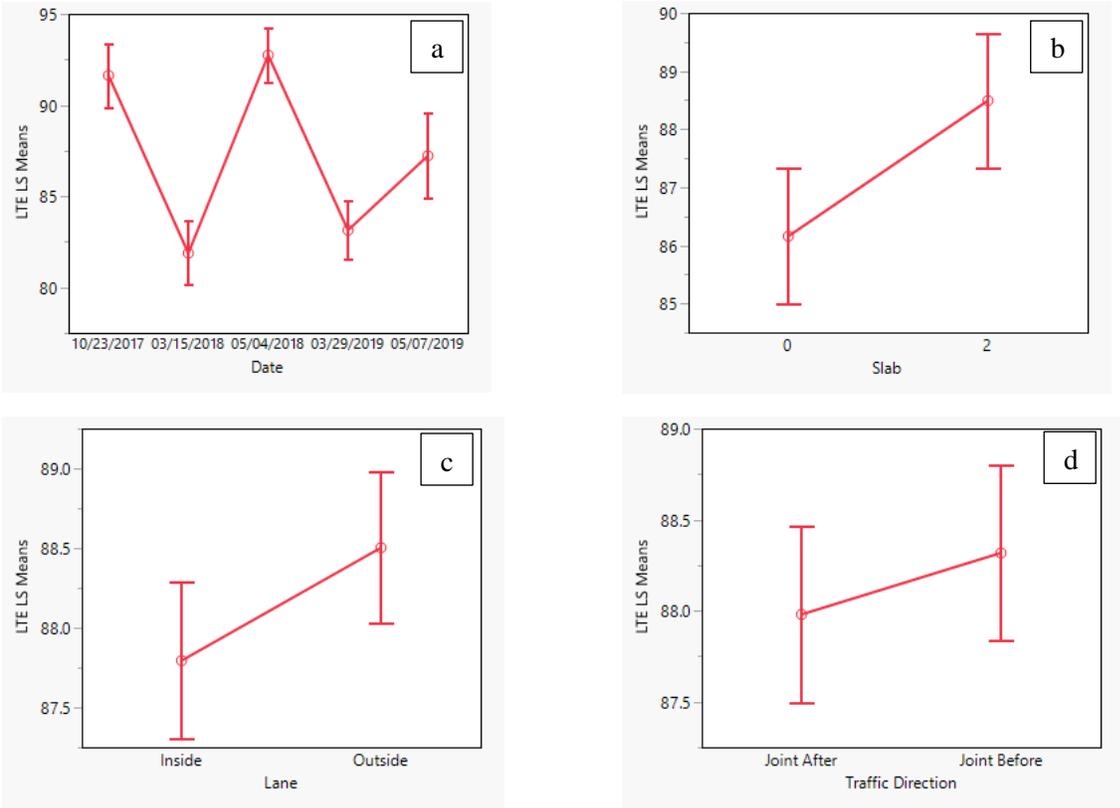
Figure 10- Least square means plots for LTE values of cell 524 as a function of test date (a), slab number (b), lane (c), and traffic direction (d)

Considering the availability of over 120 data points, parametric testing was also performed with the assumption of normal distribution of LTE data. Results were in agreement with the non-parametric study as summarized in Table 4. Based on the data presented in this table, test date, slab number, and traffic direction had significant effects on LTE results (all with P-values lower than 0.05). Least square means plots obtained for different input factors are summarized in Figure 10. A scatter in LTE data over time was observed, with a tendency for reduction over time. Results also exhibited higher LTE values for the outside lane.

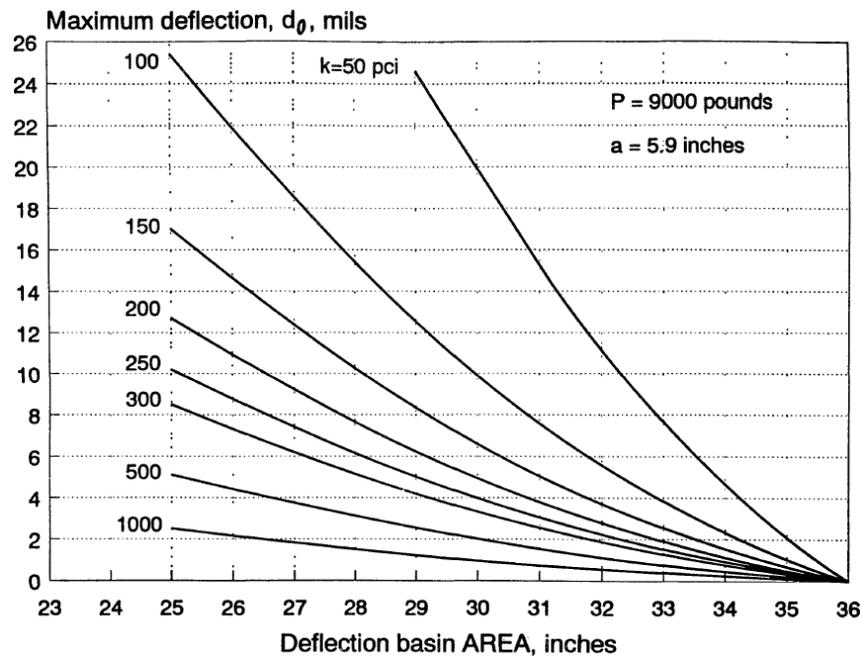
Figure 11- Dynamic k-value as a function of AREA and deflection at the center of the loading plate, borrowed from AASHTO (1993)

Figure 11 proposed by AASHTO (1993) was then used for calculation of the dynamic K-value based on the calculated AREA and deflection at the center of the loading plate (mils).

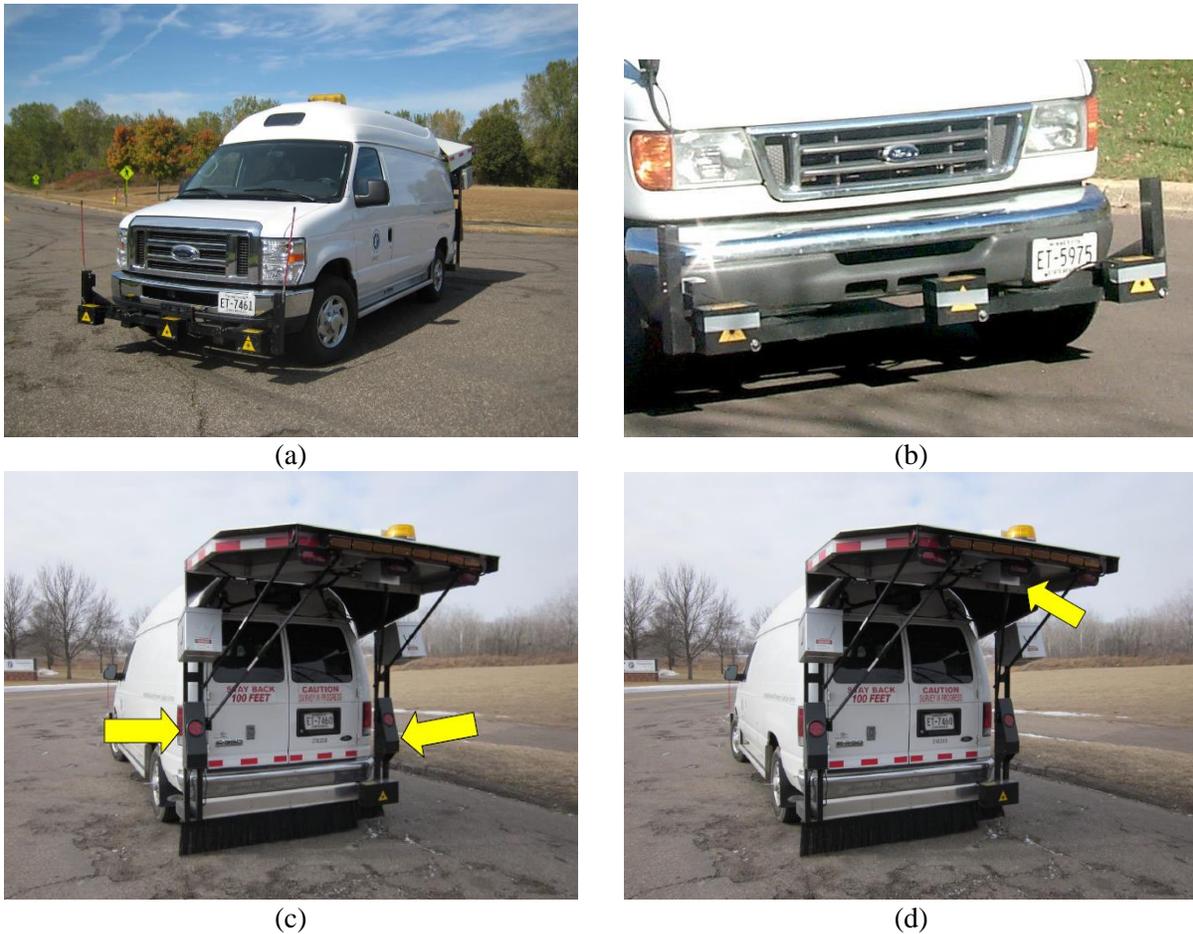
MnDOT's Digital Inspection Vehicle (DIV) shown in Figure 12 was used for collection of the ride quality data in terms of International Roughness Index (IRI) and Ride Quality Index (RQI). Lasers are mounted across the front bumper of the test vehicle to measure roughness and faulting of pavement test sections. The lasers measure the pavement's longitudinal profile, and vertical deviations from a flat surface are indicative of roughness. They take a measurement approximately every 1/8-inch as the van travels down the roadway at highway speed. There are additional lasers used for rut (wear) depth measurements mounted at the rear of the vehicle.

Figure 12- MnDOT's Digital Inspection Vehicle (DIV). (a) Pathways Services Inc. Van, (b) lasers used for measuring roughness and faulting, (c) 3-D measurements lasers, and (d) 3-D camera used to record pavement distress

MnDOT’s Digital Inspection Vehicle (DIV) shown in Figure 12 was also used for measuring wear depth and surface macro texture. Macro texture measurements were performed on 11/03/2017, 11/30/2017, 07/09/2018, and 07/14/2018 for the reference (524), low cement (138), and lower cement (238) cells. Three measurements were obtained for each test date. The average values and corresponding standard deviations are presented in Figure 19. Data obtained for reference cell (cell 524) seem to be slightly higher than those obtained for low and lower cement sections. However, one should note that the results are generally close and comparable. A slight increase in macro texture depth was observed over time and regardless of the concrete type. This is specially highlighted for the inside lanes (exposed to traffic).

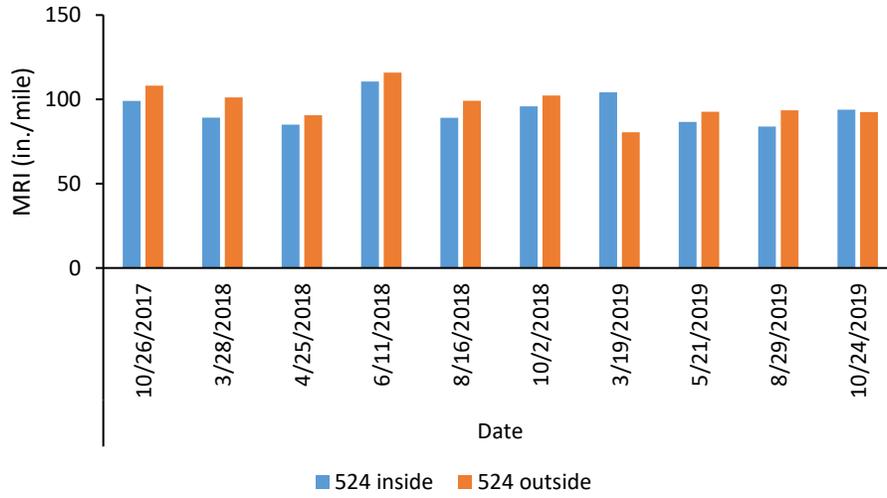
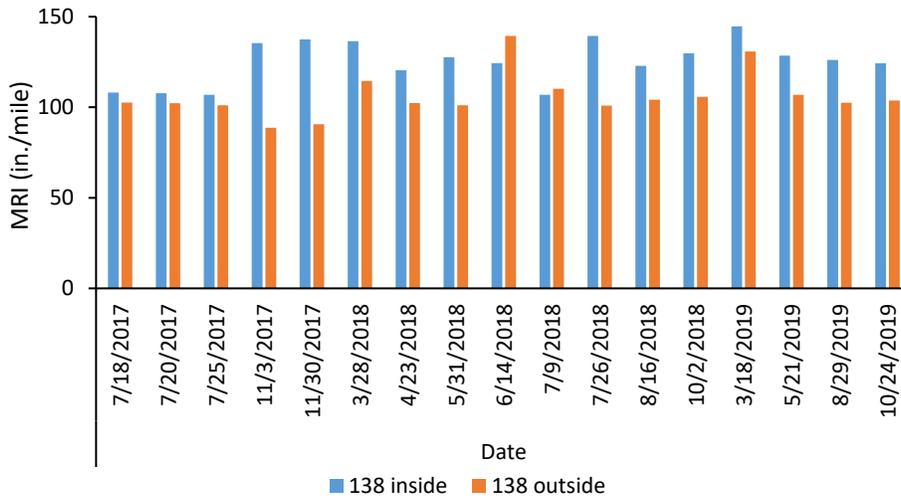
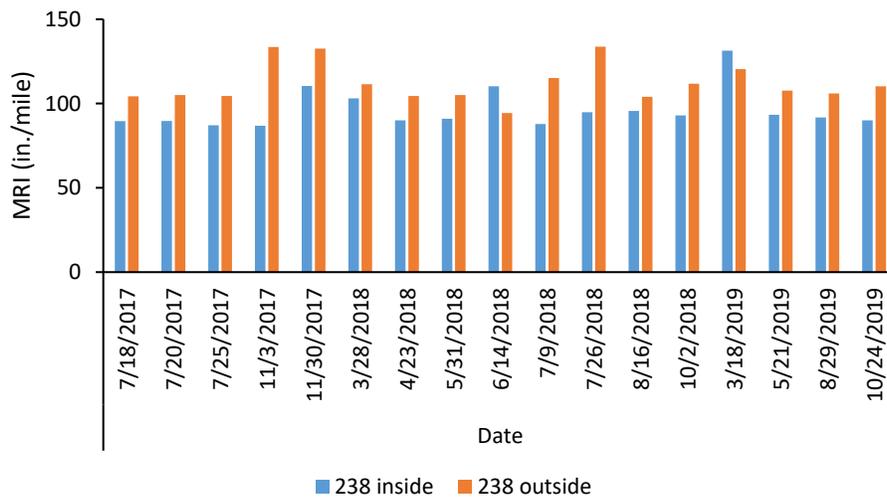
Figure 14- Variation in MRI (in./mile) values as a function of time

Tables 10-12 summarize the IRI data obtained for the investigated pavement. The reported data are the average of three IRI readings from both the right and left wheel tracks, along with the corresponding Mean Roughness Index (MRI) values. Figure 14 also presents the variation in MRI values over time, for both the inside and outside lanes of the investigated cells during the first three years.

MRI values observed for cell 524 seem to be slightly lower than those observed in cells 138 and 238. One should also consider the difference in thickness of the investigated pavements, where the reference cell is 6.0 in. thick, compared to 8.0-in. thick pavement at cells 138 and 238.

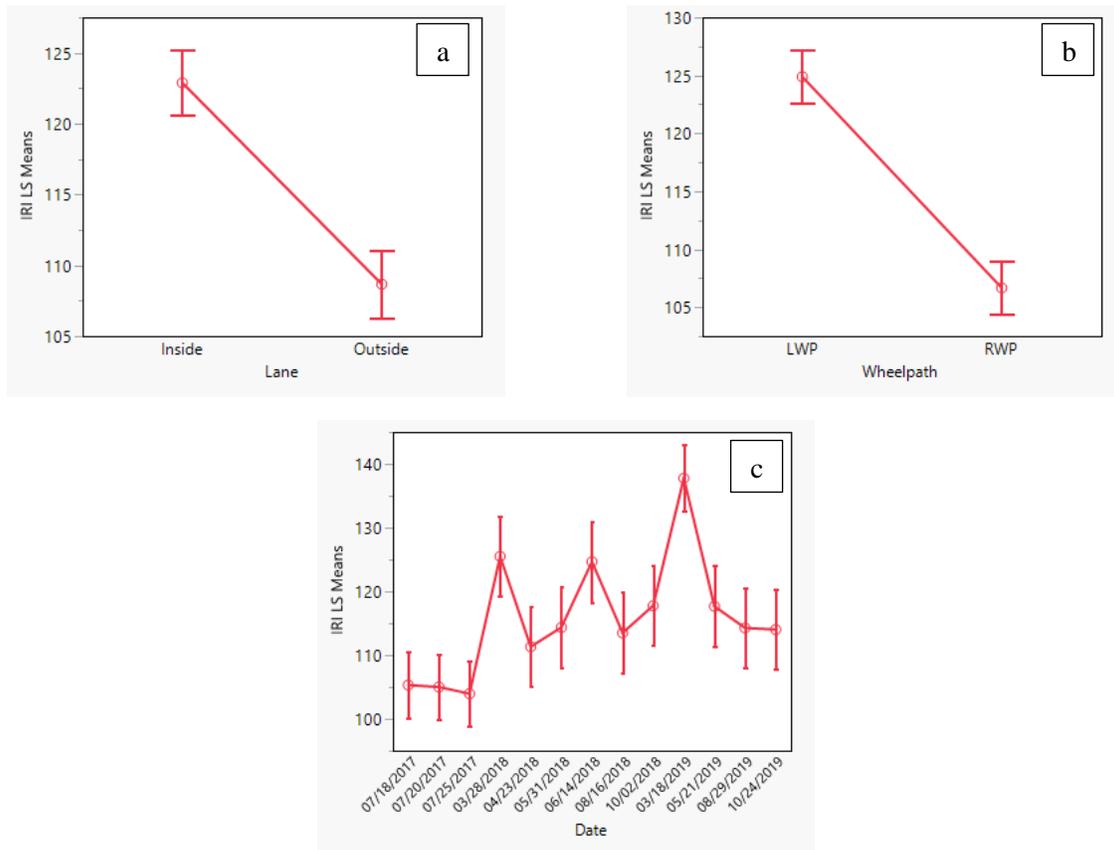
Figure 15- Least square means plots for IRI values of cell 138 as a function of lane (a), wheel path (b), and test date (c)

Given the fact that over 120 data points were included in these comparisons, which was more than the typically recommended limit of 30 points, it was also considered to assume normal distribution of the IRI data and perform additional parametric testing. Results were in agreement with findings of the non-parametric comparisons, as summarized in Table 13. All three factors (date, lane, and wheel path) were proved to have significant effects on IRI data with P-values lower than 0.05. Least square means plots obtained for different input factors are summarized in Figure 15. In general it was observed that the IRI values were lower for the outside lane and for the right wheel path. A tendency for time-dependent increase in IRI values was also observed.

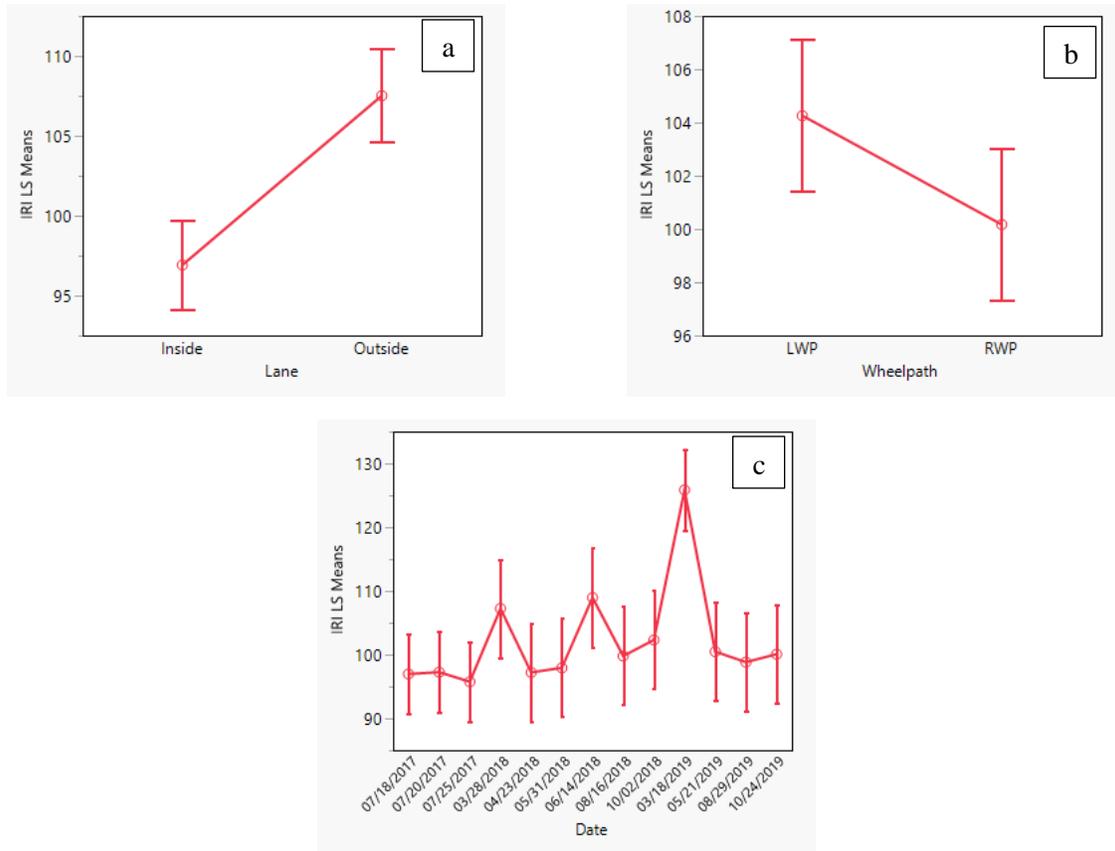
Figure 16- Least square means plots for IRI values of cell 238 as a function of lane (a), wheel path (b), and test date (c)

Given the fact that over 120 data points were included in these comparisons, which was more than the typically recommended limit of 30 points, it was also considered to assume normal distribution of the IRI data and perform additional parametric testing. Not all the results were in agreement with findings of the non-parametric comparisons, as summarized in Table 14. All three factors (date, lane, and wheel path) were proved to have significant effects on IRI data with P-values lower than 0.05. Least square means plots obtained for different input factors are summarized in Figure 16. A tendency for time-dependent increase in IRI values was also observed. Lower average IRI values were observed for the right wheel path. However, higher IRI data was observed for the outside lane at cell 238.

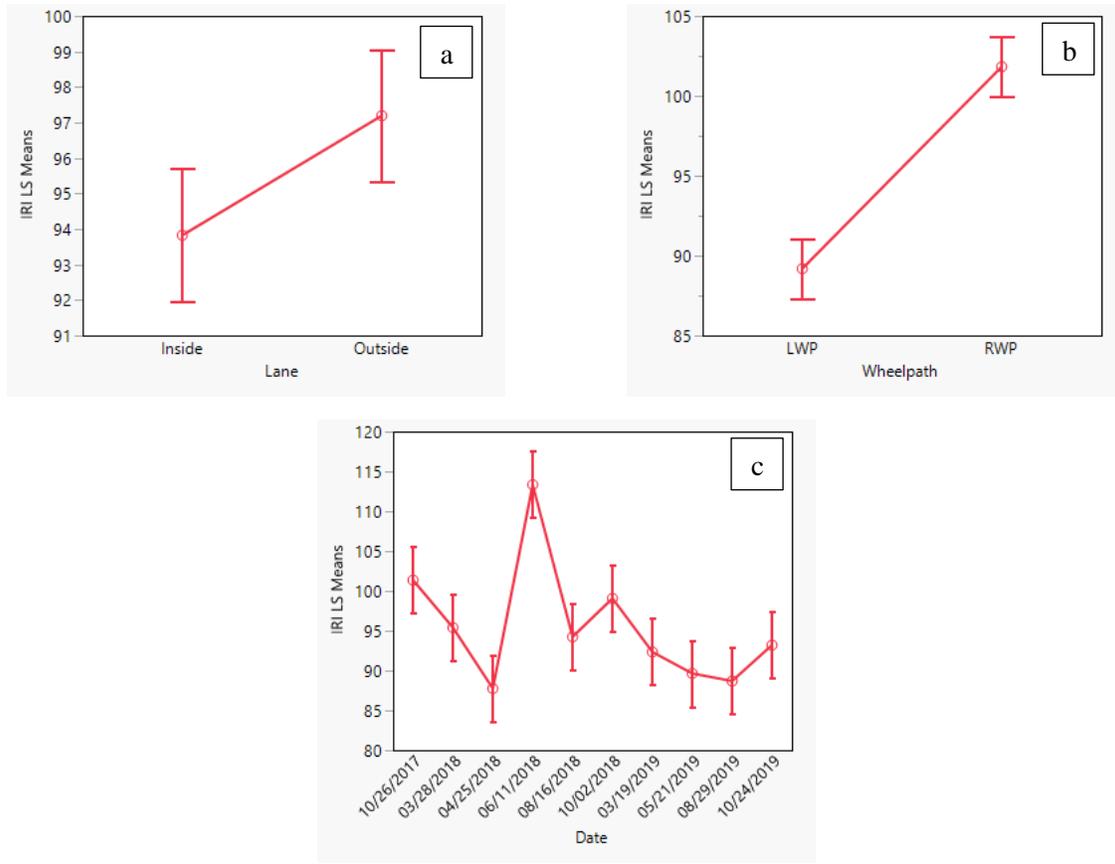
Figure 17- Least square means plots for IRI values of cell 524 as a function of lane (a), wheel path (b), and test date (c)

All three factors (date, lane, and wheel path) were proved to have significant effects on IRI data with P-values lower than 0.05. Least square means plots obtained for different input factors are summarized in Figure 17.

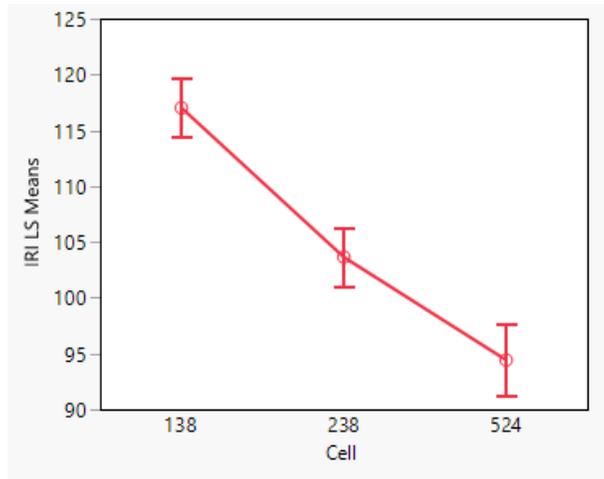
Figure 18- Least square means plots for IRI values of different cells

Even though not following normal distribution, hypothesis testing was performed using parametric testing which resulted in the same conclusion, i.e. significantly different IRI values for various cells. The least square means plot obtained for different cells is presented in Figure 18, suggesting the lowest IRI values for reference cell (cell 524) and the highest IRI numbers for low cement section (cell 138).

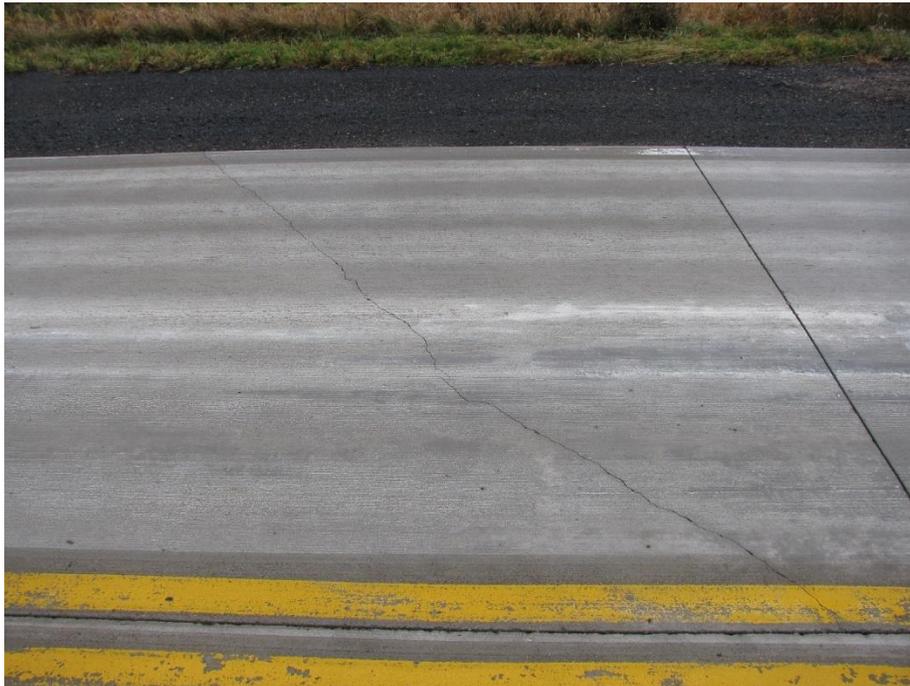
Only one diagonal crack exists in cell 138 as shown in Figure 20 and schematically presented in Figure 21. The crack starts about 1.0 ft. from the intersection of the transverse and longitudinal joints and continues with an almost 45 degrees angle towards the shoulder of the inside lane as presented in Figure 20. Potential problems with base and/or subgrade may have contributed to formation of the cracks. Stresses caused by traffic loading can be another reason for cracking in this panel.

Figure 20- Cracking occurred on inside lane at cell 138

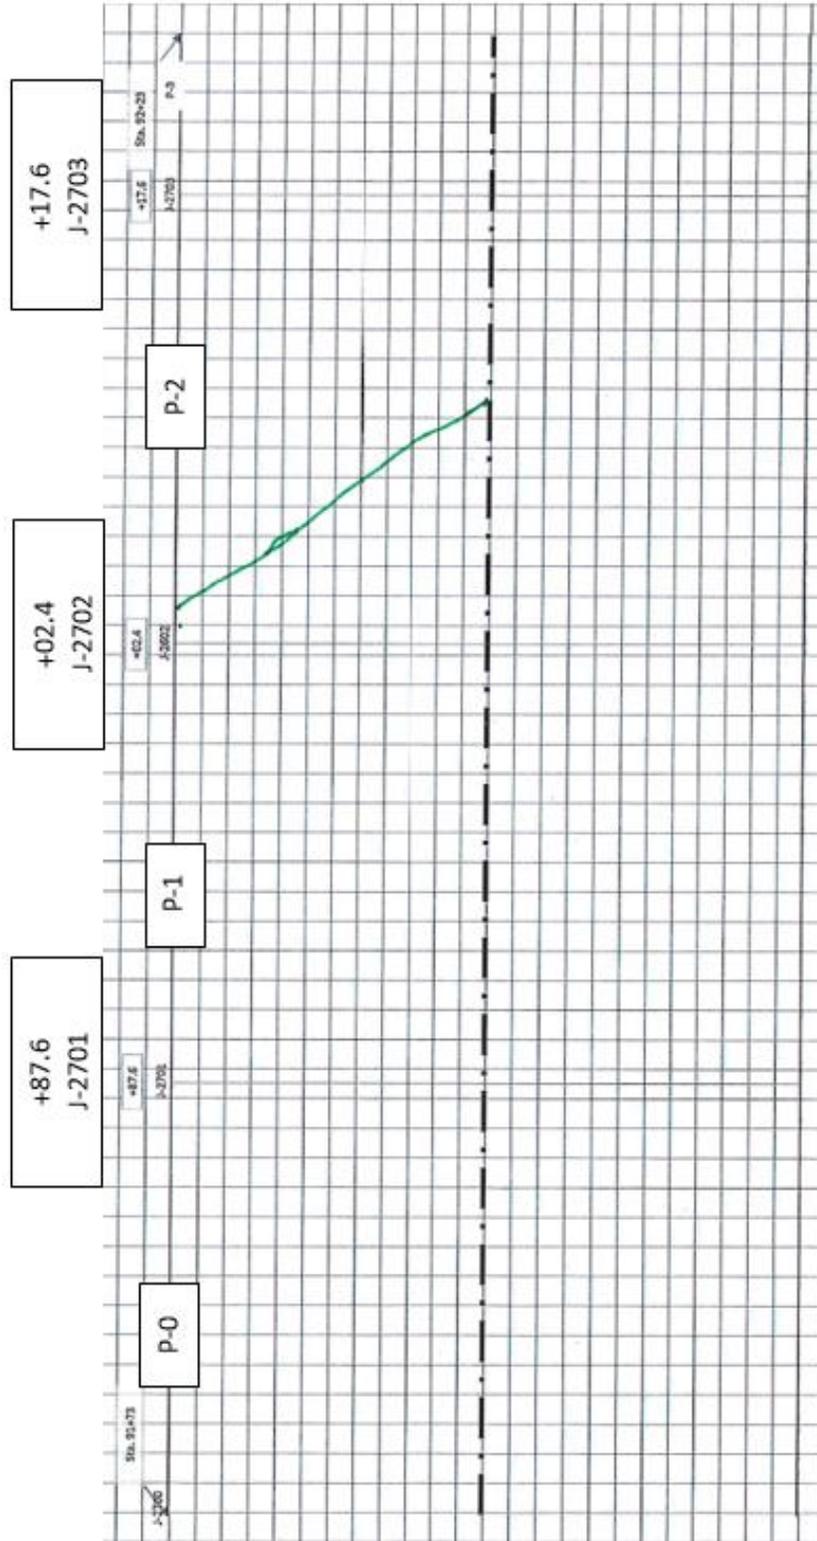
Figure 21- Schematic plan view of the cracking occurred on inside lane at cell 138

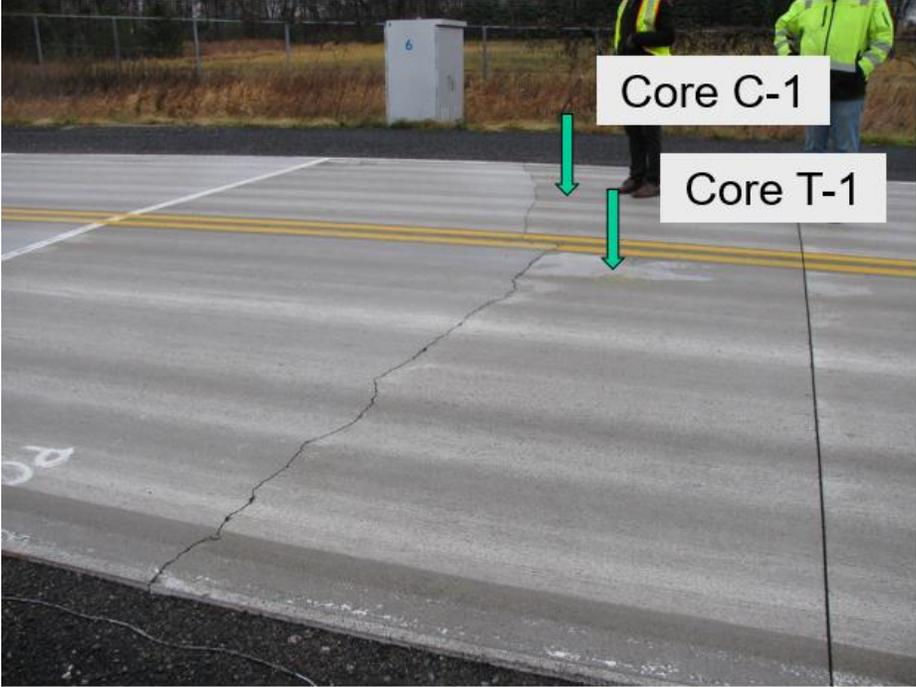
Cracking and distress in cell 238 is limited to the first panel transition from cell 138 to 238. The crack is about 5 feet from the downstream joint and angling slightly away from mid-panel as shown in Figure 22.

Figure 22- Transverse crack occurred on outside lane (left) and inside lane (right) at cell 238

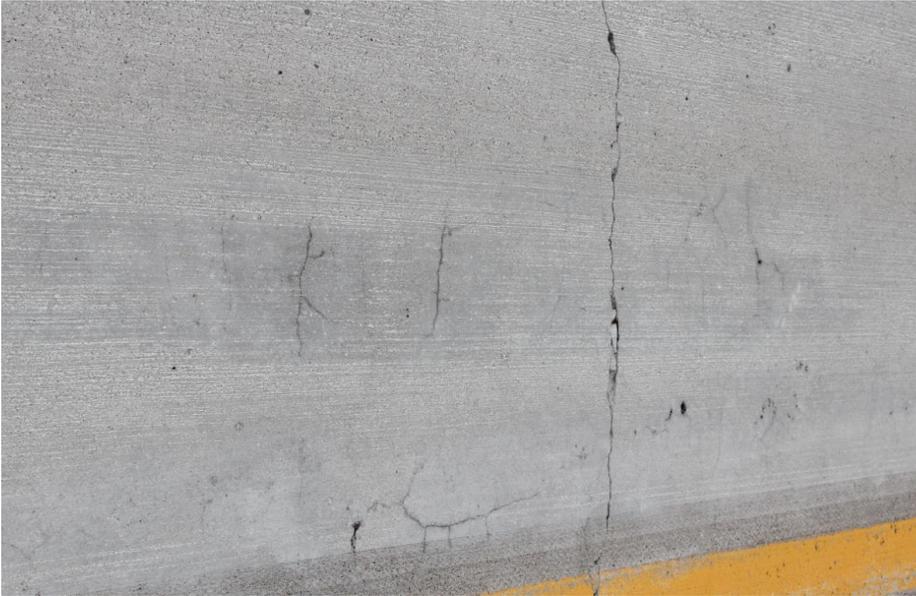
Map cracking is also available in areas adjacent to the crack as shown in Figure 23. Figure 24 presents a schematic plan view of the cracking in cell 238.

Figure 23- Further distress in form of map cracking near the wheel path at cell 238

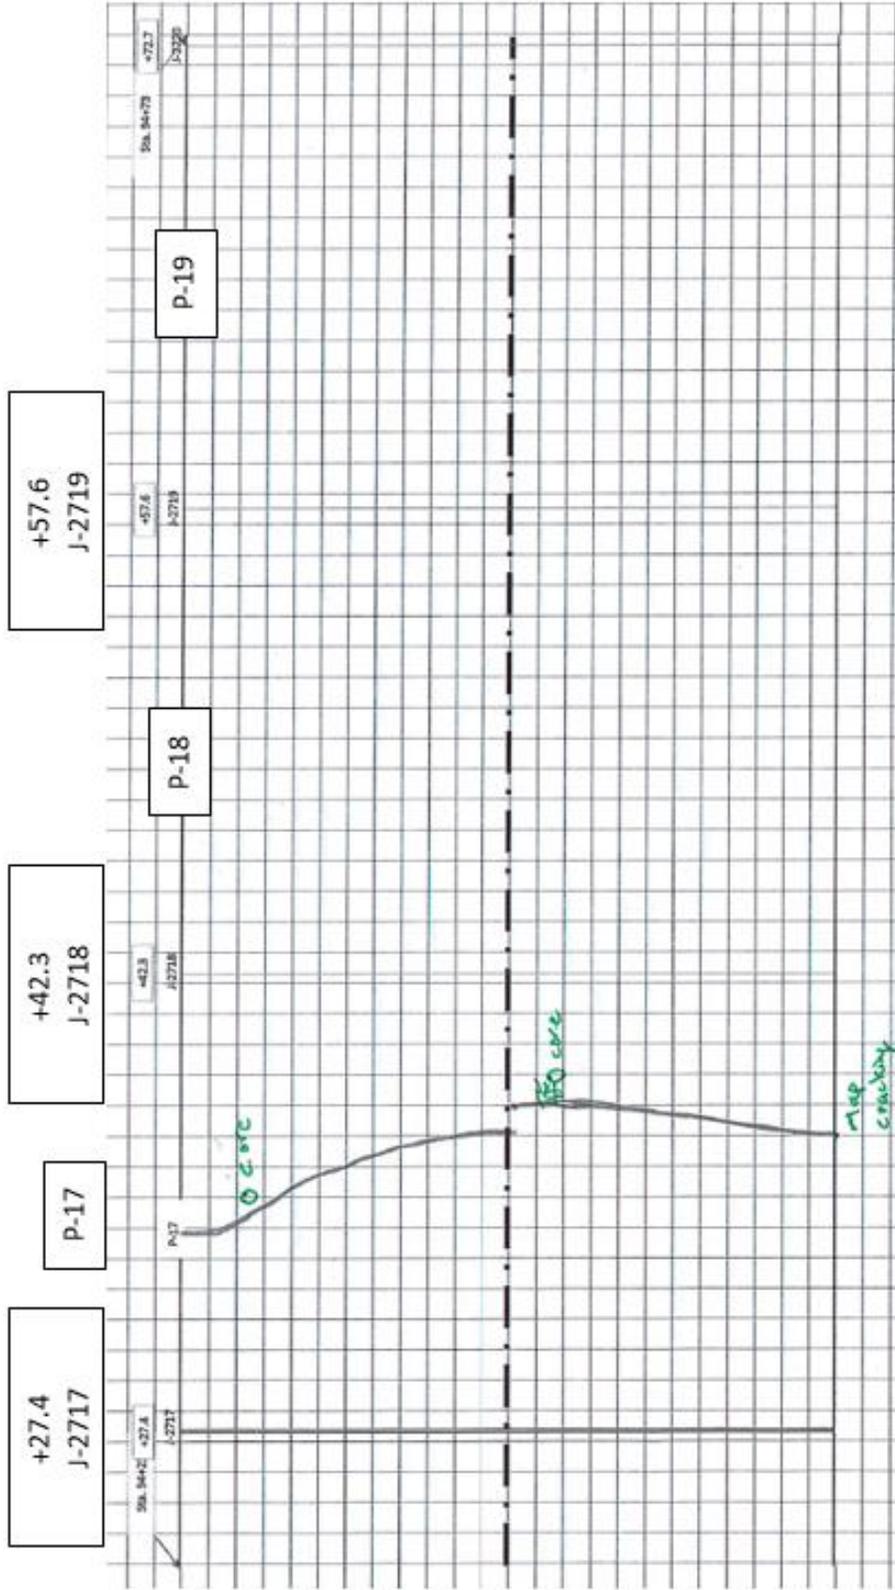
Figure 24- Schematic plan view of the cracking occurred on inside lane at cell 238
