# **REDUCED CEMENTITIOUS MATERIAL IN OPTIMIZED CONCRETE MIXTURES: ANNUAL CELL PERFORMANCE REPORT**

**Contract Number:** (C) 1003320 (WO) 3

**Task 2C: Annual Cell Performance Report**

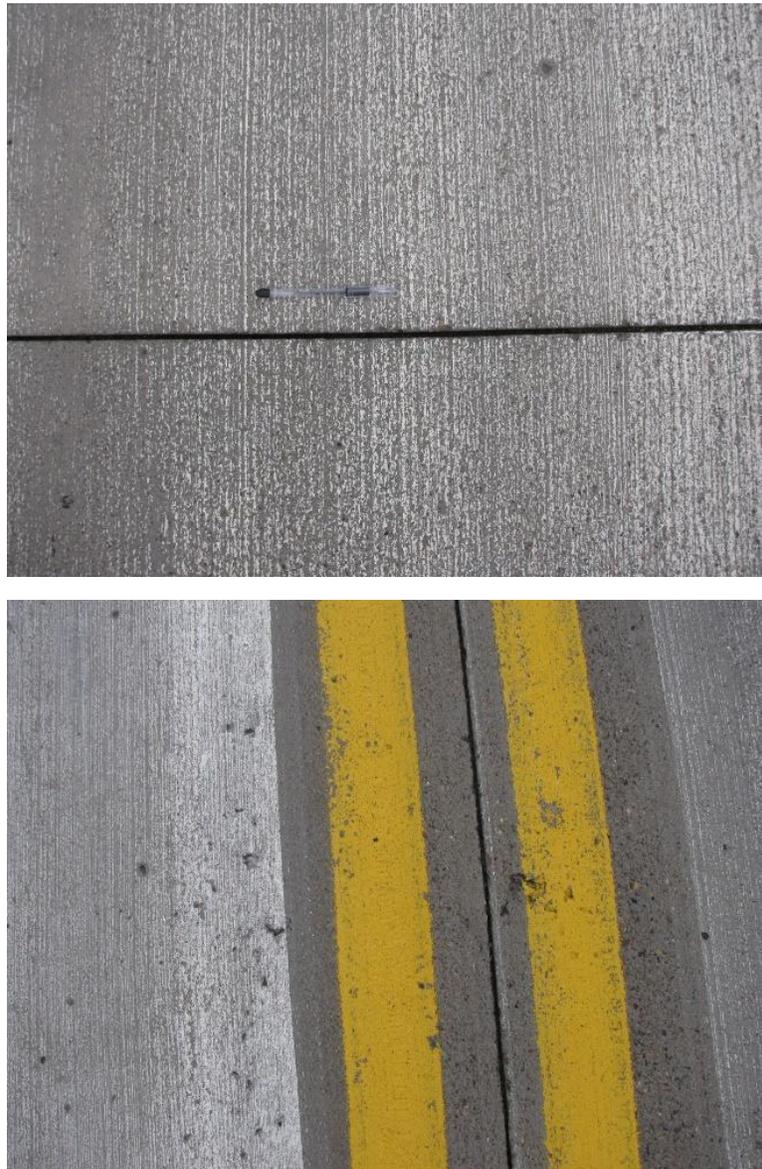
So far the in-situ inspection of the cells exposed to environmental conditions and traffic loading, indicated proper quality of the pavement surfaces at both cells. No issues were observed for the surface texture at cell 138. Finishing problems were occasionally observed at pavement surfaces in cell 238. This is believed to be due to the lower workability of the mixtures with lower cementitious materials content as stated in previous reports. Figure 25 presents examples of typical surface quality at cell 138, along with the observed finishing problems at cell 238.

Figure 25- Typical surface quality at cell 138 (top), and finishing issues observed at cell 238 (Bot.)
