# **REDUCED CEMENTITIOUS MATERIAL IN OPTIMIZED CONCRETE MIXTURES: ANNUAL CELL PERFORMANCE REPORT**

**Contract Number: (C) 1003320 (WO) 3**

**Task 3: Analysis to Determine the Early-Age Characteristics of Concrete Paving Mixes  
with Lower Cementitious Content**

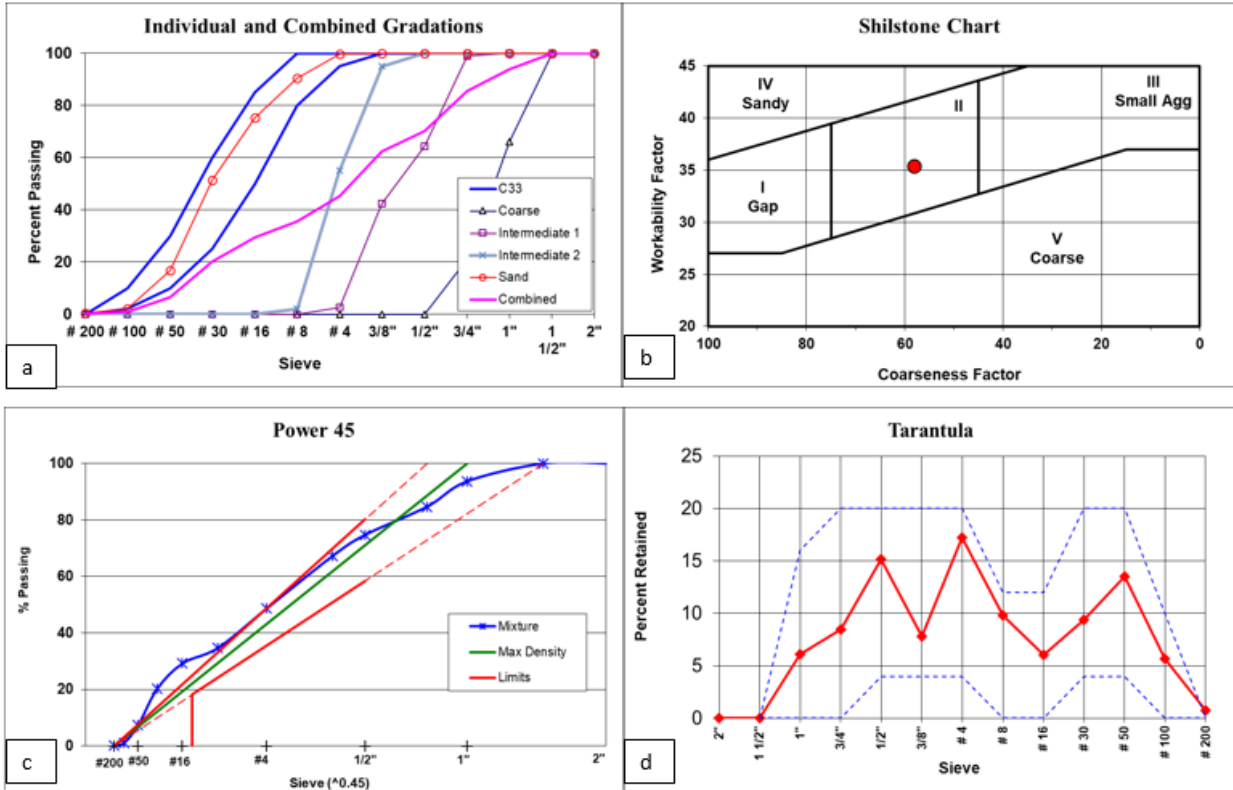
Figure 3- (a) Individual and combined gradations, (b) workability factor chart, (c) power 45 chart, and (d) Tarantula curve

Both concrete mixtures were proportioned with an optimized aggregate system, with a weight fraction of 18% coarse aggregate, 33% intermediate #1, 10% intermediate #2, and 39% fine aggregate. The combined aggregate gradations were plotted in a Tarantula curve (Ley et al. 2012), power 45 curve (Kennedy et al. 1994), and Shilstone workability factor chart (Shilstone 1990), as shown in Figure 3.

In the workability factor chart, the workability and coarseness factors of the aggregate system fall within Zone II. The combined aggregate system also met the recommendations of the Tarantula plot.

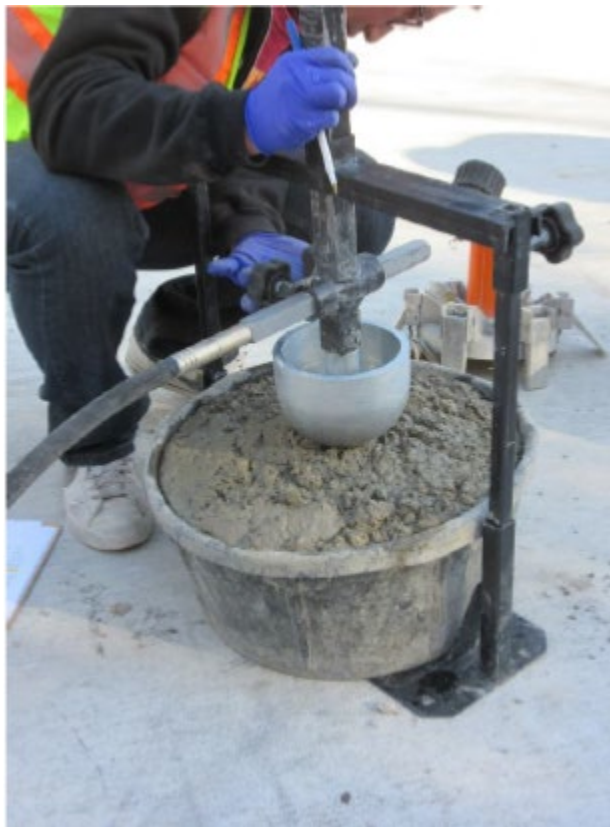
Figure 4- VKelly test setup

The VKelly tests indicated that the slump of the mixtures used for cells 138 and 238 were 2.50 and 1.50 in., respectively. The VKelly index of 0.50 in./s<sup>0.5</sup> obtained for mixture with lower cementitious content was slightly lower than the recommended minimum of 0.60 in./S<sup>0.5</sup>. However, the mixture with low cementitious content used for cell 138 exhibited a VKelly index of 0.88 in./s<sup>0.5</sup>, which was within the recommended range (Taylor et al. 2015). Slight adjustments in WRA dosage were necessary to achieve desirable workability during paving with concrete containing lower cementitious materials content. Observations were in agreement with the  $V_{\text{paste}}/V_{\text{void}}$  data obtained based on mixture proportions presented in Table 2, where values of 146% and 137% were obtained for the concrete with low and lower cementitious materials content, respectively. Observations were in agreement with previous observations of the research team, suggesting 150% as a proper value for  $V_{\text{paste}}/V_{\text{void}}$  while designing paving concrete mixtures.

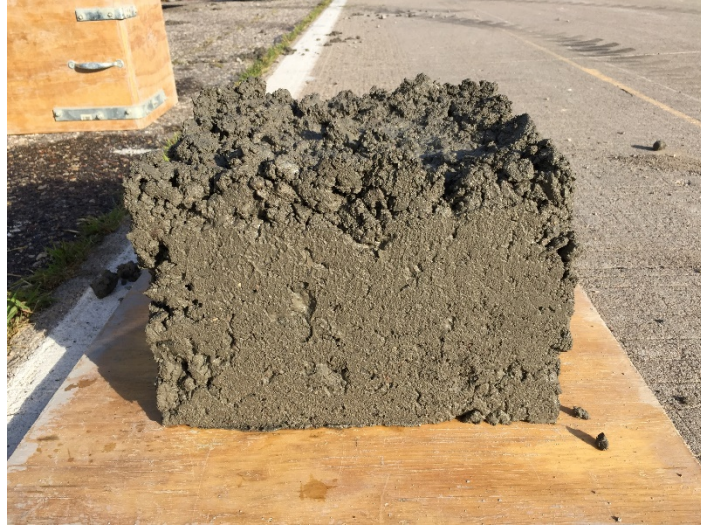
Figure 5- Box test showing voids on concrete surface

The box test indicated better workability for mixture with low cementitious content. An average visual rating of 1.0 was reported for this mixture, corresponding to less than 10 percent overall surface voids. The visual rating was between 2 and 3 for the concrete with lower cementitious content, indicating 30-50 percent overall surface voids (Cook et al. 2014). No edge slump was observed for the mixtures.

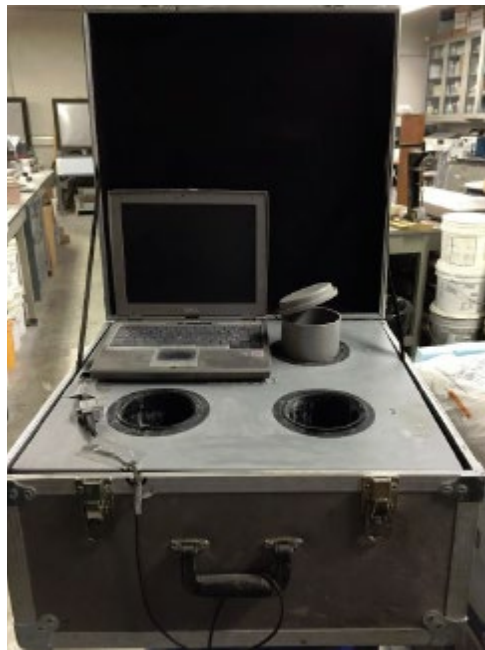
Figure 6- Calorimetry test setup for measuring the heat of hydration

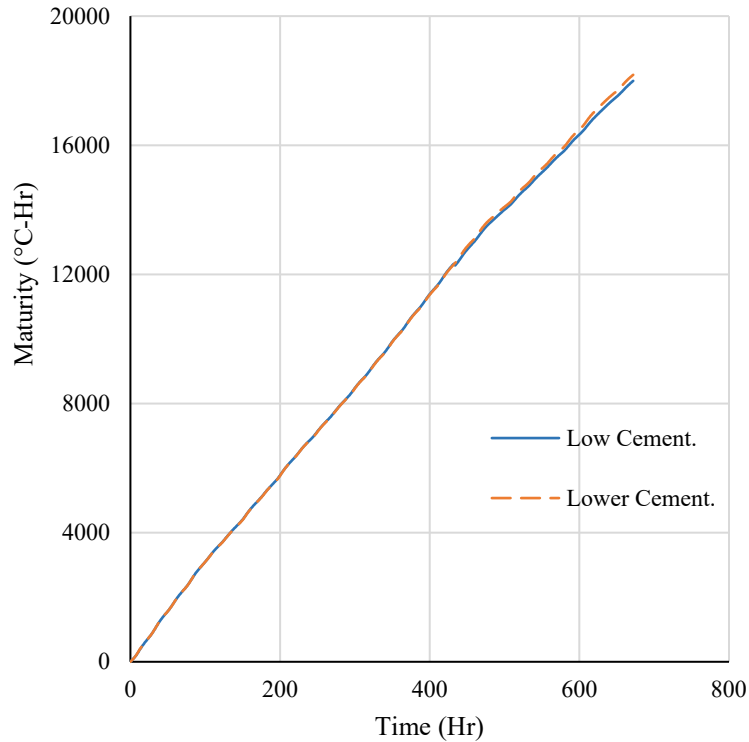
Figure 8 presents the average maturity data recorded for the mixtures. Similar performance was observed, regardless of the binder content. This was expected given the same binder composition used in both mixtures. Observations were in agreement with the calorimetry results. Similar maturity data obtained for the two investigated mixtures suggest comparable strength development for investigated mixtures, i.e. similar saw-cutting time frame and similar time to potential opening to traffic.

Figure 8- Average maturity data

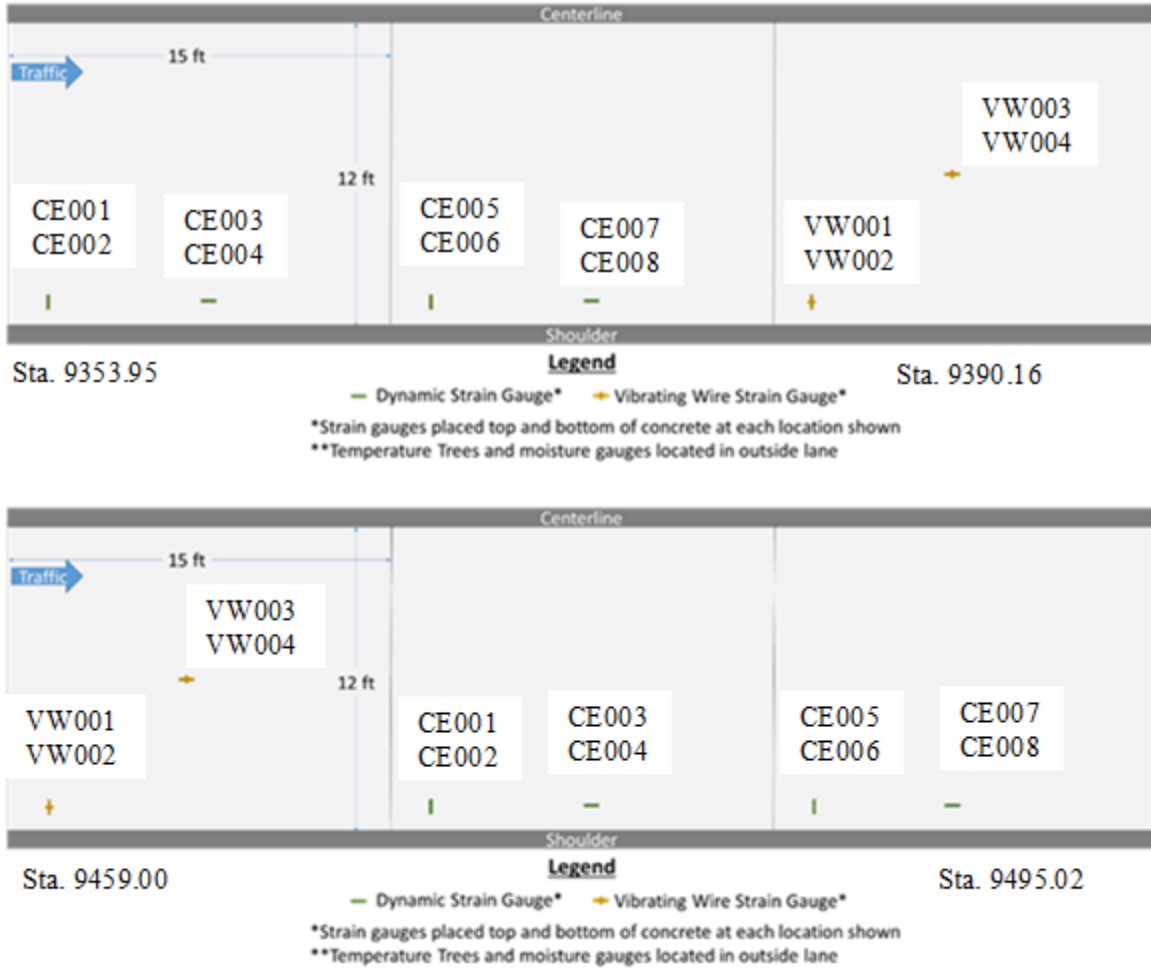
Figure 10- Sensor installation plan for cell 138 (top) and cell 238 (bottom).

Vibrating wire strain gages (VW) embedded at corner and mid-panel areas were used to monitor the total in-situ deformations due to environmental loads. The recorded deformations were caused by a combination of concrete shrinkage, warping due to moisture loss, curling due to temperature gradient within the depth of concrete, and linear deformation of the sensors and the surrounding concrete due to variations in temperature. Table 3 and Figure 10 present the layout and details of the sensor installation.

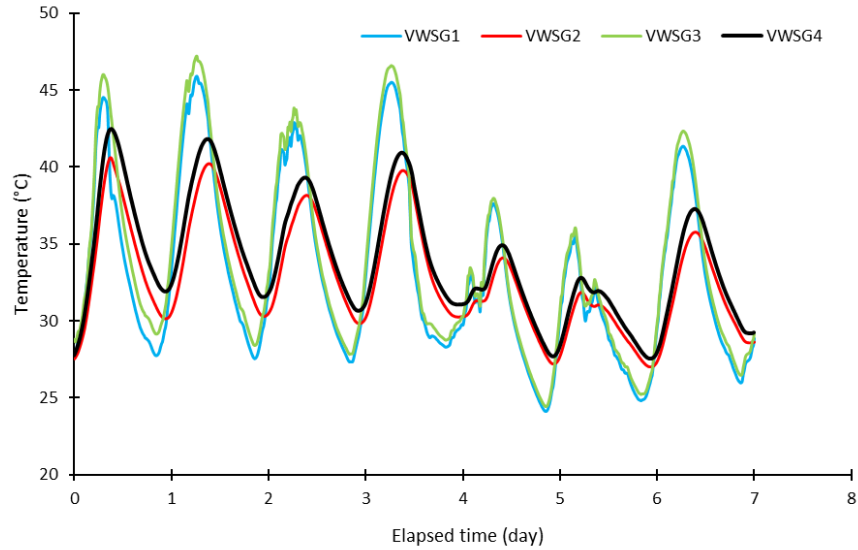
Figure 12- Variation in concrete temperature registered by the VWSGs embedded at cell 238

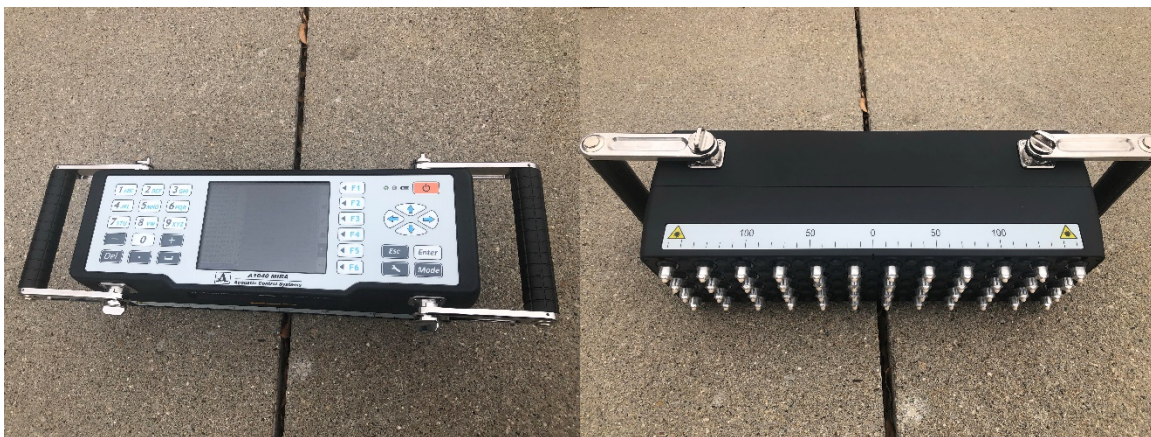
Figure 13- Mira test setup

On September 21<sup>st</sup>, 2017, a non-destructive test method based on ultrasonic shear-wave tomography was employed to explore the joint activation. The MIRA device (Figure 13) contains 40 dry point contact (DPC) transducers that send and receive low-frequency (55 kHz) shear-wave ultrasonic pulses (Vosoughi and Taylor 2017). The test was repeated 10 times at each joint, and the average results were reported.

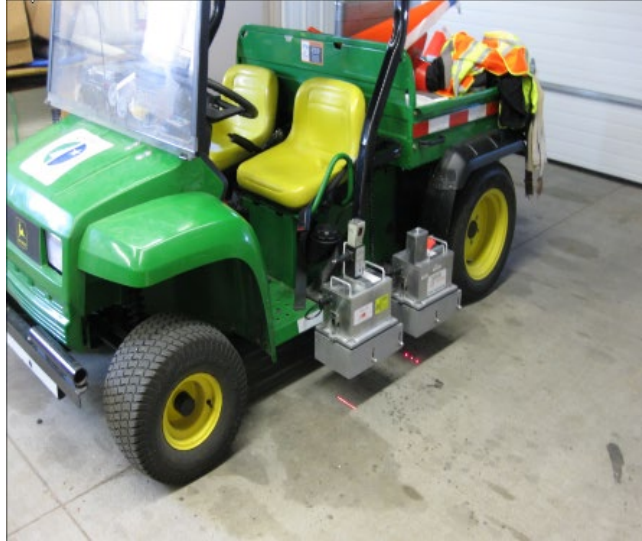
Figure 15- MnDOT's Lightweight Profiler

MnDOT's Lightweight Profiler, conforming to ASTM E-950 requirements (Figure 15) was used for collection of the ride quality data in terms of the International Roughness Index (IRI) according to the following timeline:

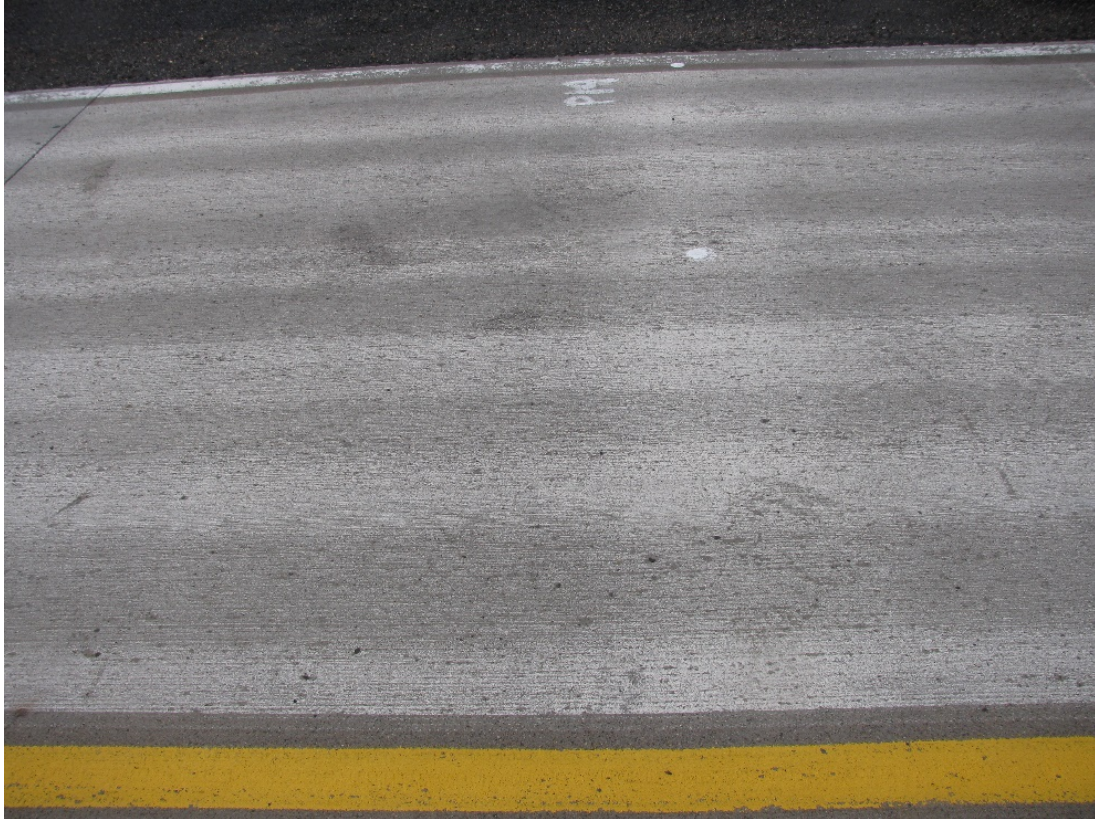
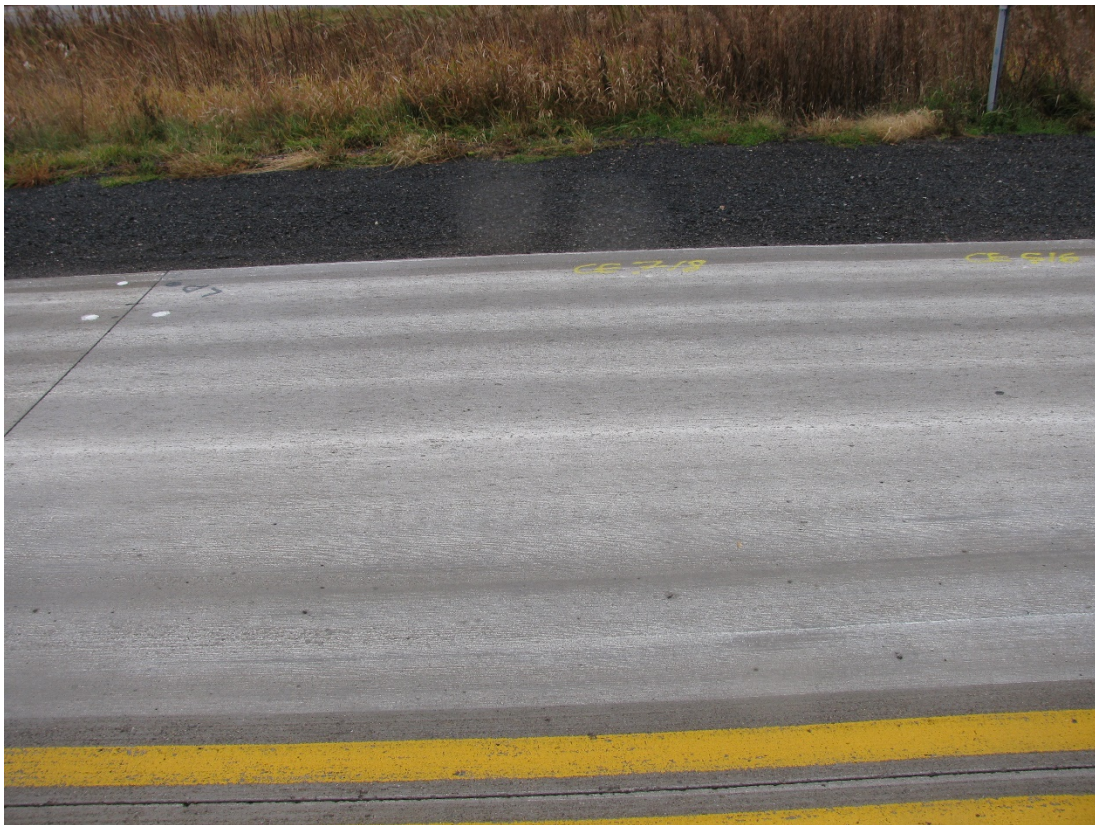
In-situ inspection of the cells after over one year of exposure to environmental conditions and traffic loading was conducted in November 2018. Figure 17 presents examples of typical surface quality at cell 138. Observations indicated proper quality of the pavement surfaces at cell 138, where minimal issues were observed with the surface texture. This verifies the proper finishing in light of adequate workability of the mixture with low cementitious materials content. A closer look at the surfaces also reveals uniform texture of the pavement surfaces at cell 138 as shown in Figure 18. Moreover, both the transverse and the longitudinal joints were in good shape and no signs of raveling and/or joint damage and staining could be detected. Examples of typical quality of longitudinal and traverse joints after over one year of service are shown in Figure 19.

Figure 17- Examples of typical pavement surfaces at cell 138

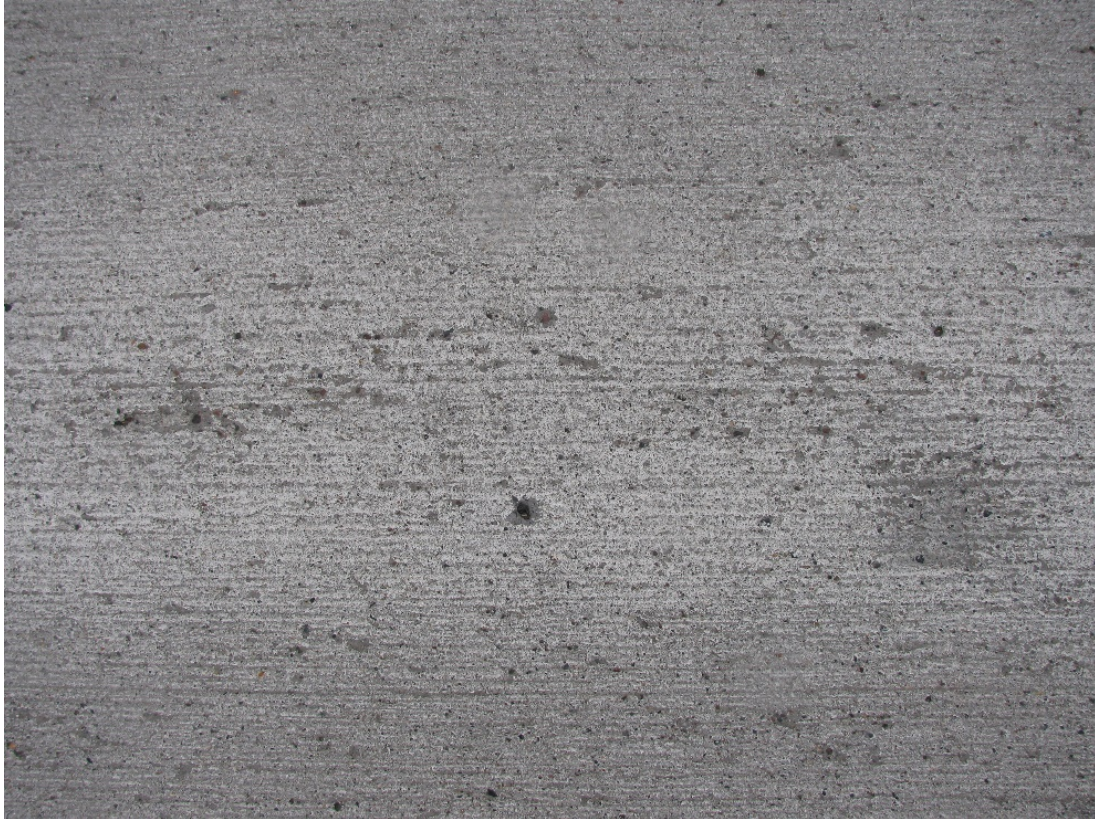
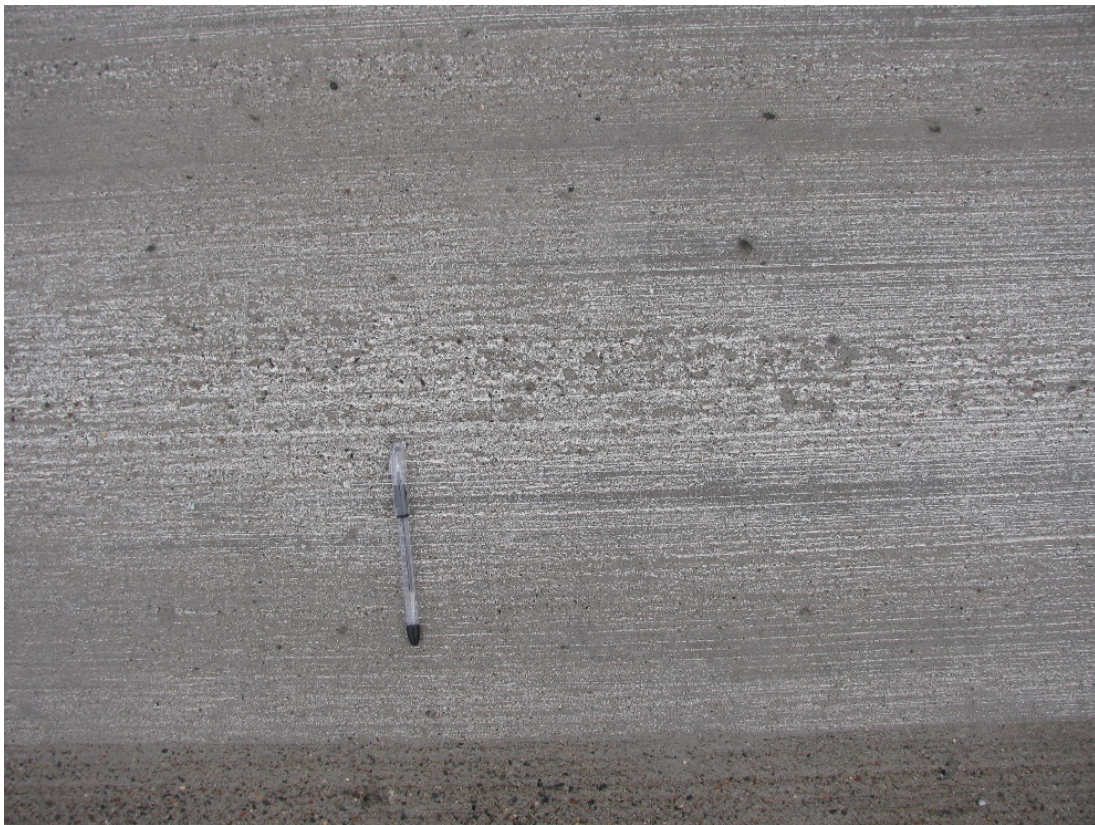
Figure 18- Examples of typical pavement texture at wheel path of cell 138

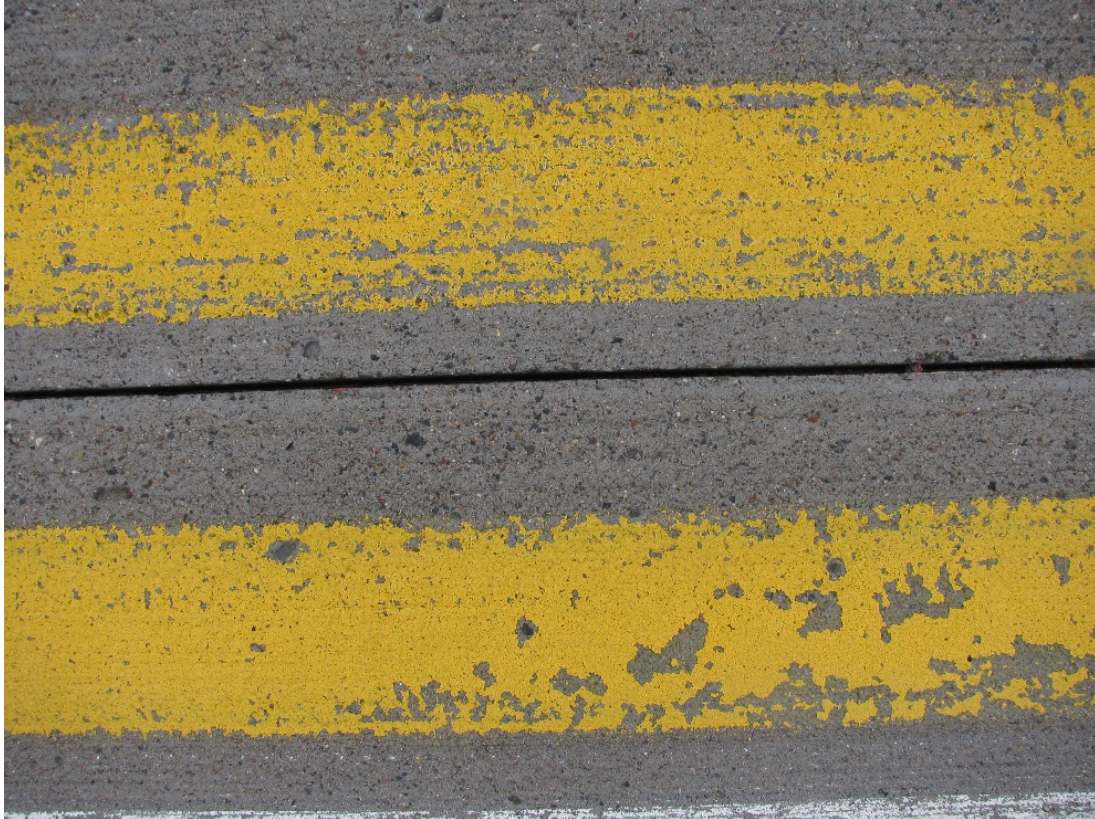
Figure 19- Example of typical condition of longitudinal joints (top) and transverse joints (bot.) at cell 138

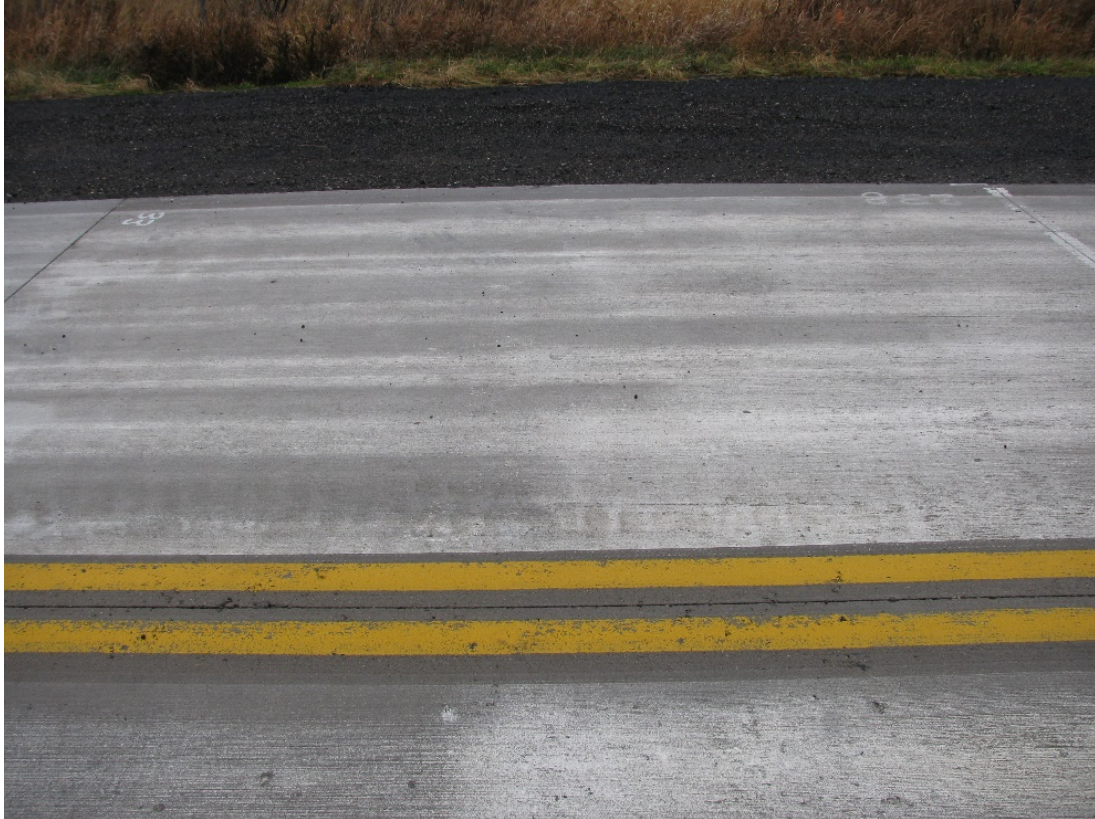
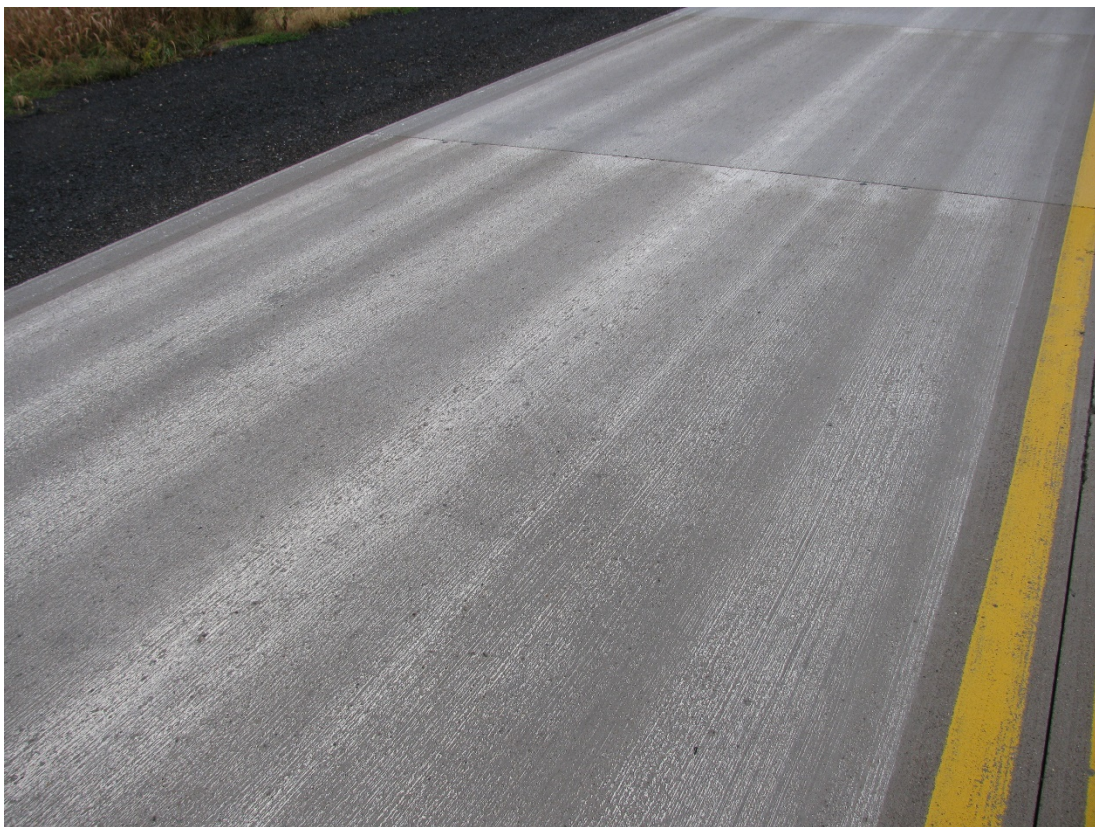
In general paved surfaces at cell 238 exhibited acceptable quality as can be seen in Figure 20. Finishing problems were occasionally observed at pavement surfaces in cell 238 as shown in Figure 21. This is believed to be due to the lower workability of the mixtures with lower cementitious materials content as discussed earlier in this report.

Figure 20- Examples of typical pavement surfaces at cell 238, outside lane (top), inside lane (bot.)

Even though the mixture prepared with lower cementitious materials content developed same maturity and early age compressive strength data to those of the mixture used in cell 138, occasional raveling could be detected at longitudinal joints at cell 238. This could be due to the reduced cohesion of the mixture and the reduced coverage of coarse aggregate with paste. Finishing problems may have also contributed to these observations. Figure 22 presents examples of typical surface quality and the observed finishing problems at cell 238.

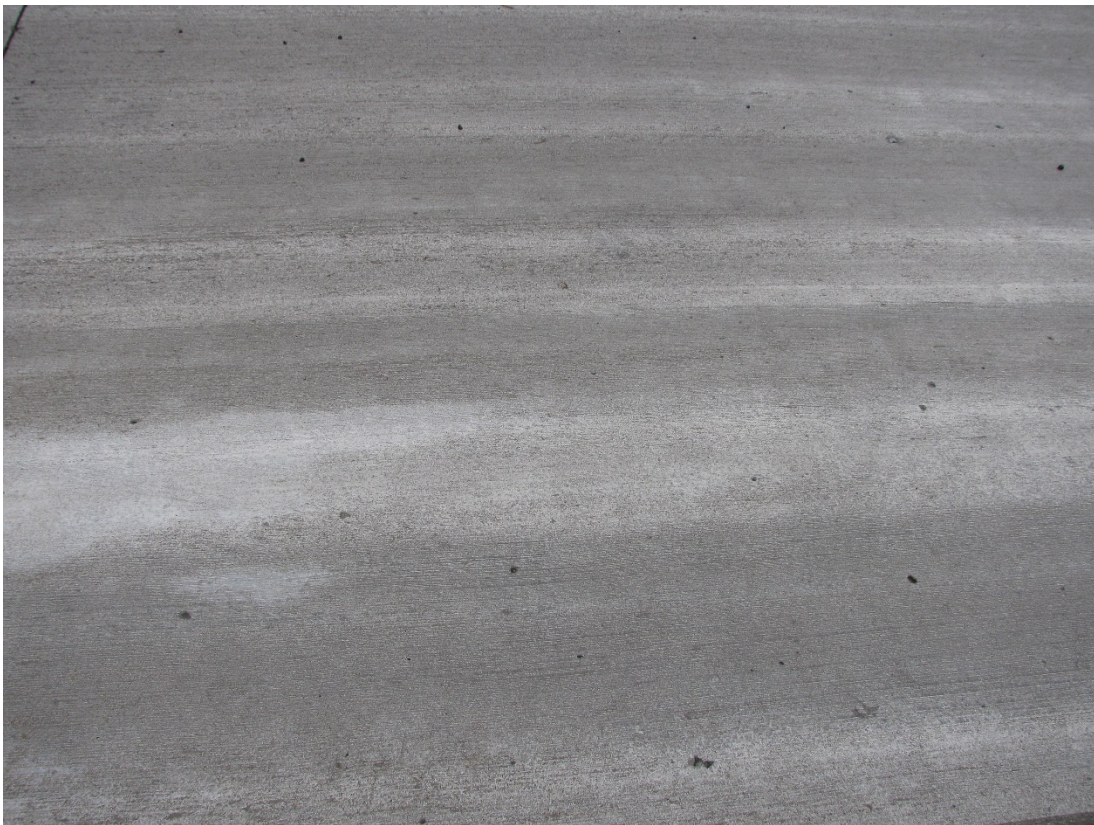
Figure 21- Examples of typical pavement surfaces at cell 138

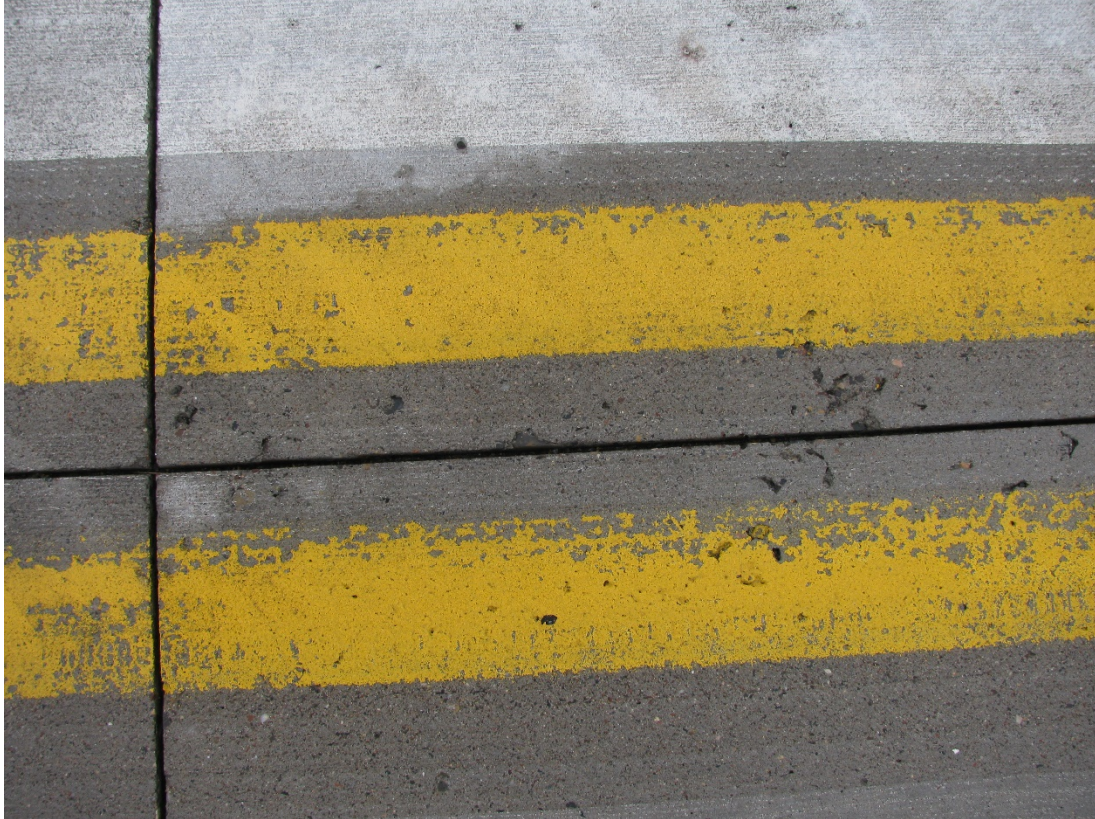
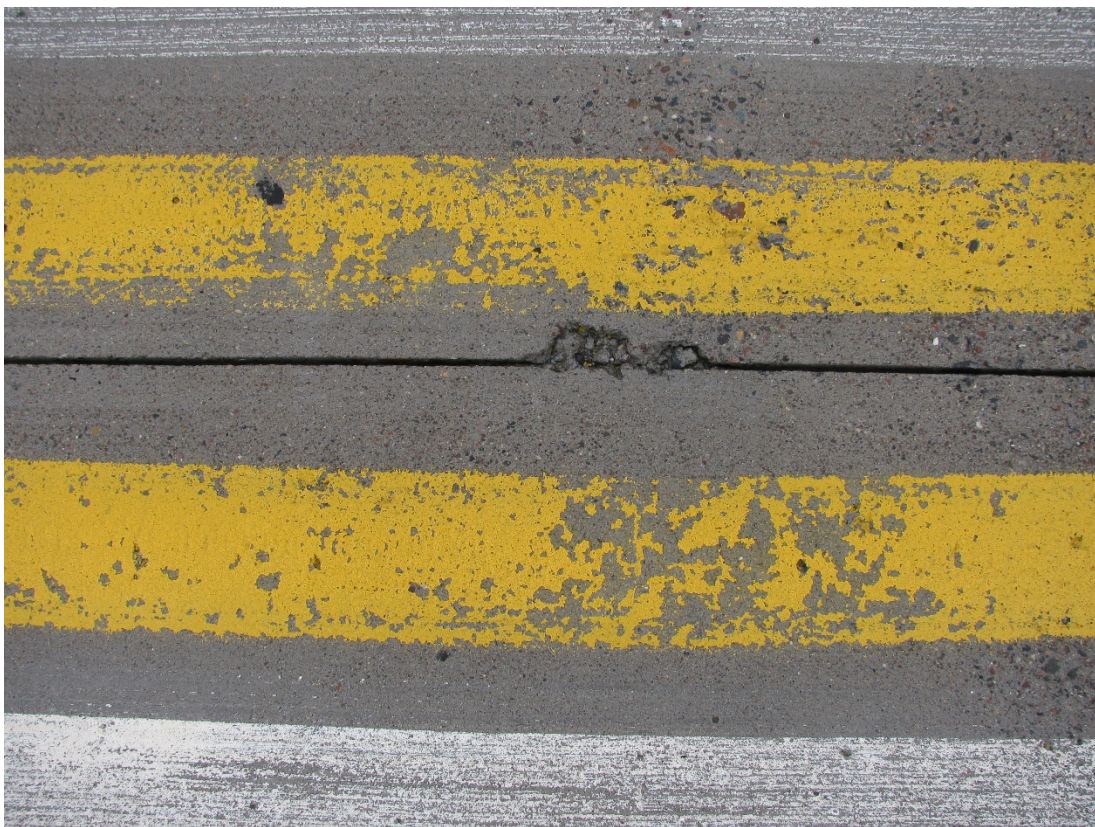
Figure 22- Typical condition of longitudinal joints (top) and occasional raveling (bot.) at cell 138

- In-situ inspection verifies proper finishing and surface quality of pavement at cell 138, along with high quality at saw cut joints. Finishing problems and raveling at longitudinal joints were more common at cell 238, indicating that given the incorporated aggregate combinations, concerns may arise while the total cementitious materials content is reduced to 470 lb/yd<sup>3</sup>.
