MnDOT Contract, No. 1003325, Work Order No. 56
NRRA Long-term Research Project

**Performance Benefits of Fiber-reinforced Thin Concrete Pavement and
Overlays**

TASKs 3 and 5 REPORT

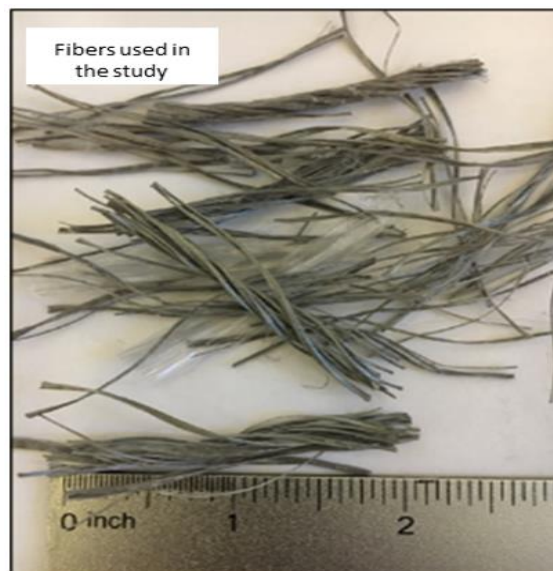
Figure 5: Fibers used in the NRR FRC study, 2017

A photograph of the fiber used in the construction is shown in Figure 5. The properties of this fiber can be found in Task 2B report for this project (MnDOT, 2018).

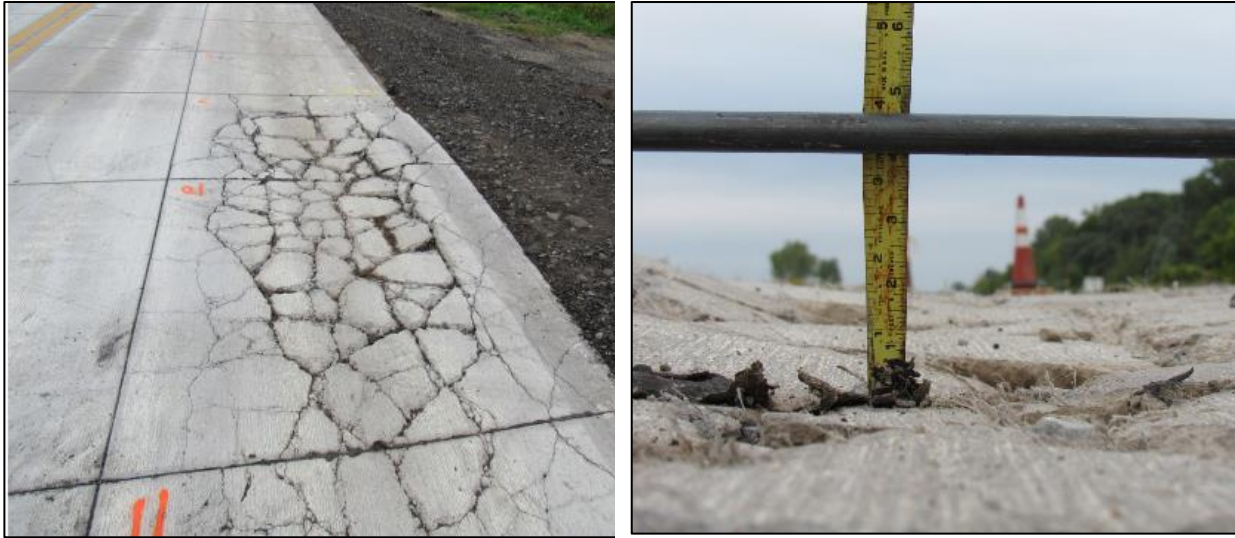
Figure 6: Shattered slabs and depression along the wheel path in Cell 139.

- The thickness of Cell 139 was 3 inches, which is extremely thin on a 6-inch unstabilized aggregate base. The cracks observed in this cell were more like bottom-up fatigue cracks of asphalt pavement with shattered slabs along the wheel path.

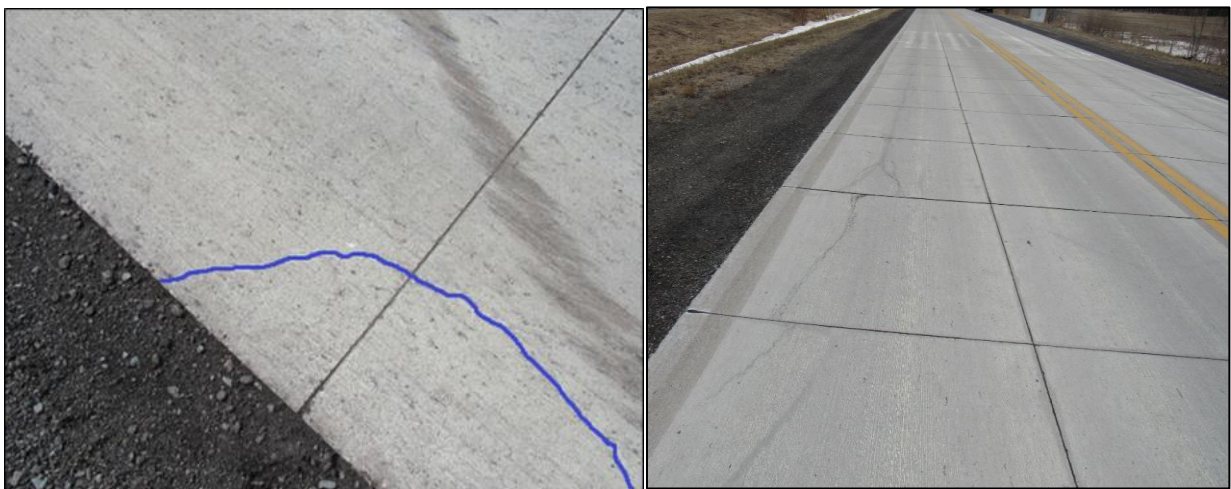
Cell 239 on the low-volume test track is similar in all aspects to Cell 139, except it is a 4-inch thick. This cell experienced longitudinal and corner cracks, as shown in Figure 7. Some of the corner cracks along the shoulder were thought to be caused by the placement of the shouldering material. Figure 8 shows the consolidated distress map indicating the cracks measured at different seasons and years.

Figure 7: Corner and longitudinal cracks in Cell 239.

- Cell 239 (4-inch thick) has performed much better than Cell 139. The dominant distress for Cell 239 was longitudinal cracking along the wheel path. This behavior coincides with the behavior observed in other thin concrete pavement overlay structures

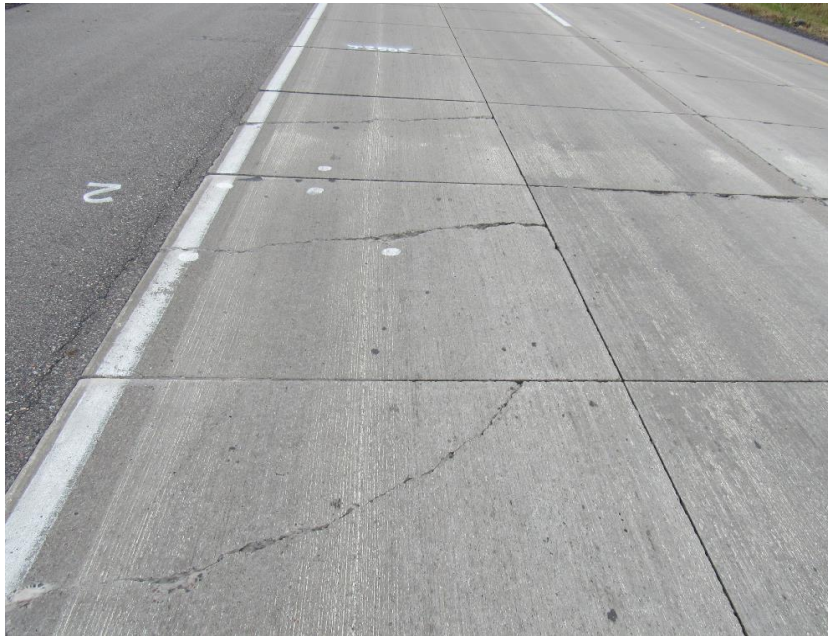
Cells 506, 706, and 806 were constructed with 5-inch thick 6ft x 6ft size slabs on an unstabilized gravel base (not overlay). Cell 606 was unintentionally constructed with 6-inch thick 6ft x 6ft size slabs. All these cells were constructed on the mainline test track (I-94 westbound). Cell 506, which is the control cell constructed without any fibers, experienced transverse, and diagonal cracks in some slabs. Figure 9 shows a photograph of three distressed slabs of Cell 506 before they were replaced in June 2020. Figure 10 shows the color-coded distress map for Cells 506 and 606.

Figure 9: Cracks observed on Cell 506 (replaced in summer 2020).

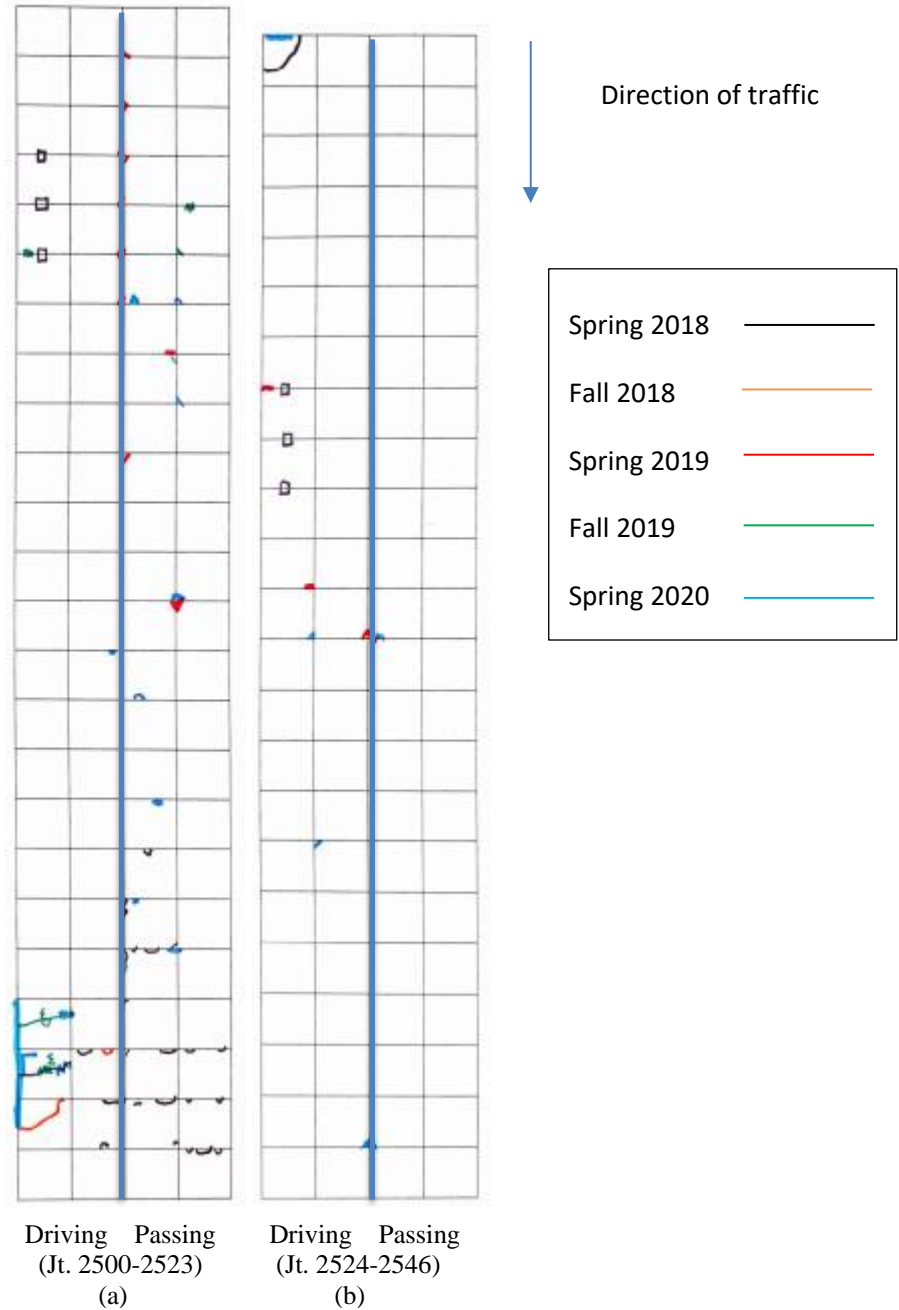
Figure 10: Distress Maps (a) Cell 506 (b) Cell 606.

Cell 606, which was constructed with 5 lbs./cy (20% residual strength) of structural fibers and 6 inches thick slabs, experienced one corner crack prior to April 2018; the severity of that crack did not change with age and ESALs. This crack is also located in the last panel next to a cell transition joint, so it can be assumed that this crack is not a typical fatigue-related crack; it occurred because of a construction issue.

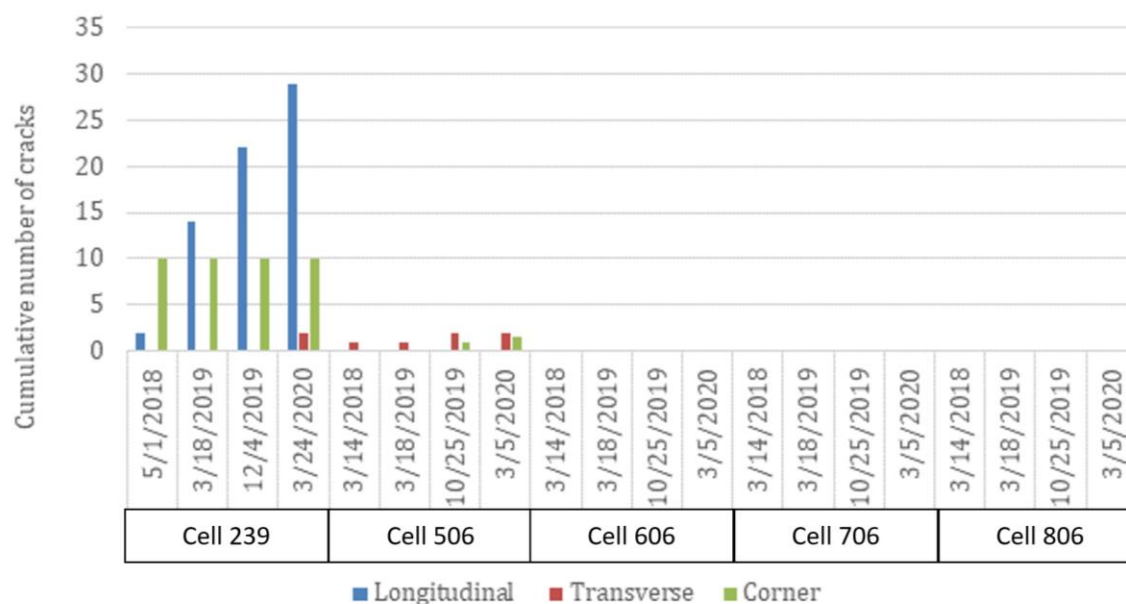
The distress survey conducted on March 2020 found one joint spalling and two additional low severity corner cracks. Cells 706 and 806, which were constructed with fiber dosages of 8 and 11.7 lbs/cy, respectively, did not experience any cracks until March 2020 except for a couple of narrow cracks in Cell 806 that originated at the location of a joint opening sensor. A summary of the fatigue cracks documented in Cells 239 and 506 through 806 until March 2020 is provided in Figure 11. This figure does not include the unique distresses that developed in Cell 139. Comparison of Figure 8 and Figure 10 and Figure 11 show that 4-inch thick Cell 239 (with 8 lbs./cy fibers) has more visible cracks than 5-inch thick 506 and 6-inch thick 606 (with 5 lbs./cy fibers), despite significantly different traffic loadings.

Figure 11: Summary of fatigue cracks of cells on gravel base until March 2020 (Cell 139 not shown).

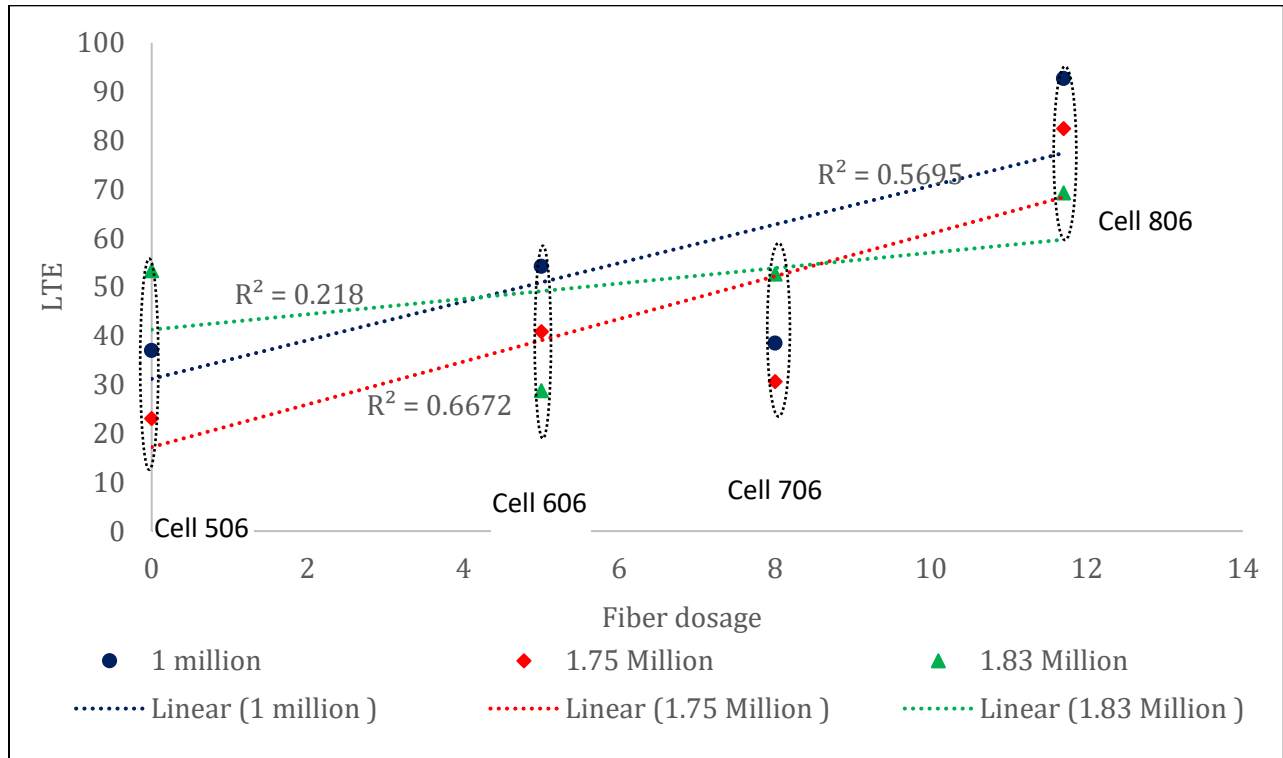
In order to quantify the increase in LTE because of fibers, the FWD data collected in this project (provided in Task 4 report) was revisited, and the LTEs measured at three different ESALs levels (at 1, 1.75, and 1.83 million ESALs) were compared between the four cells, Cell 506 through 806, that have various fiber dosages (Figure 20). The above-mentioned three different ESALs were selected because of the availability of the FWD test data at those ESALs. The LTEs measured at 1, and 1.75 million ESALs gave somewhat good correlations between the LTEs and ESALs. The LTEs measured at 1.83 million ESAL did not yield a good correlation as the joints have supposedly deteriorated and fibers' effect had likely minimized. While a very accurate quantification of the LTE gain from a dosage of fiber is not possible from this study., Also, Cell 606 was 6 inches thick, as opposed to 5 inches for the other three cells. If all the cells were 5 inches thick, then the conclusion on the fibers' LTE conclusion could be different. Nevertheless, the laboratory study conducted by Barman et al. (2018) and other similar studies provided enough evidence on the fibers' contribution to the LTE. Based on the above-mentioned facts, it may be conservatively stated that every 2 to 2.5 lb/cy fiber dosage (specific to the fibers used in this particular study) may increase the LTE by 10% approximately. At the same time, it is cushioned that this contribution may change based on the fiber type and pavement design.

Figure 20: Influence of fiber dosage on the LTE.

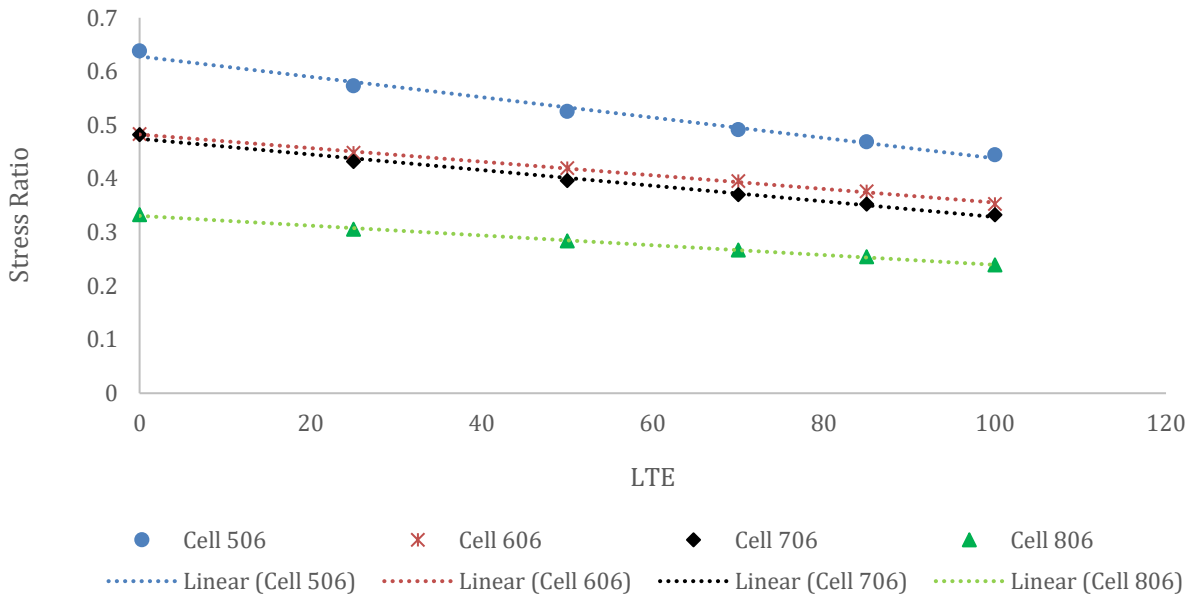
Figure 22 shows the stress ratios computed at the critical locations for various LTEs for Cells 506 through 806. The reason for the lower stress ratios for the FRC cells compared to the plain concrete cell (Cell 506) are the (i) slightly higher modulus of rupture for the FRC cells and (ii) fiber stiffness, which acts against the crack width opening below the saw-cut. Figure 22 shows that at a given LTE, the stress ratio is less in the FRC cells. In addition, the LTE is also generally higher for the FRC cells for a given crack width when fibers are in the stretched condition. It may be stated the relationship between the stress ratio and the LTE presented in Figure 22 may change according to the field conditions; nevertheless, the analysis shows the potential to account for the fibers' contribution in calculating the design stress.

Figure 22: Stress ratio as a function of LTE for Cells 506 through 806.

- The study included a finite element analysis. Through this analysis, it was shown that structural fibers have the potential to decrease the stress ratio in the critical locations.

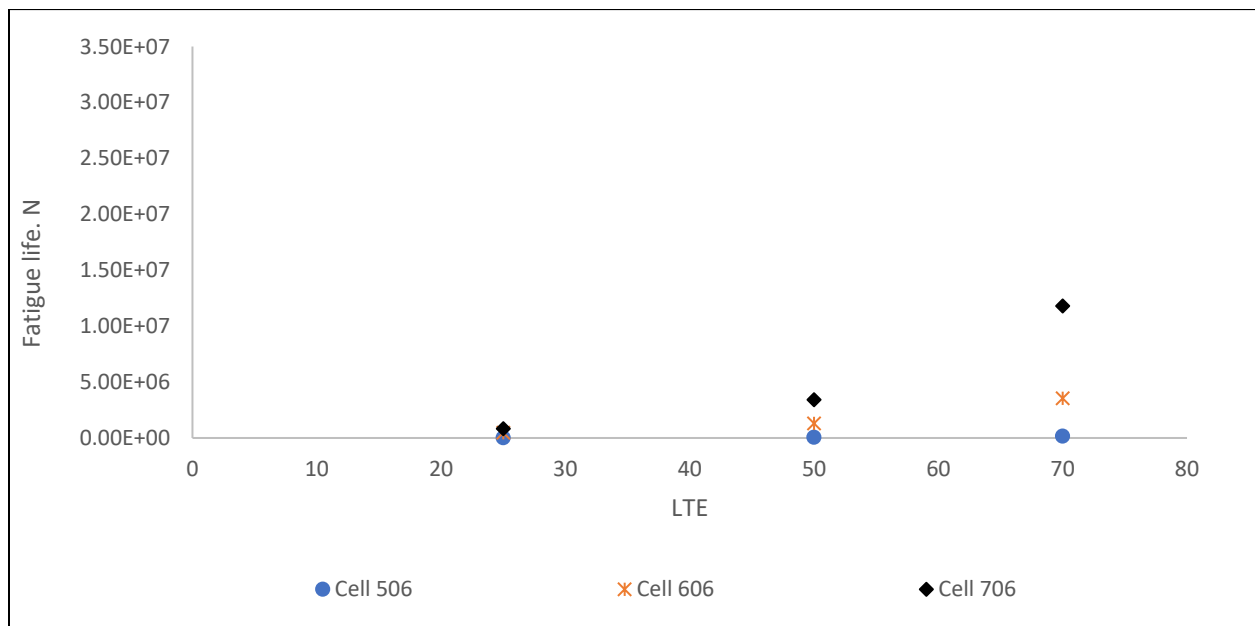
The reduced stress ratio in the concrete slabs is likely to increase the fatigue life. Based on the limited literature survey conducted, it can be stated that there is no widely accepted fatigue model for ultra-thin and thin FRC pavements, where pavement is directly constructed on the unstabilized base, and the fatigue crack propagation was considered to be affected by the fiber. The MEPDG fatigue model (ARA, 2004) provided below in Equation 1 was used to compute the fatigue lives for various stress ratios that depend on the concrete properties, crack width, and LTE (function of fiber dosages). While an accurate quantification may not be possible with this limited analysis, Figure 23 shows the estimated fatigue lives for the four cells that were constructed with various fiber dosages. While an accurate quantification of fatigue life may not be possible with this limited analysis, Figure 23 shows that higher fatigue life can be achieved if the joints have higher LTE, which can be obtained by using synthetic fibers. However, it shall be noted that the predicted fatigue life values presented in Figure 23 do not represent the real-world values, as LTE keeps changing with time and depend on many other variables. The other important fact is that Equation 1 is for plain concrete and does not depend on the post-crack properties of concrete. The FRCs' essential contribution is in their post-crack performance, so a more accurate prediction of the fatigue life of an FRC pavement or overlay shall be determined using a fatigue model that accounts for the post-crack performance of concrete. Nevertheless, this analysis assures that if LTE can be increased by using synthetic fibers, so is the fatigue life.

Figure 23: Demonstration of the benefit of fibers in Fatigue life (Cell 506- no fiber; Cell 606- 5lb/cy, Cell 706 – 8 lb/cy fiber)

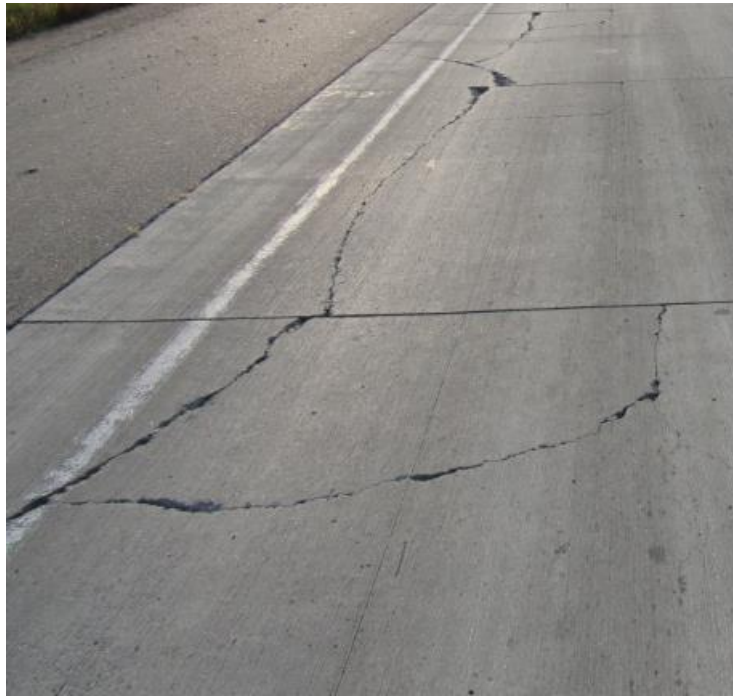
Cells 705 and 805 were constructed to study whether the inclusion of fibers can influence the slab size, more specifically, if fibers can help increase the slab size to reduce the construction cost. Cell 705 was constructed in 2017 as a 5-inch thick unbonded concrete overlay placed over a nonwoven geotextile fabric, secured to an existing 7.5-inch-thick concrete pavement originally constructed in 1993. Cell 705 was constructed with “large” slabs for the given thickness, 12 ft x 12 ft (passing lane), and 14 ft W x12 ft L (driving lane). Figure 24 shows photographs of typical longitudinal, transverse, and corner cracks that developed in Cell 705 during the first year of service. These kinds of cracks propagated with age and ESALs, as shown in Figure 26, and the driving lane of the cell was eventually taken out of service during the third year of service, after approximately 3 million ESALs.

Figure 24: Typical cracks that developed in Cell 705 during the first year of service (highlighted for clarity).

Figure 25: Cracks in Cell 705 in the third year of service.

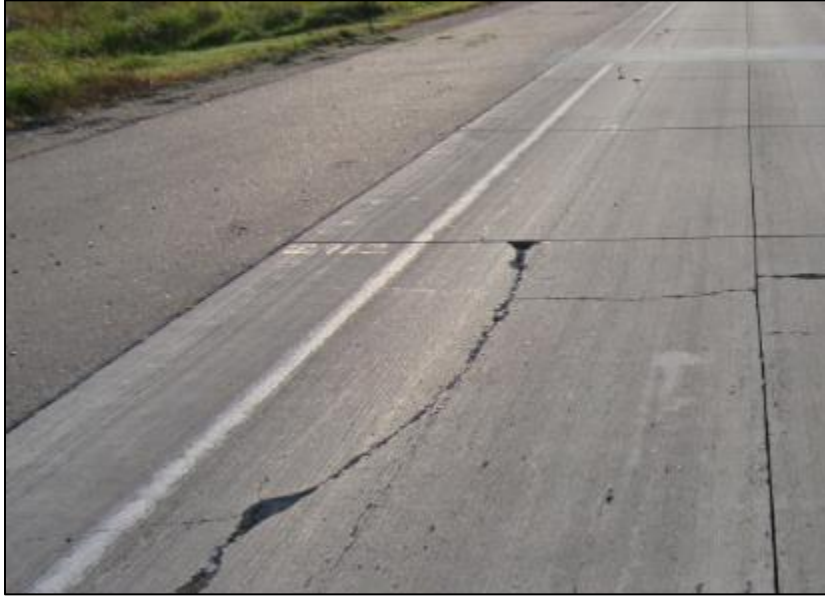
Cell 805, which was also constructed as a 5-inch thick unbonded concrete overlay, had narrower slabs (6 to 8 ft wide x 12 ft long) compared to Cell 705, as shown in Table 1. This cell also experienced longitudinal cracks, transverse cracks, and corner cracks. Figure 26 shows photographs of typical cracks in Cell 805 observed in the first year of service. Similar to Cell 705, this cell also deteriorated and was finally taken out of service during the third year of service, after approximately 3 million ESALs. Figure 27 shows cracked slabs in Cell 805 in the third year of service.

Figure 26: Typical cracks observed in Cell 805 (highlighted for clarity).

Figure 27: Cracks in Cell 805 in the third year of service.

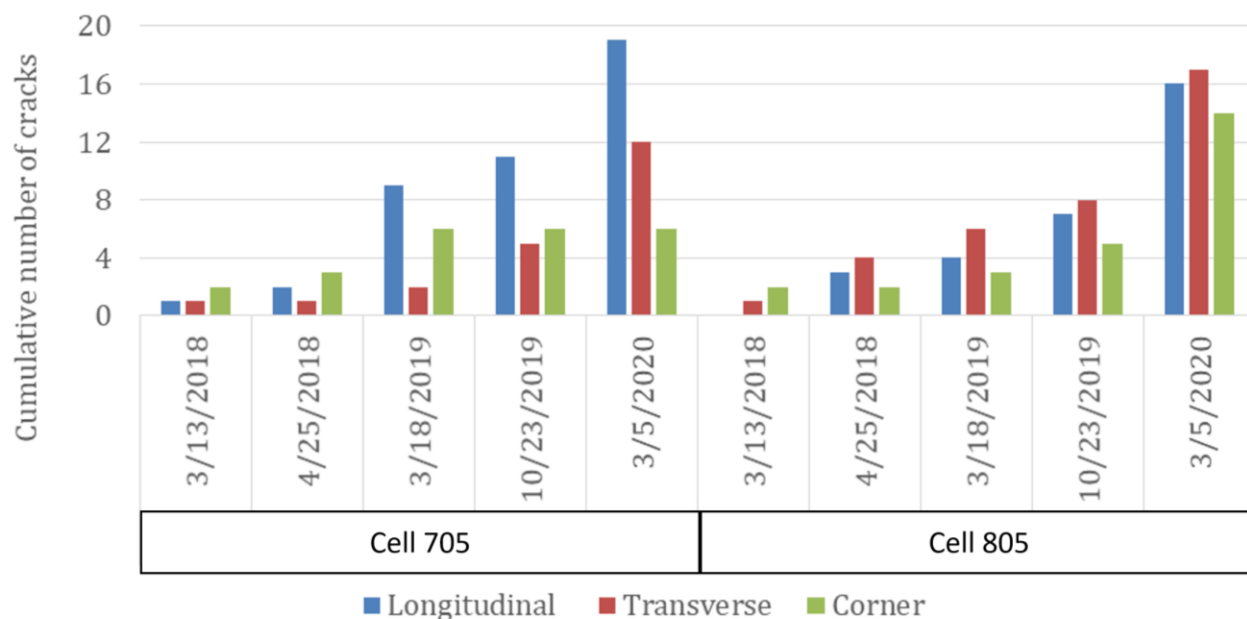
Color-coded distress maps for Cell 705 and 805 are provided in Figure 28. Figure 29 presents the cumulative numbers of cracks on different dates for the two cells. Based on the distress survey data available until March 2020, 11 out of 22 panels were cracked in Cell 705, of which eight were in the driving lane; a total of 50% slabs have cracked after 2.7 million ESALs. For Cell 805, 14 out of 40 slab panels have cracked, of which 13 were in the driving lane; 65% of the slabs in the driving lane and 35% (15% less than Cell 705) of total slab panels cracked after 2.7 million ESALs. Cell 705 experienced more longitudinal cracks than transverse and corner cracks. The reason for the larger number of longitudinal cracks in this cell may be due to the higher amount of curvature of thin wider slabs, which resulted in

higher amount of stresses in combination of the wheel load. Cell 805 experienced longitudinal, transverse, and corner cracks in comparable quantities. Similar to Cell 705, the driving lane of this cell was eventually taken out of service during the third year of service, after approximately 3 million ESALs.

Figure 29: Cumulative number of various cracks in Cell 705 and 805.
