DESIGN AND CONSTRUCTION GUIDELINES FOR THERMALLY INSULATED CONCRETE PAVEMENTS

TPF-5(149)

MnDOT Contract No. 89261

July 2009

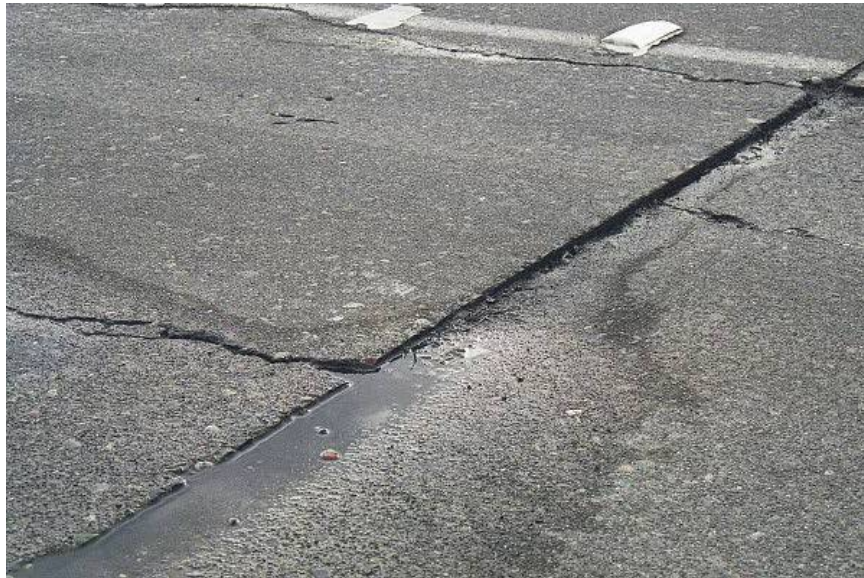
Figure 2.4. Faulting in jointed PCC pavement (WSDOT Pavement Guide).

Repeated heavy axle loads crossing transverse joints creates the potential for joint faulting, as shown in Figure 2.4. Faulting can become severe and cause loss of ride quality and require premature rehabilitation if any of the following conditions occurs:

- Repeated heavy axle loads
- Poor joint load transfer efficiency (LTE)
- Presence of an erodible base, subbase, or subgrade beneath the joint
- Presence of free moisture under the joint.

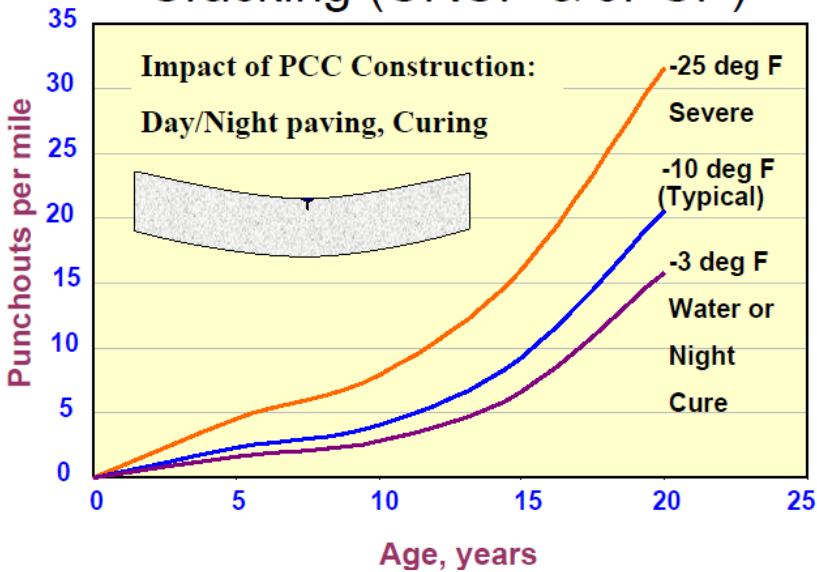
Figure 2.6. Built-in curl and pavement performance.

Although the fact of initial (“built-in”) curling was relatively well-known to researchers, only recently has this effect been acknowledged as a contributing factor to distresses and long-term pavement performance. Figure 2.6 illustrates the importance of considering built-in curl. Built-in curling is influenced by many factors, including material properties (PCC shrinkage, coefficient of thermal expansion, heat of hydration, etc.), placement conditions (ambient temperature, ambient relative humidity, wind, sunshine) and curing techniques. Excessive built-in curling can increase the initial roughness of concrete pavements and may increase top-down cracking and faulting in JPCP and punchouts in CRCP.

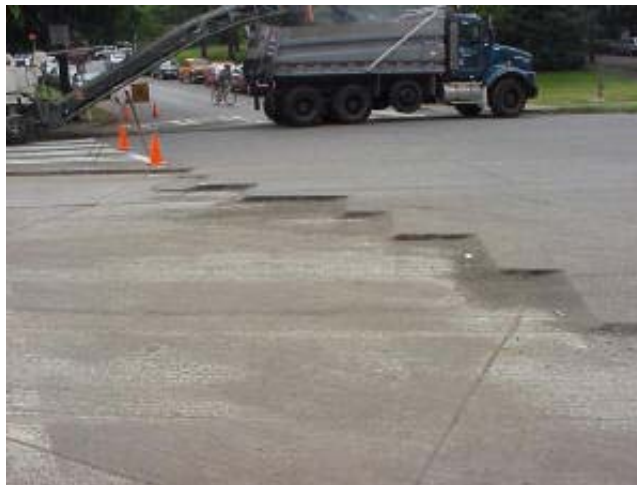
Figure 3.1. Milled road showing complete removal of the HMA overlay to expose the PCC slabs beneath (WSDOT).

- Surface preparation – Before placing the AC overlay on the existing PCC pavement it is important to repair, clean, level, and coat it with a binding agent (Figures 3.1 and 3.2). These techniques help insure the bonding of the overlay to the existing surface and are critical for pavement performance.

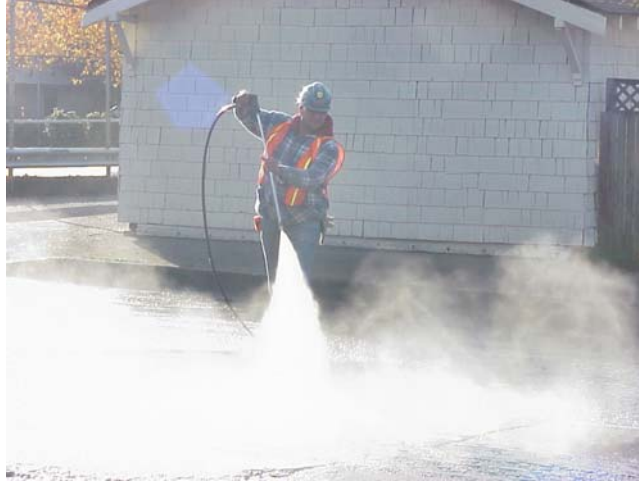
Figure 3.2. Washing the Existing Surface Prior to Overlay (WSDOT).

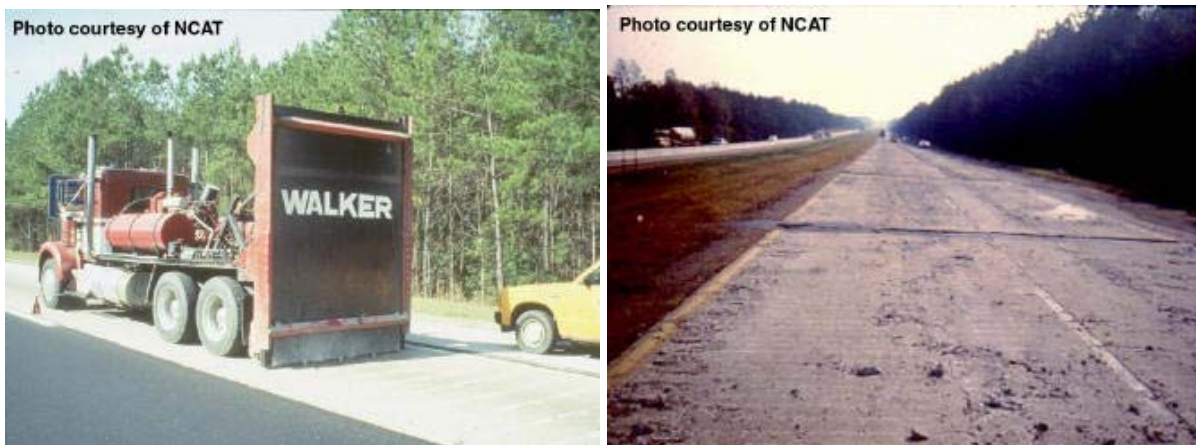
Figure 3.4. At left, guillotine hammer used for cracking and seating PCC; at right, PCC pavement after cracking and seating with guillotine hammer (WSDOT)

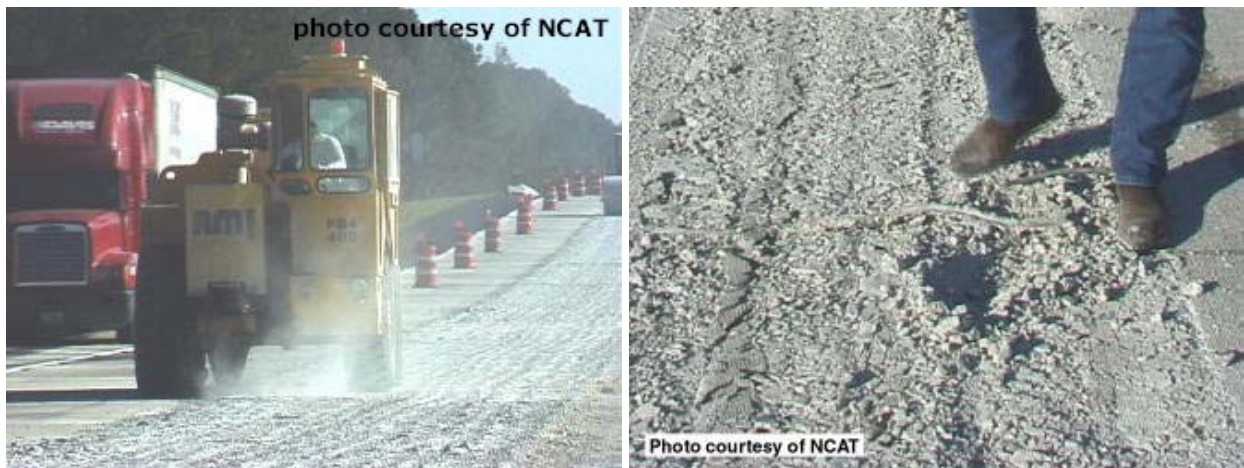
Figure 3.5. At left, resonant pavement breaker used to rubblize PCC pavement; at right, PCC pavement after rubblization with a resonant pavement breaker (WSDOT).

The rubblization process consists of converting a badly distressed PCC pavement into a high quality aggregate base. A National Asphalt Pavement Association (NAPA) study reported that the strength of the rubblized layer can be approximately 1.5 times greater than a conventional dense graded aggregate base (PCS 1991). This method of rehabilitation is usually considered cost effective when the PCC pavement has suffered structural distresses such as D-cracking, alkali-silica reaction, freeze-thaw damage, faulting, and patching of more than 10% of cracked slabs (Thompson 1999). Figure 3.5 presents a rubblized PCC pavement using resonant pavement breaker.

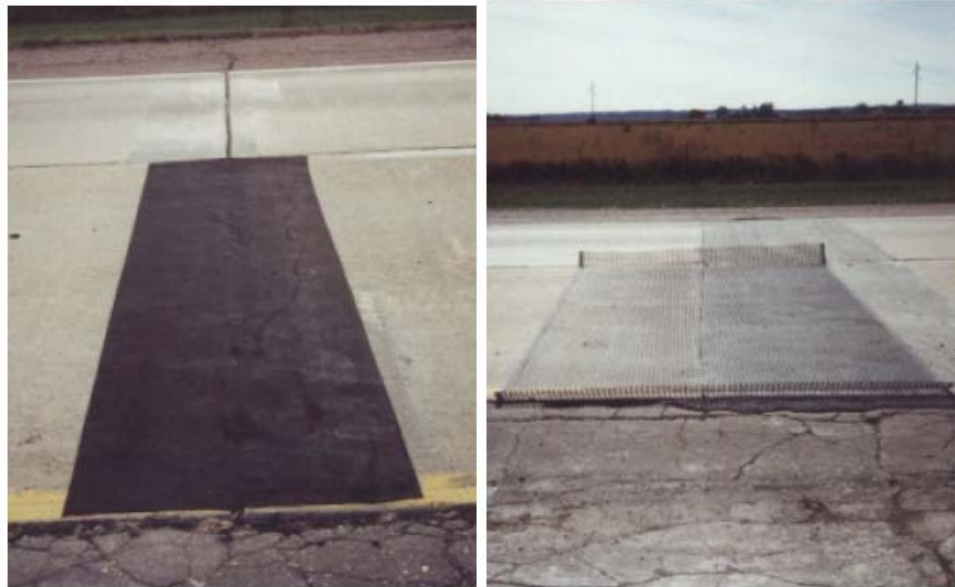
Figure 3.6. Linq-Tac -711N (at left) and Strata Grid-200 geogrid products (Rumpca and Storsten 2000).

The results indicated that most of the joints reflected through to the asphalt overlay regardless of the use of a geogrid treatment. Table 3.5 illustrates the results of the study, obtained through the use of statistical software, with the mean amount of reflective cracks experienced by each treatment. The largest observed difference in performance was between sawed joints and unsawed joints, with 12% of the sawed joints experiencing reflective cracks and 25% of the unsawed joints experiencing reflected cracks. As the results indicate, the most economical and best performing option was the section that did not use a geosynthetic fabric, had minimal joint treatment, and had sawed joints (Rumpca and Storsten 2000). In support of this conclusion is the survey conducted by Bennert and Maher (2007), whose survey of DOTs on the use of interlayers concluded that the worst performance is given by paving fabrics and geotextiles.

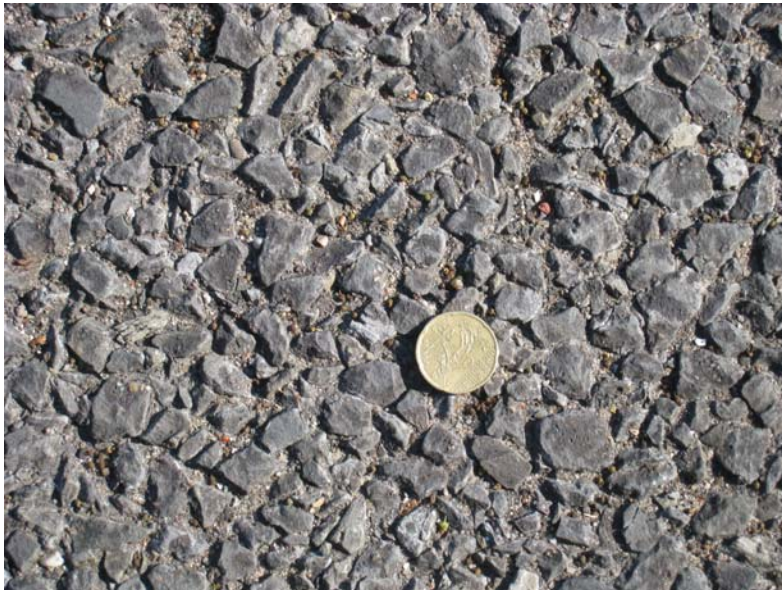
Figure 4.2. Close-up of the porous asphalt surface of the A12 motorway. Note fines infiltrating the porous asphalt surface on the edge of the traffic lane (SHRP2 2009).

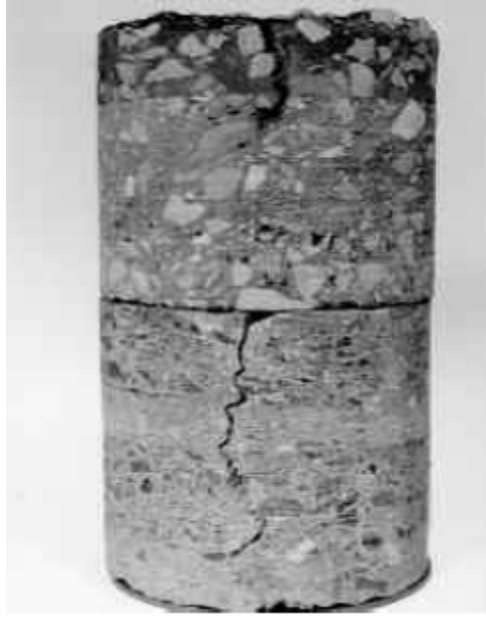
Figure 5.1. Core sample from recently initiated top-down crack in as-built AC/PCC (Nesnas and Nunn 2004).

Nernas and Nunn (2004) recently reported that cracking in the asphalt layer of an as-built AC/PCC composite system generally initiates in the upper layer and travels downward, contrary to asphalt overlays of cracked pavements where reflective cracks initiate at the asphalt-concrete interface and propagate upwards. The researchers cited field evidence in the investigation of over 50 recent cracks in nine as-built composite pavements, such as Figure 5.1, to support their claim, and developed a response model which treats the concrete and asphalt layers as a composite system that acknowledged the following:

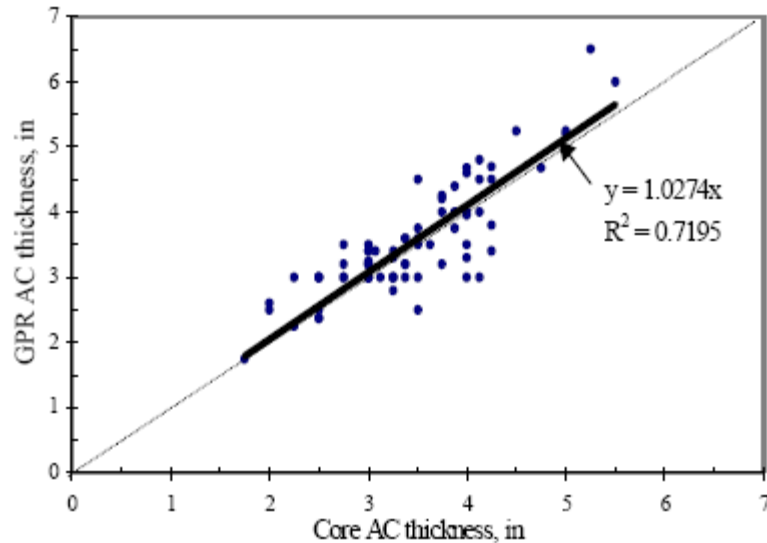
Figure 6.1. GPR vs. Core Thickness for Asphalt Overlay on I-90 (Maser 2001).

Ground penetrating radar (GPR) was successfully used to evaluate the asphalt thickness and the condition of the underlying concrete of three composite pavements across the country (Maser 2001). The evaluations were conducted at highway speeds so as not to interfere with the normal operation of the corridor. The results were correlated with data from core samples (shown in figure 6.1 below) and used for planning and scoping of future rehabilitation activities (Maser 2001).

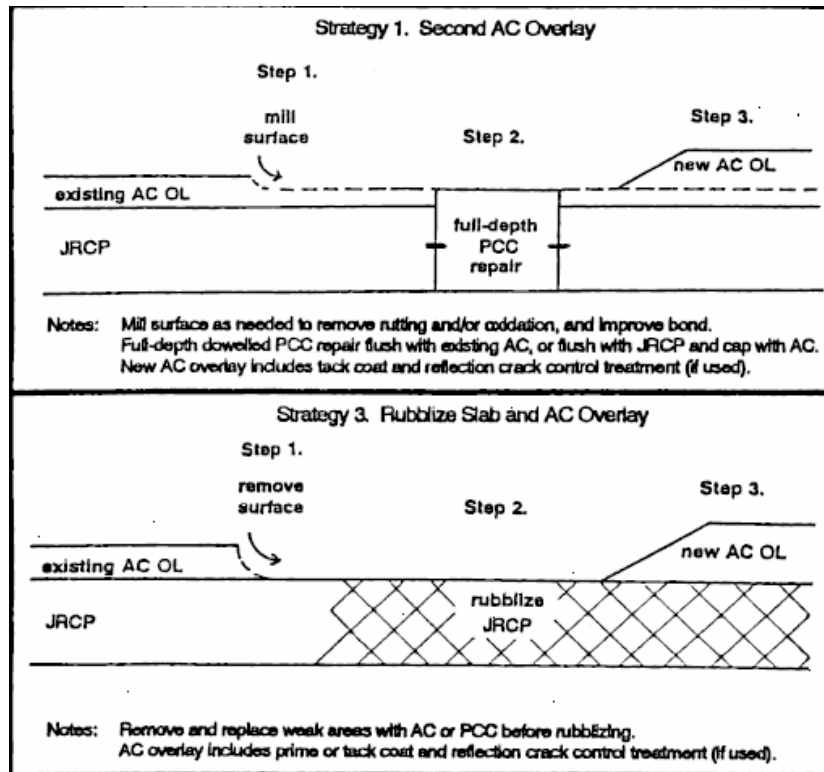
Figure 6.2. Composite Pavement Rehab Strategies 1 and 3 (Gharaibeh et al. 1997).

Note that rehabilitation strategy four (Figure 6.4) is an unbonded concrete overlay, and rehabilitation strategy three (Figure 6.3) is an asphalt overlay placed on a rubblized concrete pavement. These strategies are recommended only when the structural capacity of the underlying concrete pavement has diminished considerably, and were recommended over the second generation 3.25 in. AC overlay as the most cost effective option in the vast majority of cases. However, when the 3.25 in. AC overlay was compared with the 5 in. AC overlay, the additional structural capacity of the thicker overlay yielded a longer service life, which made it more cost effective in the long term (Gharaibeh et al. 1997).

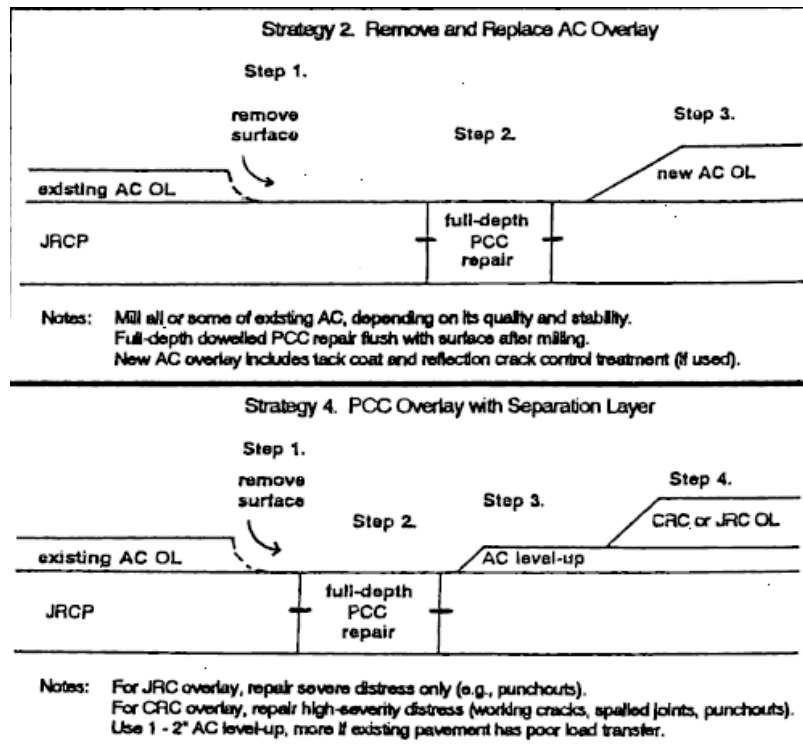
Figure 6.3. Composite Pavement Rehab Strategies 2 and 4 (Gharaibeh et al. 1997).
