Composite Pavement Technology

Timothy R. Clyne, P.E.
Minnesota Department of Transportation

January 13, 2011

*Presented to the
Transportation Learning Network and the NDLTAP*

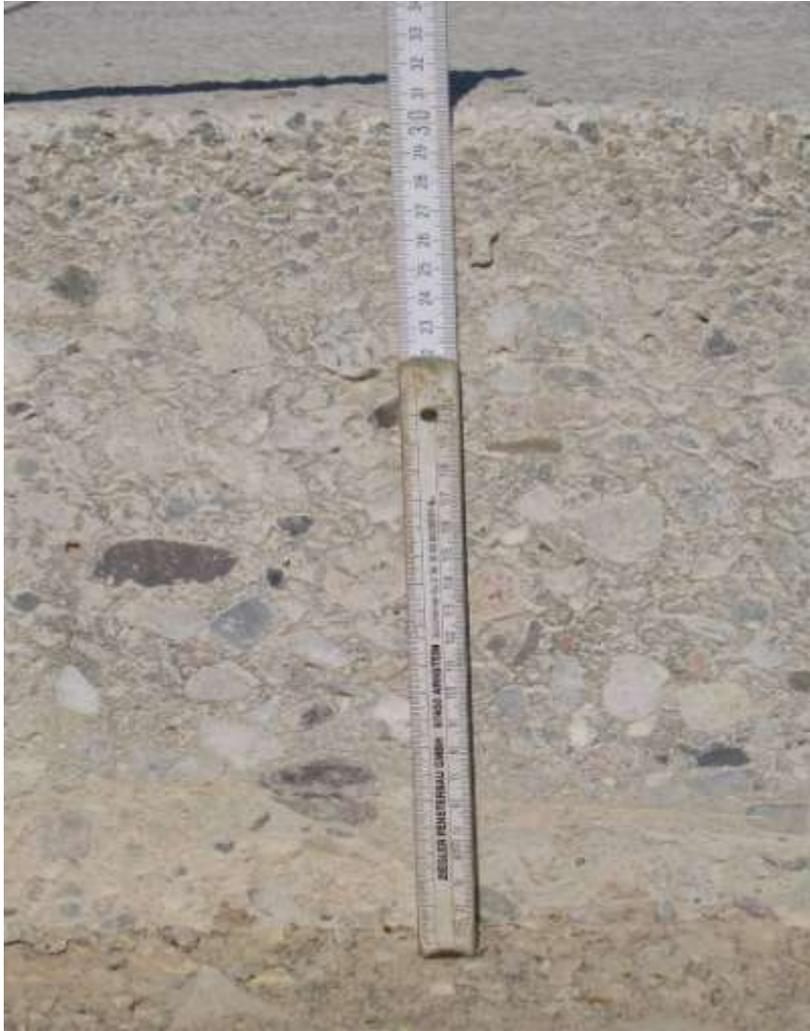
What is a Composite Pavement?

- AC/PCC or PCC/PCC pavement constructed as an integrated system
- Provides strong, durable, safe, smooth, and quiet surface
- Requires minimal maintenance

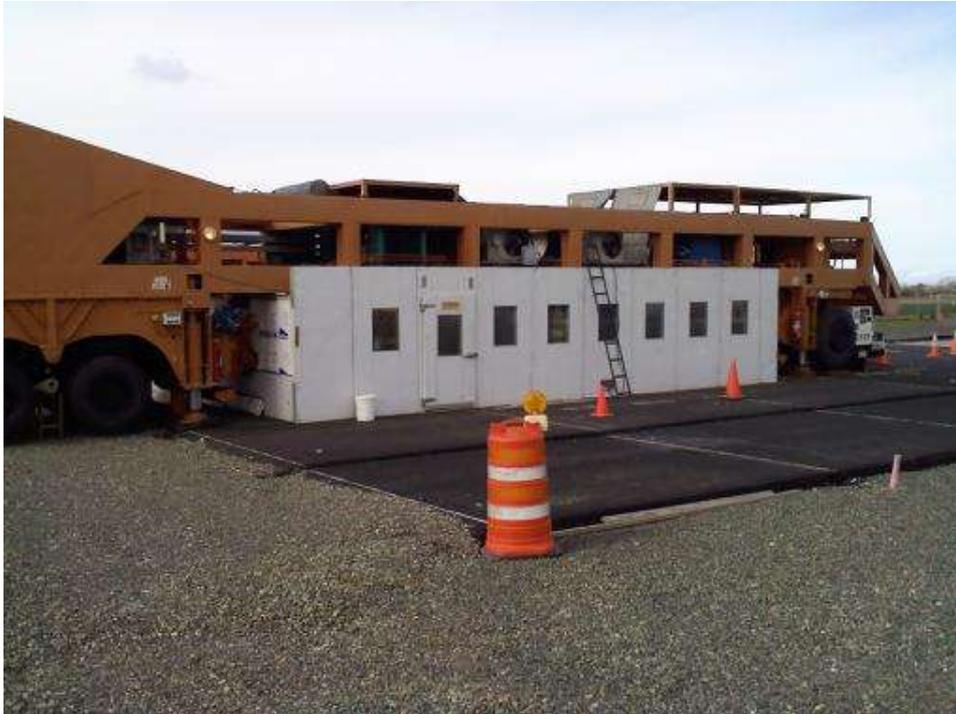
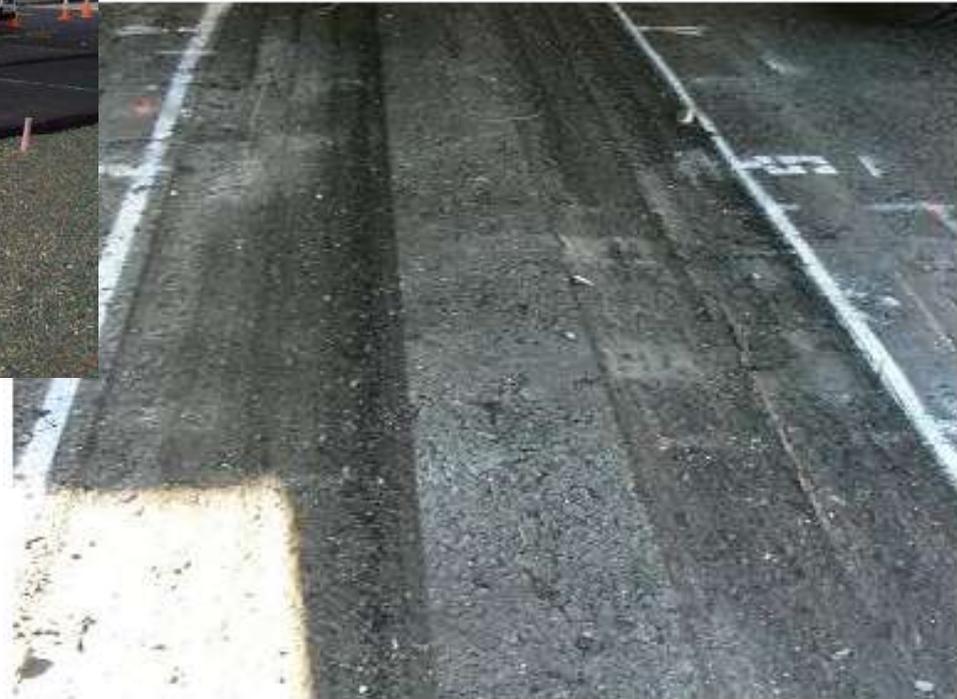
Construction of Composite Test Sections at UCPRC for HVS Testing

- Several Test Sections
- HMA/PCC Only
- Instrumentation
- Rutting & Cracking Behavior

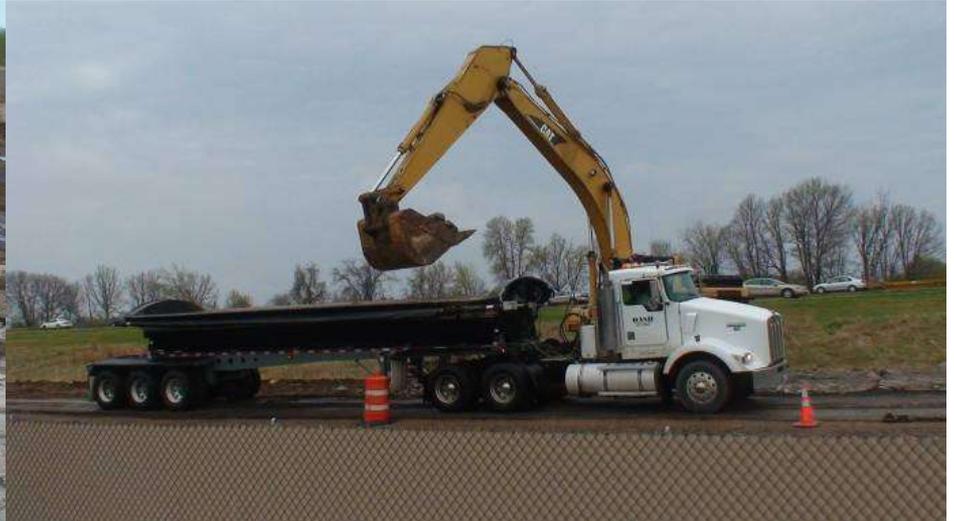
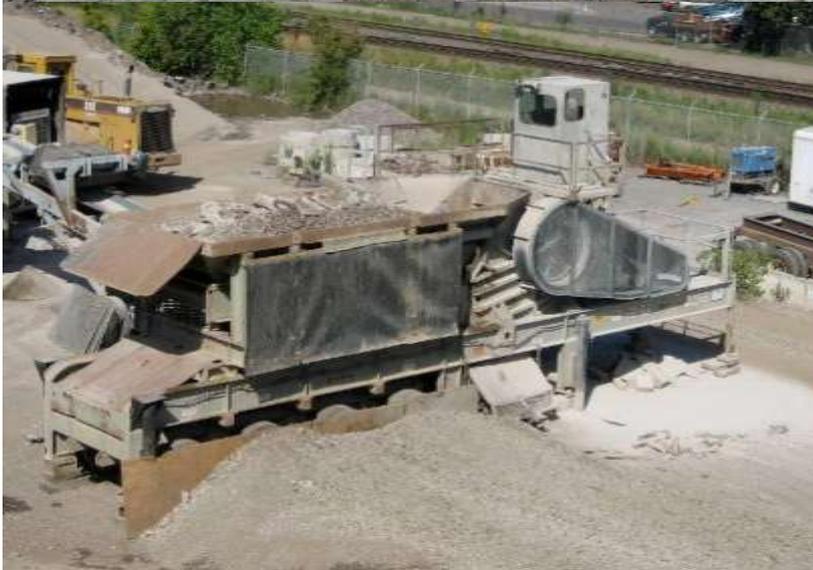
RCA Salvage Operations

RCA Percent Absorption 2.93%

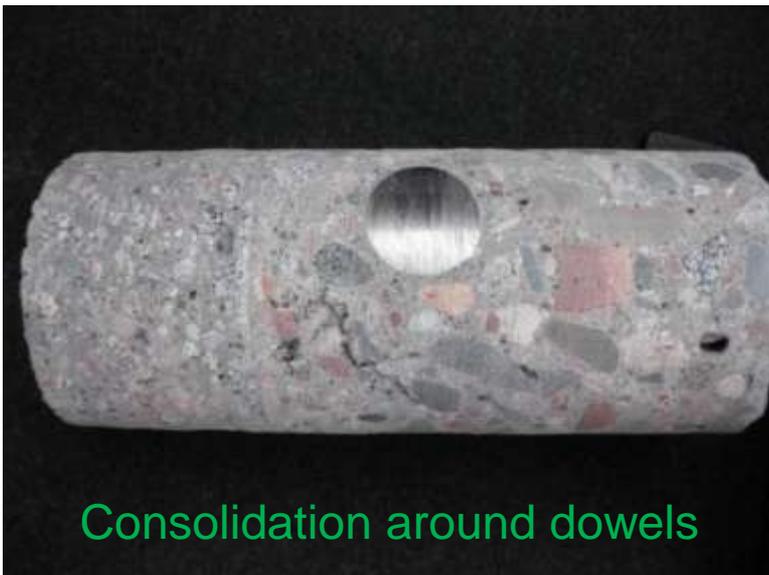
Joint Condition

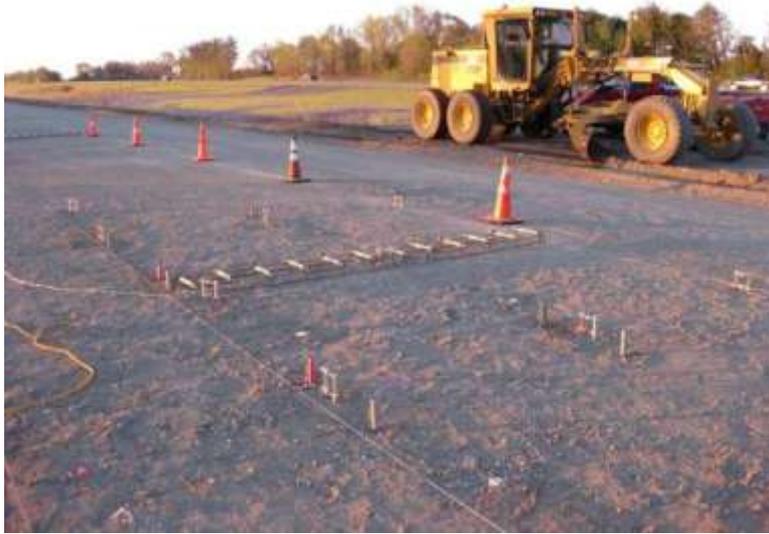
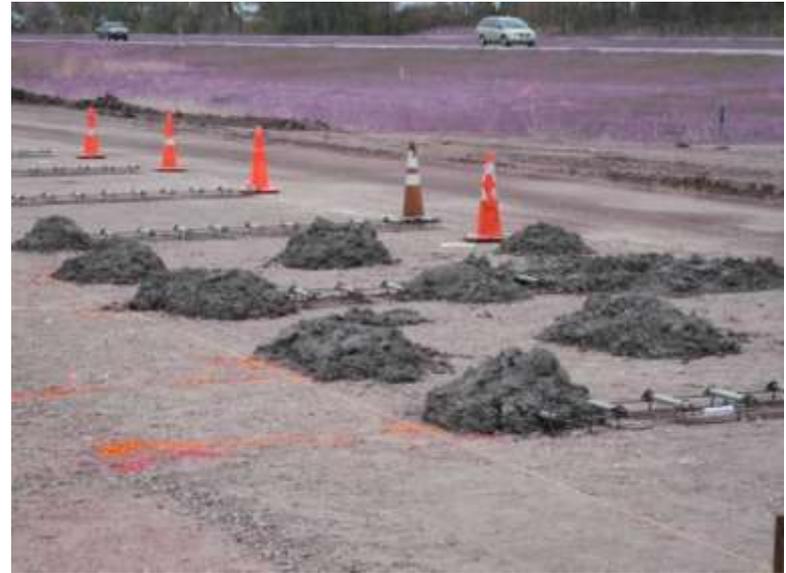
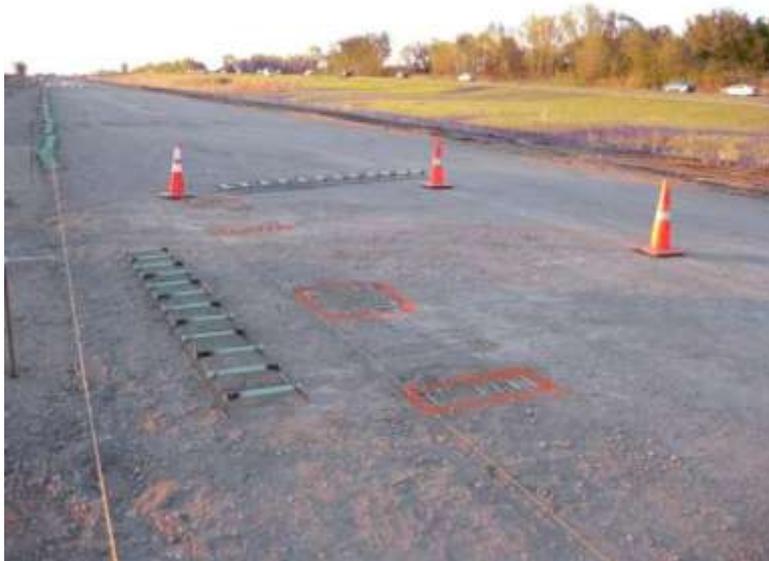
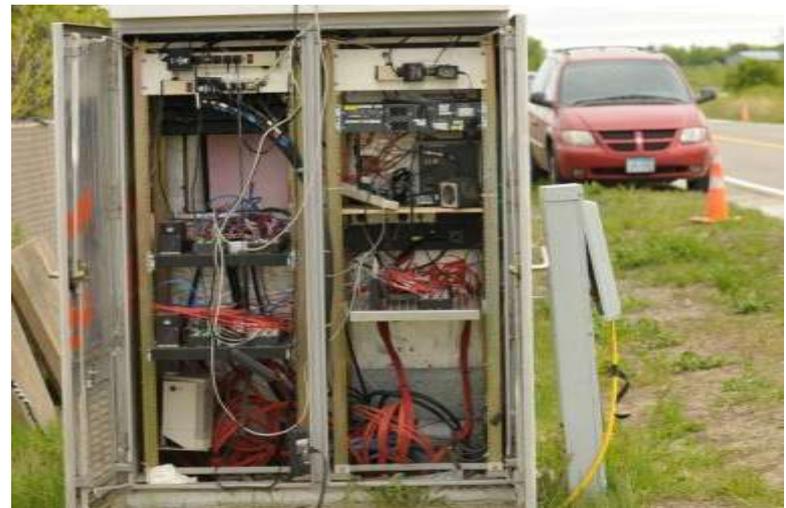
Temperature, Moisture, Static & Dynamic Strain Gauges

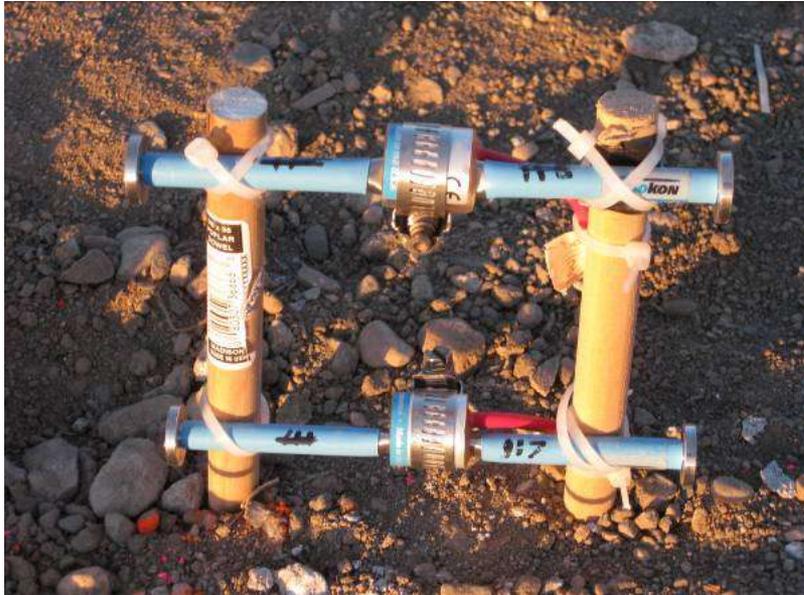
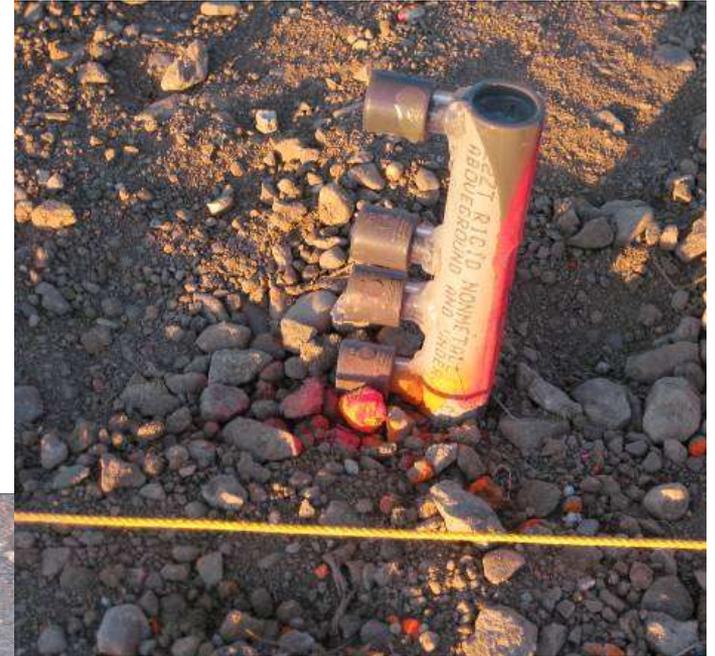
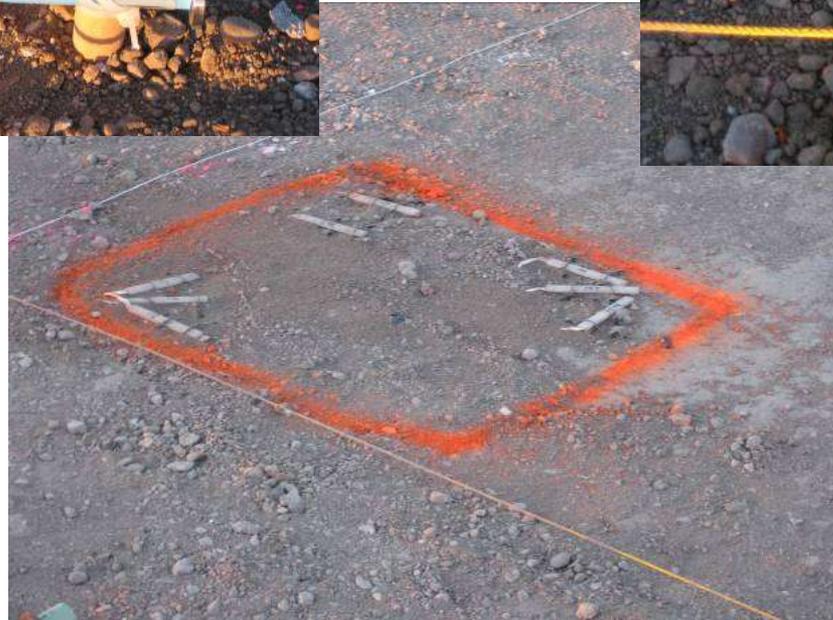
Vibrating Wires, Moisture/Humidity Sensors, CE Strain Gauges

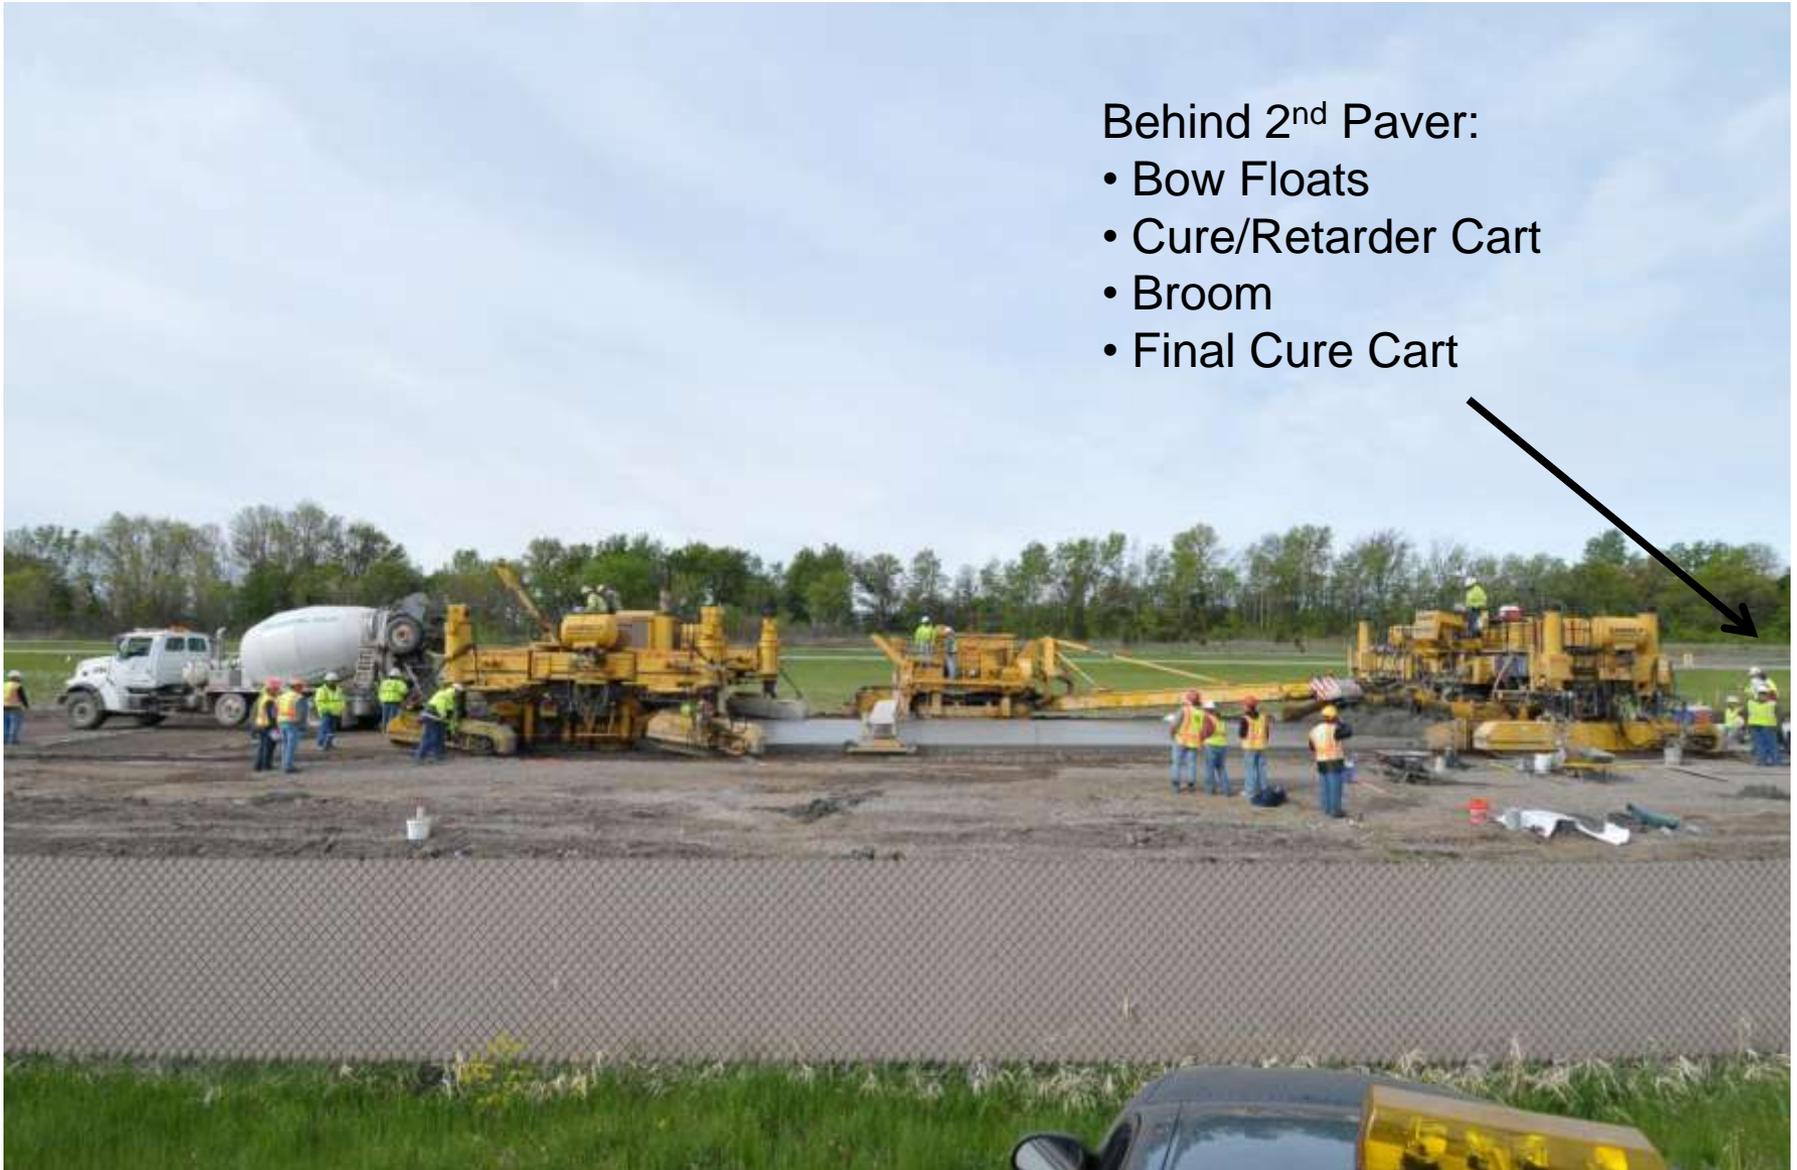
Wet-on-Wet PCC/PCC Paving

Behind 2nd Paver:

- Bow Floats
- Cure/Retarder Cart
- Broom
- Final Cure Cart

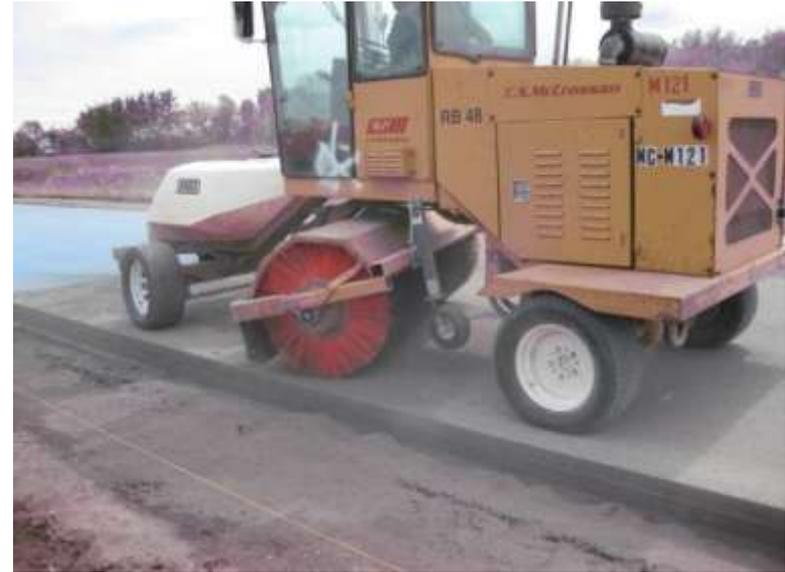
Exposed Aggregate Concrete Texture

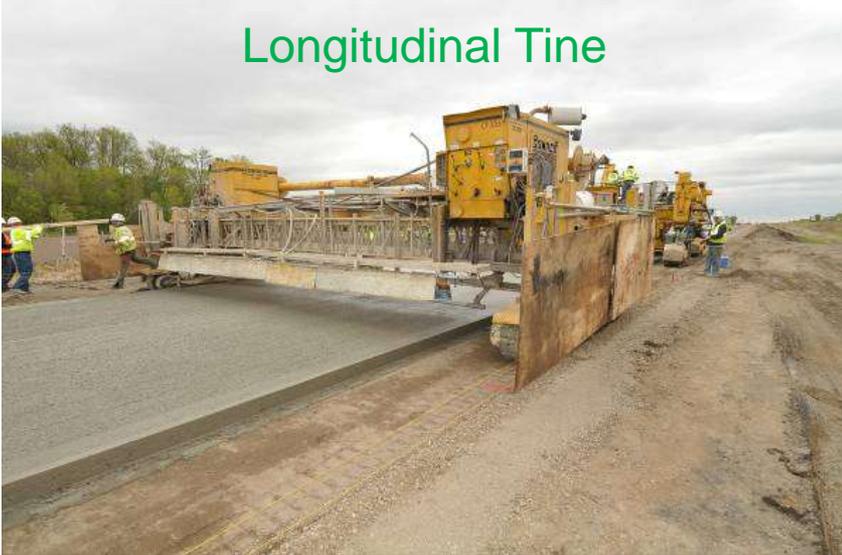
Longitudinal Tine

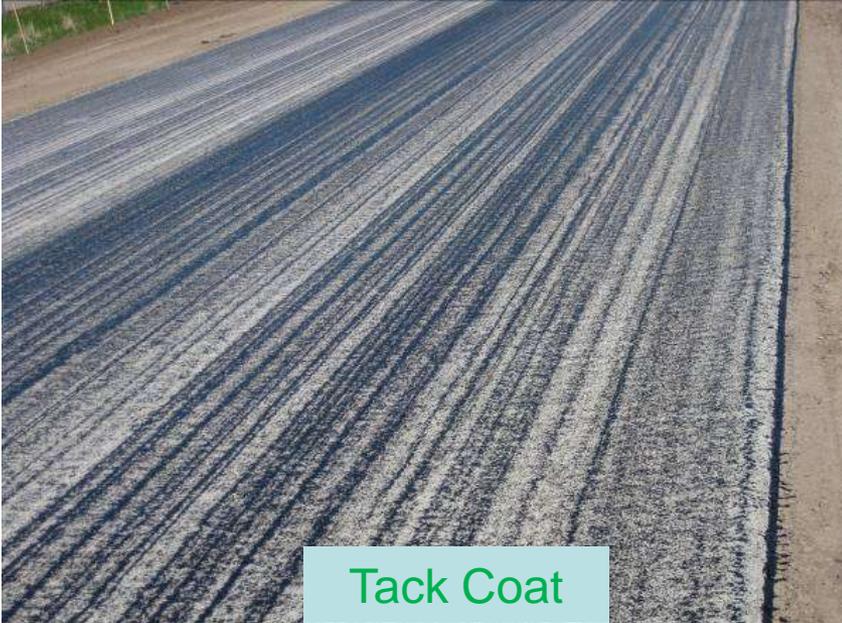
HMA Paving & Rolling

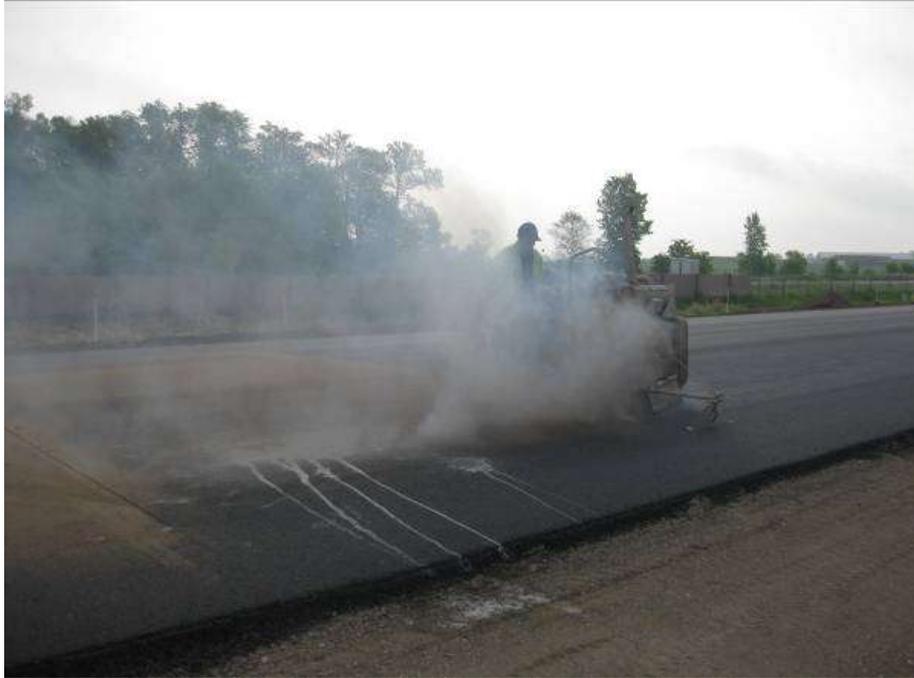
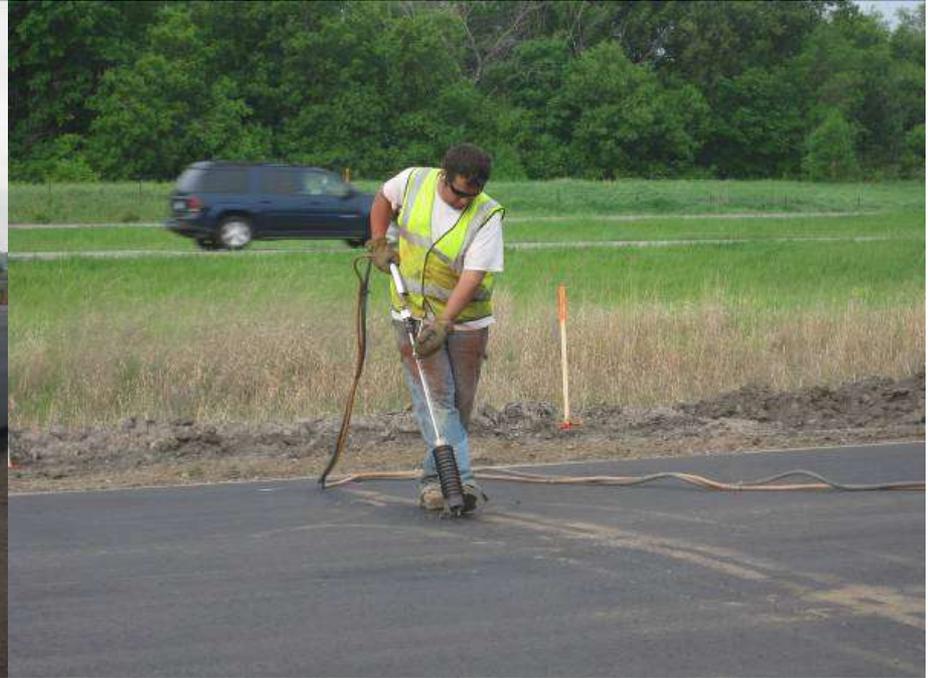
Sawing and Sealing

- 100 ft: no seal
- 375 ft: saw & seal
 - 1 ft into shoulder
 - 1 ft away from edge of shoulder

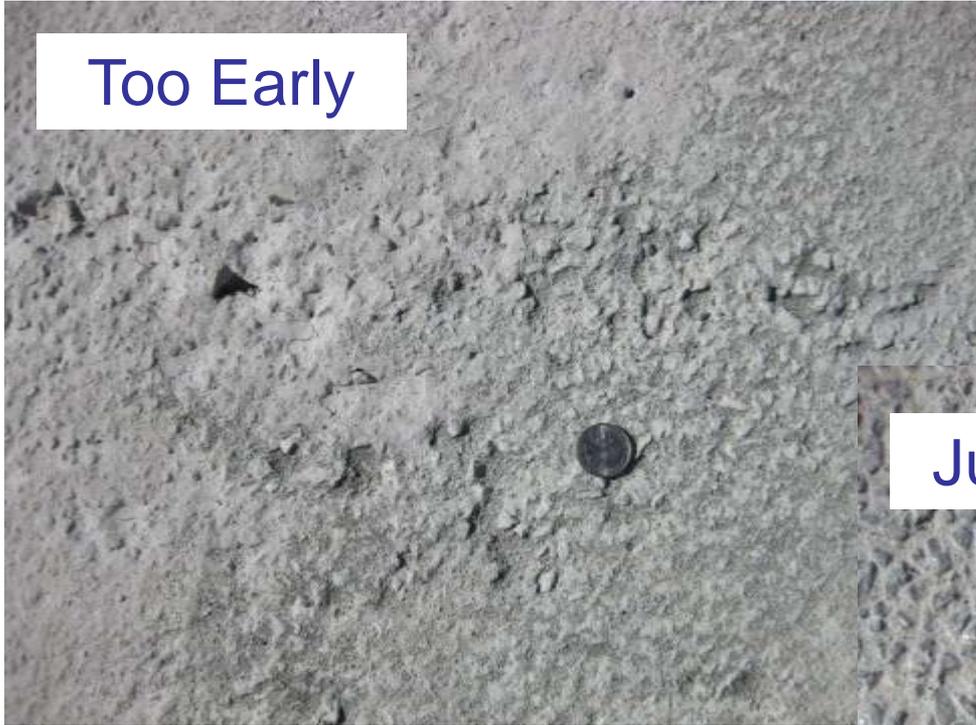
Lessons Learned: Brushing Time

Too Early

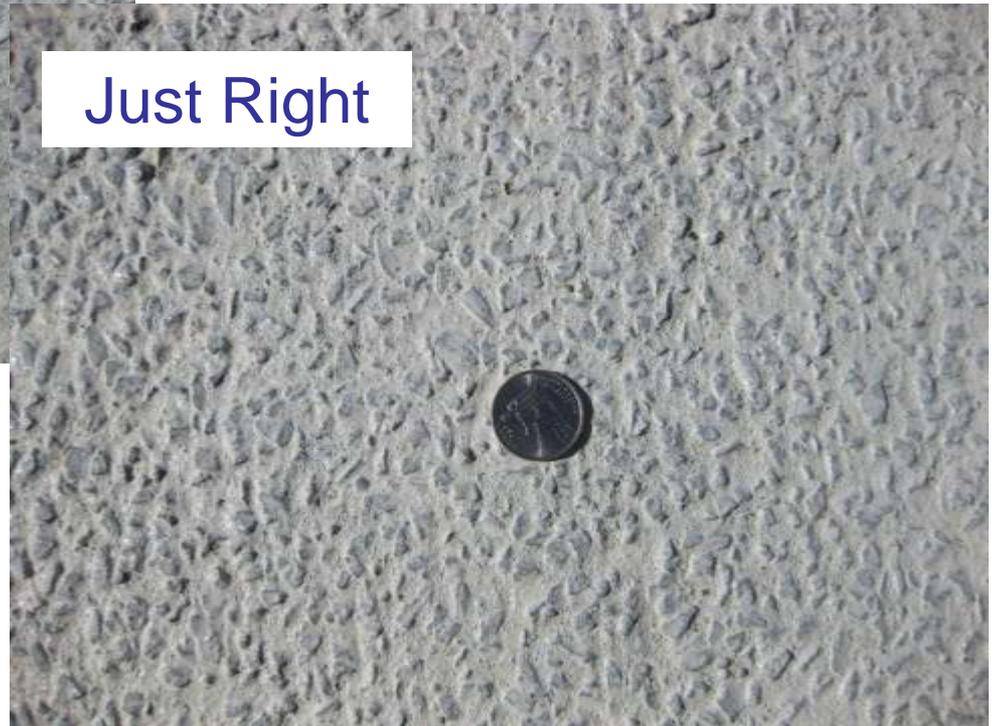
Just Right

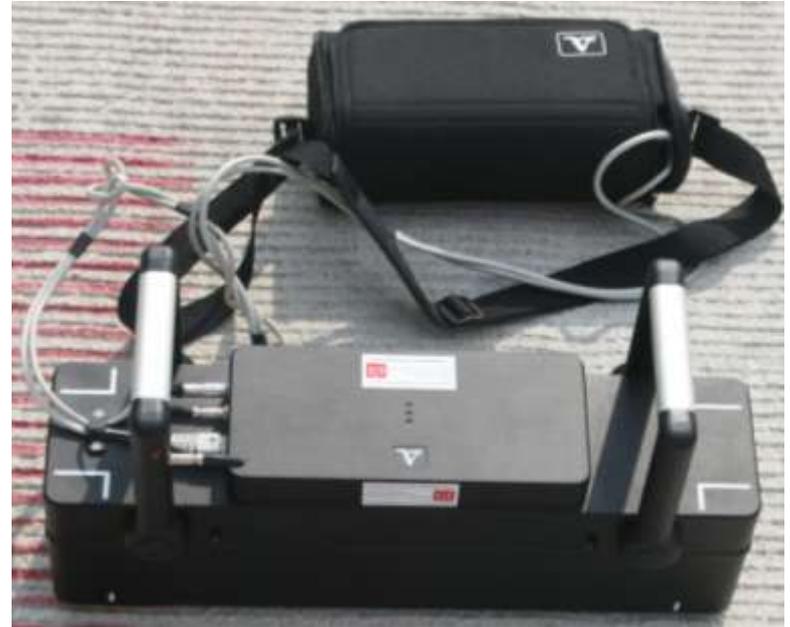
NDT Evaluation, Ultrasound Imaging

- Ultrasonic tomography used to evaluate PCC-PCC non-destructively
- Use technique to get quicker QA without sacrificing reliability
- Device used on R21 MnROAD demo slabs and mainline section

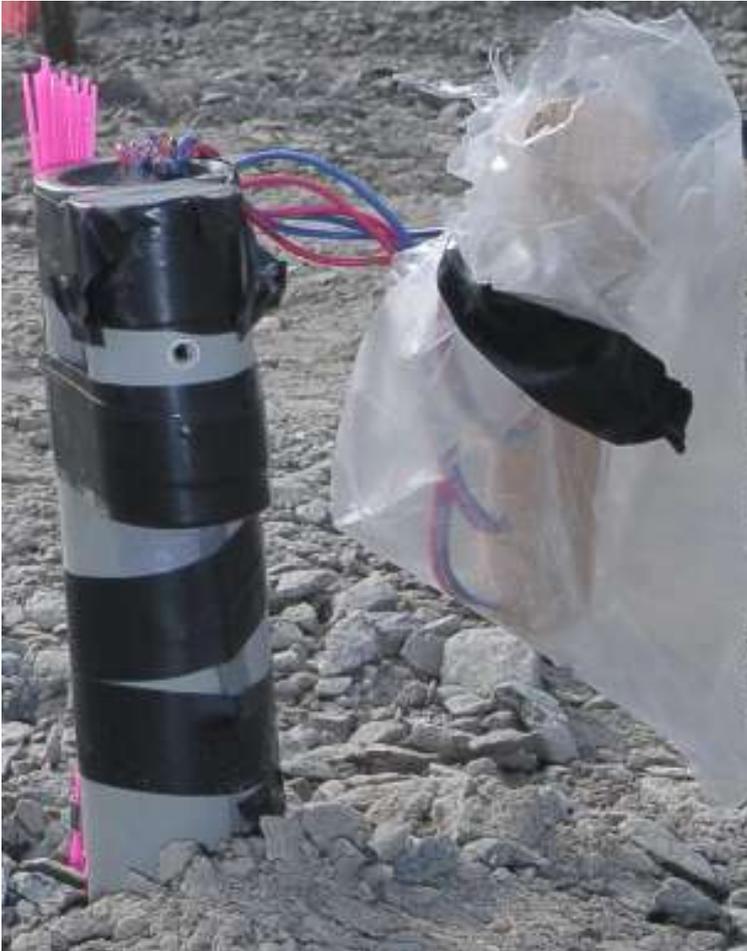
Instrumentation

- 6.5% failure rate overall
- Strains, joint opening, temperature, moisture data
- Will use this response data to validate MEPDG models

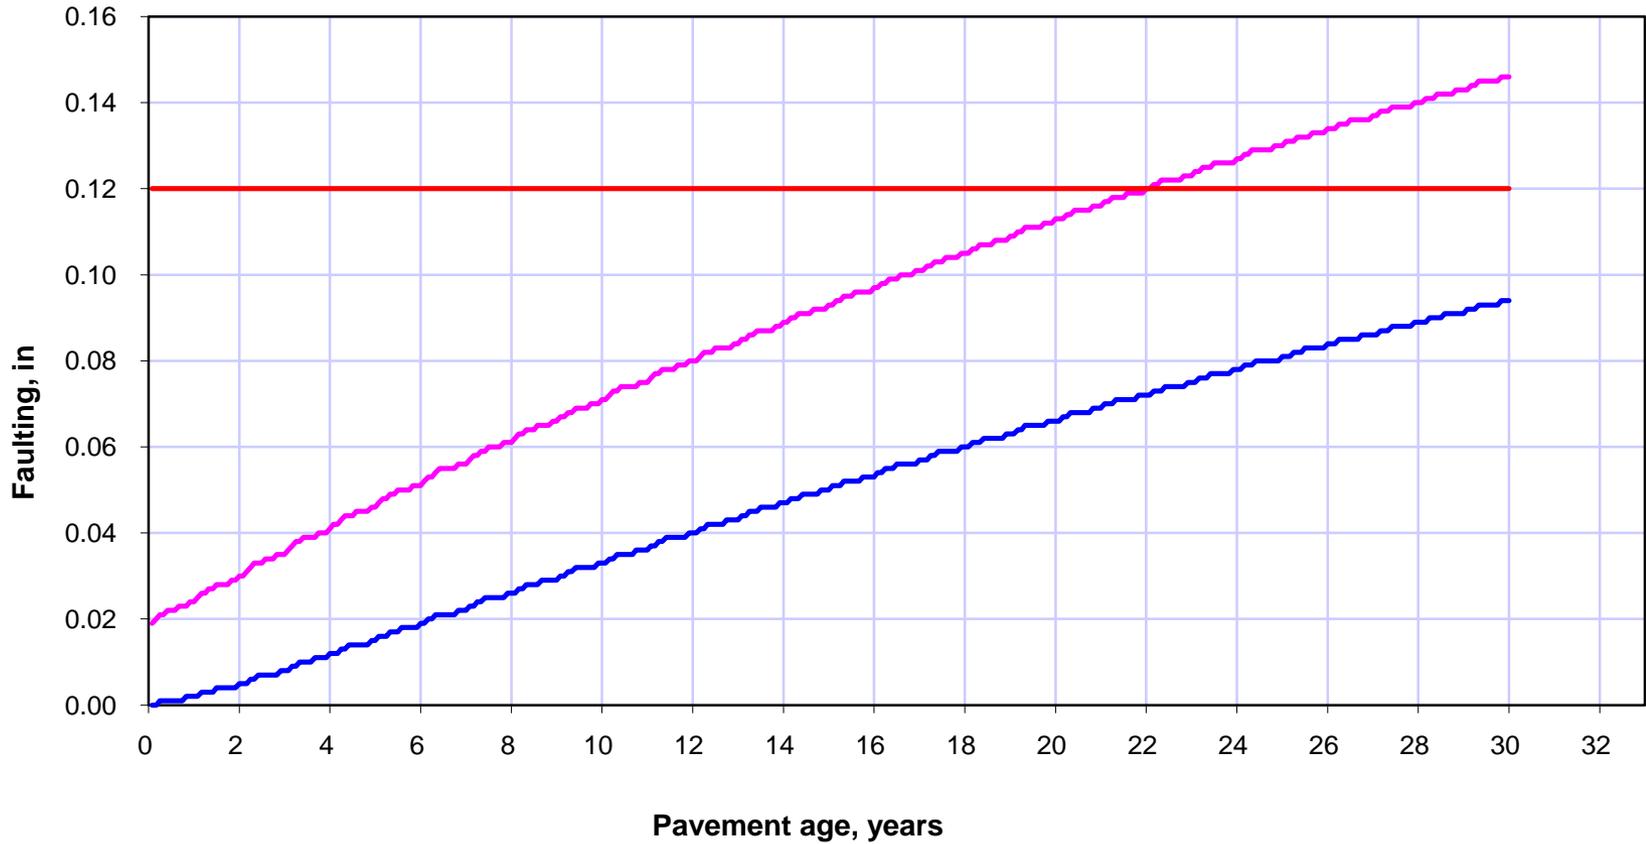
Faulting, EAC / LCC Predictions

Predicted Faulting

- Transverse Cracking < 5 % slabs
- Joint faulting < 0.10 in. mean
- IRI < 125 in/mile
- Two layer composite concrete pavement with “cheap” concrete lower layer should be in good condition

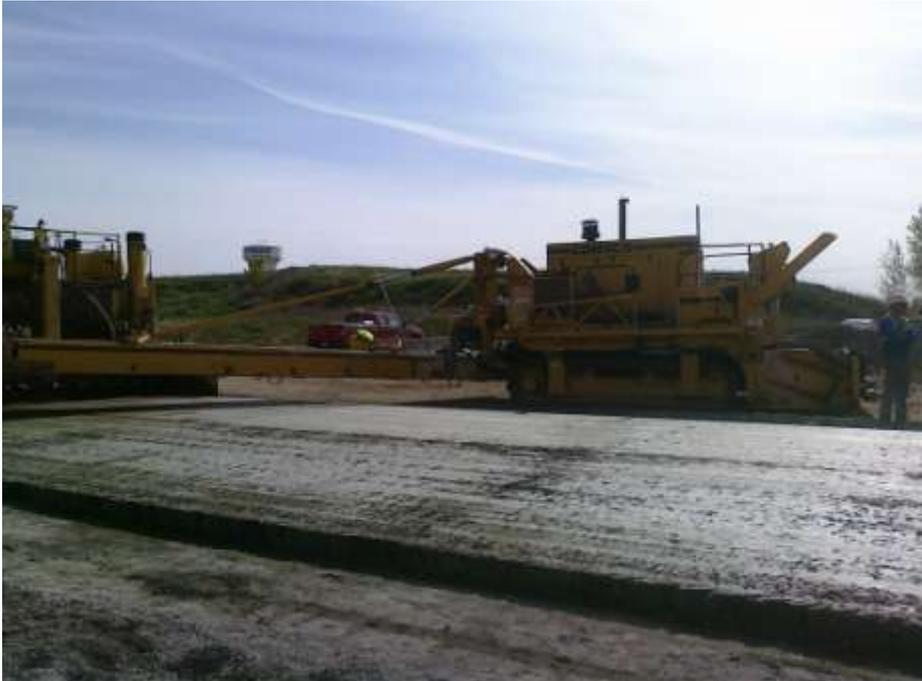
The lower lift comprised of recycled concrete as the source of coarse aggregate.

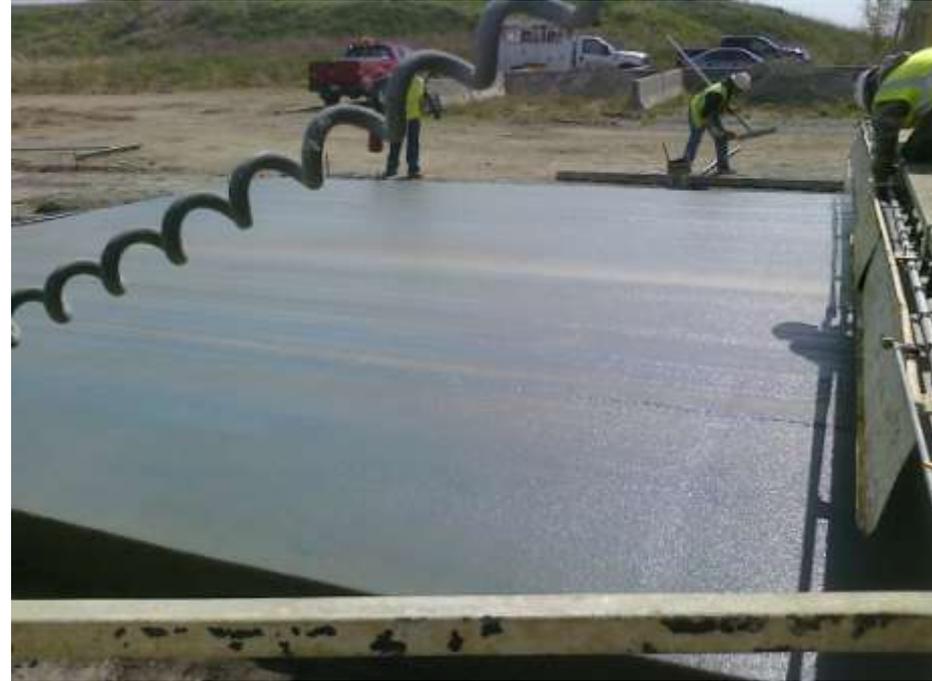
The upper lift used the high quality, Class A aggregates.
