EXPLORING POROUS PAVEMENT MAINTENANCE STRATEGIES

Mn/DOT demonstrated a porous pavement vacuuming process using equipment owned and operated by Reliakor, a Minnesota based Company at MnROAD on November 4, 2009. Pervious concrete test cells 85 and 89 and porous asphalt cells 86 and 88 were vacuumed. Representatives from Mn/DOT Metro District, Mn/DOT Research, Mn/DOT Tech Support, Mn/DOT Maintenance Research, the City of Minneapolis, DNR, and Reliakor Services Inc were in attendance.

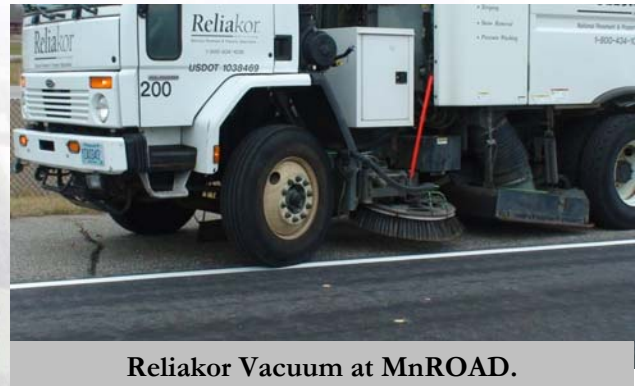
Reliakor Vacuum at MnROAD.

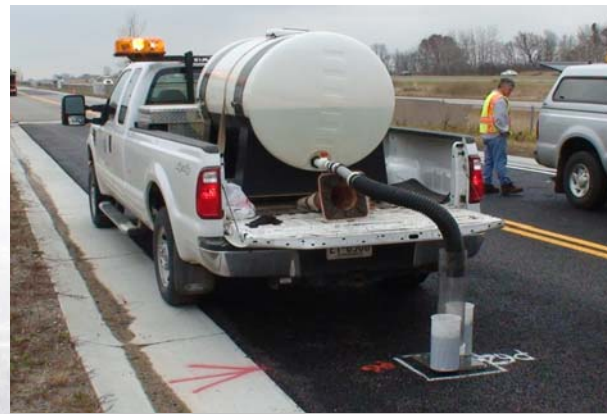
Flow measurements were made the day before and immediately after vacuuming. The change in permeability was measured using a falling head permeability device. This device consisted of a 90 centimeter long clear vertical six inch diameter tube that was sealed to the pavement surface using duct seal compound. A water tank and hose was then used to fill the tube with water. The water was then allowed to calm down and drain smoothly before timing began. The time that it took the water to drain from 37 cm to 11 cm was recorded at each test spot.

Mn/DOT Permeability Device.

One spot was tested in each test cell at the wheel path. Since the pervious concrete test cells (85 and 89) were very clean with no surface distress there was very little change in flow time. In the porous asphalt test cells, there was a 30% and 23% decrease in flow time in cells 86 and 88 respectively. This greater improvement is likely due to the removal of the raveled surface aggregate.
