TECHNICAL SUMMARY

Preventing Stripping of Asphalt Pavements under Chip Seals

This Technical Summary pertains to LRRB-produced Report 2013-08, “Stripping of Hot-Mix Asphalt Pavements under Chip Seals,” published April 2013. The full report can be accessed at <http://www.lrrb.org/PDF/201308.pdf>.

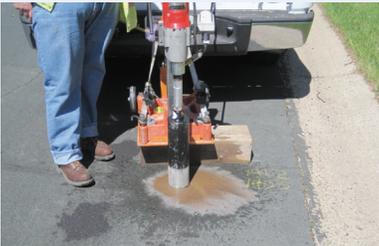
Researchers took core samples of city streets for air void and permeability testing in the laboratory.

After testing laboratory samples, researchers conducted similar testing on core samples taken from city streets experiencing stripping. They also developed field test requirements for using a field permeameter and nuclear density gauge—which determines density by measuring reflected radiation—to evaluate whether a street is a good candidate for a chip seal and will be less likely to strip.

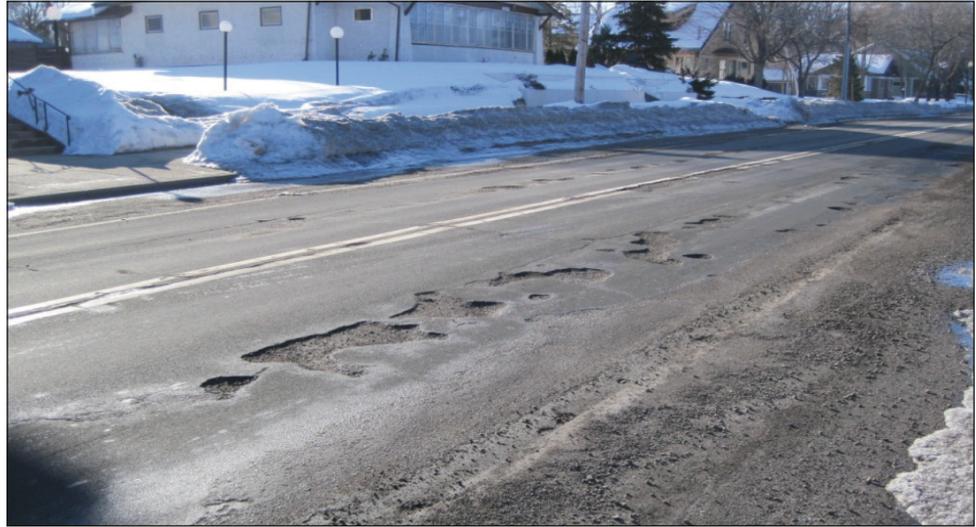
Stripping tends to occur under chip seals of urban curb-and-gutter streets because their closed structure traps water, which can damage asphalt where density is low. Results showed that using a more breathable fog seal instead of a heavier chip seal may help alleviate this problem.

Results also showed that alternative use of a lighter fog seal could help alleviate stripping by stopping water infiltration while allowing water vapor to escape.
