Protocols and Criteria for Acoustic Emission Monitoring of Fracture-Critical Steel Bridges

Minnesota
Department of
Transportation

June 2015

Research Project
Final Report 2015-36

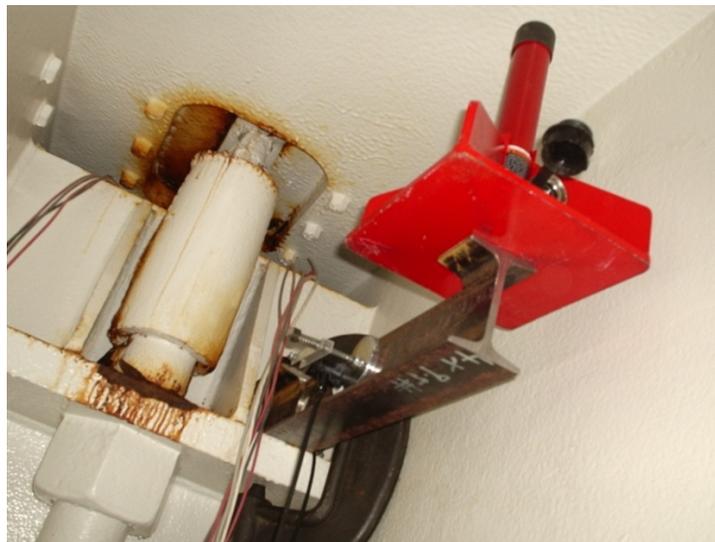
The beam location allowed for 12.9" of free space between the notched beam and the ceiling (top flange of tie girder). An 11" tall hydraulic jack was placed with its supporting base on the beam and oriented so the cylinder jacking action was against the ceiling. For the first set of tests Velcro® was used to secure the jack to the beam in order to hold the jack in place before and after loading. For the second set of tests the jack was manually held in place until the jacking force created enough friction to hold it in place for the tests.

Figure 6.2: Field setup for notched beam test
