# Implementation of LED Roadway Lighting

Minnesota  
Department of  
Transportation

**May 2016**

Research Project  
Final Report 2016-17

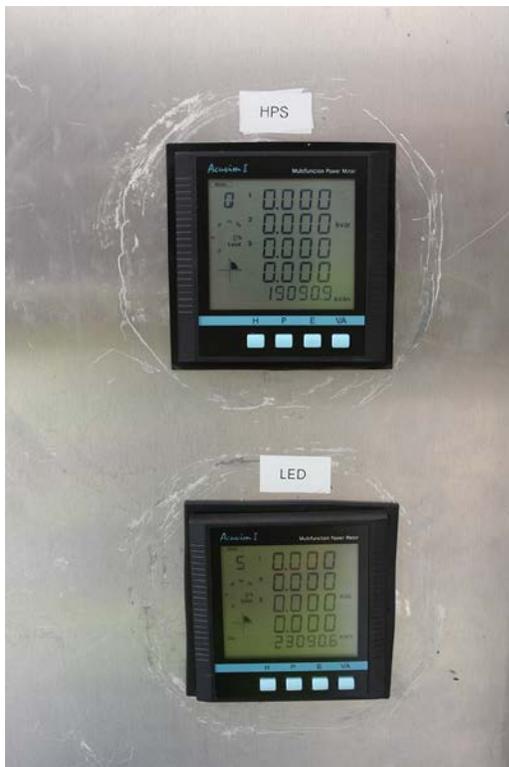
*Figure 2.3 Meter Configuration photo*

Two Accuenergy “Acuvim II” data-logging meters were installed in the test site service cabinet that enabled the LED and HPS circuits to be monitored independently and simultaneously through the use of current transformers placed in-line with the respective branch circuit conductors. Data was downloaded to a laptop quarterly for in-office processing.

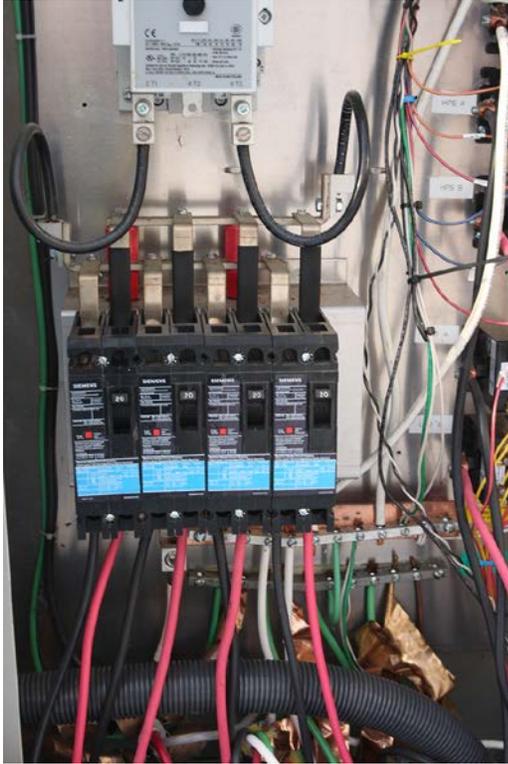
***Figure 2.5 Breaker Configuration photo***

Two 240/480 volt multi-wire branch circuits were established to energize the LED and HPS luminaires. In this configuration, the LED circuit is independent of the HPS circuit, and each circuit uses a two-pole circuit breaker as overcurrent protection. Each multi-wire branch circuit consists of two current carrying conductors and one grounded (neutral) conductor. This configuration constitutes two 240-volt circuits in each multi-wire branch circuit. Both the LED and HPS circuits are configured in the same fashion. Both circuits share common connections at the main circuit breaker and the neutral and ground bussing.

The circuits are configured to operate nightly via a photocell and contactor mounted in the test site service cabinet.
