## TECHNICAL SUMMARY

# Examining Possible Causes of Stripping in Asphalt Pavement Under Chip Seals

*This Technical Summary pertains to the LRRB-produced Report 2017-35, “Prevention of Stripping Under Chip Seals,” published October 2017. The full report can be accessed at [mndot.gov/research/reports/2017/201735.pdf](http://mndot.gov/research/reports/2017/201735.pdf).*

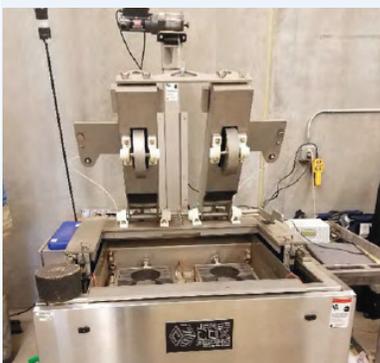
The Hamburg wheel track test reveals weaknesses in asphalt mixes, such as loss of adhesion between binder and aggregate.

- **Hamburg wheel tracker tests.** Weaknesses in bituminous mixtures, such as a weak bond between binder and aggregate, can be revealed when a heavy steel wheel repeatedly passes over a specimen. Researchers tested paired specimens—one with a chip seal and one without—from 18 locations.
- **Disk-shaped compact tension tests.** Researchers evaluated the fracture energy of seven specimens.
- **Falling head permeability tests.** The speed of water passing through low-permeable material allows the calculation of coefficients of permeability. Investigators tested the permeability of 68 samples from 18 locations.
- **Tensile strength ratio tests.** Tensile strength loss due to damage under accelerated water conditioning was measured in 18 specimens.
- **Asphalt mix evaluation.** Researchers examined the properties of asphalt mix samples from the 1990s and later.

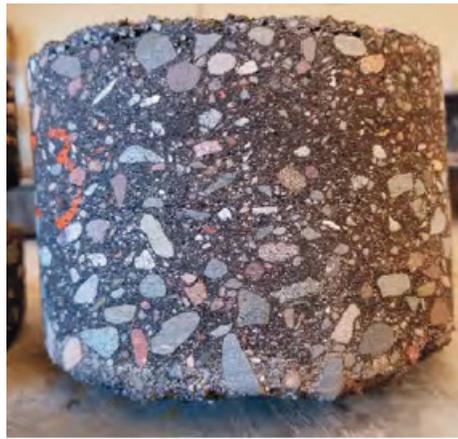
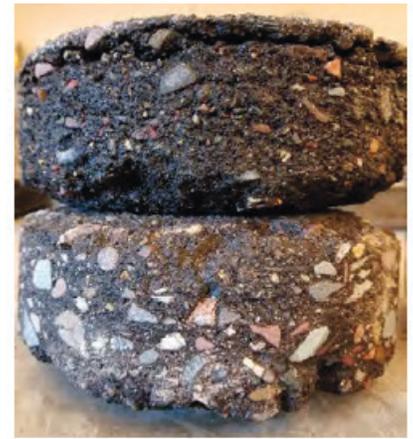
The samples above show an intact asphalt core (left) and a stripped core (right) under chip seal and between asphalt lifts that were collected from a site in Shoreview, Minnesota.

Despite this intention, some chip sealed roads laid in the last two decades have shown premature aging, displaying asphalt stripping—the loss of bond between bituminous cement and aggregate beneath the chip seal—at a rate high enough to generate concern among Minnesota’s city engineers. Hundreds of miles of Minnesota roadways are showing signs of early failure. The chip sealing seems to have decreased rather than increased the effective life of some pavements.
