Implementation of New Guidelines for Tightening Large Anchor Rods of Support Structures for Signs and Luminaires

Bridge Engineering Center
Iowa State University

Research Project
Final Report 2020-14

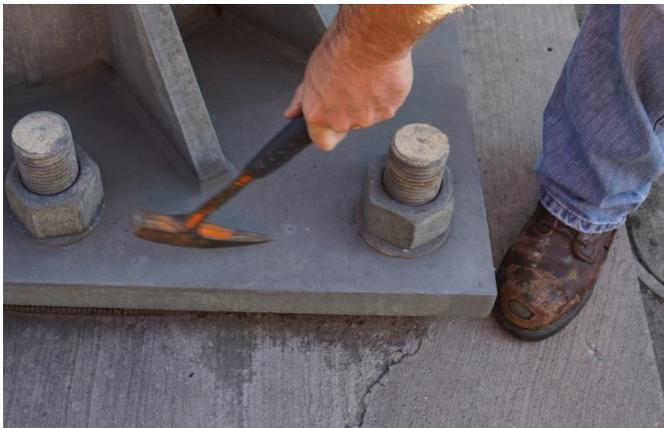
Before any maintenance on the structure, the connection is checked for inadequate clamping force by striking two opposite edges of the top and leveling washer with a pick (Figure 3.1.1).

Figure 3.1.1 Checking for clamping force in connection

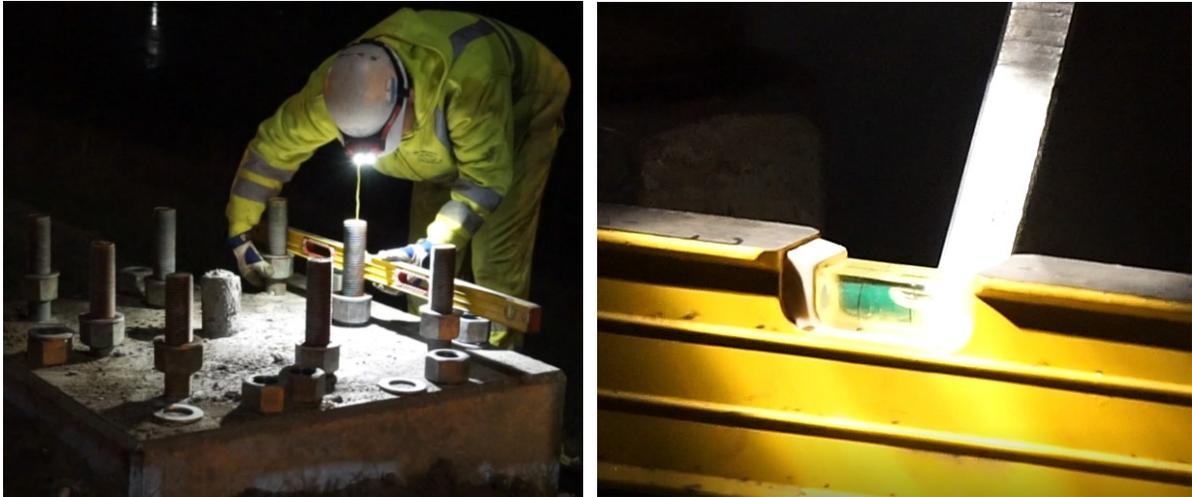
Grade 55 anchor rods were used in both installations. Both of the structures were installed by Global Specialty Contractors of Eagan, Minnesota. Both structures were installed at night due to traffic control requirements. Before the installation of the posts, the leveling nuts were leveled as illustrated in Figure 3.2.2.

Figure 3.2.2 Leveling nuts on sign truss structure (left) and final installation of COSS out of plumb (right)

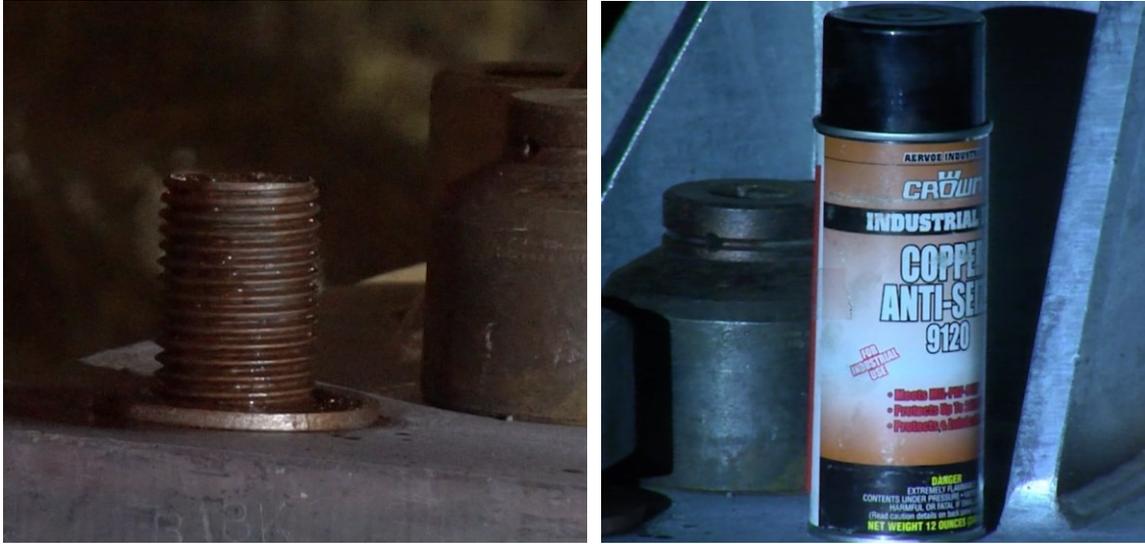
After leveling, the installation and placement of the sign structure, anchor rods, washers, and nuts could be lubricated. In the contractor's previous experience, only the anchor rods were lubricated, which would result in significantly greater friction while tightening. A copper anti-seize spray was used as the lubricant for the installation. While this was not the MnDOT-specified lubricant, spray copper anti-seize has a nut factor approximately the same as the approved lubricant, so it is possible that the pre-tension force that developed in the anchor rods was still sufficient to prevent loosening. Figure 3.2.3 (left) and (right) shows the lubricated anchor rod connection and the lubricant used, respectively.

Figure 3.2.3 Lubricated anchor rod connection (left) and lubricant utilized (right)

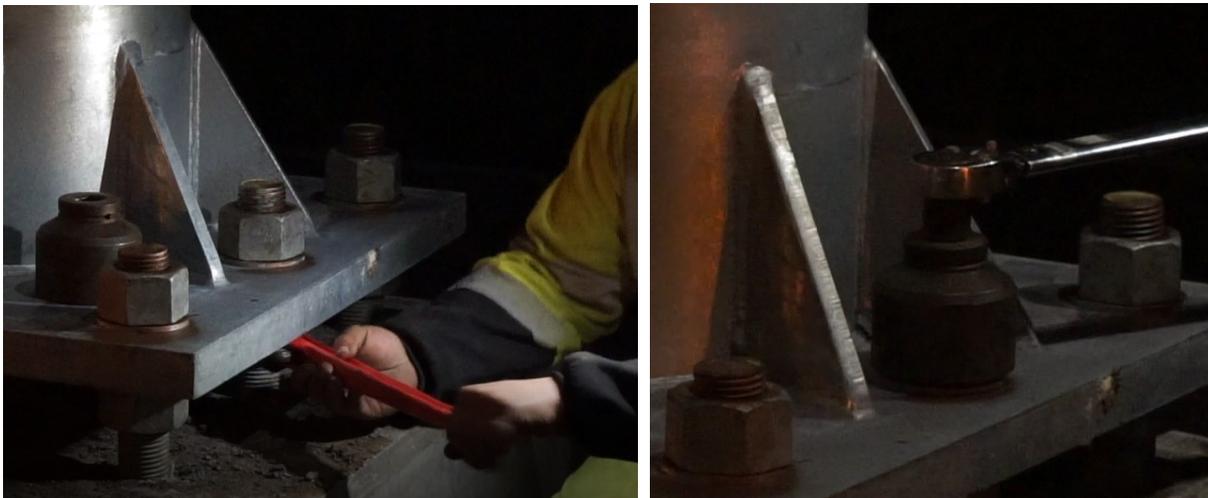
After lubrication, the leveling nuts were approximately snugged with a pipe wrench (Figure 3.2.4 left).

Figure 3.2.4 Tightening leveling nuts with pipe wrench (left) and snugging top nuts with a calibrated wrench (right)

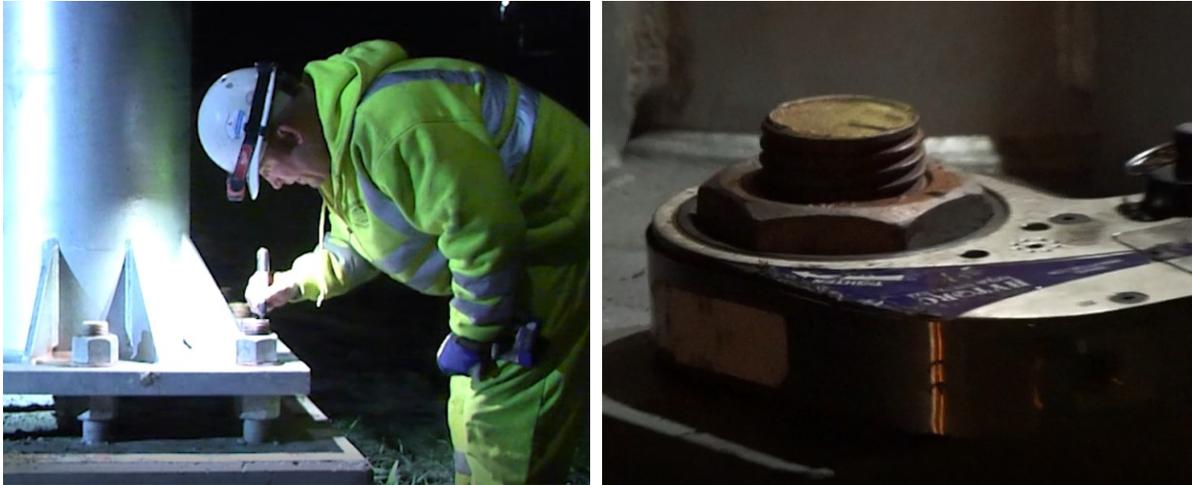
After snug-tightening, the contractor marked each rod and nut as reference for the turn-of-nut tightening (Figure 3.2.5 left).

Figure 3.2.5 Marking each rod and nut as reference for the turn-of-nut tightening (left) and tightening using a hydraulic wrench (right)

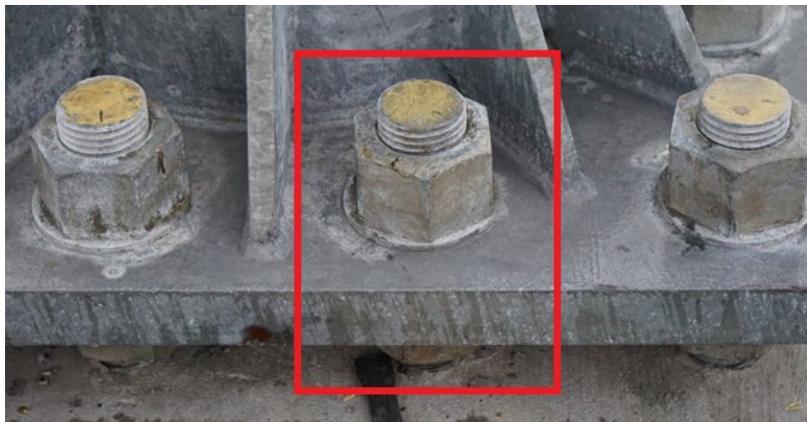
During July 2019, both of the OH sign structures observed in October of 2018 were inspected to ensure that no nuts had come loose with the new procedures. The full-span truss sign I-94-689 was found to have no loose nuts after checking both the top and leveling nuts. On the COSS OH 280-023, all of the nuts were tight, but, after inspection of the leveling nuts, it was found that nut 8 was slightly angled with the rod itself out of plumb (Figure 3.2.6), likely causing the issue.

Figure 3.2.6 Out-of-plumb anchor rod on COSS OH 280-023

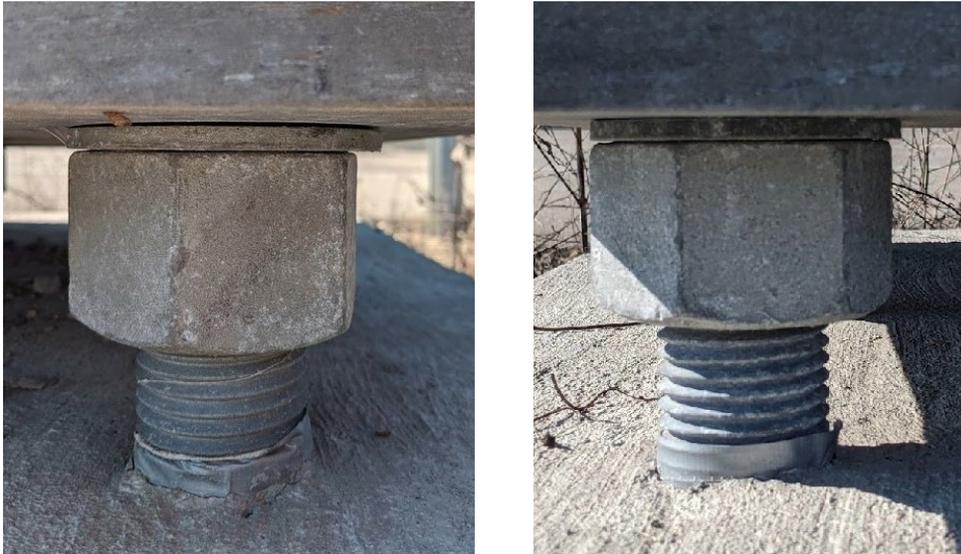
between it and the baseplate when compared to Figure 3.2.7 (right), which is rod #8 on the same structure. Note that the space between the washer and the nut is due to the geometry of the nut.

Figure 3.2.7 Gap between baseplate and washer #5 out of plumb (left) and bolt #8 plumb for reference (right)

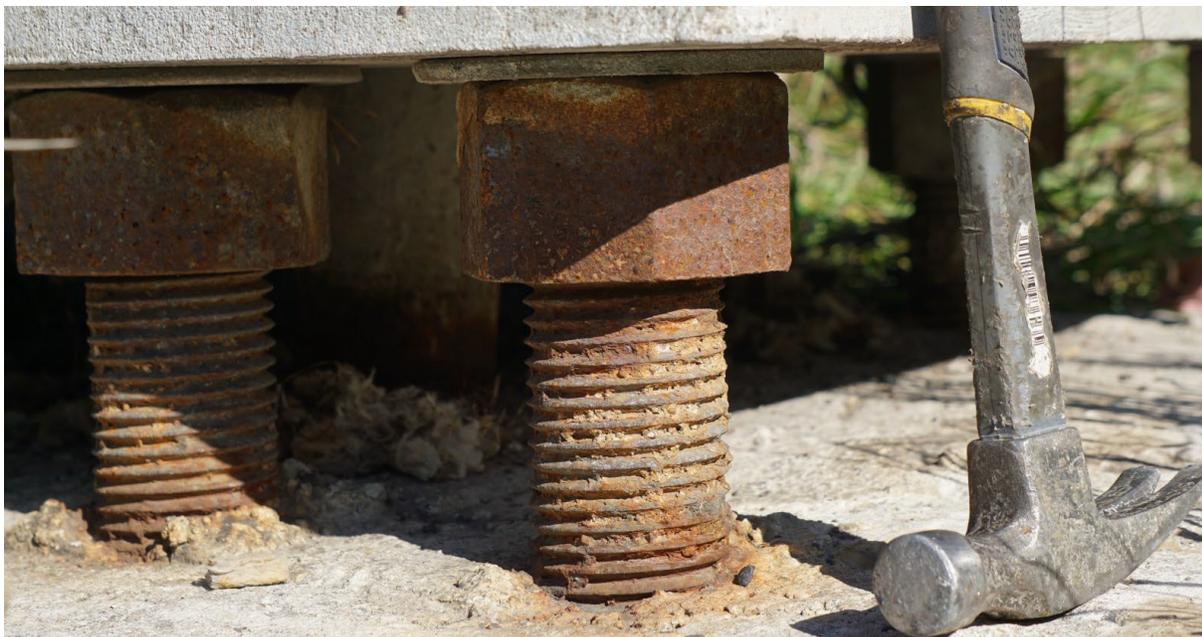
Conditions were also noted during inspections of the existing signs. For most, the installations were fairly new and in good condition. The I-494-153 sign truss structure was in slightly worse condition than the other observed structures and is an older design as indicated by the 8x2 rod layout pattern. Figure 3.2.9 shows the standoff distance issues that were found during inspection.

Figure 3.2.9 Large standoff distance on I-494-153 structure

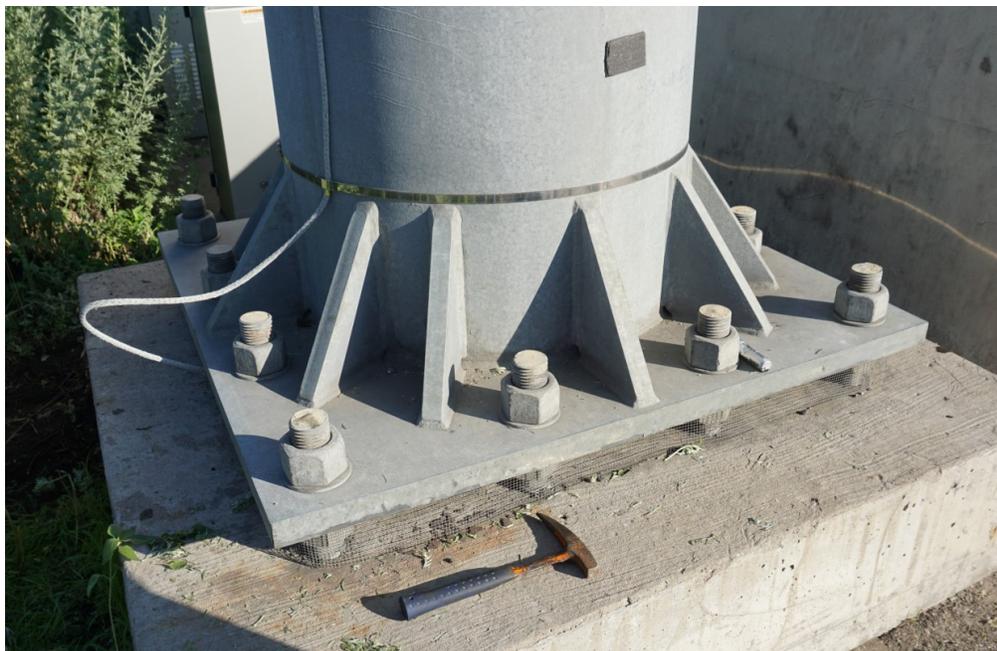
I-94-601 (INCREASING SIDE) – FIGURE 3.2.10

Figure 3.2.10 I-94-601 Base

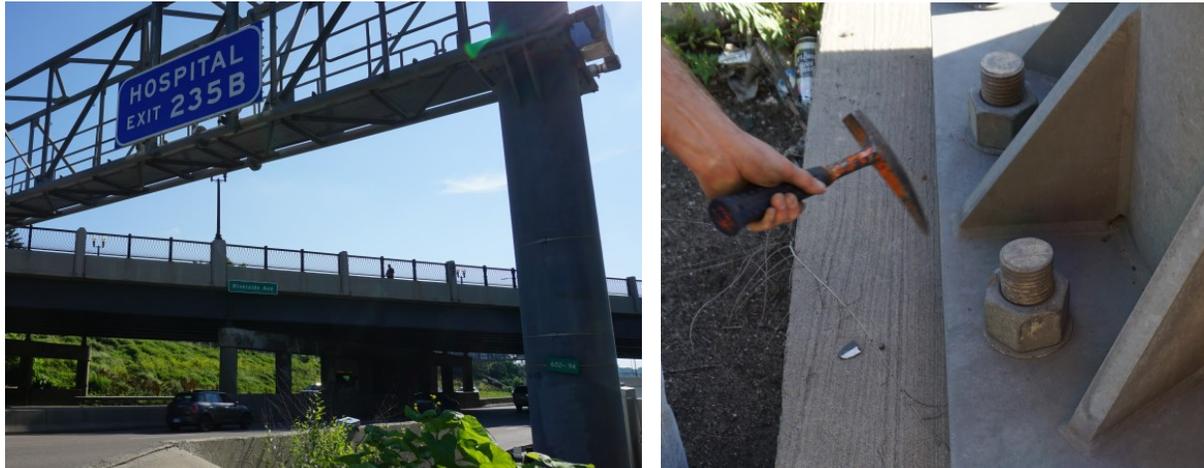
Inspection and maintenance for this structure took longer than the first, due to the new procedure being used. While striking the washers, concerns were voiced by MnDOT maintenance personnel about whether a washer was pushed up against the rod, so it would likely be beneficial to strike opposite sides of the washer when checking for looseness, as demonstrated in Figure 3.2.11 (right).

Figure 3.2.11 Full truss OH sign I-94-602 (left) and inspecting rod pre-tension force (right)

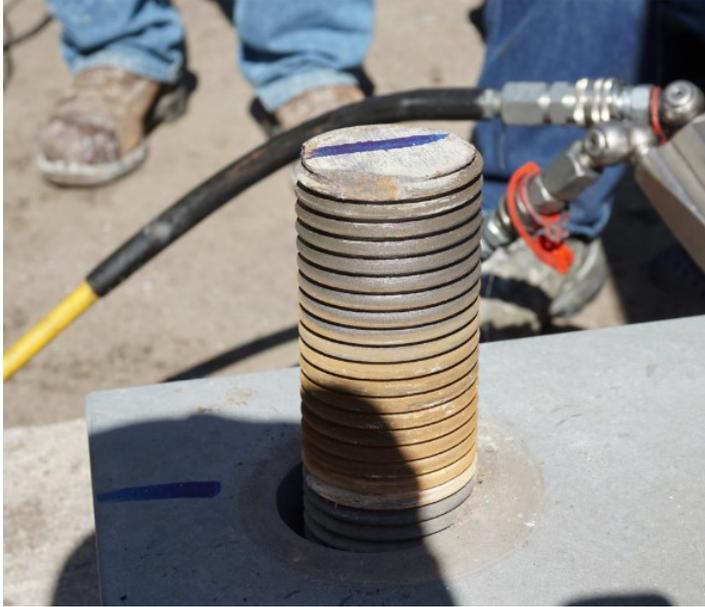
After inspection, nuts 1, 2, 3, 8, 9, and 10 were found to be loose, so the new procedure was used for retightening. While taking off the nuts, it was discovered that many were rusty or corroded on the interior of the threads. The condition of the threads was likely due to chlorides from deicing salt infiltrating through small gaps, but was somewhat unexpected considering that the threads are completely covered by the nuts and washers. Rod 10 was found to be out of plumb (Figure 3.2.12), which led to a much higher turn-of-nut value than expected that possibly did not develop the full tension in the rod.

Figure 3.2.12 Rod 10 out of plumb and misaligned

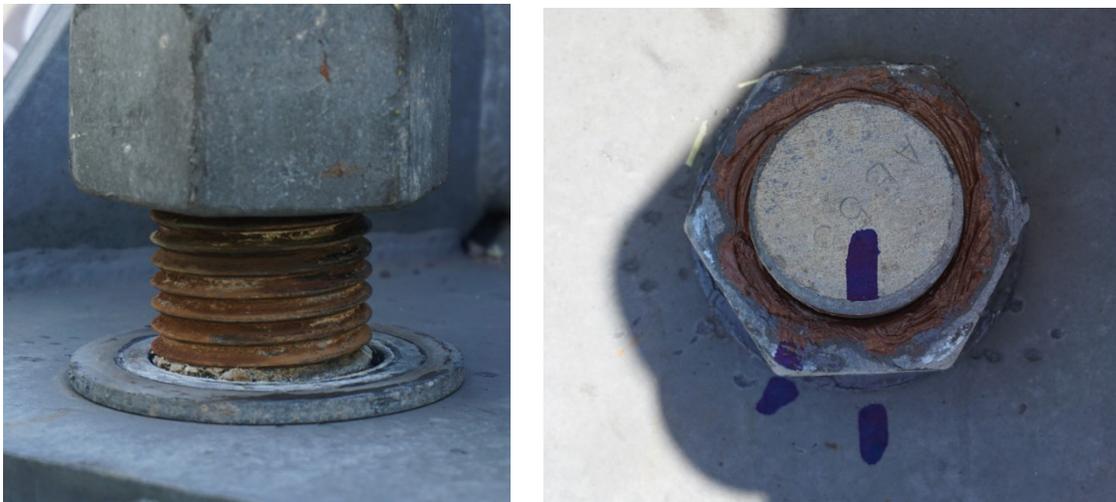
Only one rod, #3, was found to be loose, but the procedure was still followed to take all of the nuts off and lubricate to reset the installation. Much like the previous structure, rod threads were fairly corroded on the inside of the nut (Figure 3.2.13 left).

Figure 3.2.13 General condition of anchor rods (left) and sample turn-of-nut verification (right)

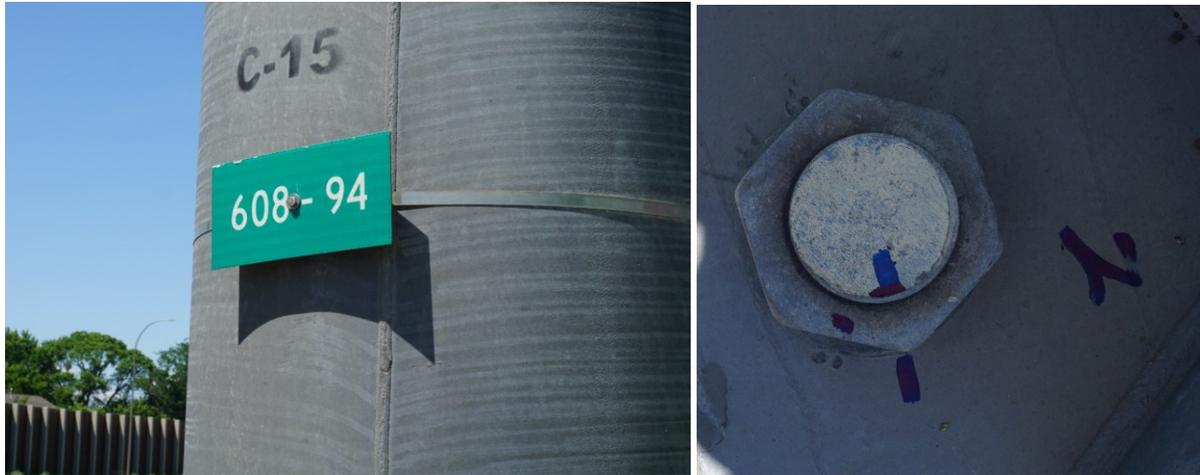
On this structure none of the washers moved when struck, so it served as another control variable where all of the nuts were brought to 110% T_v in a star pattern. In Figure 3.2.14 (left), the post has a tag marking the designation and a C-15 marking painted on.

Figure 3.2.14 I-94-608 Post (left) and 1/12 turn on nut #8 (#2 in star pattern) (right)

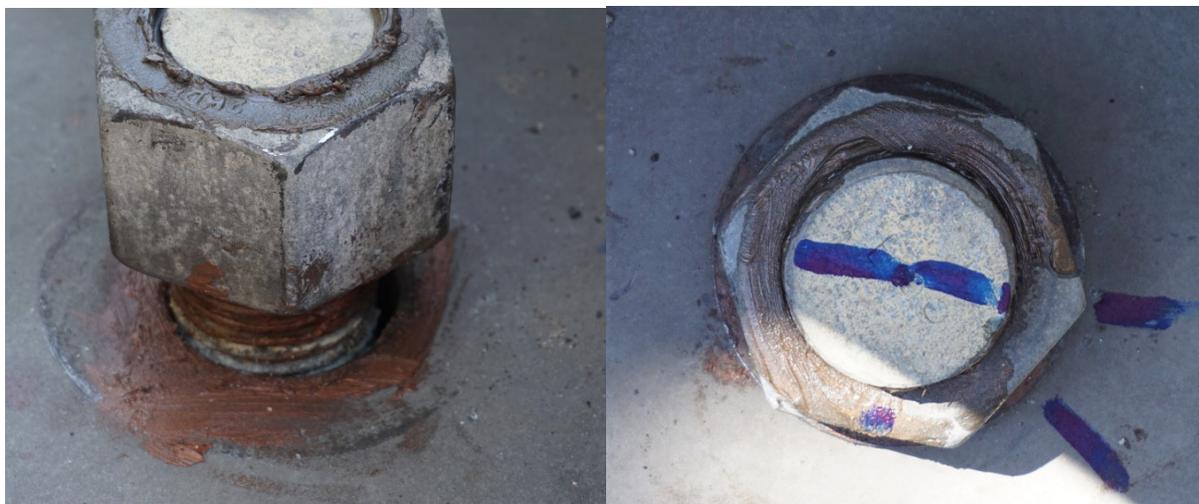
On this structure, nuts 7, 11, and 12 were found to be loose and rod 8 was missing a top washer (Figure 3.2.15 left).

Figure 3.2.15 Missing washer on rod 8 (left) and excessive turn of nut on rod 11 (right)

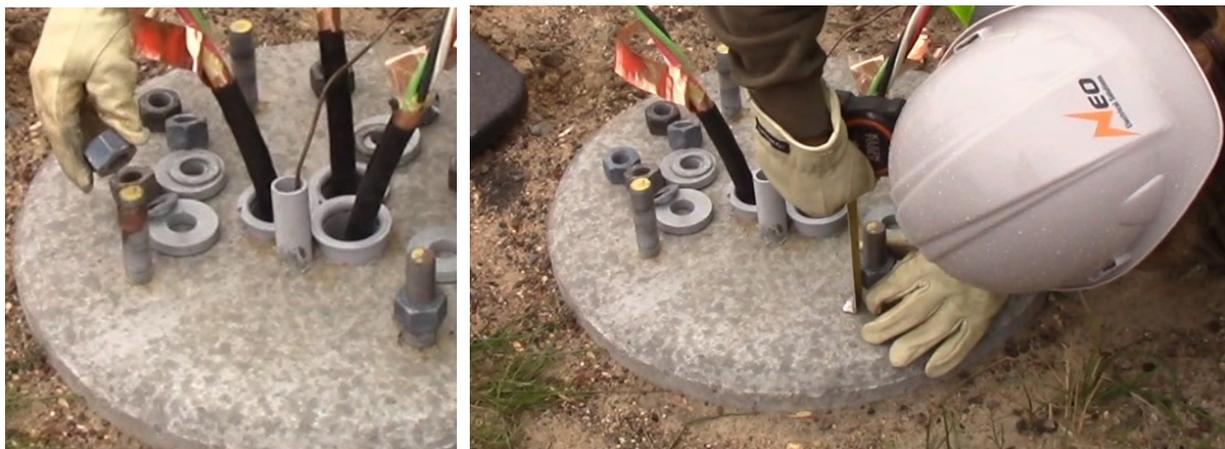
The contractor lubricated the bearing surfaces of the leveling nuts and washers and the threads of the anchor rods. As the leveling nuts were turned down onto the anchor rods, the inside threads of the nuts were also lubricated, as shown in Figure 3.3.1 (left).

Figure 3.3.1 Placing leveling nuts (left) and verifying standoff distance (right)

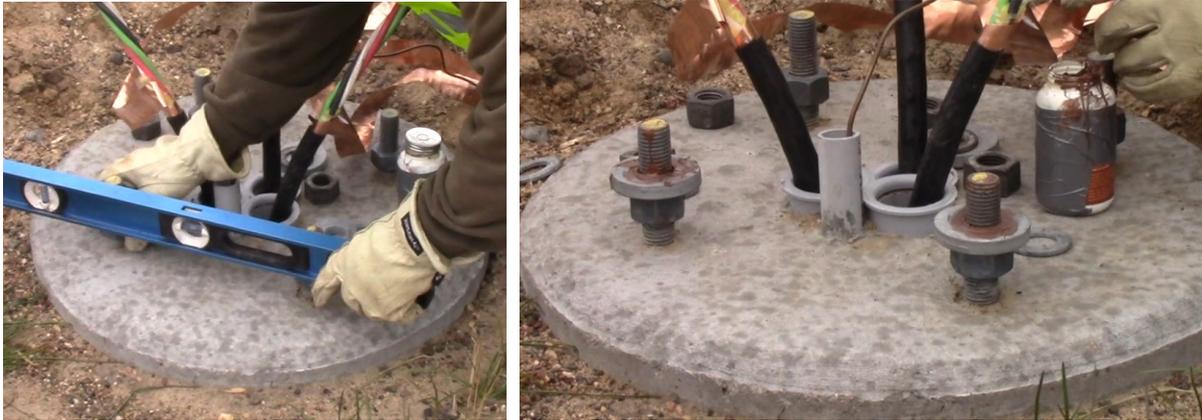
The contractor used a level to level the leveling nuts (Figure 3.3.2 left).

Figure 3.3.2 Leveling process (left) and improper lubrication of leveling nuts (right)

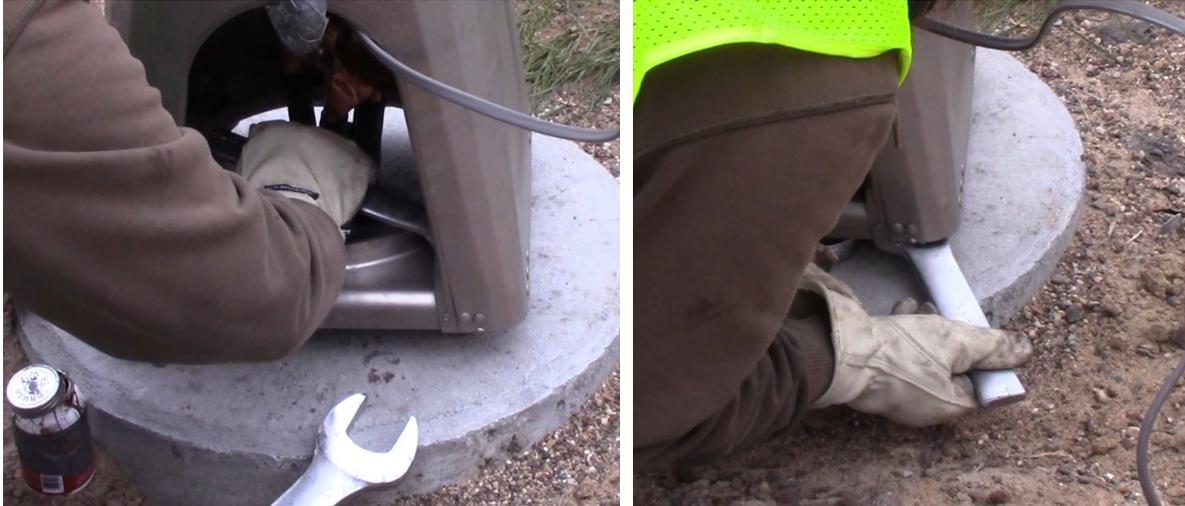
Next, two cycles of snug tightening were completed in a star pattern sequence. The top nuts were tightened to the snug-tight condition first, followed by the snug-tight condition of the leveling nuts. The contractor had the option of using either a 12" long offset wrench made by the pole manufacturer, a 12" long open-end and closed-end wrench, or a torque wrench set to 50 ft-lbs. For the first cycle, the contractor utilized the manufacturer's 12" long offset wrench to bring the leveling and top nuts to a snug-tight condition, as shown in Figure 3.3.3.

Figure 3.3.3 Snugging top nuts (left) and snugging leveling nuts (right)

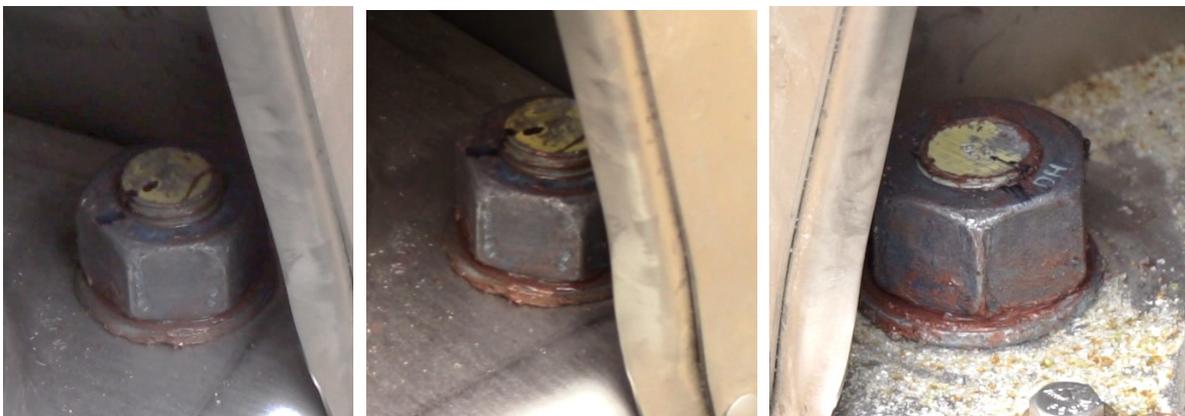
Figure 3.3.4 (left to right) shows examples of one nut before, at a second step, and after the contractor completed turn-of-nut pre-tensioning, respectively.

Figure 3.3.4 Nut turns at initial, second step, and final values (left to right)

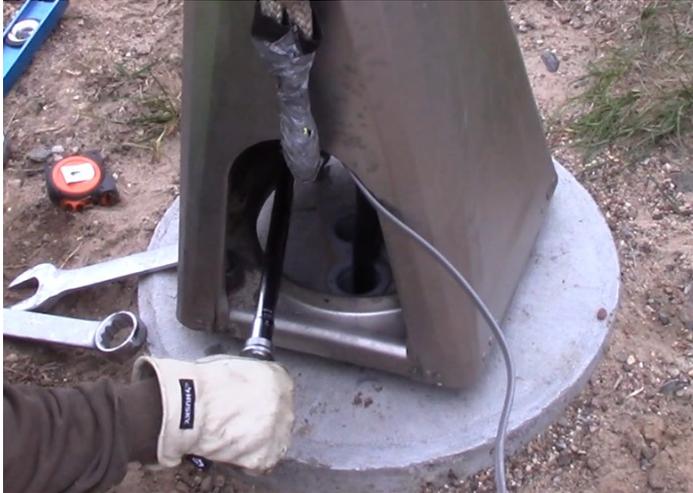
The last step, shown in Figure 3.3.5, required the contractor to use a torque wrench set to 200 ft-lbs.

Figure 3.3.5 Applying verification torque

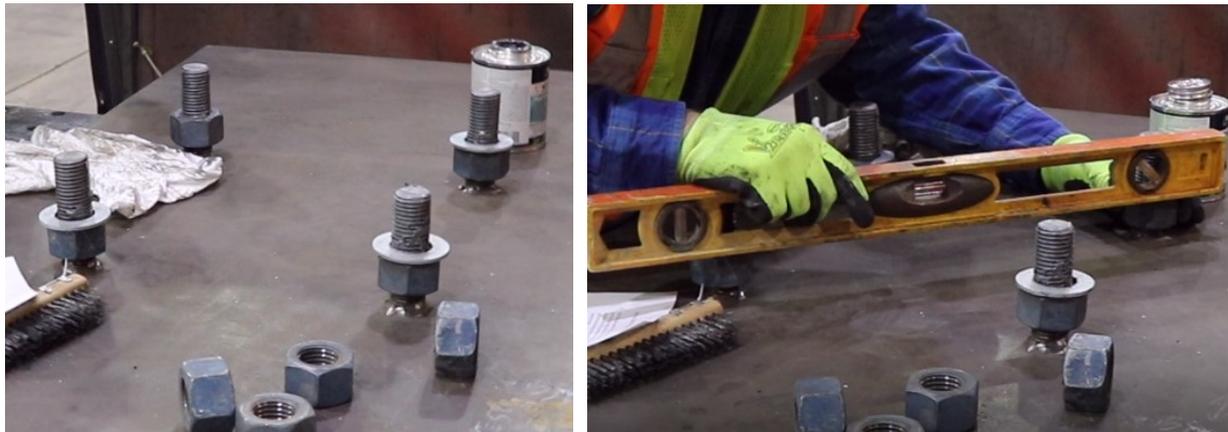
The Grade 55 anchor rods were welded onto a steel plate for demonstration purposes. The initial installation was done correctly, without lubrication on the top of the leveling nut washers, as shown in Figure 3.3.6 (left).

Figure 3.3.6 Correctly installed leveling nuts and washers (left) and leveling installation (right)

Figure 3.3.6 (right) illustrates correct leveling procedures performed on the installation. After leveling, the base was placed, and all required surfaces were lubricated with the specified grease, as shown in Figure 3.3.7 (left).

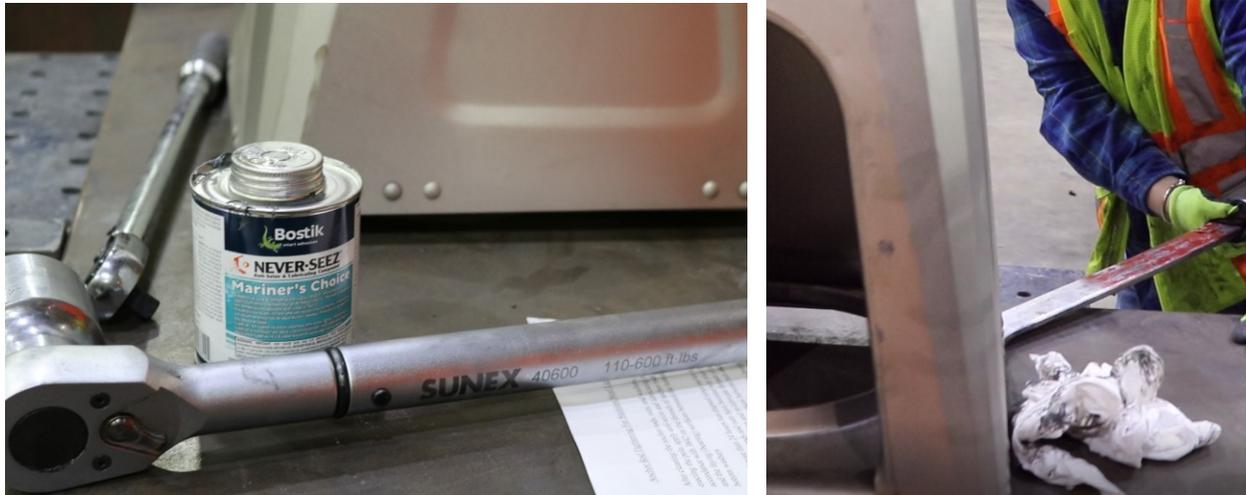
Figure 3.3.7 Calibrated torque wrenches and specified grease (left) and snug tightening leveling nuts (right)

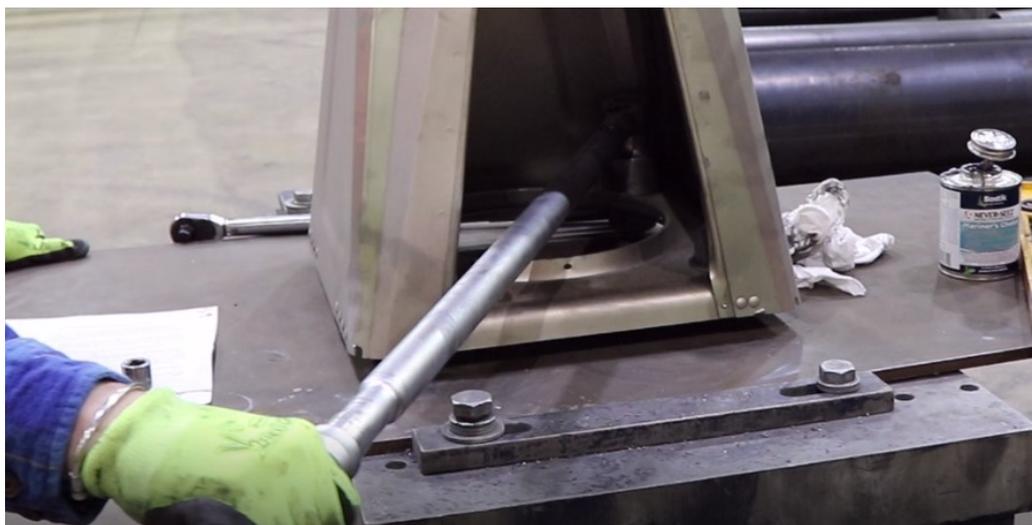
Finally, the anchor rods were immediately stressed to the full 400 ft-lbs in one step with a calibrated torque wrench (Figure 3.3.8).

Figure 3.3.8 Final verification torque on the structure installation

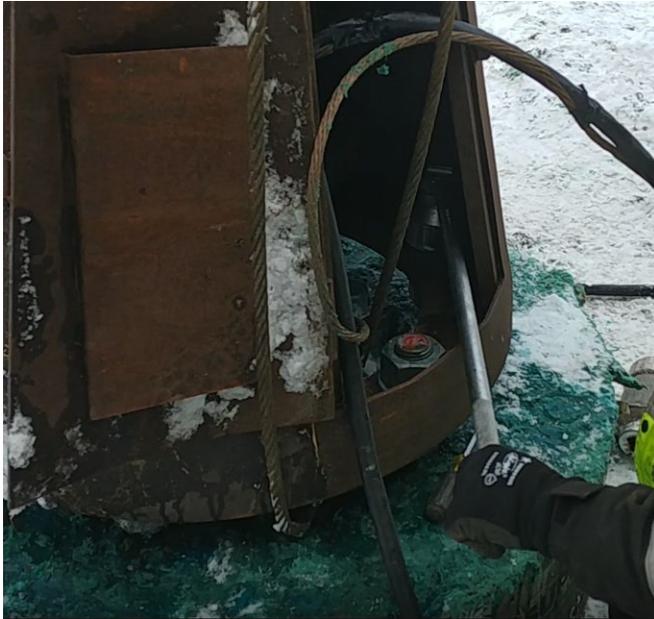
On the single observed HMLT installation, the tower anchor rods were pre-tensioned to snug tight with a calibrated manual wrench. It was intended that the HMLT anchor rods would be fully pre-tensioned at a later date using a hydraulic torque wrench. The manual wrench worked fairly well in the updated base, especially with the raised winch detail. As shown in Figure 3.3.10, clearance was limited when torquing the nuts closest to the door and required a fairly fine-toothed socket wrench to tighten.

Figure 3.3.10 Manual wrench installation tightening of HMLT anchor rods

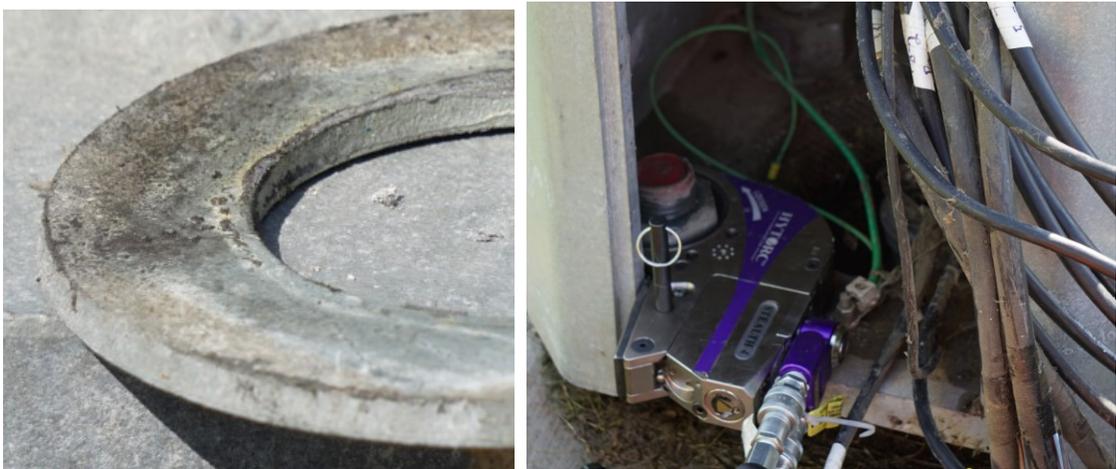
The wrench was still able to tighten the nuts, but care was needed to prevent wedging or pinching when using the wrench placed on top of the ground wire. The ground connection could also be loosened to help with clearance (3.3.13 right).

Figure 3.3.13 Galvanizing dimples on washer (left) and moved grounding wire (right)

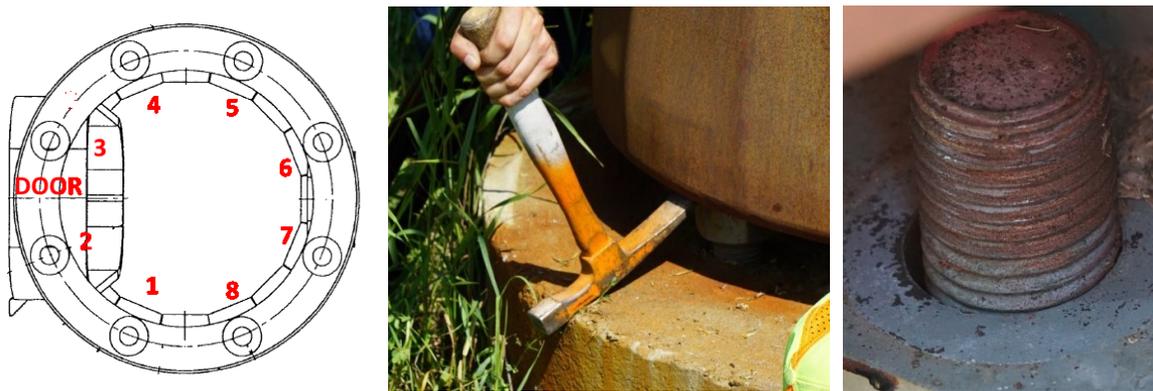
Figure 3.3.16 Rod numbering (left), checking washers for looseness (center), and prior copper anti seize lubrication on rod (right)

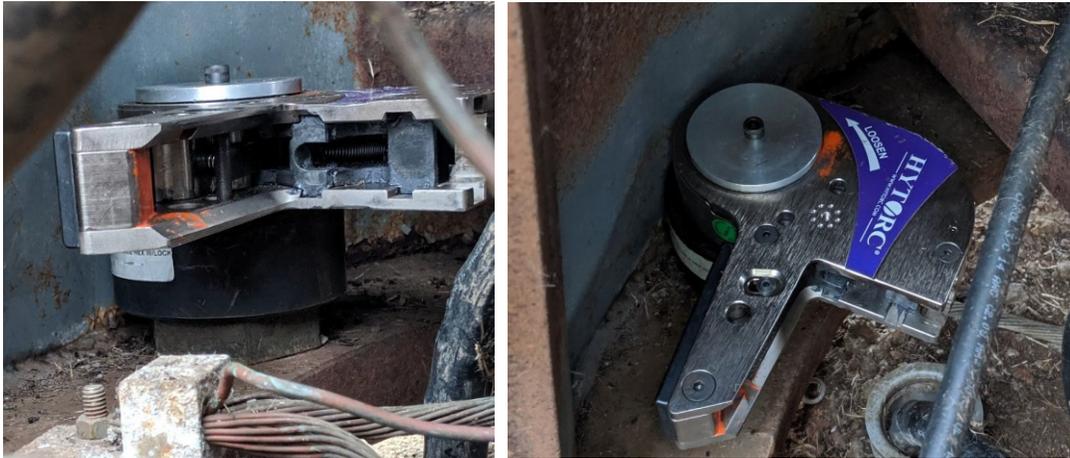
Figure 3.3.17 HYTORC Stealth 4 hydraulic wrench with stack socket

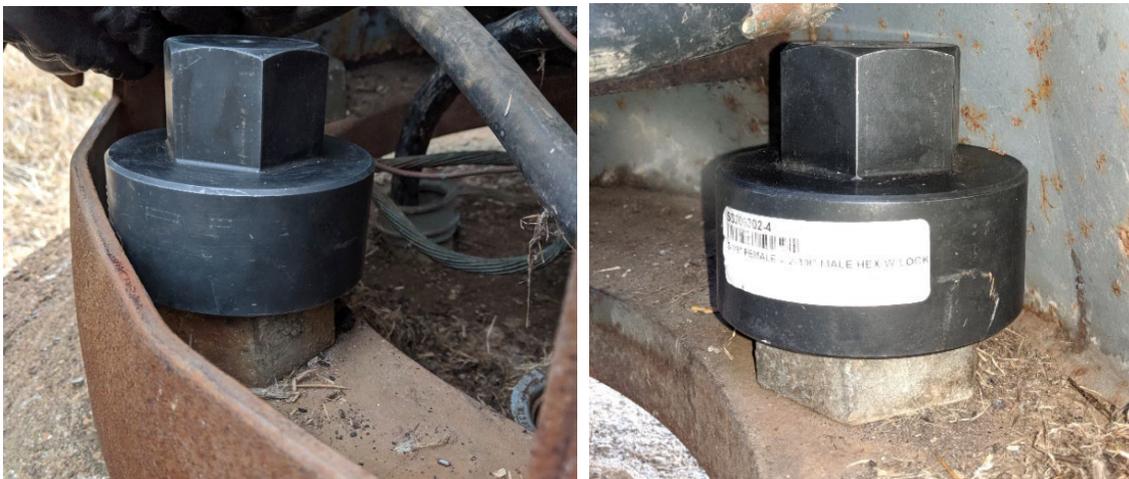
Figure 3.3.18 Wedging on door frame (left) and socket raised into wall by nut protrusion (right)

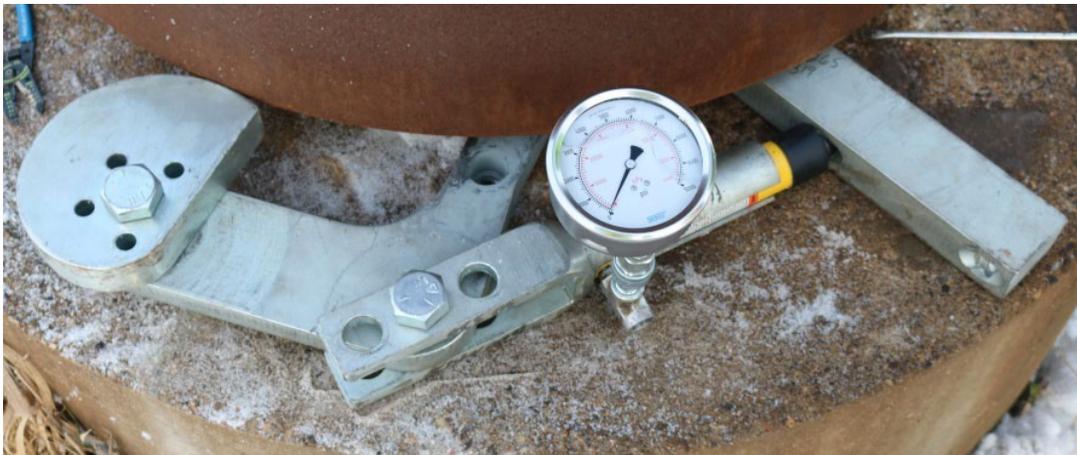
Figure 3.3.24 Millerbernd wrench operation at closest setting

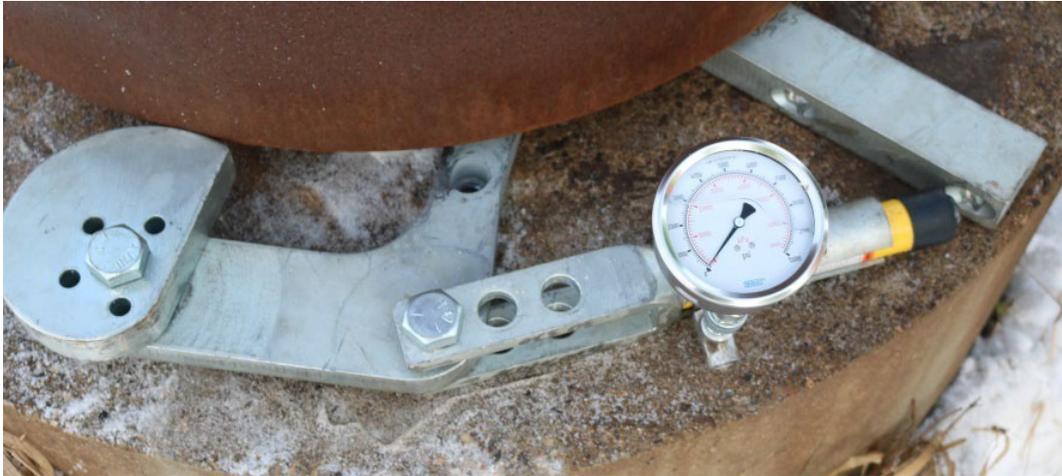
Figure 3.3.25 Millerbernd wrench operation at farthest setting

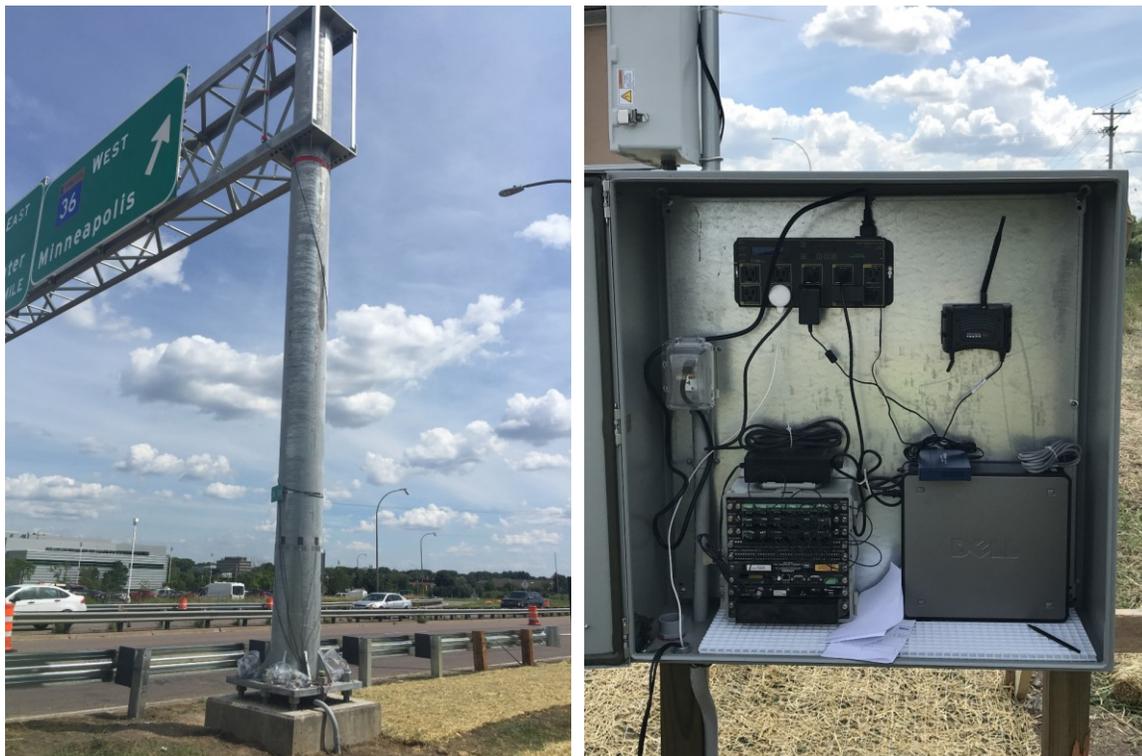
Figure 4.1.1 Instrumented sign post (left) and data logger cabinet (right)

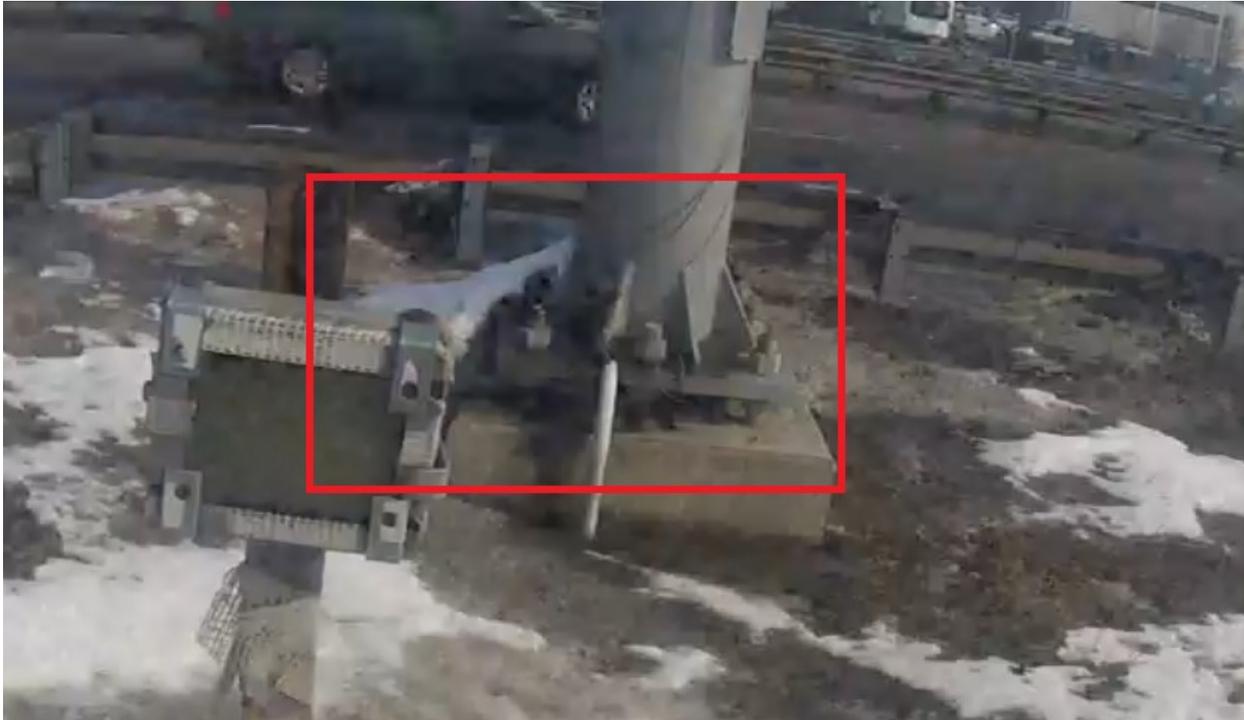
Figure 4.2.5 Snow and ice piled on anchor rod gauges
