Subject: Guidance on Use of Late Season/Cold Weather Temporary Pavement Markings based on Winter 2007/2008 Performance

Pictures and Retroreflectivity Readings for Winter 2007-08 Late Season Markings

Late Season Marking Performance Summary for 2007/2008

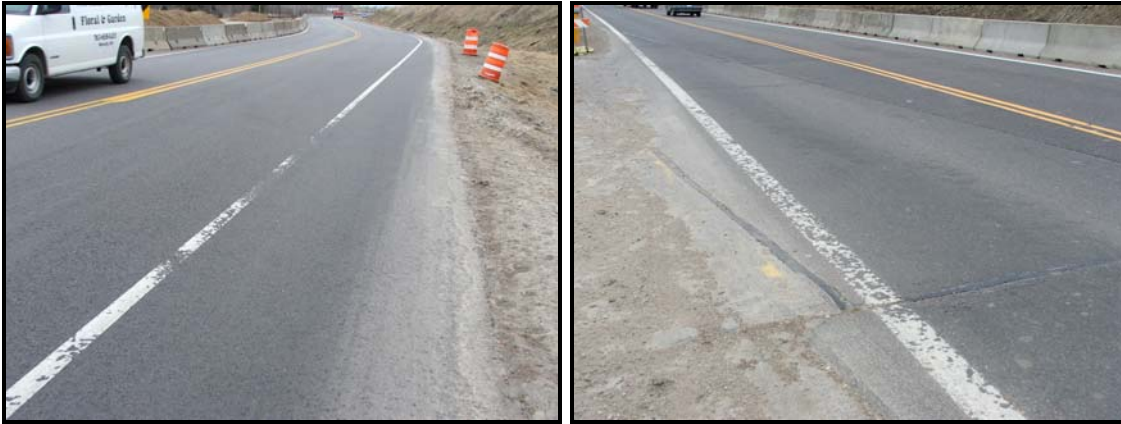
US 12 in Metro

Cold-weather epoxy was used on this project. The retroreflective numbers were adequate, and while the enough of the markings made it through the winter intact to be visible to the driver, they were not in great shape visually.

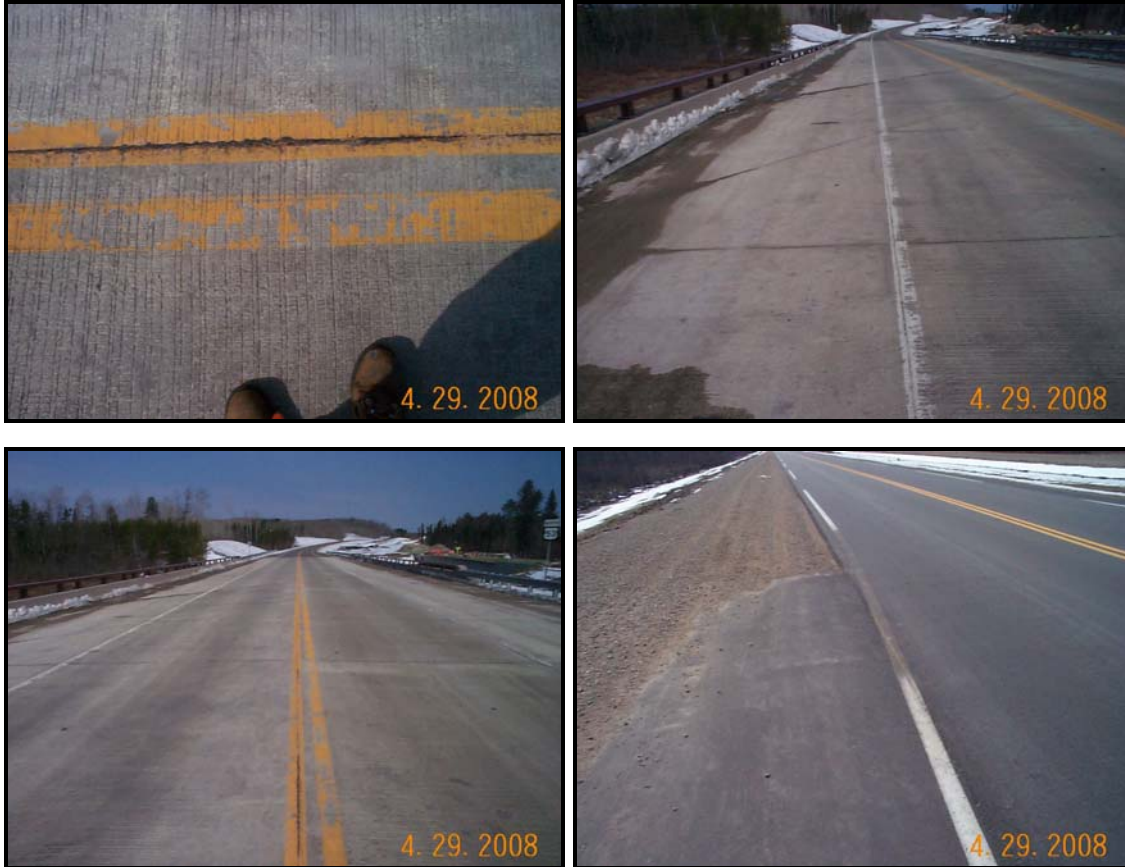
US 53 in District 1

The retroreflectivity readings for these **cold-weather epoxy** pavement markings were substandard for the centerline, and many sections of both edge lines and centerline were either heavily worn or missing in many parts.

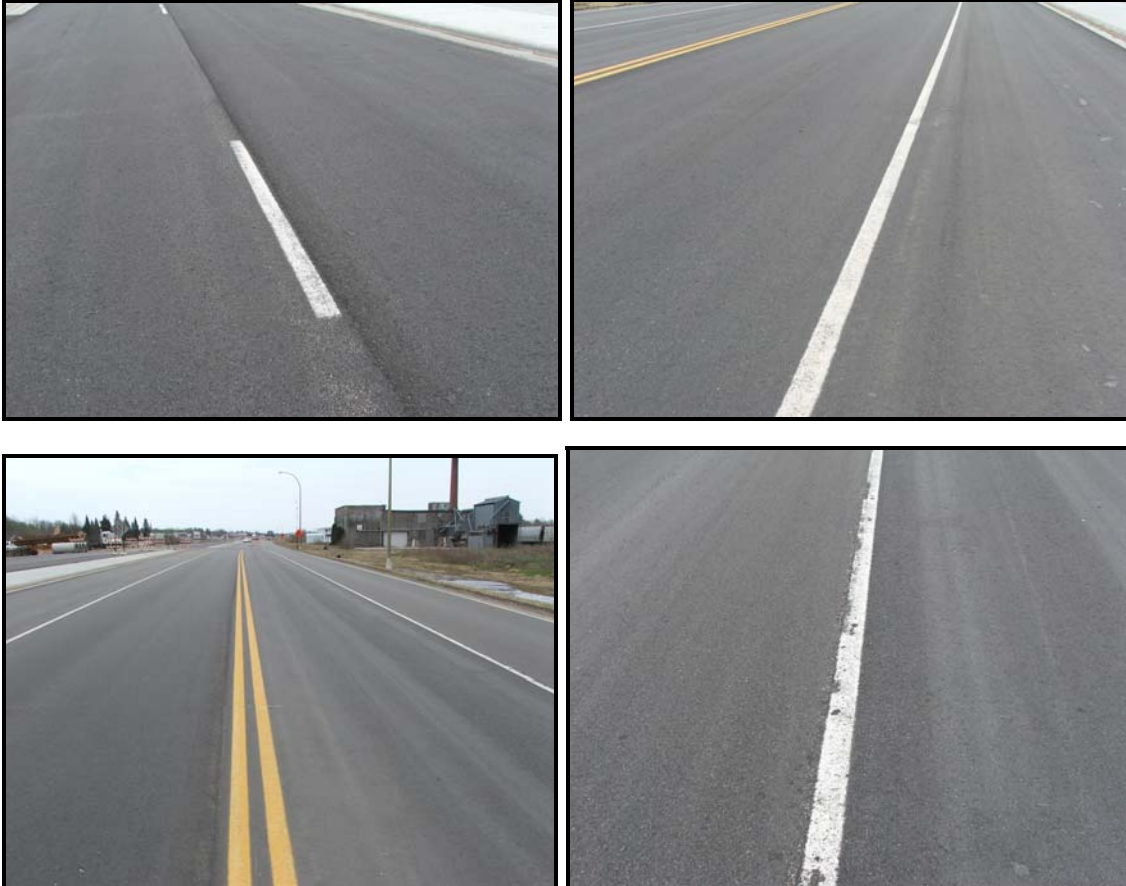
US 10 in District 3

Cold-weather latex was used on this project. This product performed very well and held up well through the winter. The retroreflective readings were all over 100. However, the lane lines barely exceeded this threshold, and as the bottom-right picture shows, the lines were in need of replacement.
