# **FINAL REPORT**

## **MOTION IMAGING RECORDING SYSTEM (MIRS)**

**Prepared for:  
MIRS Committee Members**

**Prepared by:  
Robert C. Weinholzer  
Assistant to the Commissioner  
Mn/DOT**

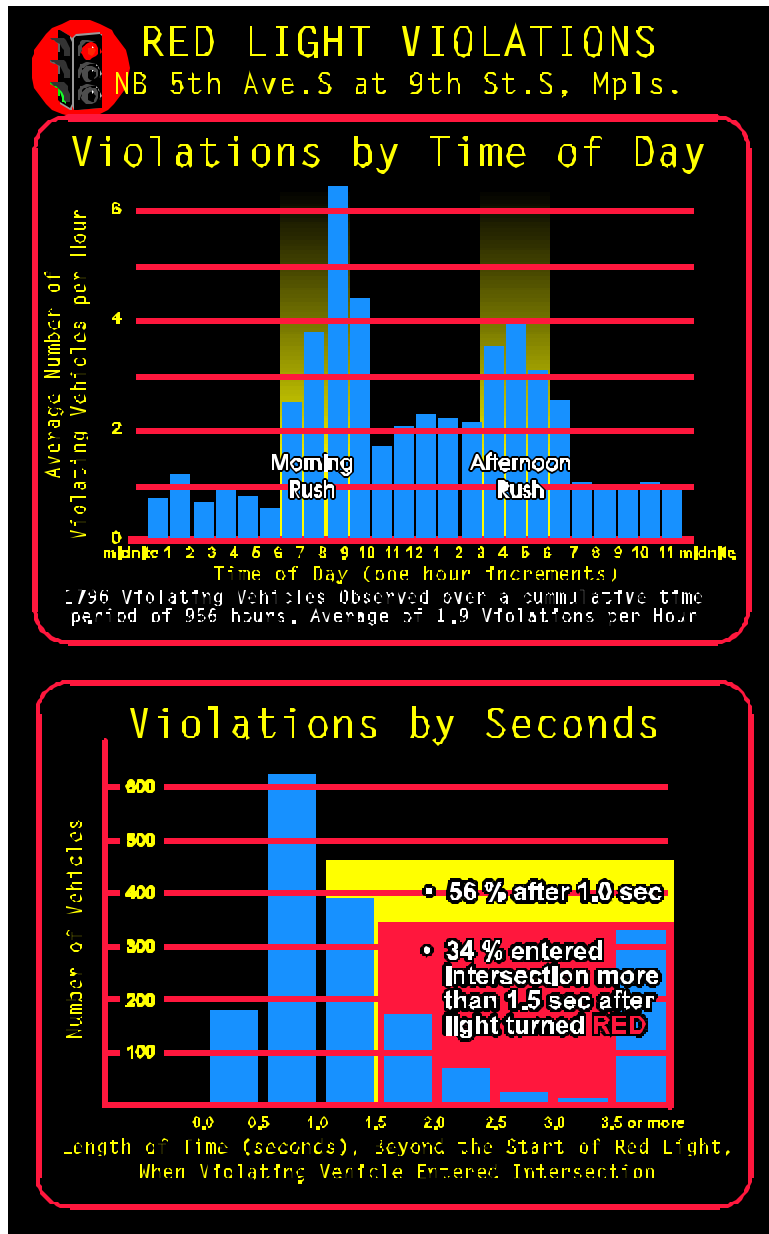
The camera ran for 956 hours and 7 minutes and detected 1,796 violations. This is approximately 45 per day, or 1.88 per hour. Figure 8 is a bar graph which shows the number of violations for each hour of the day. Without question, the greatest number of violations occurred between 8:00 and 9:00 AM, with an average of 6.43 per hour. The second and third highest totals were between 9:00 and 10:00 AM with 4.4 per hour, and between 4:00 and 5:00 PM with 4.03 per hour. These results are not surprising in that they are either during or near the rush hours.

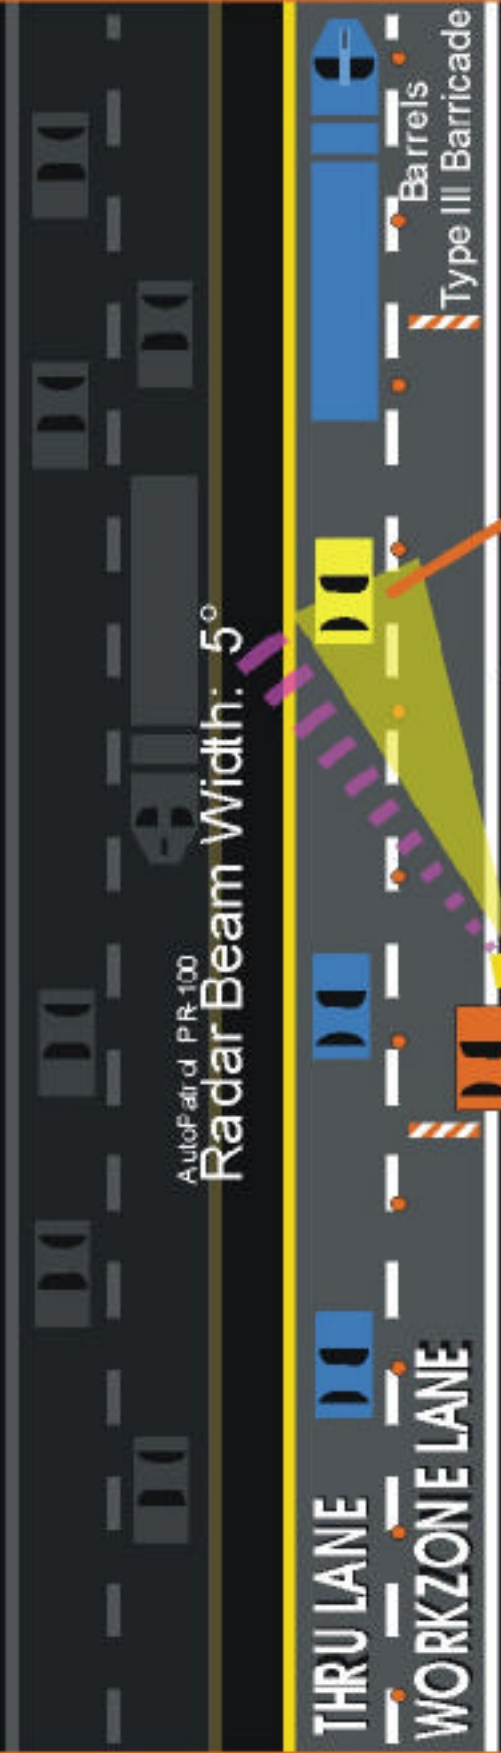
Figure 14

# WORK ZONE SPEED LIMIT TYPICAL MIRS INSTALLATION

Tripod Mounted  
35mm Camera  
with Radar Beam  
Speed Detection

Photo is taken when the  
AutoPatrol radar detects  
a vehicle exceeding a  
pre-set threshold speed

The principal difference between the equipment used in the detection of work zone speeding violations and the detection used in red light and railroad crossing violations is the portability of the former. Whereas the camera/computer rests in a metal housing at red light and railroad crossing installations, the speed camera rests on a tripod at work zones. This means the unit can be easily moved from one work zone to another, while the red light and railroad crossing equipment is stationary. It takes approximately twenty minutes for one person to assemble or dismantle the installation.
