**Civil Engineering Studies**  
Transportation Engineering Series No. 142  
Traffic Operations Lab Series No. 18

## **High Tension Cable Median Barrier: A Scanning Tour Report**

A report prepared by  
**Traffic Operations Laboratory**  
Department of Civil and Environmental Engineering  
University of Illinois at Urbana-Champaign

January 2006

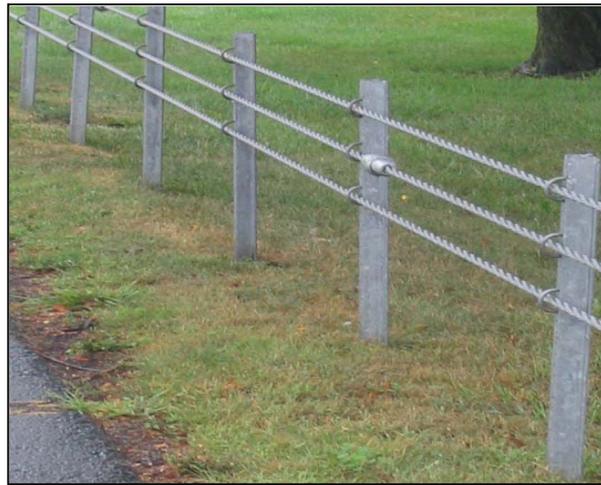
**Figure 1.** U.S. High Tension Cable System

The manufacturer recommends using non pre-stretched cable, but pre-stretched cable can be supplied upon request. A template to attach the hook bolts at the correct height is helpful in the installation process because the posts have one hole every inch.

The system is typically tensioned at 5,600 lb, and anchored with a Texas Transportation Institute's (TTI) proprietary Cable Guardrail Terminal End. TTI's end treatment was designed for rocky or hard soils, and is NCHRP 350 approved (details on TTI's end treatments can be found in acceptance letter of U.S. High Tension Cable System – FHWA website). Upper and lower cables are recommended to be located on the side of the post closest to the roadway, leaving the middle cable on the opposite side.

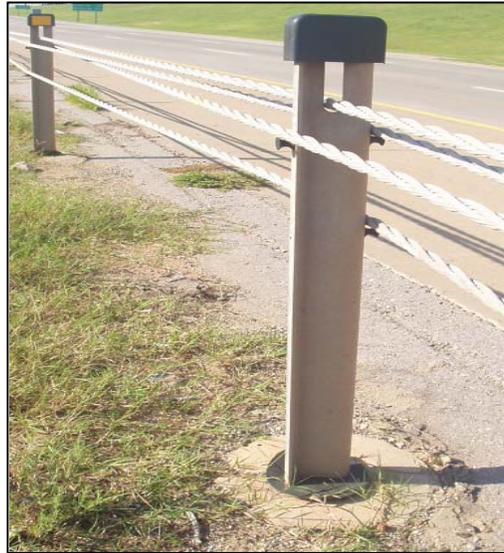
**Figure 2.** Brifen Wire Rope Safety Fence System

Fence) WRFS uses an exclusive S-shape post in its TL-3 version. The manufacturer recommends only pre-stretched cables.

Posts are installed in concrete foundations with a minimum strength of 3,500 PSI or can be driven using a post with a soil plate. In the four-cable system, the three lower cables are interwoven around the posts and the upper cable is placed in a slot on the top of each post. The end treatment is a customary part of the design and extends 19 posts in total: 4 posts for the Wire Rope Gating Terminal (WRGT), and 15 posts for the transition to the line posts.

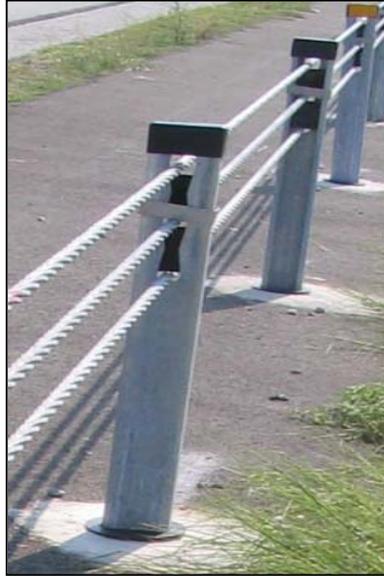
**Figure 3. CASS System**

CASS (**C**able **S**afety **S**ystem) is a three-cable system by Trinity Industries, Inc. It uses pre-stretched cable, and the posts have an opening in the upper part to accept the cables, which are kept in correct position by wider slot sections at specified cable heights, a plastic cap on the top of the post, plastic spacer blocks, and a steel strap. Posts are installed in steel sockets that can be either driven directly into the soil, or cast in concrete cylinders. TTI's Cable Guardrail Terminal Ends are used to anchor the system.

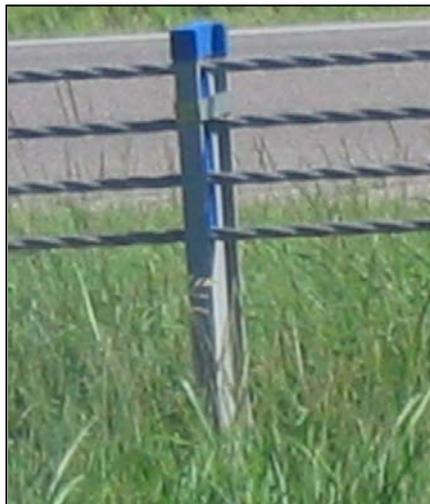
**Figure 4. Safence System**

Safence is a 4-cable WRSF system originally developed in Sweden by Blue Systems AB in 1993. Cables in the Safence system are factory pre-stretched. It uses I-section or C-section posts, which can be driven directly in the soil or installed in concrete cylinders. Spacers are placed between the cables to maintain adequate separation. Up to date, crashworthy end terminals have not been developed and tested.
