ROAD SAFETY AUDIT REPORT
An Examination of TH 3 from CSAH 46 (160th Street W.) to CSAH 50 (Elm Street)
In the City of Farmington and Empire Township

December 6, 2006

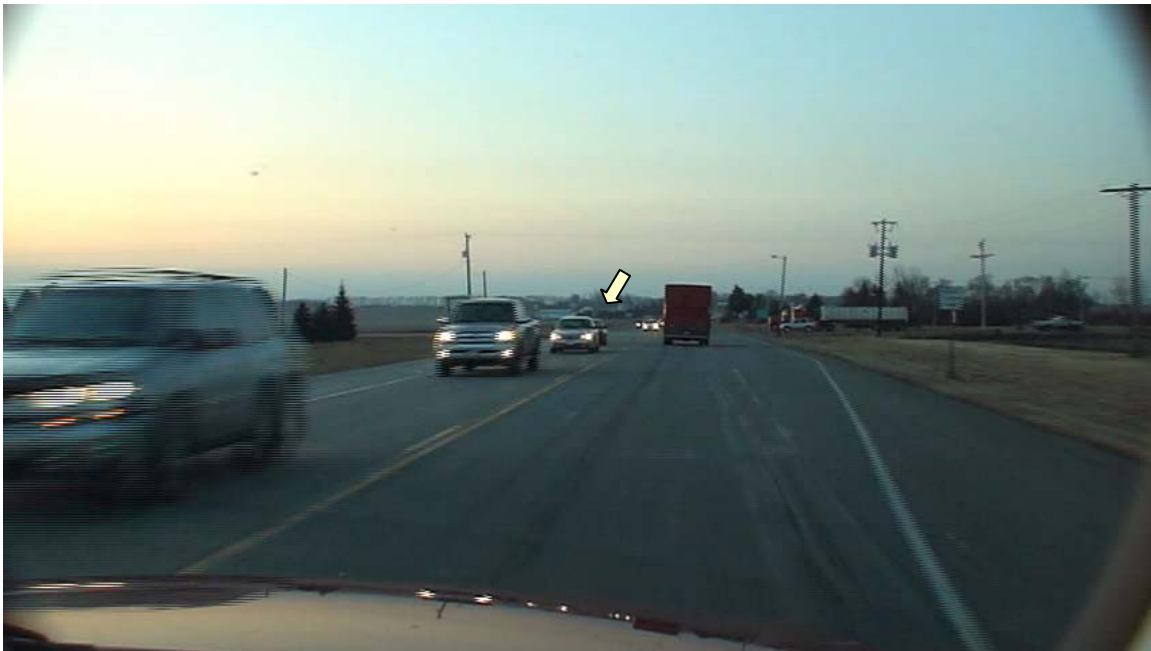
TH 3 southbound just north of 170th Street at about 7:30 AM. Photo illustrates a platoon of northbound vehicles following too closely (barely a skip stripe apart or less where there should be at least three to four skip stripes between vehicles at 55 mph for a safe two second headway)

5. Expand the Dakota County Safe Communities Programs
 - a. Focus on Younger Driver education programs
 - b. Implement a “Stop Tailgating” program similar to the Wright County Safe Communities effort
 - c. Engage local media in a campaign to concur with targeted enforcement of aggressive driver behavior and commercial vehicle violations
6. Enhance the Dakota County Technical College Commercial Driver’s Education Training Program to include an enhanced safety component for drivers as it is likely they may work for local companies
