AUTOFLAGGER Research Project

- Final Report -

Original Report Dated April, 2000

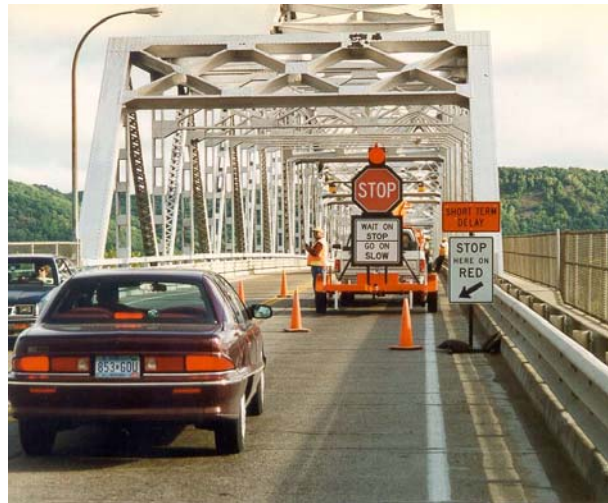
The AUTOFLAGGER is a device intended to act as an enhancement to the flagging operation on two lane roadways by lowering the overall exposure of the flaggers to injury or death. Removing the flaggers from the traffic lane and repositioning them in a location away from the flow of traffic accomplish this reduction in exposure.

When used as intended by the manufacturer a unit is placed at each end of the job-site and the single flagger takes a position within the work area, which provides an unobstructed view of both units. From this location the flagger can now control all traffic entering the project from either direction.
