AUTOFLAGGER Research Project

- Final Report -

Original Report Dated April, 2000 – Finalized February 2005

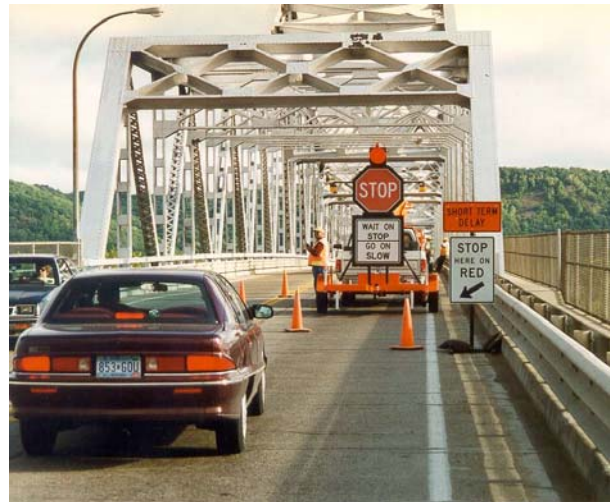
The AUTOFLAGGER is a device intended to act as an enhancement to the flagging operation on two lane roadways by lowering the overall exposure of the flaggers to injury or death. Removing the flaggers from the traffic lane and repositioning them in a location away from the flow of traffic accomplish this reduction in exposure.

When used as intended by the manufacturer a unit is placed at each end of the job-site and the single flagger takes a position within the work area, which provides an unobstructed view of both units. From this location the flagger can now control all traffic entering the project from either direction.
