Winona Bridge Work Package #5

Bridge No. 5900 (Existing Bridge) Rehabilitation and Reconstruction

Installment #3

The \$30 million Cost Growth

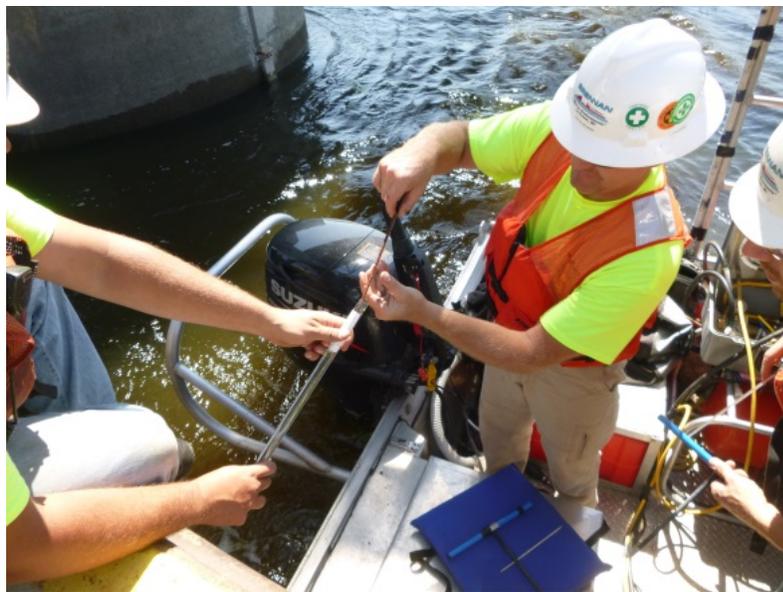
Timber Piling Cores from existing Bridge No. 5900

The condition of the through-truss was investigated in the field and found to have deteriorated more rapidly from recent inspections. Field investigations were conducted by the CMGC contractor in work package #3 to assess the condition of the timber piling so the *Final Design* team was confident in the structural support and health of the existing foundations. The light weight deck recommended in *Preliminary Design* was evaluated in detail and found to provide a minimal reduction in structural strengthening of through-truss members and also deemed not worth the potential service life reduction and health of the concrete deck that will be subject to a freeze-thaw environment with application of de-icing salt.

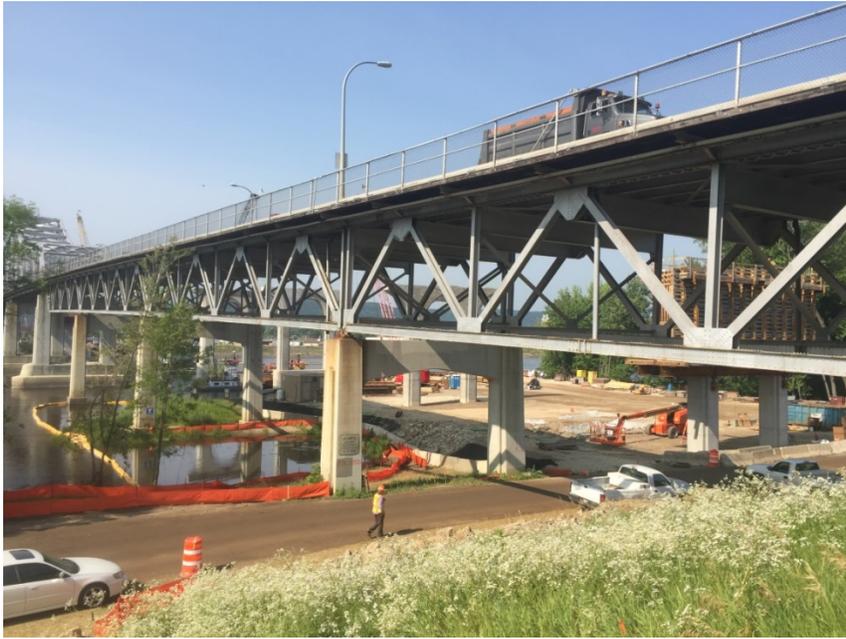
Bridge No. 5900 – Latsch Island Deck Trusses

- **Structural Steel:** In the CMGC process, the estimating teams and contractor traditionally use “plug prices” at the 30% and 60% design cost estimate level. These prices are based on their recent estimating/bidding experience with similar work. At the 90% design estimate level, the team strives to obtain physical price quotes from subcontractors and suppliers. In regards to the structural steel, primarily related to the deck truss approach spans, there was an increase in the steel pricing of approximately \$2.5 million from the initial preliminary cost estimates. This is related to steel material costs, detailing, and high labor costs associated with the intricate fabrication of the historically replicated deck trusses. In addition, the costs for the deck trusses are higher than estimated in preliminary design at an even greater amount.

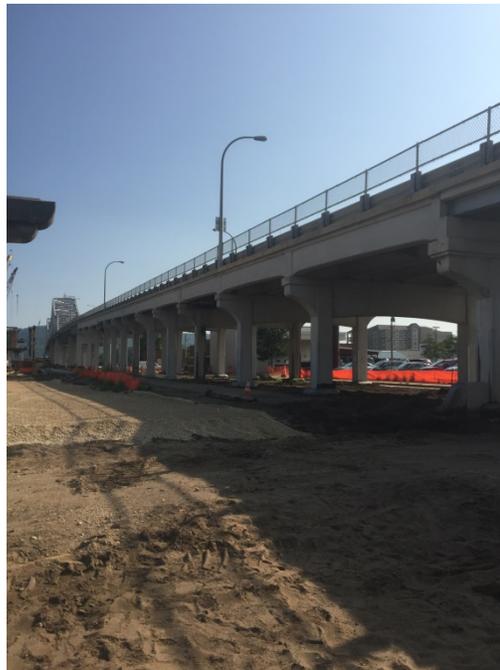
Bridge No. 5900 – Winona Concrete Beam Spans

- **Winona Approach Beam Span Lengths and Historic Beams:** For the Winona approach spans on the existing bridge, there are short span lengths and non-standard concrete beams that are intended to be replicated to meet the historical character of these elements. There is, however, a premium of approximately \$2.2 million to accomplish this.

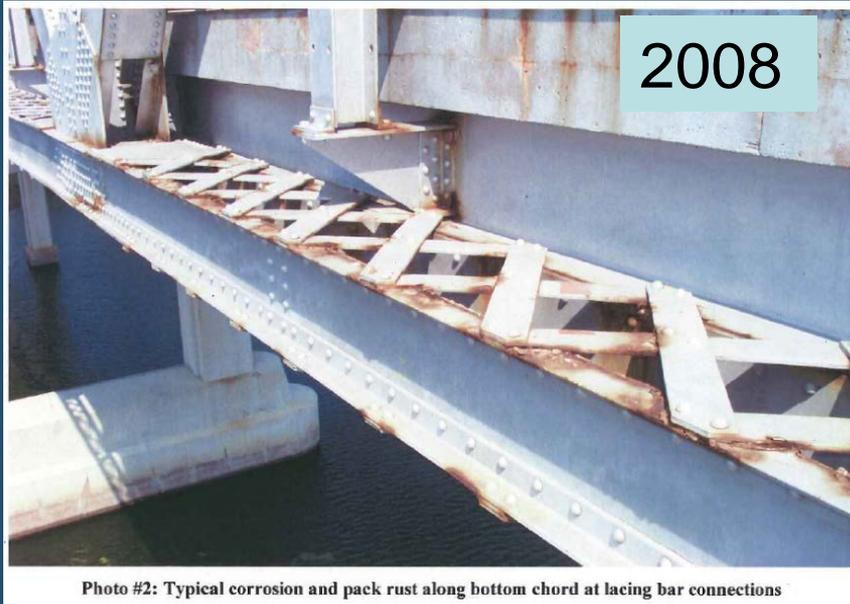
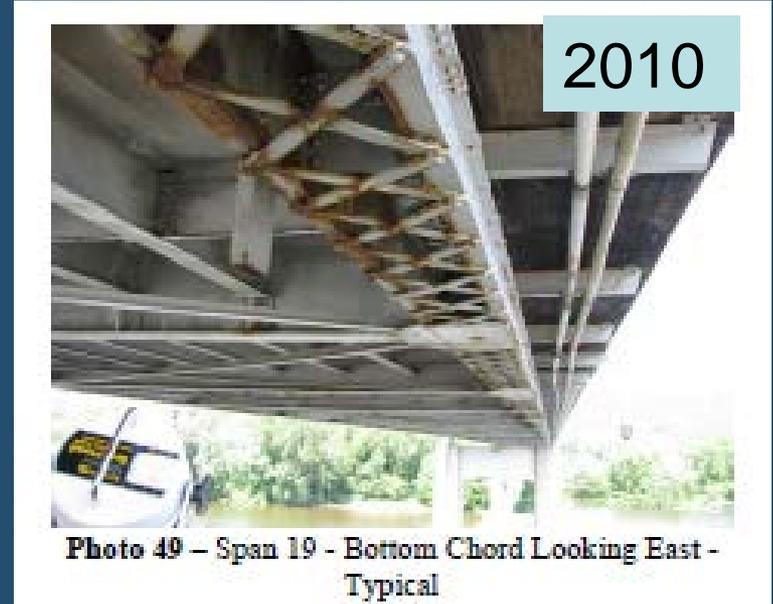
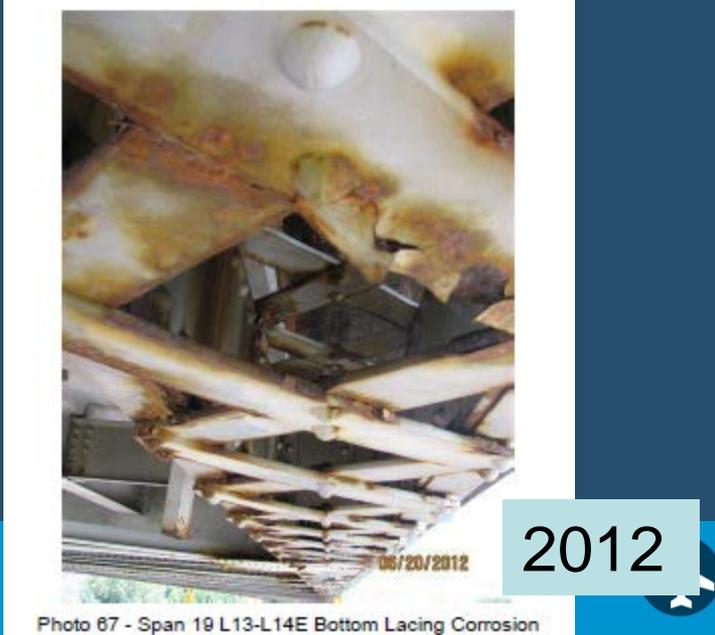
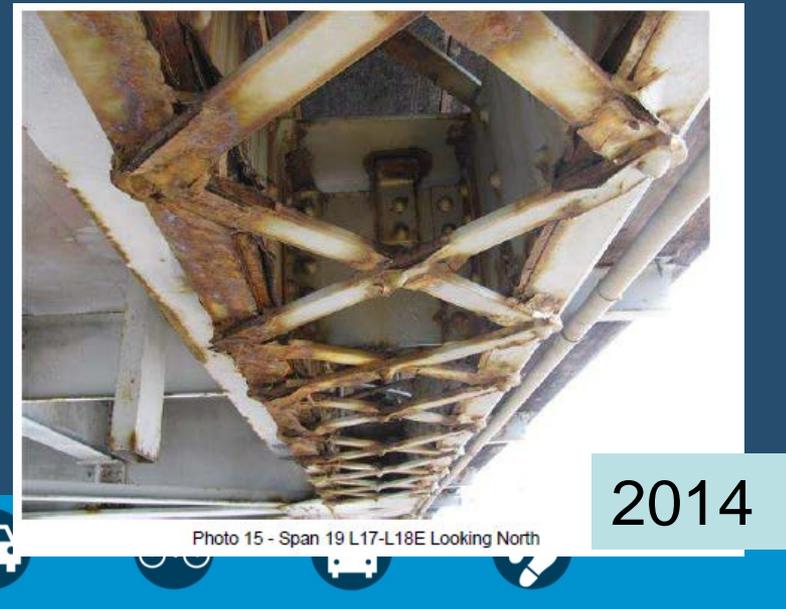
Bridge 5900 Inspection Report Conditions

- **Through-truss Deterioration Rate:** The Winona Bridge Project Management team spent considerable time and effort in reviewing recent bridge inspection reports for Bridge No. 5900. As shown in Appendix A, the rate of deterioration has accelerated in recent years with some very evident changes from 2013 to 2014 in the reports. The “moderate deterioration went from 75% to 0%, the extensive deterioration went from 25% to 85%, and severe deterioration went from 0% to 15%. The photos in Appendix A are from the same location and span several years.
