Figure 5
Predicted 2020 Pavement Condition
Greenbush-Badger

Figure 6
Predicted 2020 Pavement Condition
Roseau

Figure 7
Predicted 2020 Pavement Condition
Warroad

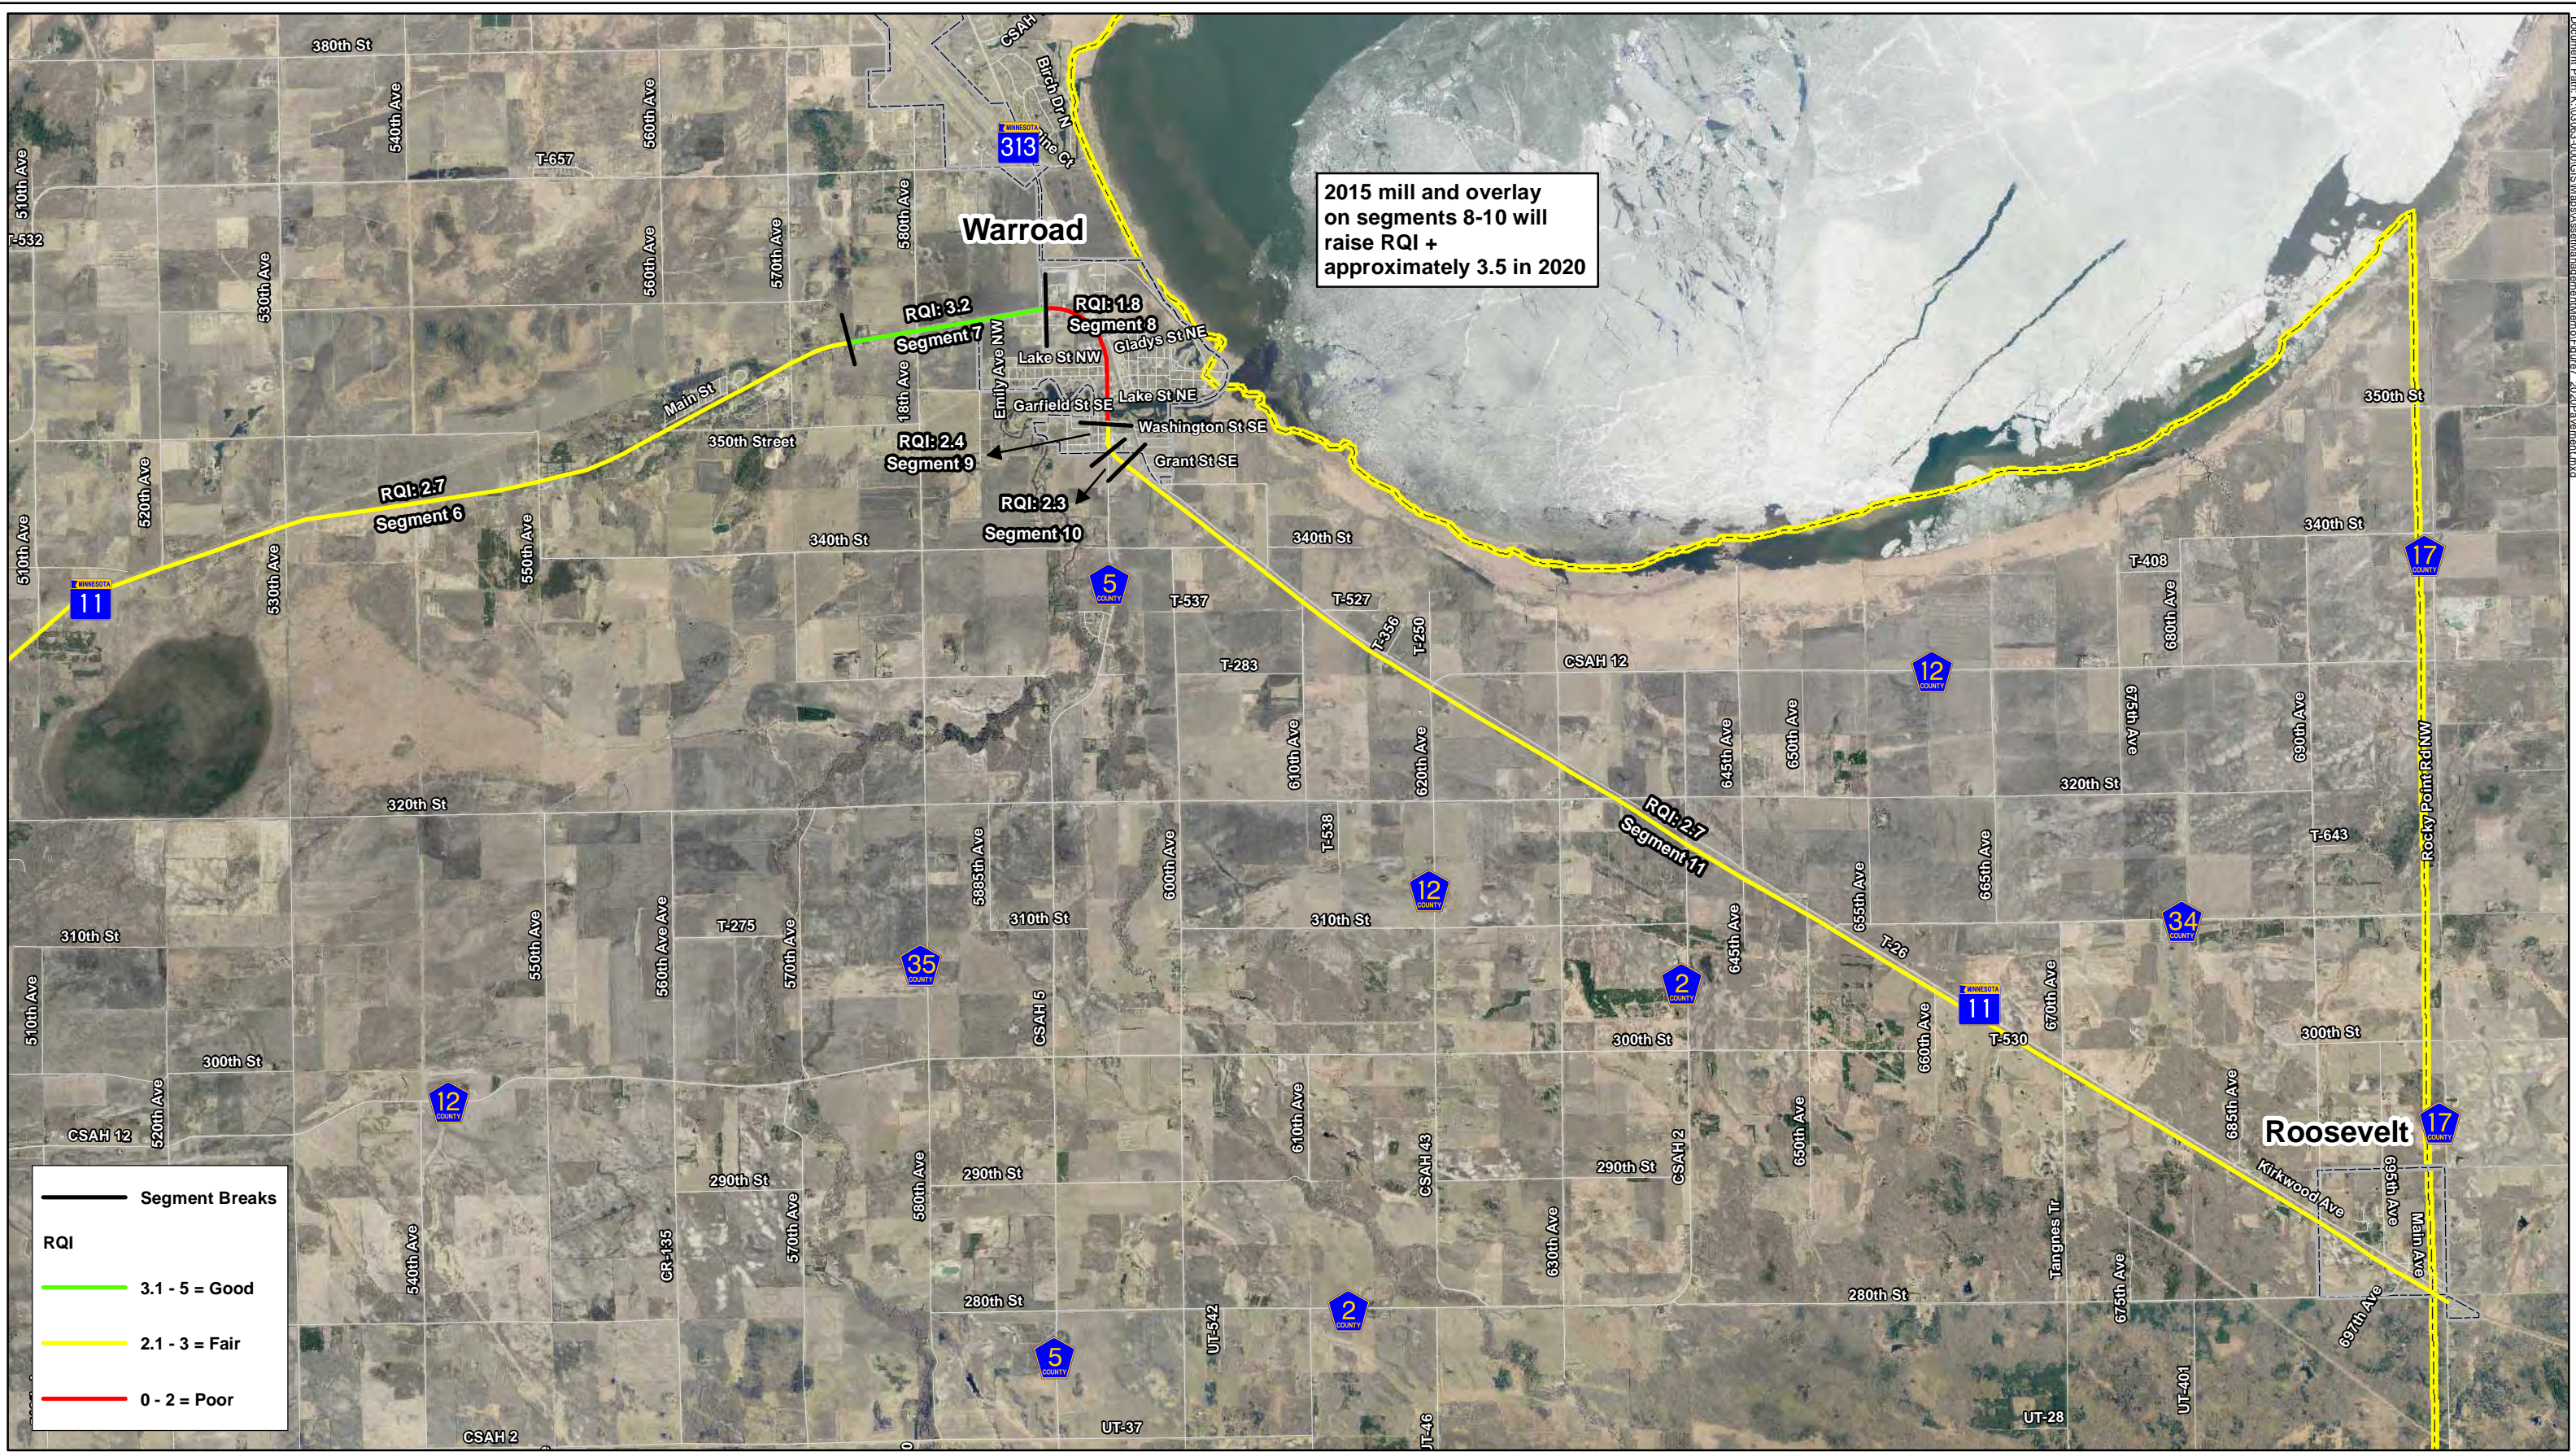
2015 mill and overlay on segments 8-10 will raise RQI + approximately 3.5 in 2020

- 3.1 - 5 = Good
- 2.1 - 3 = Fair
- 0 - 2 = Poor
