***REPAIR RECOMMENDATION REPORT  
BRIDGE NO. 9040***

*(T.H. 63 over Mississippi River and CP Railway)*

**RED WING BRIDGE PROJECT**

**January 28, 2013**

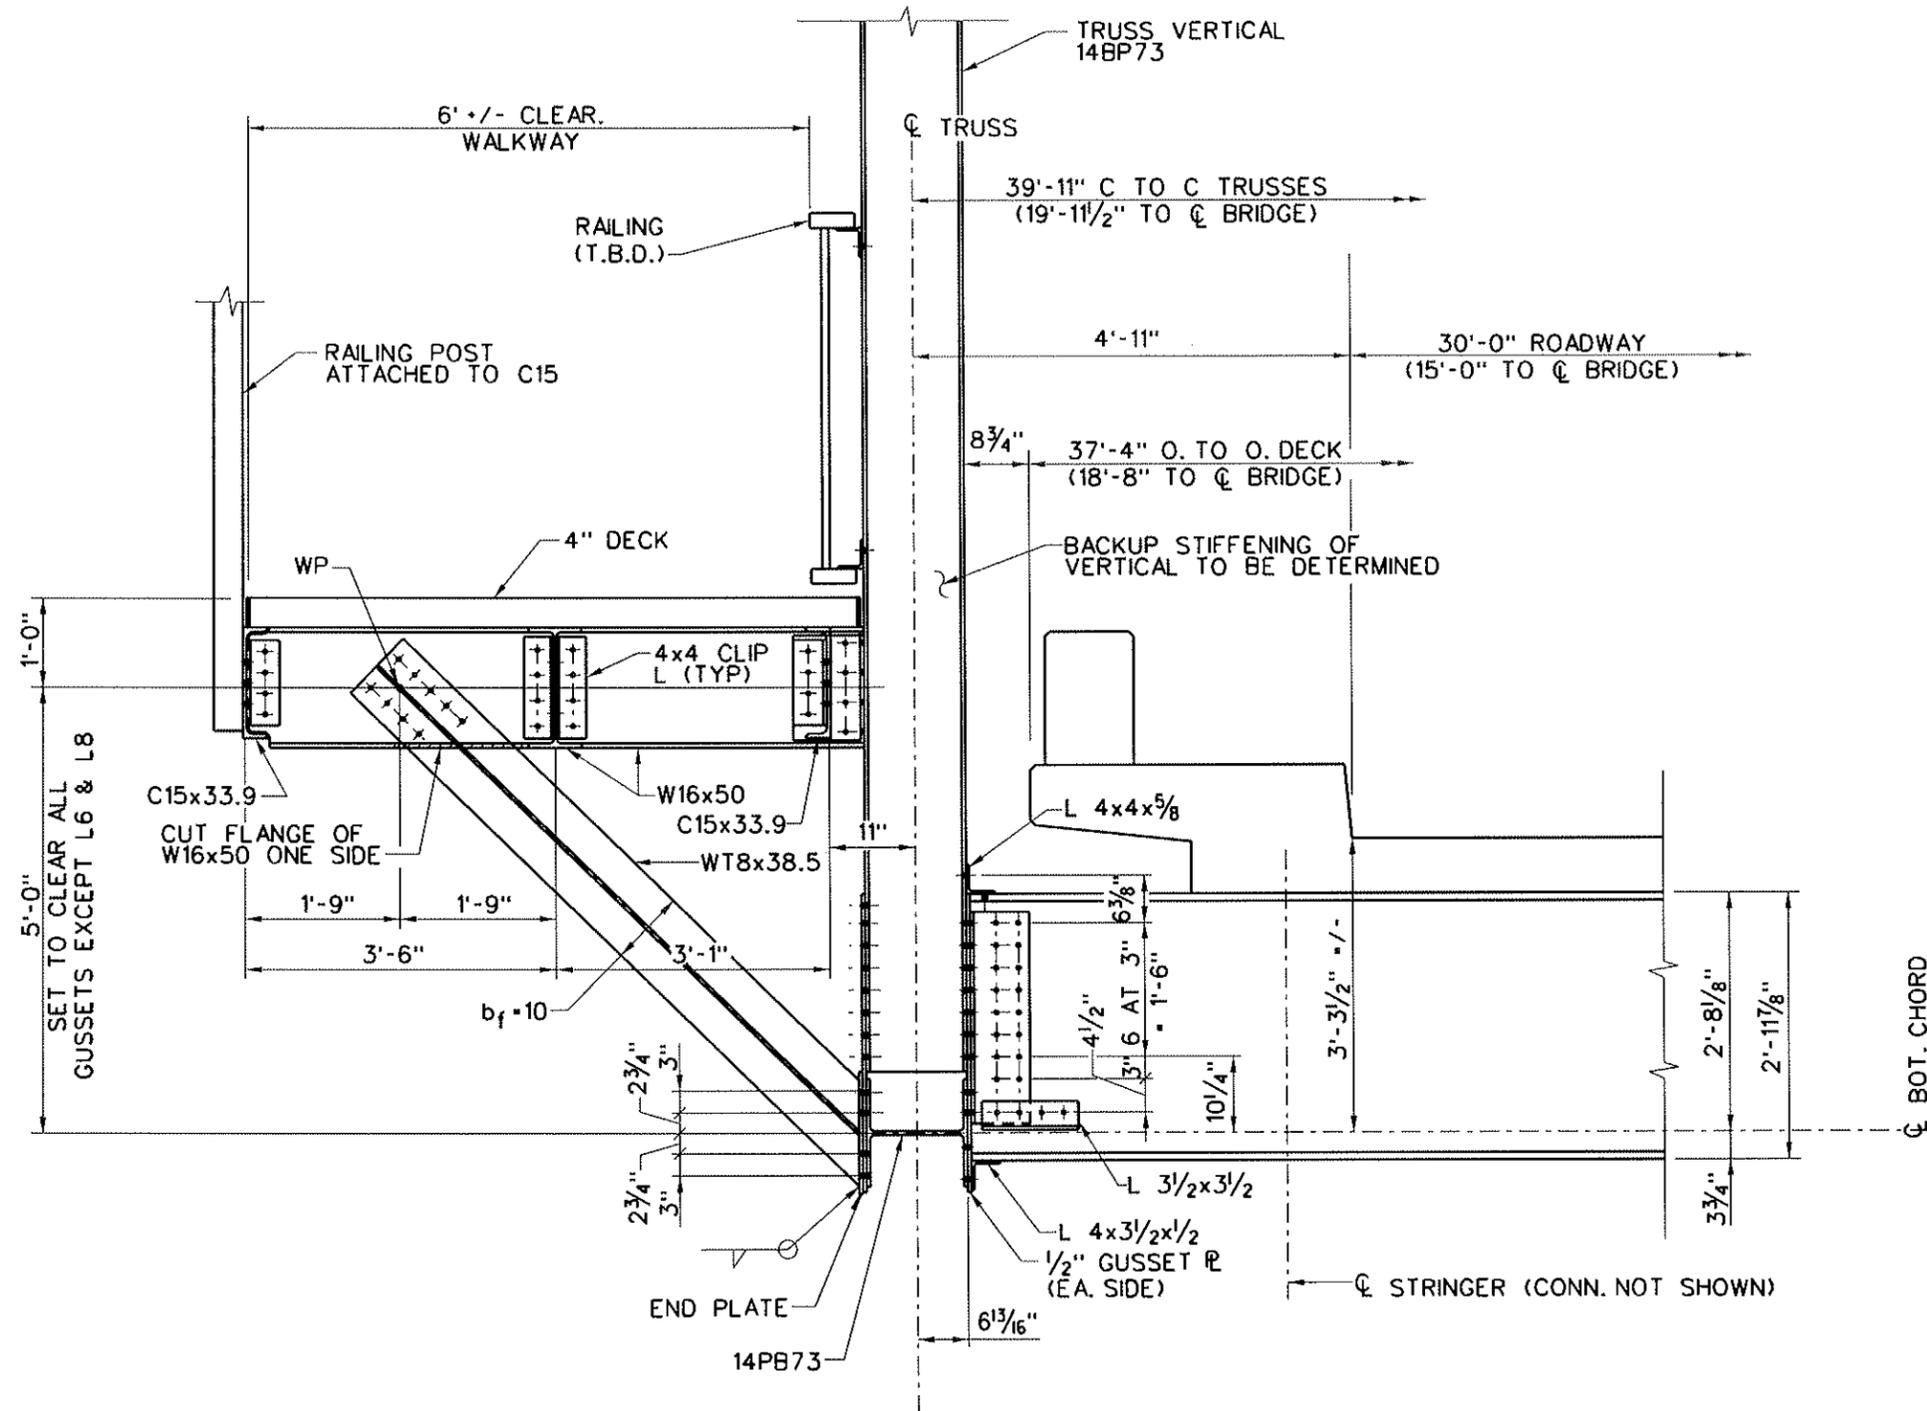
**TYPICAL BRACKET SECTION**

(SHOWN AT P.P. L1)  
SCALE 1"=1'-0"

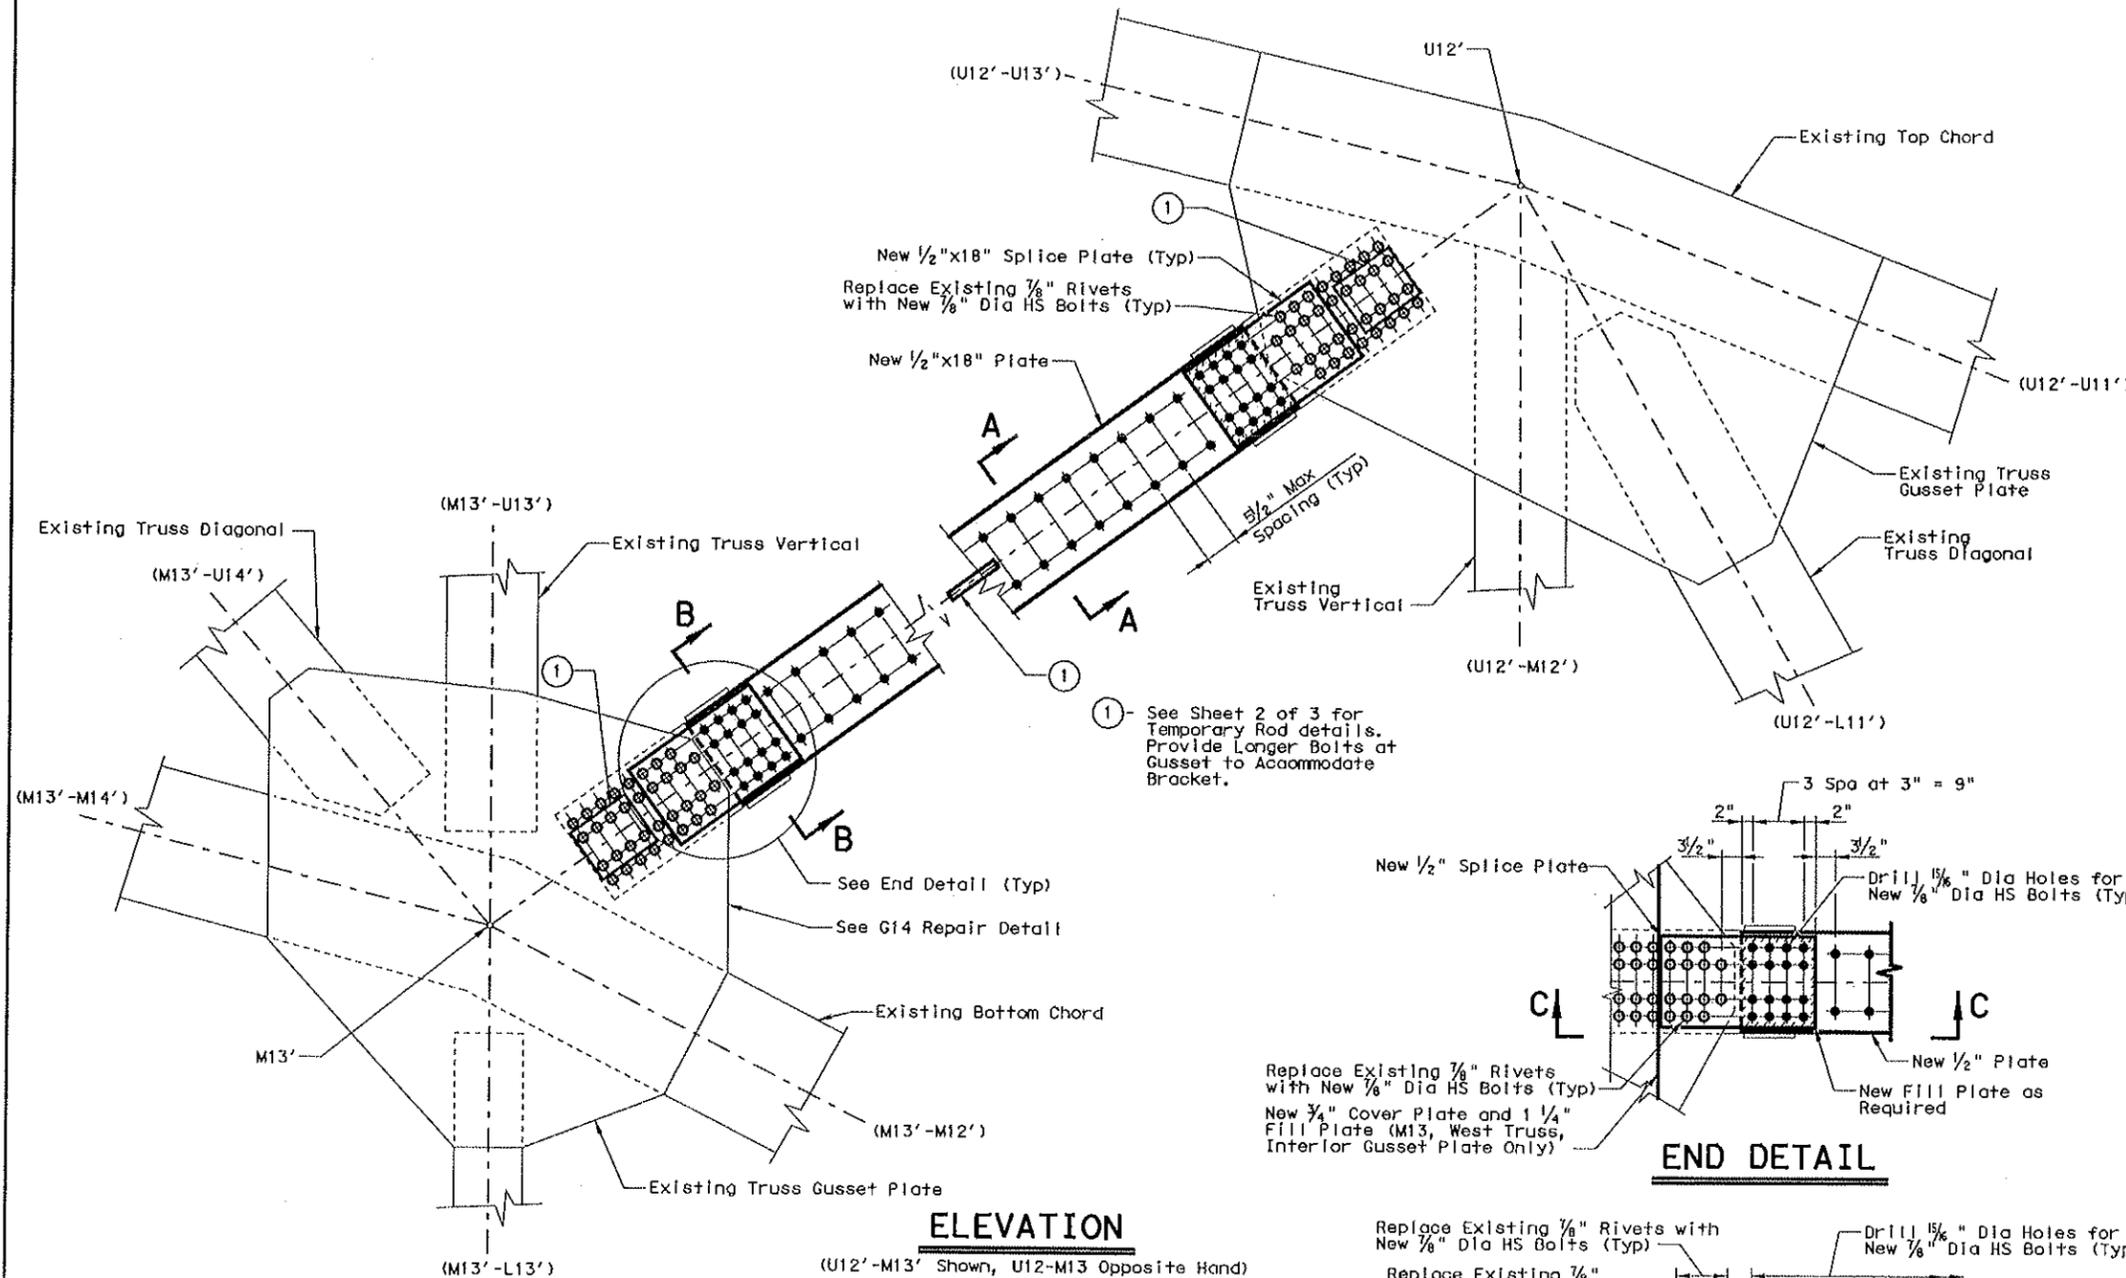
**REPAIR M01**

**SECTION A-A**

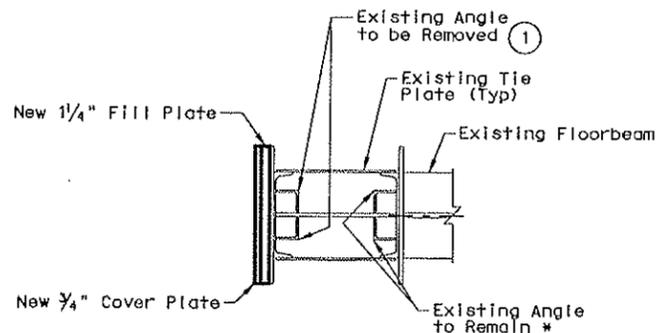
**SECTION D-D**

- (1) L5x3x3/8 at U4 East.  
 L4x4x3/8 at All Other Locations.

1. Drill Holes in New Fill Plate and New Cover Plate to Match Existing Hole Layout.
2. Install New Plates per Bearing Plate Detail.
3. Remove Existing Angles as Shown to Allow Rivet Replacement. Grind Welds Smooth on Truss Members.
4. Replace Individual Rivets with New HS Bolts. A Maximum of 4 Rivets may be Removed at Any Given Time.
5. Install New Fill Plate and New Cover Plate. Install Second Nut on HS Bolts.
6. Drill Holes and Install New HS Bolts as Shown Around Perimeter of New Cover Plate.

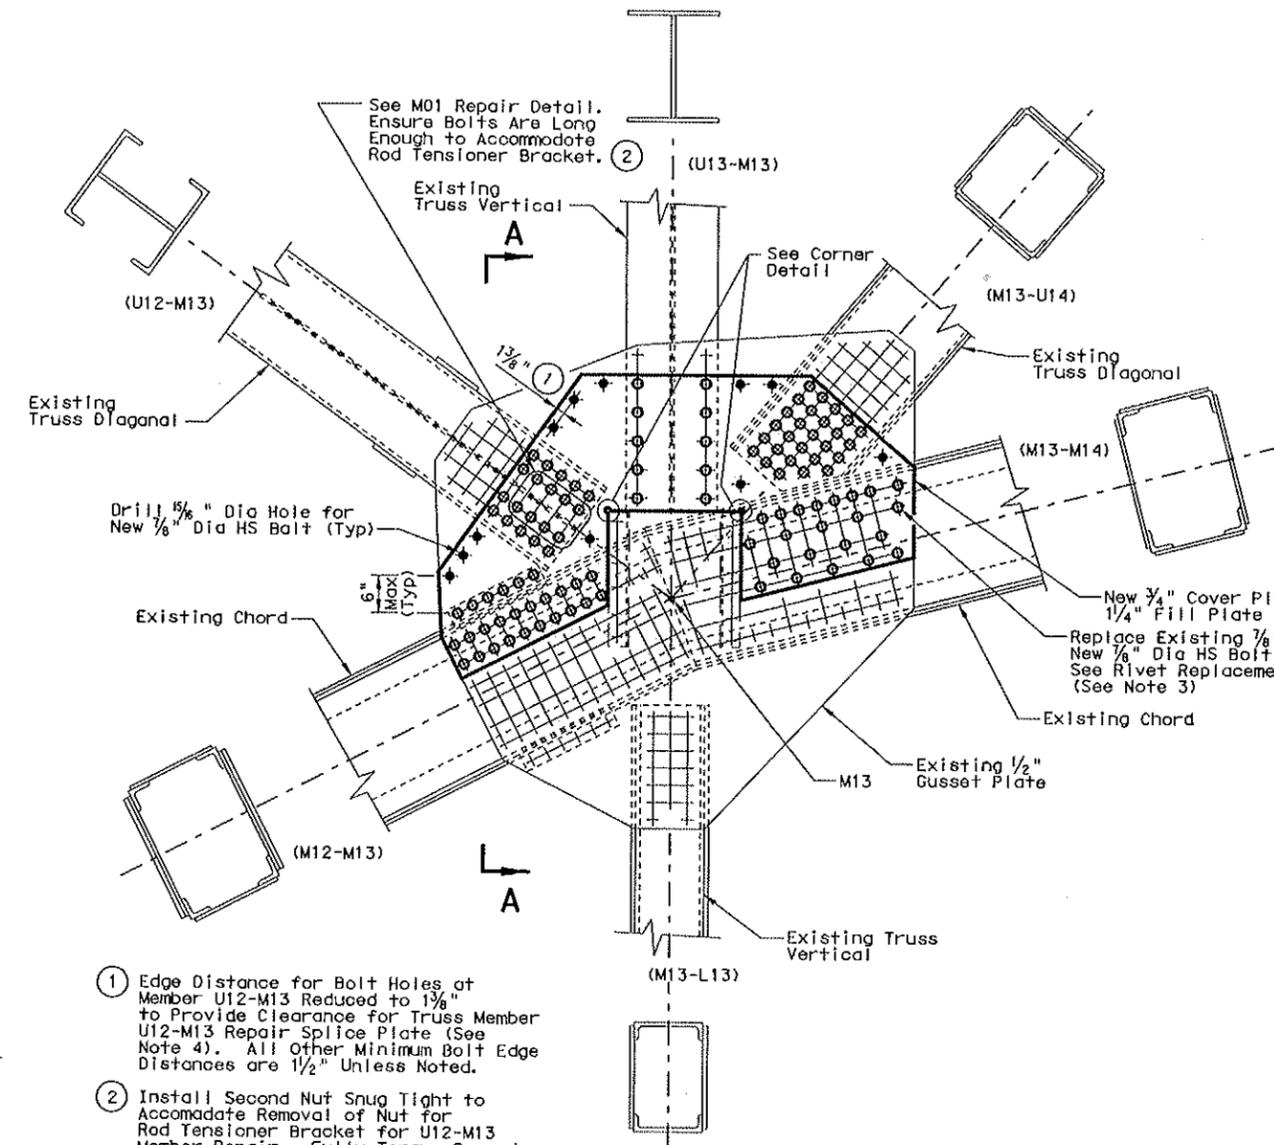
**ELEVATION**

- ① Edge Distance for Bolt Holes at Member U12-M13 Reduced to 1 3/8" to Provide Clearance for Truss Member U12-M13 Repair Splice Plate (See Note 4). All Other Minimum Bolt Edge Distances are 1 1/2" Unless Noted.
- ② Install Second Nut Snug Tight to Accommodate Removal of Nut for Rod Tensioner Bracket for U12-M13 Member Repair. Fully Torque Second Nut for Final Installation.

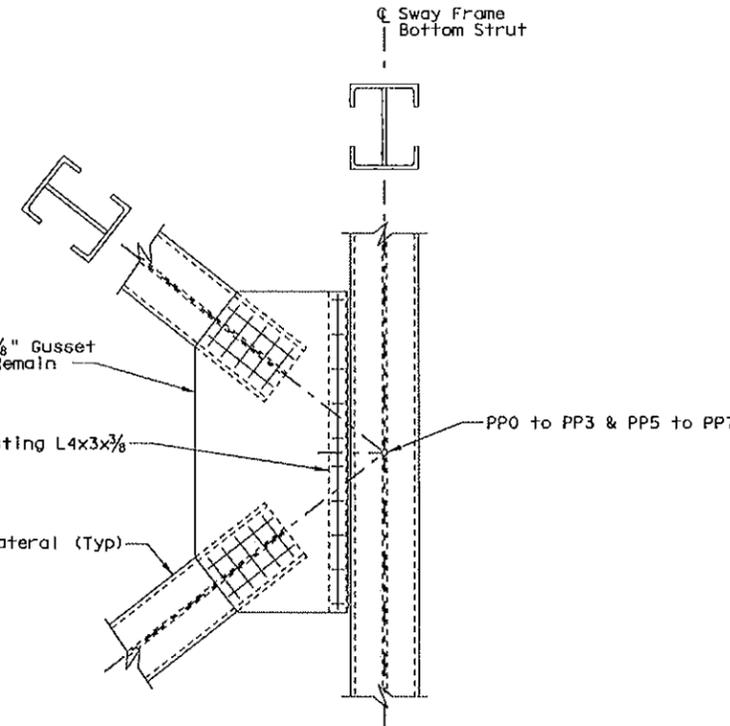
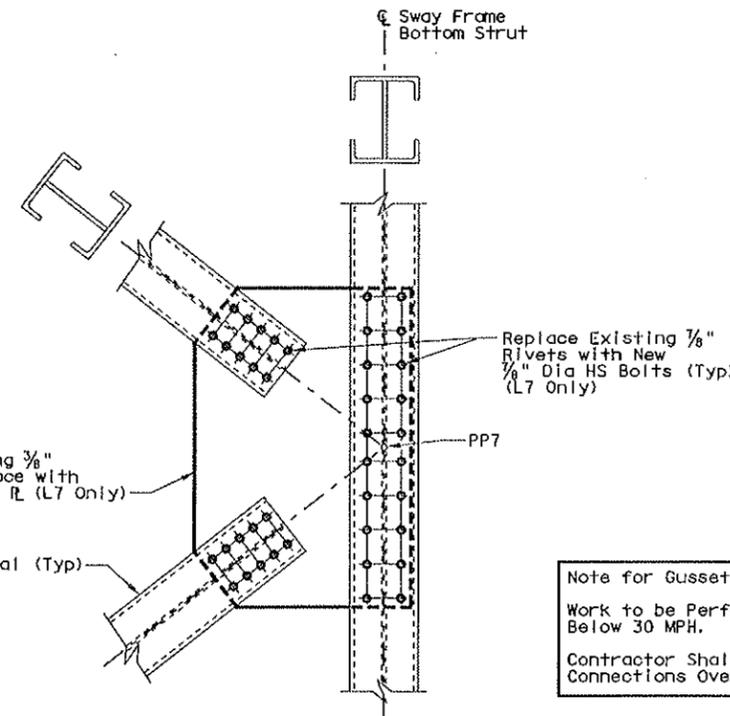
**REPAIR G04**

**PLAN - BOTTOM LATERAL TOP GUSSET PLATE**

**PLAN - BOTTOM LATERAL BOTTOM GUSSET PLATE**

(2 Locations - New Plate at L7 Only)

Note for Gusset Replacement:  
 Work to be Performed with Wind Below 30 MPH.  
 Contractor Shall Not Leave Uncompleted Connections Overnight.

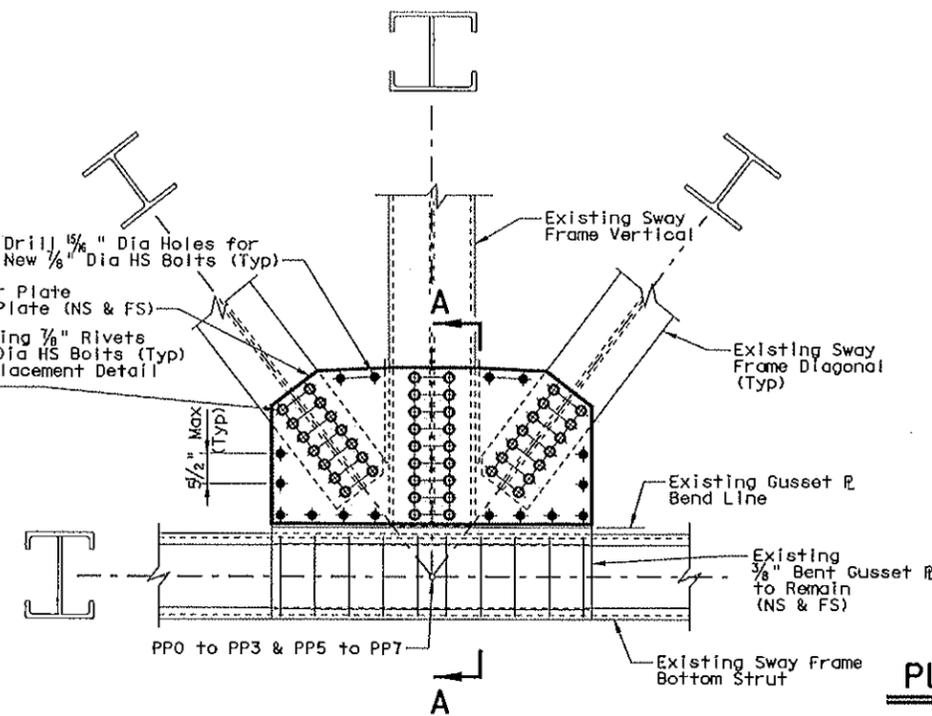
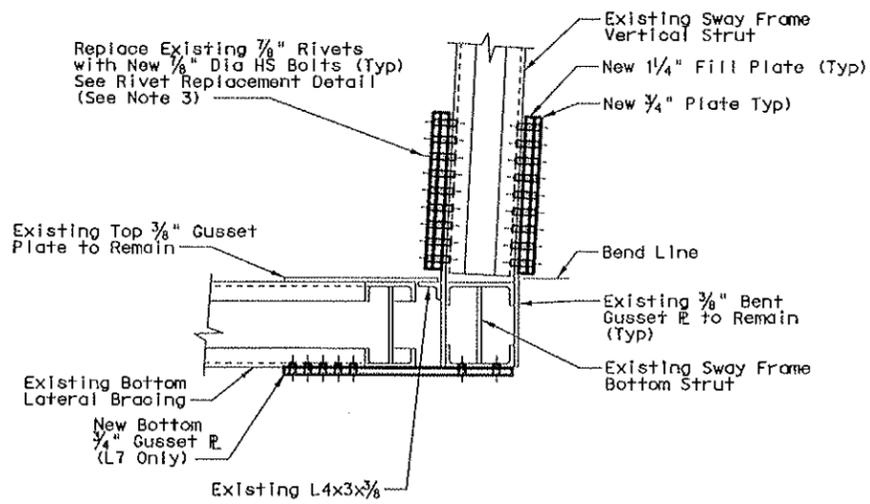
**REPAIR G03**

**ELEVATION**

(14 Locations - 2 Sides per Location)  
 (Span 27 Shown, Span 31 Similar)

**SECTION A-A**

(L7, L6, L5 As Shown,  
 L3, L2, L1 Lateral Bracing Opposite Hand)

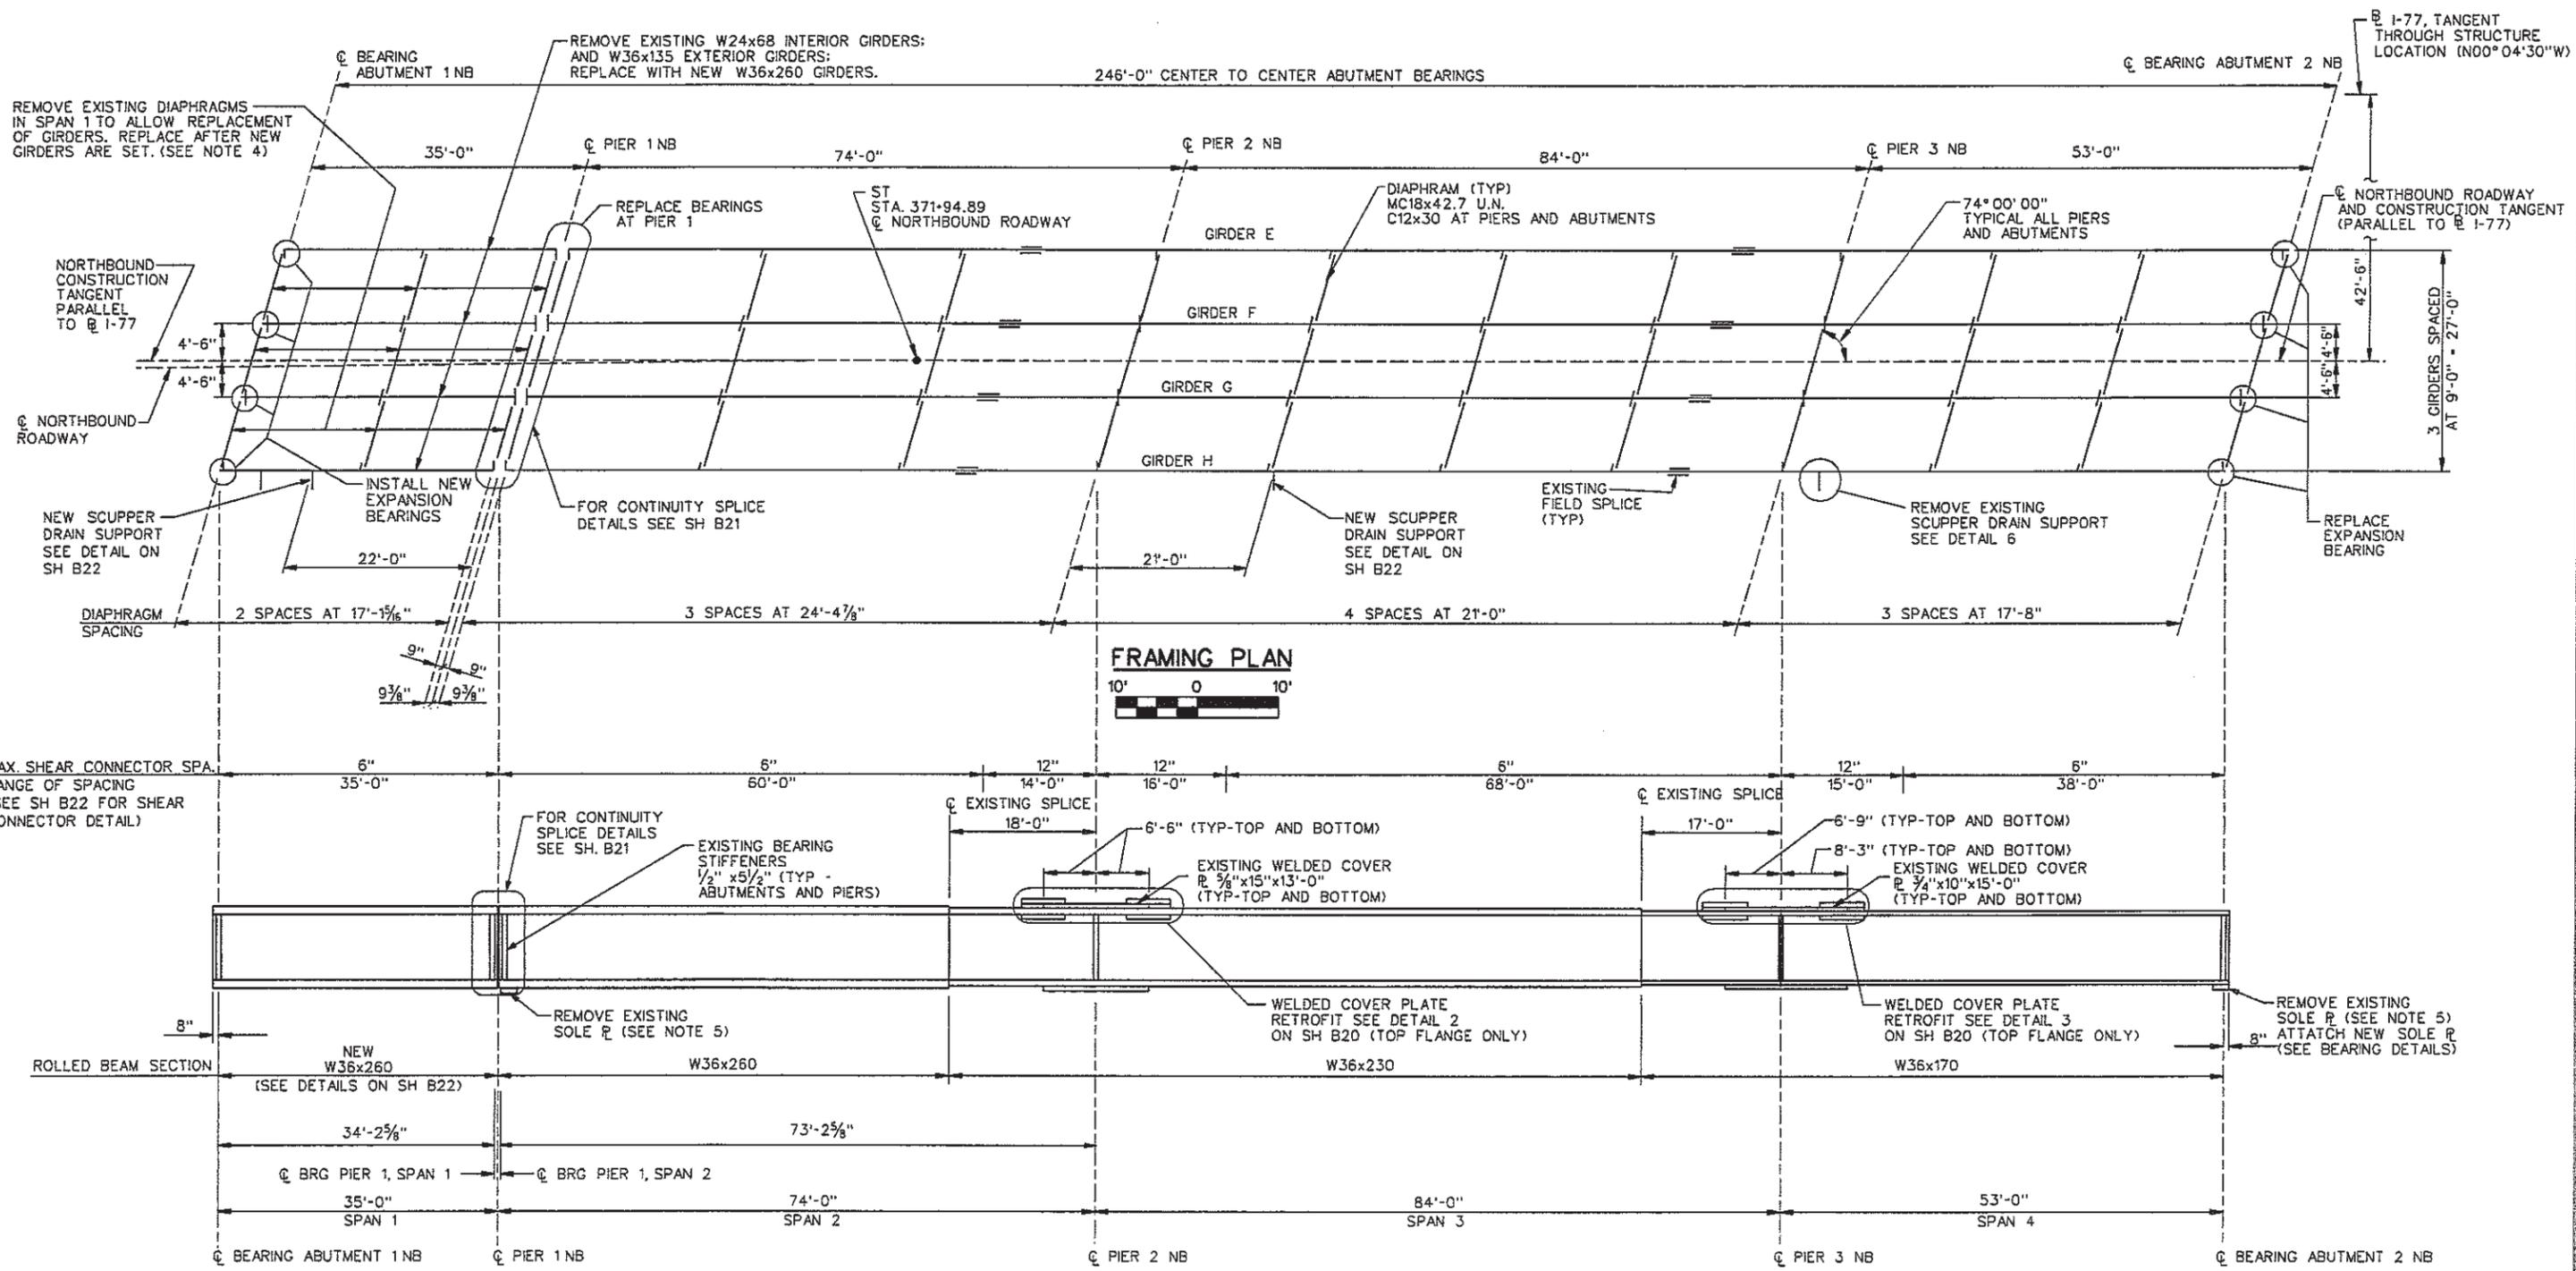
**FRAMING PLAN**  
10' 0 10'

**GIRDER ELEVATION**  
10' 0 10'

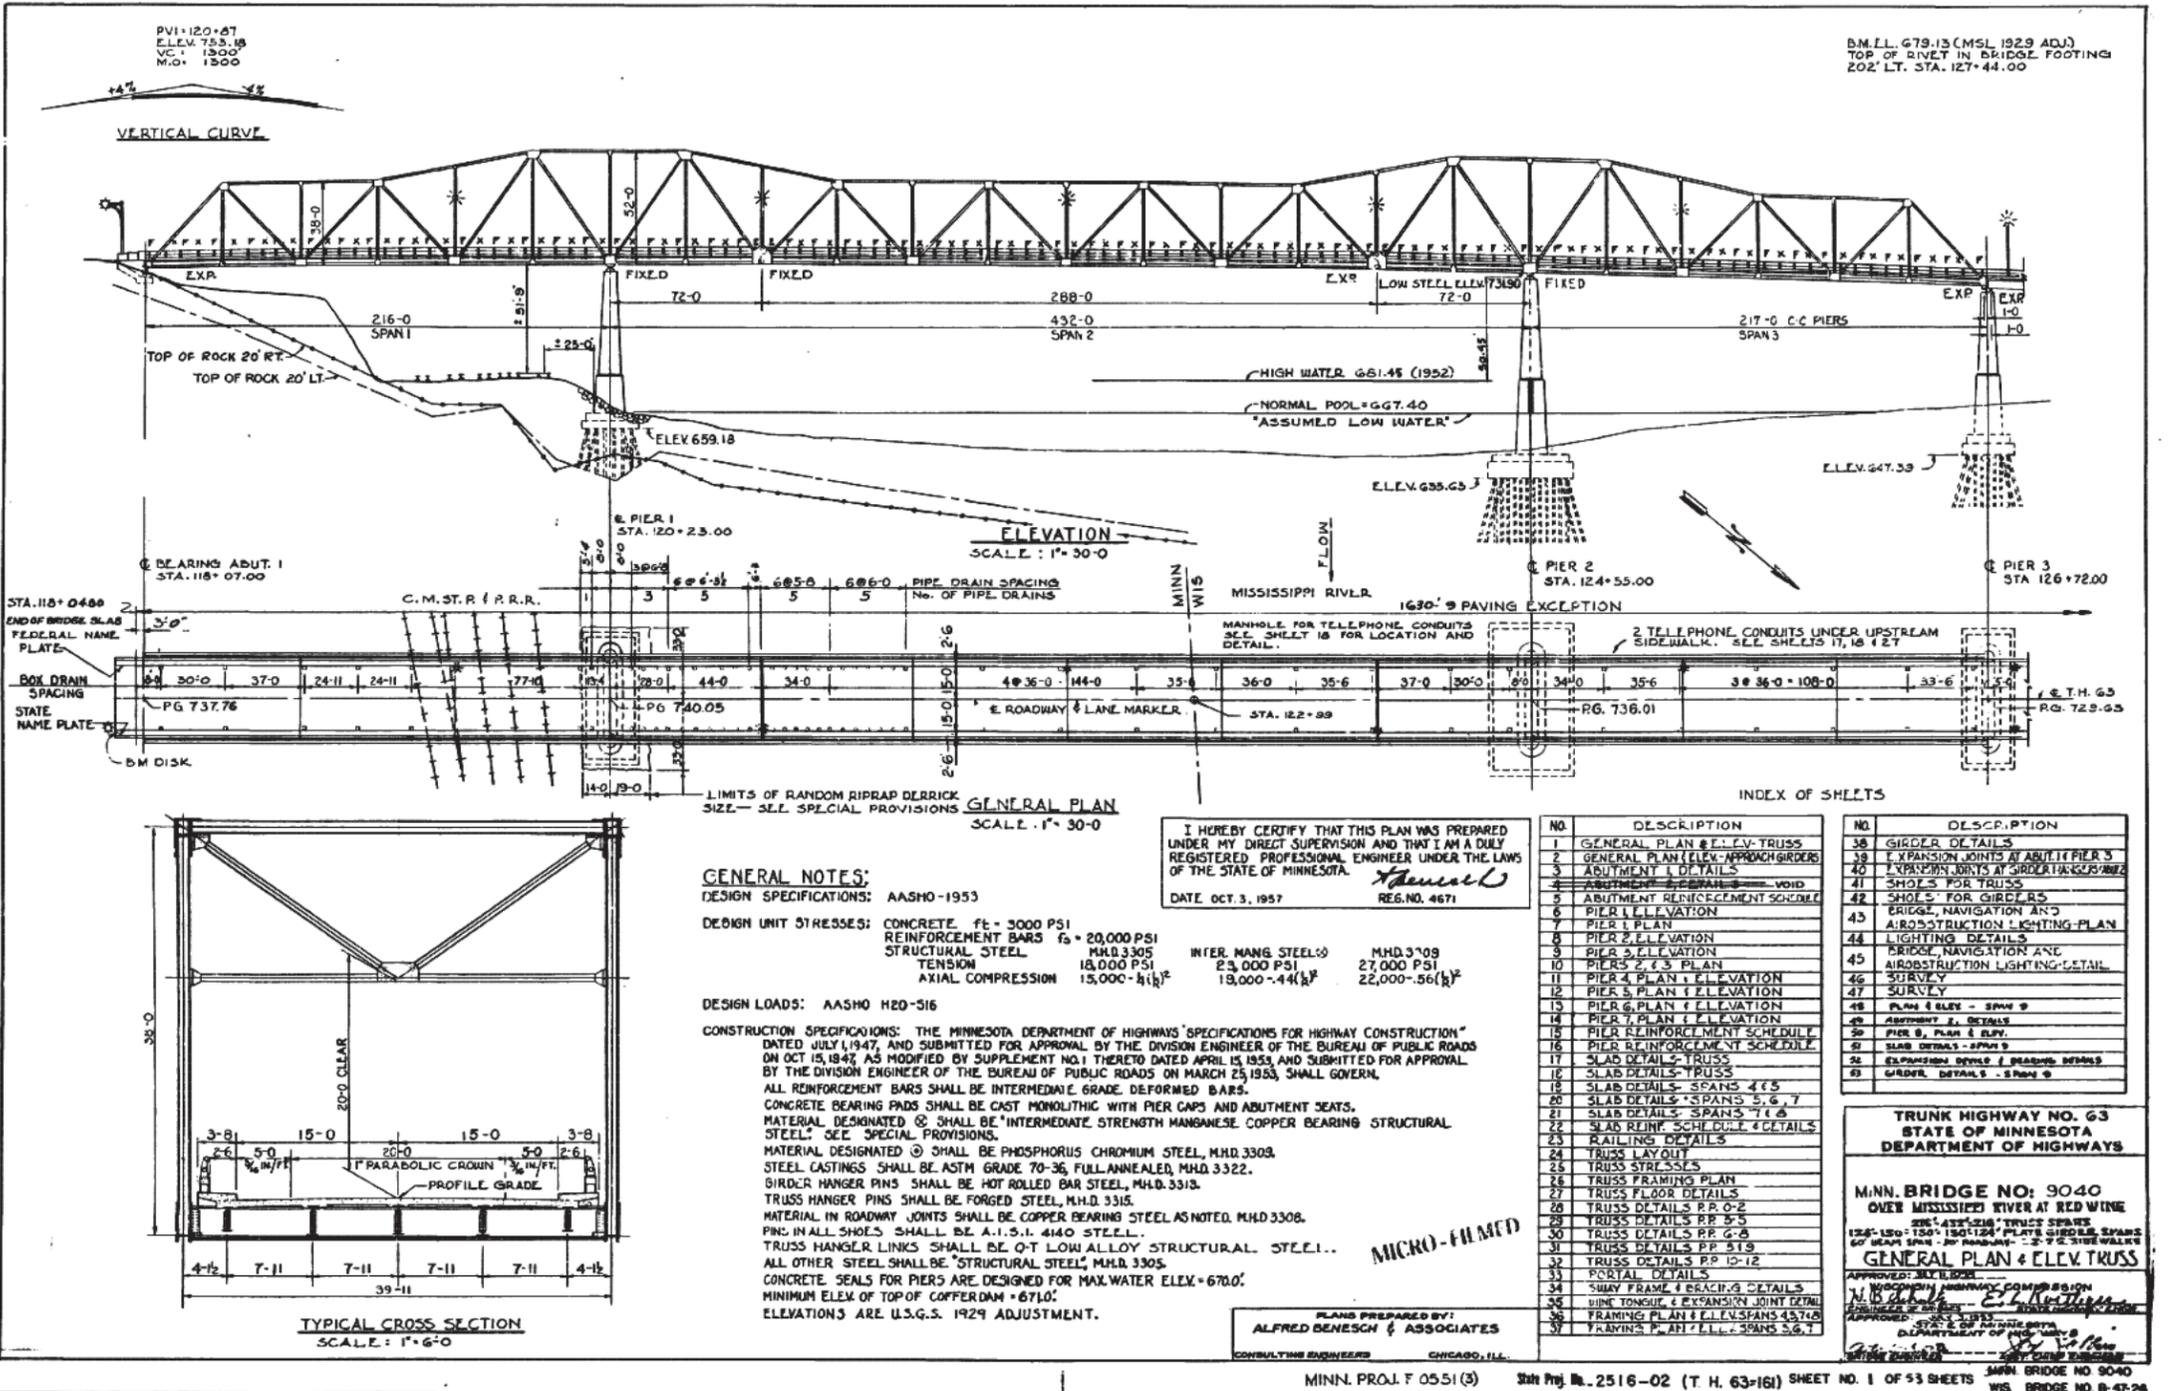
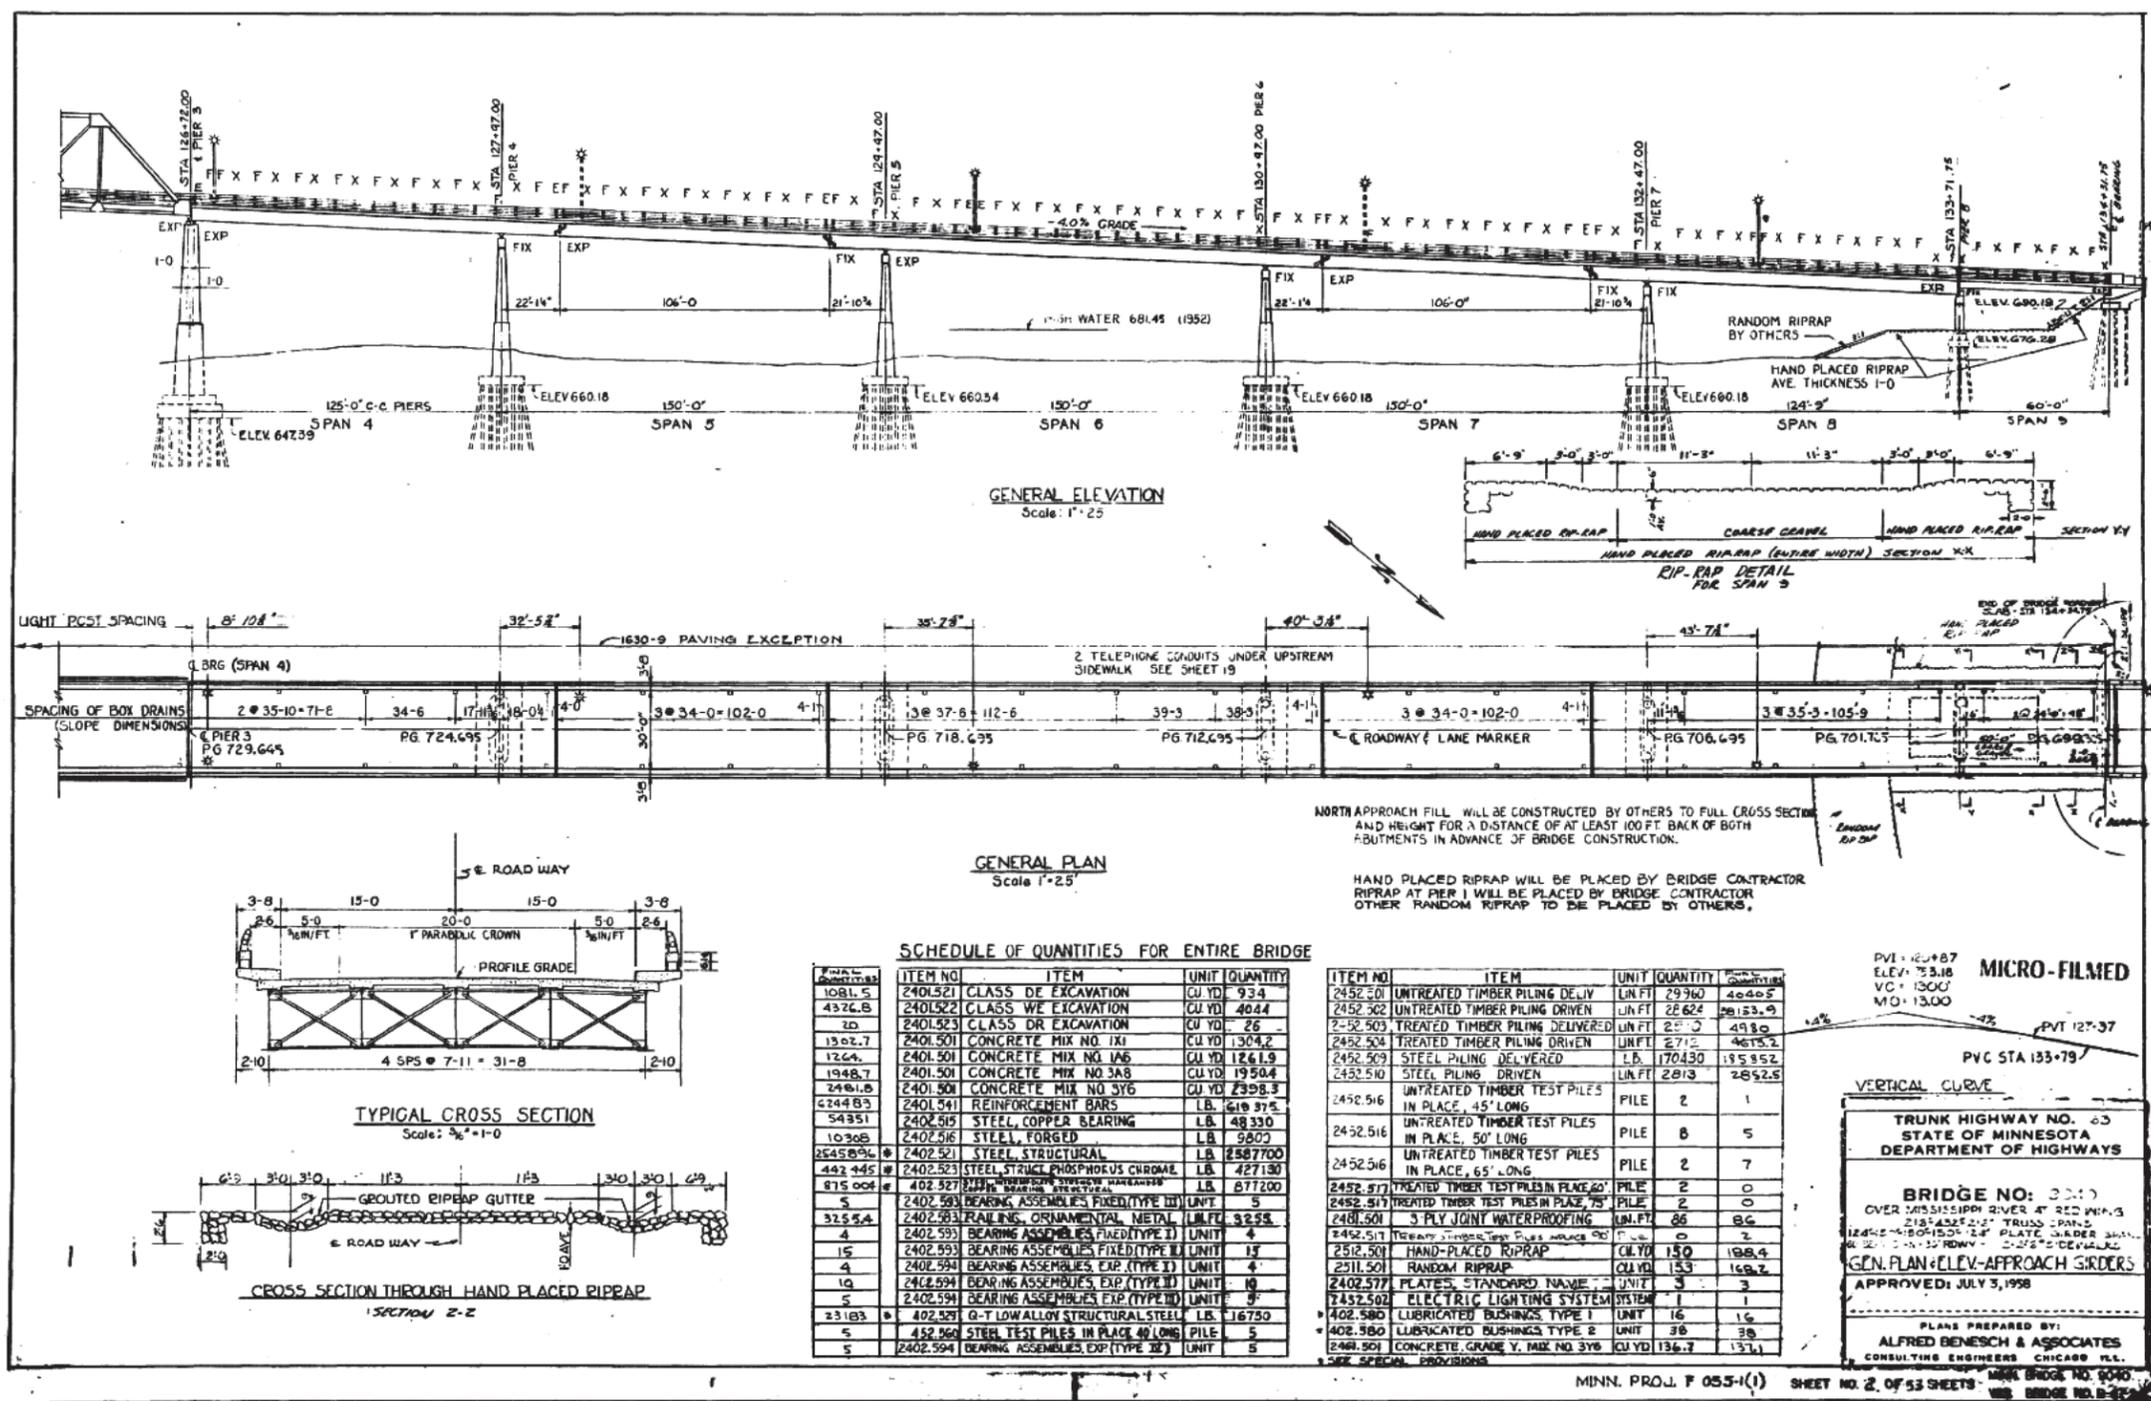
GENERAL ELEVATION  
Scale: 1"=25'

GENERAL PLAN  
Scale: 1"=25'

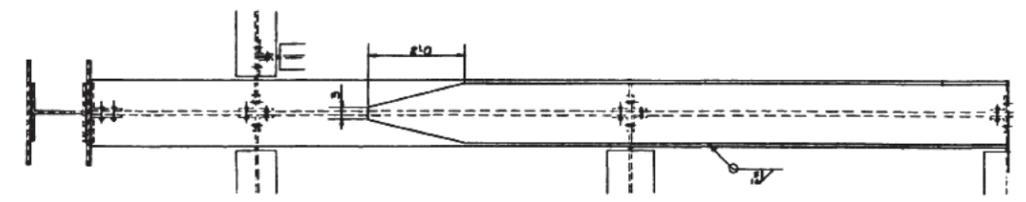
COVER PLATE AT FLOOR BEAM  
SCALE 3/8"=1'-0"
