HE-MPC-3009

STATEWIDE BRIDGE SURVEY FORM

MNDOT No.: 27664  
Historic Name: Broadway Ave. Bridge  
Common Name: Merriam Street Bridge  
Owner: City of Minneapolis  
Year Built: 1887/198\_  
Engineer: Andrew Rinker, City Engineer  
Fabricator: King Bridge Company, Cleveland, OH  
Contractor: King Bridge Company, Cleveland, OH

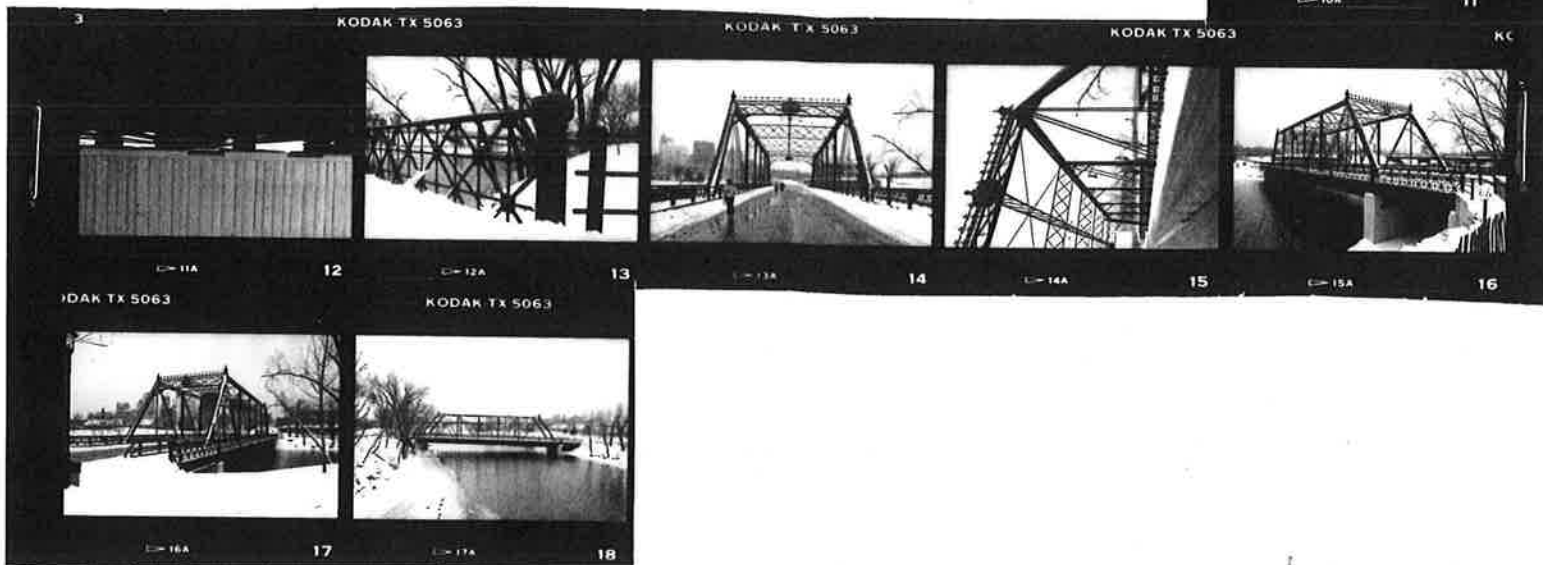
PLAQUE 1887

BLT BY KING IRON

BR. CO. CLEVELAND O.

ANDREW PINKER, CITY ENR.

1 MAIN SPAN(S) PIN JOINT THROUGH (REAR STEEL I-BM, DEEP, WELDED)

2 APPROACH SPAN(S) STEEL STRINGERS I-BM ROLLED

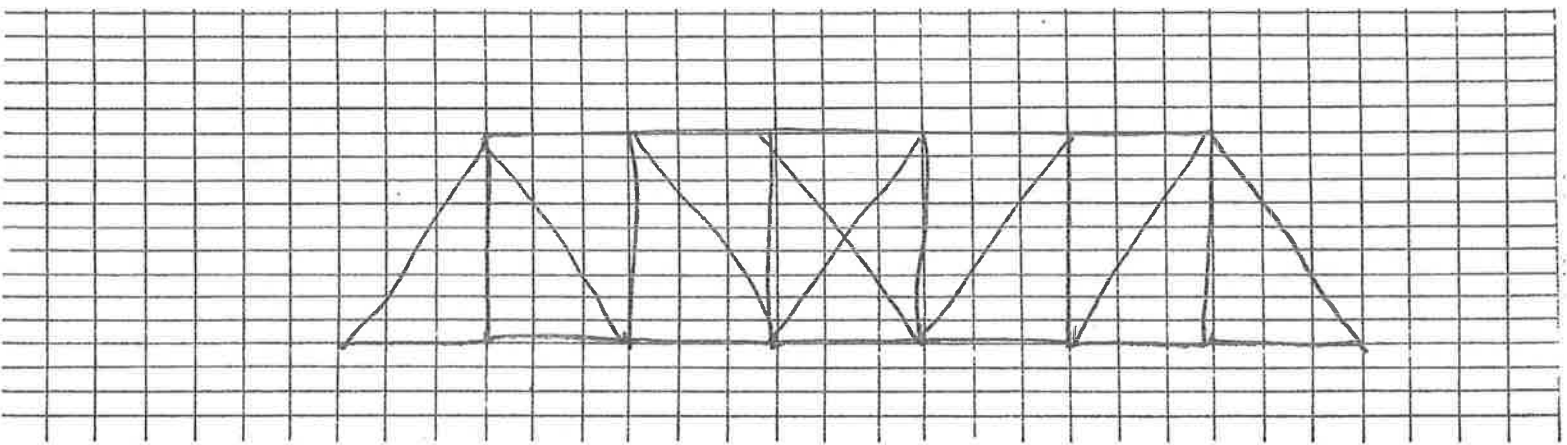
MEMBER DESCRIPTION:

LOWER CHORD: PUNCHED EYEBARS

SUPERSTRUCTURE: VERTICALS: L I V A F T

RAILING: LATTICE WITH STRAPS DIAGONALS: PUNCHED EYEBARS

SUBSTRUCTURE: CONCRETE PIERS & ABUTS UPPER CHORD: I L
