# Minnesota Department of Transportation (MnDOT) Local Historic Bridge Report- Abridged

Bridge Number: R0657

Bridge R0657, built in 1935, carries pedestrian traffic over the Minnesota River near the foot of 8<sup>th</sup> Avenue in the city of Granite Falls, Yellow Medicine County. The bridge connects the downtown area with the east side of town. The City of Granite Falls owns the bridge. Bridge R0657 is a three-span steel suspension bridge and is significant as a rare example of that bridge type in Minnesota. Furthermore, the bridge was built by the Minneapolis Bridge Company, a significant bridge builder in Minnesota.

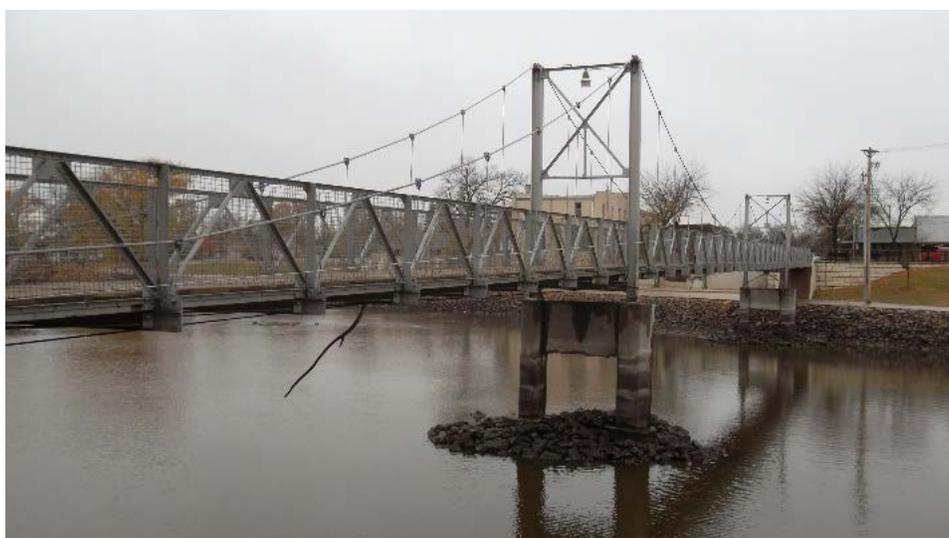
**Feature 1: Design and construction of a suspension bridge, including the two steel towers, steel wire main cables, and suspender cables.**

Bridge R0657 is a 280-foot, three-span, steel suspension bridge. The center span is 130 feet long and the approach spans are 75 feet long each. Two towers are composed of steel I-beam piles and are supported with steel I-beam, angle, and plate bracing. X-bracing runs between the piles. The steel members feature rivets and some replacement bolts. Steel wire main cables and suspender cables run between the towers. Steel I-beam cable anchors connect the vertical cable members to the bridge deck. Angle sections with batten plates form a Warren-with-verticals configuration that functions as the bridge railing. A thin mesh-like metal screen runs along the interior of the truss on both sides of the concrete panel deck.

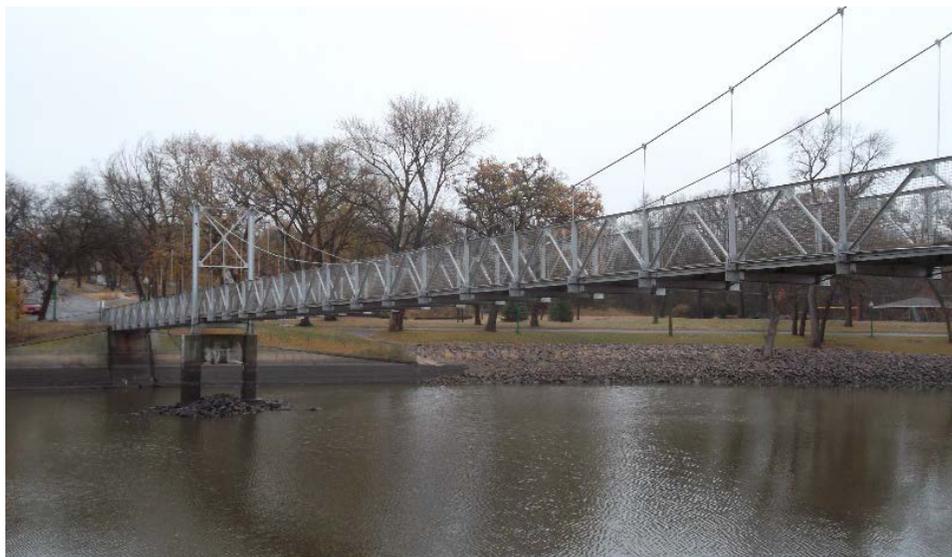
Feature 2: Stiffening truss with riveted steel members in pony Warren-with-verticals configuration.
