Technical Memorandum

Re: Purpose and Need
I-94 UBOL Resurfacing Maple Grove to Rogers and Brockton Interchange
S.P. 2780-97 (I-94 Resurfacing)
S.P. 229-010-001 (Brockton Interchange)

The purpose of this technical memorandum is to document the purpose and needs of the I-94 Unbonded Overlay (UBOL) Resurfacing from Maple Grove to Rogers and the Brockton Interchange (the project). The project is located along I-94 between the cities of Rogers, Dayton, and Maple Grove as shown on **Figures 1-3**.

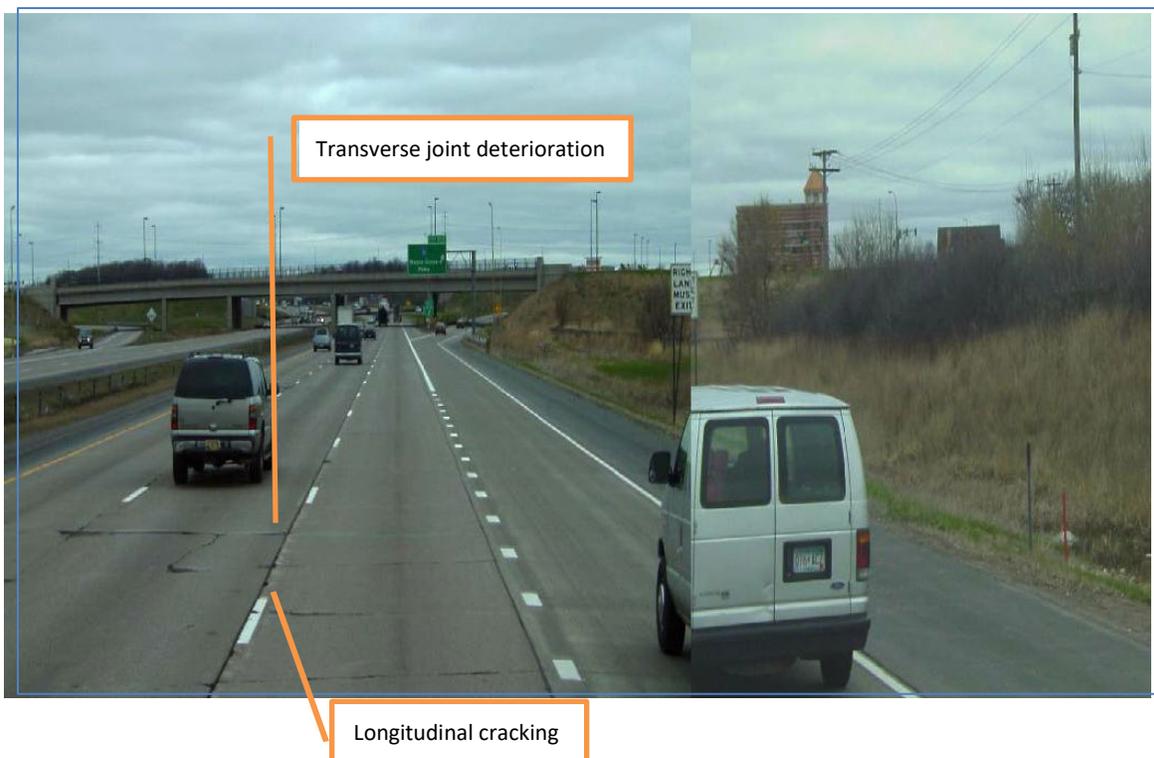
Figure 5: 2009 Videolog Image of Concrete Condition

As discussed, the section of I-94 within the project area was originally constructed in 1973 and has required numerous maintenance projects to address faulted joints and to install edge drains. The most recent pavement rehabilitation project was a major concrete paving rehabilitation (CPR) and diamond grind in 2010. Prior to this project, MnDOT Metro Materials projected that, without adding structural capacity to the roadway as part of this project, the improvement to RQI would not last beyond nine years. **Figure 5** shows the condition of the roadway prior to the 2010 CPR. Severe deterioration of the transverse joints is evident, as well as significant transverse and longitudinal cracking in the concrete panels. During the 2010 CPR, every transverse joint in the concrete pavement was repaired, as well as multiple mid-panel cracks and shattered slabs. During construction, the contractor constantly struggled with shallow groundwater as they removed the deteriorated concrete and prepared the grade for new patches. In addition, ultra-high early strength concrete was used in the patches, which sets and cures rapidly allowing for earlier opening to traffic but is also less durable than traditional concrete.

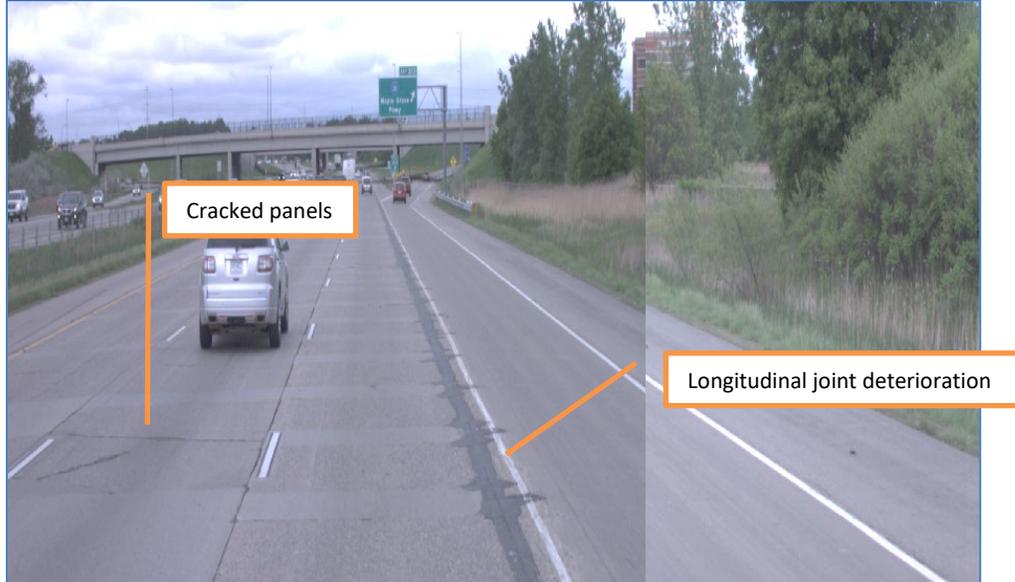
Figure 6: 2017 Videolog Image of Concrete Joint Condition

The resulting ride quality after the 2010 CPR and diamond grinding project improved to an RQI of 3.6. This put I-94 in the project area in the “good” category, but not as high as would be expected after a major improvement project. Since then, the pavement has continued to deteriorate. New transverse joint failures have materialized, and severe longitudinal joint deterioration has occurred. The joints between adjacent concrete lanes have widened creating potholes, and the bituminous shoulder has sunk, cracked, and developed severe potholes. **Figures 6 and 7** show the current condition of the roadway including the deterioration along the longitudinal joints and additional cracked panels.

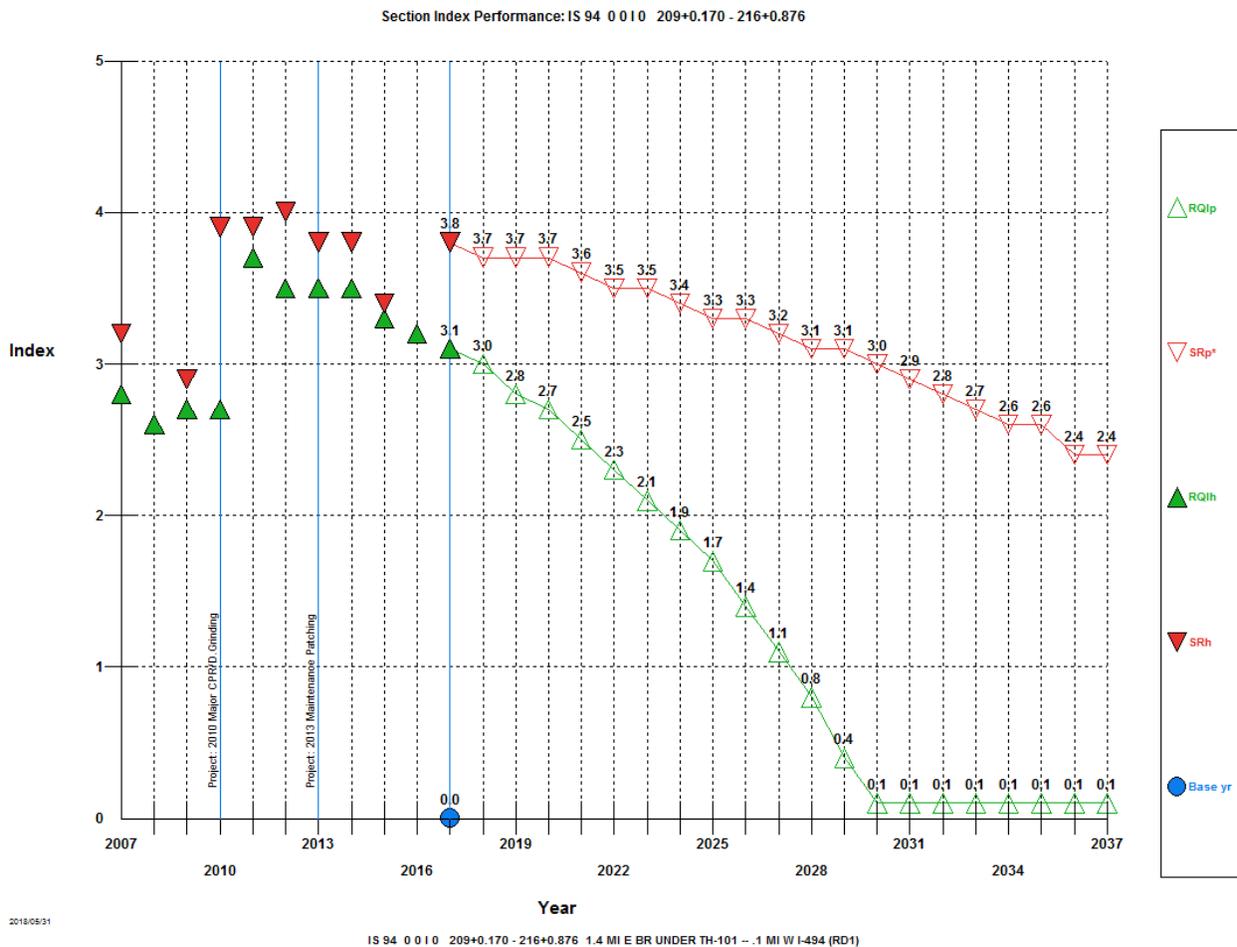
Figure 8: HMPA Pavement Performance Plot in the I-94 Project Area³

Figure 8 shows the Highway Pavement Management Application (HPMA) plot of current and future pavement condition on I-94 in the project area. The green triangles show RQI and the red triangles show Surface Rating (SR), a measure of MnDOT uses to quantify pavement distress. SR is based on visible defects on the pavement surface, which are symptoms indicating some type of problem or phenomenon of pavement deterioration such as cracks, patches, and ruts. SR ranges from 0.0 to 4.0, with a higher SR indicating better condition. A road in need of major rehabilitation or reconstruction will generally have an SR near or below 2.5.

The RQI has been steadily declining over the last three years, and that decline will accelerate in the years ahead. This year the RQI is projected to drop from “good” into “fair” condition and will drop into “poor” condition in six years. By 2026, the RQI will be at 1.4, which is unacceptable. The SR is also projected to steadily decline, though not as quickly as RQI.

- Rehabilitation projects have been frequent since initial construction of this section of I-94.
- Multiple diamond grinding efforts have reduced the structural integrity of the pavement by reducing concrete thickness.
- Pavement condition continues to deteriorate, and the pace of deterioration is accelerating.
- Maintenance crews are expending significant time, efforts, and resources to patch potholes and maintain the surface in an acceptable condition.
- HPMA projections indicate that the pavement condition will be in very poor condition by 2026.

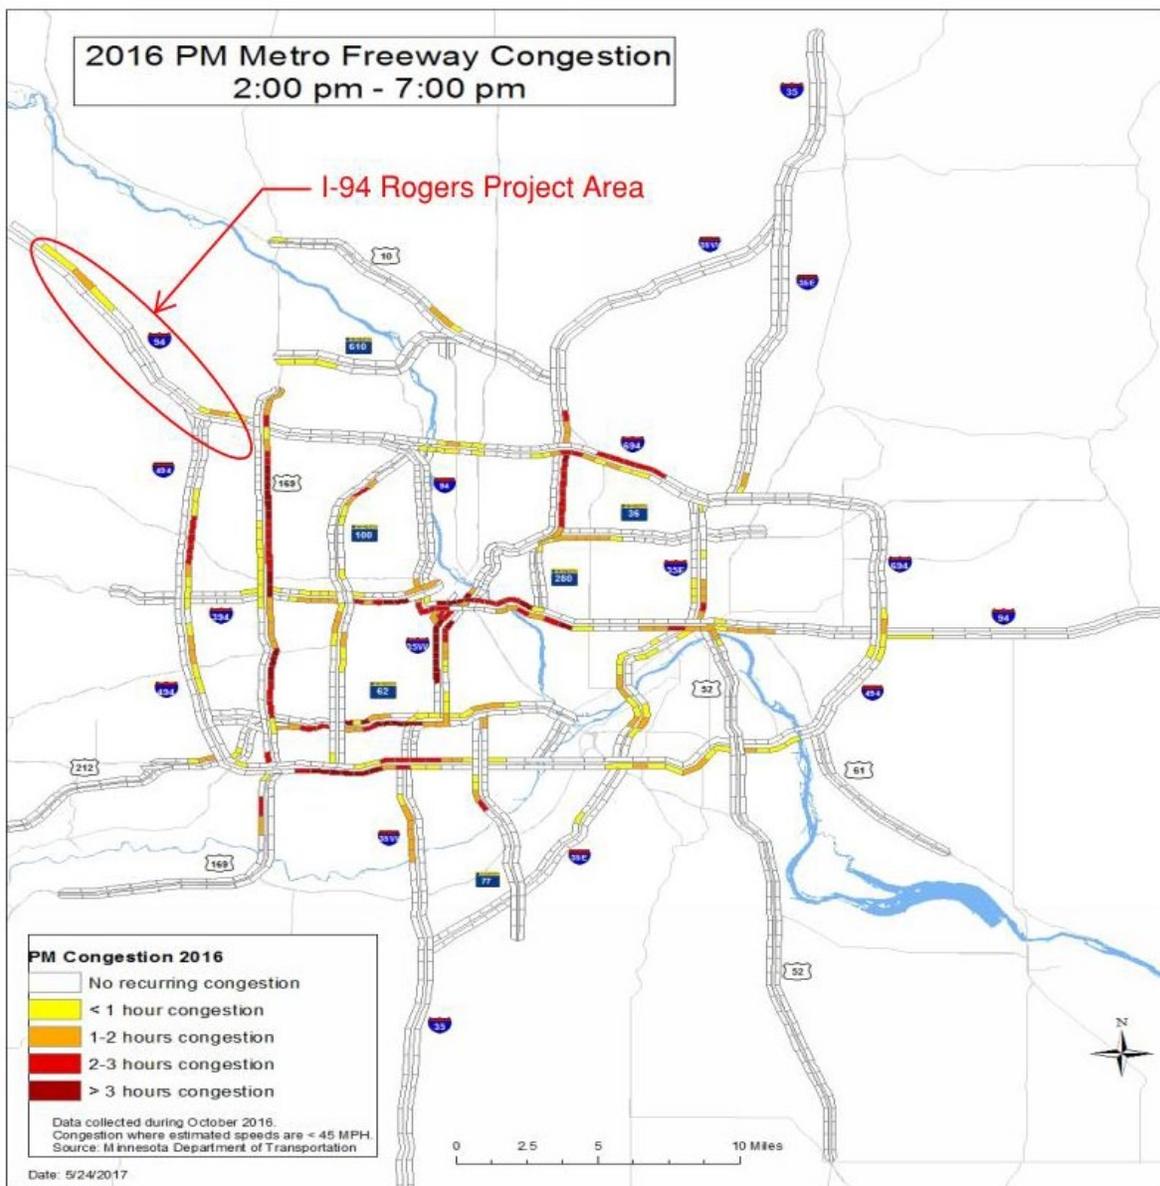
Figure 9: 2016 Metro Freeway Congestion (PM)⁵

In the AM peak period (5:00 a.m. to 10:00 a.m.) congestion in the project area is eastbound. There are one to two hours of congestion from approximately TH 101 to Maple Grove Parkway, and two to three hours of congestion east to the eastern limits of the project.

In the PM peak period (2:00 p.m. to 7:00 p.m.) congestion in the project area is westbound. There are up to two hours of congestion in the area between approximately TH 101 and CSAH 81.

The evening peak period maps from the 2016 and 2017 *Metropolitan Freeway System Congestion Reports* are included in **Figures 9** and **10**.

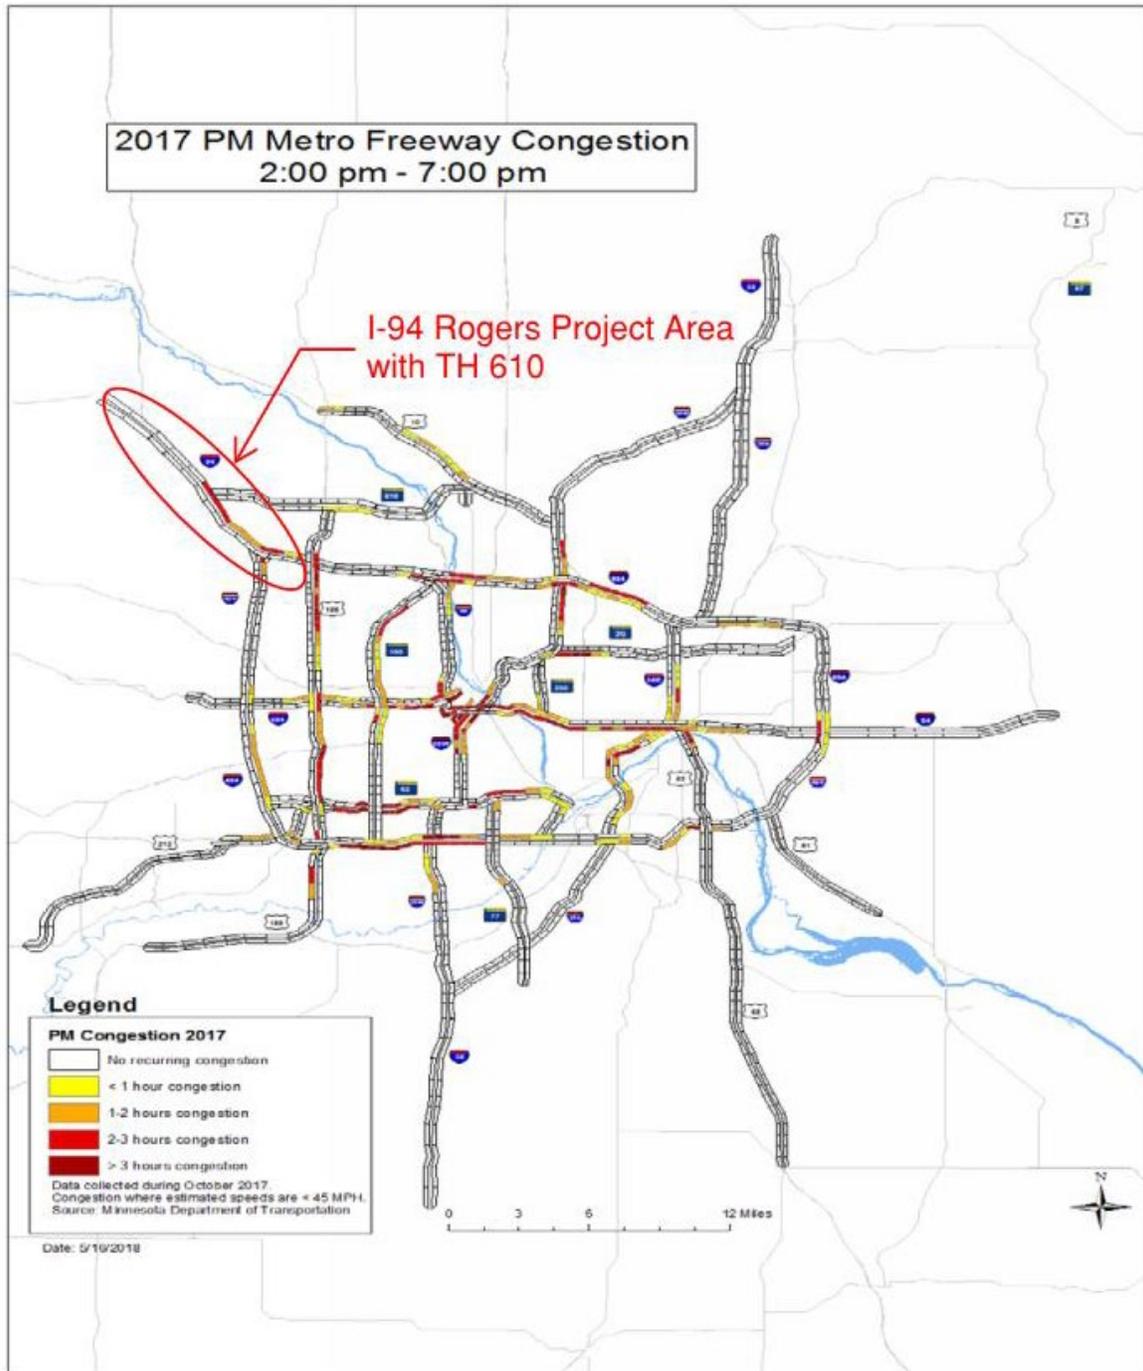
Figure 10: 2017 Metro Freeway Congestion (PM)⁶

In 2017, the AM peak period congestion was similar to 2016. There are from less than one to two hours of congestion from approximately TH 101 the eastern limits of the project.

In 2017, with the addition of the TH 610 partial interchange, the PM peak period congestion worsened in the project area in the westbound direction. There are up to three hours of congestion. The congestion is first experienced by motorists as far east as the junction between I-94 and I-494/I-694 and continues to beyond the point where traffic from TH 610 enters I-94.

Based on this analysis, Performance Criteria 1 of the TH 610 IAR is met, as there are over two hours of congestion indicated immediately upstream of the merge point for westbound I-94 and TH 610. The comparison between 2016 and 2017 further indicates that the TH 610 merge is the cause for congestion at this location.

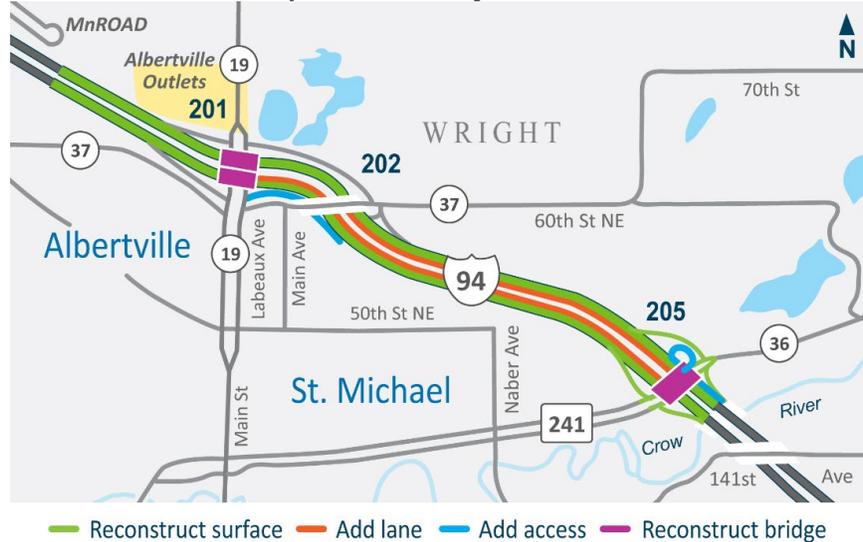
Figure 13: Planned I-94 Improvement Project from Albertville to St. Michael¹²

MnDOT has identified a future project to improve I-94 from TH 241 in St. Michael (approximately 2.7 miles west of the project area) to just west of Wright County Road 19 in Albertville. As shown in **Figure 13**, this project includes pavement reconstruction, an additional lane on eastbound I-94 from County Road (CR) 13 to TH 241 and on westbound I-94 from CR 37 to TH 241, bridge reconstruction, a new eastbound access to I-94 between CR 19 and CR 37, a new access loop ramp from westbound I-94 to southbound TH 241, and drainage improvements along the corridor. The project is intended to improve the capacity of the interstate by adding a third lane in each direction and making interchange improvements at TH 241, CR 37, and CR 19. By providing additional capacity through this area, additional pressure will be placed on the bottlenecks and congested areas that are present within the project area.

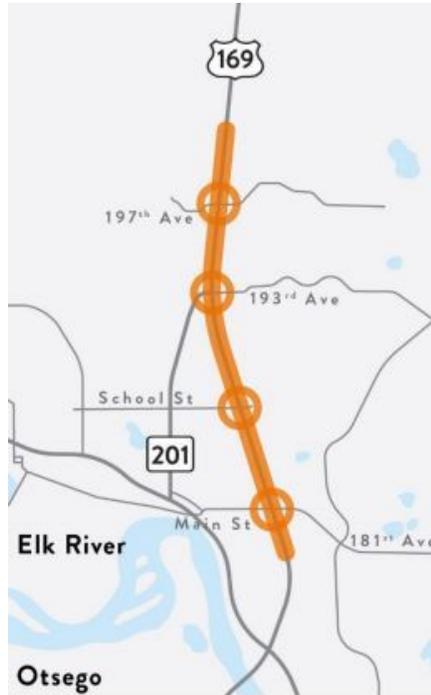
Figure 14: Planned Highway 169 Redefine Project in Elk River¹³

The second project is the Highway 169 Redefine, which is a planned freeway conversion along TH 169 in Elk River. This proposed project will construct new interchanges at Main Street and School Street, 193rd Avenue, and a partial interchange at 197th Avenue (see **Figure 14**). By converting this segment of TH 169 from an expressway to a freeway, additional capacity will be provided along TH 169, which provides a north-south connection to TH 101 approximately six miles north of the project area. Therefore, this project is also anticipated to result in increased traffic along TH 101 and I-94 within the project area.

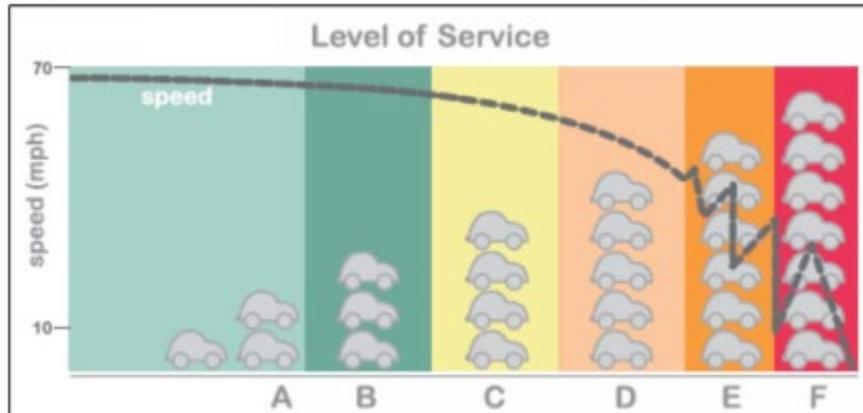
Figure 11: Freeway Traffic Flow Characteristics by Level of Service

Another method to measure congestion and mobility along I-94 is by roadway Level of Service (LOS). LOS is a grading system of A-F used to approximate congestion levels on roadway segments and at intersections. The LOS for freeway segments is based on vehicle density, as measured in vehicles per lane per hour. **Figure 11** illustrates the relationship of LOS A-F in terms of density of vehicles (cars, buses, freight) on the freeway. Vehicle speeds on the freeway can be maintained at higher densities (i.e., LOS C and D); however, as the density increases to LOS E and F, the freeway approaches capacity, speeds start to fluctuate, and traffic breaks down.

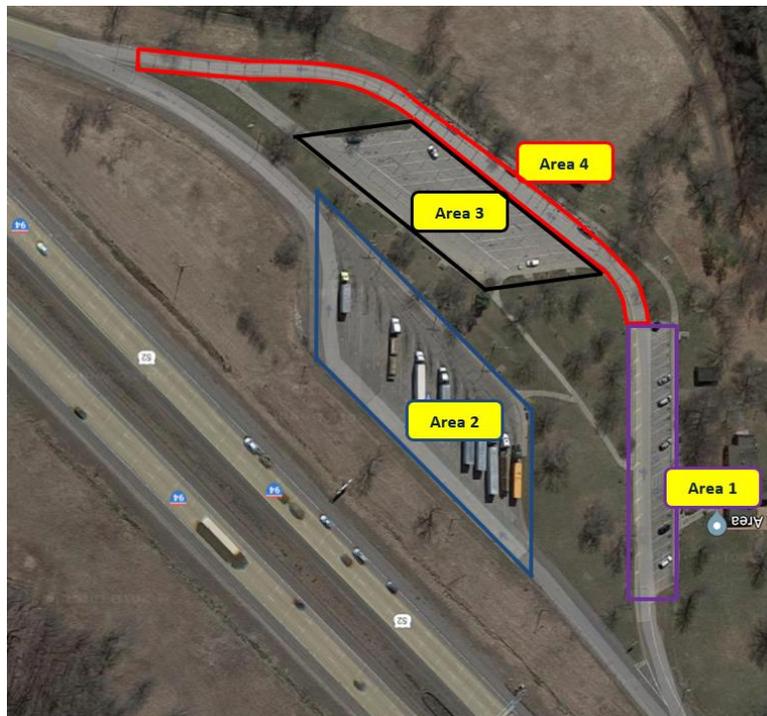
Figure 1 – Areas of pavement evaluated at the Rest Area in Maple Grove

WSB & Associates, Inc. (WSB) was tasked with performing a visual observation of the pavement conditions at the rest area in Maple Grove. Since MnDOT does not rate or collect data on the pavement condition of these rest stops, WSB performed a site visit on April 26, 2018 and documented the condition of the paved areas based on a visual review of the paved areas. Please note, no measurements or distresses/pavement ratings were obtained during this site visit. A summary of the findings is included in this memo along with a map (**Figure 1**) breaking down the areas of the pavement that were investigated. Photos of the areas investigated are included in **Appendix A**.

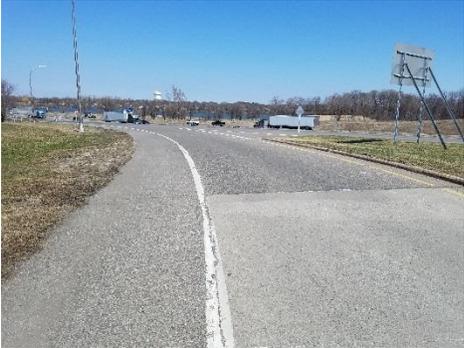
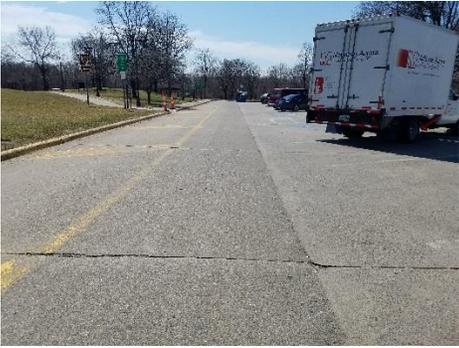
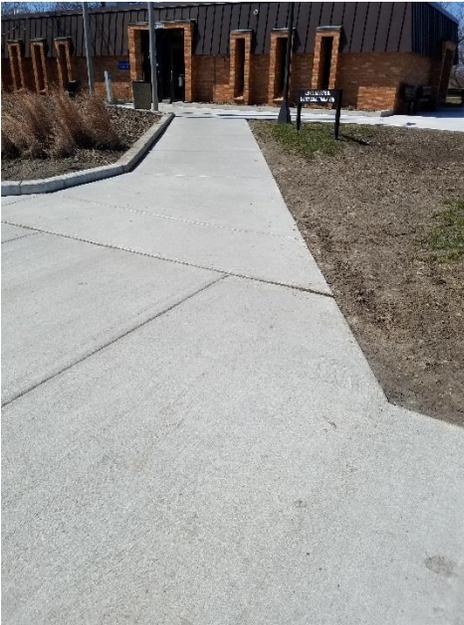
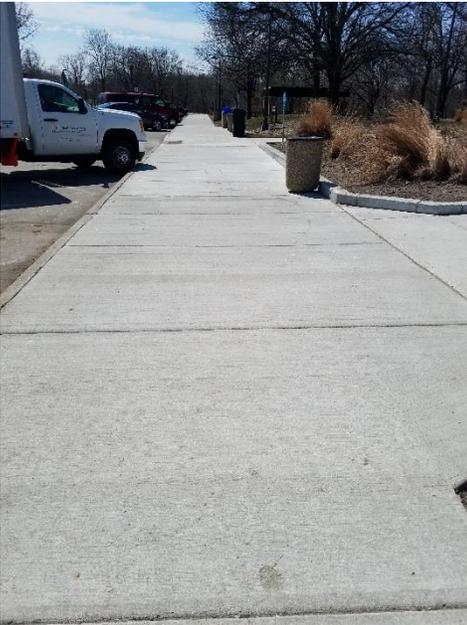
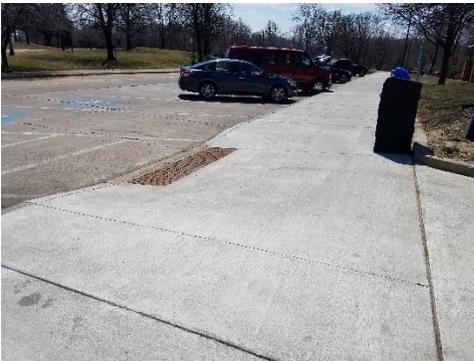
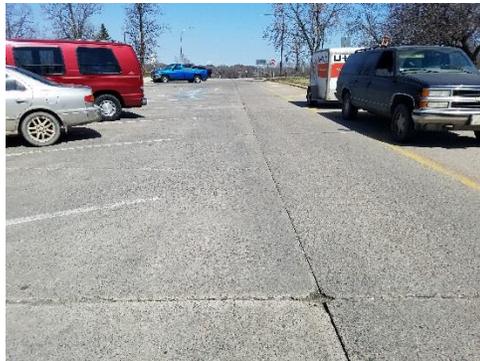
Area 1: Parking Stalls at Visitor Center, On Ramp and Visitor Center Sidewalk

Area 1 included the on ramp to the rest area, the car parking stalls in front of the Visitor Center, the driving lane in front of the Visitor Center, and the sidewalk around the Visitor Center. As can be seen in the photos, the sidewalk is brand new and no distresses were noted. It is believed that this concrete was placed in 2017. It is worth noting that it does not appear that all the concrete curb was replaced at this time, only part of the curb looked new. Of the remainder of the parking areas in this rest stop, Area 1 was in the best condition. As can be seen in the photos, there were areas of moderate to severe spalling at the joints. There were also areas of severe longitudinal cracking. It appeared that a few slabs had already been replaced in this area likely due to more severe repairs being needed in the past. A few of the slabs contained areas of popouts likely caused by weathering of the aggregate.

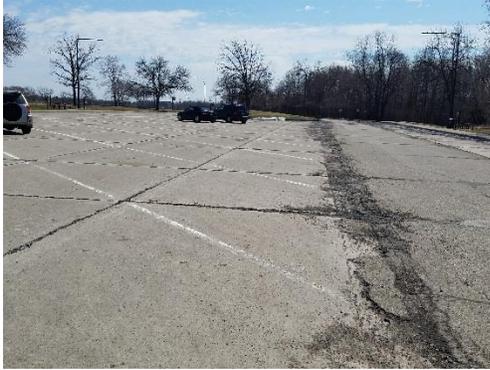
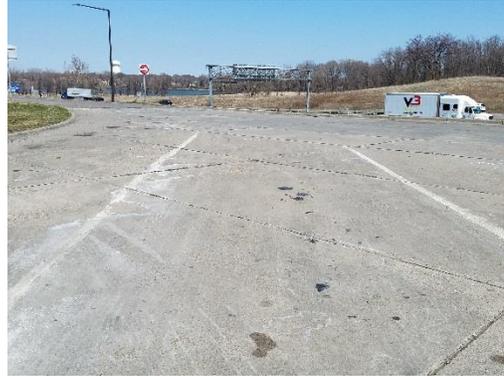
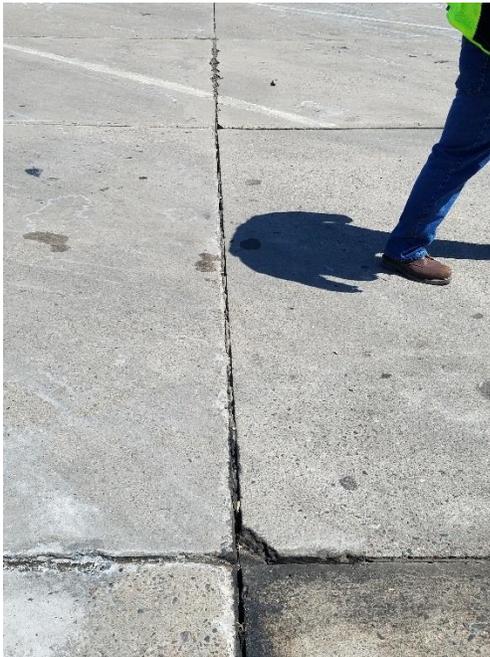
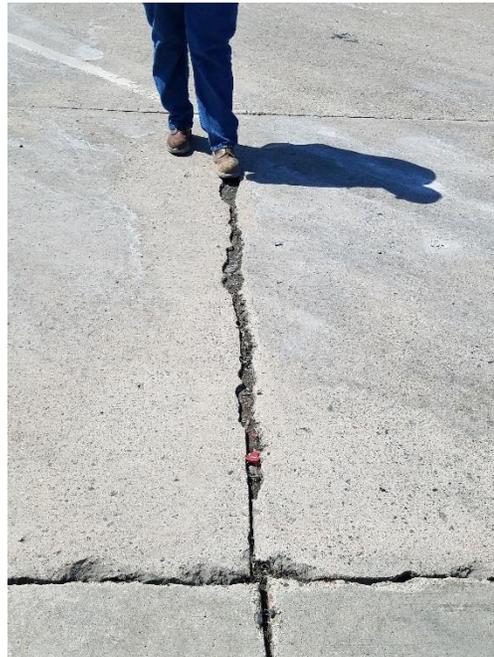
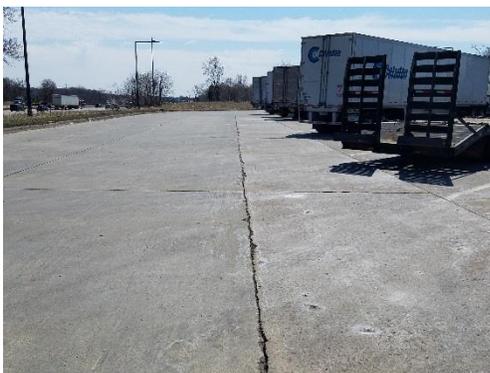
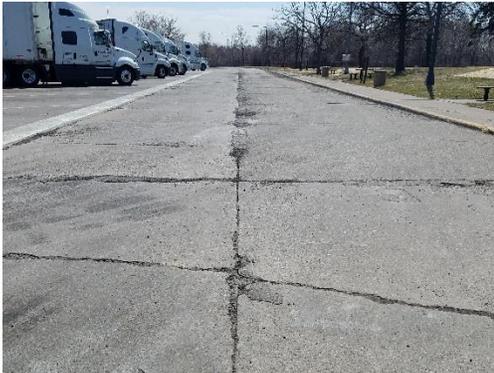
Area 2: Truck Parking Lot

Area 2 included the semi-truck parking stalls. If we were to prioritize the four areas evaluated, this was the second best. That does not mean that severe distresses were not identified. There was faulting from half an inch to an inch in places. It is our belief that these are undoweled concrete slabs, which due to the heavy parked semi-truck traffic can explain some of the distresses noted. It would be recommended to replace these slabs with doweled concrete pavement, designed to withstand the semi-truck traffic and standing point loads these trucks put on the pavement as they park overnight. In addition to the faulting, there were areas of severe spalling and joint deterioration. The driving lane in this area appeared to have been previously overlaid with bituminous. This has since deteriorated and is breaking up into chunks of pavement. The fact that this driving lane has already been overlaid indicates that this is likely the worst of Area 2. The overlay is likely masking some of the other issues that were present before it was overlaid. There was a sidewalk that connects Area 2 and Area 3. The sidewalk was in good condition, minimal distresses noted.

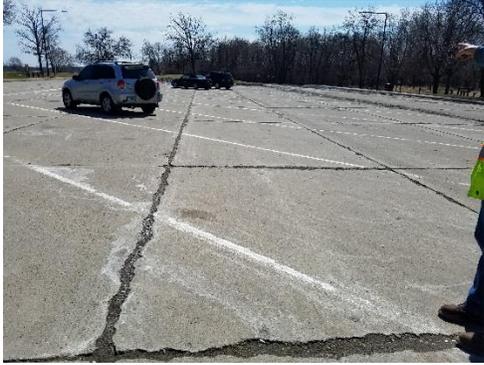
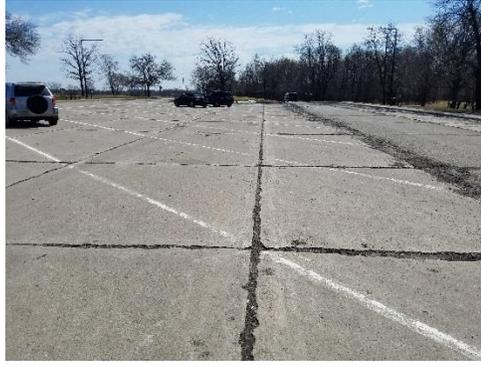
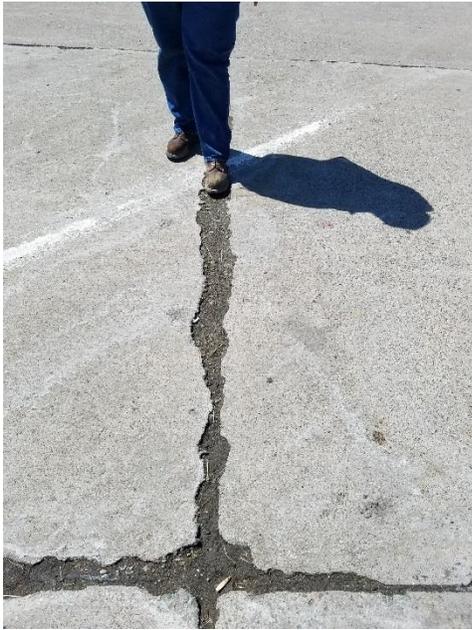
Area 3: Mixed Use Car and Truck Parking Lot

Area 3 included the mixed-use car and semi-truck parking stalls past the Visitor Center. This was tied for the worst of the four areas along with the driving lane adjacent to these parking stalls (Area 4). As can be seen in the photo, every slab in this area had severe joint spalling and deterioration, some were wide enough to fit a shoe (as seen in the photos). The widespread joint failure leads to a very low ride quality index in this area as each bump can be felt as you drive around. Due to the severe distresses present and the widespread poor condition of the pavement, it would be recommended that this area be completely reconstructed.

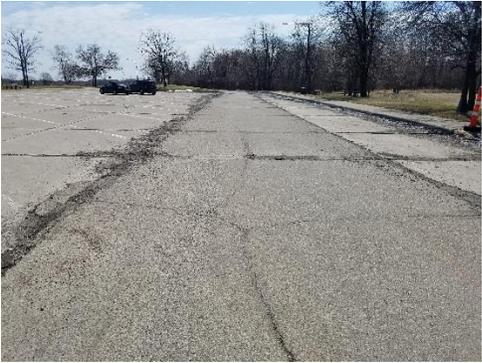
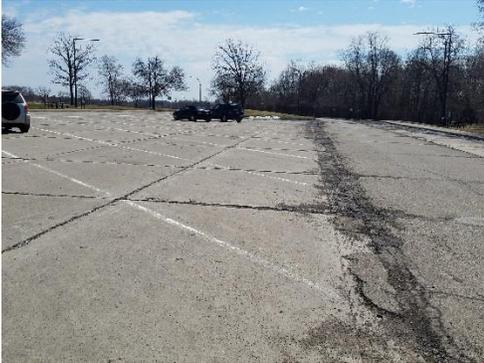
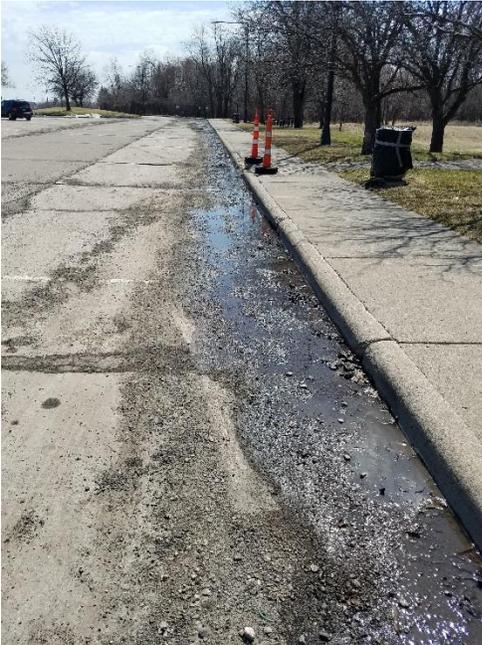
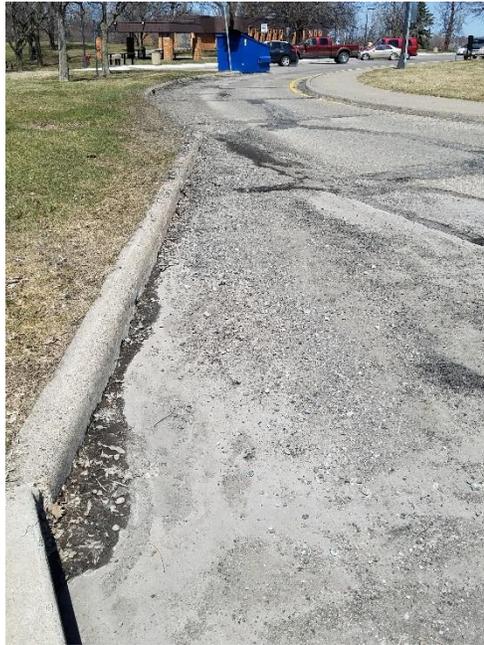
Area 4: Driving Lane for Cars

Area 4 included the driving lane adjacent to the mixed-use car and semi-truck parking stalls. This area was tied with Area 3 as the worst pavement condition at the rest area. It appeared that at one point there had been an attempt to fix this area with a bituminous overlay. This overlay has since deteriorated past the point of repair. There was severe cracking present. The curb along this driving lane was in poor condition and there was standing water along the curb due to poor drainage. It would be recommended to completely reconstruct this area including replacement of the curb and addressing the drainage issue to drain the water off the pavement.
